# INTERIM REMEDIAL MEASURE WORK PLAN

NYSDEC BCP SITE # C734108

AOC-4, Celi Drive BCP Site  
Town of Dewitt, Onondaga County, New York

December 2022

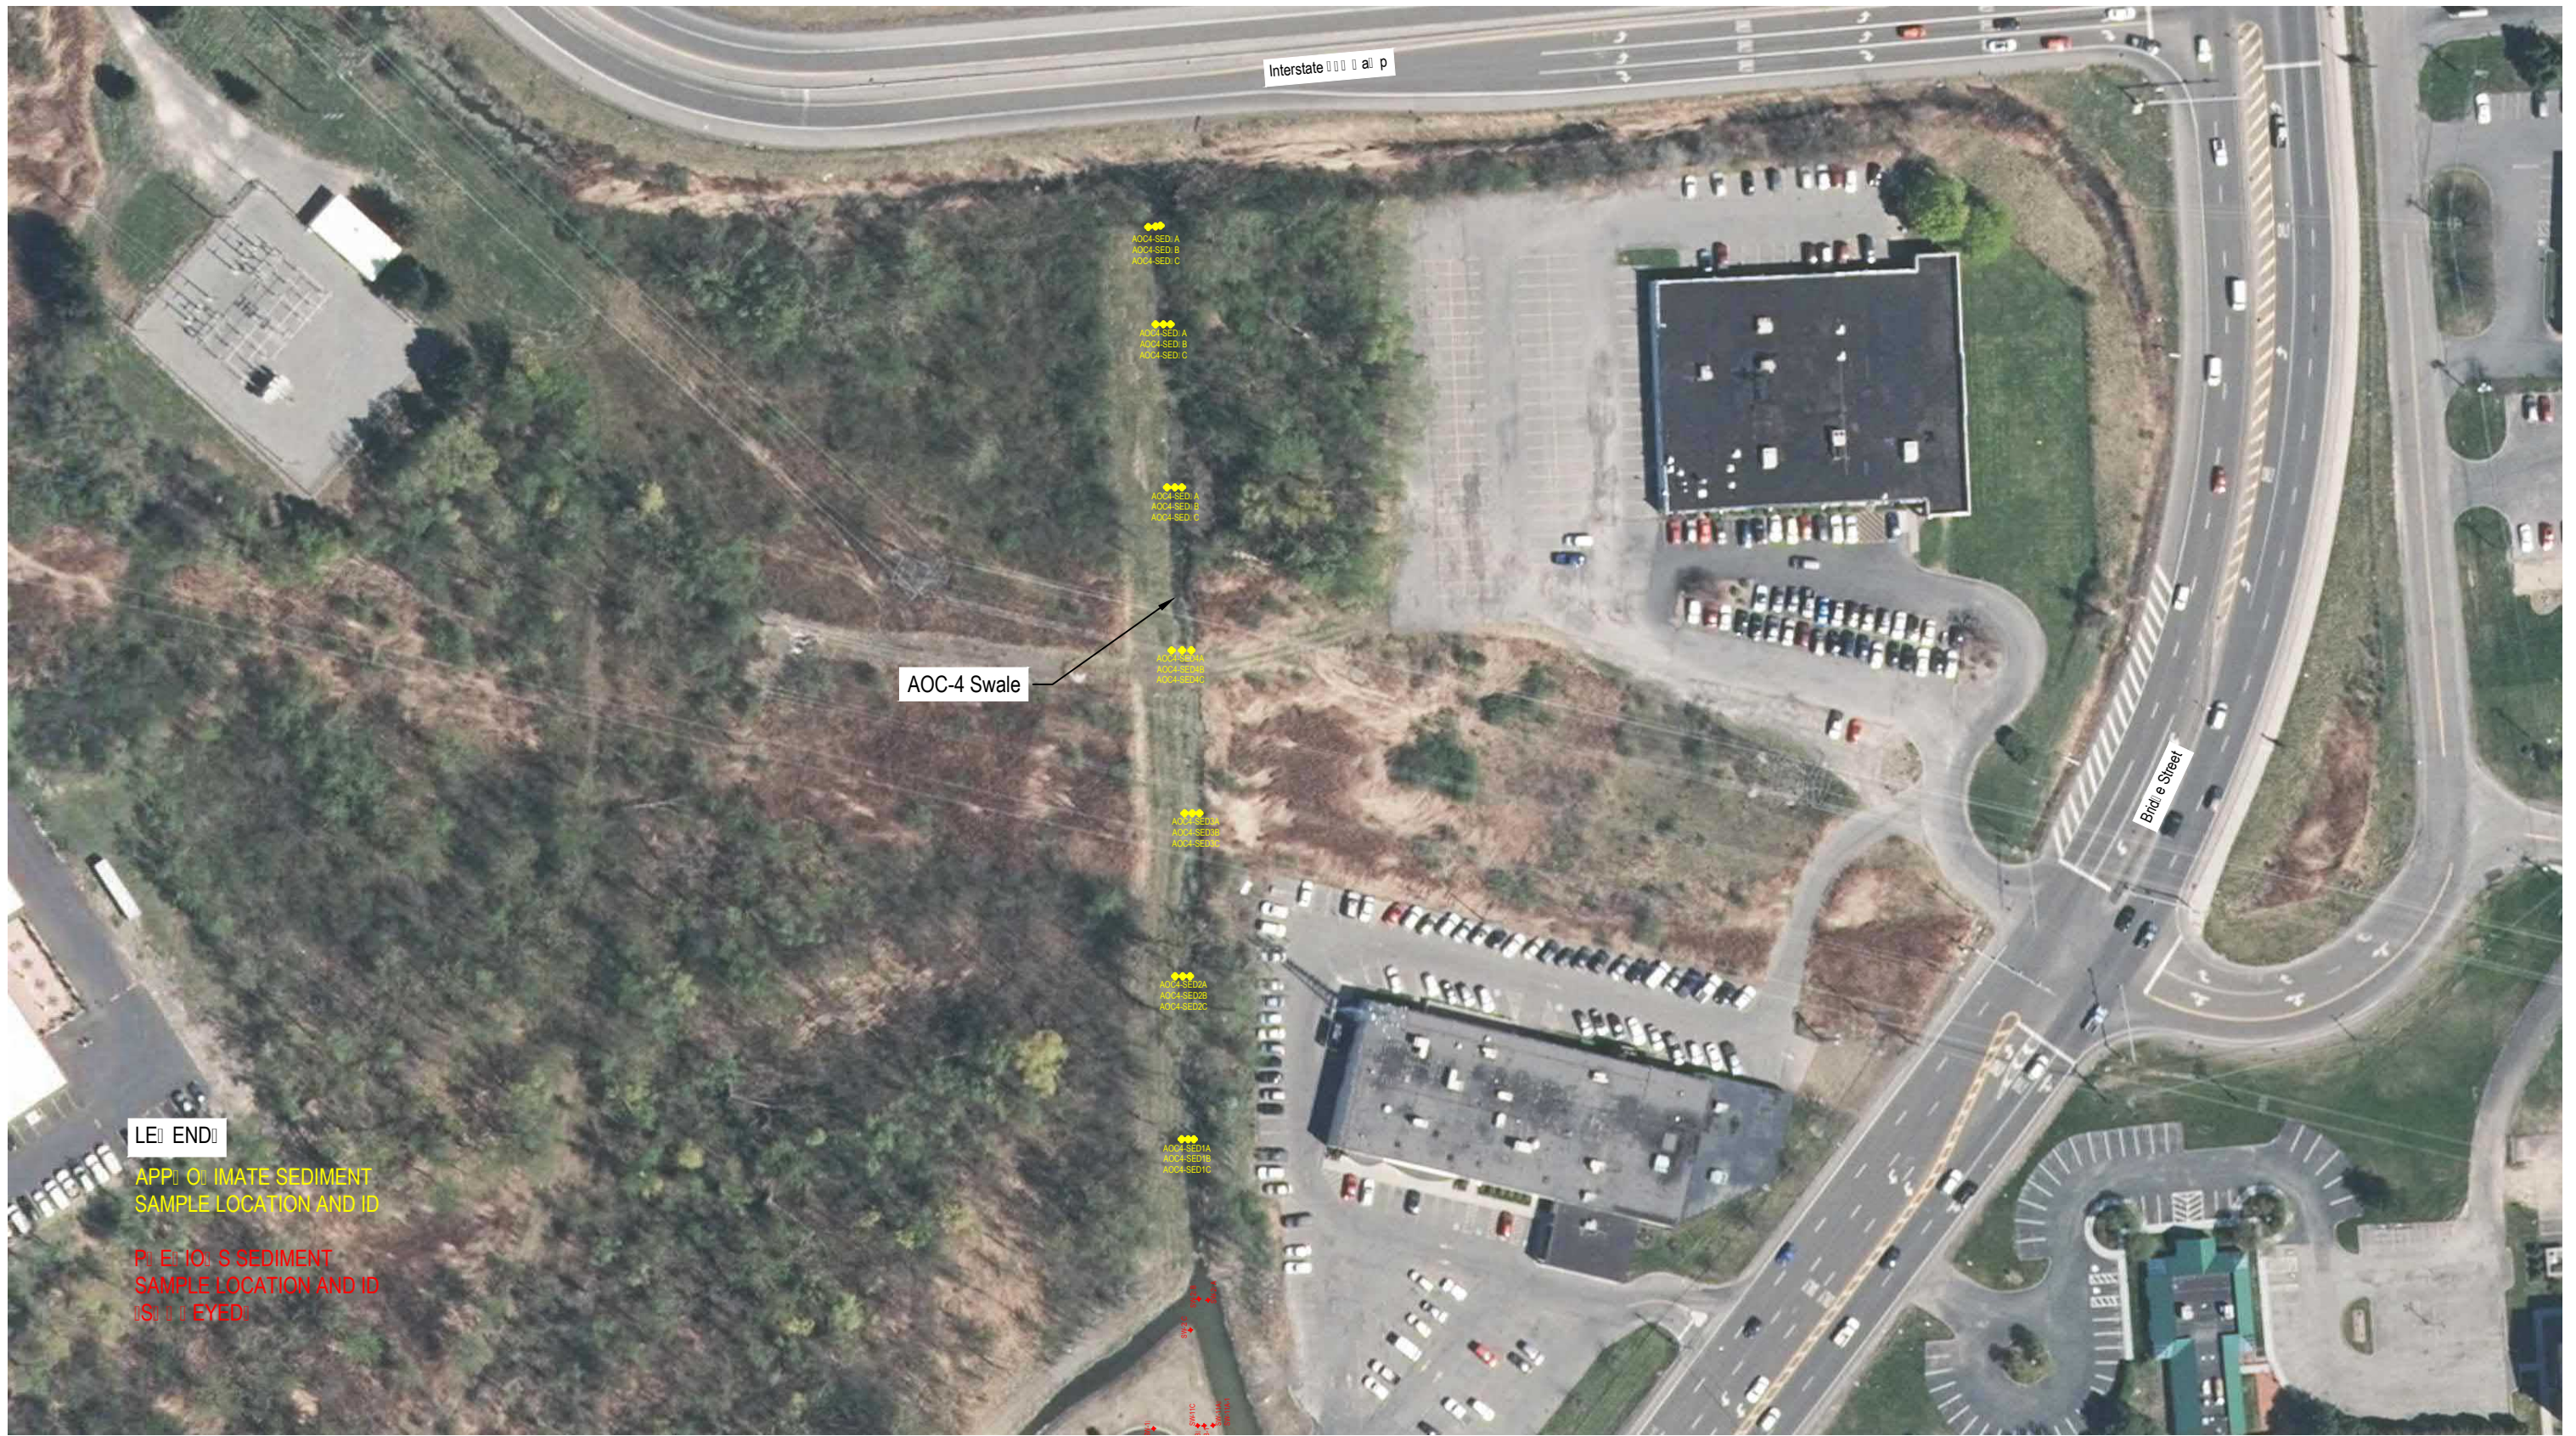
**Figure 5**

APPROXIMATE SEDIMENT  
SAMPLE LOCATION AND ID

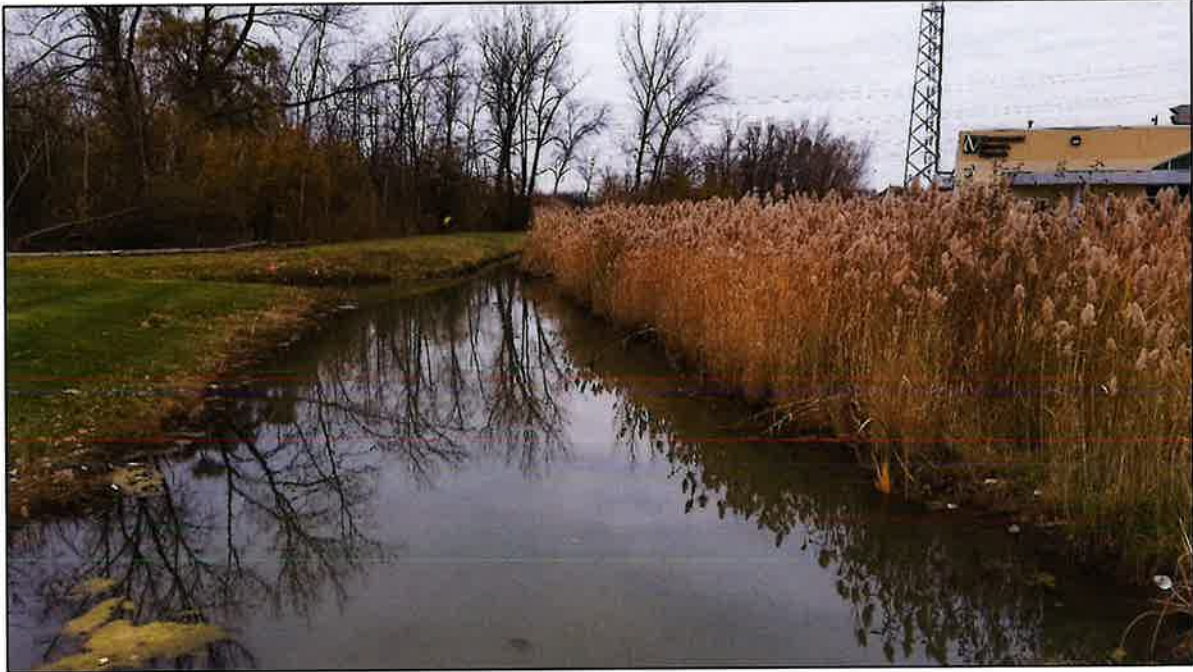
**Photo: 9. Facing N at culvert, flag "GPS BENCH 1" towards swale and PEM in Wetland Complex A (on right) (photo taken 11/14/2017).**

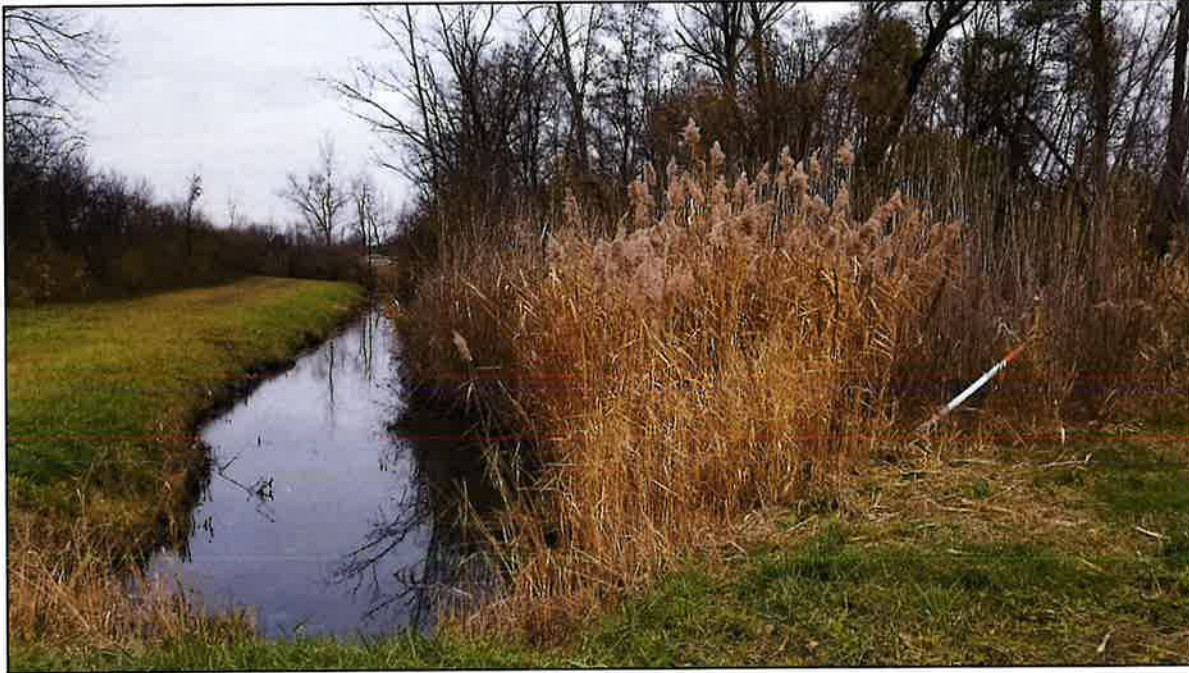
**Photo: 13. Facing N at flag "SWALE 11 CULVERT OPEN" towards access road (on left) and PEM in Wetland Complex A (on right) (photo taken 11/14/2017).**

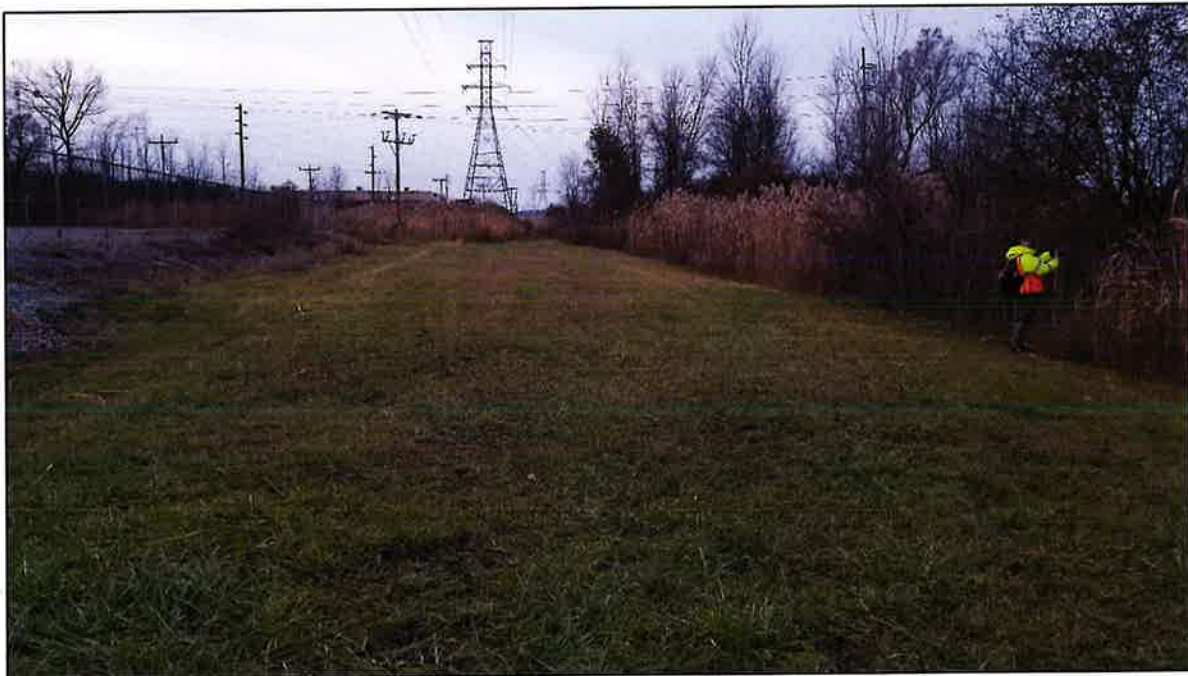
**Photo: 62. Facing W at SP-15 (upland) towards PEM in Wetland Complex A (on right) and electric substation (on left) (photo taken 11/15/2017).**

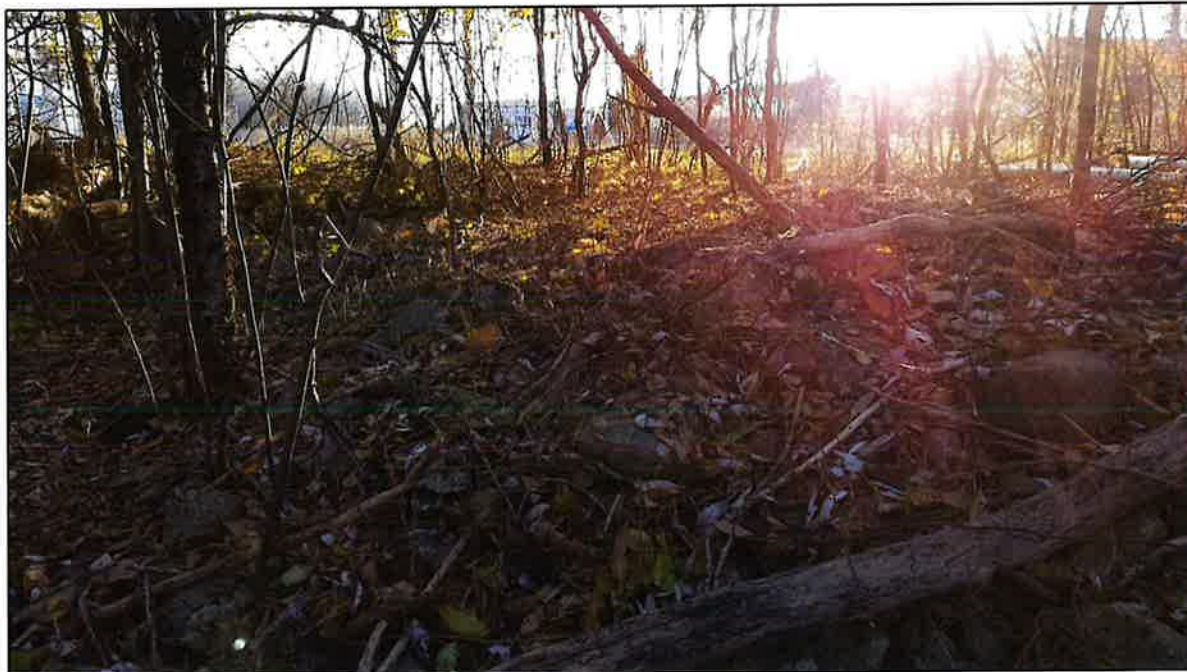
**Photo: 64. Facing E at flag “WL A 1711” towards uplands (photo taken 11/15/2017).**

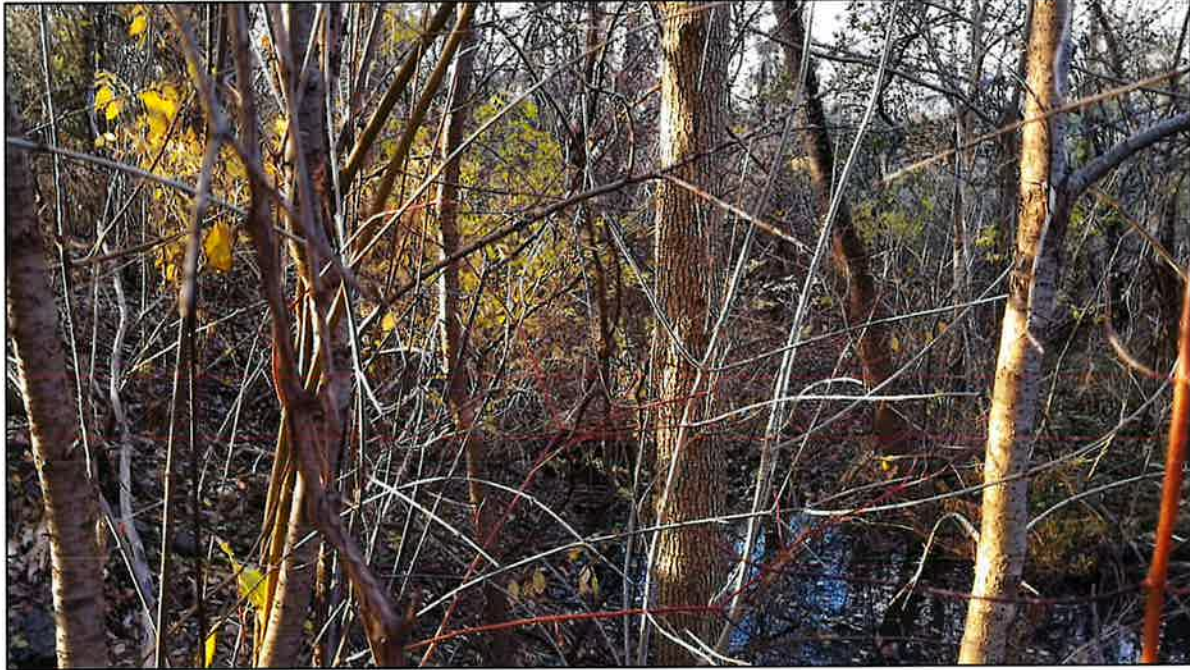
**Photo: 65. Facing S at flag “WL A 1711” towards uplands (on left) and swale (on right) (photo taken 11/15/2017).**

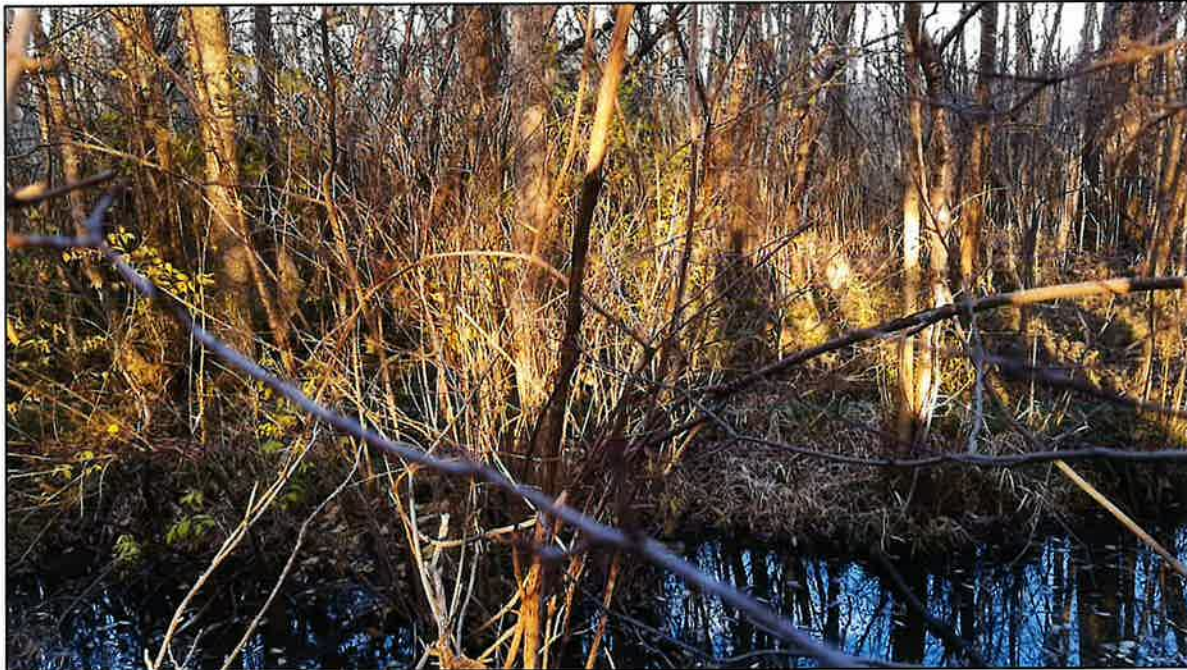
**Photo: 66. Facing W at flag “WL A 1711” towards swale (in foreground) study area boundary (in background) (photo taken 11/15/2017).**
