Syracuse Label Company, Inc.

110 Luther Avenue BCP Site (BCP Site #C734118)

Periodic Review Report - March 17, 2014 - March 17, 2015

April 13, 2015

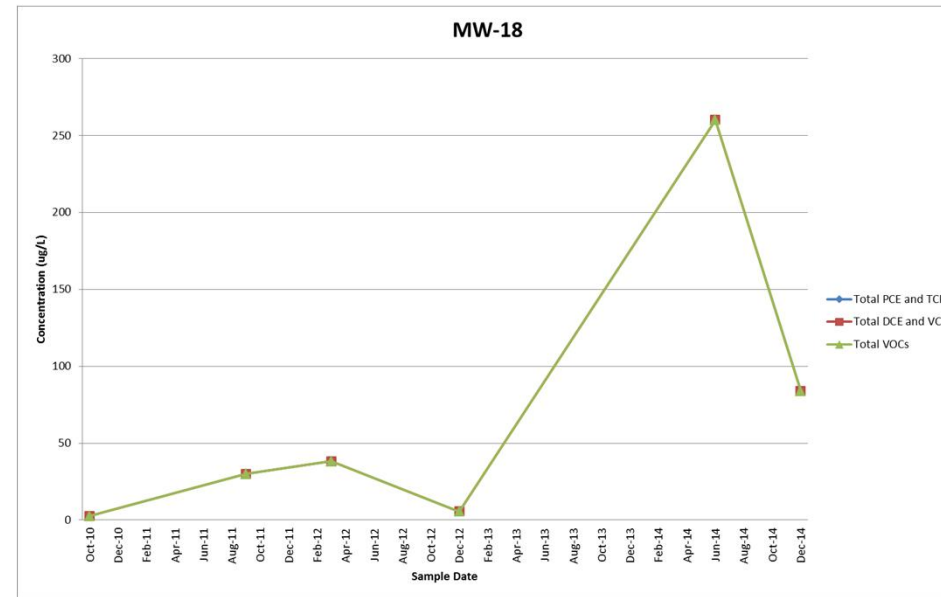
Job Number | 86-14941
 Revision | A
 Date | 04.01.2015
Figure 6

Syracuse Label Company, Inc.
 Periodic Review Report for BCP Site #C734118
 March 17, 2014 to March 17, 2015
Groundwater Data Time Series Plots

Concentrations of cis-DCE and VC showed a sharp increase in most wells sampled following implementation of the pre-COC groundwater remedy (Table 2). The increases observed for cis-DCE and VC were expected as a result of the sequential degradation resulting from groundwater remediation efforts, which are degrading PCE and TCE into cis-DCE and VC. The concentrations of cis-DCE and VC have generally shown a decreasing trend following the implementation of the corrective measures (Table 2 and Figure 6). Laboratory analytical results of samples taken from MW-13 indicate that PCE and TCE have decreased to concentrations below laboratory detection limits; however, the concentrations of cis-DCE and VC have increased following injections due to sequential degradation of PCE and TCE. Since this was the most recent (during corrective measures activities) area in which injections occurred, it is anticipated that the concentrations of cis-DCE and VC would currently be elevated. Trends in laboratory analytical results of samples taken from MW-13 will continue to be evaluated to determine if a decreasing trend is identified for cis-DCE and VC.
