**CONSTRUCTION COMPLETION REPORT
REVISION 2**

BMS Syracuse Facility Transformation Project

**Bristol-Myers Squibb Company
East Syracuse, NY**

October 2018

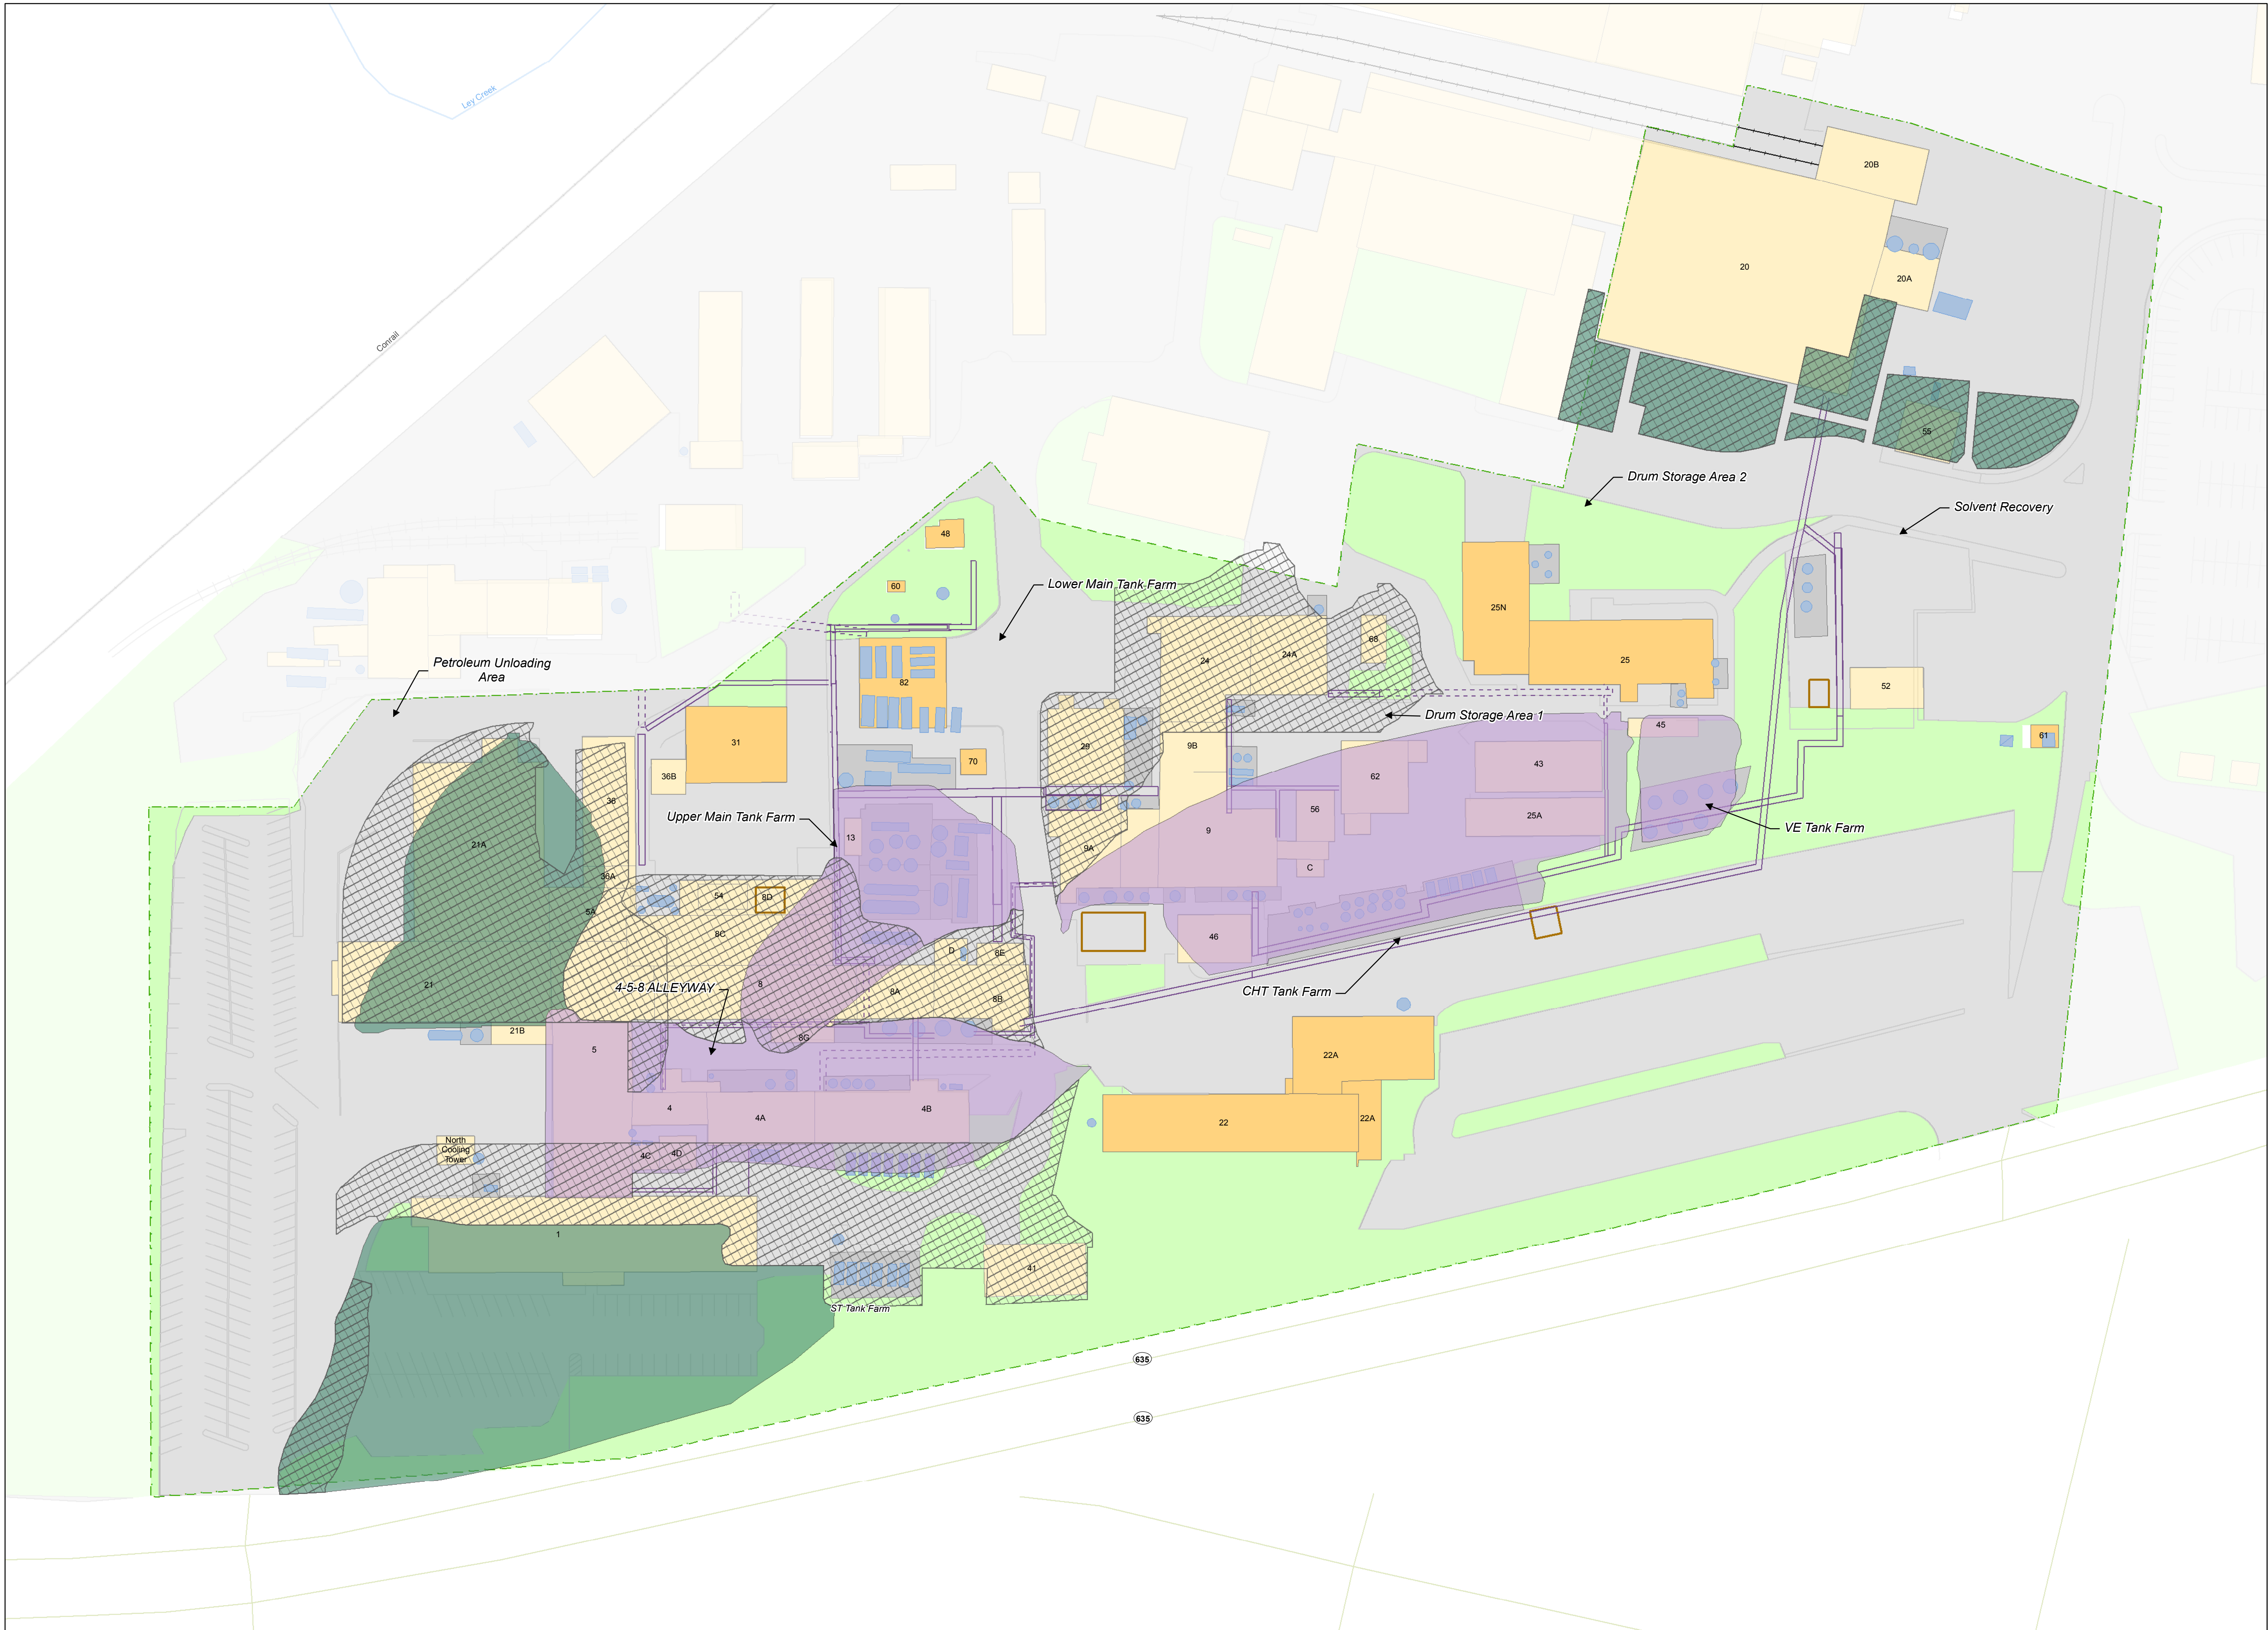
- LEGEND
- PIPERACK
 - PIPE TUNNEL / PIPE CHASE
 - PIPERACK ABOVE PIPE TUNNEL
 - TRANSFORMER AREA
 - EXTERIOR TANK LOCATIONS
 - SECONDARY CONTAINMENT
 - BMS STRUCTURES REMAINING
 - BMS STRUCTURES DEMOLISHED BY TRANSFORMATION
 - BMS FILL FROM FULTON YARD
 - FILL FROM H.W. SMITH SCHOOLS PROJECT
 - FILL FROM ST. JOSEPH'S HOSPITAL PROJECT
 - BDA BOUNDARY
 - GRASS/LANDSCAPE
 - PAVEMENT

Subsurface pipe chases were identified at two locations as shown on Figure 3-1. One pipe chase ran from Building 4 complex, beneath Building 8, to the Upper Main Tank Farm (UMTF). The second pipe chase ran from Building 8 to Building 9. The pipe chases were constructed as shallow, below-grade concrete channels with steel or wooden covers for access. Following removal of the piping, the concrete was broken up and left in place.
