## PHASE I ENVIRONMENTAL SITE ASSESSMENT REPORT

### **Widewaters Syracuse - Vacant Land**

5840 Bridge Street - Not Actual Address East Syracuse, New York 13057

Partner Project No. 21-323758.1

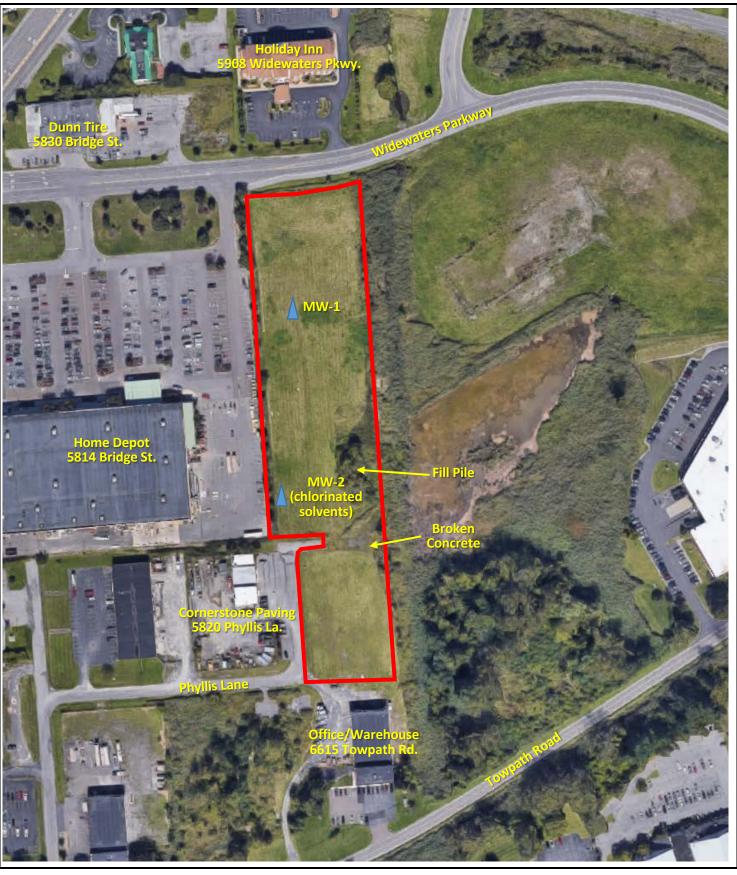
GROUNDWATER FLOW

KEY: Subject Property Monitoring Well

According to topographic map interpretation, the direction of groundwater in the vicinity of the subject property is inferred to flow toward the west-northwest. The nearest surface water in the vicinity of the subject property is Butternut Creek, located approximately 0.8 miles east of the subject property. No settling ponds, lagoons, surface impoundments, wetlands or natural catch basins were observed at the subject property during this assessment.

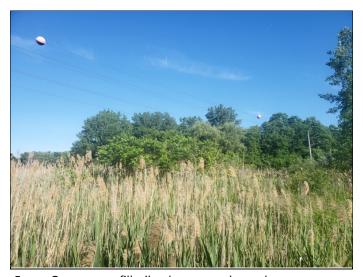
5. Overgrown fill pile along west boundary.

An overgrown fill pile was observed along the east property boundary. The pile appeared to consist of soil. Pieces of broken concrete were observed near the southeast property corner. No signs of petroleum products or hazard materials were observed in these areas.

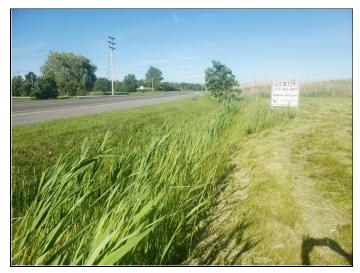
4. Swale along north property boundary, facing east.

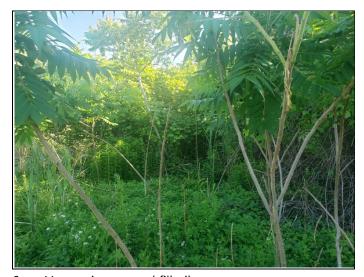
6. Vegetation around fill pile.

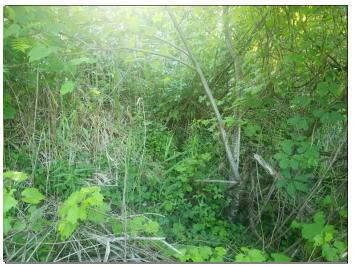
7. Close-up of soil and vegetation at fill pile.

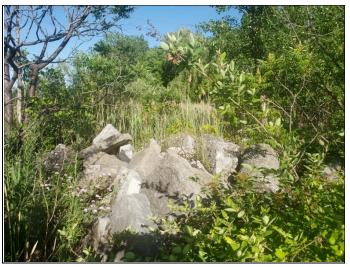
9. Broken concrete along east property boundary.

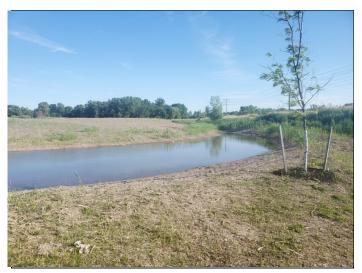
16. East adjoining vacant land and stormwater feature.

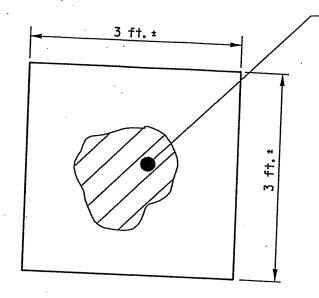
## OIL SPOT 1 = OS-1

DEPTH OF EXCAVATION 6 INCHES

SAMPLE OS-1 COMPOSITE SAMPLE OF BOTTOM PLUS ALL FOUR WALLS

OS-2 NORTH AND WEST SIDES COMPOSITE SAMPLE AT 21/2ft = HEADSPACE ANALYSIS OF CONTAMINATED SOIL RECORDED AT 125ppm. SAMPLES TAKEN FROM LIMITS OF REMEDIAL EXCAVATION WERE 5.5ppm OR LESS.

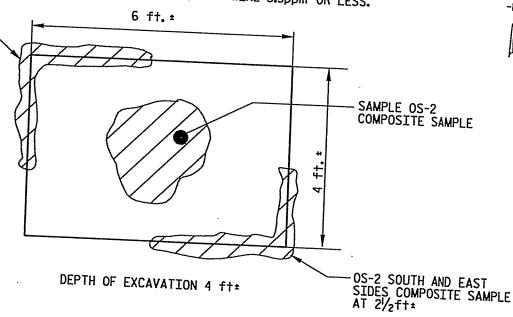
FIGURE 9

SITE REMEDIATION BRIDGE STREET ENTERPRISES DETAIL OF REMEDIATION AREAS

- Contaminated soil was removed from the three areas of concern in early October 1997. These areas were located on the southern third of the property. Post-removal soil testing found TCE below cleanup objectives, and 1,2 dichloroethene slightly above soil cleanup objectives. A total of 77 tons of soil were transported off-site.

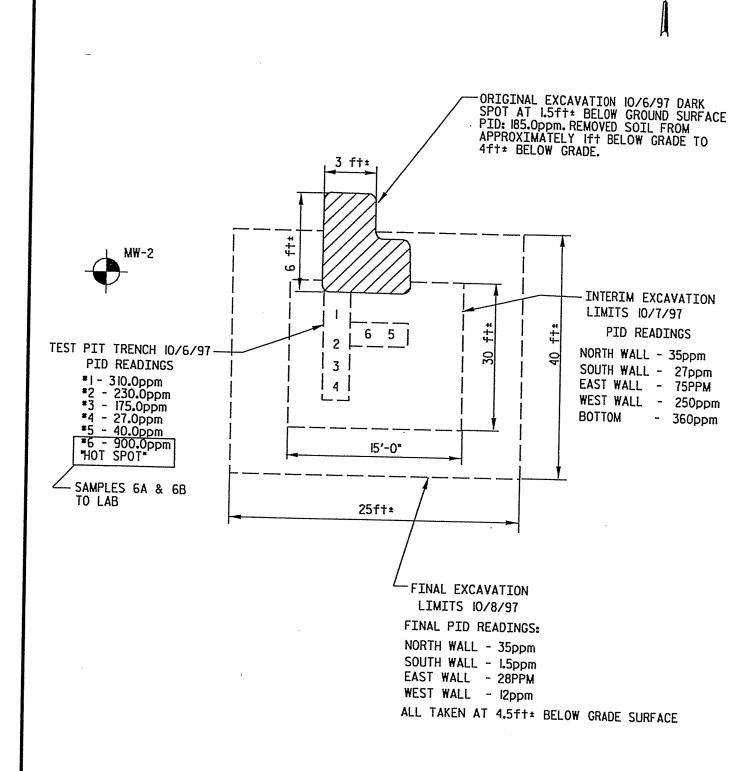
SITE REMEDIATION
BRIDGE STREET ENTERPRISES
DETAIL OF MW-2 REMEDIATION AREA

- Groundwater at MW-2 found exceedances of 1,2 dichloroethene, trichloroethane, and vinyl chloride. Vinyl chloride is also a breakdown product of TCE.
