Re: Salvation Army Site - Limited Phase II ESA  
Services

The following letter report summarizes the findings of O'Brien & Gere Engineers, Inc. (O'Brien & Gere) for the limited Phase II Environmental Site Assessment (ESA) that was conducted at the Salvation Army site located at the corner of South State Street and Burt Street, Syracuse, New York. Reportedly, the subject property is currently owned by the Salvation Army and is used as a clothing distribution center and retail store. In addition, a section of the building is currently used by the Salvation Army for apartments. It is understood that the Syracuse Housing Authority (SHA) is interested in purchasing the subject property to relocate its main office at the site. It is further understood that the relocation would require renovation of the building to meet the needs of the SHA.

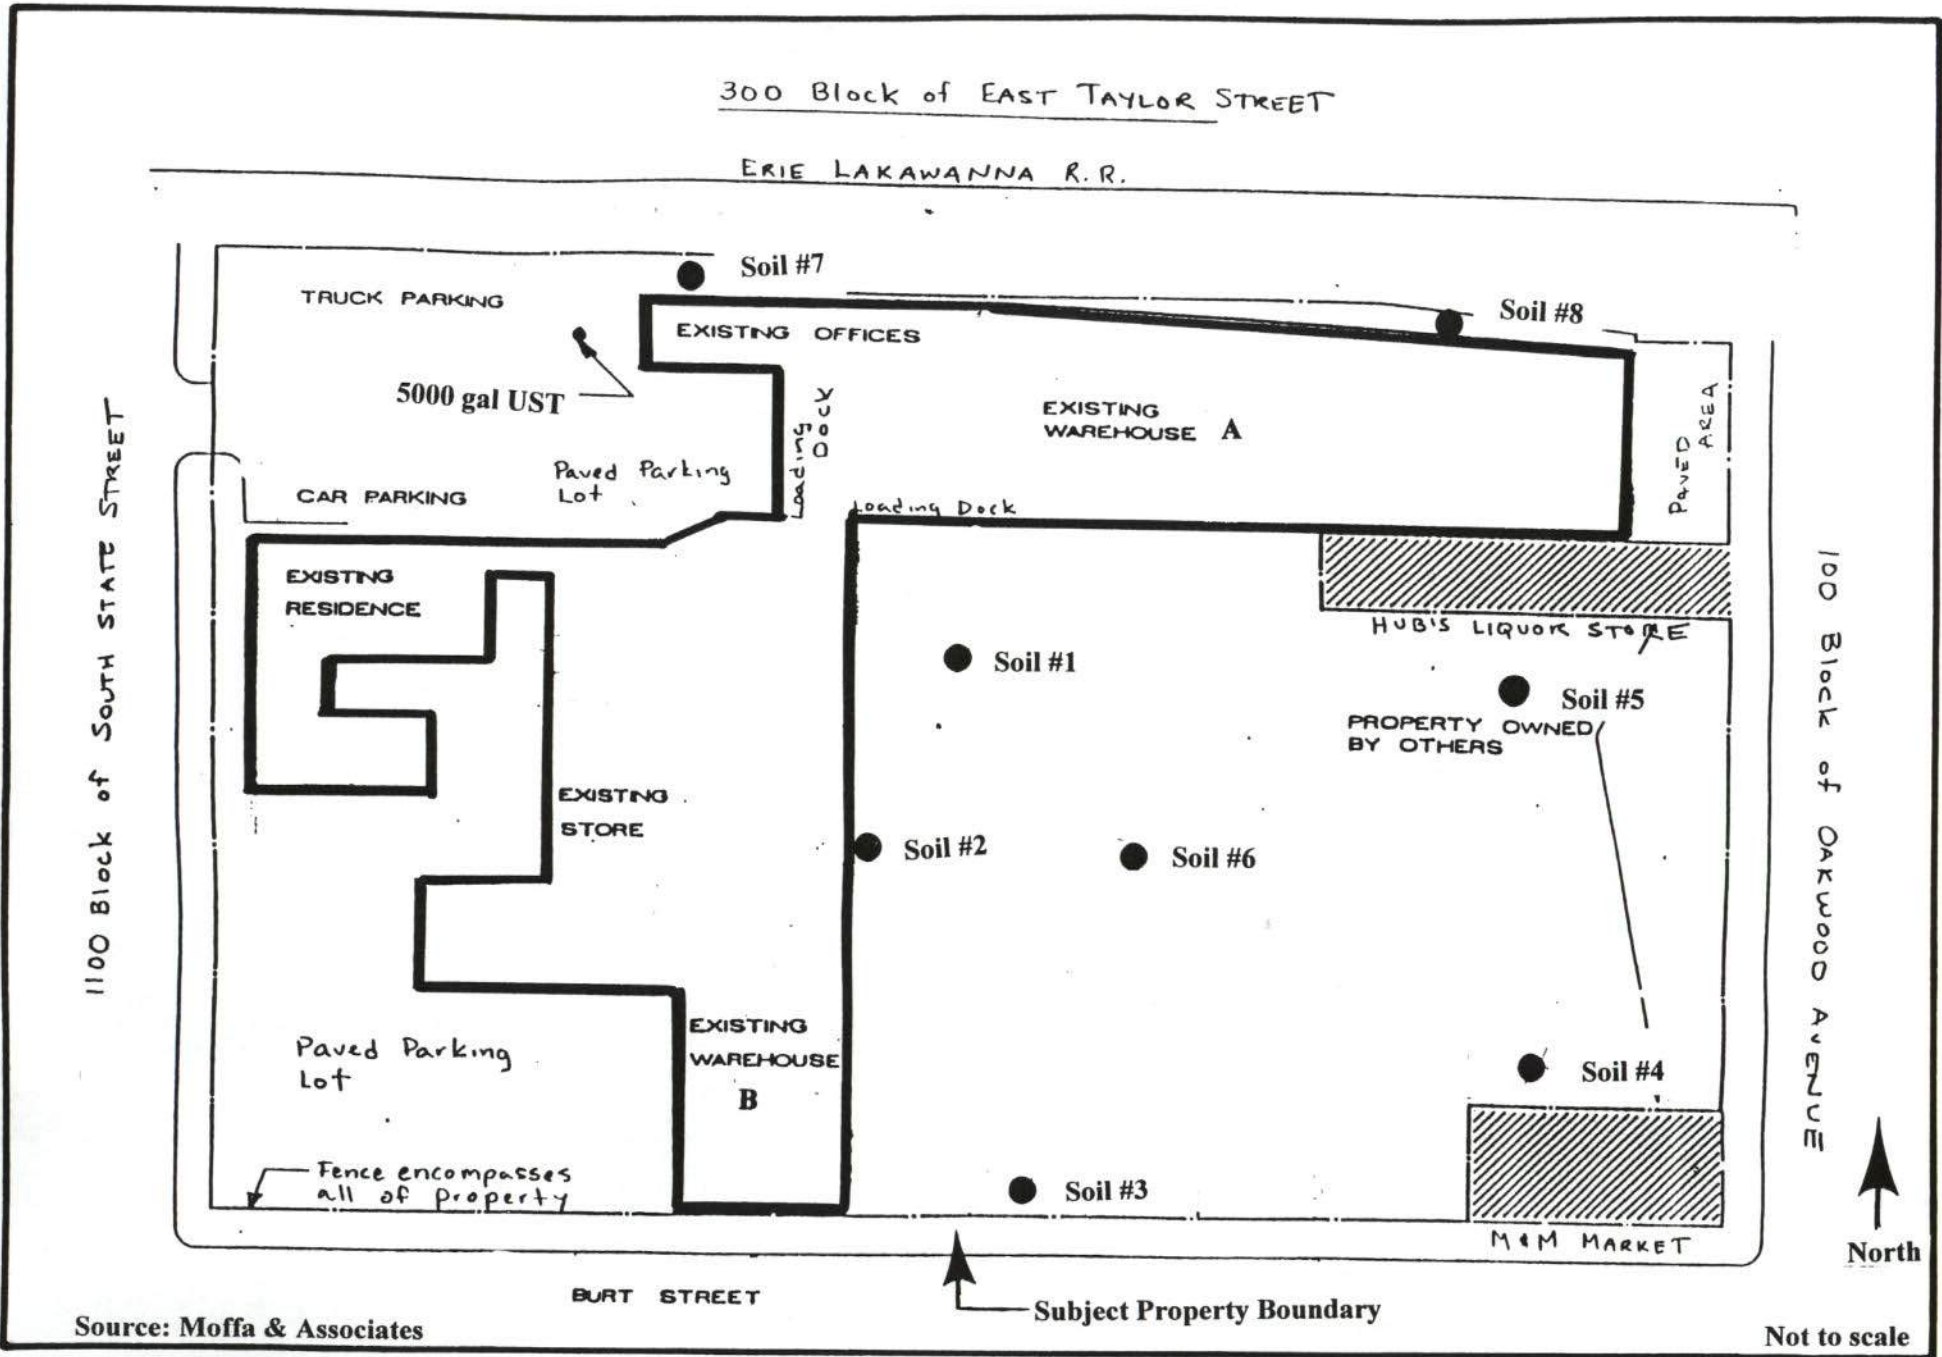
FIGURE 1 - SITE PLAN

The specific sampling locations are illustrated in Figure 1. Based on SHA direction, soil samples from beneath asphalt or buildings were not collected during the Phase II ESA. O'Brien & Gere marked the location of each sampling point with a small flag. The approximate sampling locations are illustrated in Figure 1 and identified as follows:

<u>Sample number</u>	<u>Location</u>	<u>Rational for sampling</u>
1	Paint can pile	Potential paint and solvent releases
2	East side of warehouse B	Potential past storage area
3	South boundary along fence	Potential past storage area
4	Southeast corner	Representative site sample
5	Northeast corner	Representative site sample
6	Center	Representative site sample
7	Northwest side of warehouse A	Potential past storage area
8	Northeast side of warehouse A	Potential past storage area

O'Brien & Gere's review of the above documents indicates that the Salvation Army site is registered with the NYSDEC for one UST. O'Brien & Gere's review of the database report indicates that the tank is a 5000 gallon tank for gasoline and is located in the northwest parking lot (see Figure 1). During the May and October site visits, O'Brien & Gere observed a pump and fill port located in this area. No other appurtenances associated with USTs were observed at the subject property during the O'Brien & Gere site visits.

Due to the presence of various metals and TPH at concentrations greater than NYSDEC cleanup objectives or guidelines, additional sampling is recommended to identify the extent of contamination and to identify whether site remediation is required. Depending on the sampling program, which could range from analyzing individual soil samples to conducting ground water monitoring, costs associated with additional
