REMEDIAL INVESTIGATION WORK PLAN

1153-69 WEST FAYETTE STREET CITY OF SYRACUSE, ONONDAGA COUNTY, NEW YORK

BCP SITE No. C734164

JULY 2024
REVISED NOVEMBER 2024

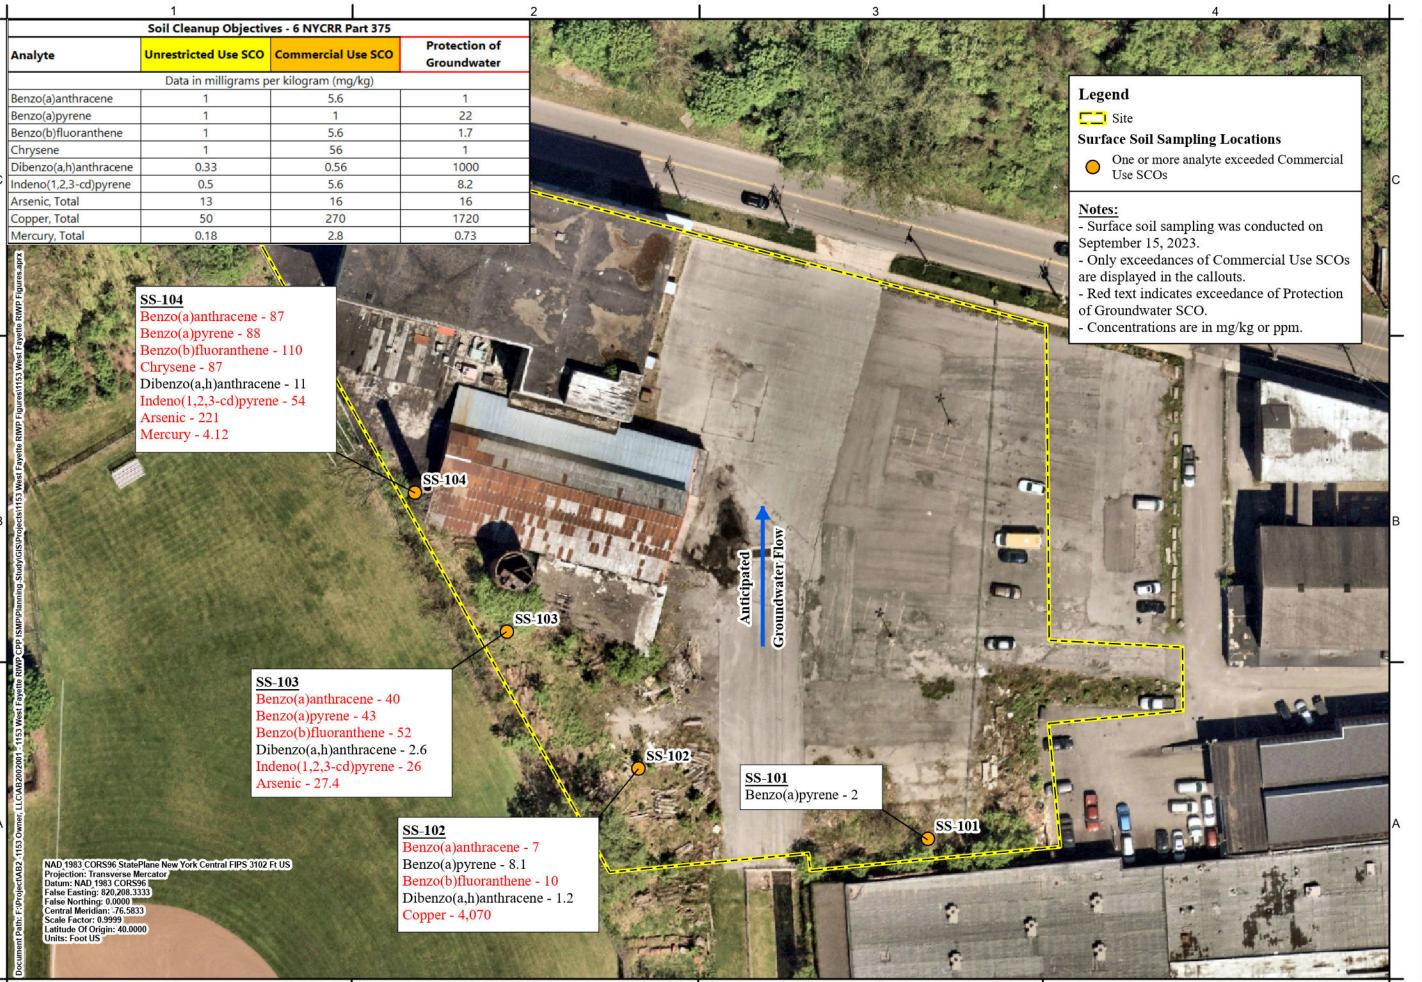
SURFACE SOIL SAMPLING RESULTS

Based on the surface soil investigation, the known contaminants of concern in the surface soil include SVOCs, organochlorine pesticides, PCBs, and metals. Impacts were observed Site-wide in areas not covered by impervious material (i.e., asphalt, buildings, etc.). Multiple SVOCs exceeded Unrestricted or Commercial Use SCOs across the Site. The highest concentrations were observed along the western side of the Site, particularly in the vicinity of the former oil house. 4,4'-DDT concentrations exceeded the Unrestricted Use SCOs at two locations along the western side of the Site, in the vicinity of former rail spurs. PCBs exceeded the Unrestricted Use SCOs at three locations along the western side of the Site. Numerous metals exceeded Unrestricted or Commercial Use SCOs across the Site.

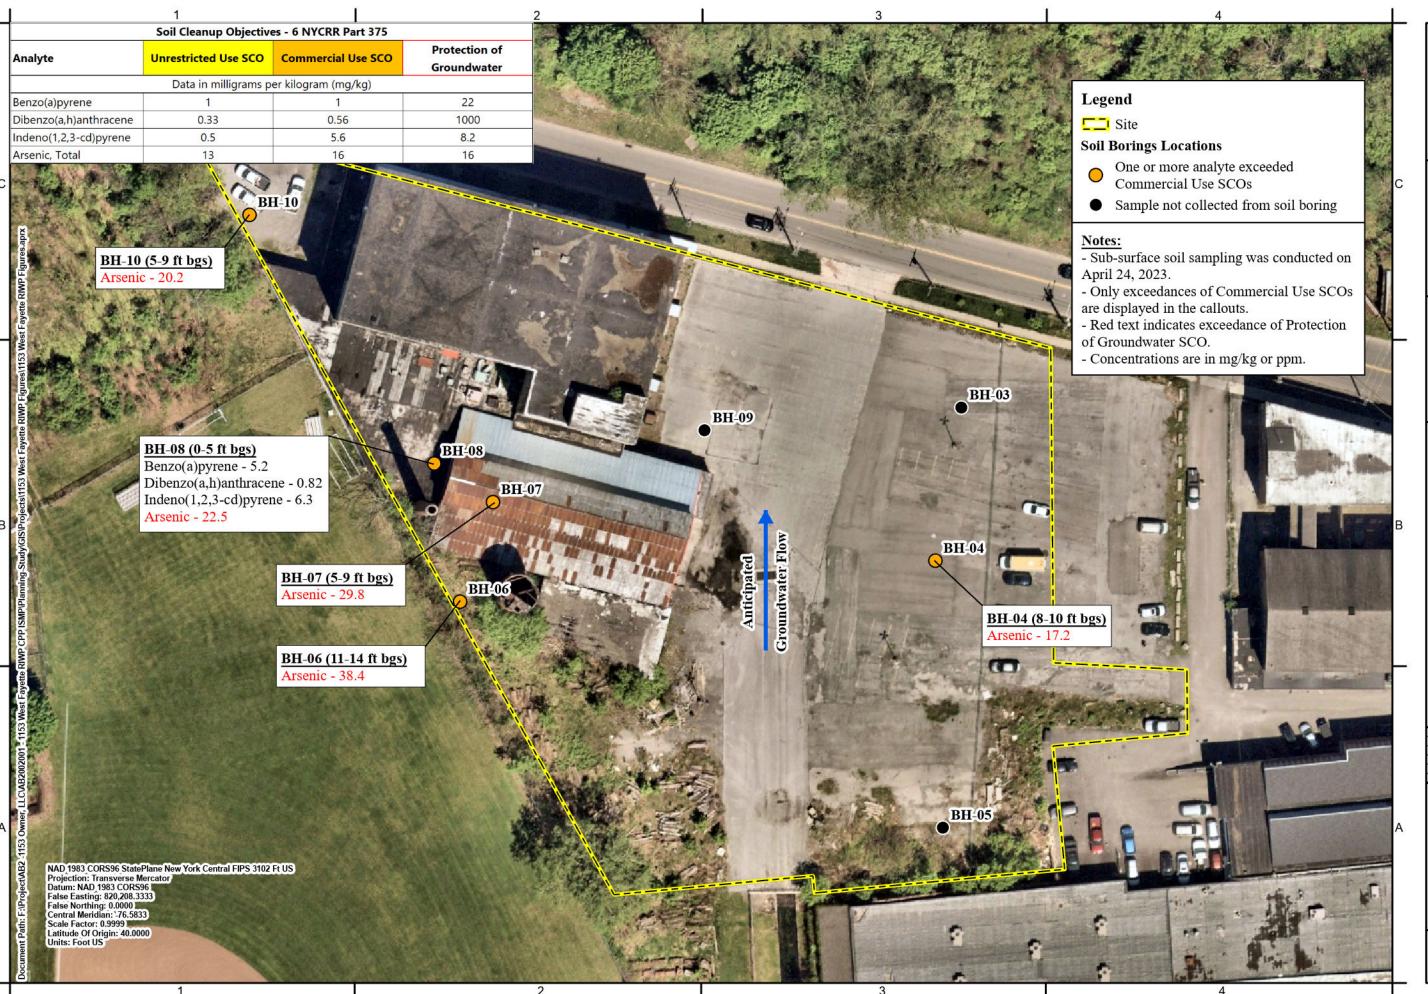
SUB-SURFACE SOIL SAMPLING DATA

Based on the Phase II ESA, the known contaminants of concern in the soil include VOCs, SVOCs, and metals. Impacts are generally within the HFM and in the vicinity of the former oil house and silo, where visual and olfactory evidence of petroleum contamination was observed (Spill No. 23-00933). Multiple SVOCs exceeded Unrestricted or Commercial Use SCOs in the vicinity of the former oil house. Numerous metals exceeded Unrestricted or Commercial Use SCO across the Site. In addition, elevated concentrations of arsenic (above Commercial Use SCOs) were detected in native soil from 11 to 14 feet bgs, in a boring adjacent to the coal silo, and from 8 to 10 feet bgs, in a boring on the east side of the Site.

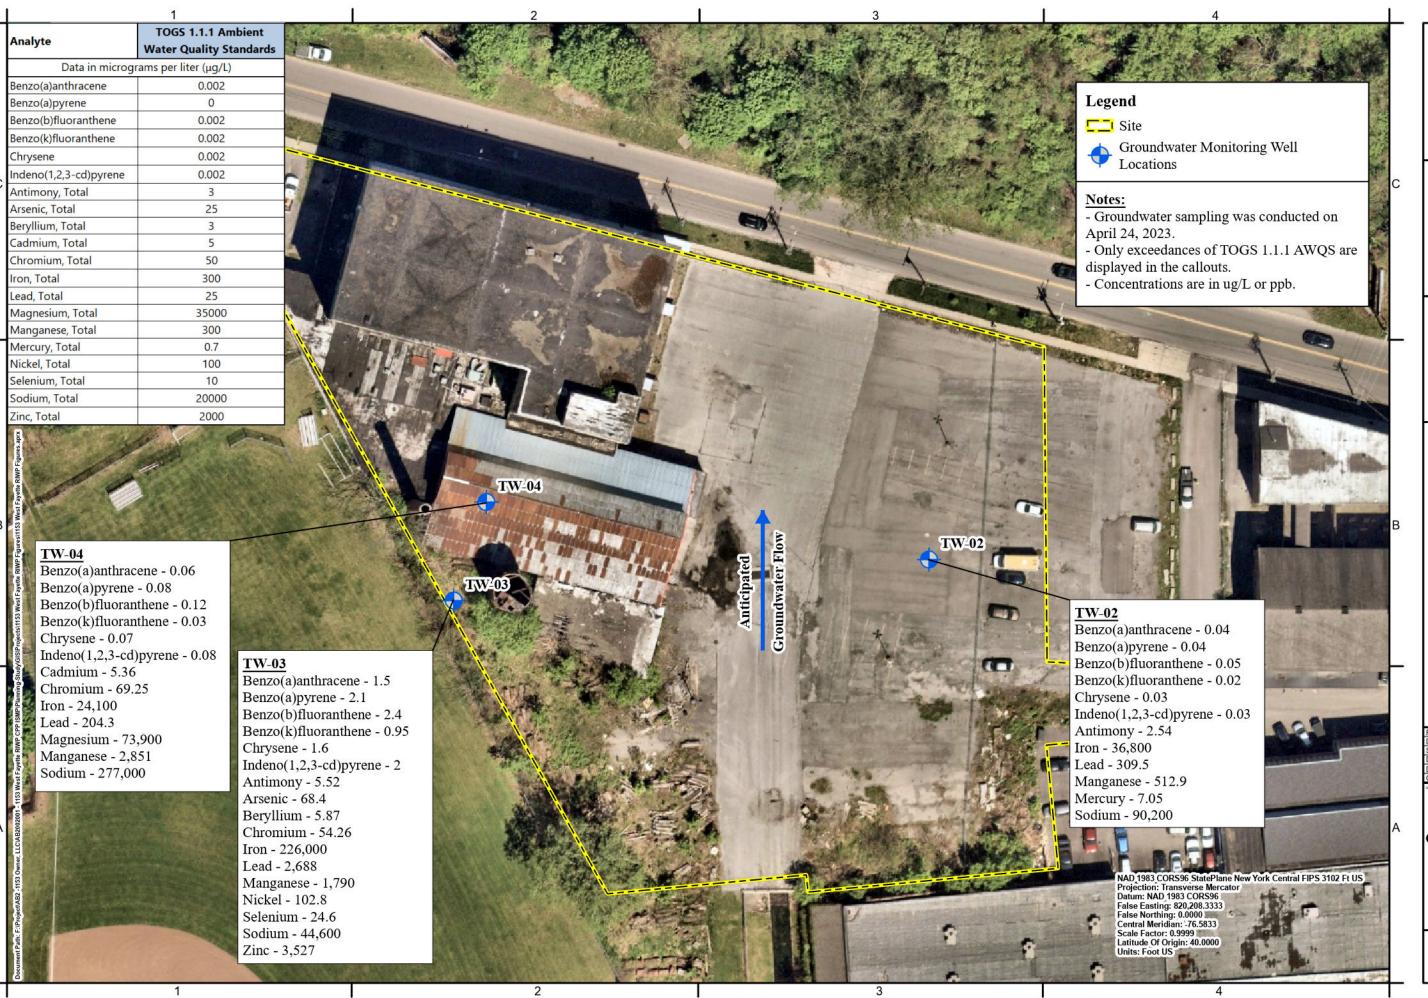
GROUNDWATER **SAMPLING** RESULTS

Based on the Phase II ESA, VOCs were not detected in groundwater at concentrations exceeding TOGS 1.1.1 AWQS. However, there was visual and olfactory evidence of petroleum contamination observed in the vicinity of the former oil house (Spill No. 23-00933). Numerous SVOCs and metals exceeded the TOGS 1.1.1 AWQS across the Site.

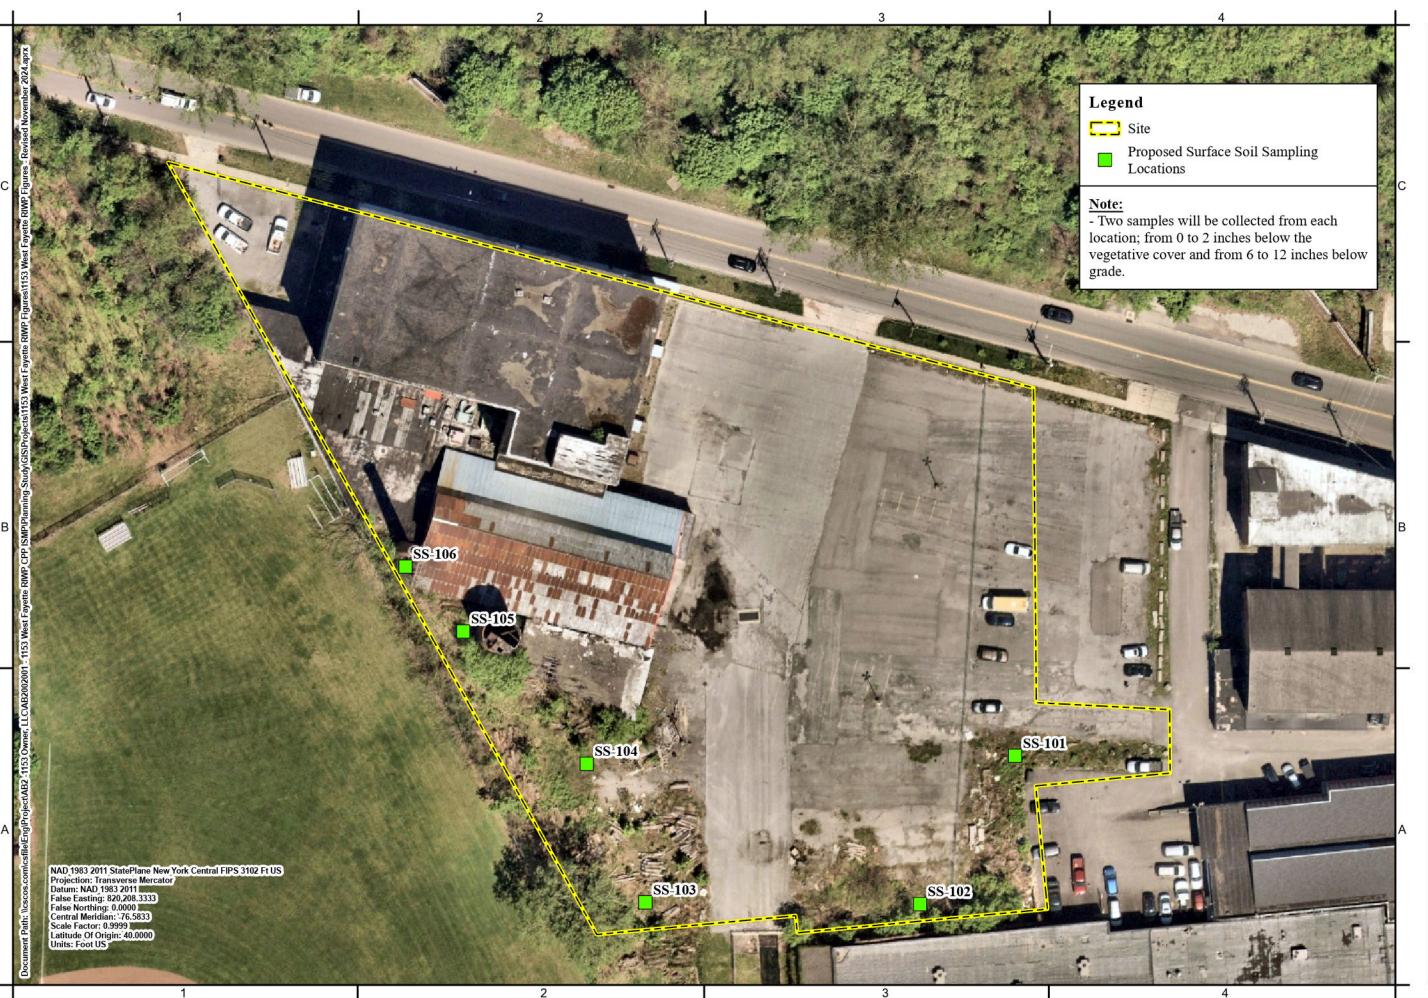
PROPOSED
SURFACE SOIL
SAMPLING
LOCATIONS

Surface soil samples will be collected across the Site. Up to twelve surface soil samples will be collected from six locations spatially distributed across the Site in areas not currently or proposed to be "capped" by asphalt or buildings. Two samples will be collected from each location using a decontaminated, stainless-steel spoon or spatula; from 0 to 2 inches below the vegetative cover and from 6 to 12 inches below grade. Surface soil samples will be collected at the locations shown on **Figure 6**.

Surface soils will be screened in the field for visible impairment (e.g. staining), olfactory indications of impairment, and / or indication of detectable VOCs with a 10.6 eV photo-ionization detector (PID). Such evidence is collectively referred to as "evidence of impairment" and the results will be recorded on a soil sample log.

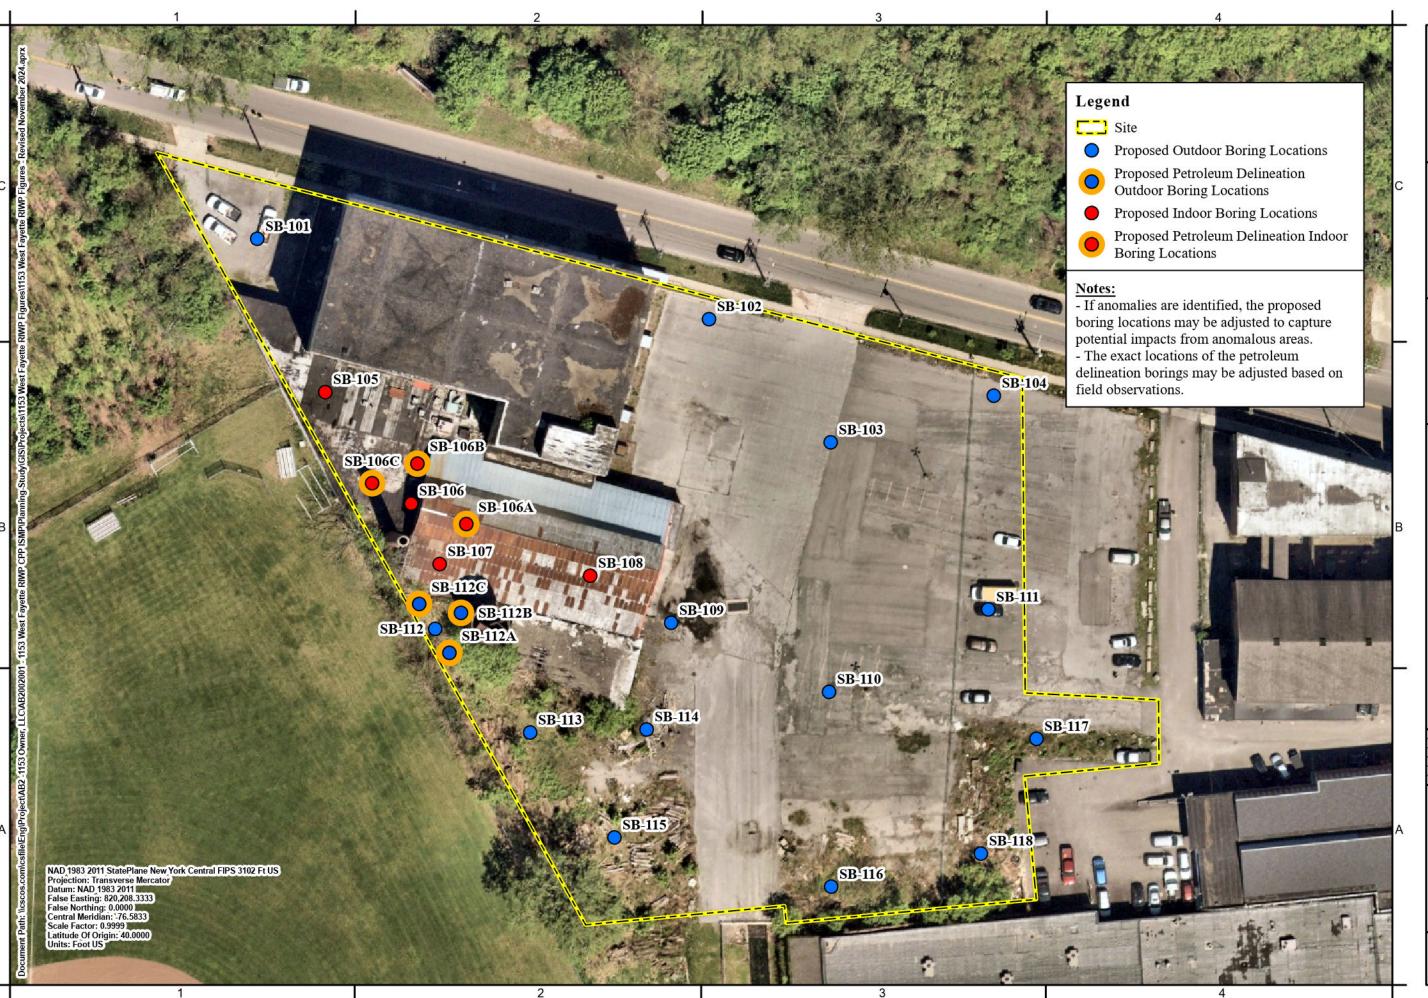
PROPOSED SOIL BORING LOCATIONS

- 18 of the 24 soil borings will be advanced to collect analytical data from the HFM and native material across the Site. The samples collected from these borings will be analyzed for a comprehensive list of contaminants, described in further detail below.
- 6 of the 24 soil borings will be advanced to delineate the petroleum impacts observed in the vicinity of the former oil house and coal silo during the Phase II ESA (i.e., Spill No. 23-00933). The exact locations of these soil borings may be adjusted based on observations made in the field. The samples collected from these borings will be analyzed for a shorter list of petroleum contaminants, described in further detail below.

A direct-push drilling rig will be used to advance the borings. Each boring location will be continuously sampled in four- or five-foot intervals using a two-inch by four- or five-foot stainless steel sampling tube fitted with a disposable acetate liner. All non-disposable sampling equipment will be decontaminated between runs and between drill locations to avoid potential cross contamination of samples.

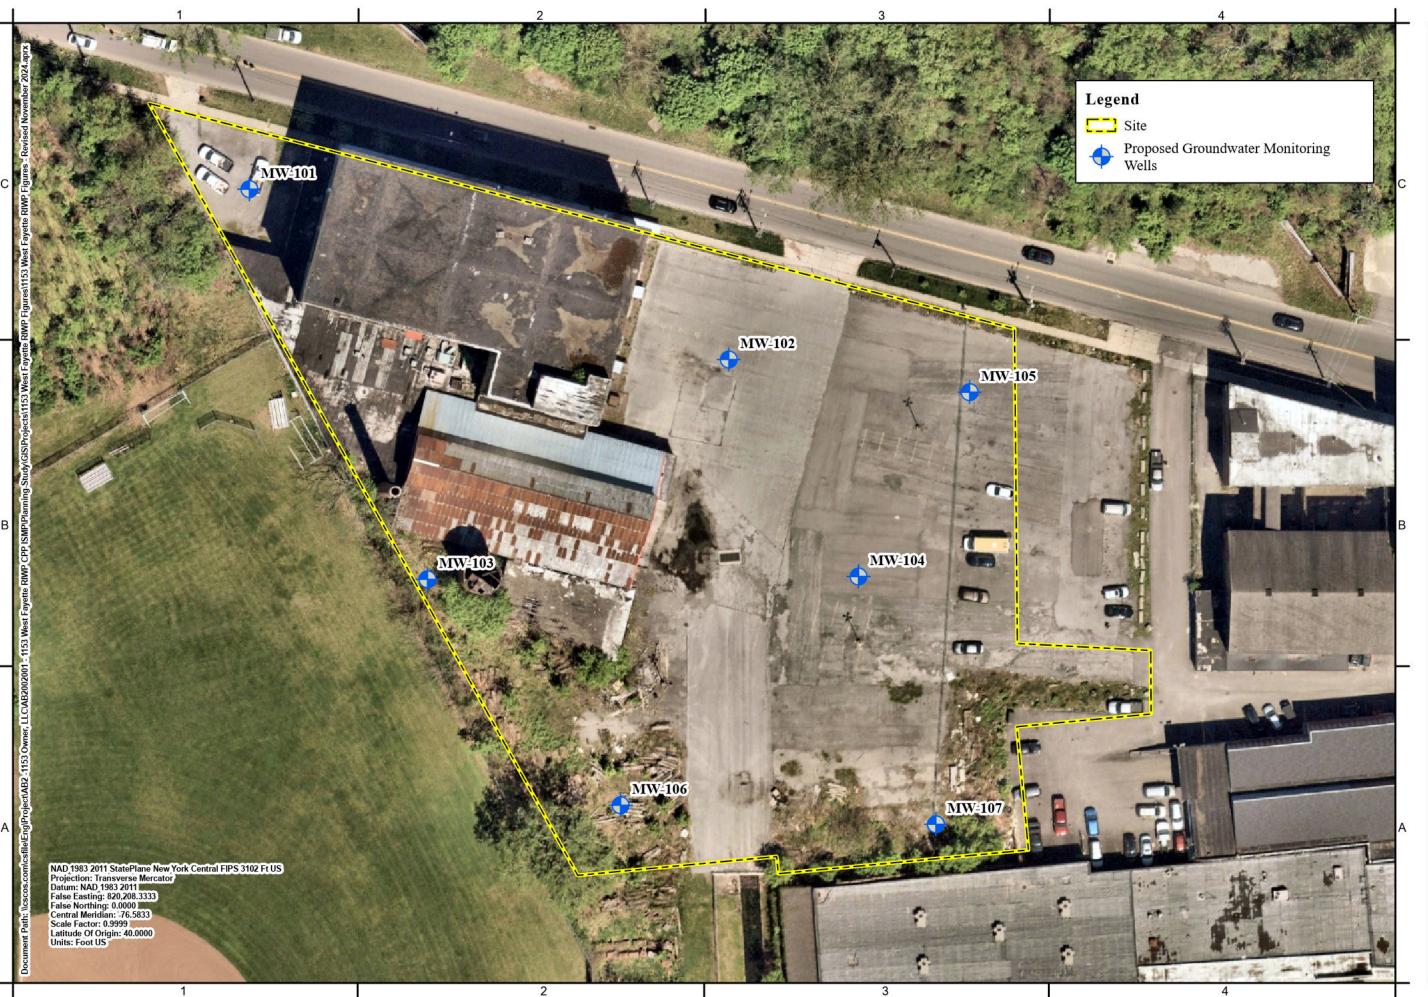
PROPOSED GROUNDWATER SAMPLE LOCATIONS

To characterize groundwater conditions at the Site, seven groundwater monitoring wells will be installed. **Figure 8** shows the proposed locations of the monitoring wells.

- Groundwater Evaluation Subsequent to completing soil investigation tasks, groundwater monitoring wells will be installed. Proposed well locations are shown on **Figure 8**. If field conditions observed during the RI require a significant change to the proposed locations, their adjusted locations will be discussed with the NYSDEC.
- Soil Vapor Intrusion (SVI) Sampling Sub-slab soil gas and indoor air samples will be collected from the existing one-story building. Crawl space air and indoor air samples will be collected from the existing six-story building. Soil vapor implants will be positioned near the periphery of the Site to assess the potential for off-site migration. An outdoor air sample will be collected from an upwind, ambient location for comparison purposes. Proposed SVI sampling locations are shown on Figure 9.
