PHASE II ENVIRONMENTAL SITE ASESSEMENT

**Fig Tree Properties
301 Wolf Street & 1920 Park Street
Syracuse, New York**

September 14, 2022

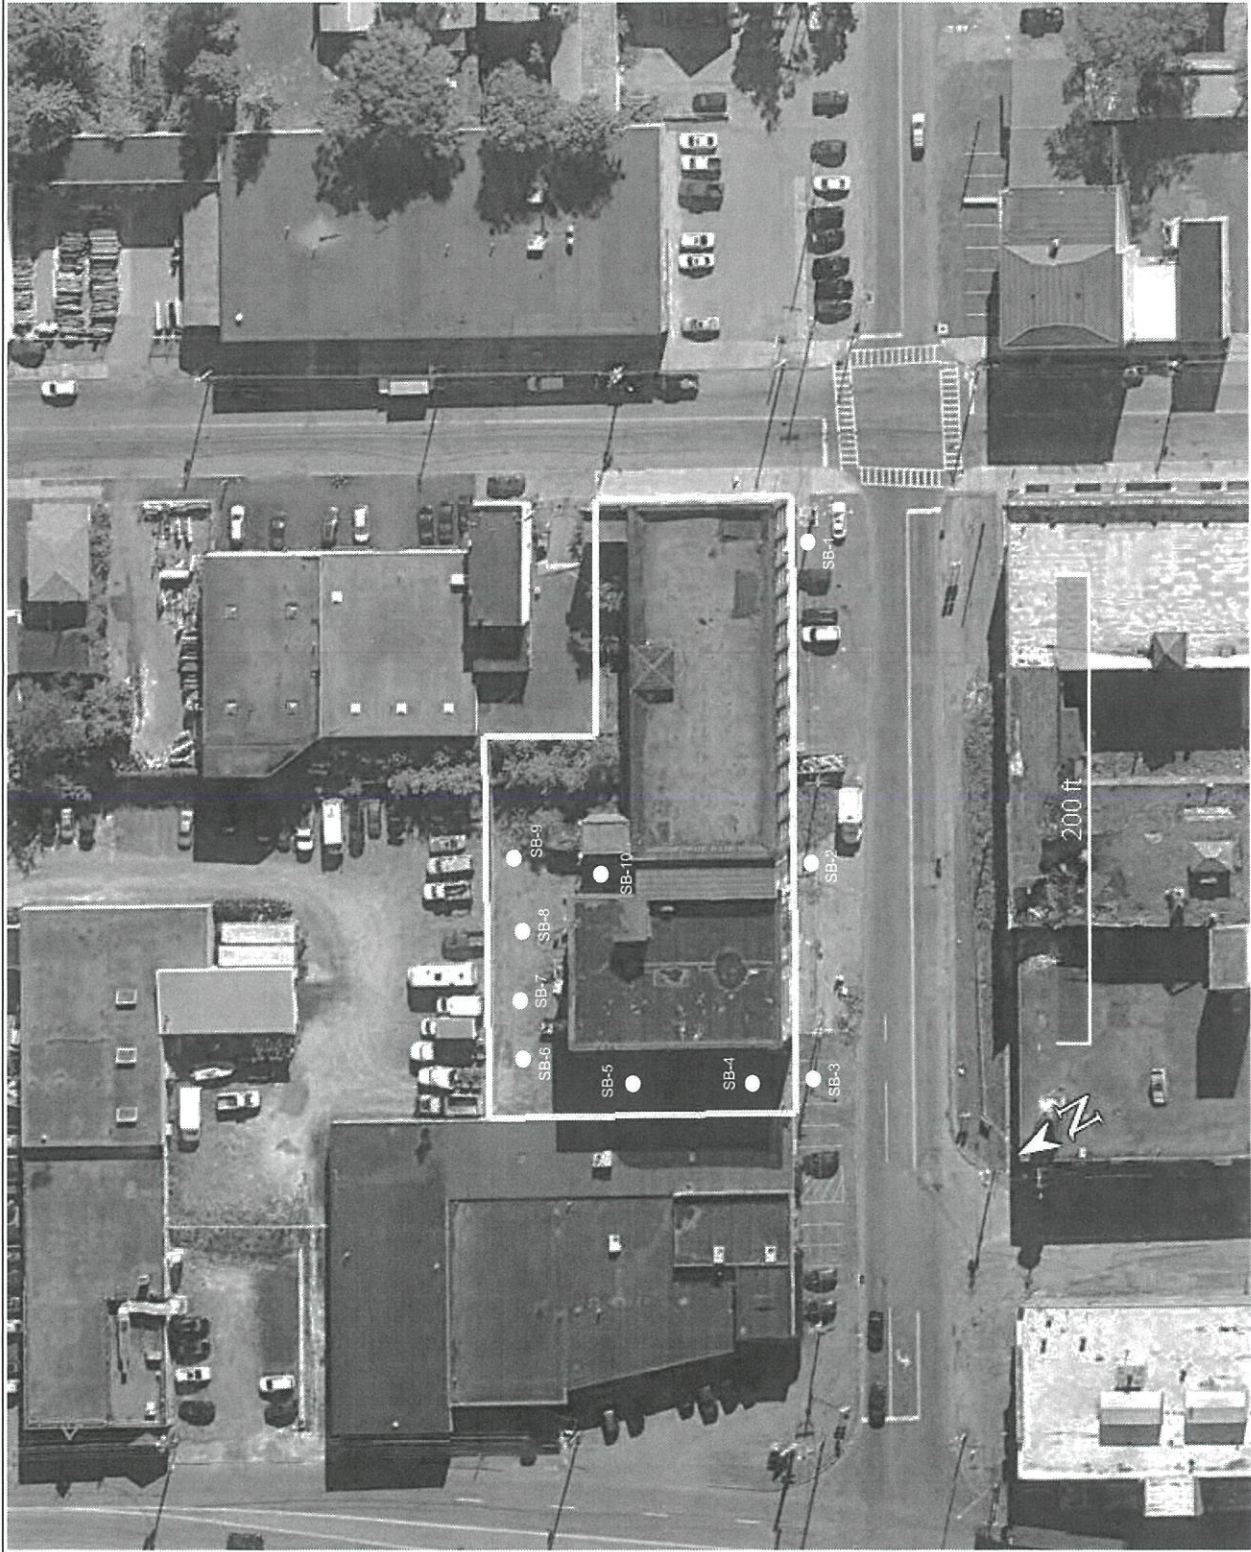
FIGURE 2
SOIL BORING LOCATION MAP

The approximate locations of the soil borings are depicted on the Site Map attached as **Figure 2**.
