**Passive Soil Vapor Survey Report**  
**Home #43 and Home #35**  
**Ithaca, New York**

EnviroGroup Limited  
Latham, New York

*January 20, 2012*

Project No. HL-0634

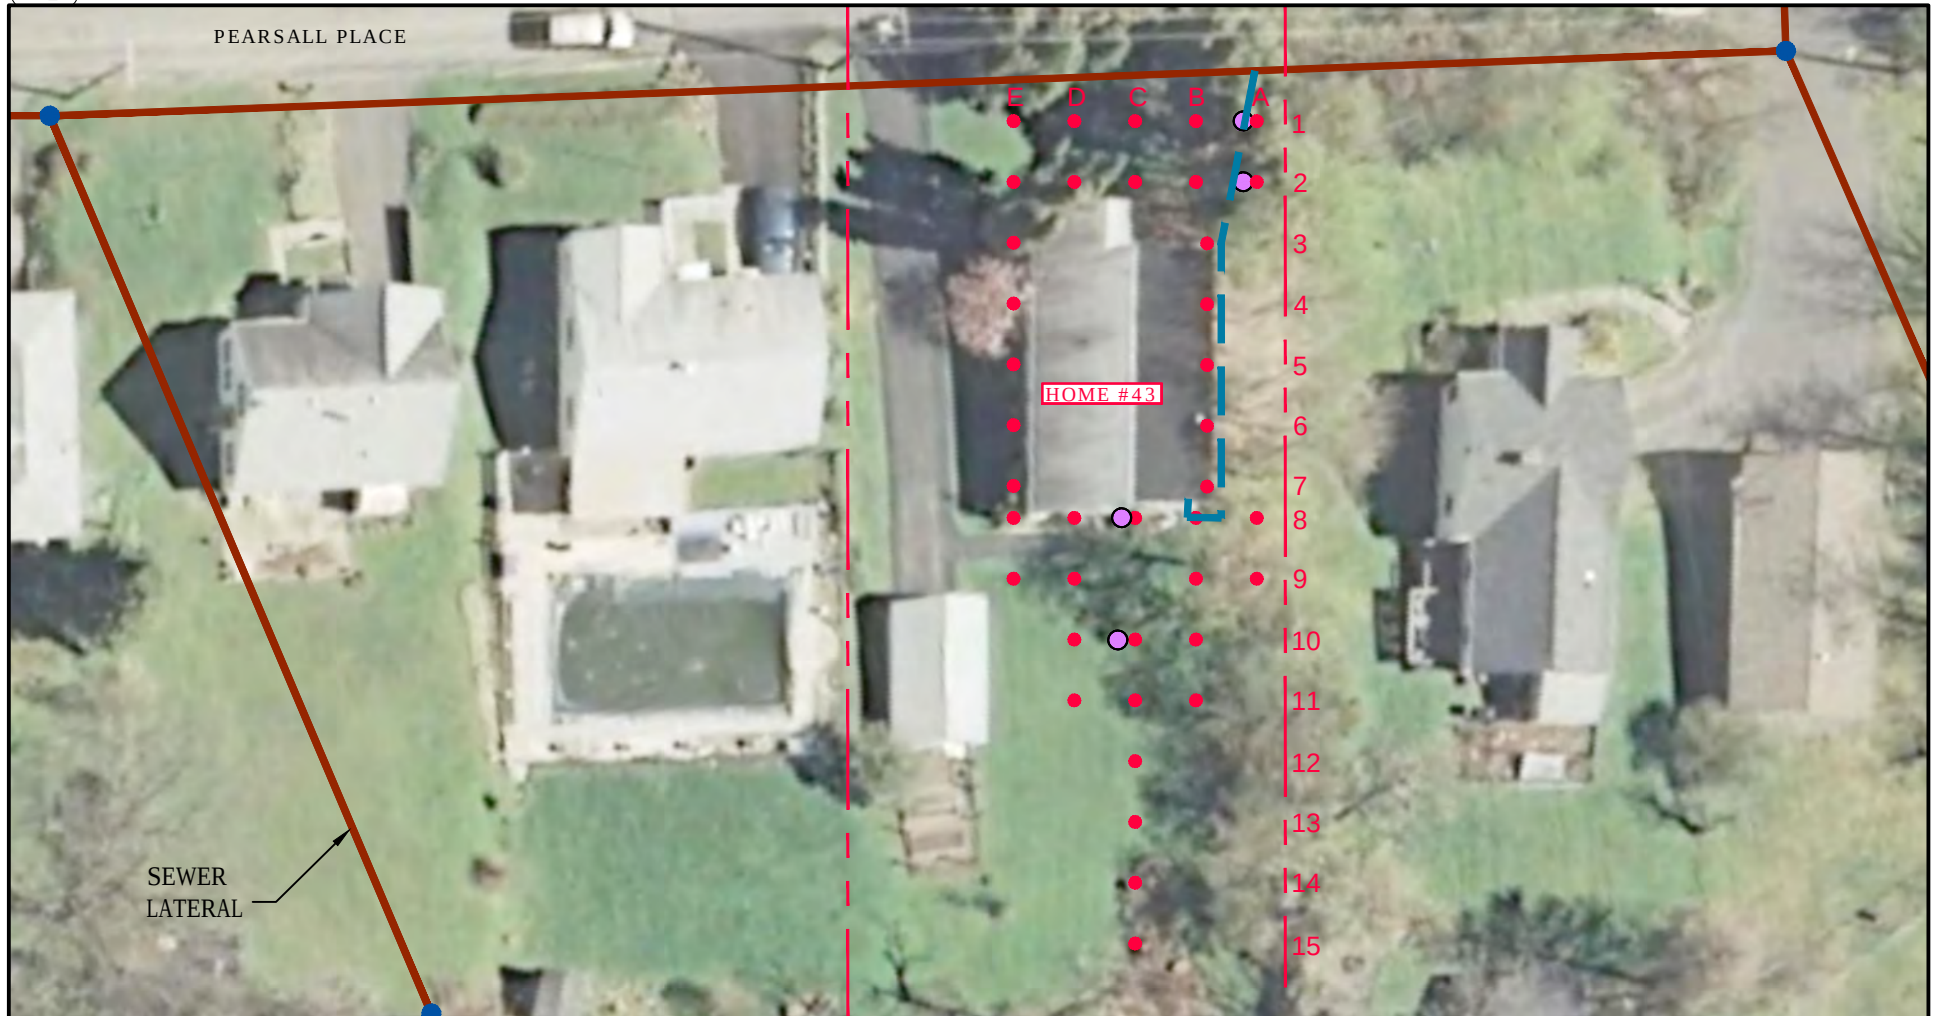
**PASSIVE SOIL VAPOR SAMPLE  
LOCATIONS, HOME #43**

Forty-two passive soil vapor samples were collected from the property at Home #43 (Figure 2). Thirty-eight of the 42 passive soil vapor probes were installed to a depth of three feet below ground surface (BGS) at the following spacing:

- A nominal 10 foot by 10 foot grid pattern in the front and back yard. The centerline of the back yard grid was extended to the south by four probes (40 feet) to evaluate the shallow soil vapor VOC trend between the Therm property and Home #43.
- A nominal 10 foot spaced row along the east and west side yards.

The remaining four of the 42 passive soil vapor probes were installed to a depth of five feet BGS (or refusal) to evaluate the influence of sample depth in the following locations:

- Two probes were installed next to three foot deep probes in the front yard near the sewer lateral to the house.
- Two probes were installed in adjacent to three foot probes along the north-south centerline of the backyard grid.

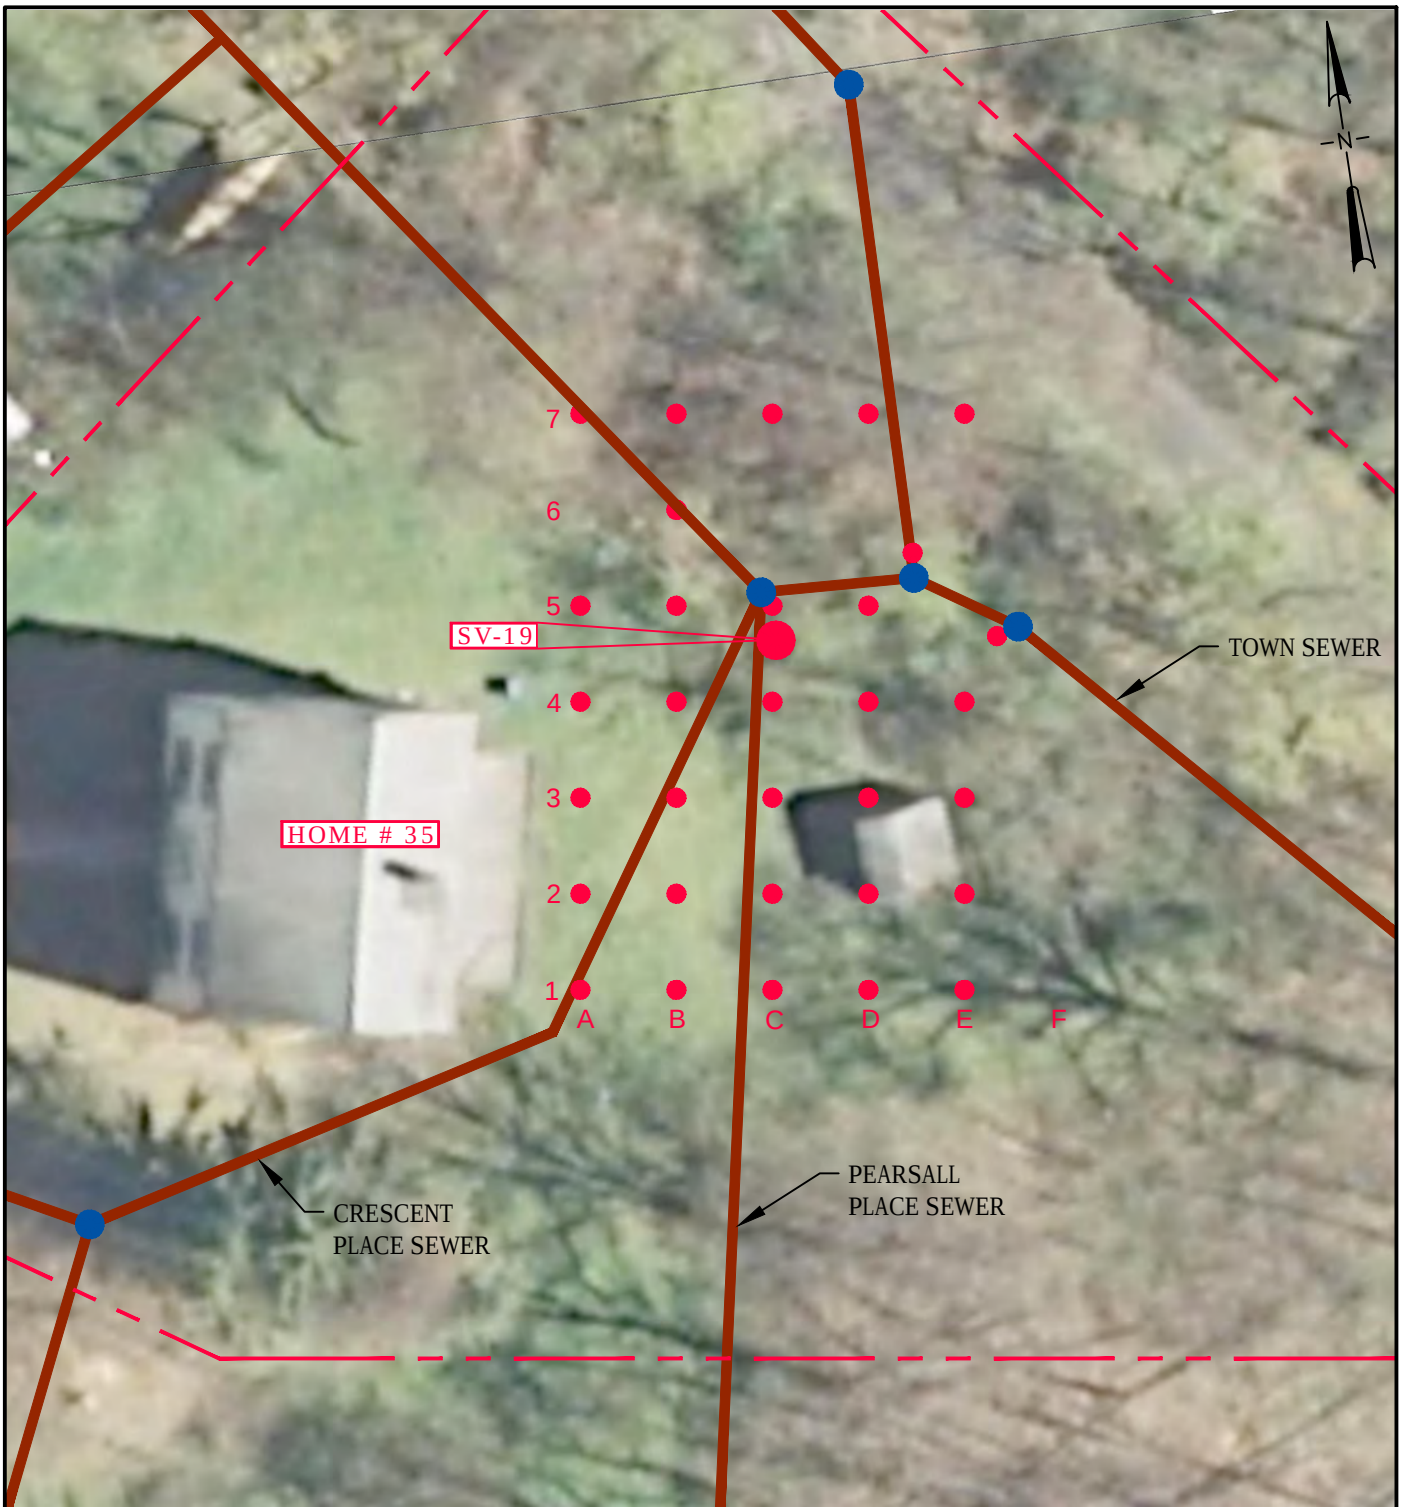
Thirty-two passive soil vapor samples were collected from the property at Home #35 (soil vapor probe SV-19 area) on a nominal 10 foot by 10 foot grid pattern extending in all directions around SV-19 (Figure 3).
