Phase I Environmental Site Assessment

**Proposed Ithaca Arthaus Project
130 Cherry Street
Ithaca, Tompkins County, New York**

**Dated:
October 29, 2018**

**Vecino Group New York, LLC
Springfield, Missouri**

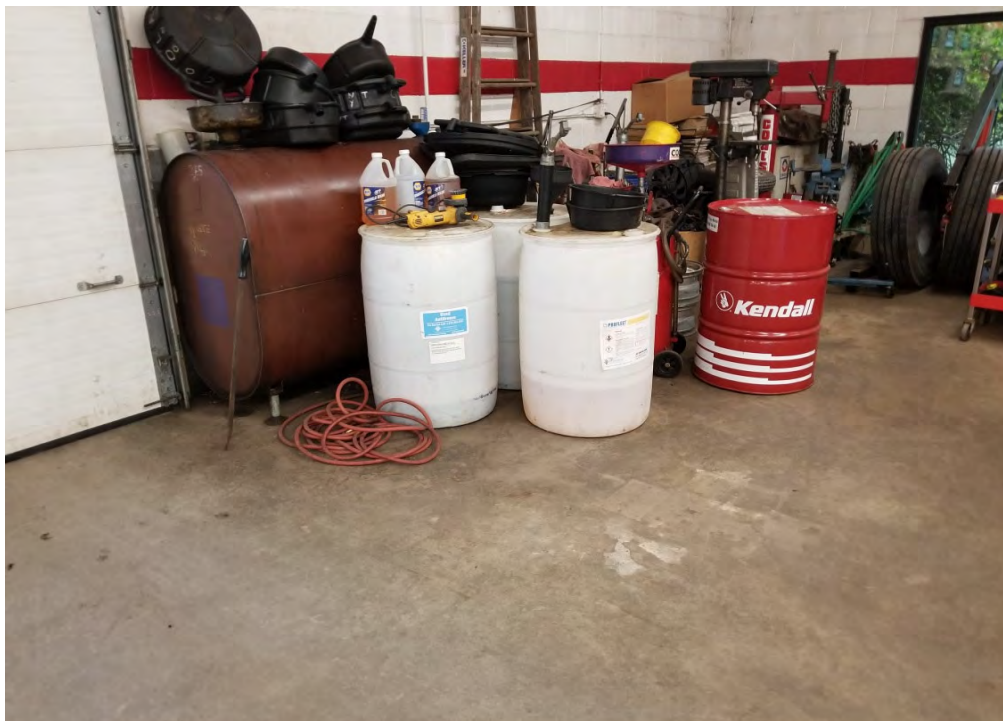
A 265-gallon waste-oil above-ground storage tank (“AST”) was observed in the southwest interior of the auto shop building. No evidence of a release was observed.

Three 55-gallon drum of used antifreeze were observed in the southwest interior of the auto shop building; the drums were observed containing fluids. No evidence of a release was observed.

One 55-gallon drum of new oil was observed in the southwest interior of the auto shop building. No evidence of a release was observed.

4. Southwest view - View of the 55-gallon drums for used antifreeze, a 265-gallon waste-oil AST, and a 55-gallon drum of new oil located on the southwest interior of the on-Site structure.

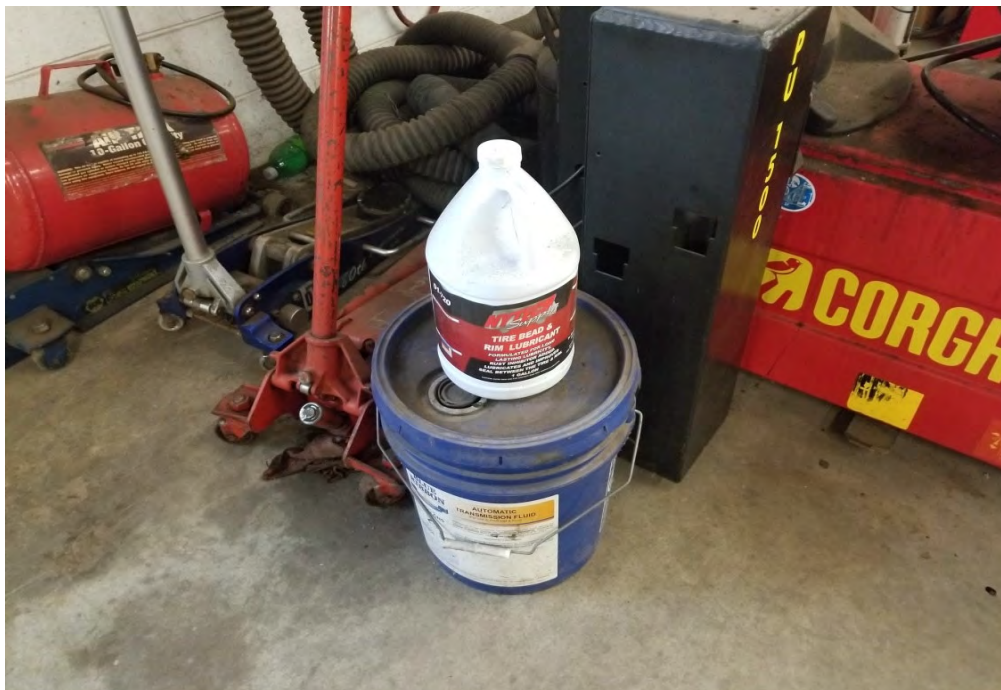
Various amounts of automotive fluid containers were observed throughout the interior of the auto shop building. No leaking or evidence of a release was observed.

5. Representative view of the various automotive fluid containers observed throughout the interior of the on-Site structure.

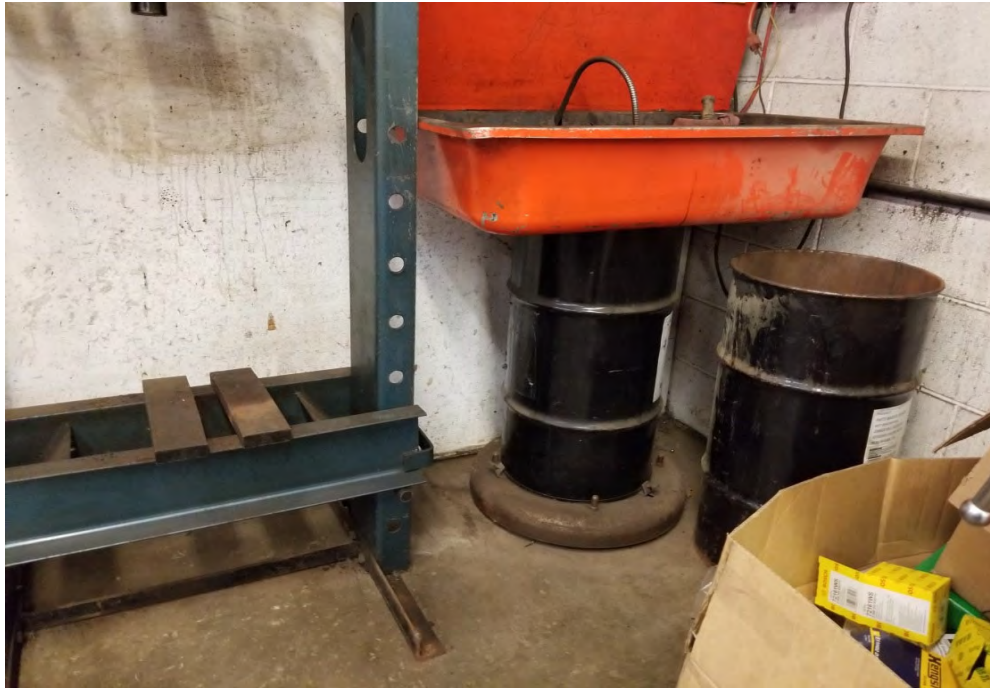
A parts washer with a catch container was observed in the northwest interior of the auto shop building. Dark staining was observed on the walls surrounding the parts washer; however, the staining is considered *de minimis*.

7. View of the parts washer and catch container observed on the northwest interior of the on-Site structure; note the *de minimis* staining on surrounding walls.

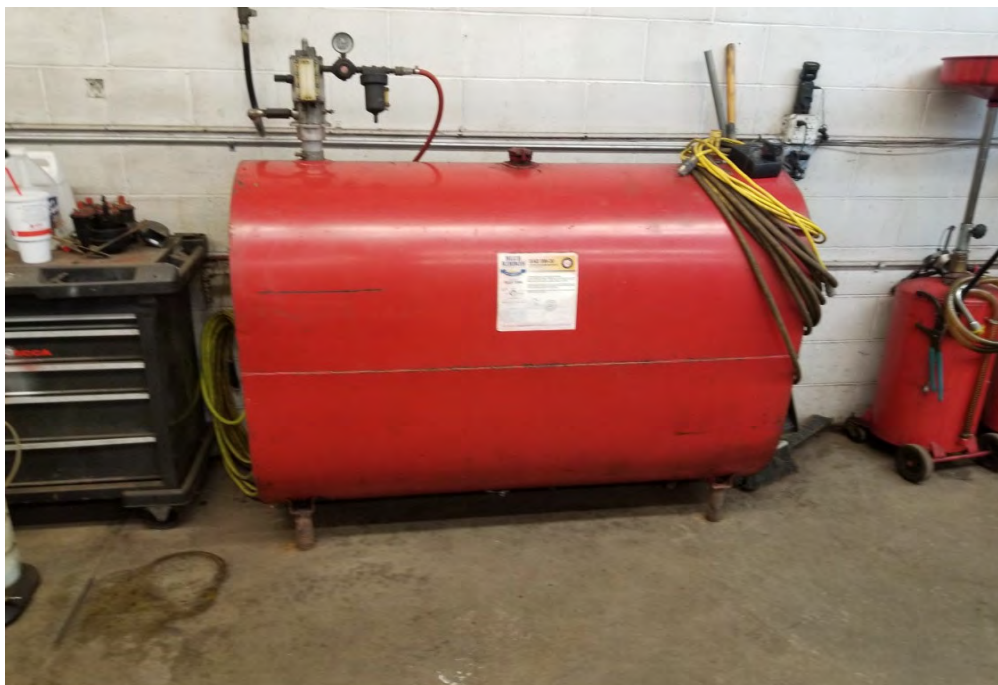
One approximately 265-gallon new oil AST was observed on the northwest interior of the auto shop building. No evidence of a release was observed.

8. View of the 265-gallon new oil AST located on the northwest interior of the on-Site structure.

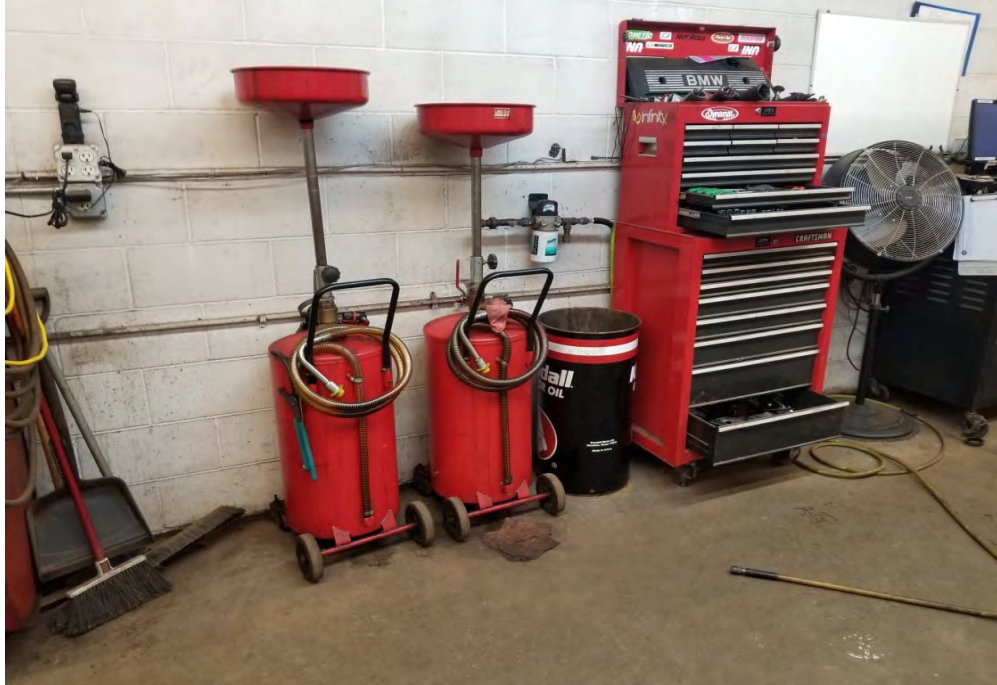
Four portable fluid transfer containers were observed in the southwest interior of the auto shop building. No evidence of a release was observed.

9. Representative view of the portable automotive fluid containers located on the interior of the on-Site structure.

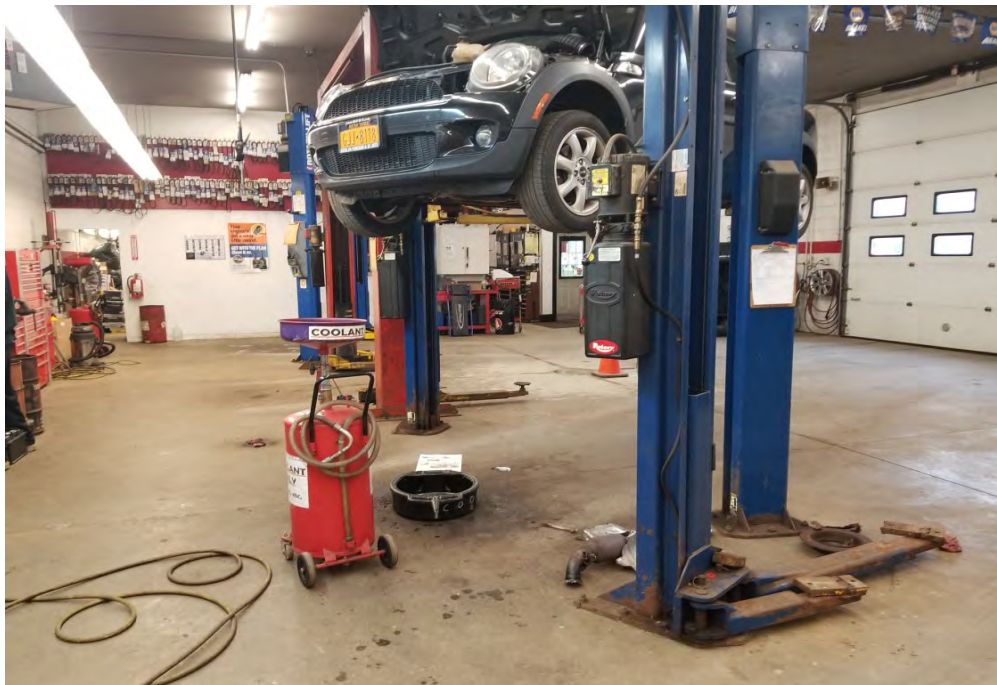
Mr. Button stated the Site has six above-ground hydraulic lifts present on the interior of the auto shop building. To his knowledge, no leaking has been observed from the lifts.

10. Representative view of the above-ground hydraulic lifts located on the interior of the on-Site structure; note *de minimis* staining on the concrete-floor

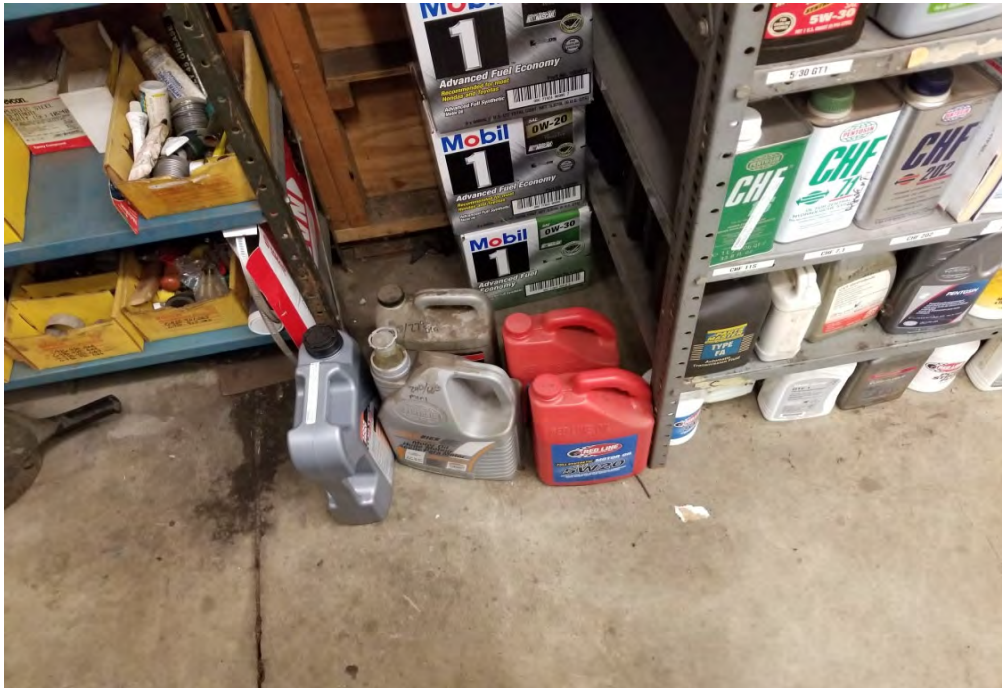
Storage for new automotive fluids was observed in the northeast interior of the auto shop building. Dark staining was observed on the concrete-floor in this area; however, the staining is considered to be *de minimis*.

11. View of the *de minimis* staining on the concrete-floor surface of the new product/automotive fluid storage room.

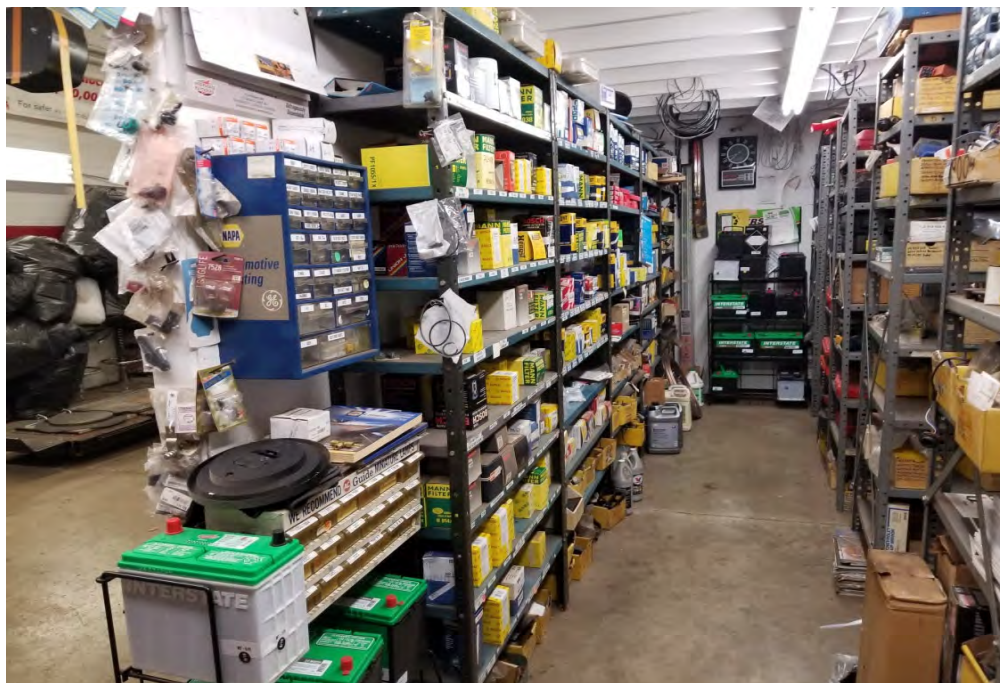
Approximately 23 new automotive batteries were observed in the northeast interior of the auto shop building. No evidence of a release was observed.

12. View of the storage room containing parts, automotive fluids and new batteries.

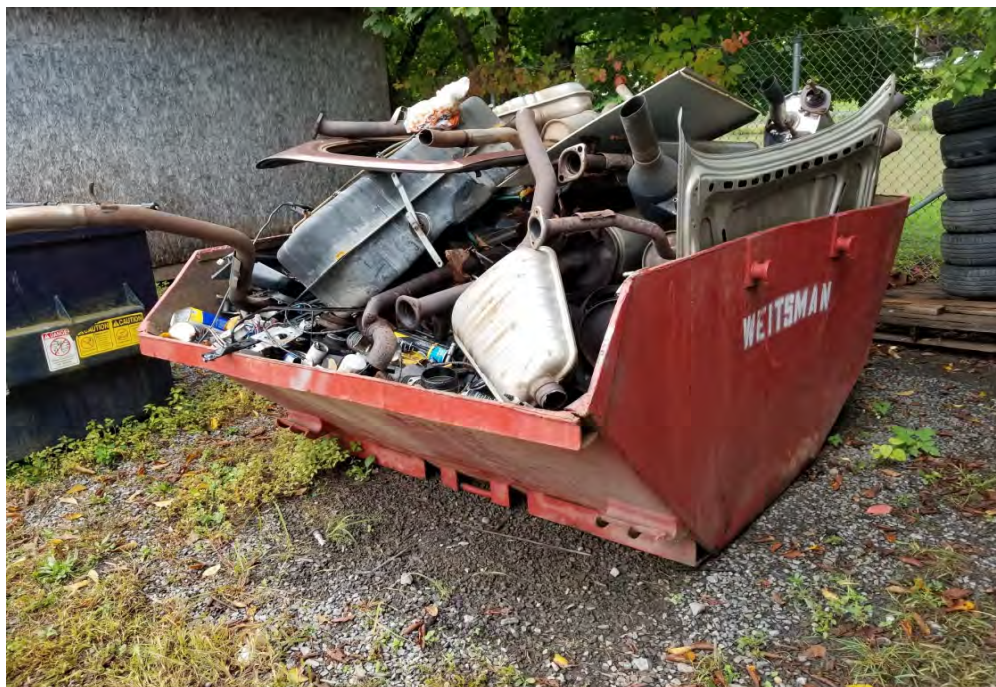
14. View of the parts dumpster located on the southwest exterior of the on-Site structure.
