**Re: Interim Remediation Measure #2 As-Built Drawings  
Former Sperry Remington – North Portion Site #c808022  
Elmira, Chemung County**

**Re: Interim Remedial Measure #2 Construction Completion Report  
Former Sperry Remington – North Portion Site #c808022  
Elmira, Chemung County**

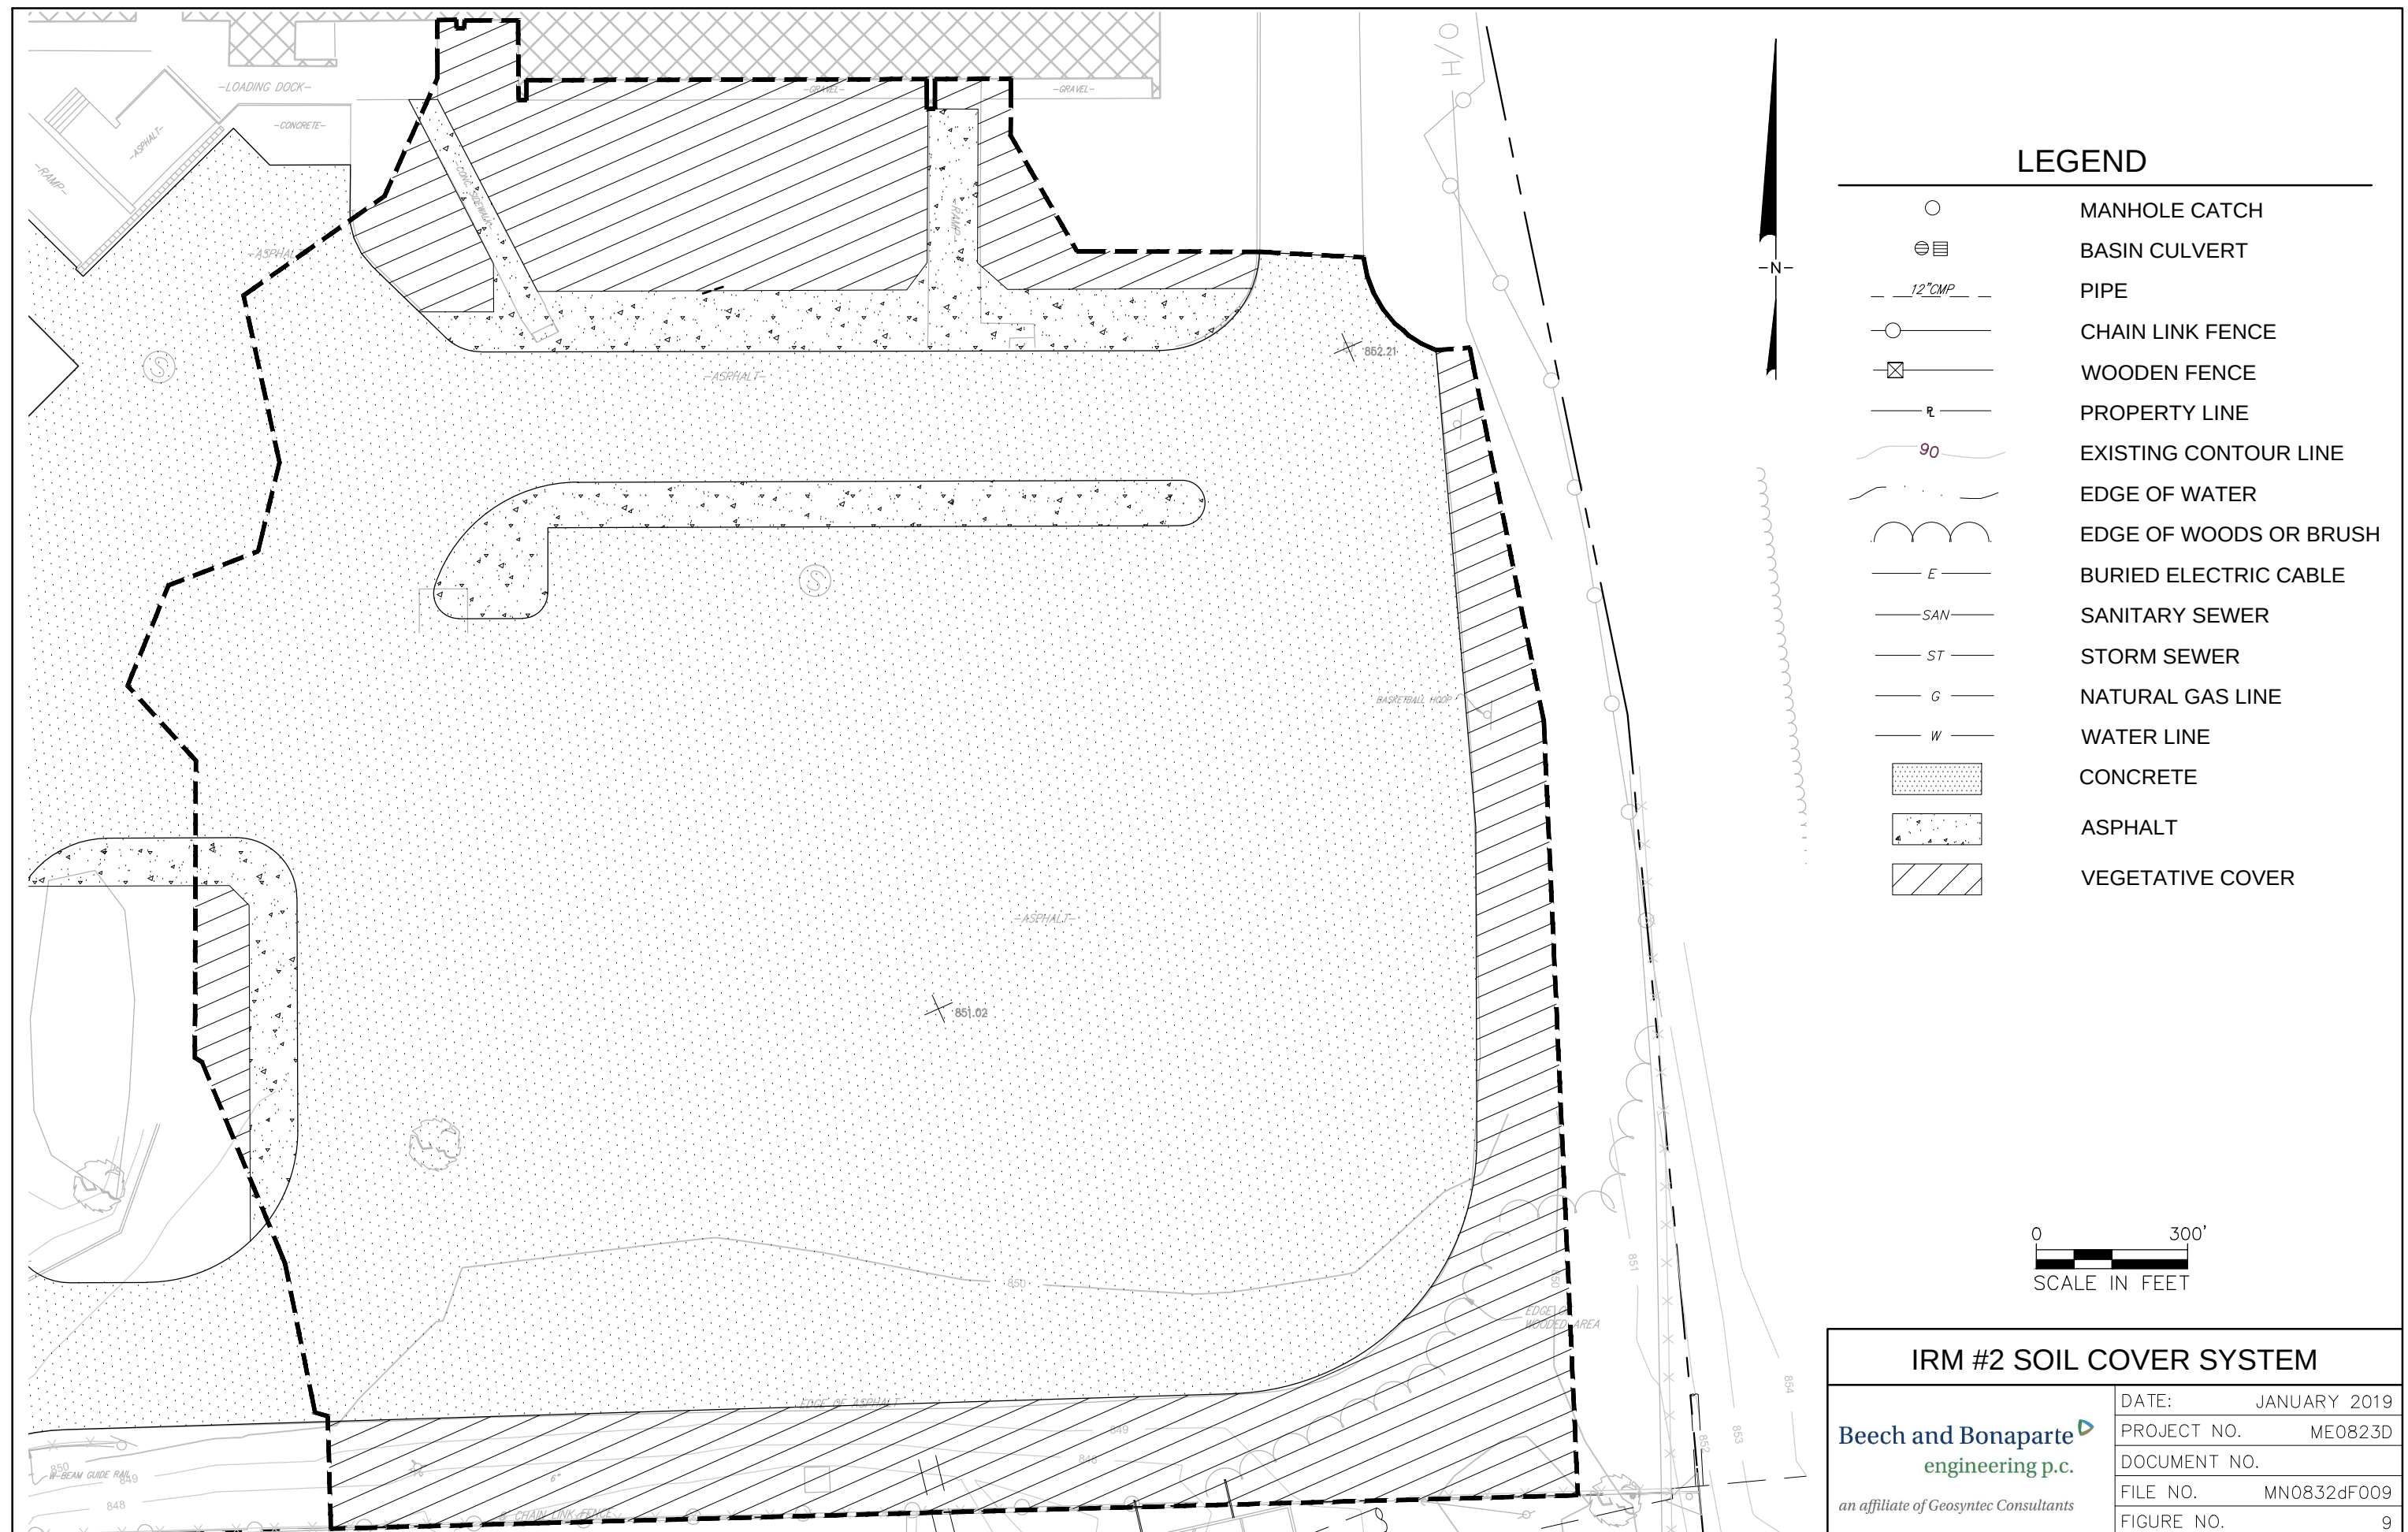
1. DEMARCATION LAYER NETTING CONSISTS OF ORANGE ONE HUNDRED PERCENT (100%) CONTINUOUS MONOFILAMENT POLYPROPYLENE SPUN BOND FABRIC WITH UV INHIBITORS, SUCH AS OD5340 OR OD7525 ORIENTED NETTING BY INDUSTRIAL NETTING, POCKET NET FENCE BY 3T PRODUCTS, OR APPROVED EQUAL.
2. IN THE EVENT THAT CONTAMINATED SOILS REMAINED IN PLACE AFTER EXCAVATION, GEOTEXTILE FABRIC WAS PLACED IN THOSE AREAS OF THE EXCAVATION BENEATH THE DEMARCATION NETTING IN ORDER TO SEPARATE CONTAMINATED SOIL REMAINING FROM THE BACKFILL.
