## Appendix H Test Pitting Logs

**Appendix H**  
**Test Pitting Summary Sheet**

# TEST PIT LOG

| SEE MAP | SEE MAP | Site: Elmira |

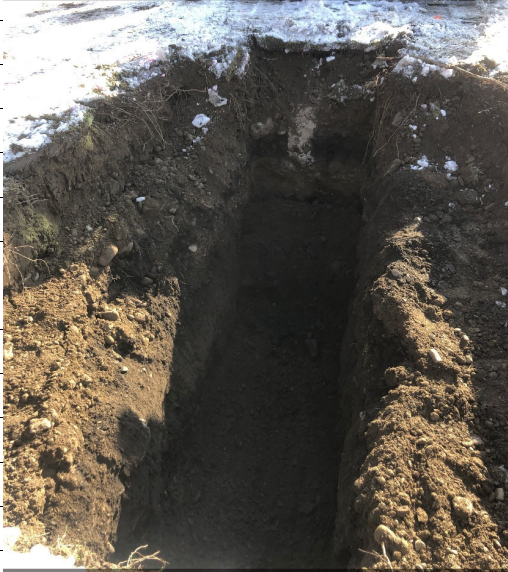
Elmira      Test Pit 2      2019-12-22  
12:25:36-05:00

| Depth<br>(ft bgs) | Horizontal Interval - feet from end of trench | | | | | | | | | | | | | | | |
|---|---|--|--|--|--|--|--|--|--|--|--|--|--|--|--|---|
| 1 | Brown clay, plastic, stiff, moist | | | | | | | | | | | | | | | |
| 2 | Light brown and grey sandy cobbles with silt, fill, rounded cobbles, loosed, fine to coarse sand, moist, poorly sorted, crushed brick and concrete fragments. | | | | | | | | | | | | | | | |

Sample Numbers: Test Pit 2 collected for analysis of PCBs, SVOCs and metals.

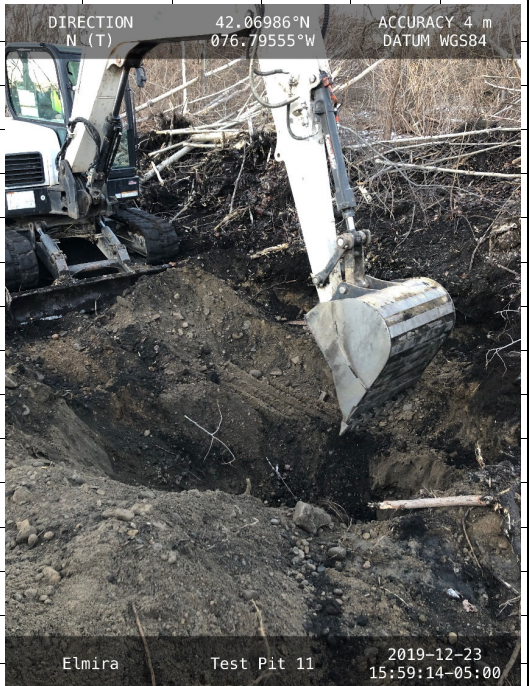
Elmira Test Pit 11 2019-12-23 15:59:14-05:00

| Depth<br>(ft bgs) | Horizontal Interval - feet from end of trench | | | | | | | | | | | | | |
|---|---|--|--|--|--|--|--|--|--|--|--|--|---|--|
| 1 | Dark brown silt with sand, subangular to subrounded, loose, fine sand, moist, poorly sorted | | | | | | | | | | | | | |
| 6 | Medium sand with silt and cobbles, rounded to subrounded cobbles, loose, fine to medium sand, moist, poorly sorted | | | | | | | | | | | | | |

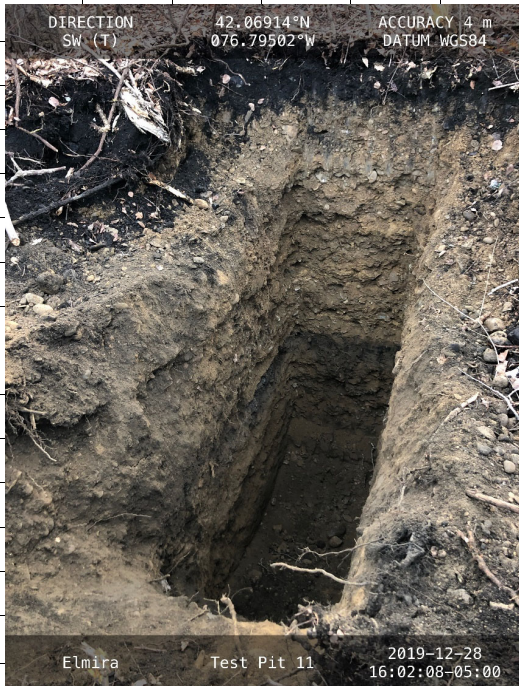
| Depth<br>(ft bgs) | Horizontal Interval - feet from end of trench | | | | | | | | | | | | | | | |
|---|---|--|--|--|--|--|--|--|--|--|--|--|--|--|---|--|
| 1 | Black silty sand, subangular, very loose, fine to medium sand, moist, poorly sorted, contains organic matter | | | | | | | | | | | | | | | |
| 2 | Tan and brown sand with with gravel and cobbles, rounded cobbles, loose, medium to coarse sand, moist, poorly sorted | | | | | | | | | | | | | | | |

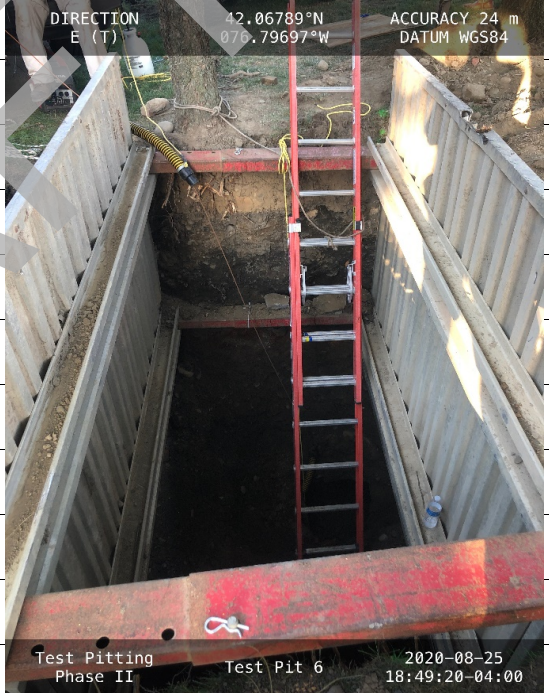
| Depth<br>(ft bgs) | Horizontal Interval - ft from end of trench | | | | | | | | | |
|---|---|--|--|--|--|--|--|--|---|--|
| 0 | Brown silty fine sand, medium dense, damp | | | | | | | | | |
| | Dark Brown fine to coarse sand with silt, gravel, and cobbles. Some fill materials (concrete rubble, brick fragments) observed throughout. Damp. Poorly sorted. Sub rounded to sub angular. | | | | | | | | | |

Additional Information: Trench box installed to approximately 10 ft bgs to access pipe segment (top of pipe approximately 9.5 ft bgs). Sewer observed to be 30-inch diameter concrete pipe.

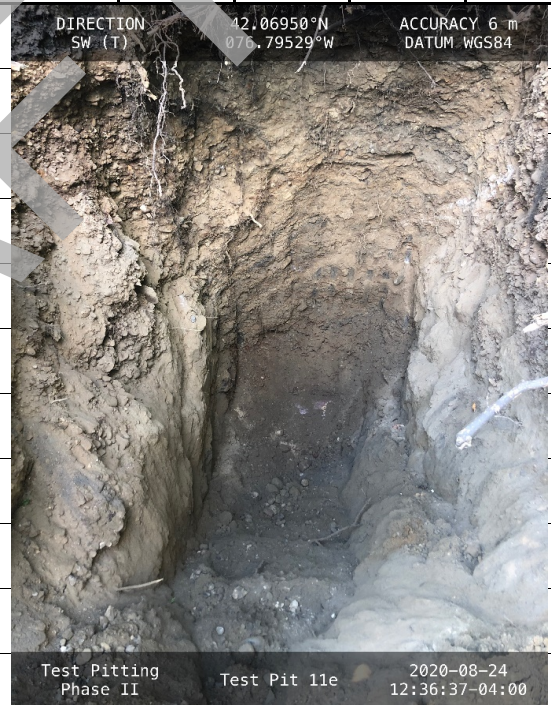
| Depth<br>(ft bgs) | Horizontal Interval - ft from end of trench | | | | | | | | | |
|---|---|--|--|--|--|--|---|--|--|--|
| 0 | Light brown silty fine sand with cobbles, medium dense, well rounded, poorly sorted, damp, organic material and plant roots present. | | | | | | | | | |
| 1 | Light brown and grey fine to coarse sand with silt, gravel, and cobbles. Some fill material (brick fragments) observed. Dry. Poorly sorted. Sub rounded to sub angular. Loose. | | | | | | | | | |
| 4 | Light brown and tan fine sand with cobbles. Fill. Dry. Poorly sorted. Sub rounded. Loose. | | | | | | | | | |

Additional Information: Top of pipe located approximately 10.5 ft bgs. Sewer observed to be 36-inch diameter clay tile pipe.

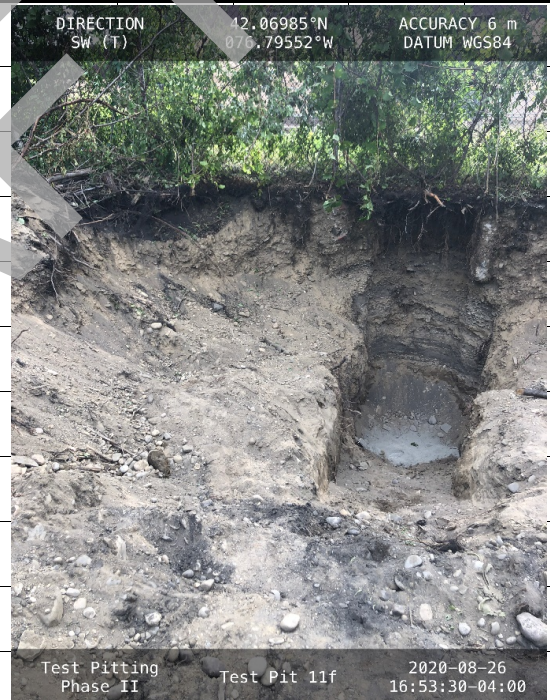
| Depth<br>(ft bgs) | Horizontal Interval - ft from end of trench | | | | | | | | | |
|---|---|--|--|--|--|--|---|--|--|--|
| 0 | Dark brown silty fine sand, very loose, damp. | | | | | | | | | |
| 1 | Dark brown, tan and grey fine to coarse sand with gravel, and cobbles. Some fill material (brick fragments) observed. Damp. Poorly sorted. Sub rounded to sub angular. Loose. | | | | | | | | | |
| 5 | Brown and tan medium sand with gravel, and cobbles. Fill. Damp Poorly sorted. Sub rounded. Loose. | | | | | | | | | |

Additional Information: Top of pipe located approximately 10.5 ft bgs. Sewer observed to be 36-inch diameter clay tile pipe.
