INTERIM REMEDIAL MEASURES #2 WORK PLAN

**FORMER SPERRY REMINGTON SITE – NORTH PORTION
777 SOUTH MAIN STREET
CITY OF ELMIRA, CHEMUNG COUNTY, NY
NYSDEC PROJECT C808022**

Project Number MN0832D
Document Number MD18136

6 JUNE 2018; REVISED 13 JULY 2018

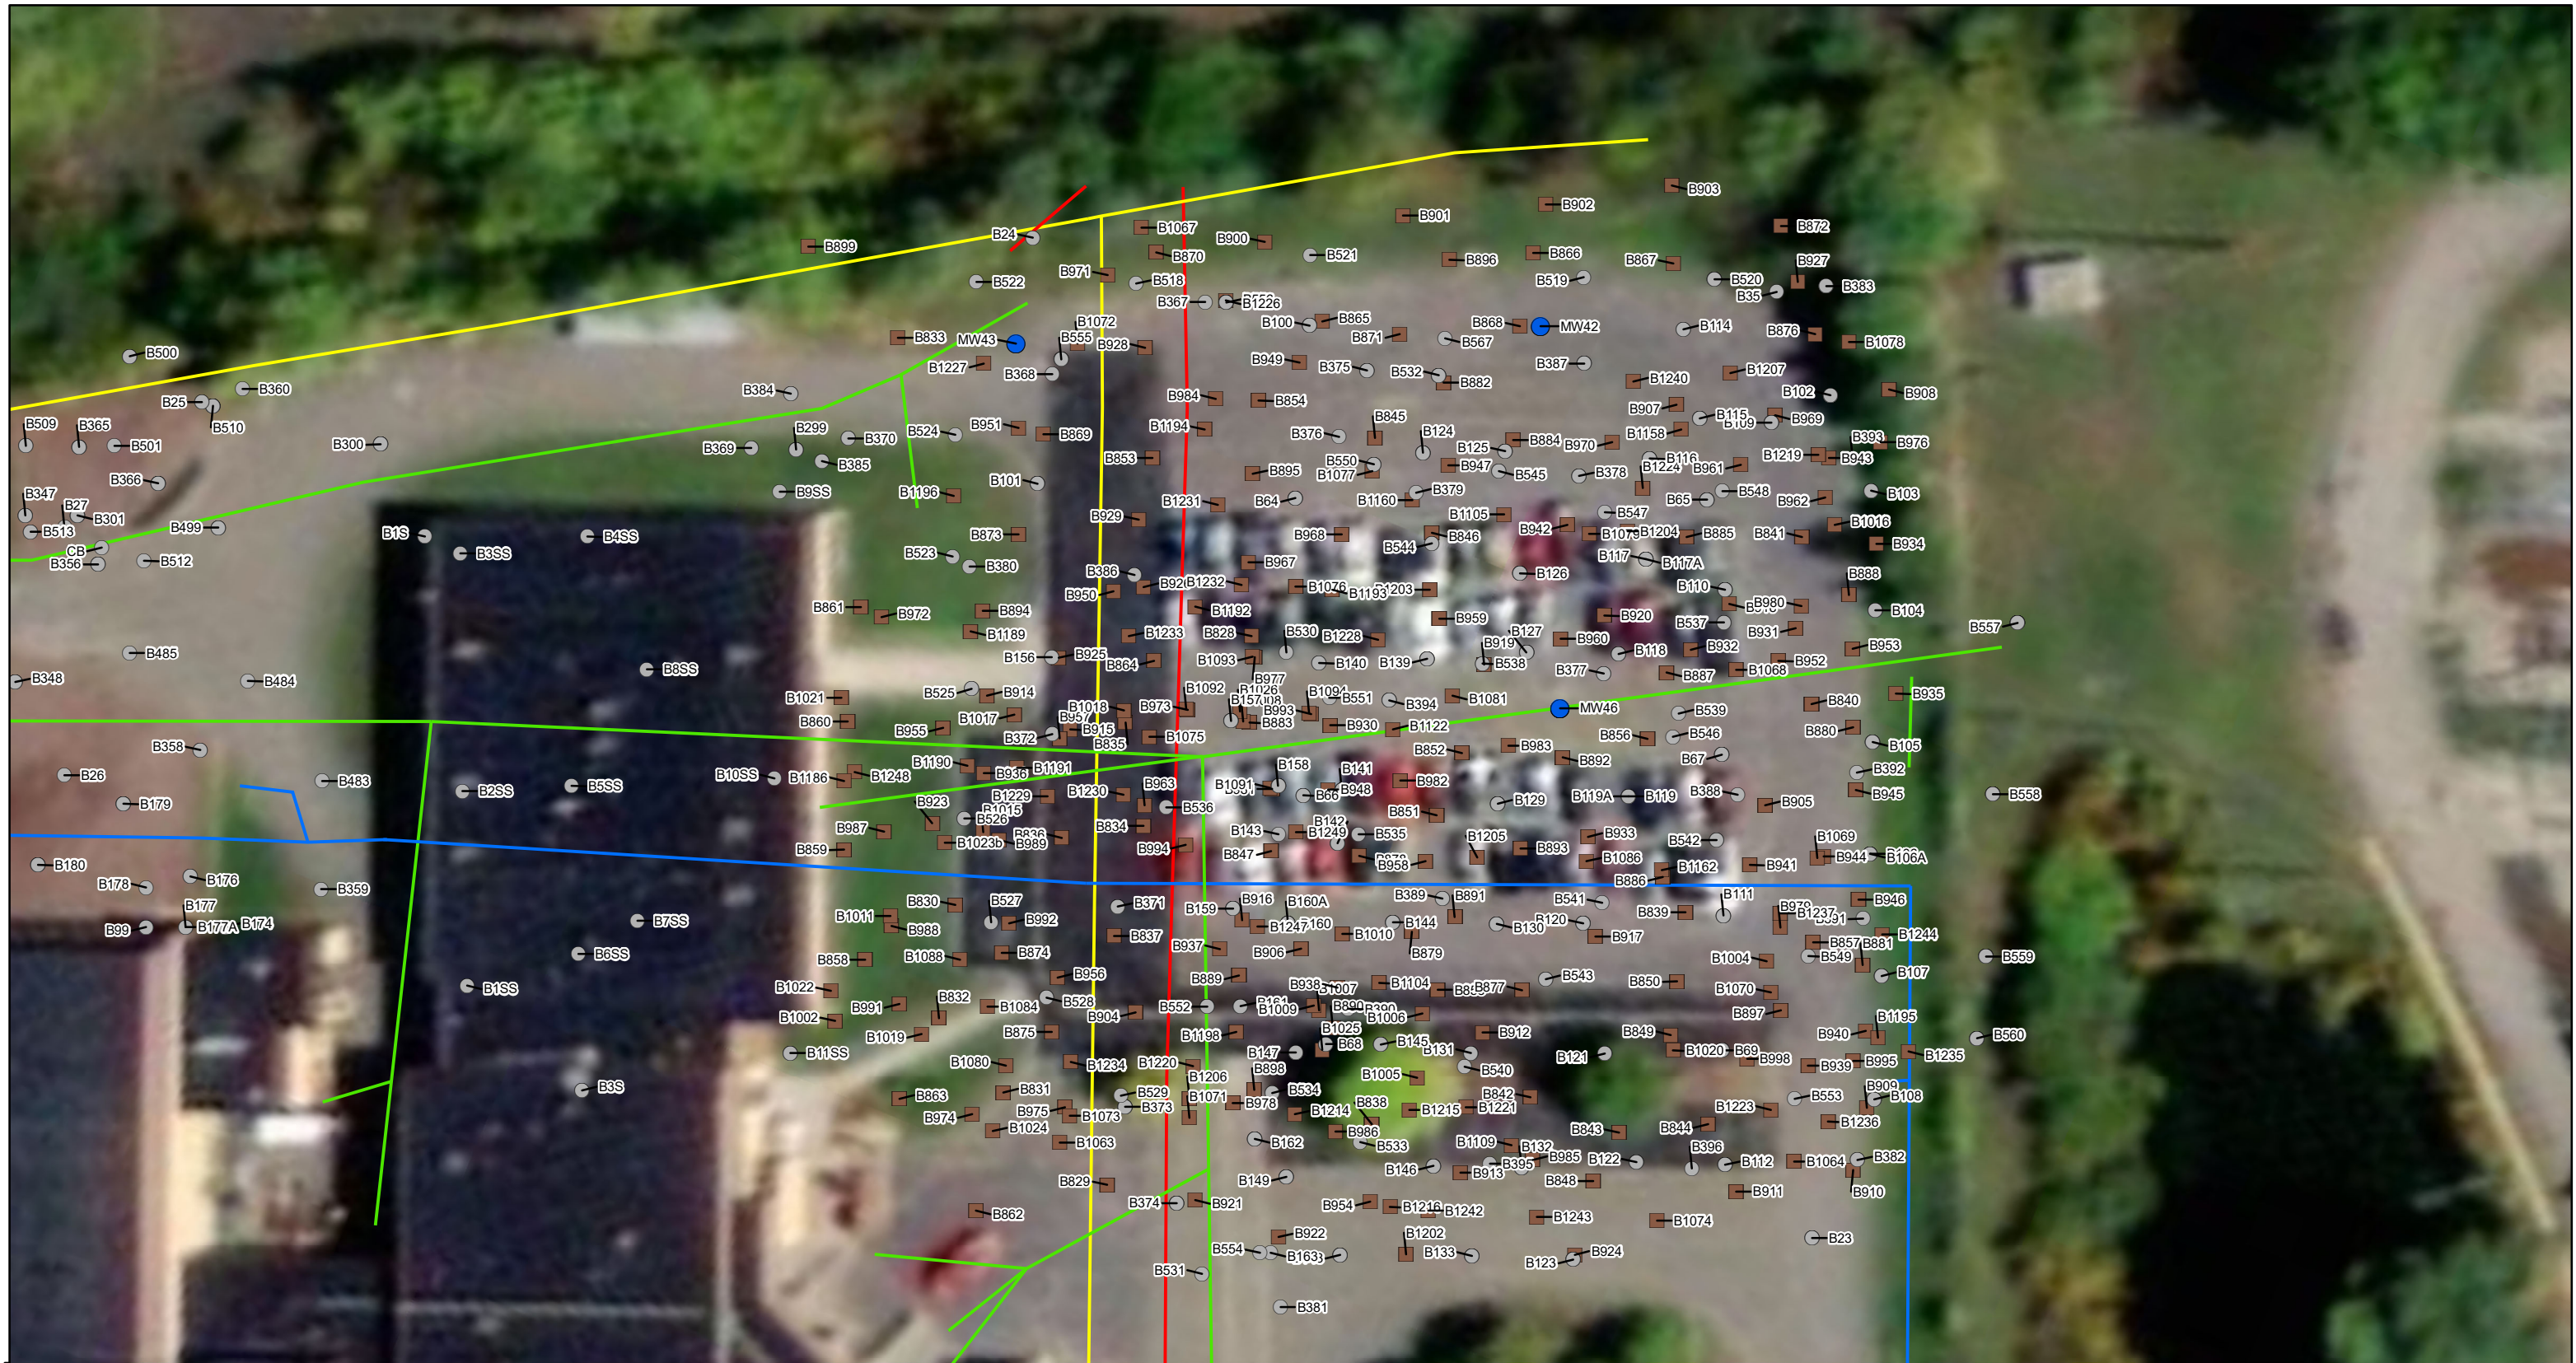
<p>Soil Investigation Summary Rear Parking Lot</p> <p>Former Sperry Remington Site North Portion IRM#2 Elmira, New York</p>	
<p>Beech and Bonaparte engineering p.c.</p> <p><small>an affiliate of Geosyntec Consultants</small></p>	
<p>Columbia, Maryland</p>	<p>July 2018</p>
<p>Figure</p> <p>3</p>

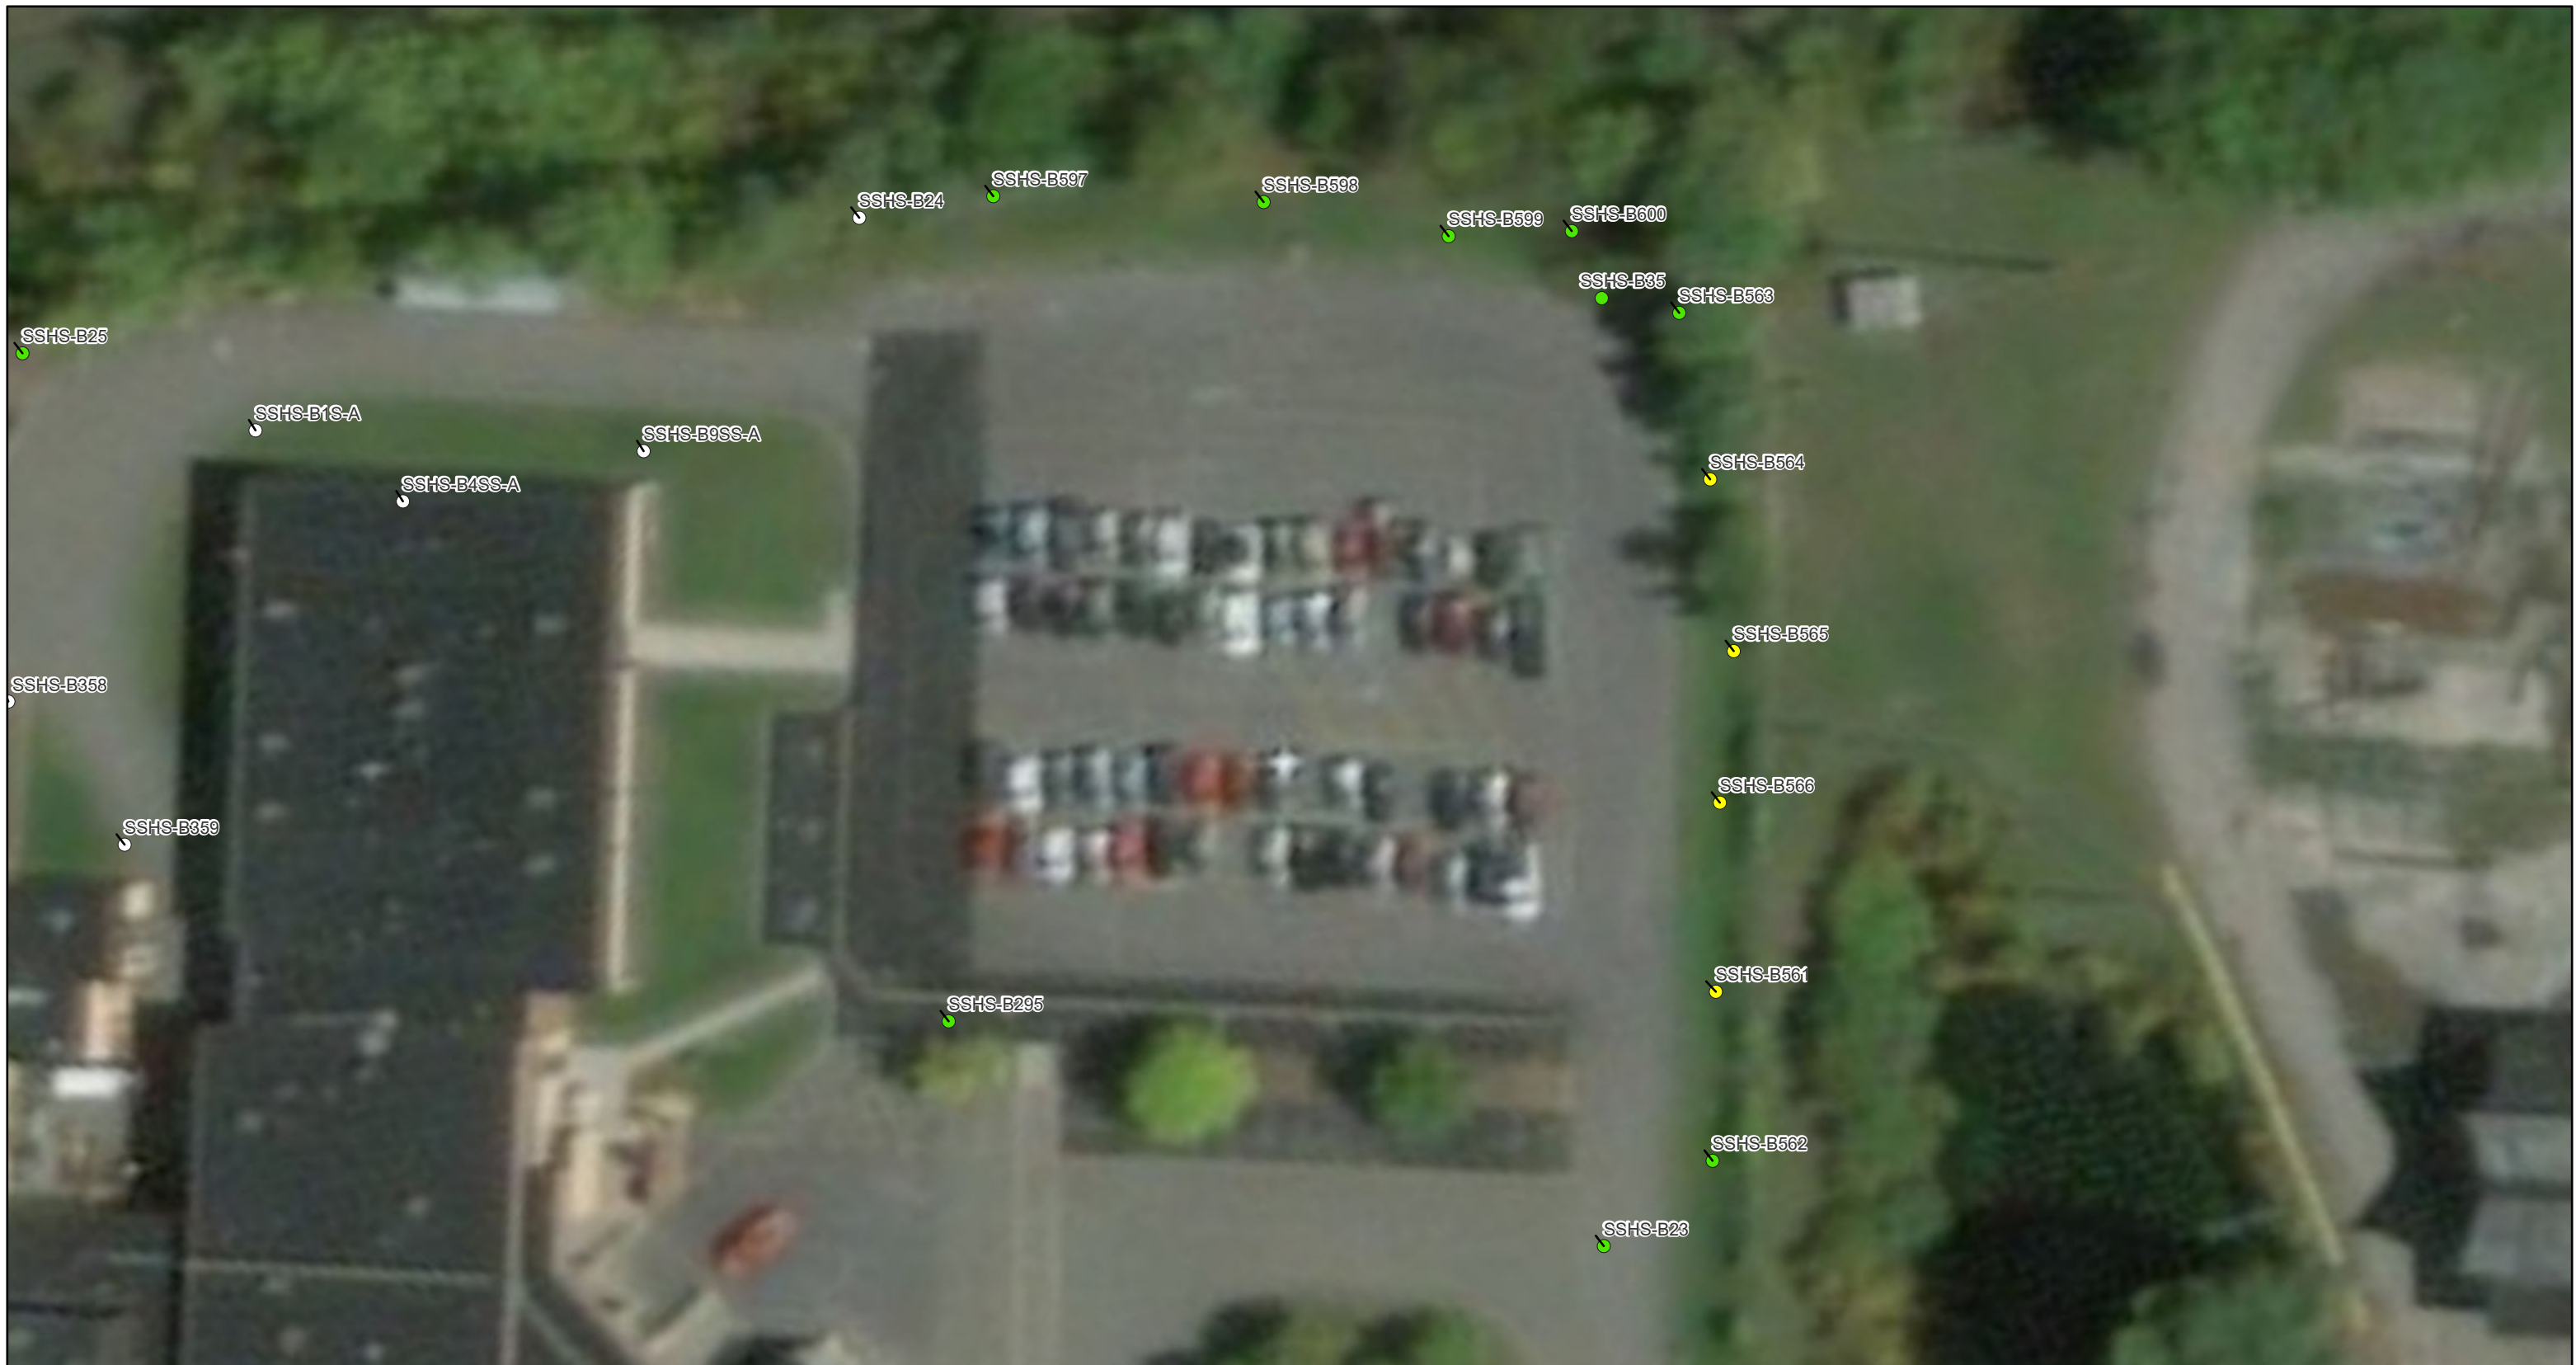
Extent of PCBs in Surface Soil Rear Parking Lot Former Sperry Remington Site North Portion IRM#2 Elmira, New York	
Columbia, Maryland	April 2018
Figure 4

Analytical results from surface and shallow subsurface soil samples are summarized on **Table 2**. Total PCB concentrations in soil are compared to the Restricted Residential SCO for total PCBs of one (1) mg/kg and to the limit of fifty (50) mg/kg for PCB remediation wastes as defined in 40 CFR §761.3 Toxic Substances Control Act (TSCA). TSCA limits are considered in PCB delineation for identification of those soils that may be classified as hazardous waste containing PCBs as defined in 6 NYCRR Part 371.4 (e). **Figures 4** and **5** present the extent of total PCBs in surface and shallow subsurface soils, respectively.

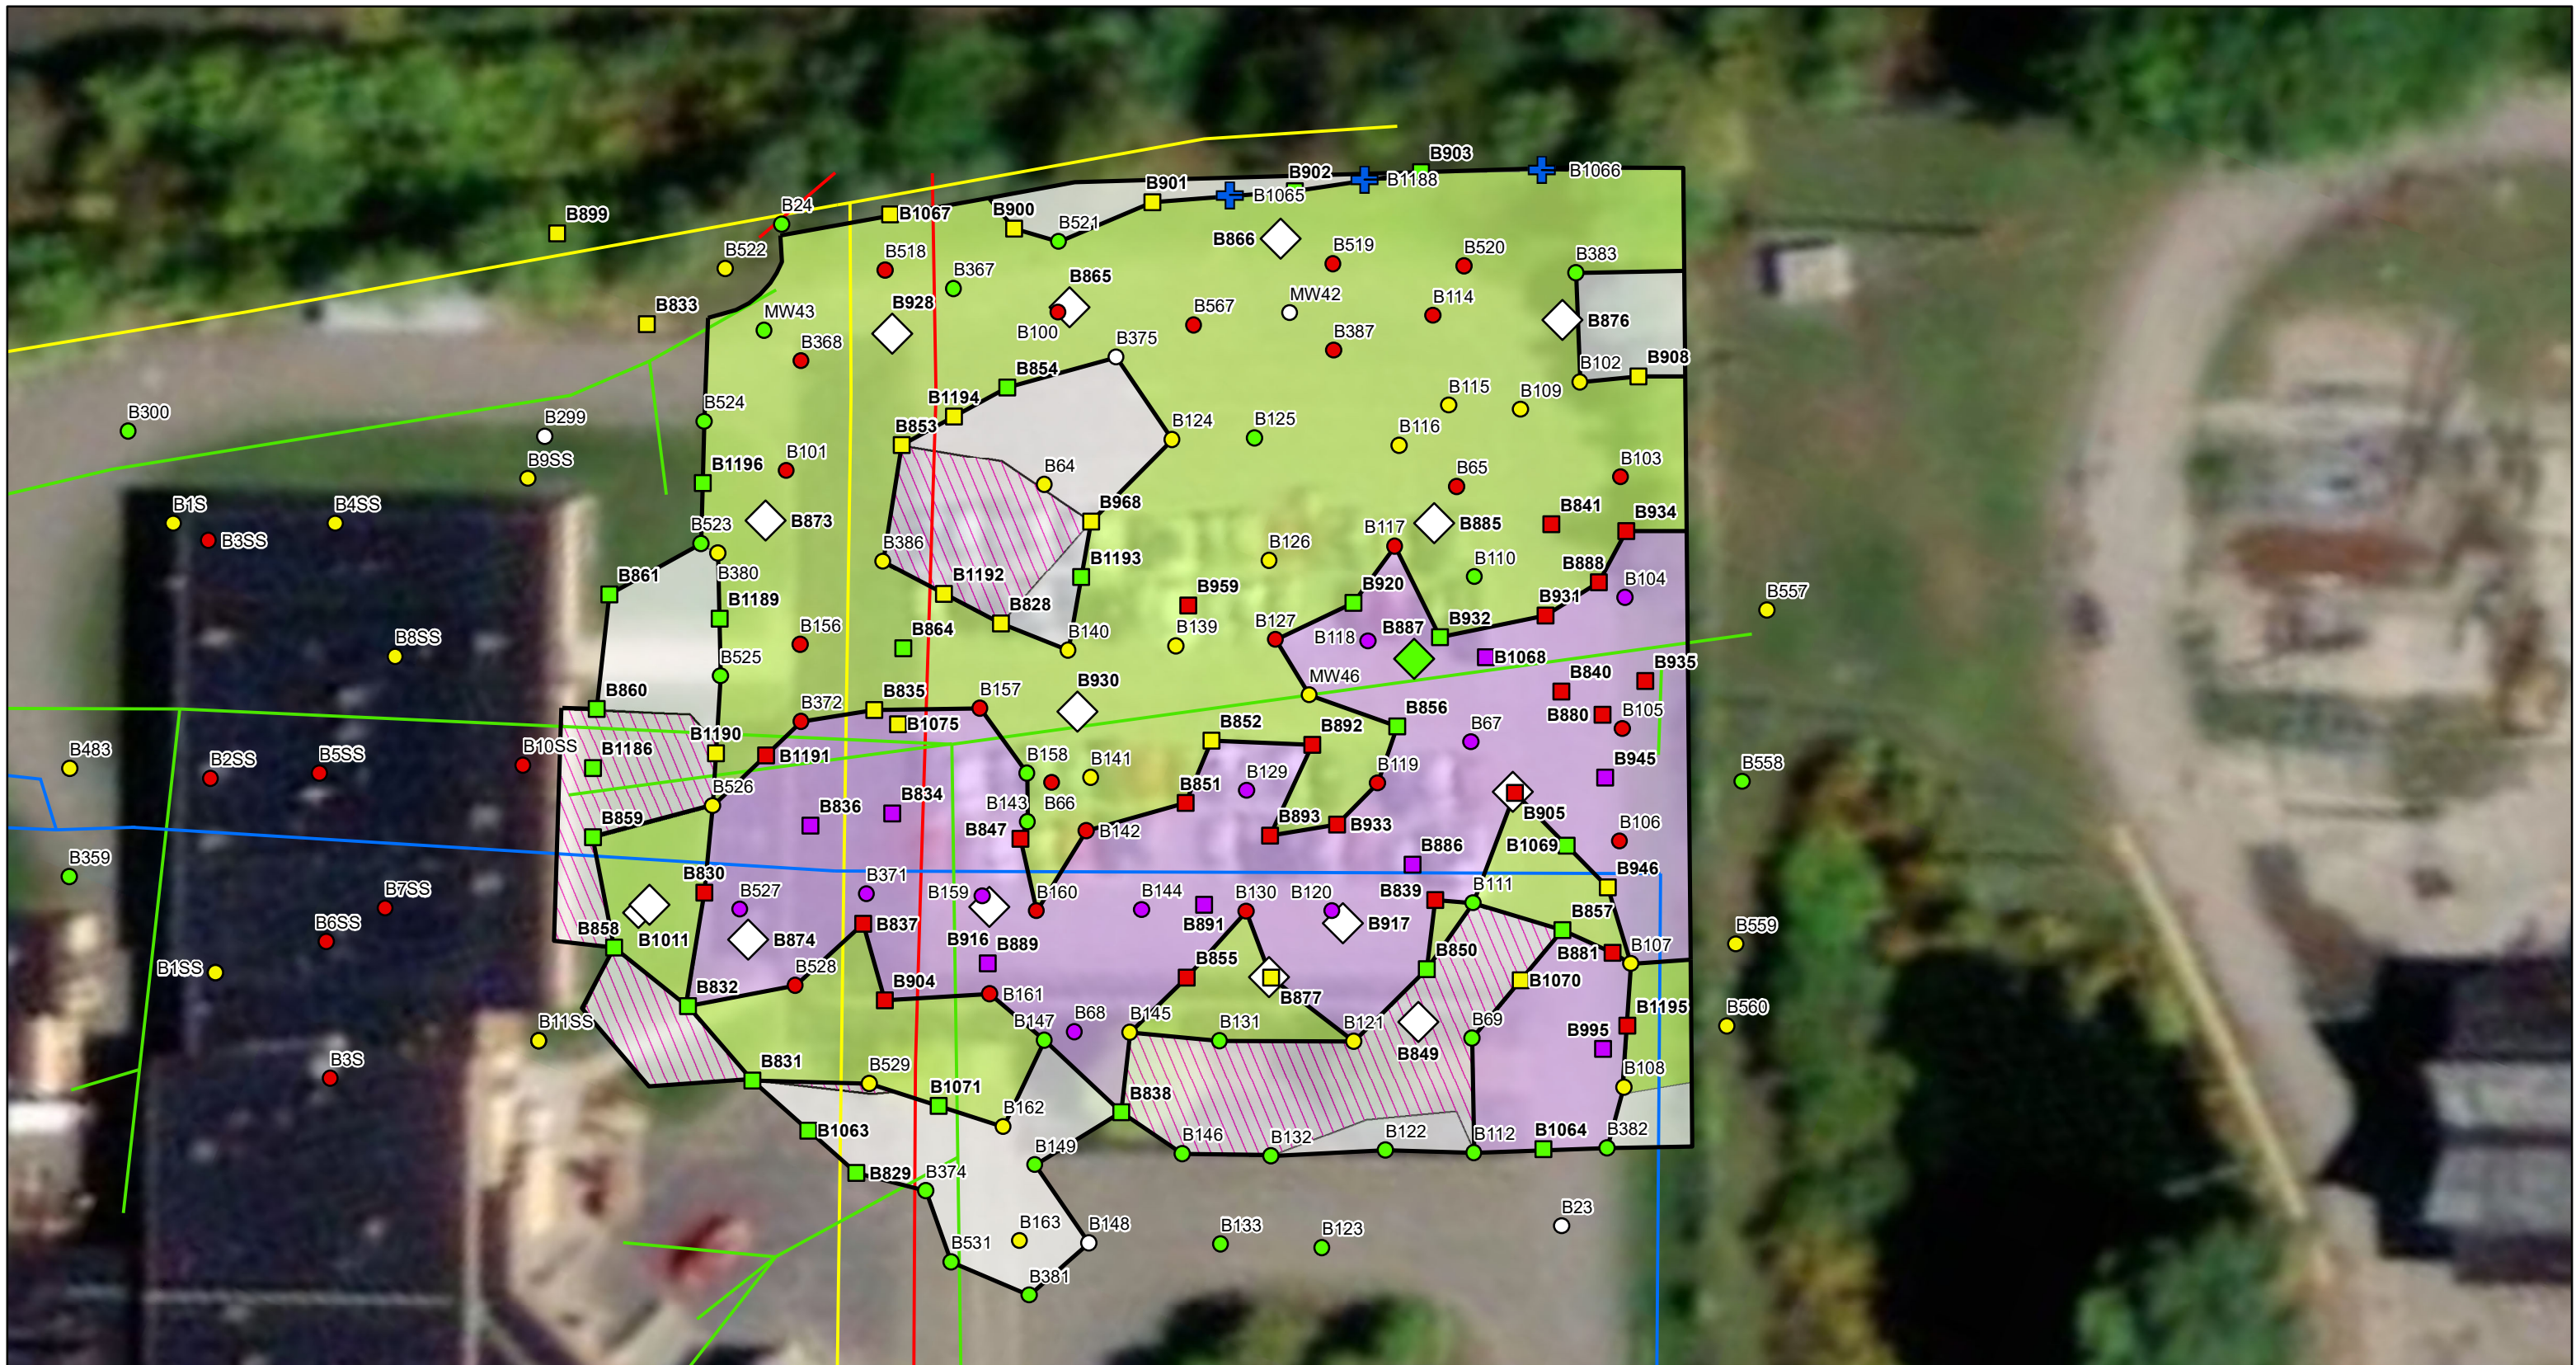
Proposed Excavation Rear Parking Lot (0-2 ft bgs)	
Former Sperry Remington Site North Portion IRM#2 Elmira, New York	
Beech and Bonaparte engineering p.c. <small>an affiliate of Geosyntec Consultants</small>	
Columbia, Maryland	July 2018
Figure 5

Figure Number	Label	Waste Category	Bottom Depth (ft)	Bottom of Excavation Area ¹ (SF)	Proposed Bottom Samples			
					Required Number of Samples	Proposed Samples	Samples Needed	Bottom Sampling Rationale
6	NH-0-1	Non-Hazardous	2	12,932	15	15	0	1 sample per 900 square feet
6	NH-0-2	Non-Hazardous	2	1,204	2	2	0	2 proposed bottom confirmation sample
6	NH-0-3	Non-Hazardous	2	793	1	2	0	1 proposed bottom confirmation sample
6	NH-0-4	Non-Hazardous	2	303	1	5	0	5 sidewall samples from 0-2 ft bgs
6	HAZ-0-1	TSCA	2	371	1	5	0	5 sidewall samples from 0-2 ft bgs
7	NH-2-1	Non-Hazardous	4	2,291	3	3	0	1 sample per 900 square feet
7	NH-2-2	Non-Hazardous	4	2,017	3	3	0	1 sample per 900 square feet
7	NH-2-3	Non-Hazardous	4	893	1	1	0	1 sample per 900 square feet
7	NH-2-4	Non-Hazardous	4	583	1	1	0	1 sample per 900 square feet
7	NH-2-5	Non-Hazardous	4	874	1	1	0	1 proposed bottom confirmation sample
7	NH-2-6	Non-Hazardous	4	422	1	5	0	5 sidewall samples from 2-4 ft bgs

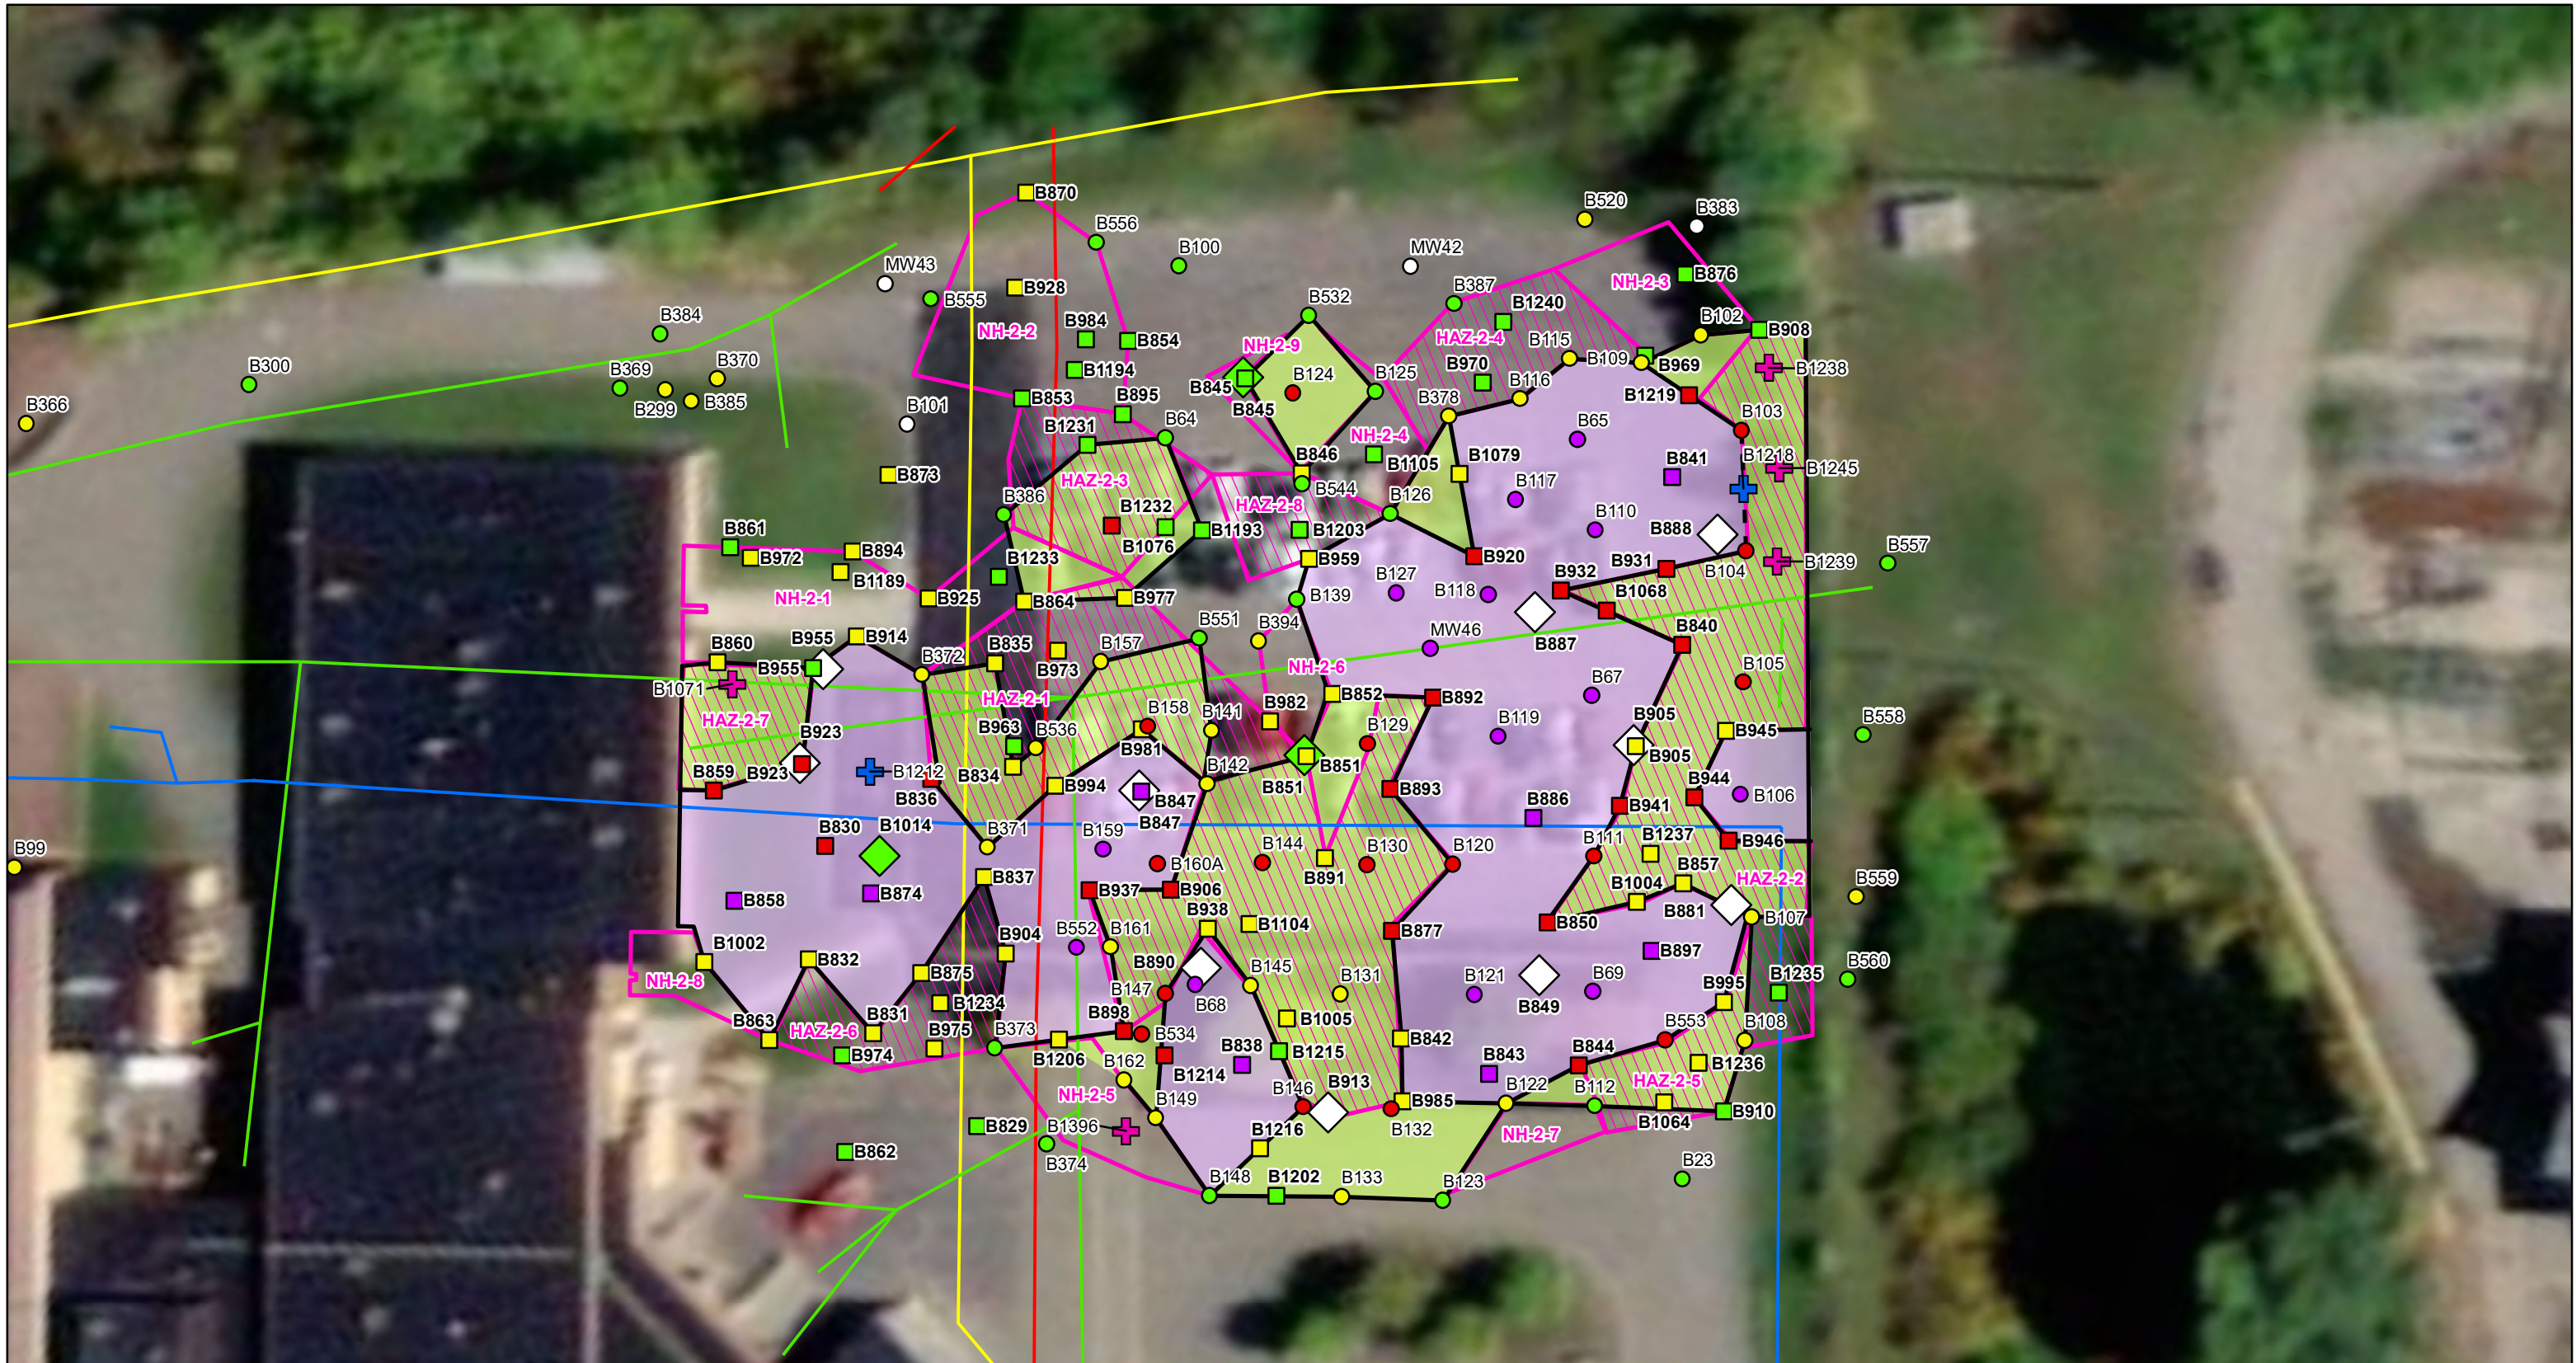
Proposed Excavation Rear Parking Lot (4-6 ft bgs)	
Former Sperry Remington Site North Portion IRM#2 Elmira, New York	
 an affiliate of Geosyntec Consultants	
Columbia, Maryland	July 2018
Figure 7

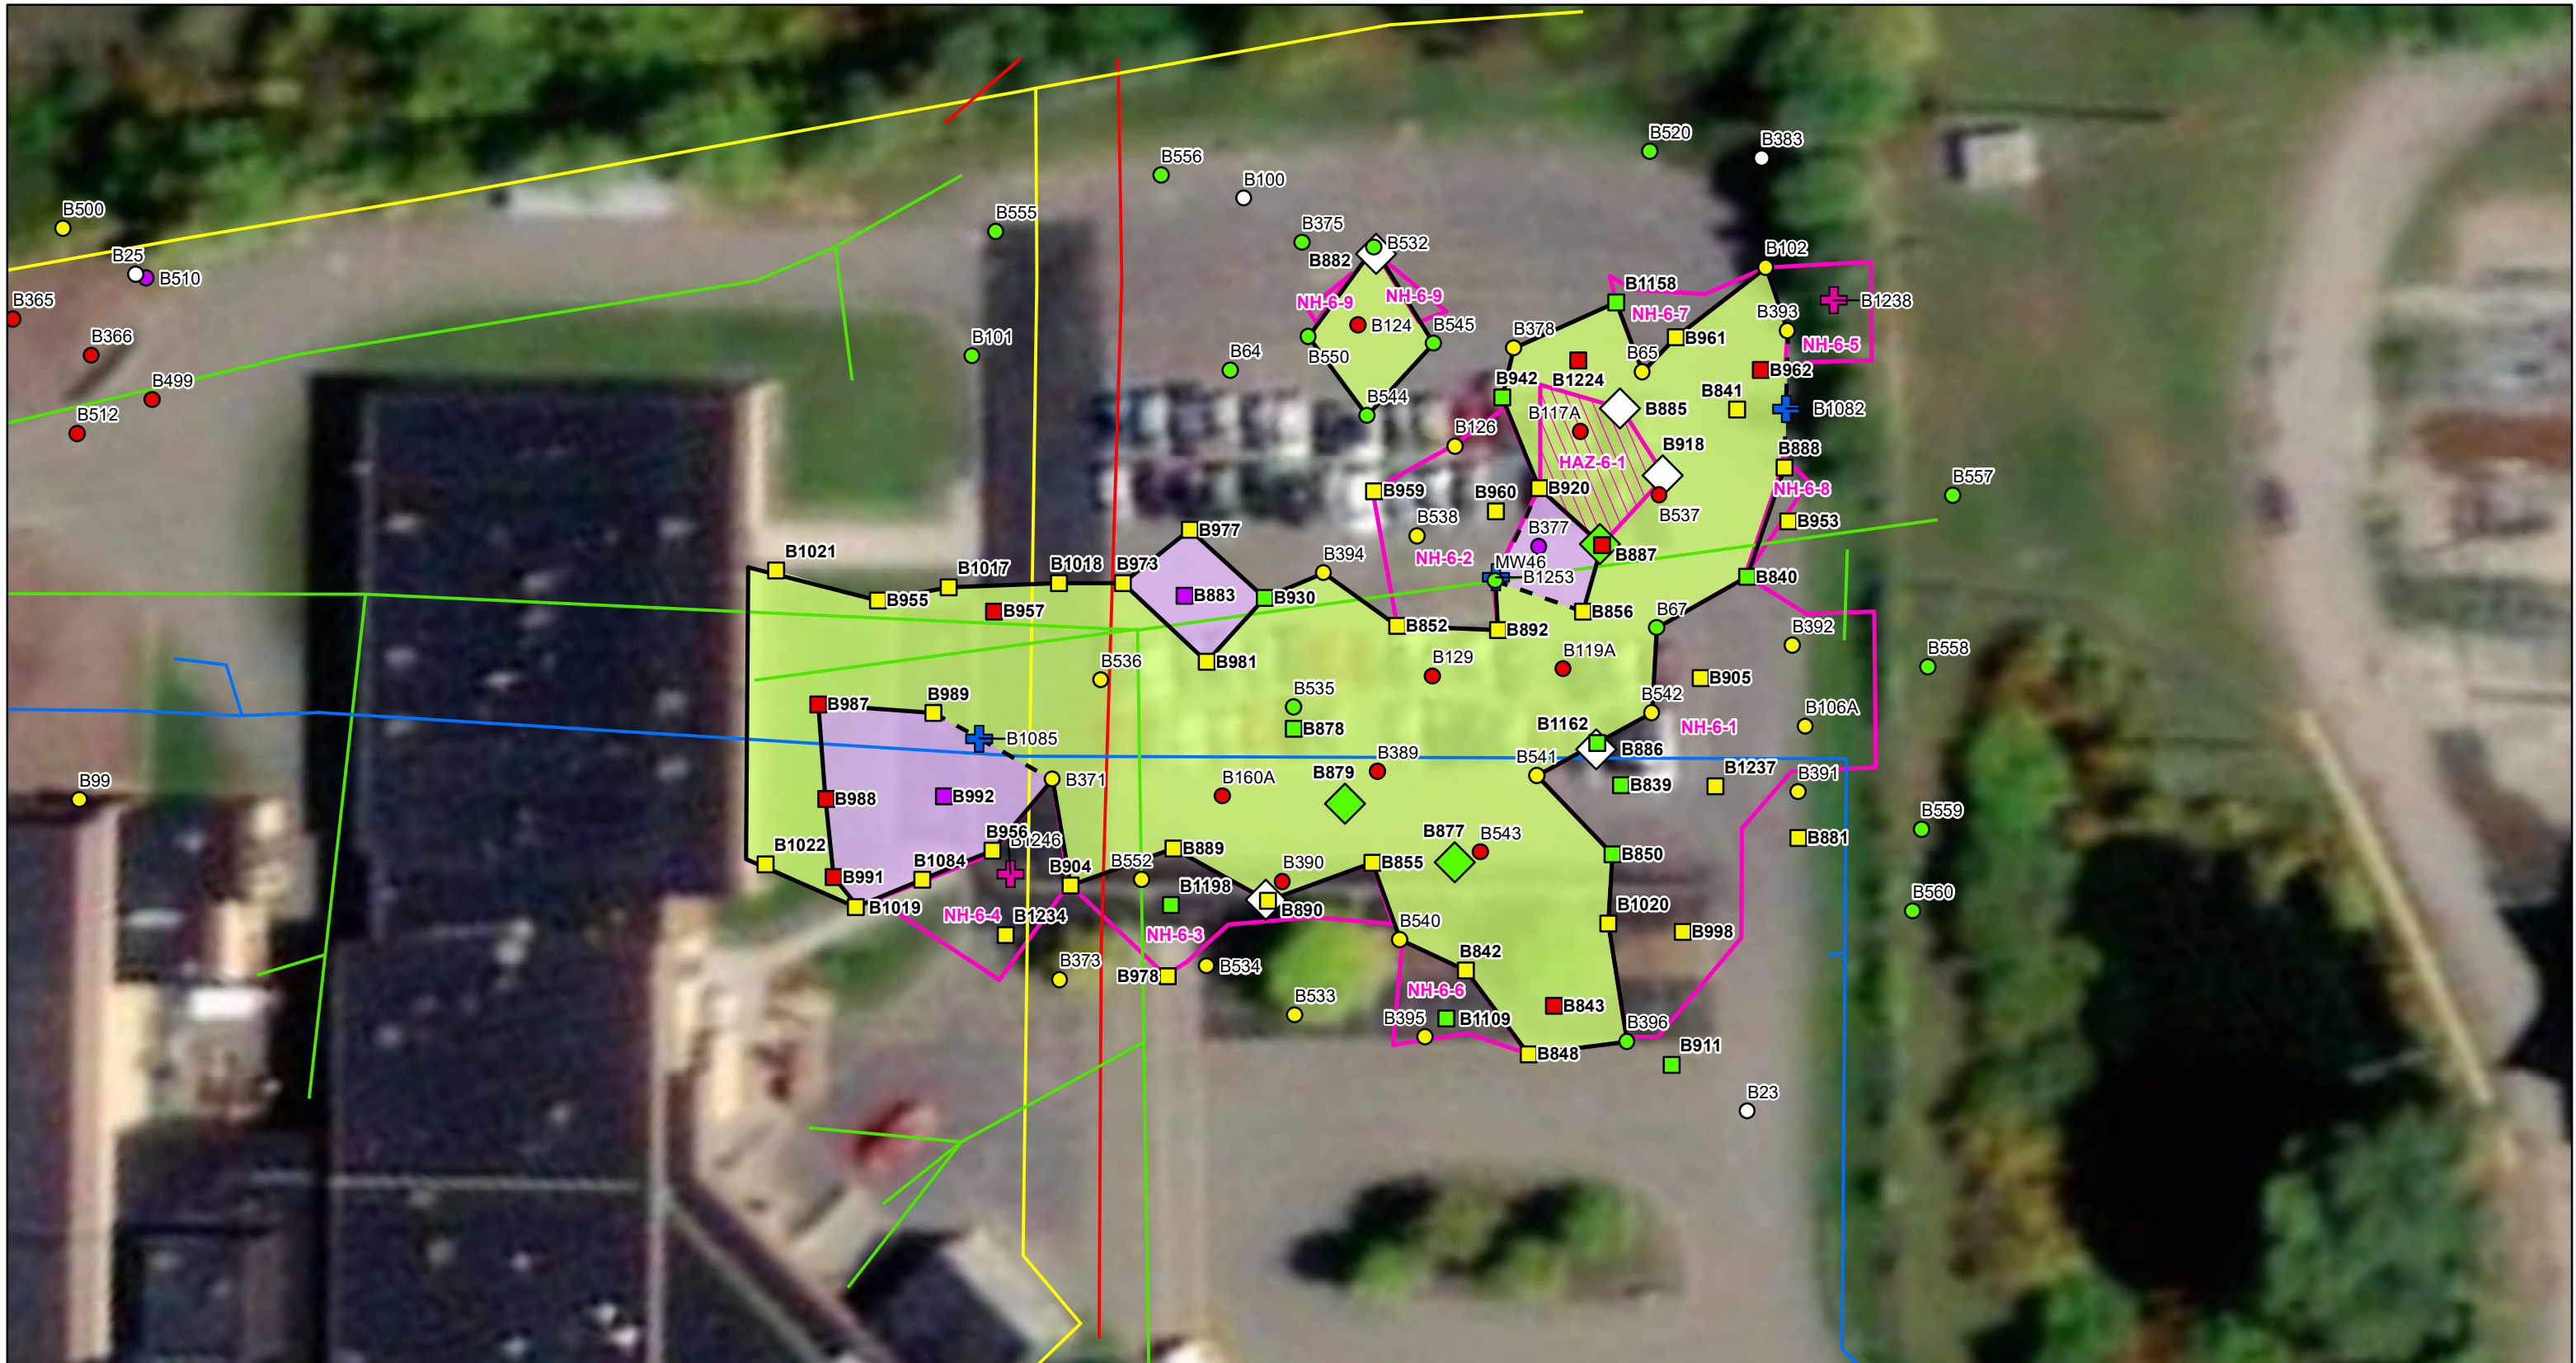
Proposed Excavation Rear Parking Lot (8-10 ft bgs) Former Sperry Remington Site North Portion IRM#2 Elmira, New York	
 an affiliate of Geosyntec Consultants	
Columbia, Maryland	July 2018
Figure 9

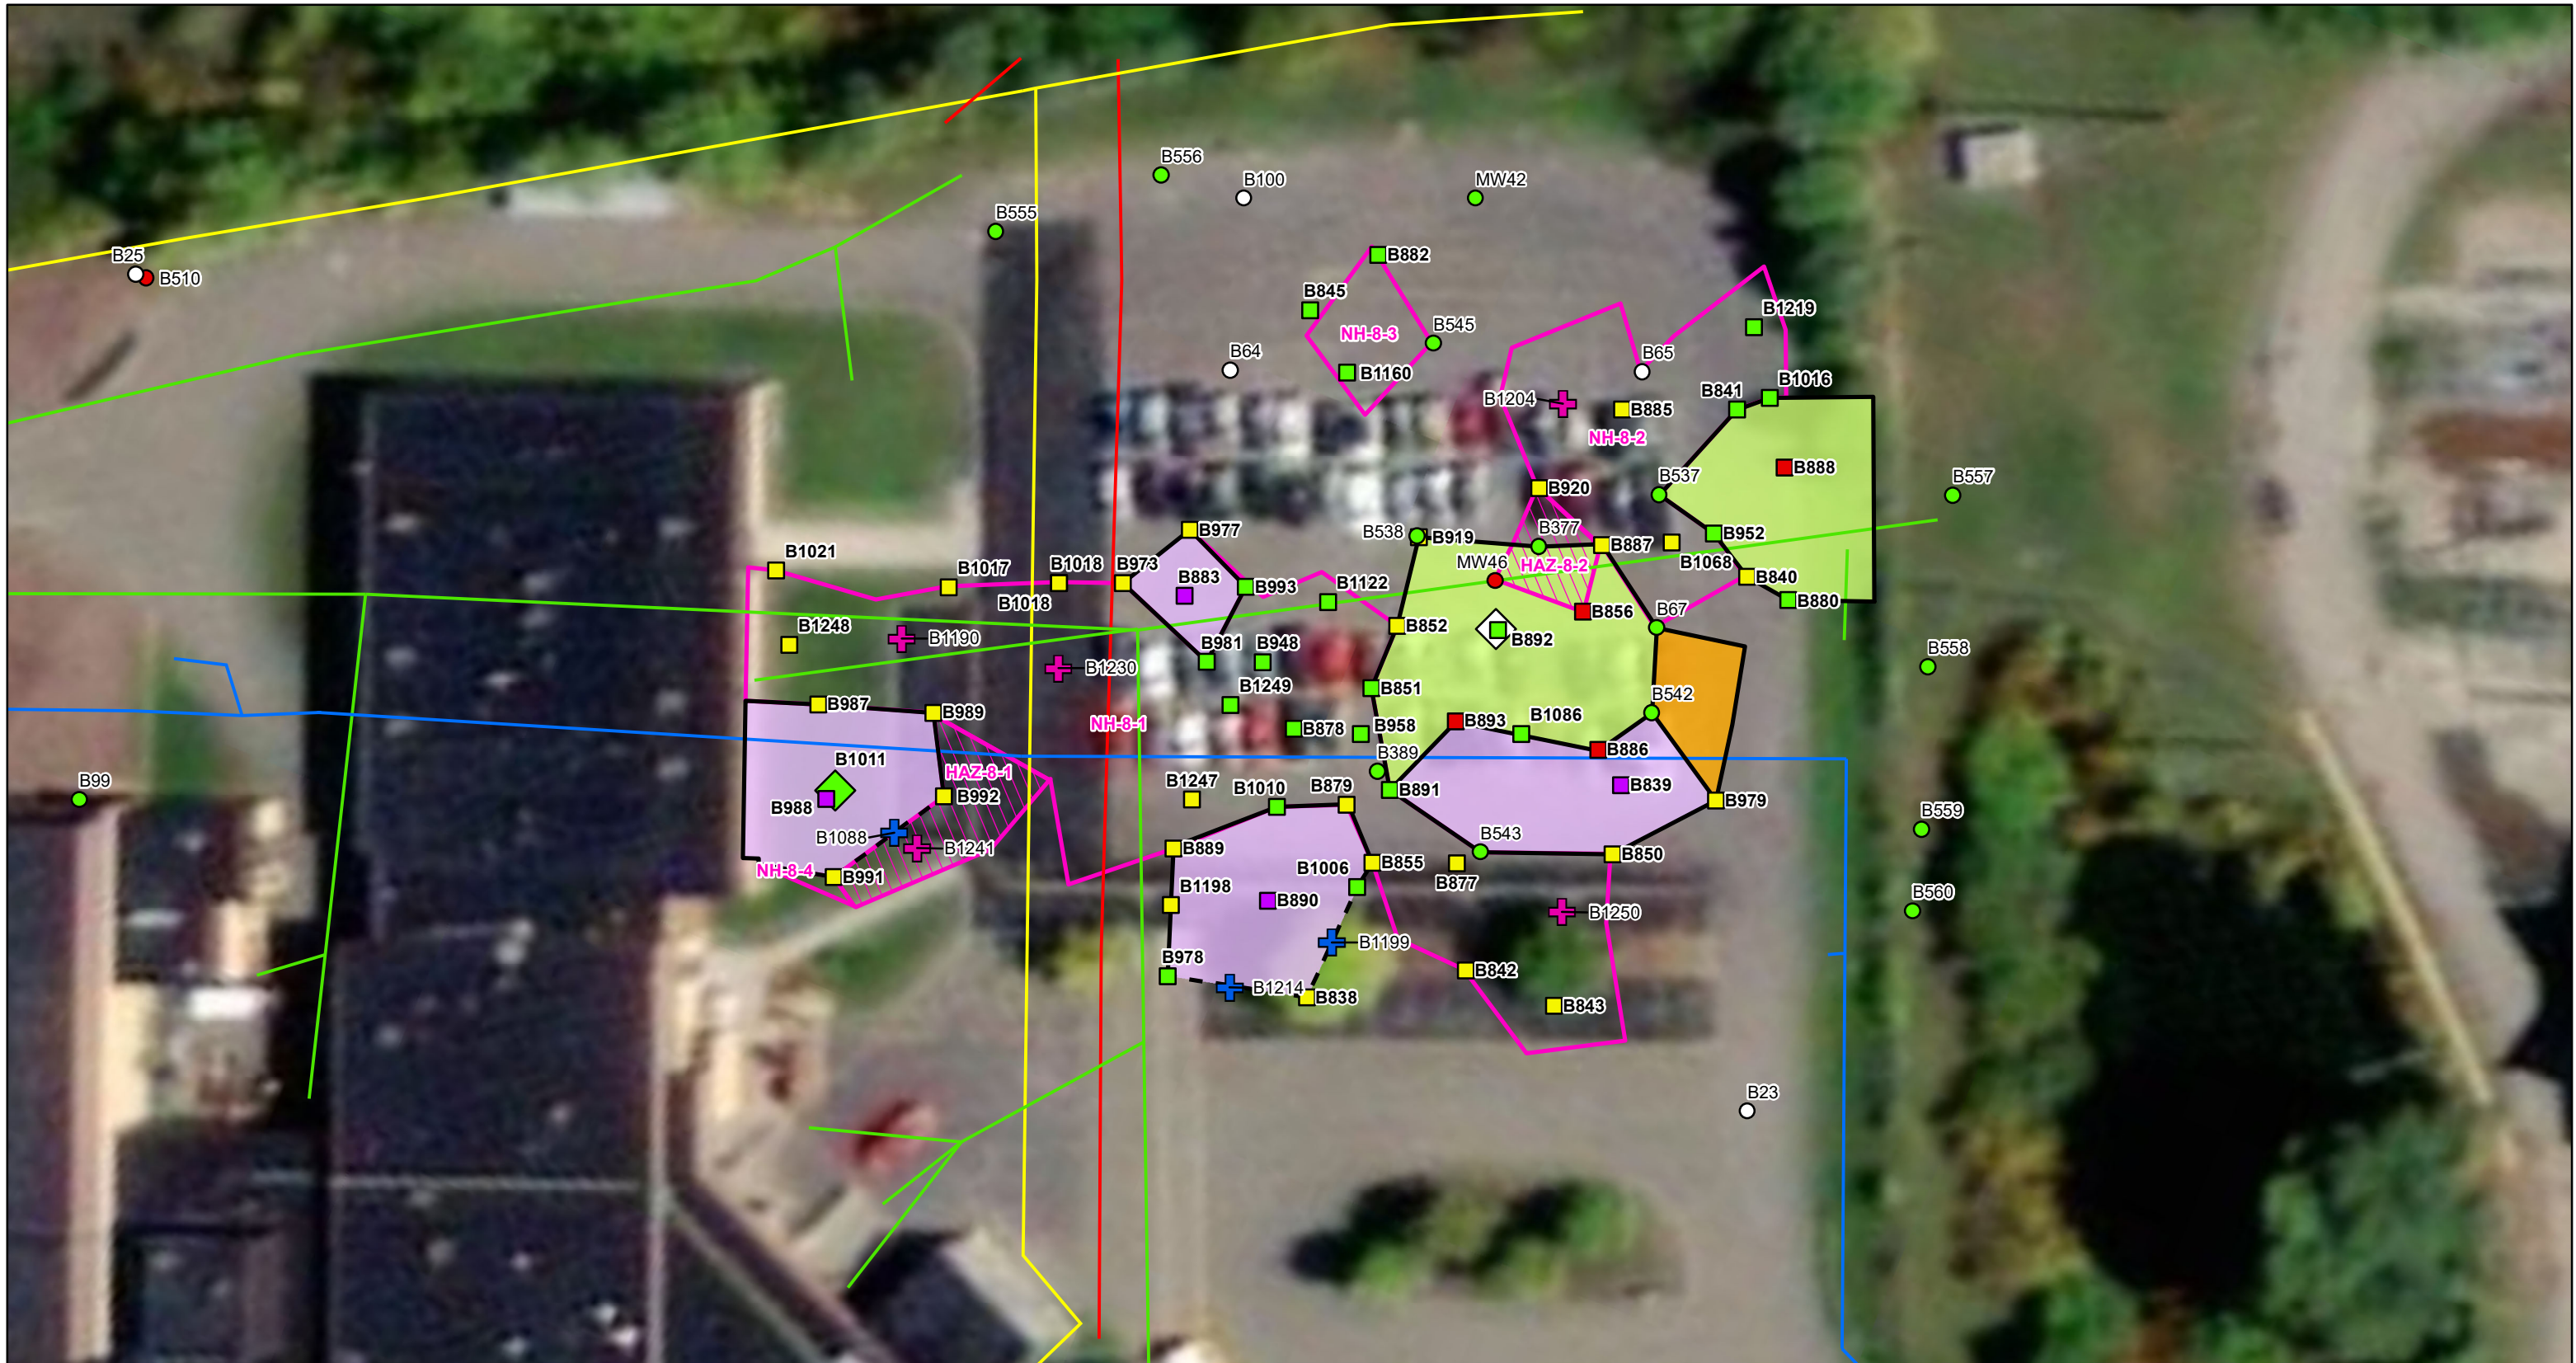
Proposed Excavation Rear Parking Lot (10-12 ft bgs) Former Sperry Remington Site North Portion IRM#2 Elmira, New York	
 an affiliate of Geosyntec Consultants	
Columbia, Maryland	July 2018
Figure 10
