INTERIM REMEDIAL MEASURES #2 WORK PLAN

**FORMER SPERRY REMINGTON SITE – NORTH PORTION
777 SOUTH MAIN STREET
CITY OF ELMIRA, CHEMUNG COUNTY, NY
NYSDEC PROJECT C808022**

Project Number MN0832D
Document Number MD18136

6 JUNE 2018; REVISED 13 JULY 2018

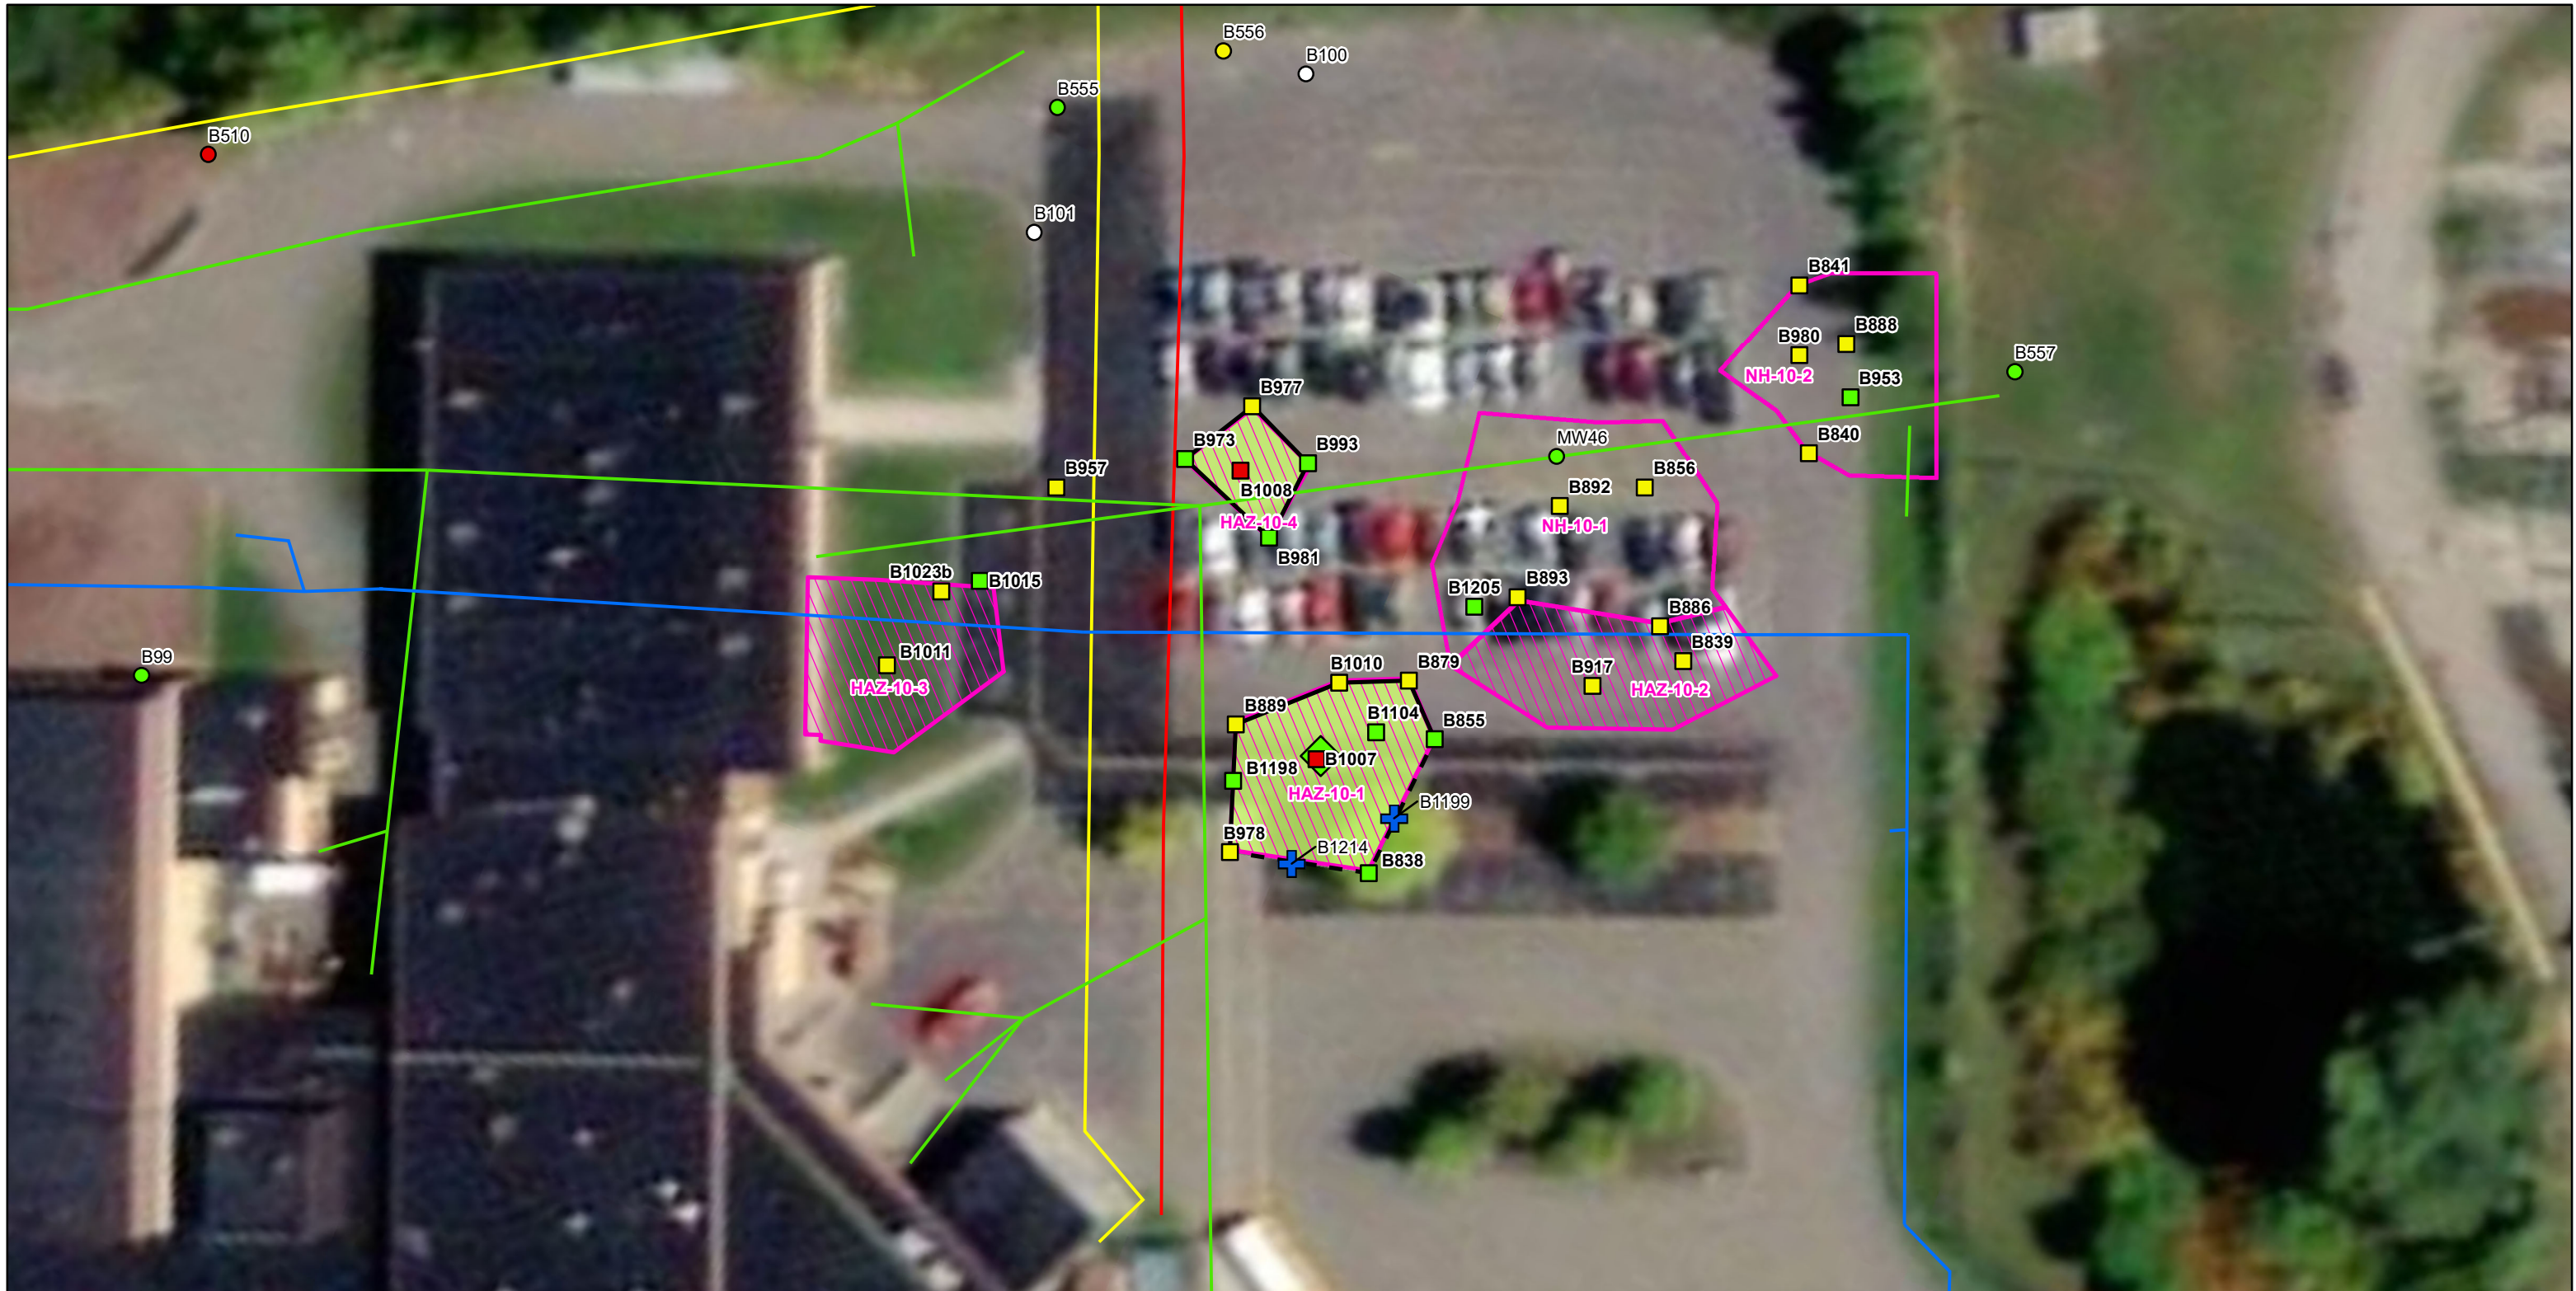
Legend Proposed Confirmation Sample (Sidewall)		Total PCB Results Soil (2018 PDI) Non-Detect 0 - 1 mg/kg 1 - 10 mg/kg 10 - 50 mg/kg > 50 mg/kg symbol: purple square"/> > 50 mg/kg		Total PCB Results Soil (Historic) Non-Detect 0 - 1 mg/kg 1 - 10 mg/kg 		Waste Characterization Sample (PDI) Lead TCLP Non-Detect Lead TCLP Detect < 5 mg/L Lead TCLP Detect ≥ 5 mg/L		Excavation Classification Non-Hazardous Bottom of 10-12 Foot Excavation Bottom of 10-12 Foot TSCA		Pre-Delineated Pre-Delineated Not Pre-Delineated Not Pre-Delineated		Utilities Natural Gas Electric Water Storm Sewer Sanitary Sewer		Notes "SSHS-" prefix removed from locations. PDI - Predisign Investigation ft bgs - Feet below ground surface Aerial imagery provided by ArcGIS Online.		Proposed Excavation Rear Parking Lot (12-14 ft bgs) Former Sperry Remington Site North Portion IRM#2 Elmira, New York		Figure 11
						Columbia, Maryland		July 2018

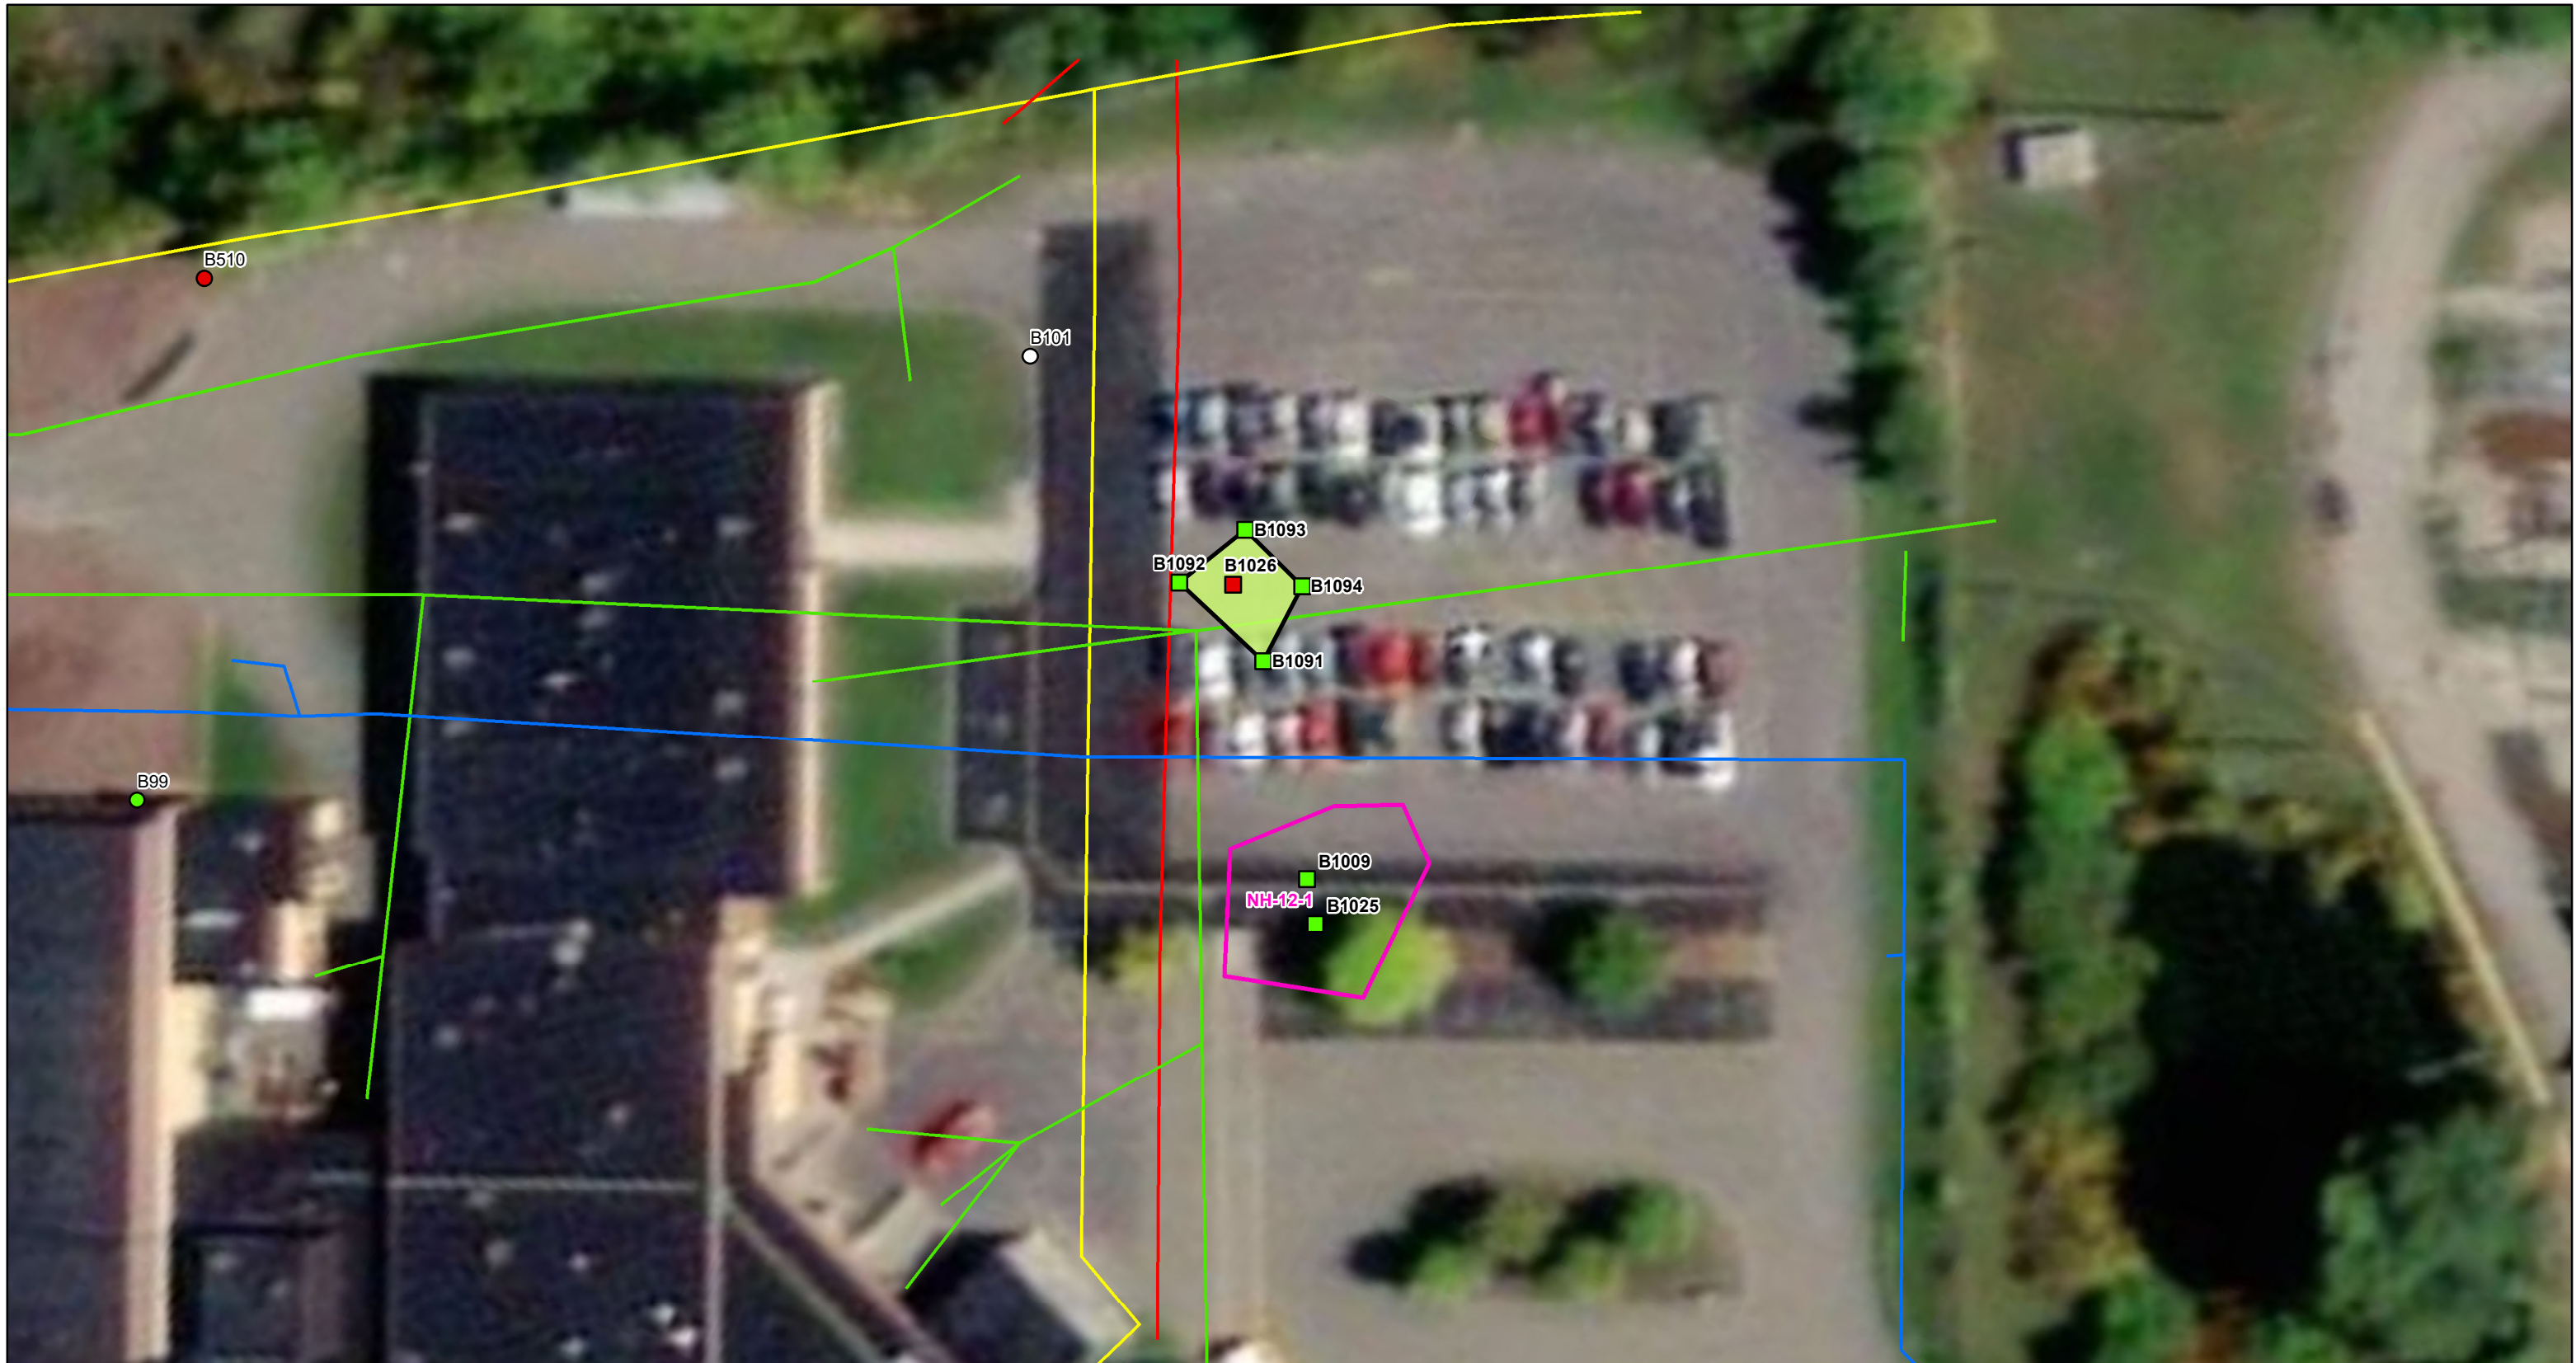
Figure
12

Total PCB Results Soil (2018 PDI)	Total PCB Results Soil (Historic)	Excavation Classification	Utilities
<ul style="list-style-type: none"> ■ 0 - 1 mg/kg ■ 10 - 50 mg/kg 	<ul style="list-style-type: none"> ○ Non-Detect ● 0 - 1 mg/kg ● 10 - 50 mg/kg 	<ul style="list-style-type: none"> Non-Hazardous Pre-Delineated Bottom of 12-14 Foot Excavation 	<ul style="list-style-type: none"> — Natural Gas — Electric — Water — Storm Sewer

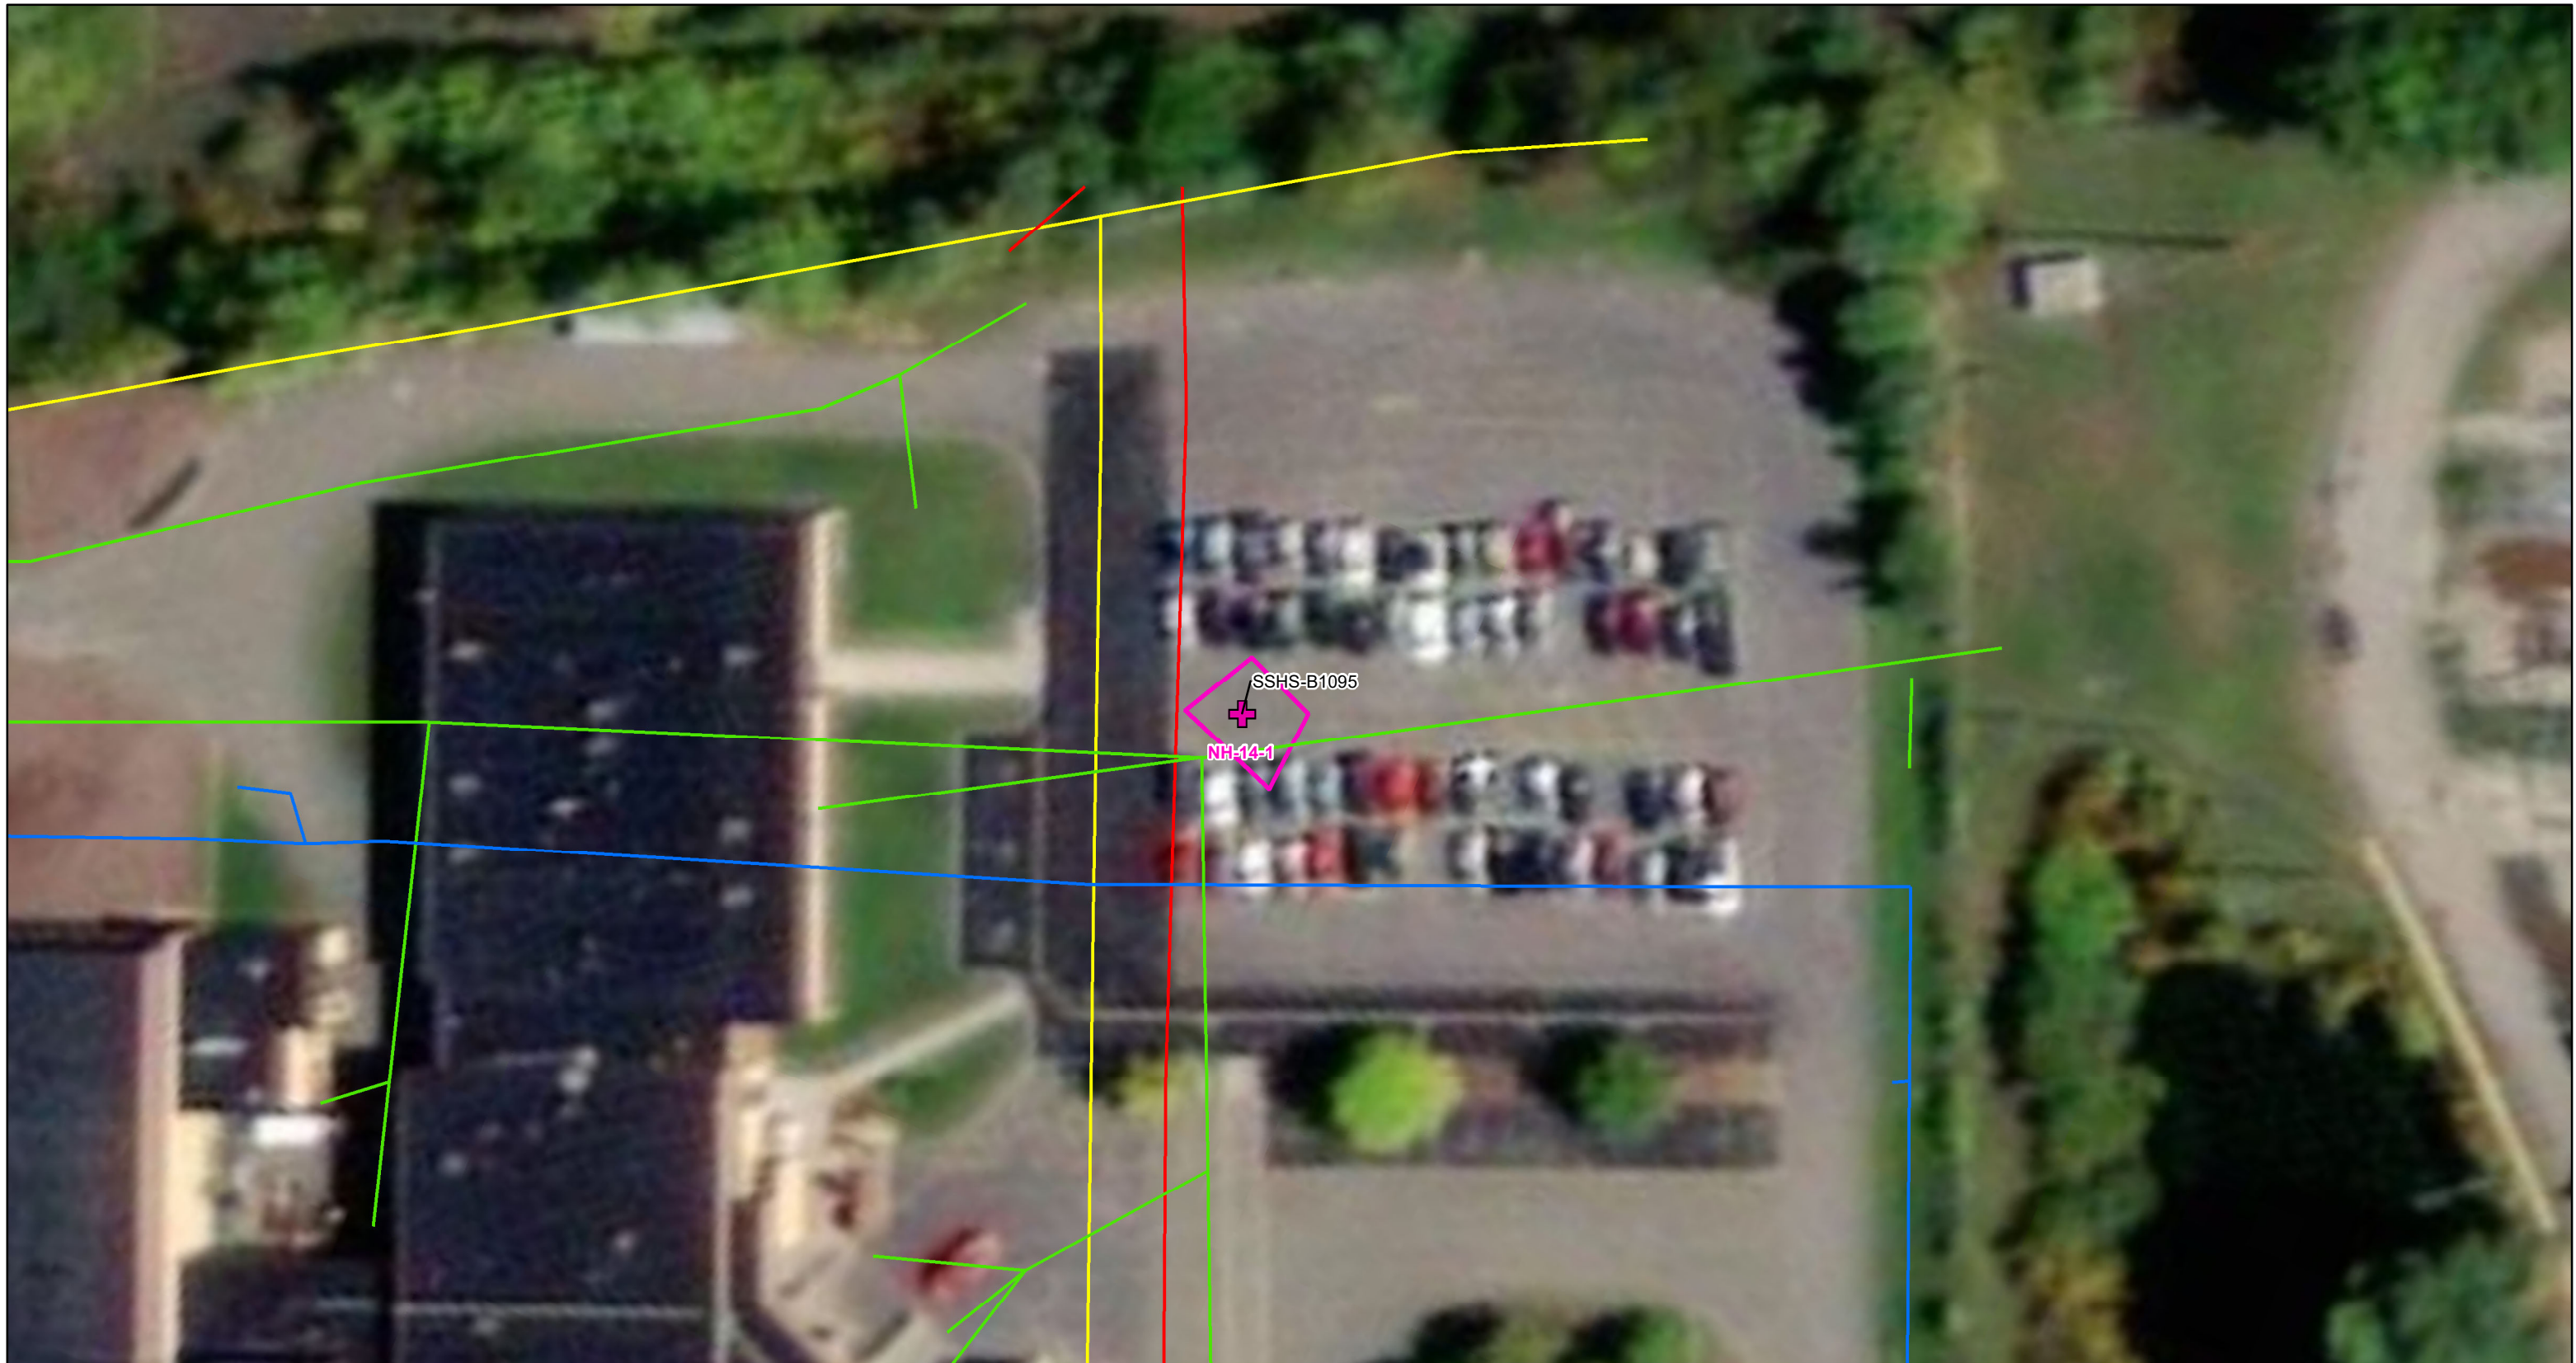
13

- + Proposed Confirmation Sample (Bottom)
 - Bottom of 14-16 Foot Excavation
- Utilities**
- Natural Gas
 - Electric
 - Water
 - Storm Sewer

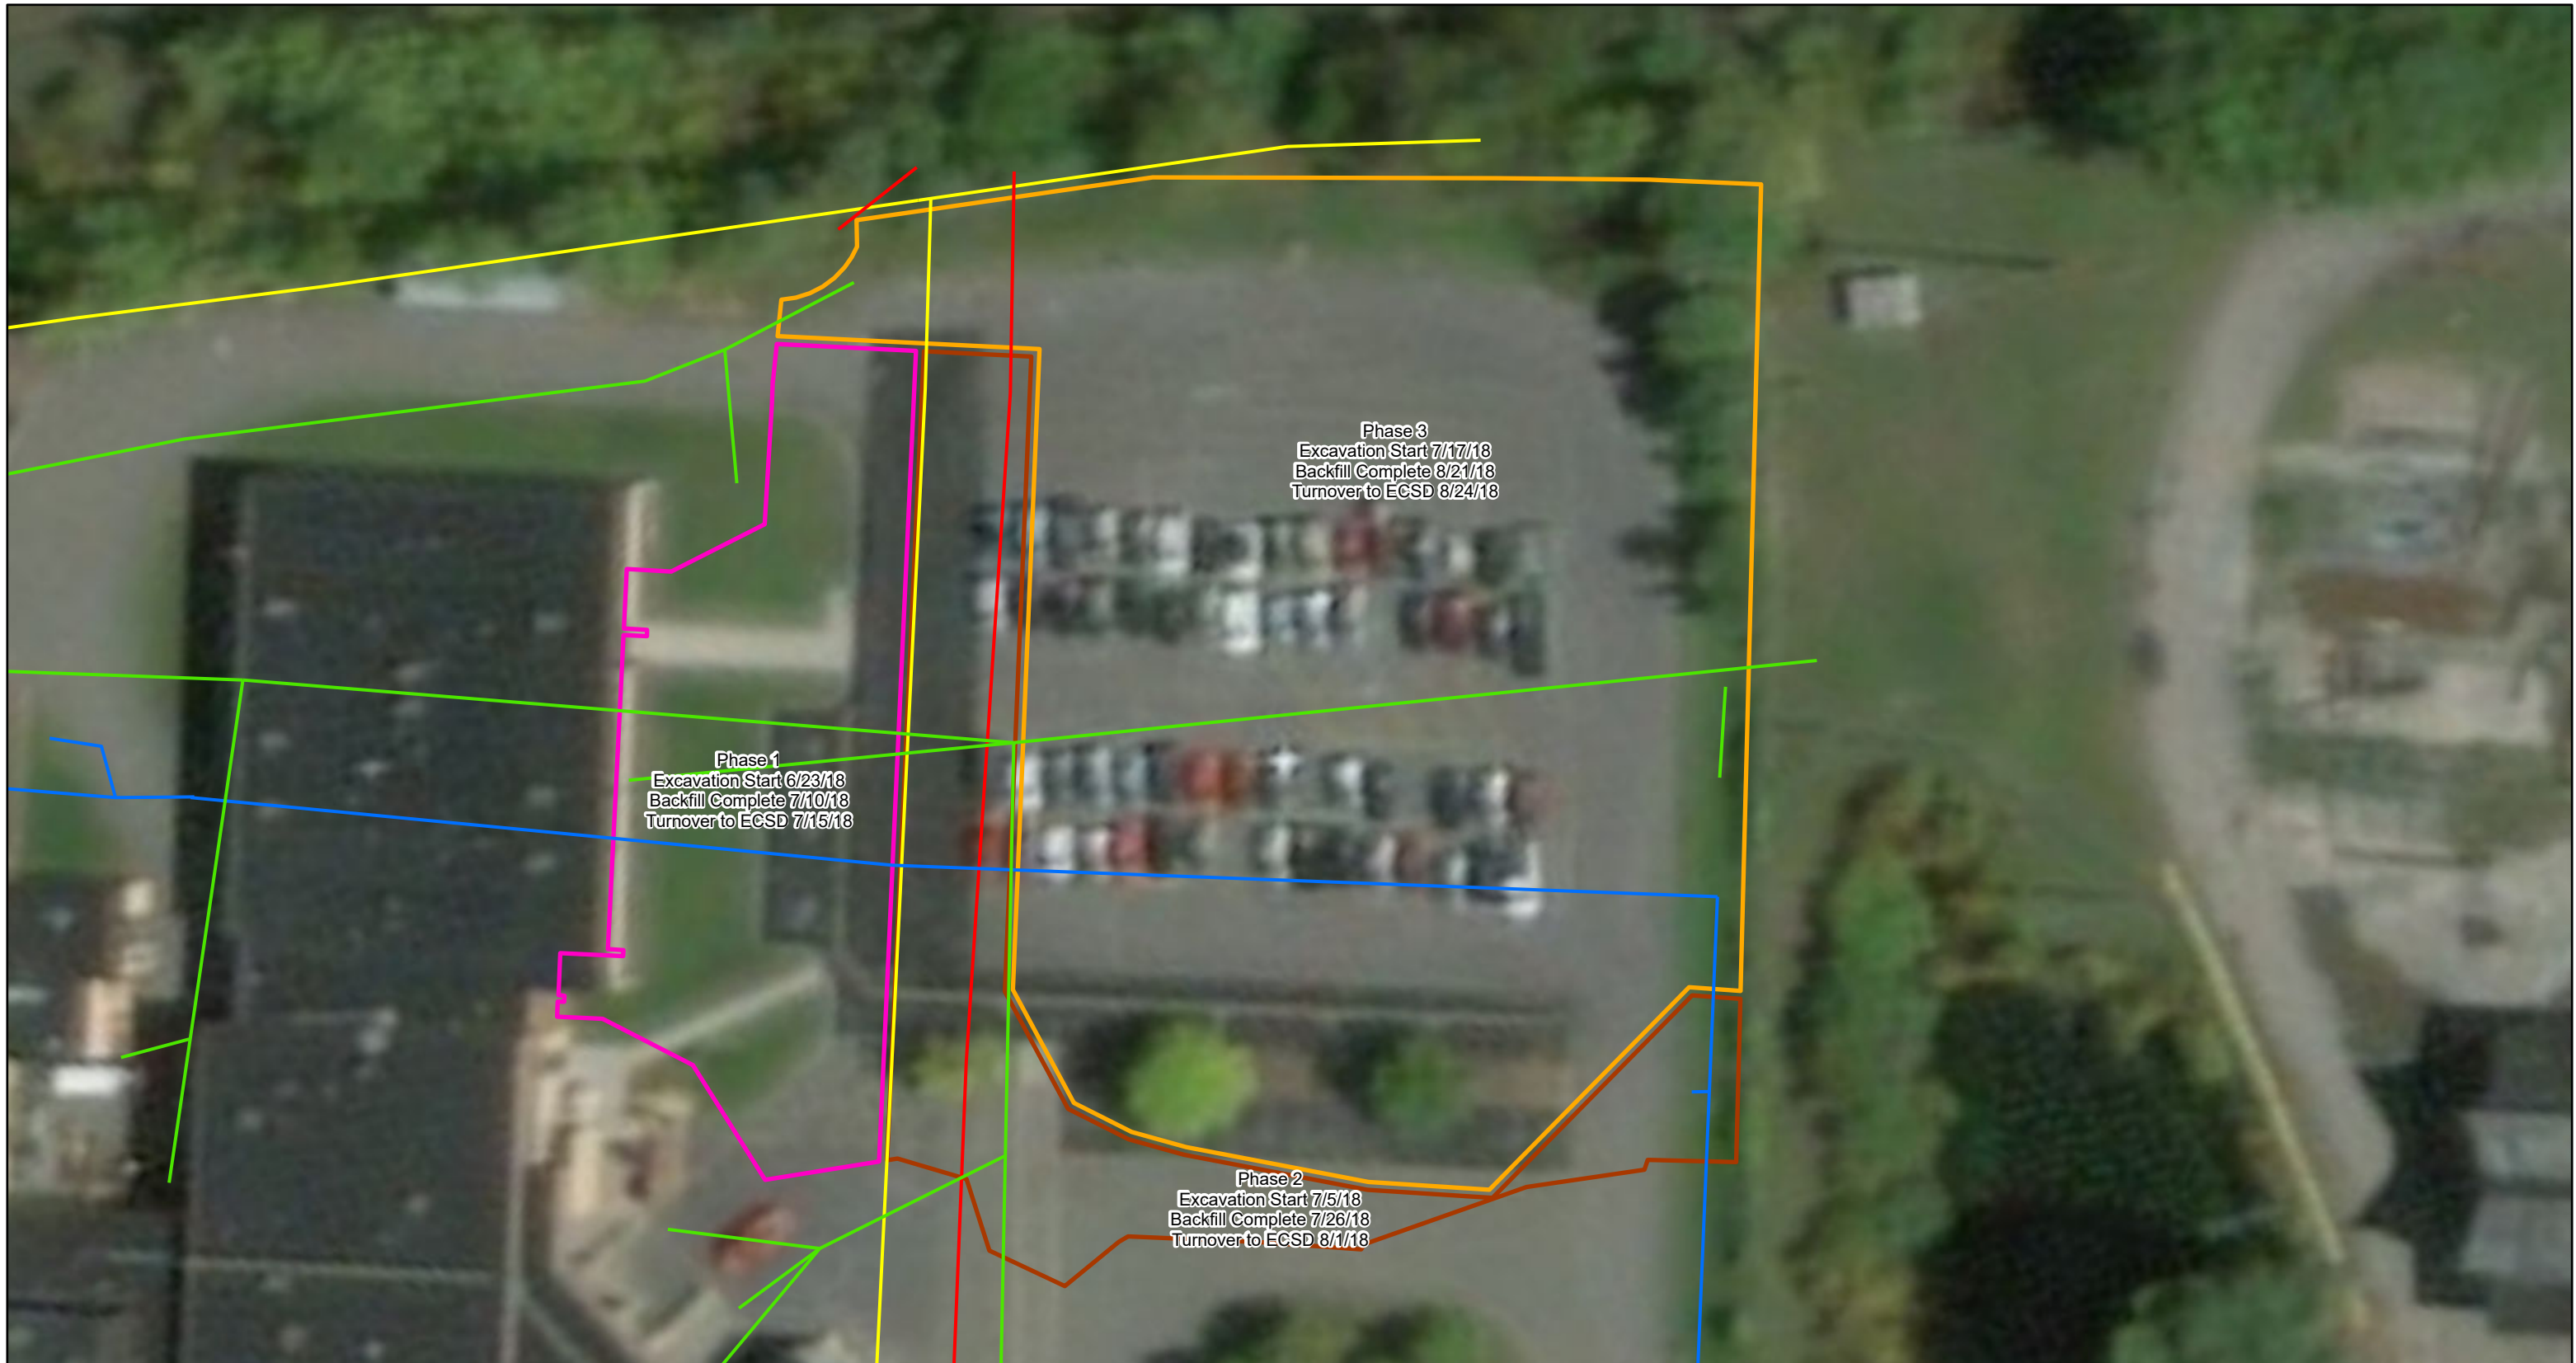
14

Excavation Phases	Utilities
 Phase 1	 Natural Gas
 Phase 2	 Electric
 Phase 3	 Water
	 Storm Sewer
	 Sanitary Sewer

During Phase I of excavation, PCB remediation waste and non-hazardous waste will be direct loaded into over the road tractor trailers which will enter and exit the Site via the EHS Service Entrance to South Main Street or direct loaded into over the road tractor trailers which will enter and exit the Site via the temporary haul road. After completion of Phase I, control of the EHS Service Entrance will be returned to ECSD and PCB remediation waste and non-hazardous waste will be direct loaded into over the road tractor trailers which will enter and exit the Site via the temporary haul road only. PCB remediation waste will be loaded in the TSCA loading area to be constructed on STCC property. At all times, materials to be stockpiled for potential reuse or material approved for reuse as backfill will be transported between the Site and the MSA via the temporary haul road.

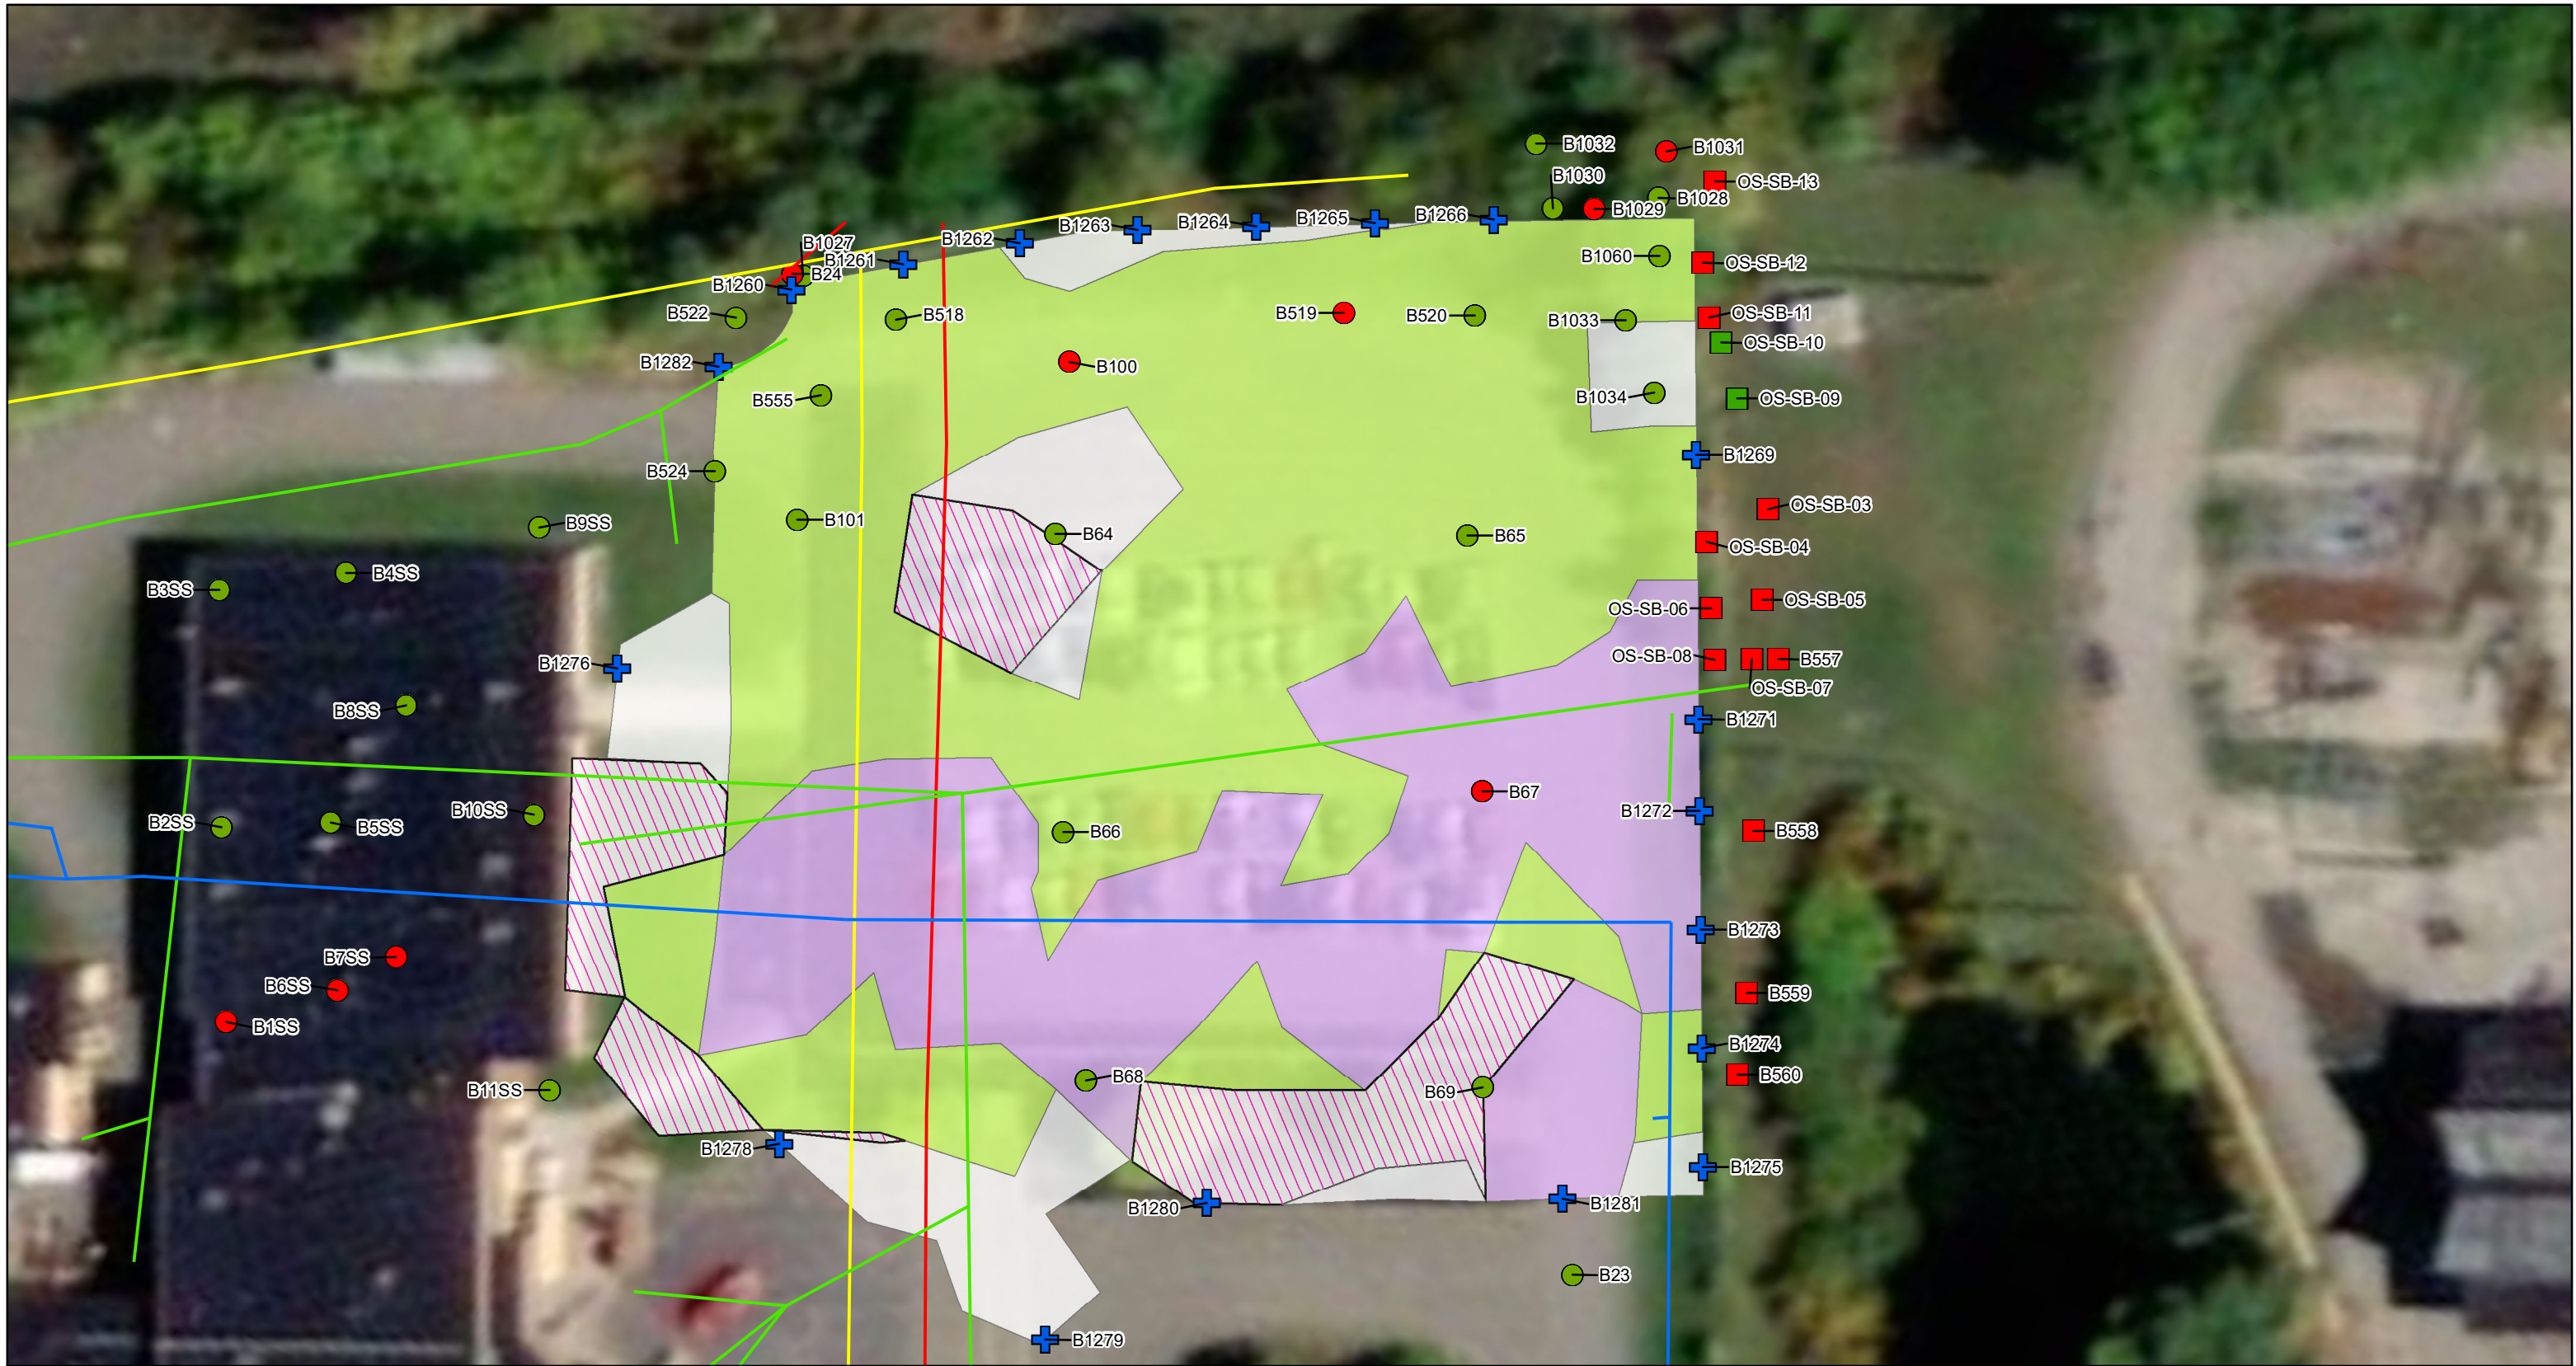
Confirmation Samples - Non-PCBs	Metals Concentration in Soil	SCO	Excavation Classification	Utilities	Notes
	Non-Detect	Restricted Residential SCO	Reuse	Natural Gas	ft bgs - Feet below ground surface
	Detect, does not exceed SCO	Industrial SCO	< 10 over TSCA	Electric	"SSHS-" prefix removed from sampling locations.
	Exceeds SCO		Non-Hazardous	Water	SCO - Soil Cleanup Objective (Table 375-6.8(b) in 6 NYCRR PART 375)
			TSCA	Storm Sewer	Aerial imagery provided by ArcGIS Online.

receiving facility requirements prior to excavation. The Rear Parking Lot has been characterized previously for metals during Site Characterization. Results of previous metals analyses are presented in **Table 8** and are compared to Restricted-Residential SCOs. As noted in the Site Characterization Report, metals with detections above Restricted Residential SCOs include arsenic, barium, copper, lead, nickel. The locations of metals Restricted Residential SCO exceedances with respect to the proposed excavations are presented in **Figures 16 to 23**. Metals Restricted Residential SCO exceedances in the 0-2 ft interval will be removed as shown on **Figure 16** within the limits of the ECSD capital improvement program. Lead was detected at 36,000 mg/kg 10-12 ft bgs at soil boring SSHA-B542. Additional soil will be excavated from the 10-12 ft interval as shown on **Figure 21** to address lead detections in this area. Other metals Restricted Residential SCO exceedances below two (2) ft bgs that are outside of the proposed excavation will be documented in the Site Management Plan following completion of the IRM. Samples will be collected from excavation sidewalls and bottoms for analyses for non-PCB COPCs to document the nature and extent of those constituents for the BCP Remedial Investigation (RI) for potential remedial action as part of the overall Site remedy. Locations of proposed samples for non-PCB COPCs are presented on **Figures 16 to 23** and listed on **Table 6**. Analyses for non-PCB COPCs will be for metals only based on Site Characterization of the Rear Parking Lot area. If non-PCB confirmation samples cannot be collected in a timely and safe manner, samples will be collected as part of the RI, as necessary.

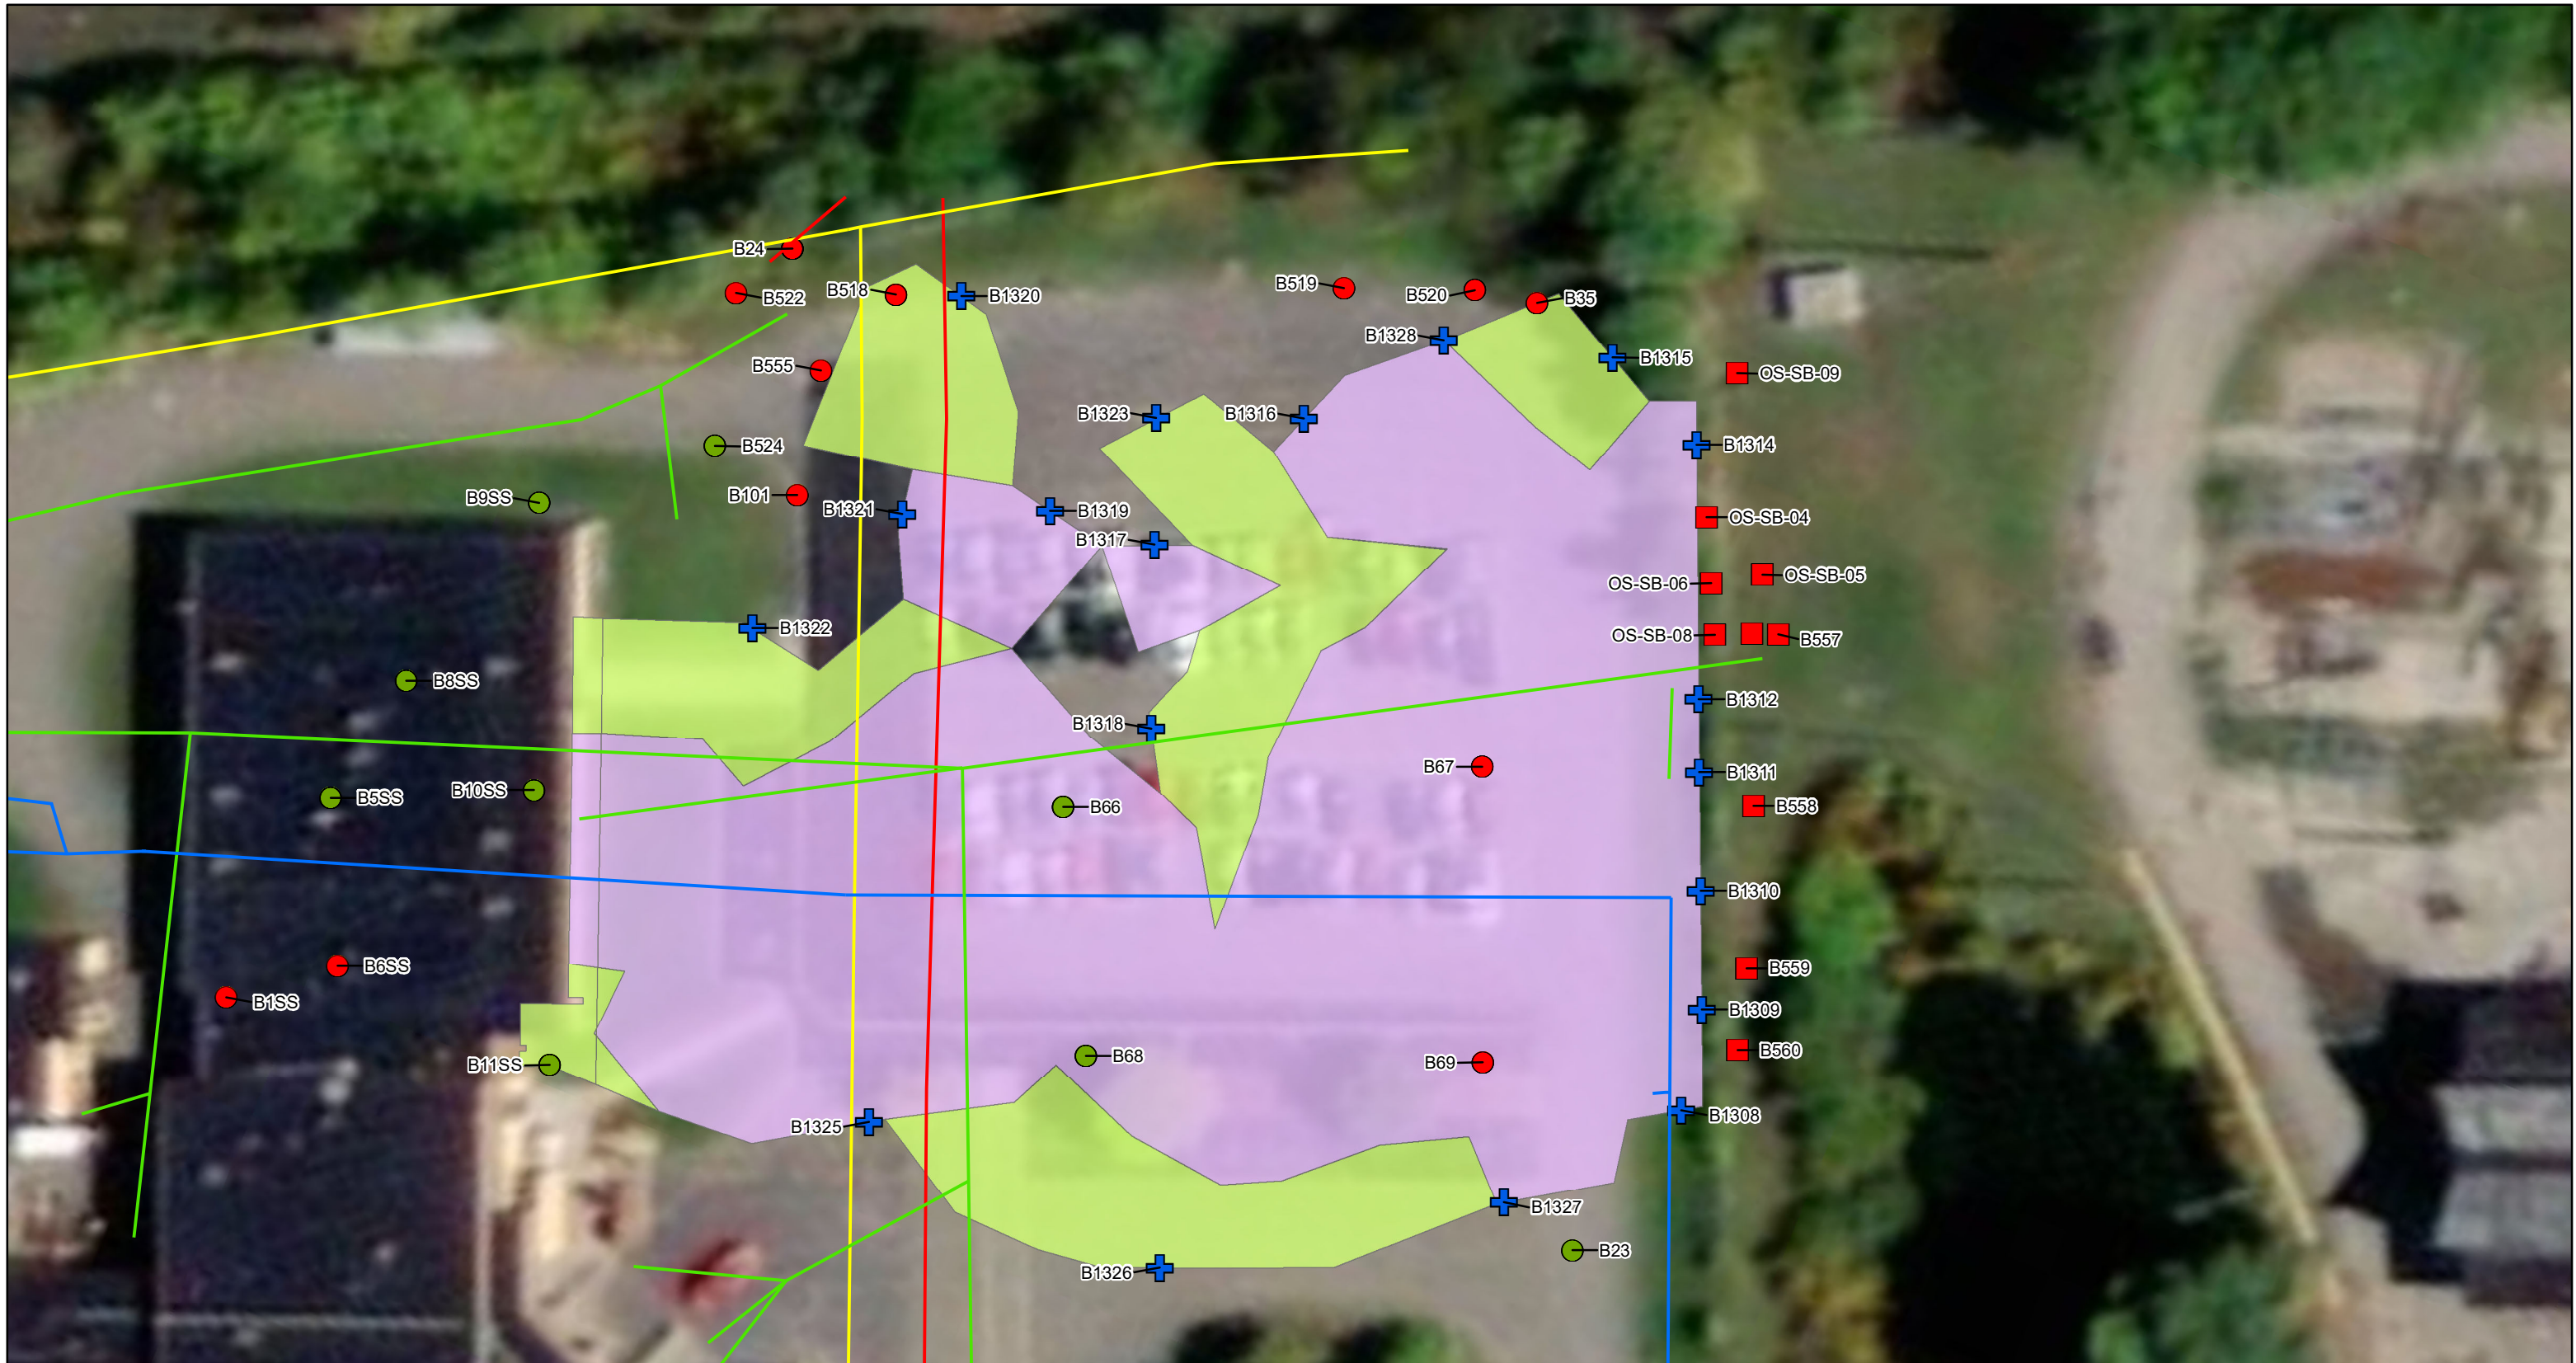
Proposed Excavation Rear Parking Lot Metals (2-4 ft bgs) Former Sperry Remington Site North Portion IRM#2 Elmira, New York		Figure 17
 <i>an affiliate of Geosyntec Consultants</i>		
Columbia, Maryland	July 2018
