INTERIM REMEDIAL MEASURES #2 WORK PLAN

**FORMER SPERRY REMINGTON SITE – NORTH PORTION
777 SOUTH MAIN STREET
CITY OF ELMIRA, CHEMUNG COUNTY, NY
NYSDEC PROJECT C808022**

Project Number MN0832D
Document Number MD18136

6 JUNE 2018; REVISED 13 JULY 2018

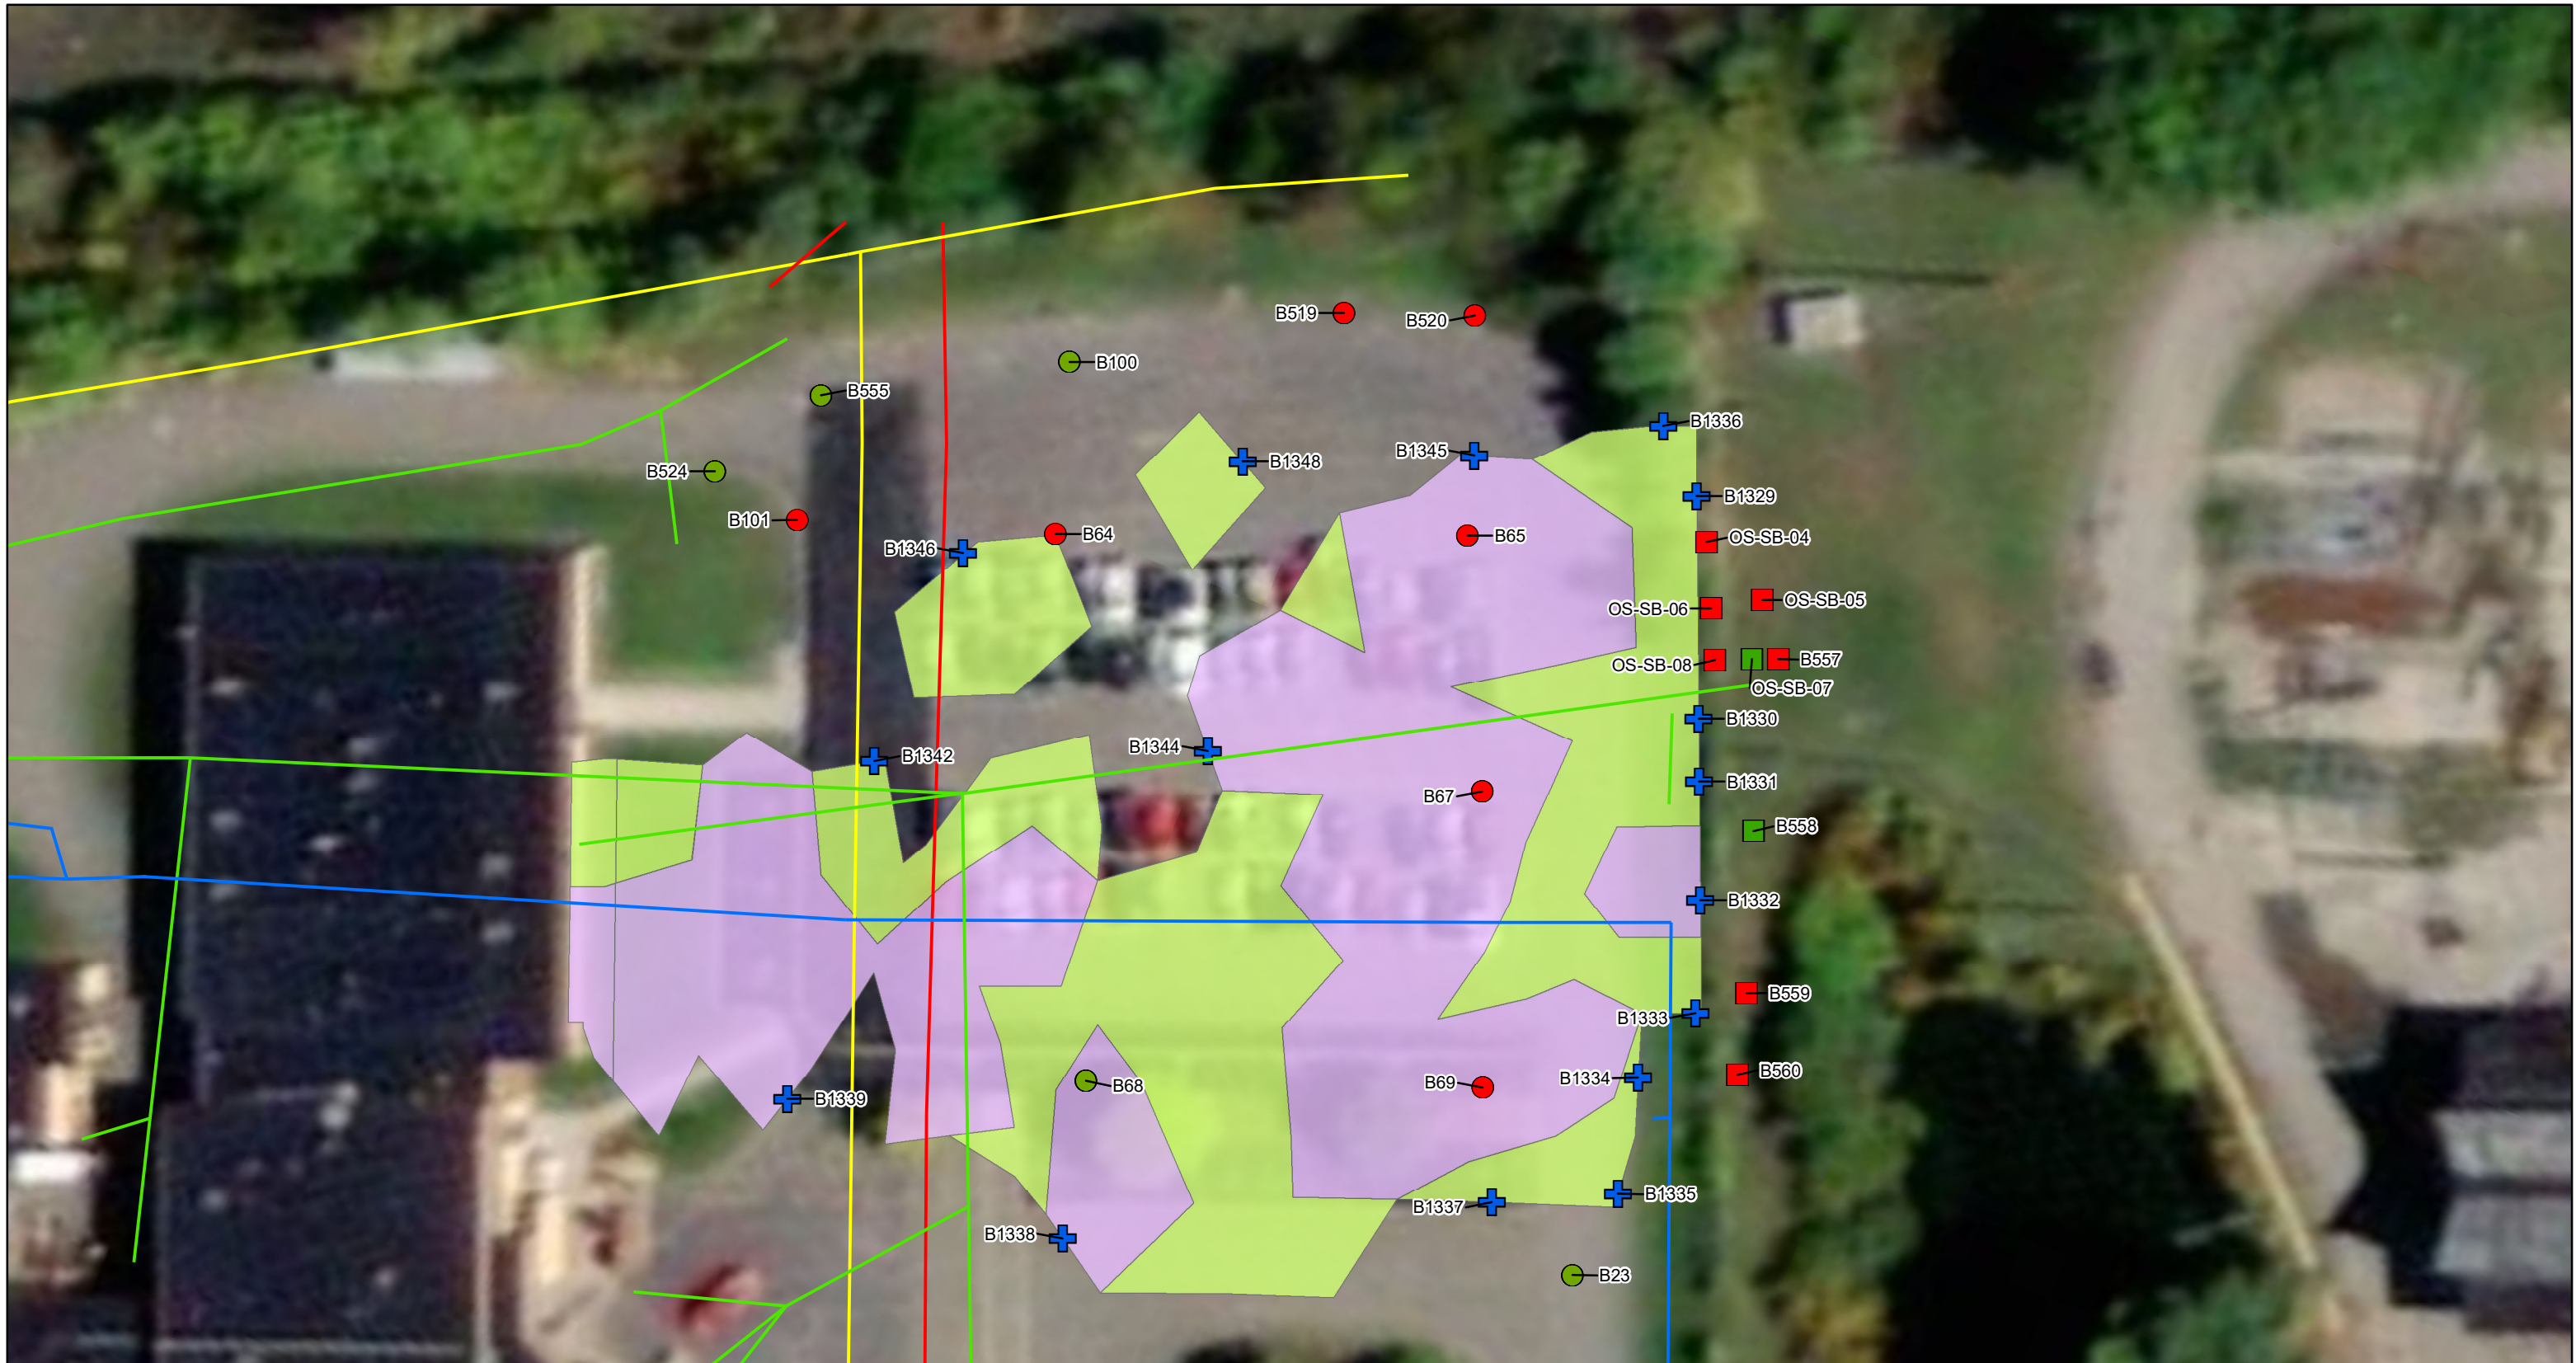
Proposed Excavation Rear Parking Lot Metals (4-6 ft bgs) Former Sperry Remington Site North Portion IRM#2 Elmira, New York	
 <i>an affiliate of Geosyntec Consultants</i>	
Columbia, Maryland	July 2018
Figure 18

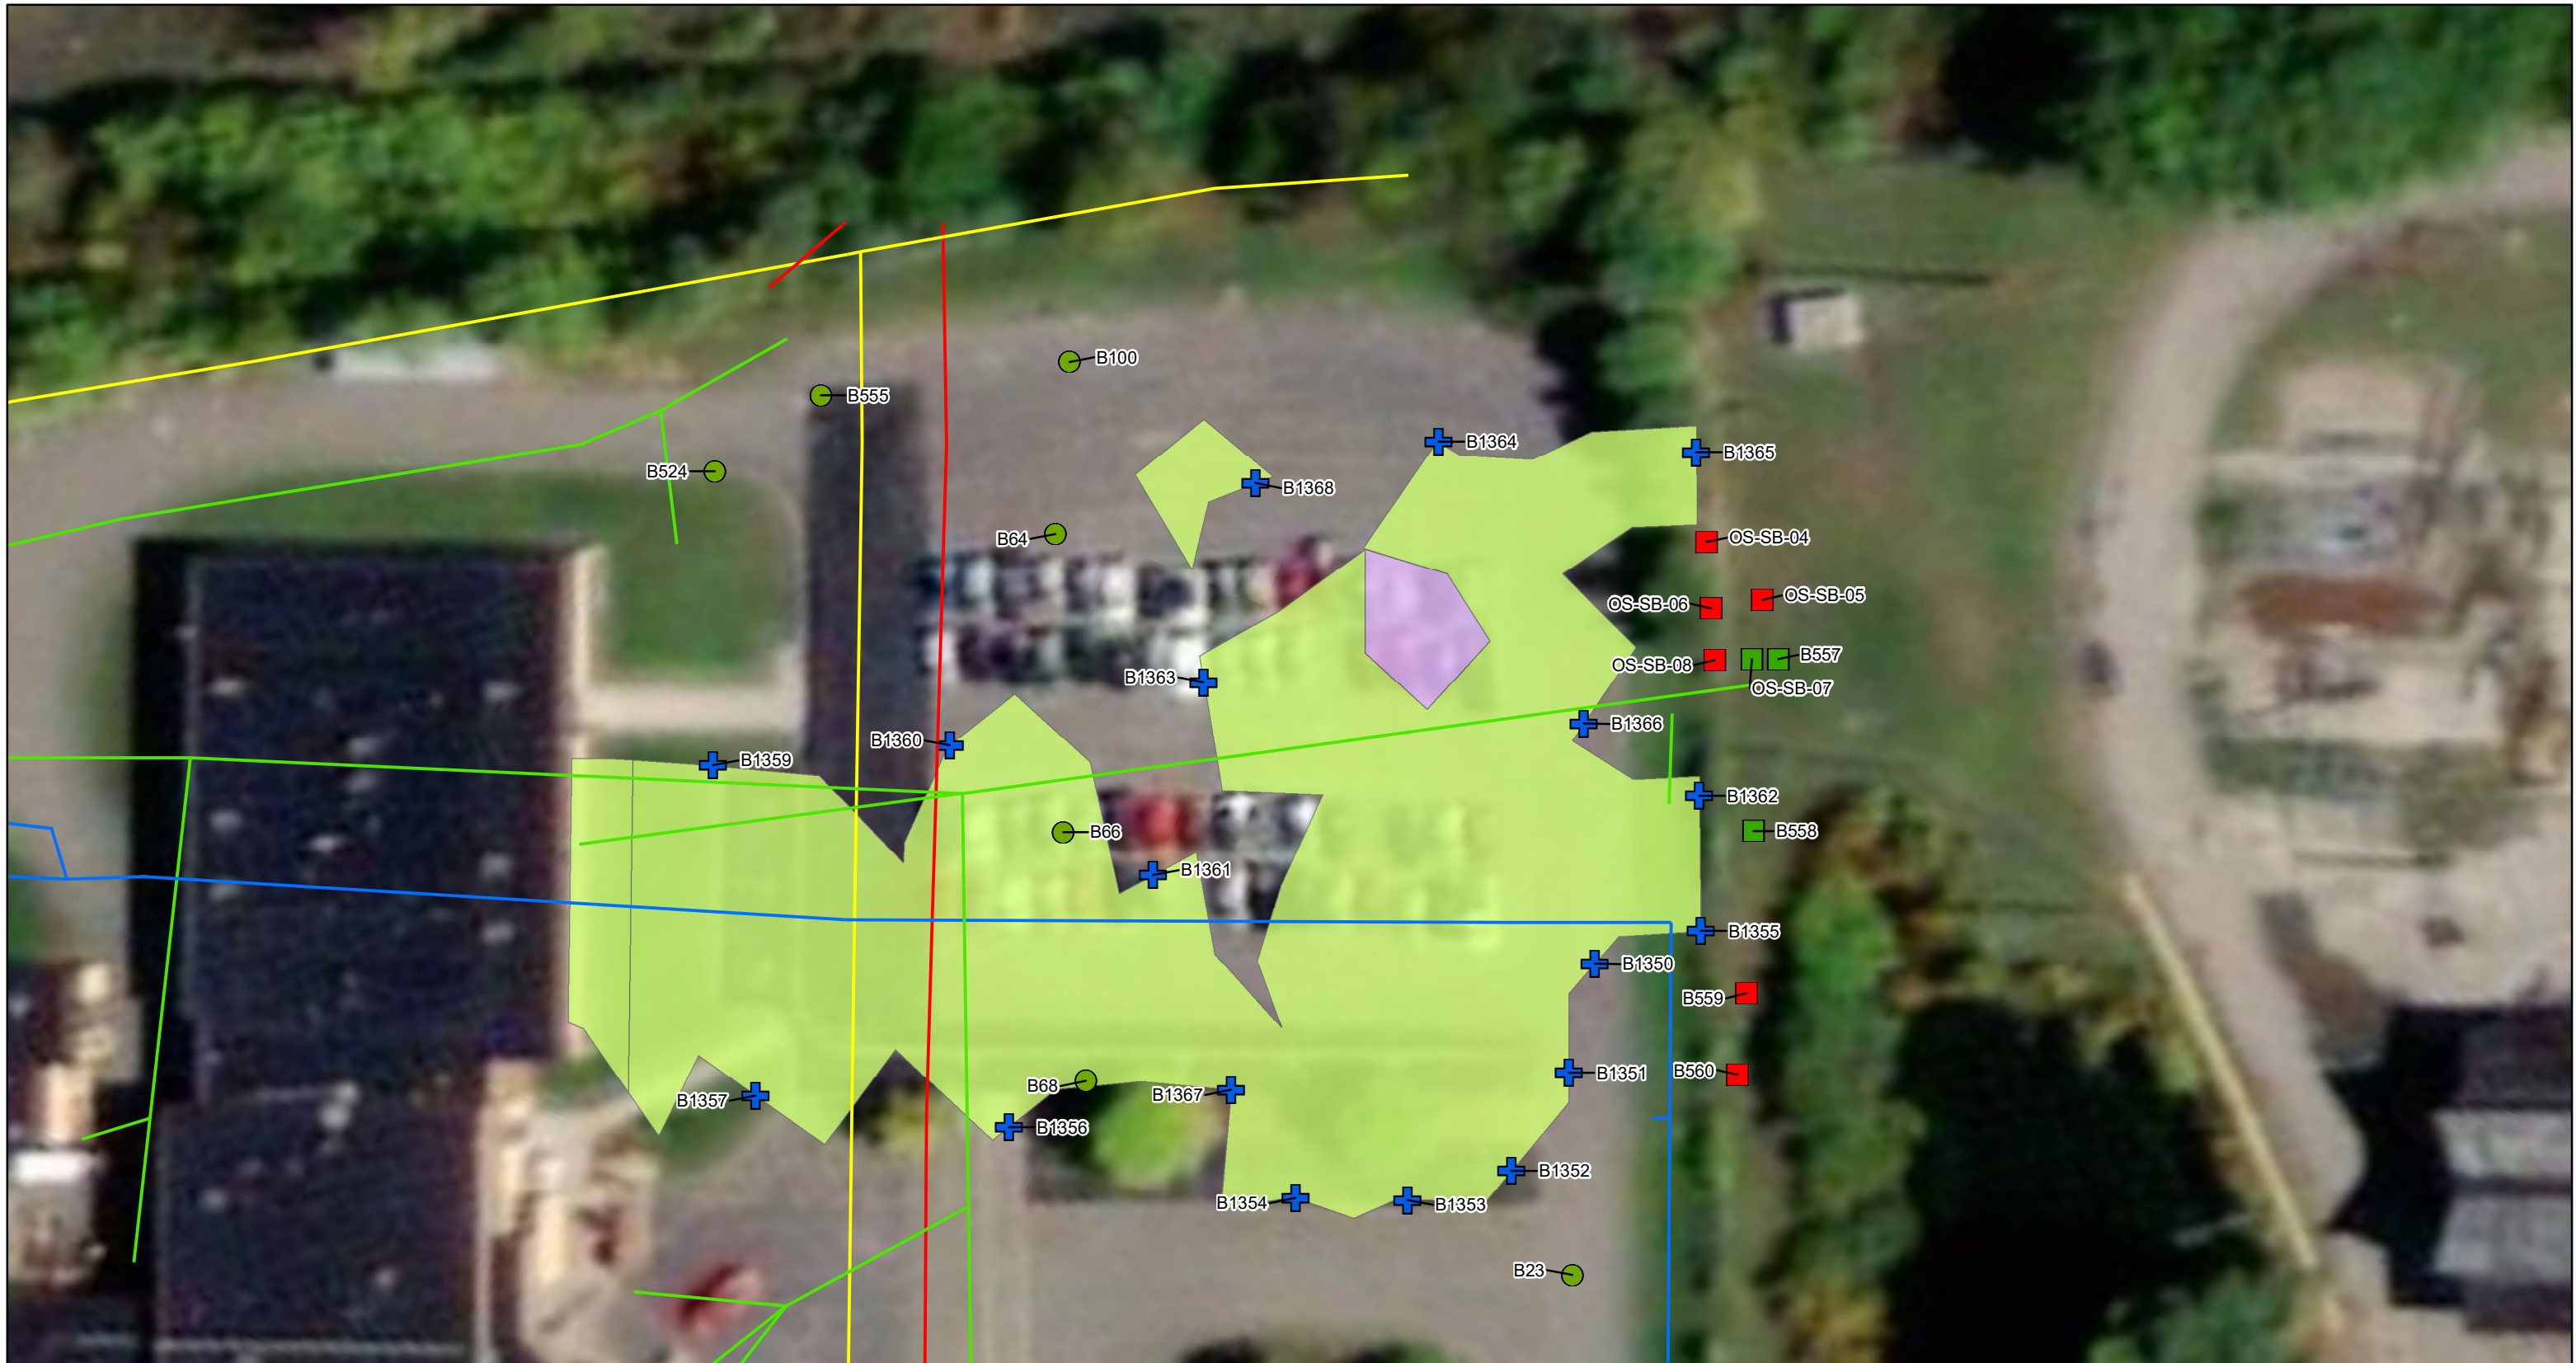
<p align="center">Proposed Excavation Rear Parking Lot Metals (6-8 ft bgs)</p> <p align="center">Former Sperry Remington Site North Portion IRM#2 Elmira, New York</p>		<p align="center">Figure 19</p>
<p align="center">Beech and Bonaparte engineering p.c. <small>an affiliate of Geosyntec Consultants</small></p>		
<p>Columbia, Maryland</p>	<p>July 2018</p>

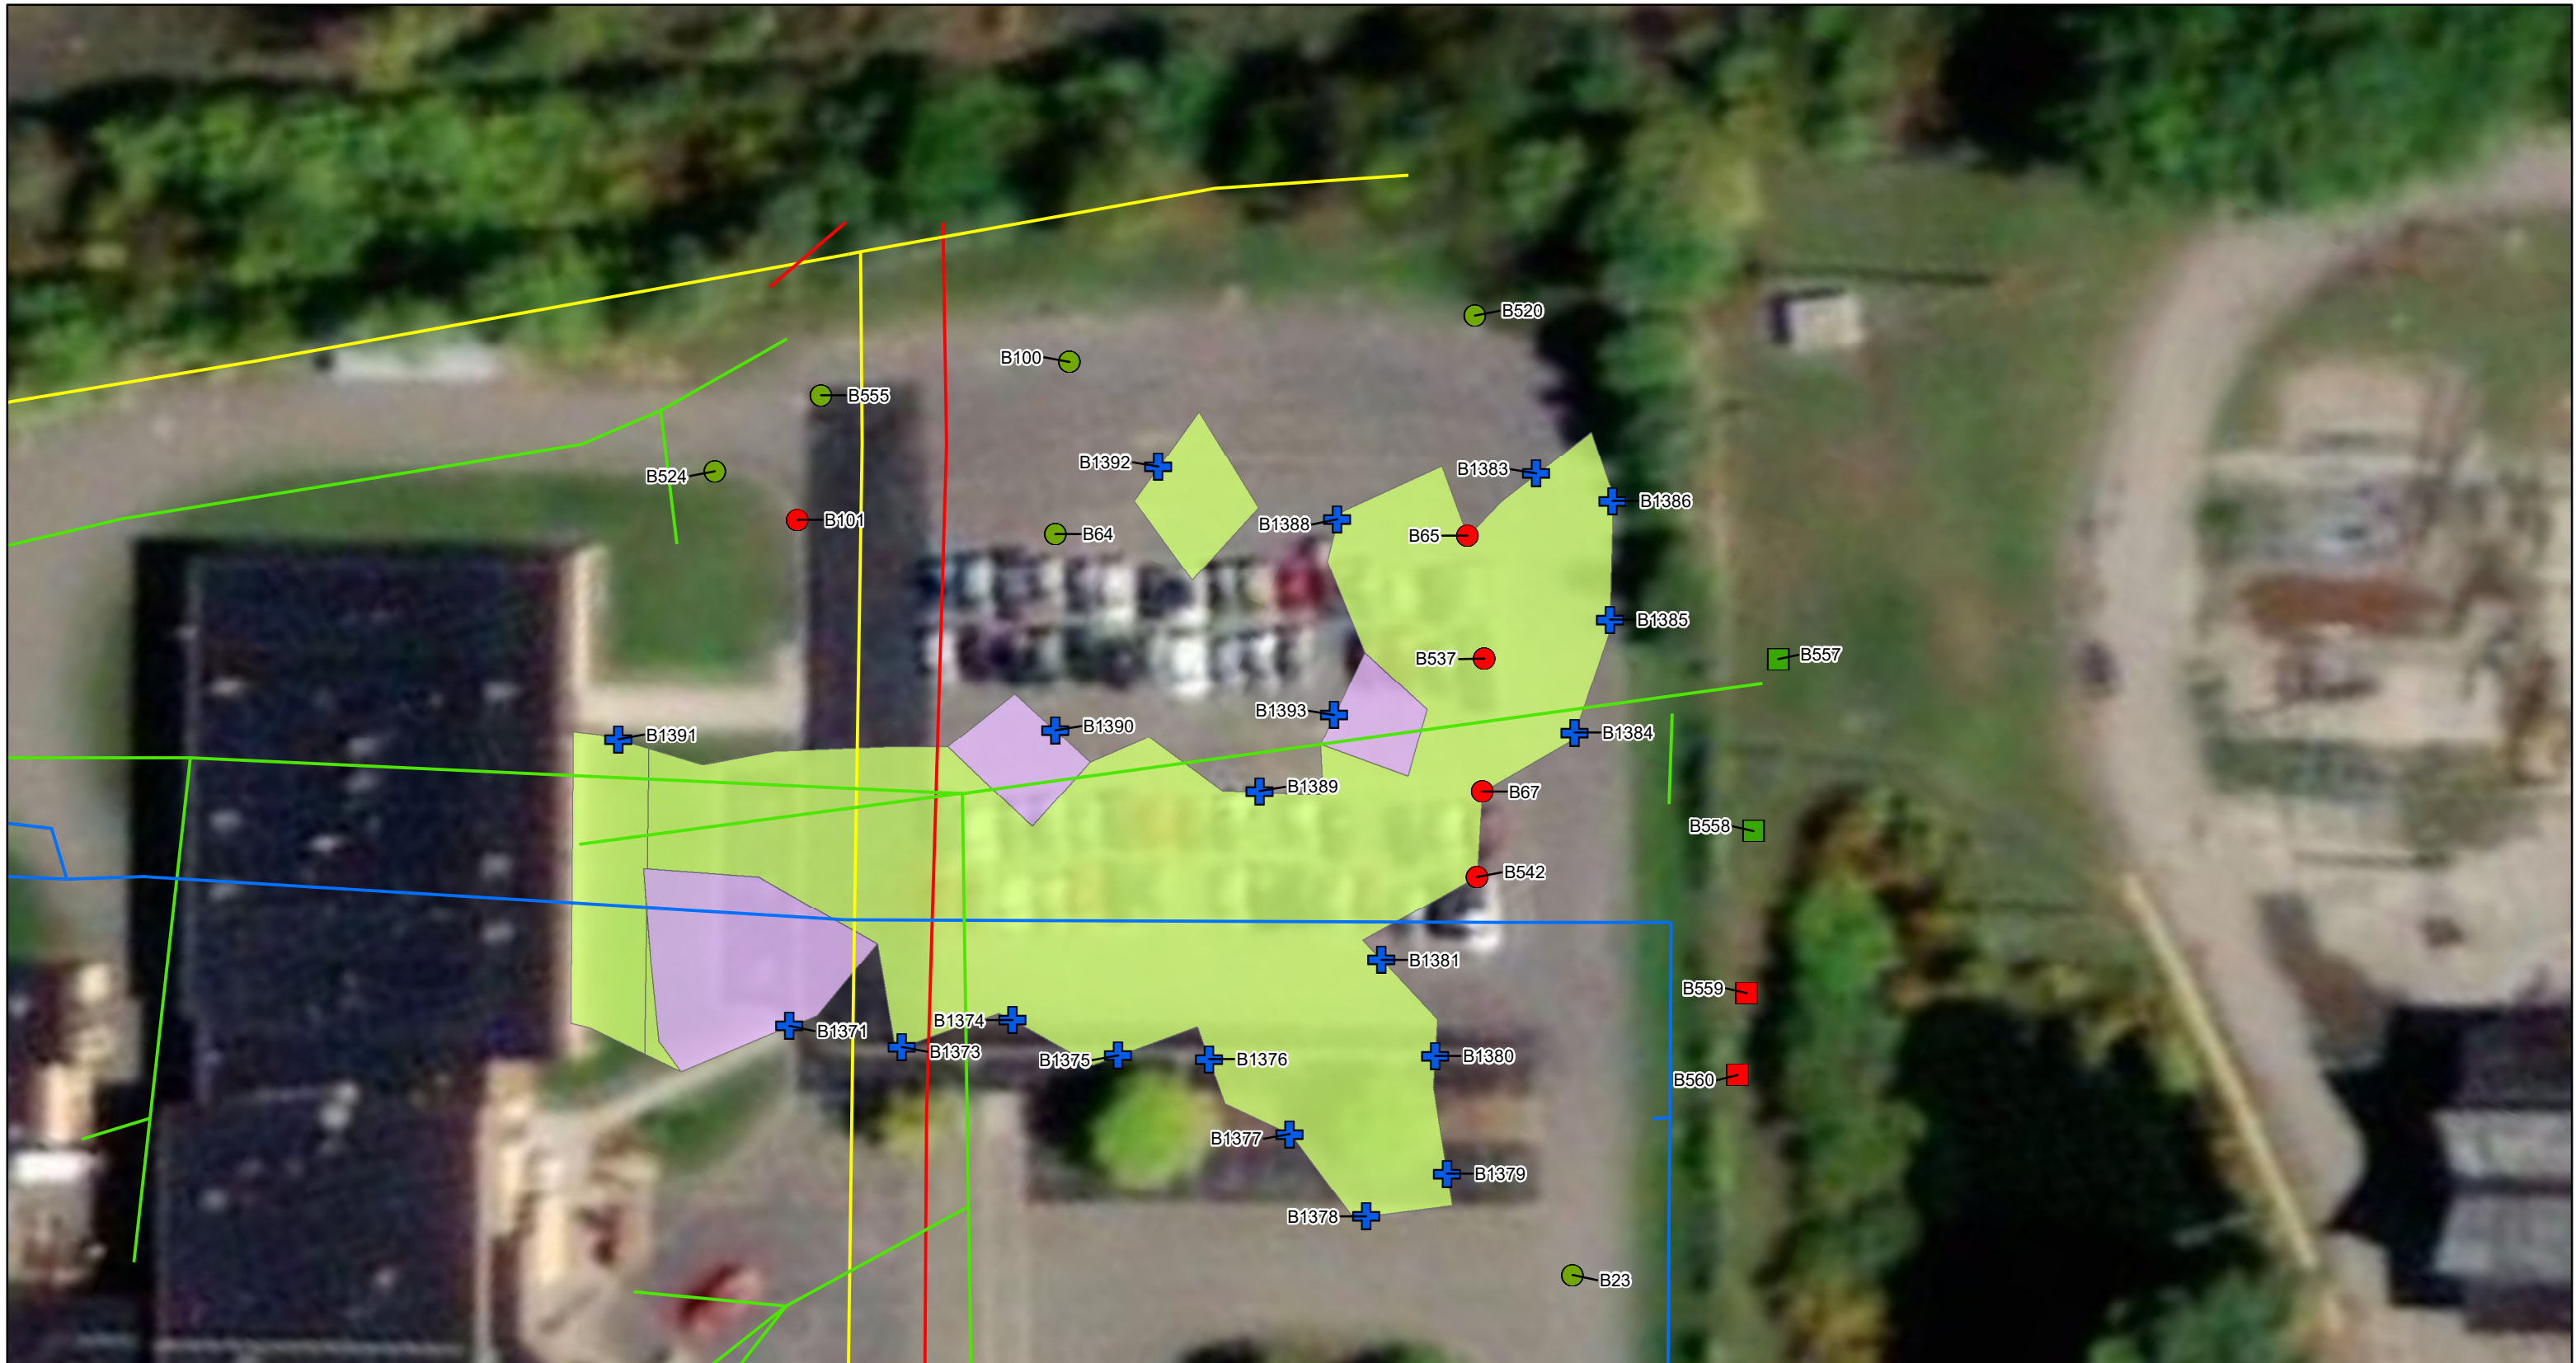
Proposed Excavation Rear Parking Lot Metals (8-10 ft bgs)	
Former Sperry Remington Site North Portion IRM#2 Elmira, New York	
Beech and Bonaparte engineering p.c. <small>an affiliate of Geosyntec Consultants</small>	
Columbia, Maryland	July 2018
Figure 20

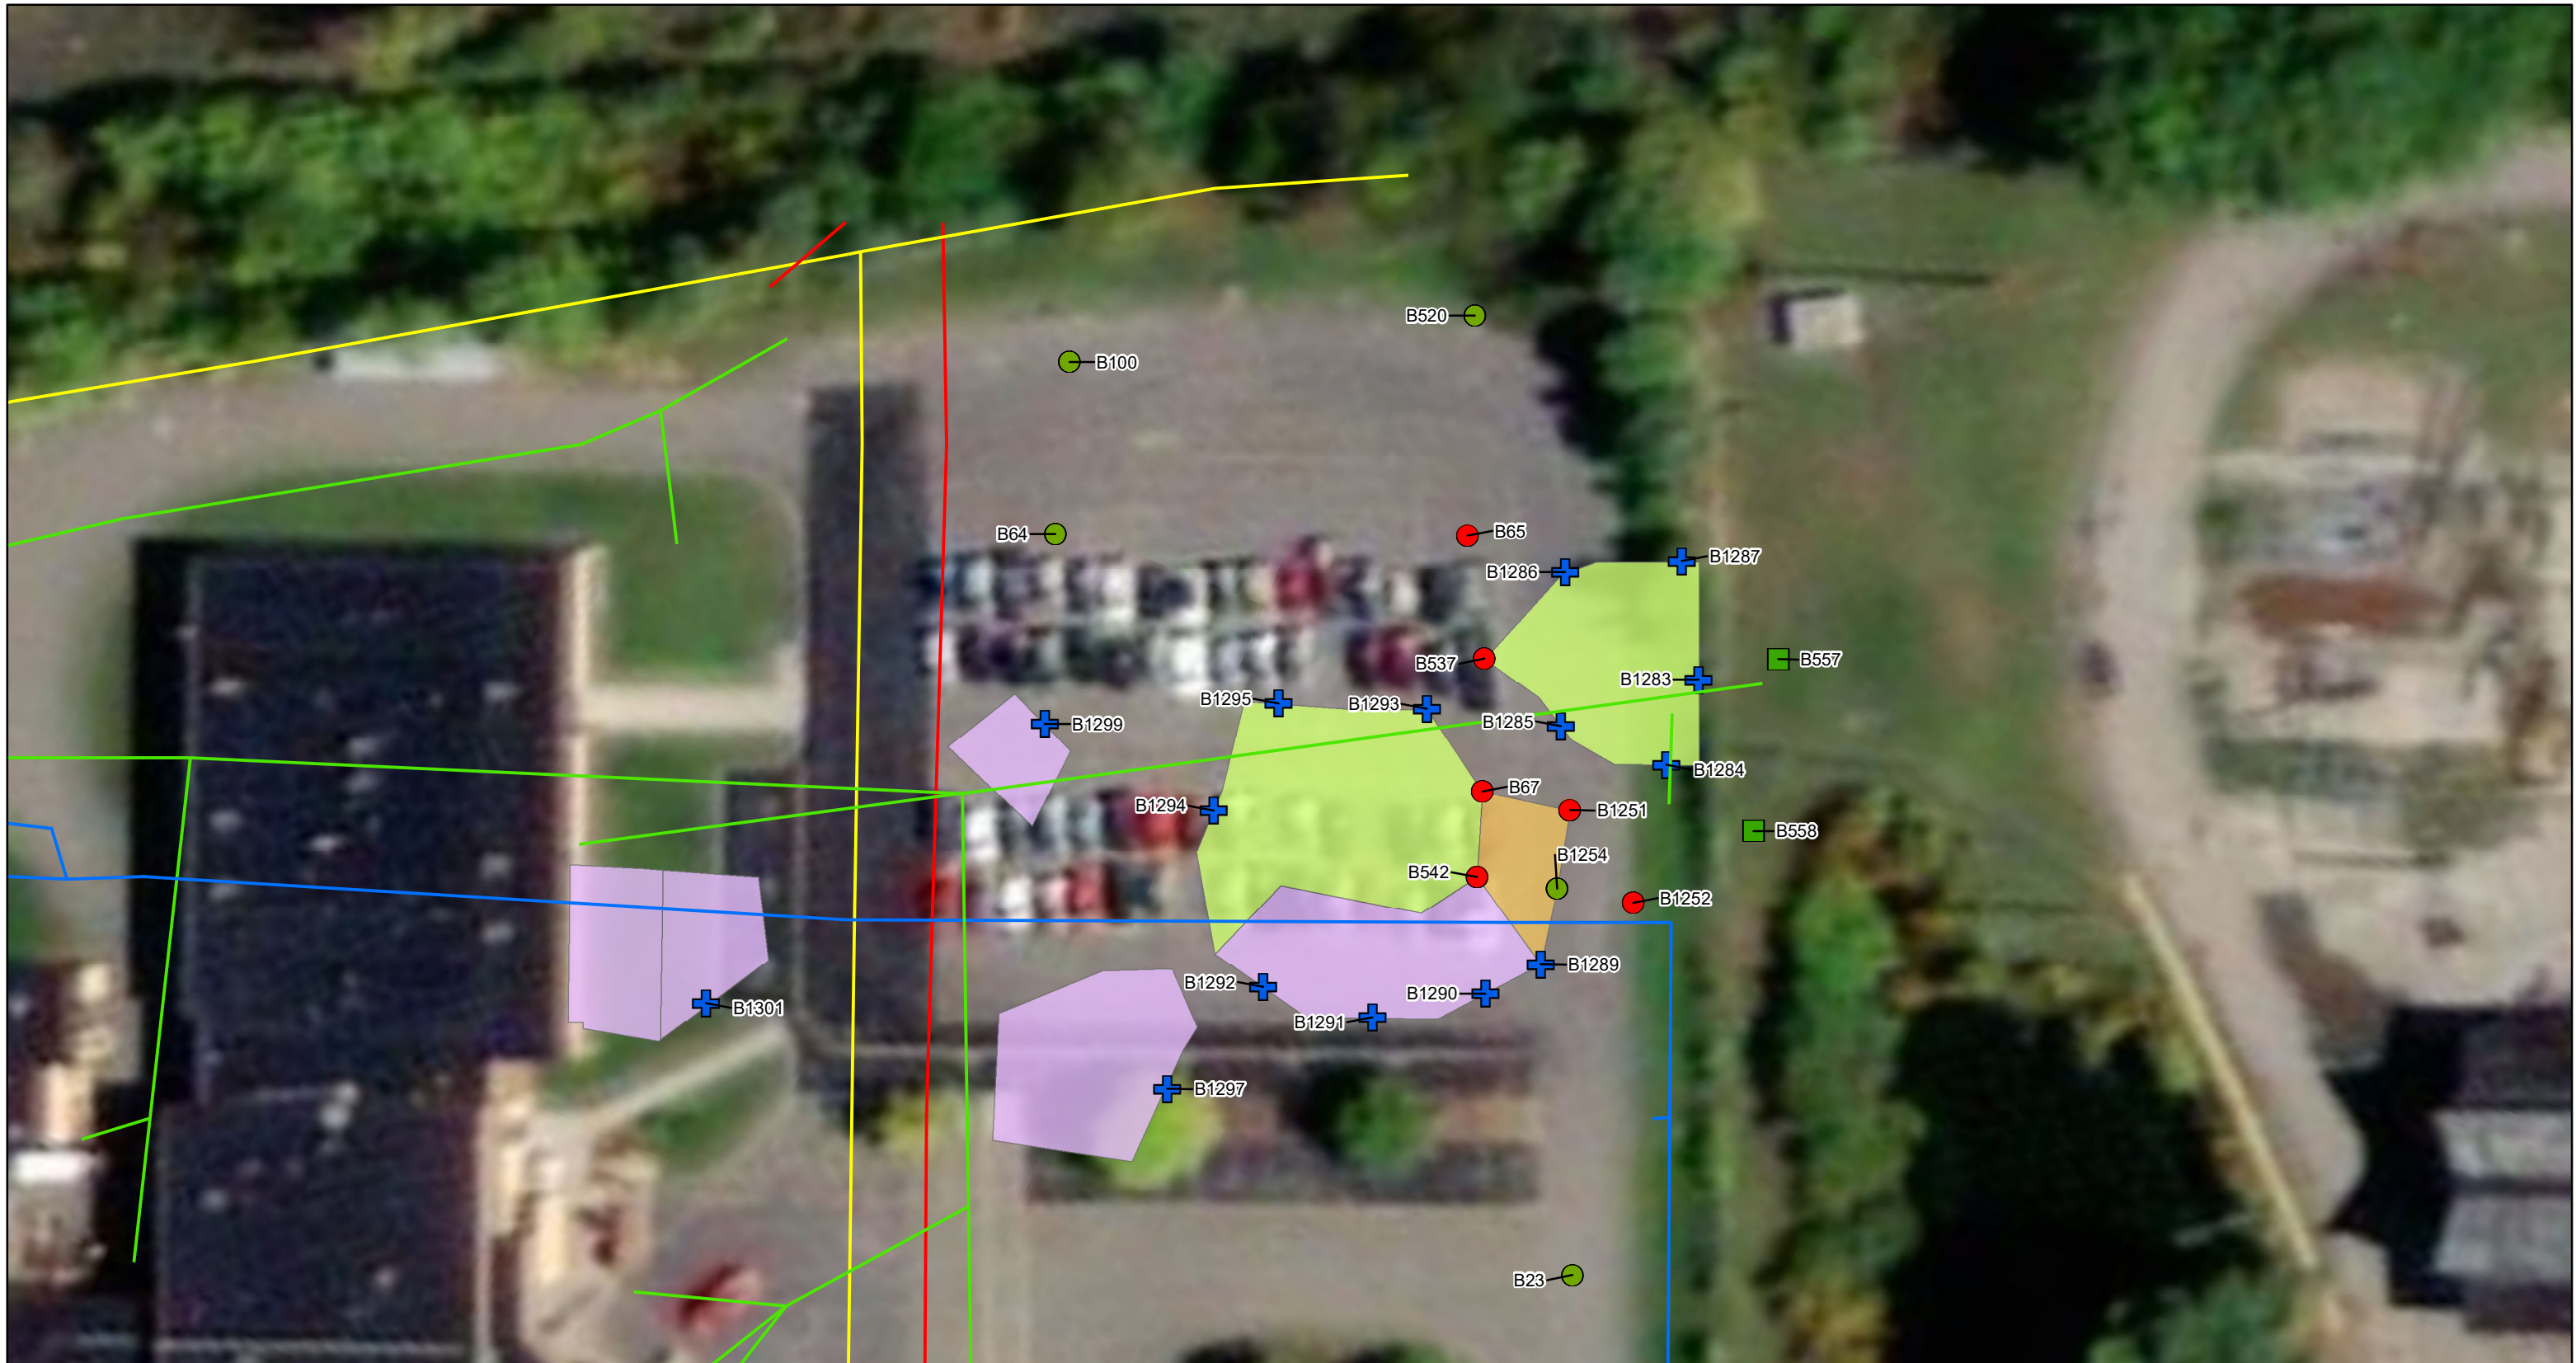
Proposed Excavation Rear Parking Lot Metals (10-12 ft bgs)		Figure 21
Former Sperry Remington Site North Portion IRM#2 Elmira, New York		
Beech and Bonaparte engineering p.c. <small>an affiliate of Geosyntec Consultants</small>		
Columbia, Maryland	July 2018

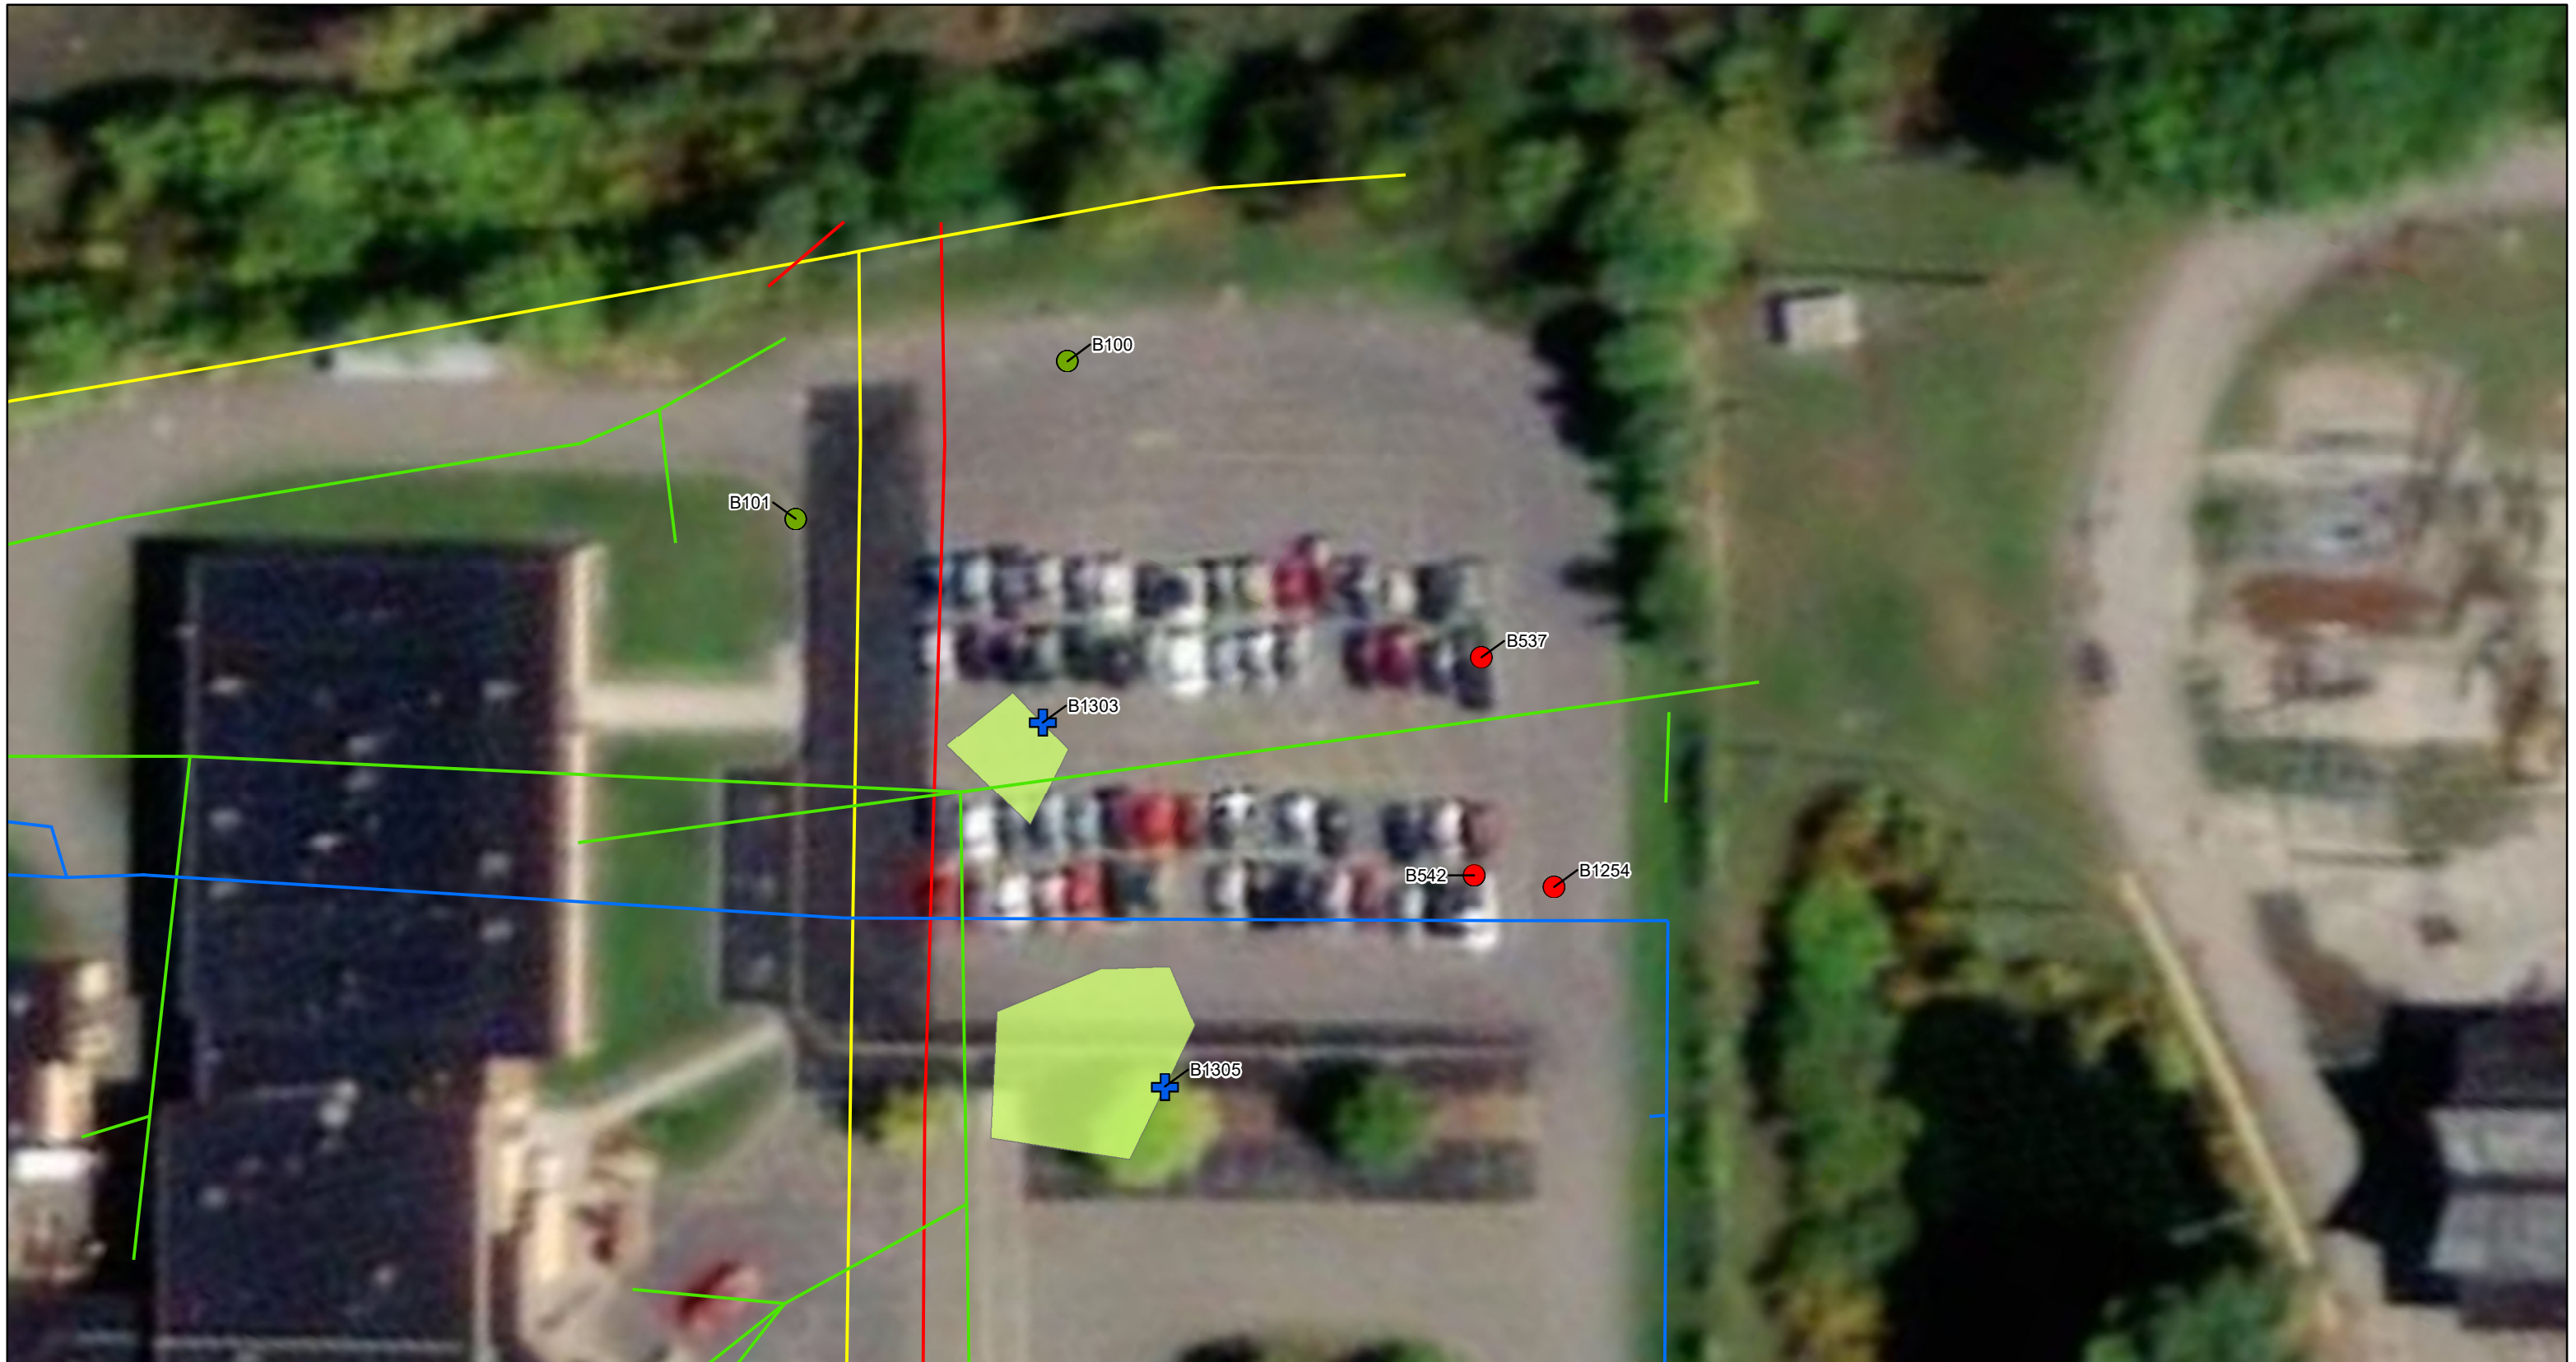
Proposed Excavation Rear Parking Lot Metals (12-14 ft bgs) Former Sperry Remington Site North Portion IRM#2 Elmira, New York	
Beech and Bonaparte engineering p.c. <i>an affiliate of Geosyntec Consultants</i>	
Columbia, Maryland	July 2018
Figure 22

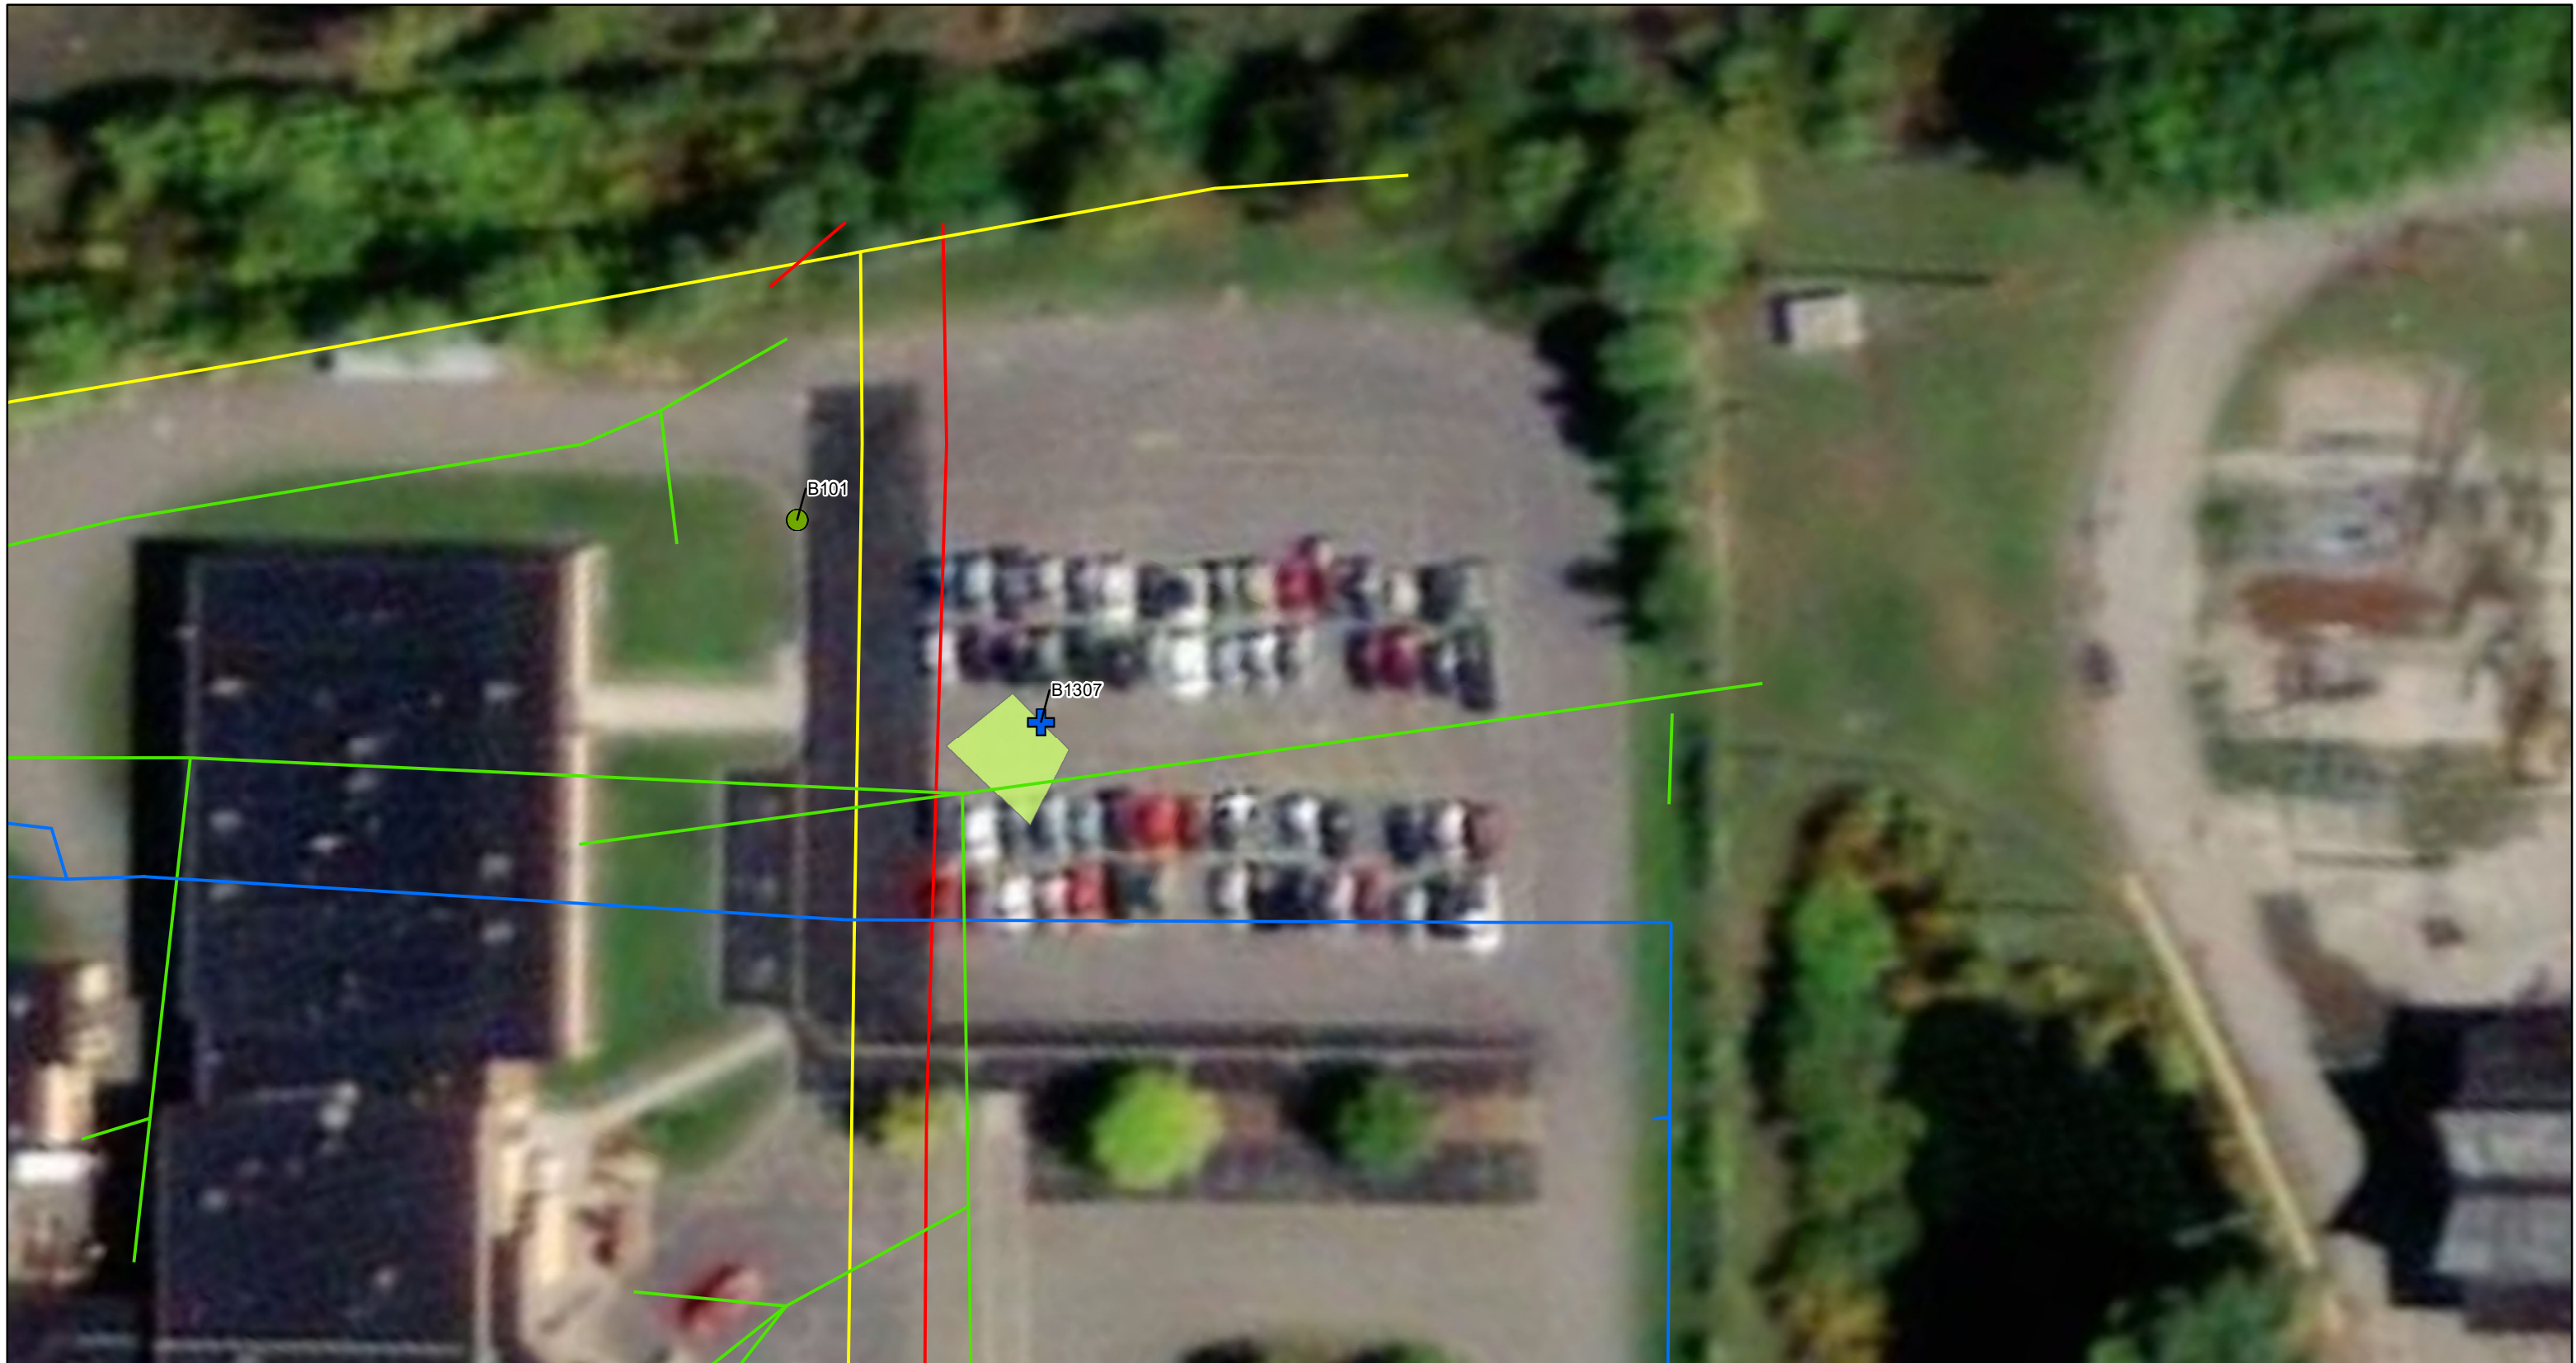
<p align="center">Proposed Excavation Rear Parking Lot Metals (14-16 ft bgs) Former Sperry Remington Site North Portion IRM#2 Elmira, New York</p>	
<p align="center">Beech and Bonaparte engineering p.c. <i>an affiliate of Geosyntec Consultants</i></p>	<p align="center">Figure 23</p>
<p>Columbia, Maryland</p>	<p>July 2018</p>
