INTERIM SITE MANAGEMENT PLAN

**FORMER SPERRY REMINGTON SITE – NORTH PORTION
777 SOUTH MAIN STREET
CITY OF ELMIRA, CHEMUNG COUNTY, NY
NYSDEC PROJECT C808022**

Document Number MD19160

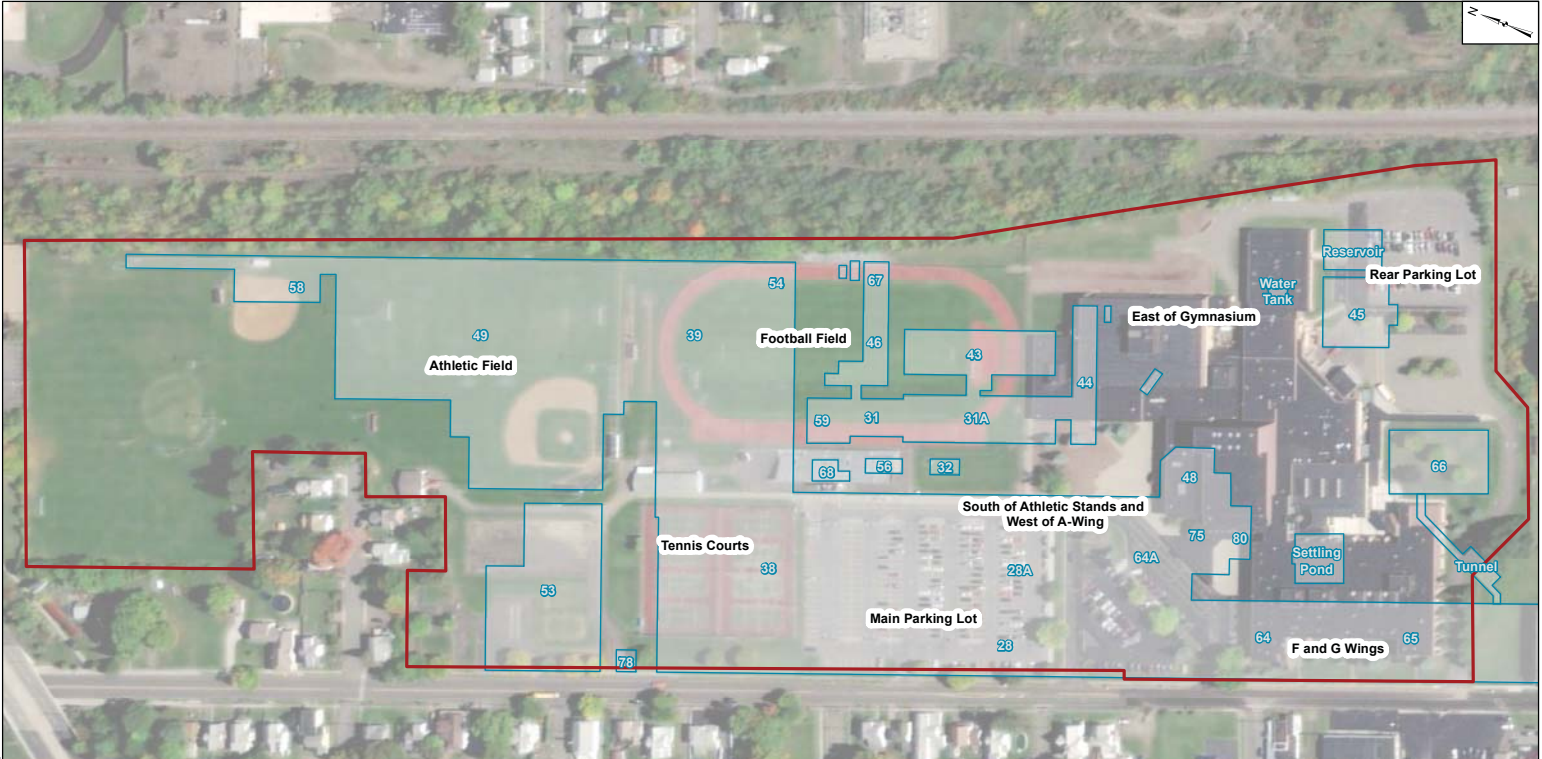
Figure 1-2

Explanation
 Site Boundary
 Historical Structure

Remington Rand Building Number	Former Plant Operation	Remington Rand Building Number	Former Plant Operation
28, 28A, 38, 64A	Machine Shop, Factory Building	54	Oil Handling
31A	Tool Hardening	56	Machine Shop
31	Carbonizing	58	Steel Storage
32	Electrical Building	59	Not Identified
39	Not Identified	64, 65	Machine Shop
43	Heat Treating	66	Storage
44	Blower Room and Cooling Shed	67	Sand Blasting
45	Engine Room	68	Locker Room
46	Sand Blasting	75	Not Identified
48	Not Identified	78	Not Identified
49	Machine Shop	80	Not Identified
53	Garage, Recreation Hall and Cafeteria

A figure showing the Site location and boundaries of this Site is provided in **Figure 1-2**. The boundaries of the Site are more fully described in the metes and bounds site description that is part of the Property Description provided in **Appendix A**. The necessity for an environmental easement requiring compliance with the SMP will be evaluated when a final remedy for the Site has been completed and a final SMP has been prepared.

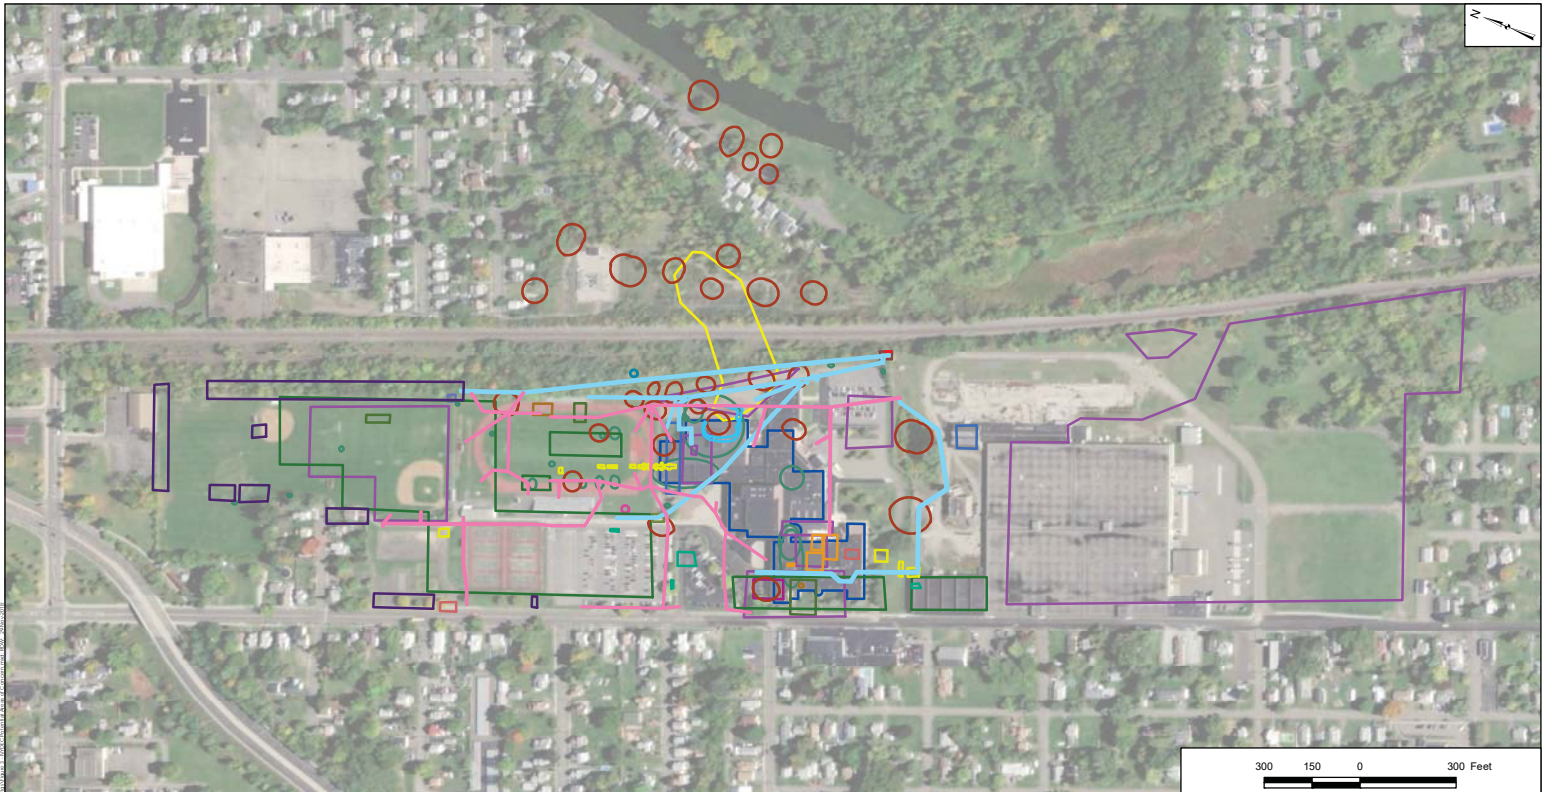
Figure 2-5
Columbia, Maryland	December 2018

NYSDEC Potential Areas of Concern
 Former Sperry Remington - North Portion #08022
 Elmira, New York

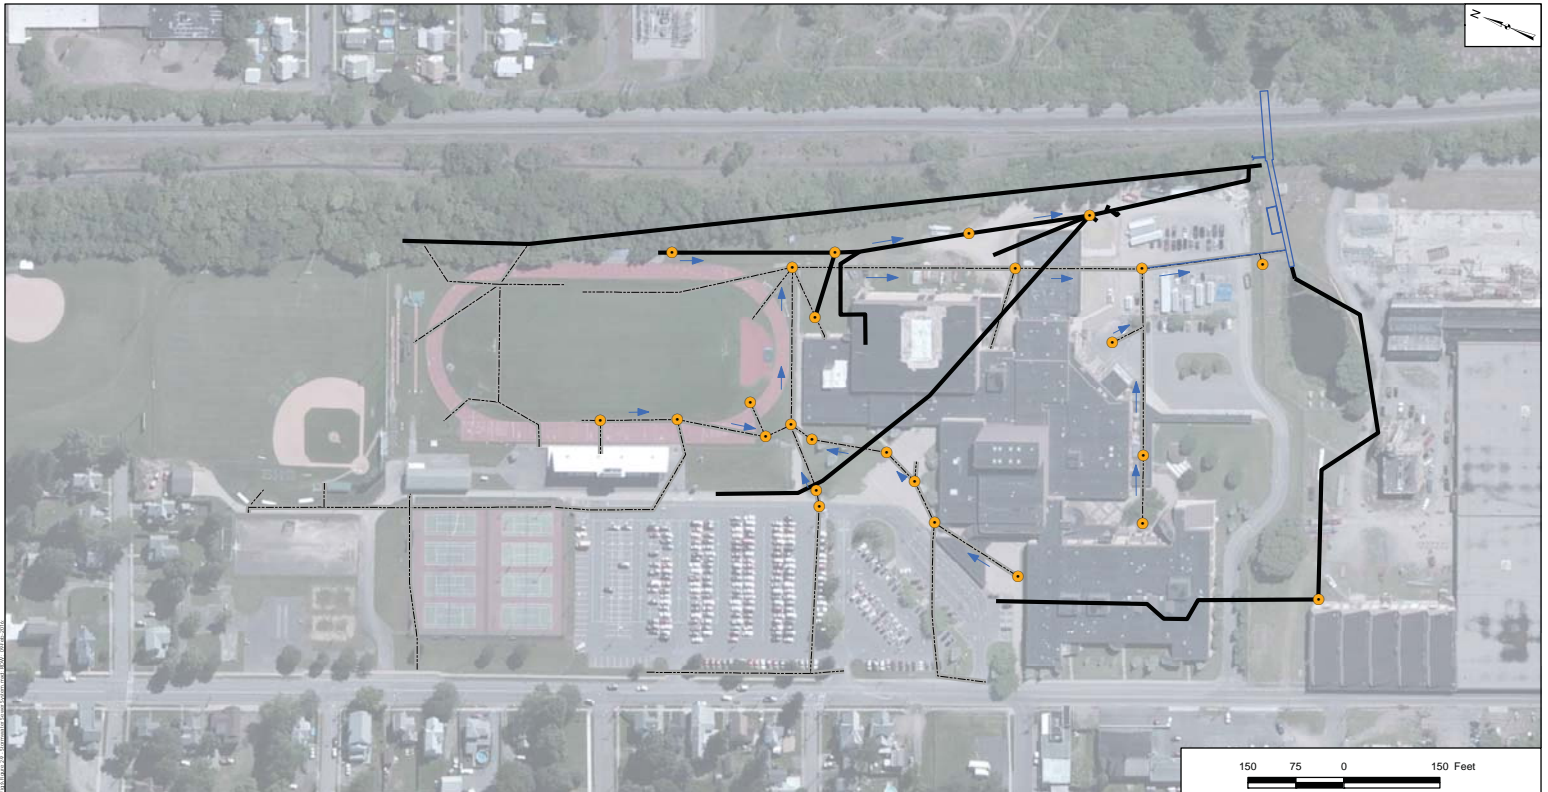
- Catch Basin
- ➔ Direction of Stormwater Flow
- Former Storm Water Sewer (Pre-1979)
- - - Current Combined Industrial Sewer (Post-1979)
- Former Sperry Remington Site (#808043) Investigation

<p>150 75 0 150 Feet</p>	
<p>Stormwater Sewer System Former Sperry Remington - North Portion #808022 Elmira, New York</p>	
<p>Geosyntec consultants</p>	
<p>Columbia, Maryland</p>	<p>February 2016</p>
<p>Figure 2-6</p>

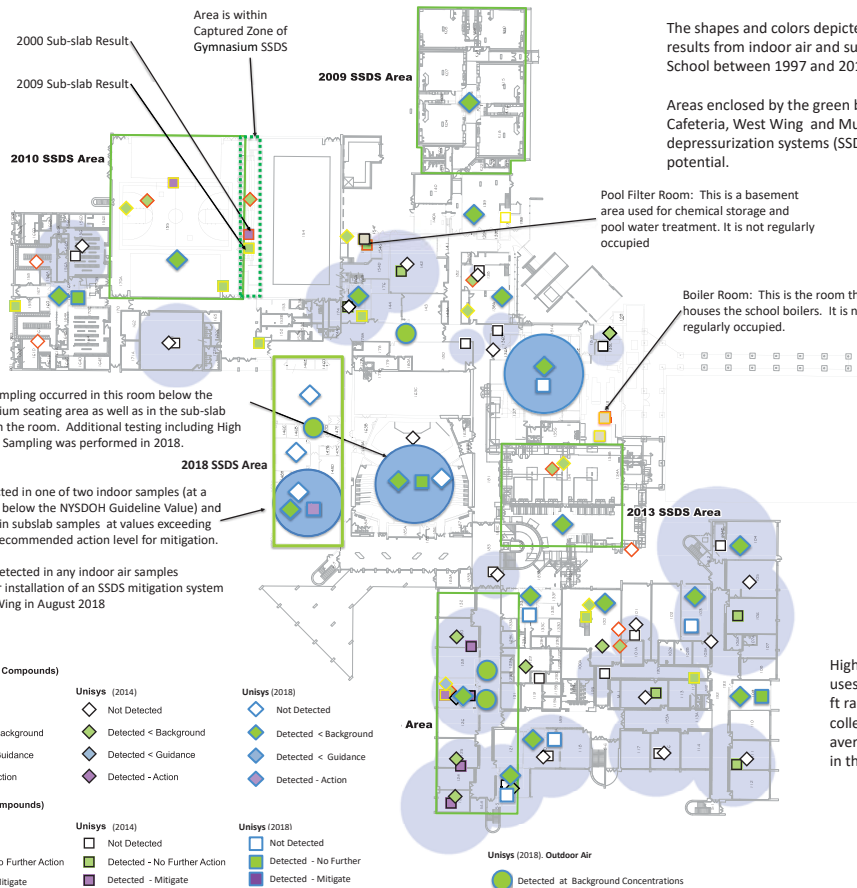
The shapes and colors depicted on this figure represent the locations and results from indoor air and sub-slab samples collected at Elmira High School between 1997 and 2018.

Areas enclosed by the green boxes: Gymnasium, K Wing Science Addition, Cafeteria, West Wing and Music Wing have operating sub-slab depressurization systems (SSDS) installed to mitigate the vapor intrusion potential.

Previous Indoor and Sub-slab Sampling Results and Results from 2018 SVIA Sampling Former Sander Heintzberg Site, North Parkton Elmira, New York	
Geosyntec CONSULTANTS	
Columbia, Maryland	December 2018
Figure 2-8

The locations where vapor mitigation systems have been installed to address the VI potential are depicted by green rectangles on **Figure 2-8**. All of the occupied areas where indoor/sub-slab sample pairs with a Matrix recommended action of mitigate are being addressed by an SSD system which has been shown to be effective (i.e. create a robust vacuum field below the floor area) without the need for HVAC operation to positively pressurize the building, and despite the presence of unsealed cracks in the building slab.
