# NEW YORK STATE DEPARTMENT OF ENVIRONMENTAL CONSERVATION

Re: Site Management Plan  
Former Alliance Metal Stamping & Fabrication  
Site N°: C828101  
Gates (T), Monroe (C)

## Recharge Well Cleanout and Maintenance Procedures

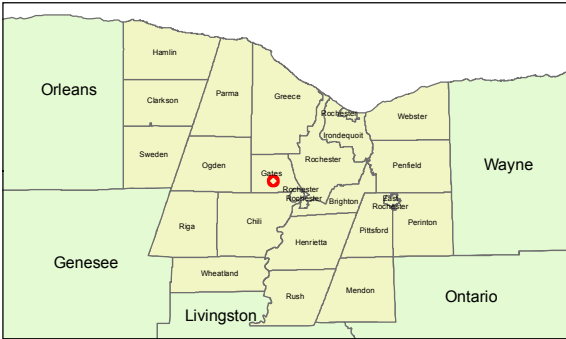
Figure No. 6B  
Title: Remaining Groundwater Sample Exceedances Intermediate & Deep Bedrock Wells

Figures 6A and 6B summarize the results of all samples of groundwater that exceed the SCGs after completion of the remedial action. Exceedances of groundwater standards at the Site are described below.

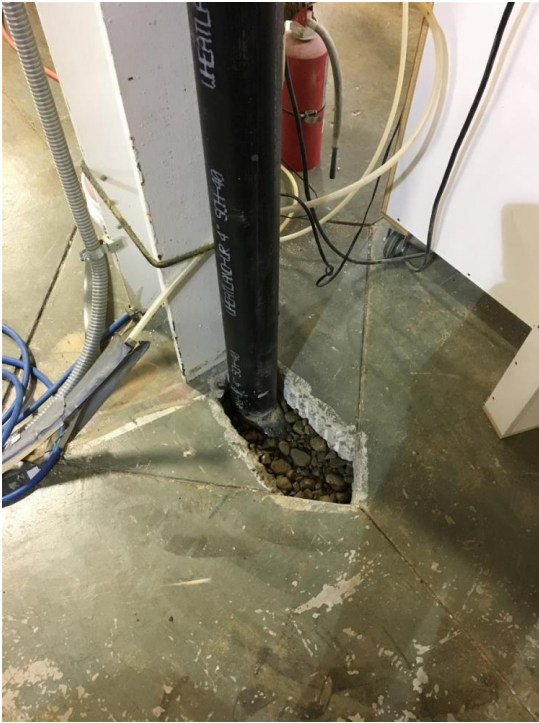
| <b>Photograph ID: 1</b> | | | |

| <b>Photo Location:</b><br>Backfilled suction cavity | | | |

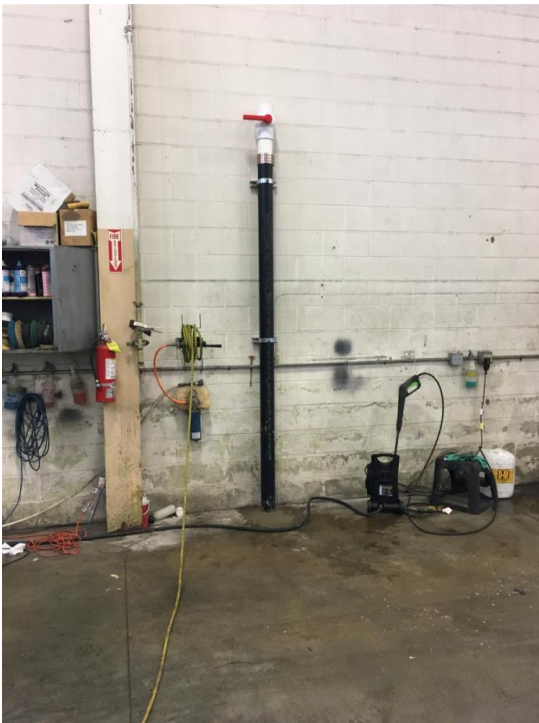
| <b>Photograph ID: 2</b> | | | |

| <b>Photo Location:</b><br>Suction point SP-35 riser prior to installation of overhead piping | | | |

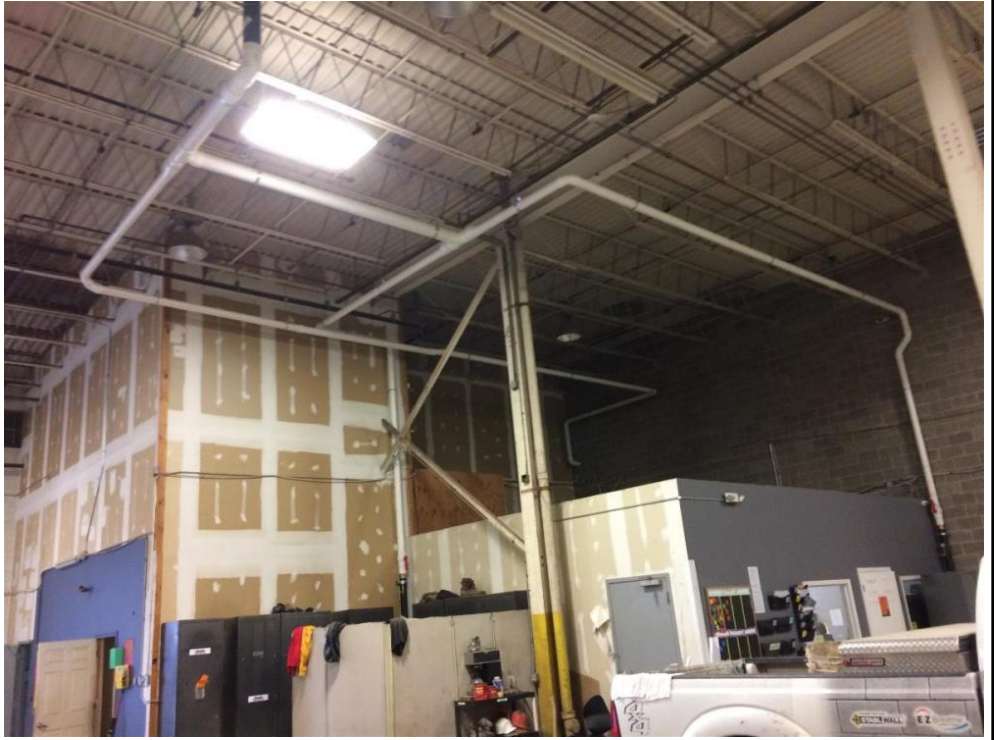
| <b>Photograph ID: 3</b> | | | |

| <b>Photo Location:</b><br>SSDS overhead piping leading to fan stack riser R-21 in EverDry Shop | | | |

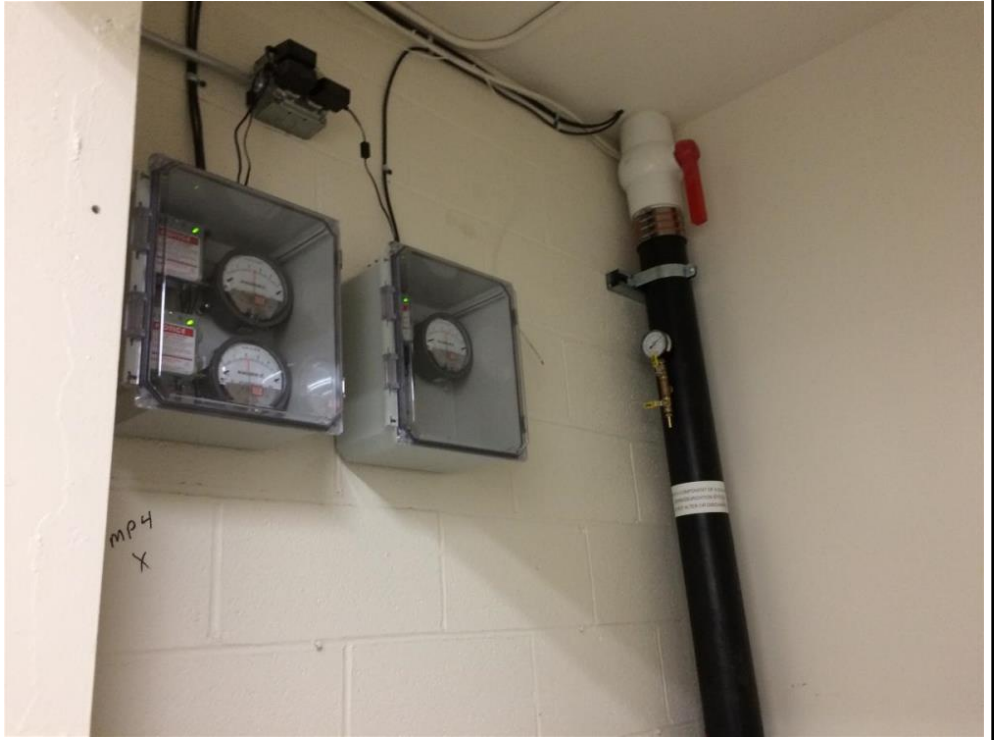
| <b>Photograph ID: 4</b> | | | |

| <b>Photo Location:</b><br>Monitoring panel group 3 and riser for Suction point SP-23 | | | |

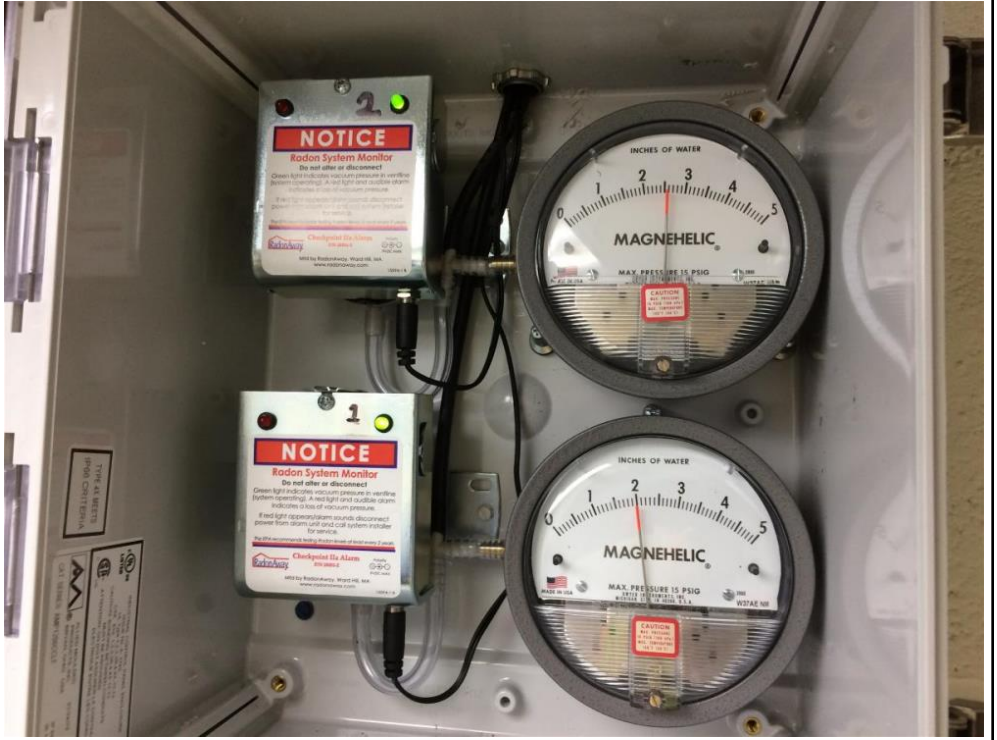
| <b>Photograph ID: 5</b> | | | |

| <b>Photo Location:</b><br>Monitoring panel close-up for SSDS fans 1 and 2 | | | |

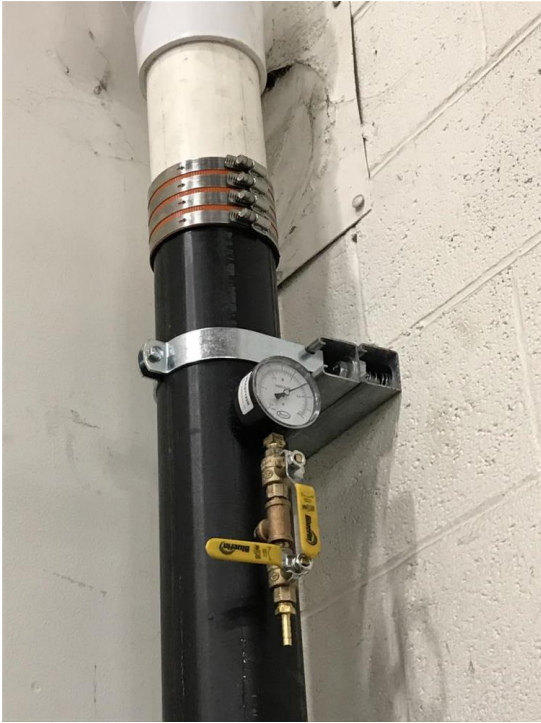
| <b>Photograph ID: 6</b> | | | |

| <b>Photo Location:</b><br>Suction point riser gauge close-up | | | |

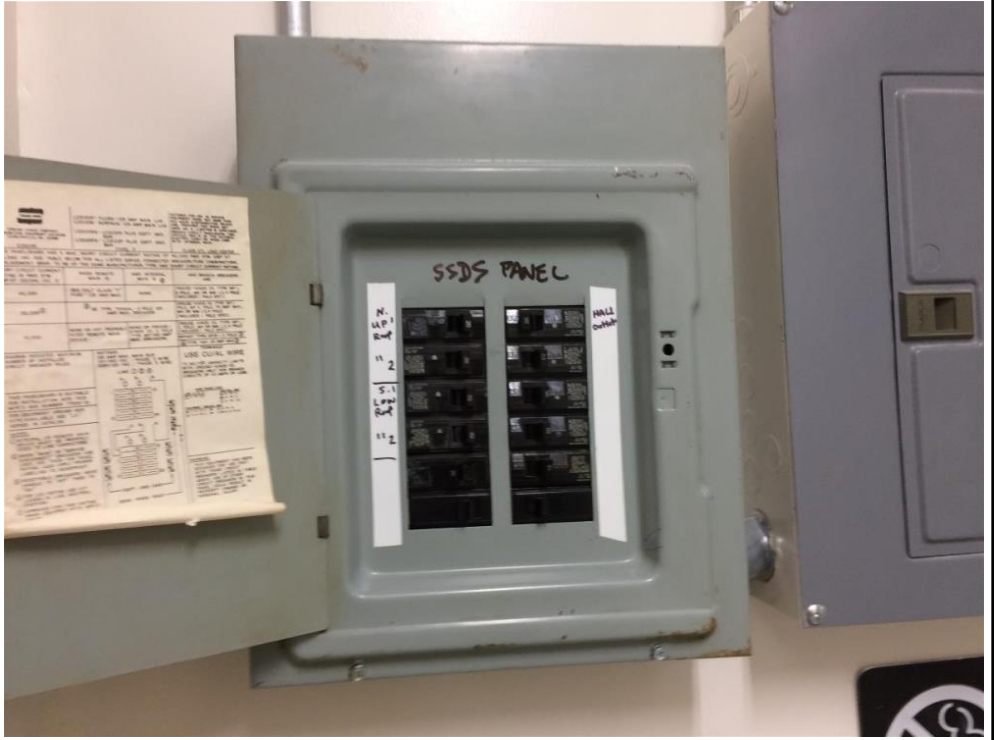
| <b>Photograph ID: 7</b> | | | |

| <b>Photo Location:</b><br>Panel box for SSDS electrical system breaker switches | | | |

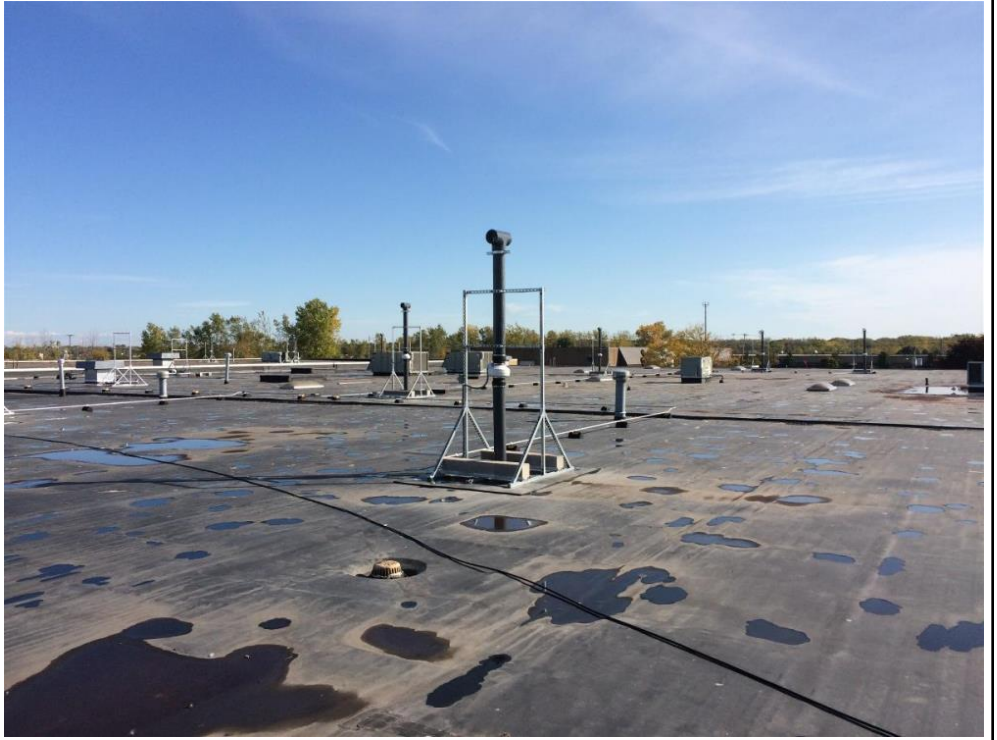
| <b>Photograph ID: 8</b> | | | |

| <b>Photo Location:</b><br>View of SSDS discharge stacks on building roof | | | |

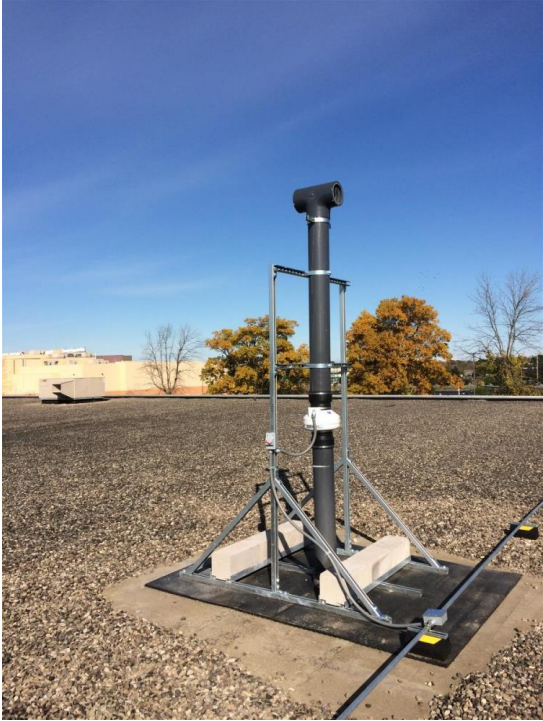
| <b>Photograph ID: 9</b> | | | |

| <b>Photo Location:</b><br>Discharge stack and support structure prior to installation of support cables and discharge vent screen | | | |

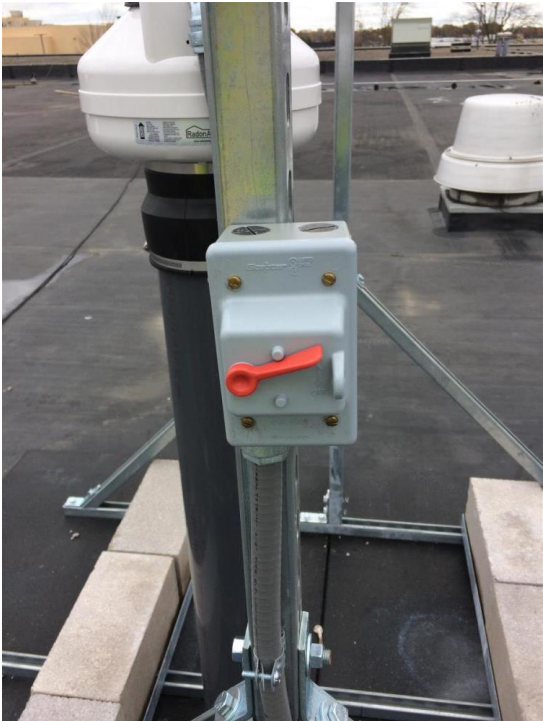
| <b>Photograph ID: 10</b> | | | |

| <b>Photo Location:</b><br>Close-up of on/off for switch for SSDS fan on rooftop support structure | | | |

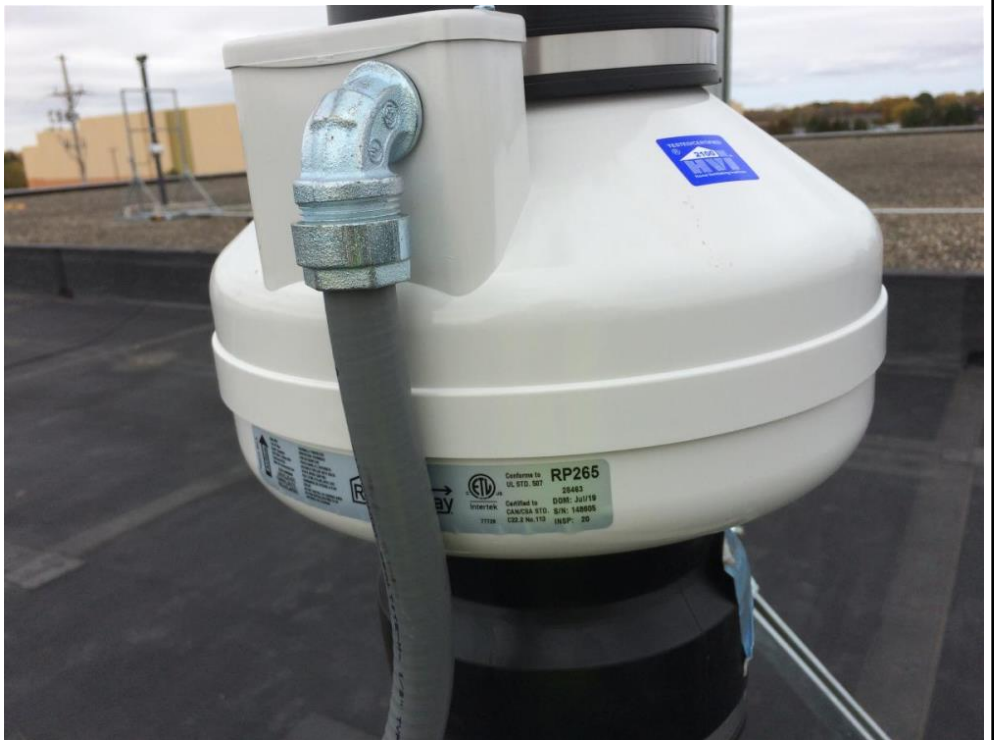
| <b>Photograph ID: 11</b> | | | |

| <b>Photo Location:</b><br>Close-up of SSDS fan model RP265 | | | |

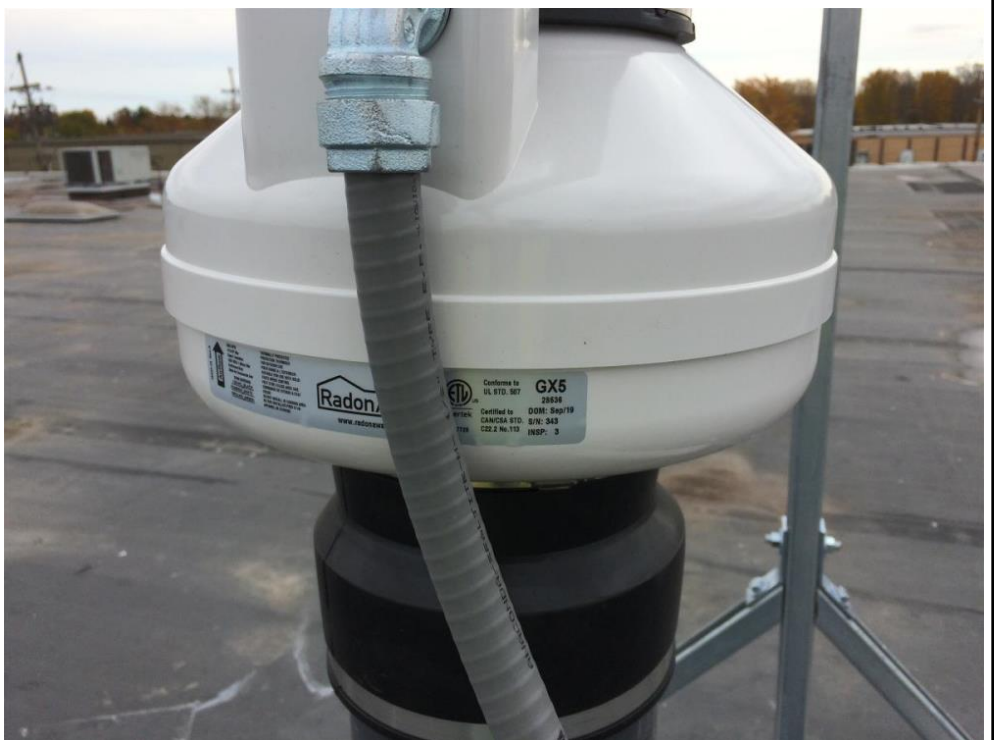
| <b>Photograph ID: 12</b> | | | |

| <b>Photo Location:</b><br>Close-up of SSDS fan model GX5 | | | |

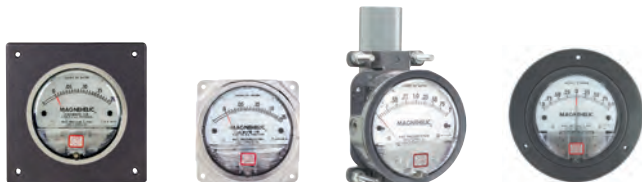
Flush, Surface or Pipe Mounted

A single case size is used for most models of Magnehelic® gages. They can be flush or surface mounted with standard hardware supplied. Although calibrated for vertical position, many ranges above 1" may be used at any angle by simply re-zeroing. However, for maximum accuracy, they must be calibrated in the same position in which they are used. These characteristics make Magnehelic® gages ideal for both stationary and portable applications. A 4-9/16" hole is required for flush panel mounting. Complete mounting and connection fittings, plus instructions, are furnished with each instrument. See pages 6 and 7 for more information on mounting accessories.

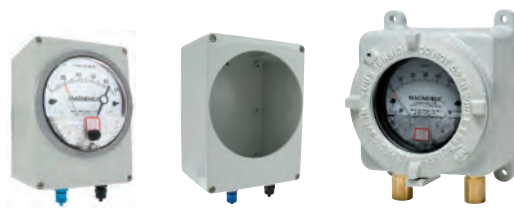
Enclosure Mounted

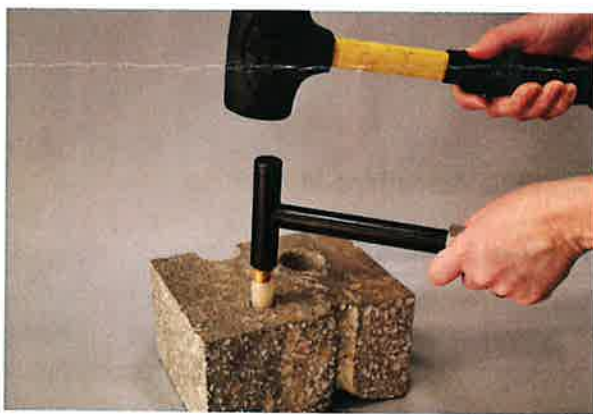
Figure 2. Installing the FLX-VP

- 3) If a flush mount installation is required, drill a 1½-inch (38mm) diameter hole at least 1¾-inches (45mm) into the slab. Use of a VAPOR PIN® drilling guide is recommended.
- 4) Drill a 5/8-inch (16mm) diameter hole through the slab and approximately 1-inch (25mm) into the underlying soil to form a void. Hole must be 5/8-inch (16mm) in diameter to ensure seal. It is recommended that you use the drill guide.
- 5) Remove the drill bit, brush the hole with the bottle brush, and remove the loose cuttings with the vacuum.
- 6) Place the lower end of the assembled FLX-VP into the drilled hole. Place the small hole located in the handle of the installation/extraction tool over the barb fitting, and tap the FLX-VP into place using a dead blow hammer (Figure 2). Make sure the installation/extraction tool is aligned parallel to the FLX-VP to avoid damaging the barb fitting.

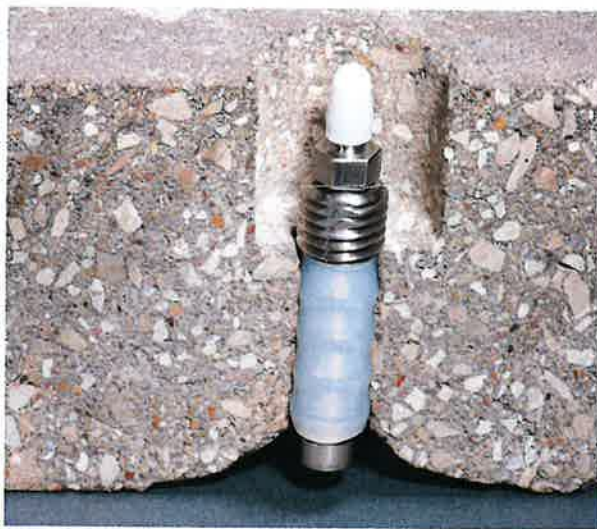
Figure 3. Installed FLX-VP

During installation, the silicone sleeve will form a slight bulge between the slab and the FLX-VP shoulder. Place the protective cap on FLX-VP to prevent vapor loss prior to sampling (Figure 3).

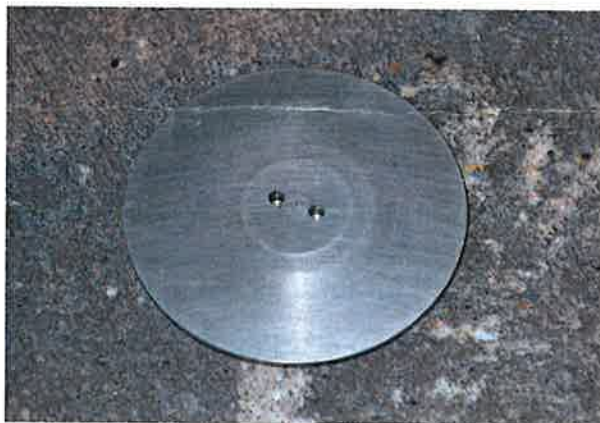
Figure 4. Secure Cover Installed

- 7) For flush mount installations, cover the FLX-VP with a flush mount cover, using either the plastic cover or the optional stainless-steel Secure Cover (Figure 4).

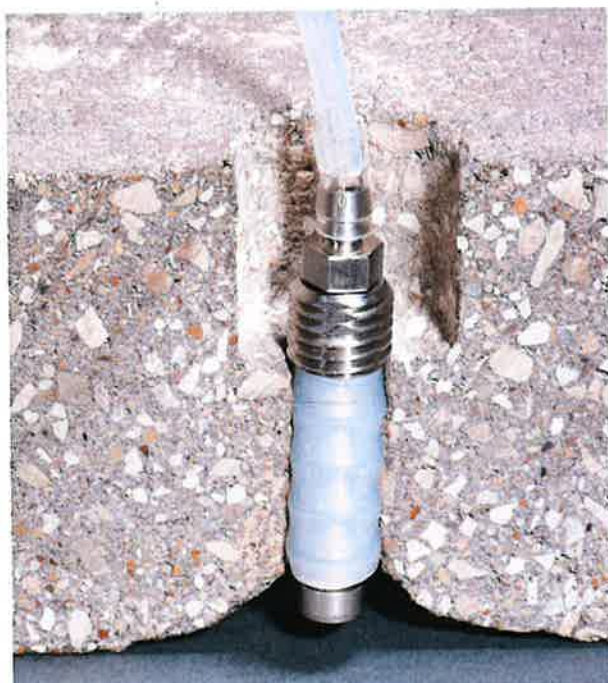
Figure 5. FLX-VP sample connection

- 9) Remove protective cap and connect sample tubing to the barb fitting of the FLX-VP. This connection can be made using a short piece of Tygon™ tubing to join the FLX-VP with the Nylaflow tubing (Figure 5). Put the Nylaflow tubing as close to the FLX-VP as possible to minimize contact between soil gas and Tygon™ tubing.

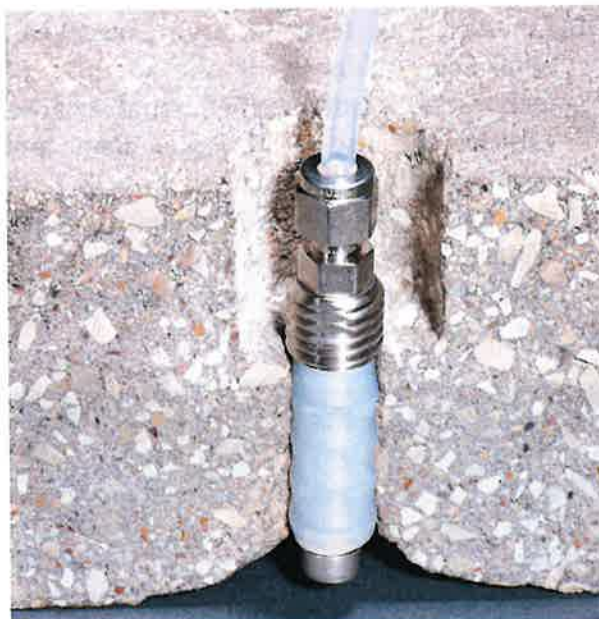
Figure 6. FLX-VP with Swagelok® connection

If you wish to directly connect to FLX-VP accessory (e.g. Swagelok fitting, TO-17 tube, or quick connect) unscrew the barb fitting and replace with accessory (Figures 6 and 7).

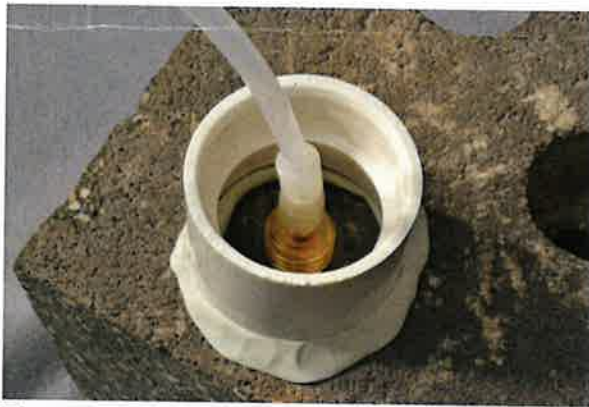
Figure 8. Water dam used for leak detection

- 10) Conduct leak tests in accordance with applicable guidance. If the method of leak testing is not specified, an alternative can be the use of a water dam and vacuum pump, as described in SOP Leak Testing the FLX-VP via Mechanical Means (Figure 8). For flush-mount installations, distilled water can be poured directly into the 1 1/2 inch (38mm) hole.

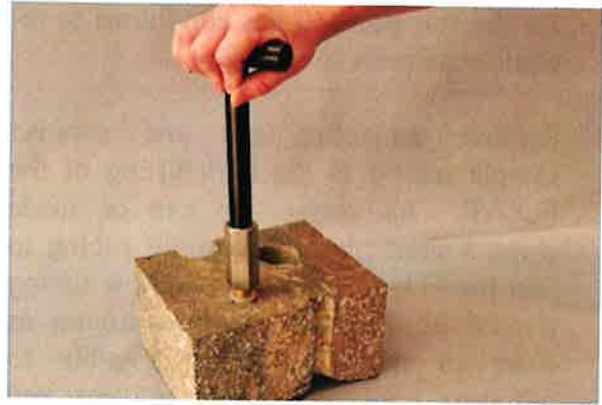
Figure 9. Removing the FLX-VP

- 1) Remove the protective cap, and thread the installation/extraction tool onto the barrel of the FLX-VP (Figure 9). Continue turning the tool clockwise to pull the FLX-VP from the hole into the installation/extraction tool.
- 2) Fill the void with hydraulic cement and smooth with a trowel or putty knife.

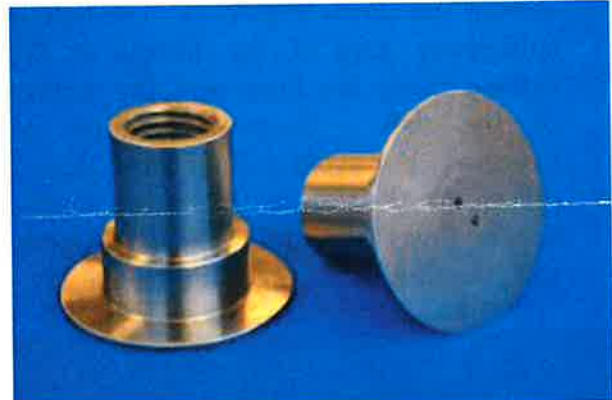
Figure 1. VAPOR PIN® Secure Cover

- VAPOR PIN® Secure Cover (Figure 1);
- VAPOR PIN® Drilling Guide (Figure 2);
- Hammer drill;
- 1½-inch diameter hammer bit (Hilti™ TE-YX 1½" x 23" #00293032 or equivalent);
- 5/8-inch diameter hammer bit (Hilti™ TE-YX 5/8" x 22" #00226514 or equivalent);
- assembled VAPOR PIN®;
- #14 spanner wrench;
- Wet/Dry vacuum with HEPA filter (optional); and

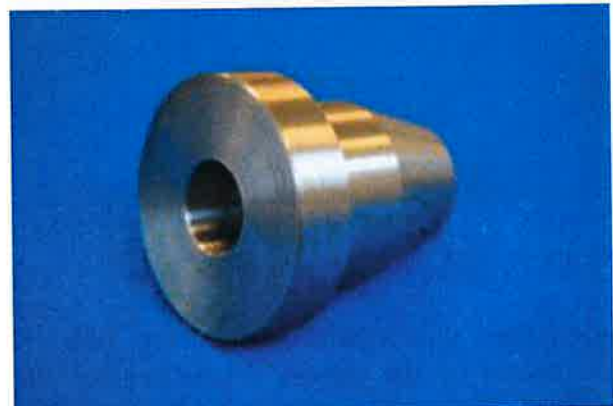
Figure 2. VAPOR PIN® Drilling Guide

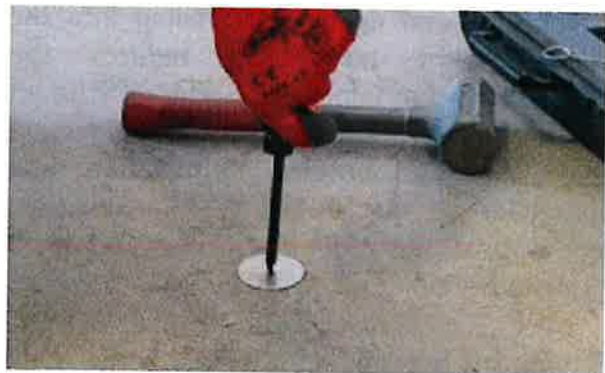
Figure 5. Tightening the Secured Cover

- 7) Screw the Secure Cover onto the VAPOR PIN® and tighten using a #14 spanner wrench by rotating it clockwise (Figure 5). Rotate the cover counter clockwise to remove it for subsequent access.
