BROWNFIELD CLEANUP PROGRAM
REMEDIAL INVESTIGATION REPORT

SPEEDY'S CLEANERS
3130 Monroe Avenue
Town of Pittsford
Rochester, New York 14618

NYSDEC Site # C828109

Prepared by:
Passero Associates
100 Liberty Pole Way
Rochester, NY 14604

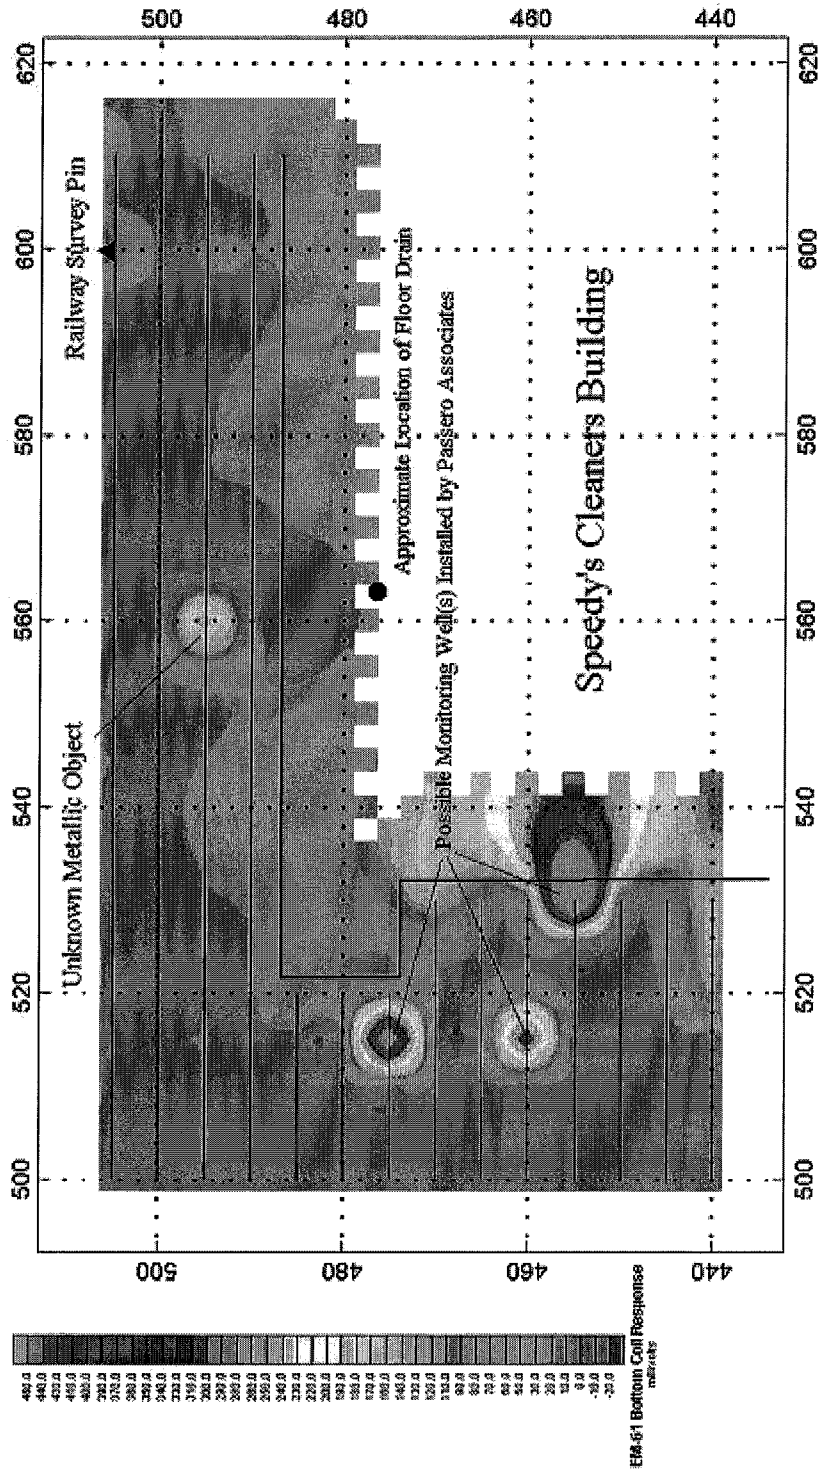
Figure D-1
 Speedy's Cleaners Site
 Pittsford, New York
 EM-61 High Resolution Metal Detection Survey
 Bottom Coil Response Results
