VOLUNTEERS OF AMERICA – BACK LOT REMEDIAL INVESTIGATION REPORT

**214 Lake Avenue – Back Lot
Rochester, NY
Site C828126**

Submitted to: New York State Department of Environmental Conservation

Prepared by: Bergmann Associates

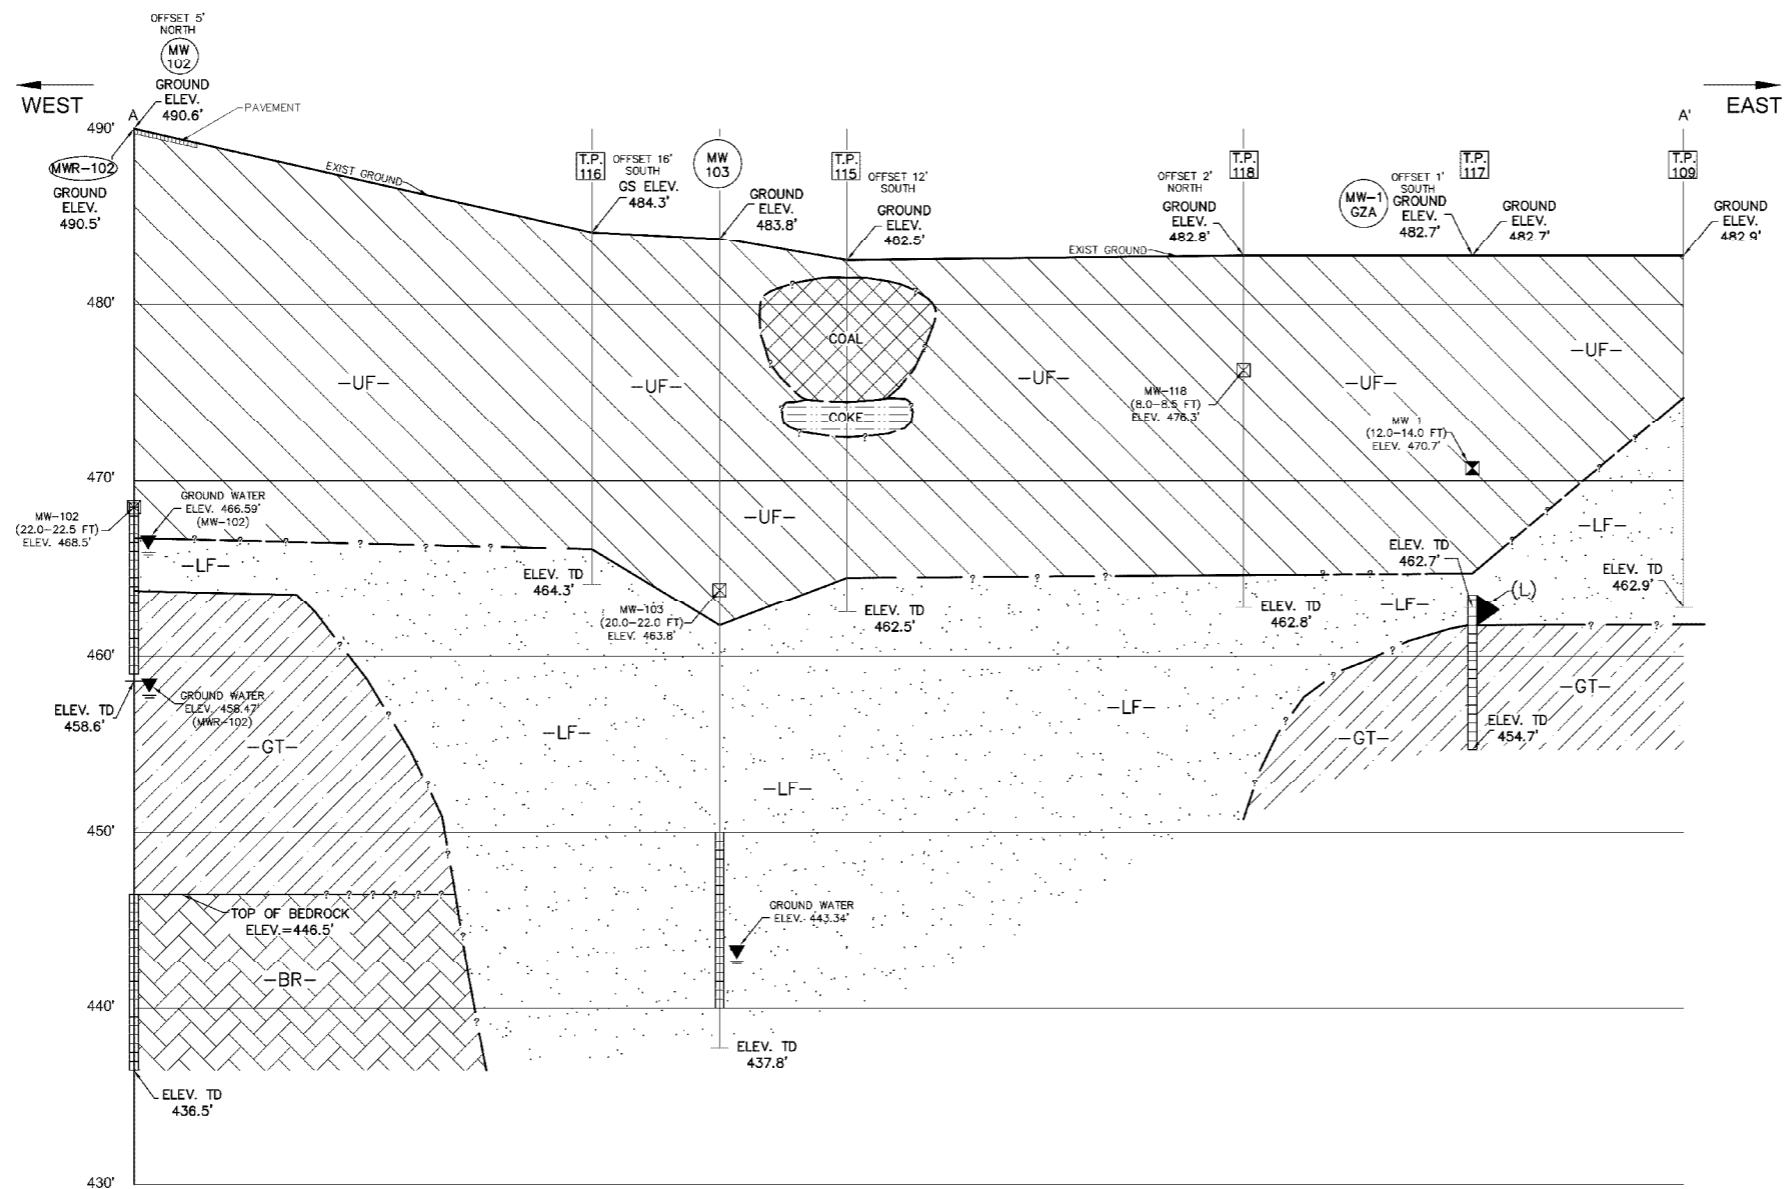
**GEOLOGIC CROSS SECTION
A TO A'**

- LEGEND:**
- UPPER FILL (UF)
 - GLACIAL TILL (GT)
 - LOWER FILL (LF)
 - BEDROCK (BR)
 - LACUSTRINE (L) (GZA 1996)
 - COKE
 - COAL
 - WELL SCREEN INTAKE
 - TEST BORING/MONITOR WELL, GZA 1996
 - TEST PIT EXPLORATION
 - DEPOSIT INTERVAL
 - DEPOSIT INTERVAL (LESS CONFIDENT-APPROXIMATE)
 - DEPOSIT INTERVAL (LEAST CONFIDENT-VERY APPROXIMATE)
 - TD = TOTAL DEPTH
 - GS = GROUND SURFACE
 - GEOQUEST SOIL SAMPLE LOCATION / ELEVATION
 - GEOQUEST GROUNDWATER ELEVATION JULY 2009
 - GZA-1996 SOIL SAMPLE
 - PAVEMENT

GEOLOGIC CROSS SECTION A TO A'
FOR
REMEDIAL INVESTIGATION
EASTERN PORTION OF PARCEL A AND PARCEL B
214 LAKE AVENUE
ROCHESTER, NEW YORK
DECEMBER 16, 2009

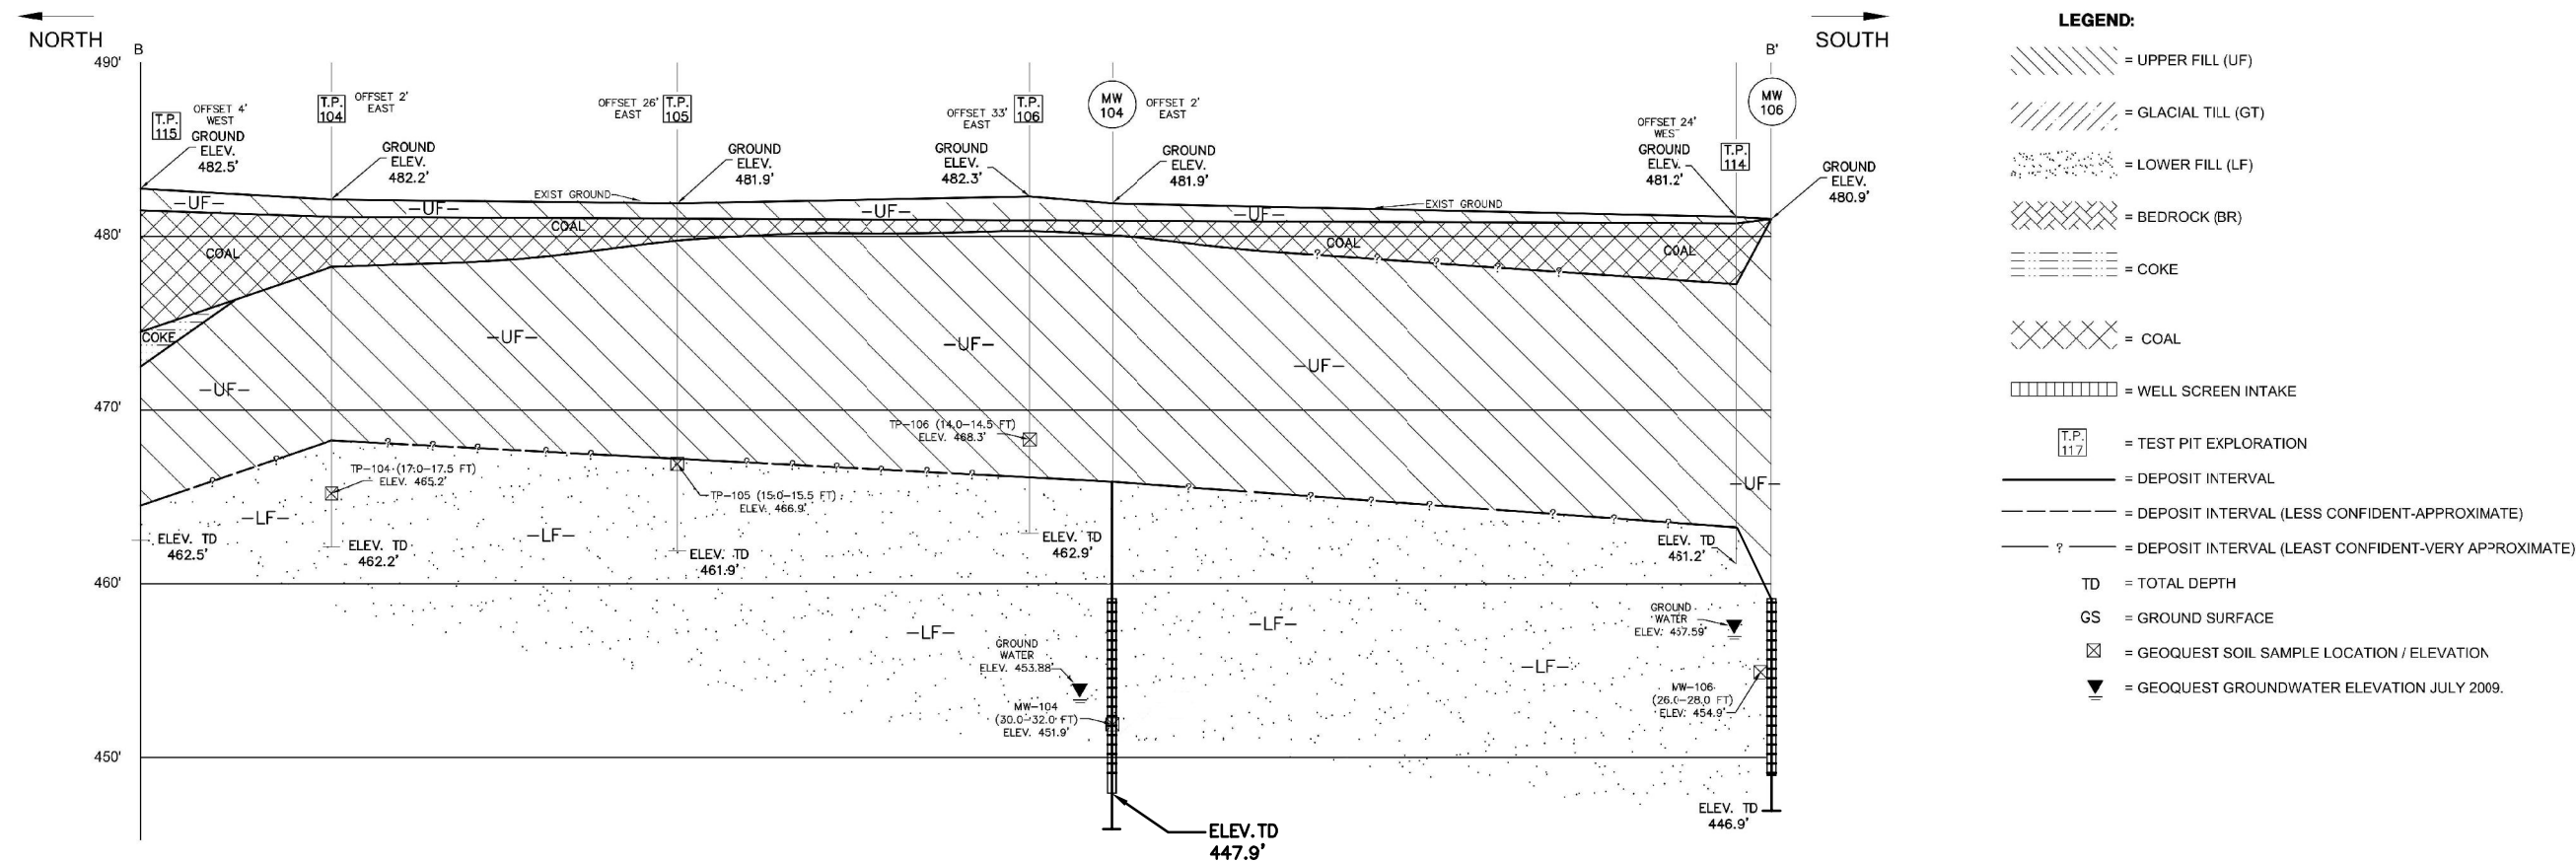
**GEOLOGIC CROSS SECTION
B TO B'**

GEOLOGIC CROSS SECTION B TO B'
FOR
REMEDIAL INVESTIGATION
EASTERN PORTION OF PARCEL A AND PARCEL B
214 LAKE AVENUE
ROCHESTER, NEW YORK
DECEMBER 16, 2009

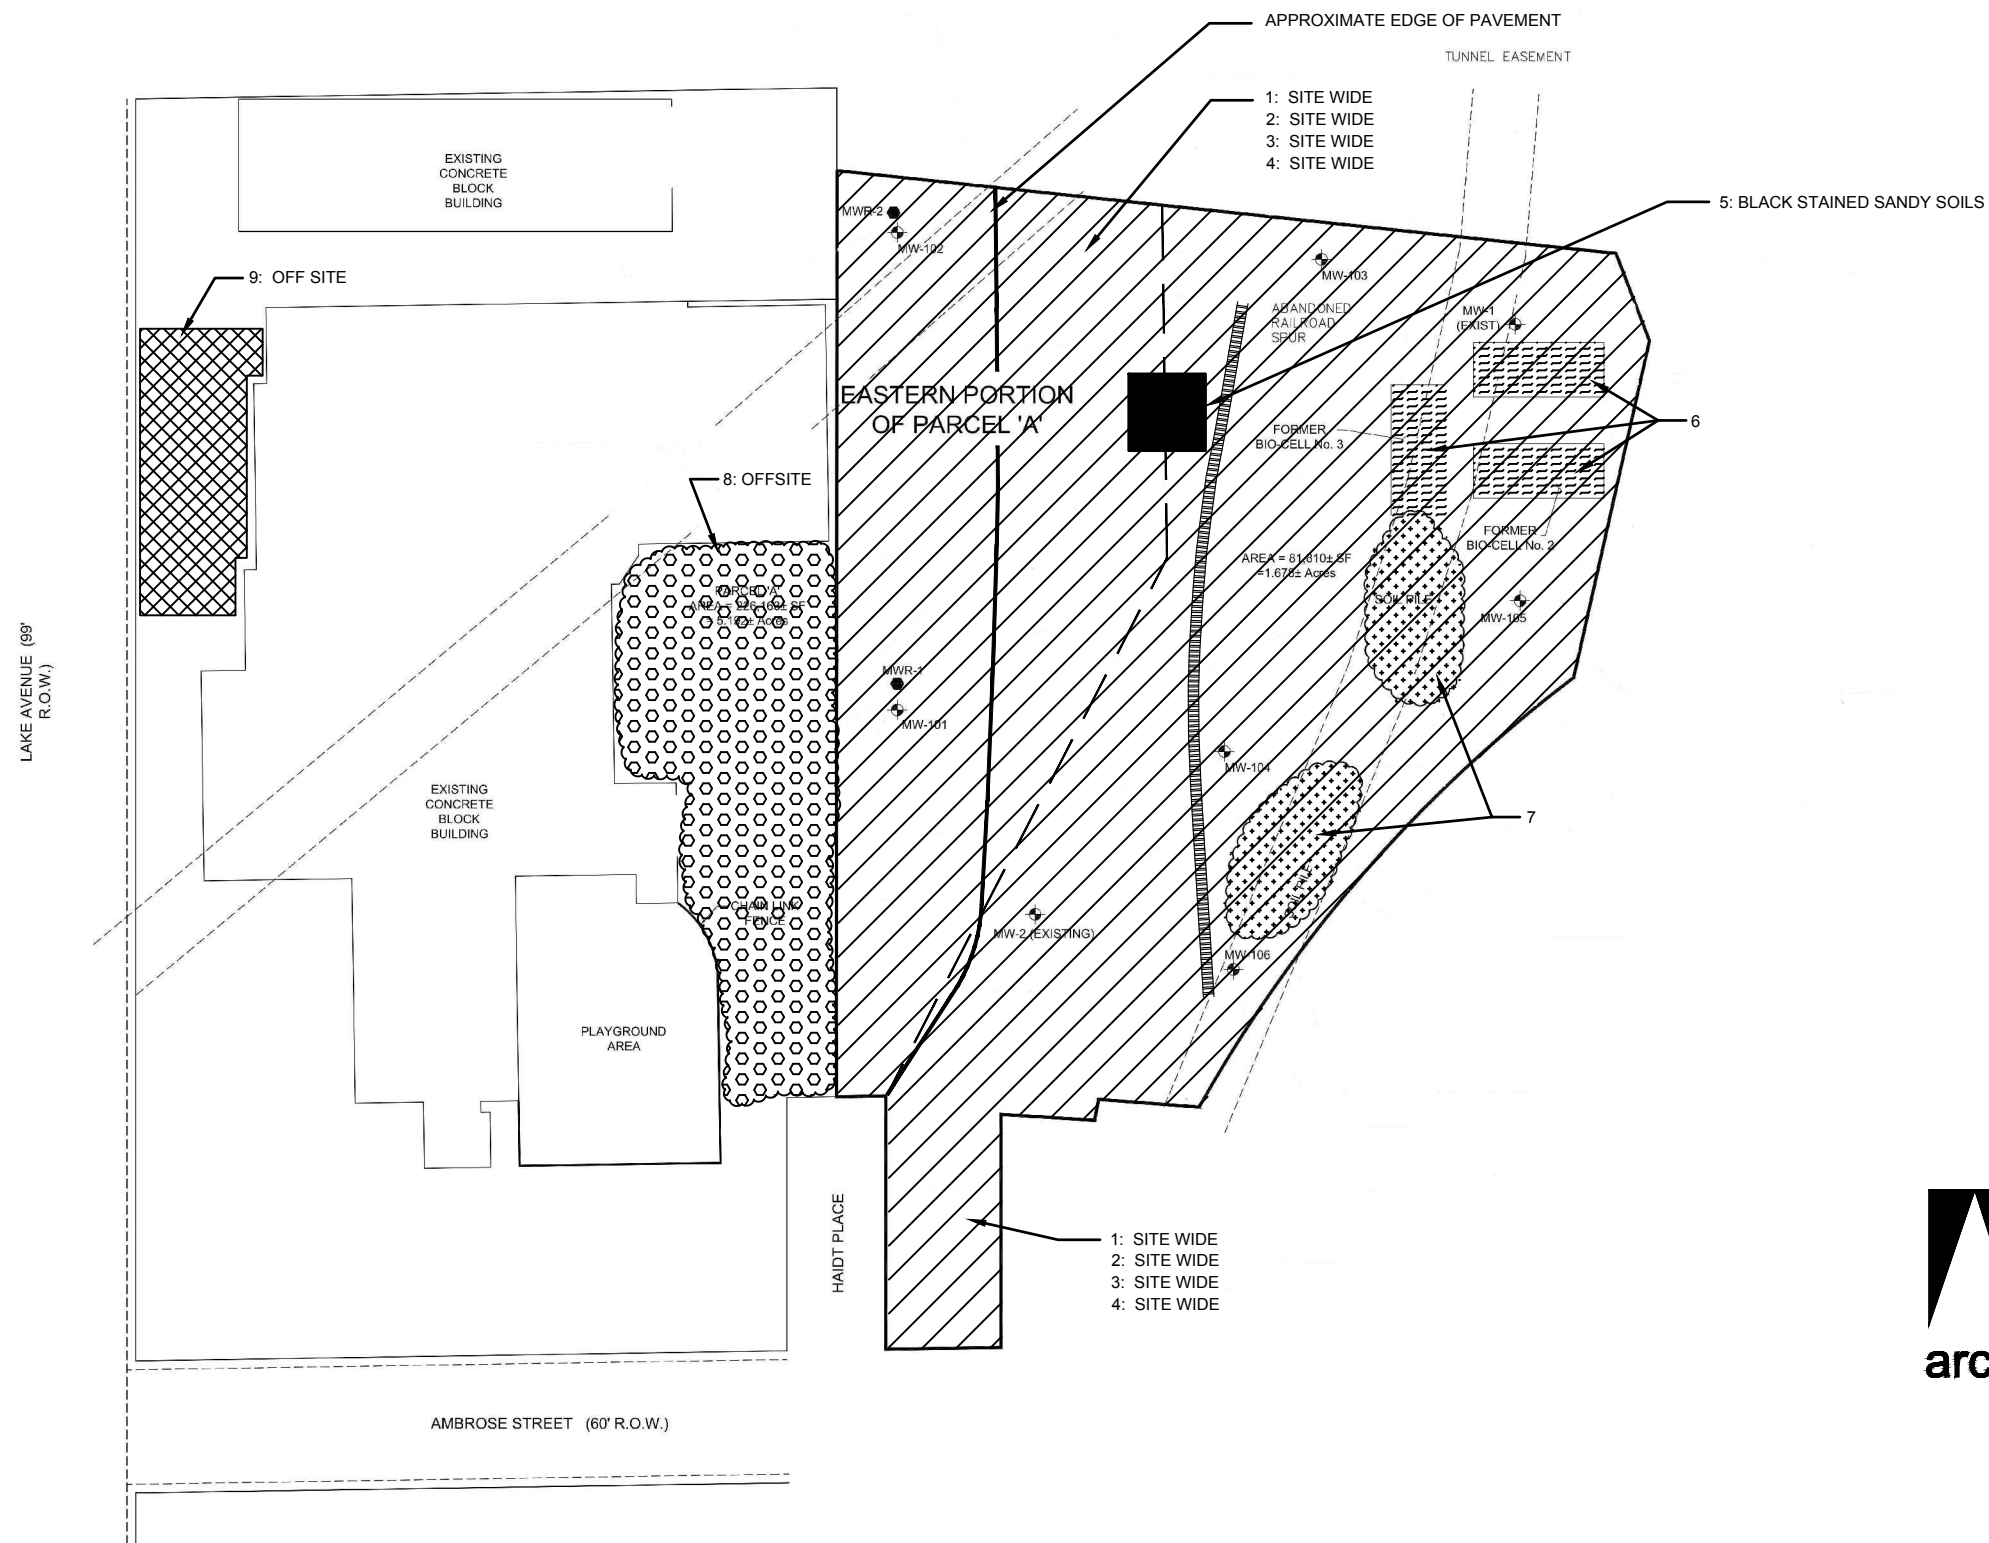
FIG. 7

1. ALL LOCATIONS ARE APPROXIMATE.
2. SEE REPORT TEXT (PAGE 25) FOR DESCRIPTION OF BLACK STAINED SANDY SOILS.

One unusual area of black stained sandy soil, which was not representative of the other historic fill on the Site, was encountered during the Supplemental RI at the north end of the Site. This area is approximately 35 ft by 35 ft. and these soils were encountered at approximately 6 to 8 feet below the ground surface in test pits TP-131 and TP-132. The extent of these soils extends to depths greater than 20 feet and is centered on test pit location TP-132. The total organic vapors detected from the

black stained sandy soils ranges from approximately 19.8 ppm to 84 ppm in TP-131 and 59 ppm to 440 ppm in TP-132. Total organic vapors were measured with a Photoionization detector in accordance with the soil screening procedures detailed in the RI Work Plan.

Based on the results from the previous GZA investigations, further site observations, and review of the Site history, the RI Scope of Work focused on the following potential environmental conditions, which were identified in the RI work plan and are shown on Figure 7.

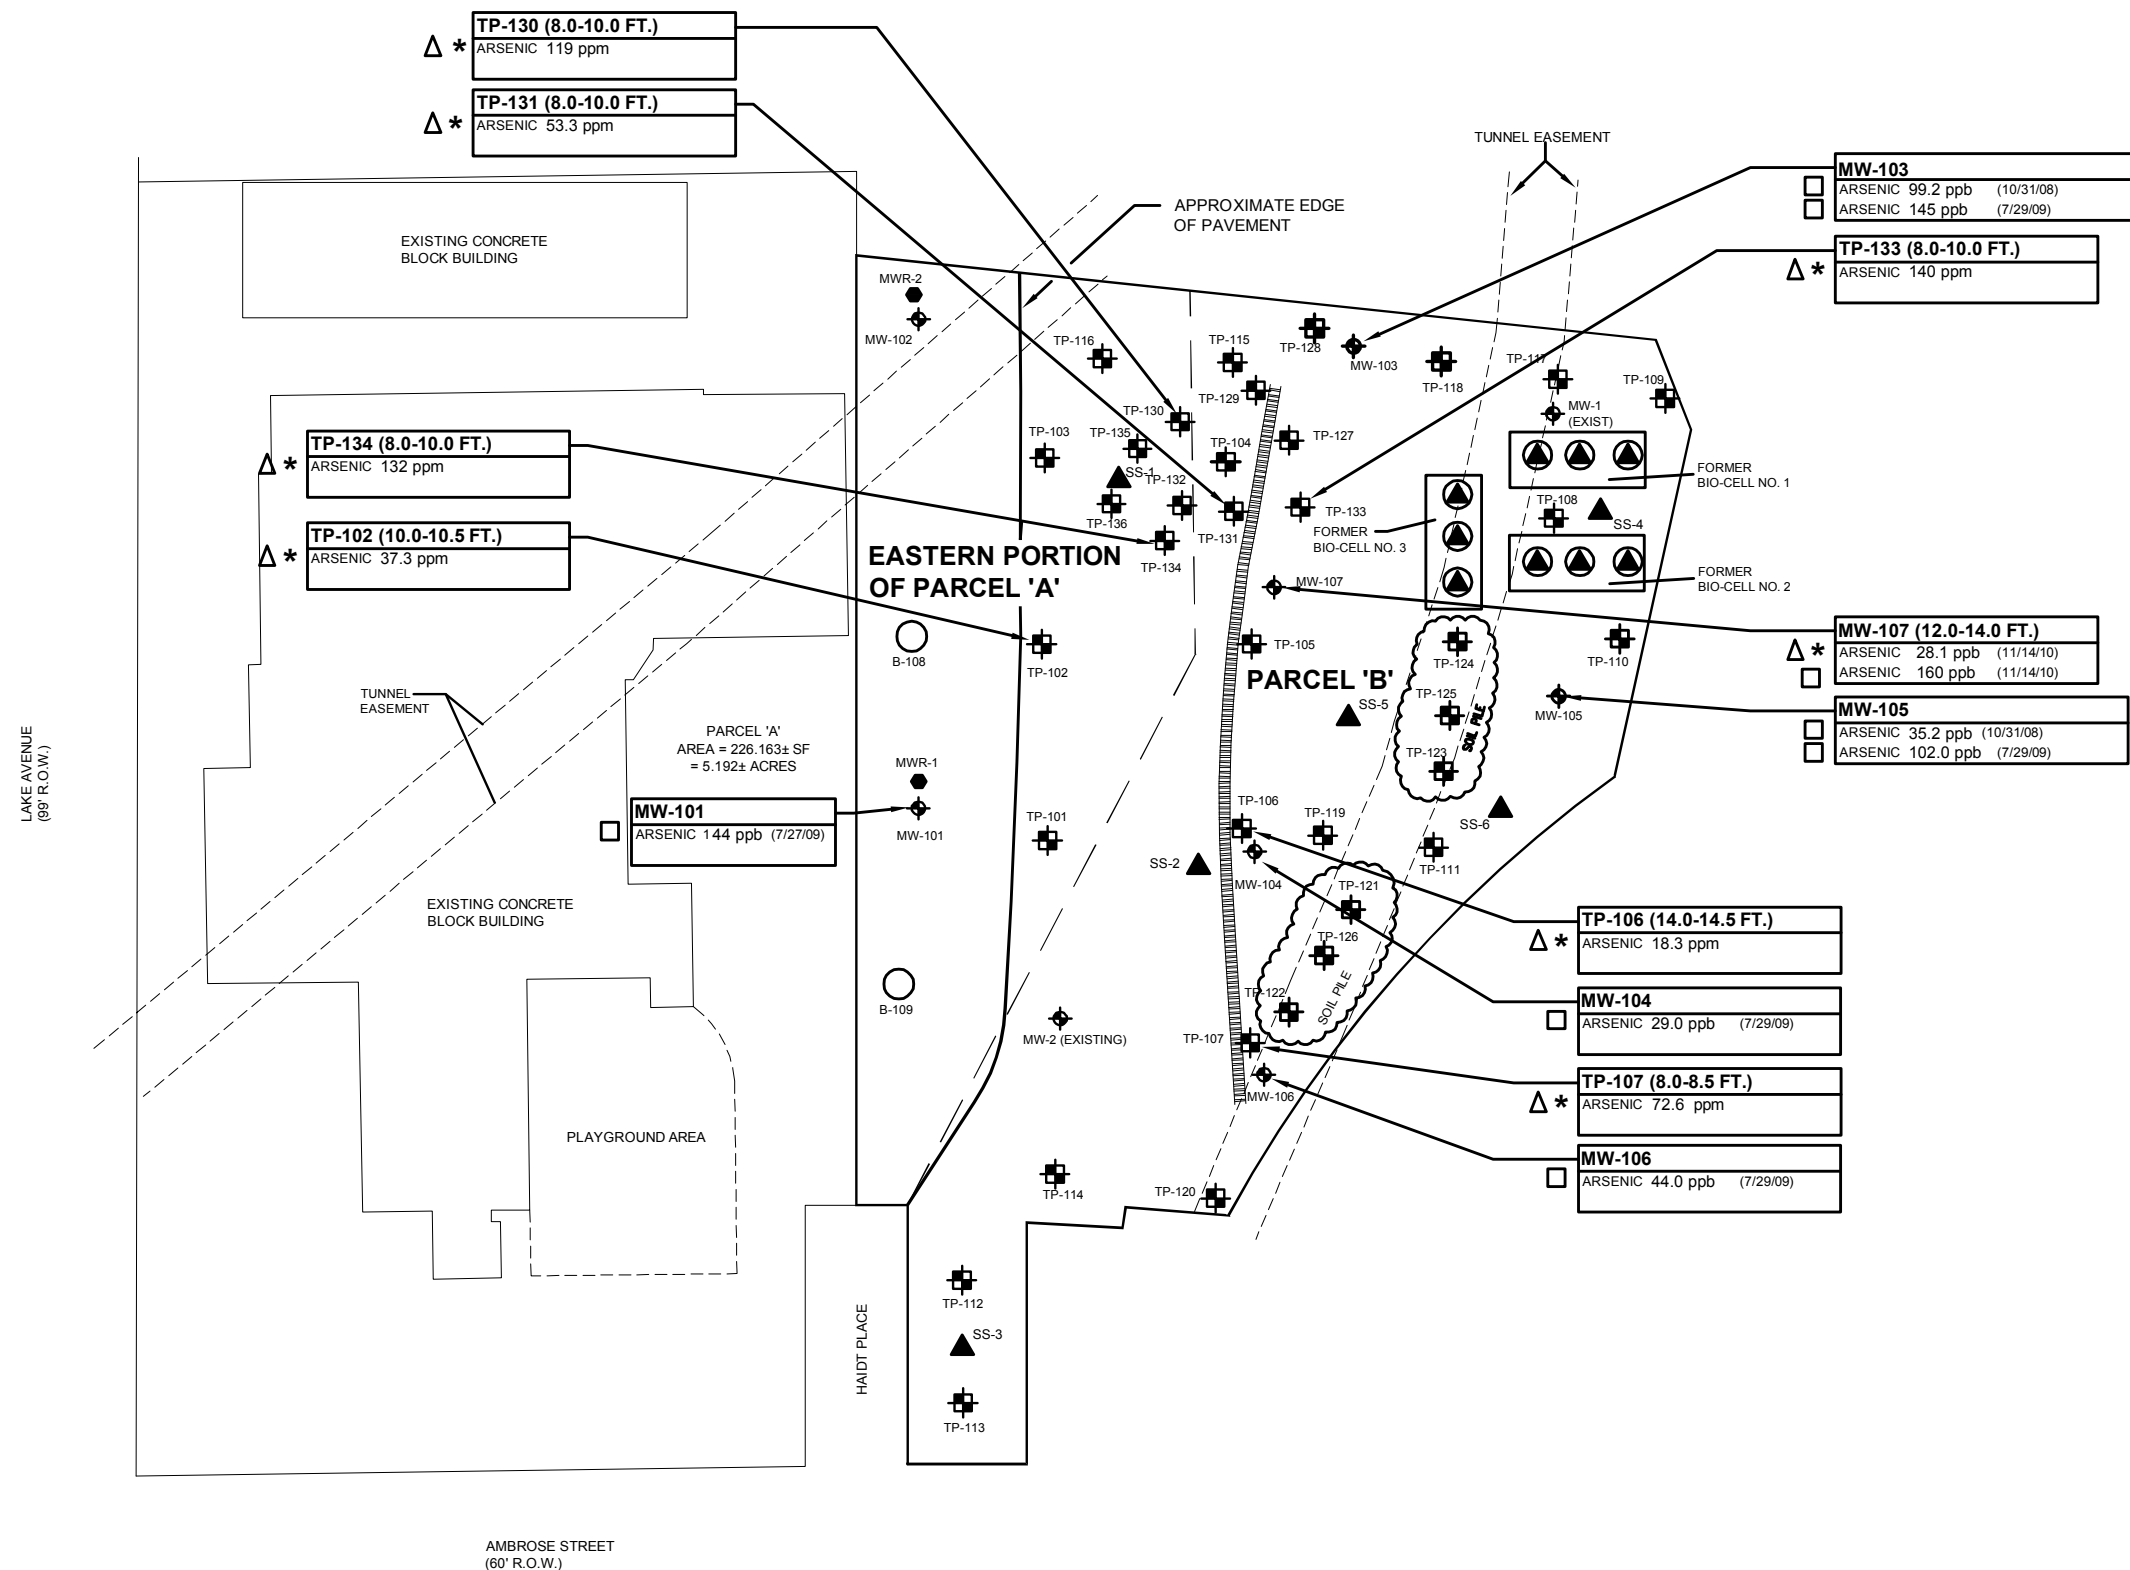
- INDICATES DETECTION OF ARSENIC IN GROUNDWATER SAMPLE IN ppb THAT EXCEEDS PART 703.5 GROUNDWATER STANDARDS
- CONCENTRATIONS OF ARSENIC DETECTED IN SOIL SAMPLE THAT EXCEED COMMERCIAL SOIL CLEANUP OBJECTIVES.
- CONCENTRATIONS OF ARSENIC DETECTED IN SOIL SAMPLE THAT EXCEEDS PROTECTION OF GROUNDWATER CLEANUP OBJECTIVES.
- EXISTING BUILDING
- PROJECT SITE BOUNDARY
- EAST BOUNDARY OF PARCEL 'A' AND WEST BOUNDARY OF PARCEL 'B'
- FORMER BIO-CELL
- SOIL PILE
- TEST PIT LOCATIONS
- SOIL BORING LOCATION
- MONITOR WELL LOCATION
- BIO-CELL COIL SAMPLE LOCATION
- APPROXIMATE LOCATION OF SURFACE SOIL SAMPLE
- ABANDONED RAILROAD SPUR
- APPROXIMATE EDGE OF PAVEMENT

**DISTRIBUTION OF ARSENIC IN
SOIL AND GROUNDWATER SAMPLES**
FOR
REMEDIAL INVESTIGATIONS
EASTERN PORTION OF PARCEL A AND PARCEL B
214 LAKE AVENUE
ROCHESTER, NEW YORK

sample TP-132 for EPA 8015B diesel range organic reported 2,200 ppm. Arsenic was also detected in the black stained sand and silt fill soil samples from TP-131 (53.5 ppm), which exceeded the Commercial SCO level of 16 ppm.

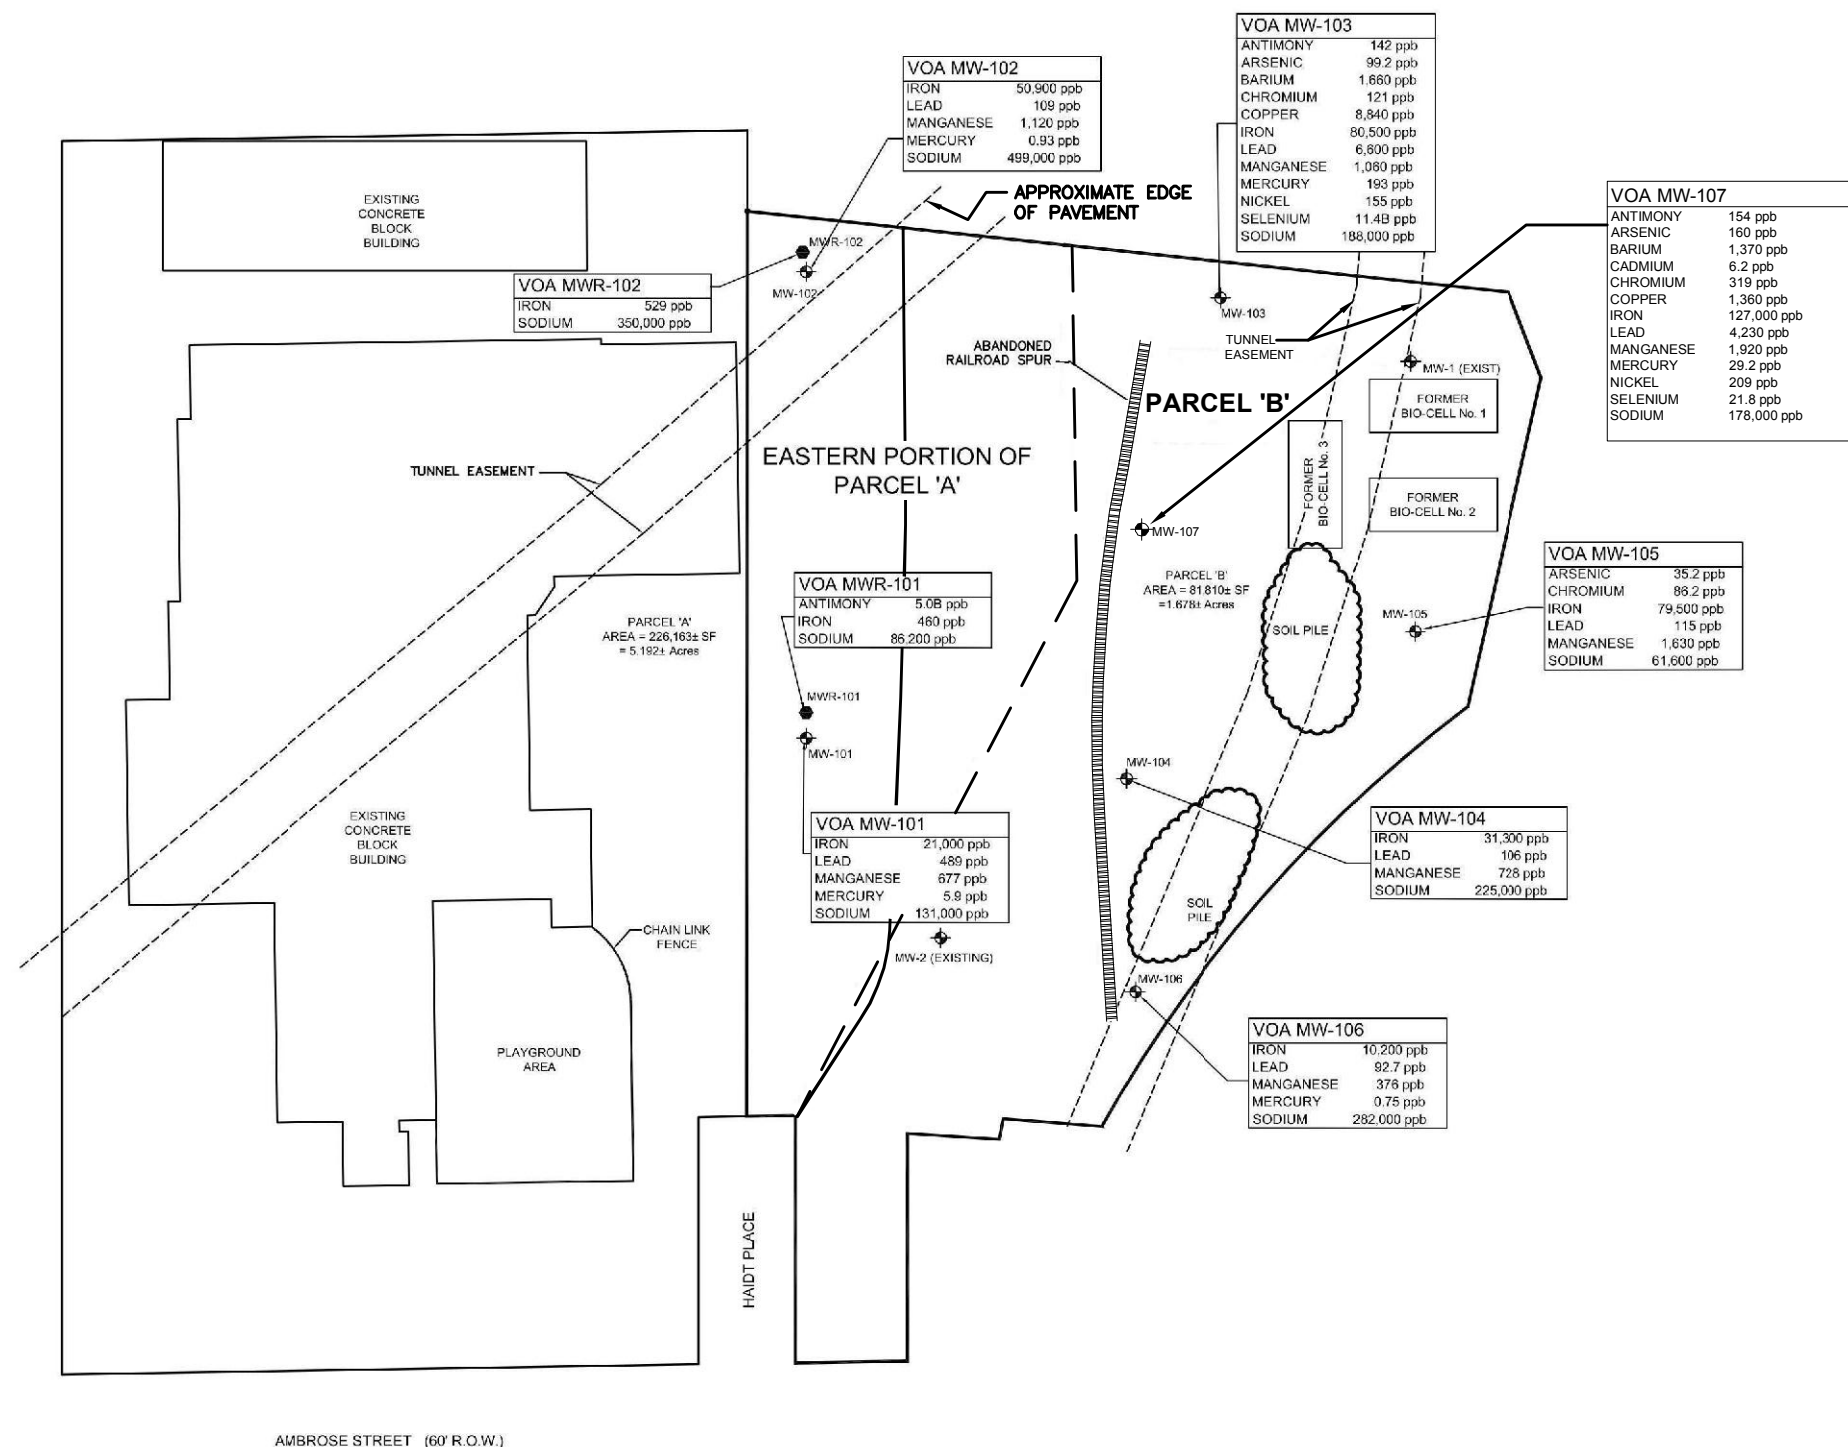
- LOCATIONS OF SUBSURFACE LOCATIONS ARE APPROXIMATE.
- SAMPLES COLLECTED FROM MONITORING WELLS ON OCTOBER 30 & OCTOBER 31, 2008. SAMPLE FROM MW-107 COLLECTED ON NOVEMBER 4, 2010
- CONCENTRATIONS EXPRESSED IN PARTS PER BILLION (ppb).
- CONCENTRATIONS FOR METALS EXCEED NEW YORK STATE GROUNDWATER STANDARDS.

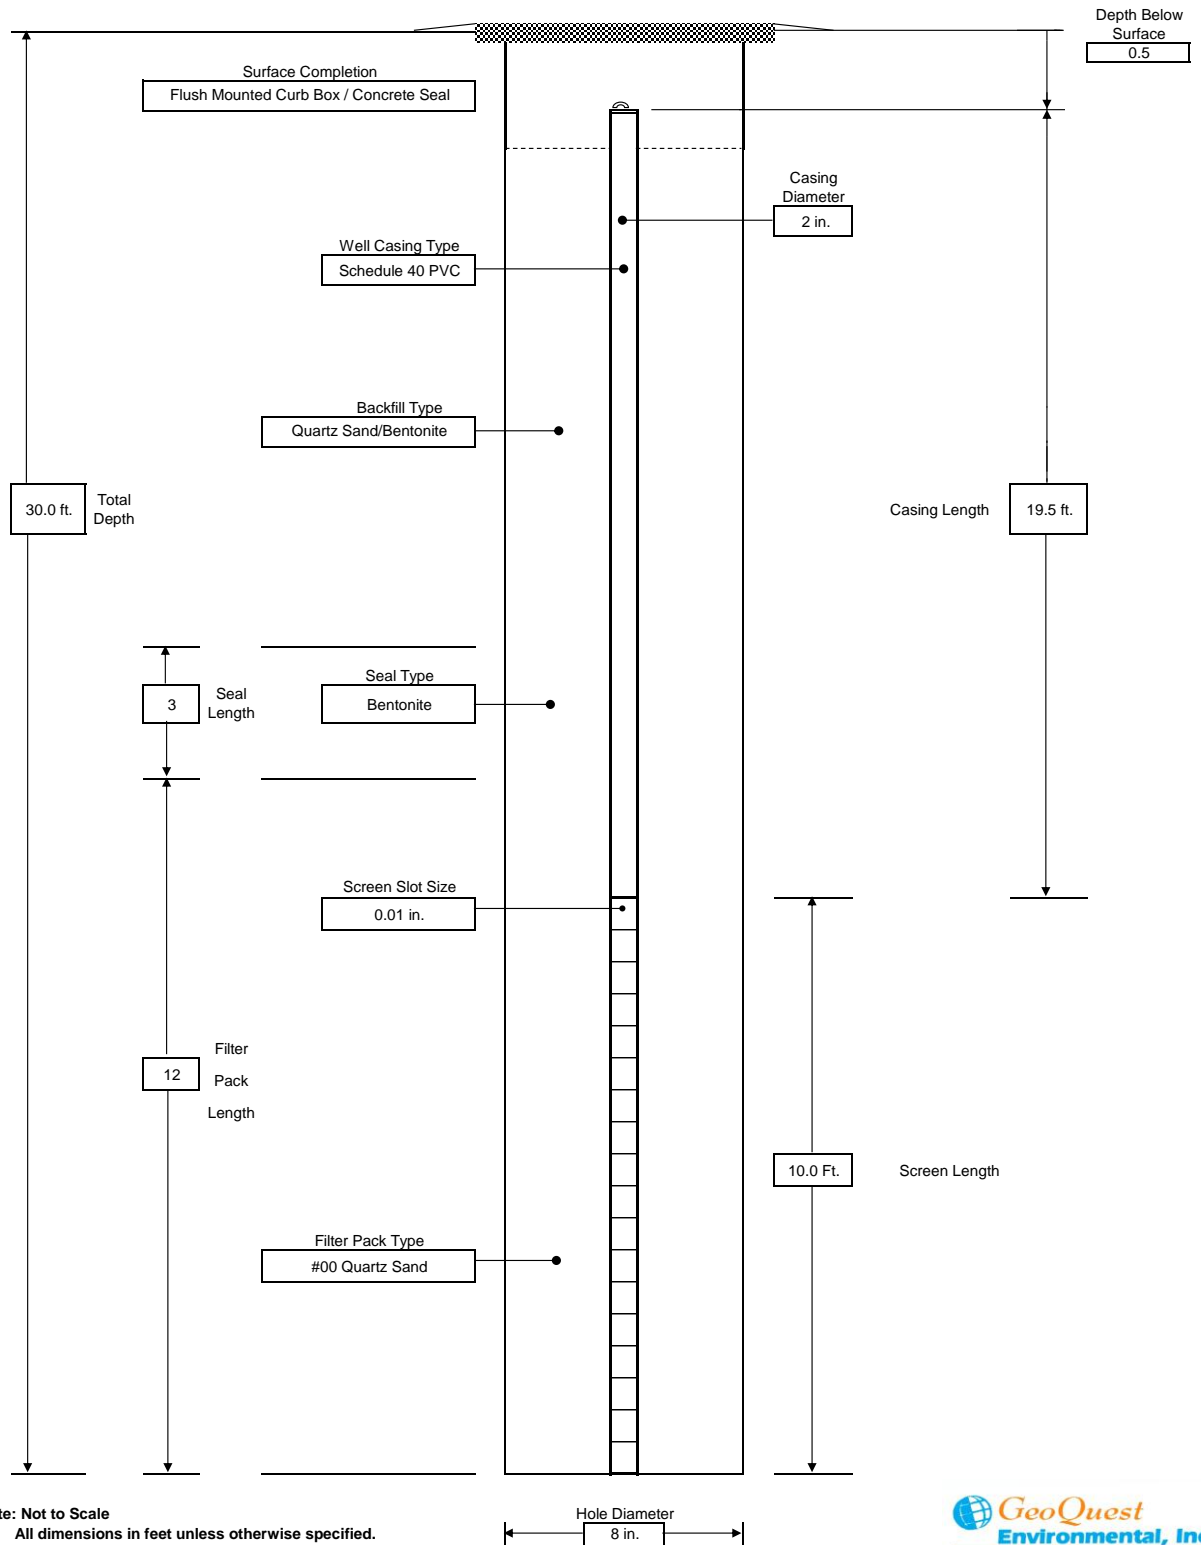
| Project: | Volunteers of America, 214 Lake Avenue, Rochester, NY | Well Name: | MW - 102 | WELL COMPLETION LOG | |

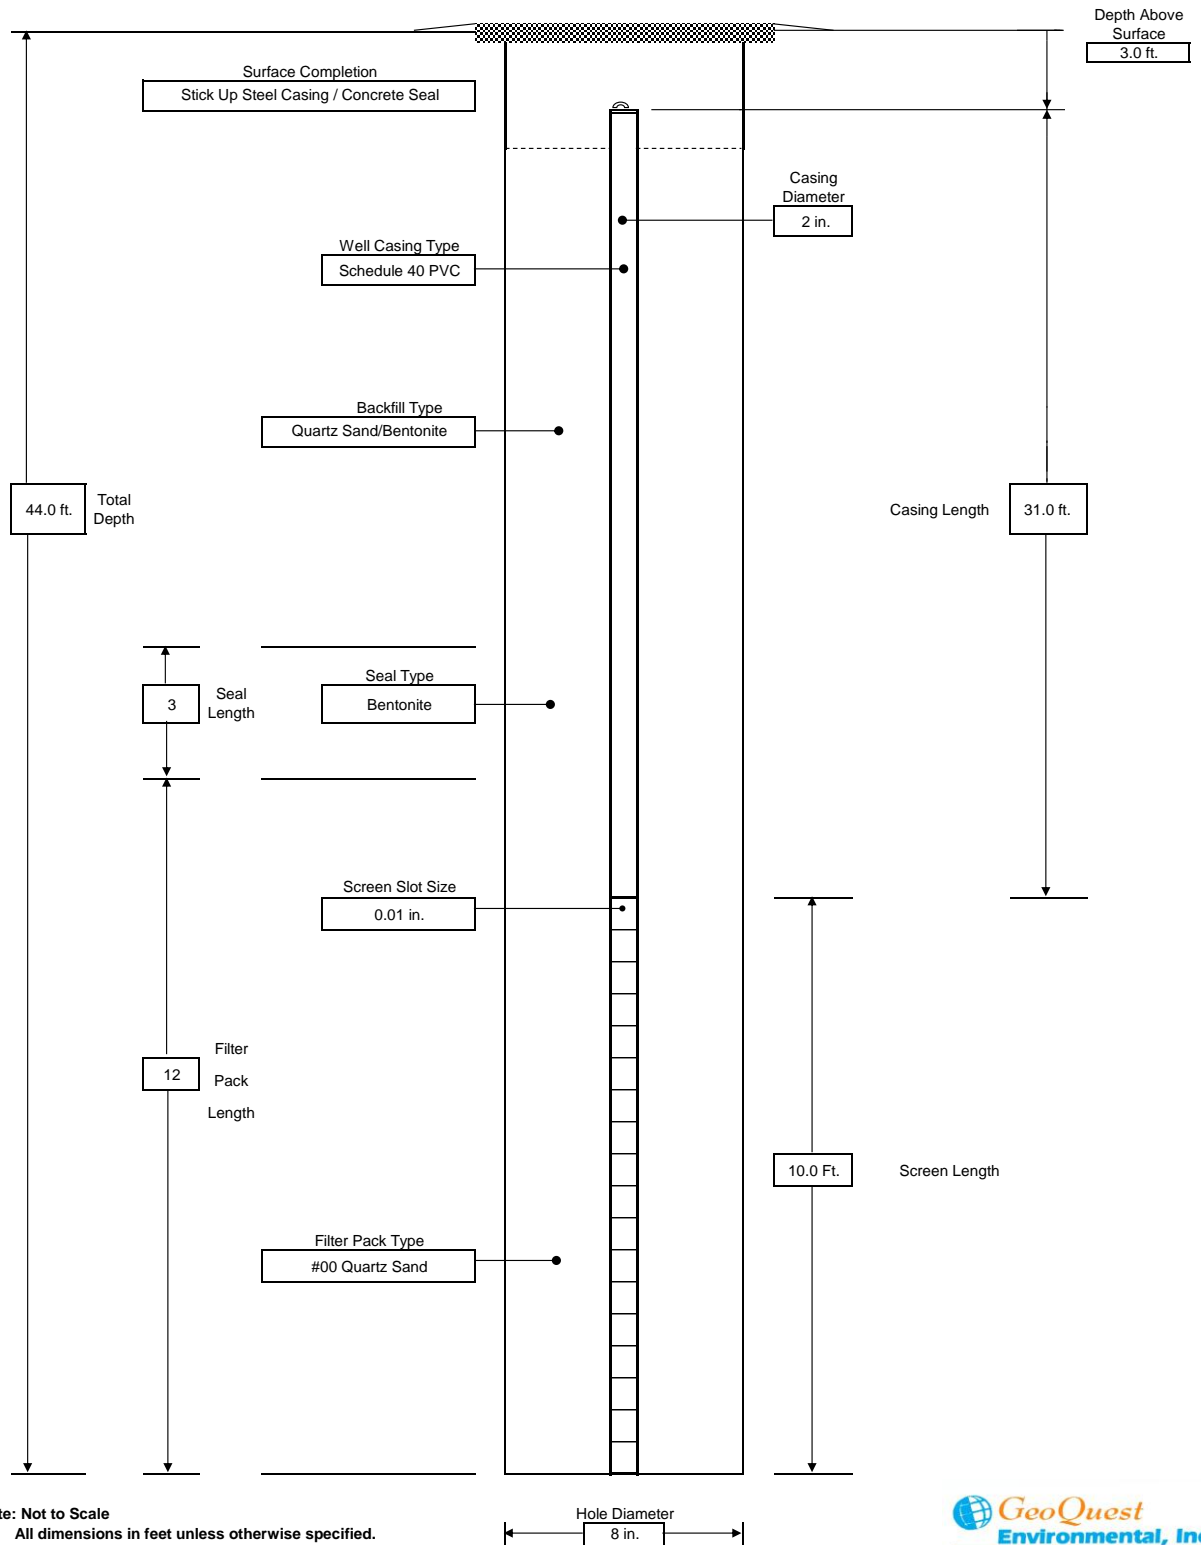
| Project: | Volunteers of America, 214 Lake Avenue, Rochester, NY | Well Name: | MW - 104 | WELL COMPLETION LOG |

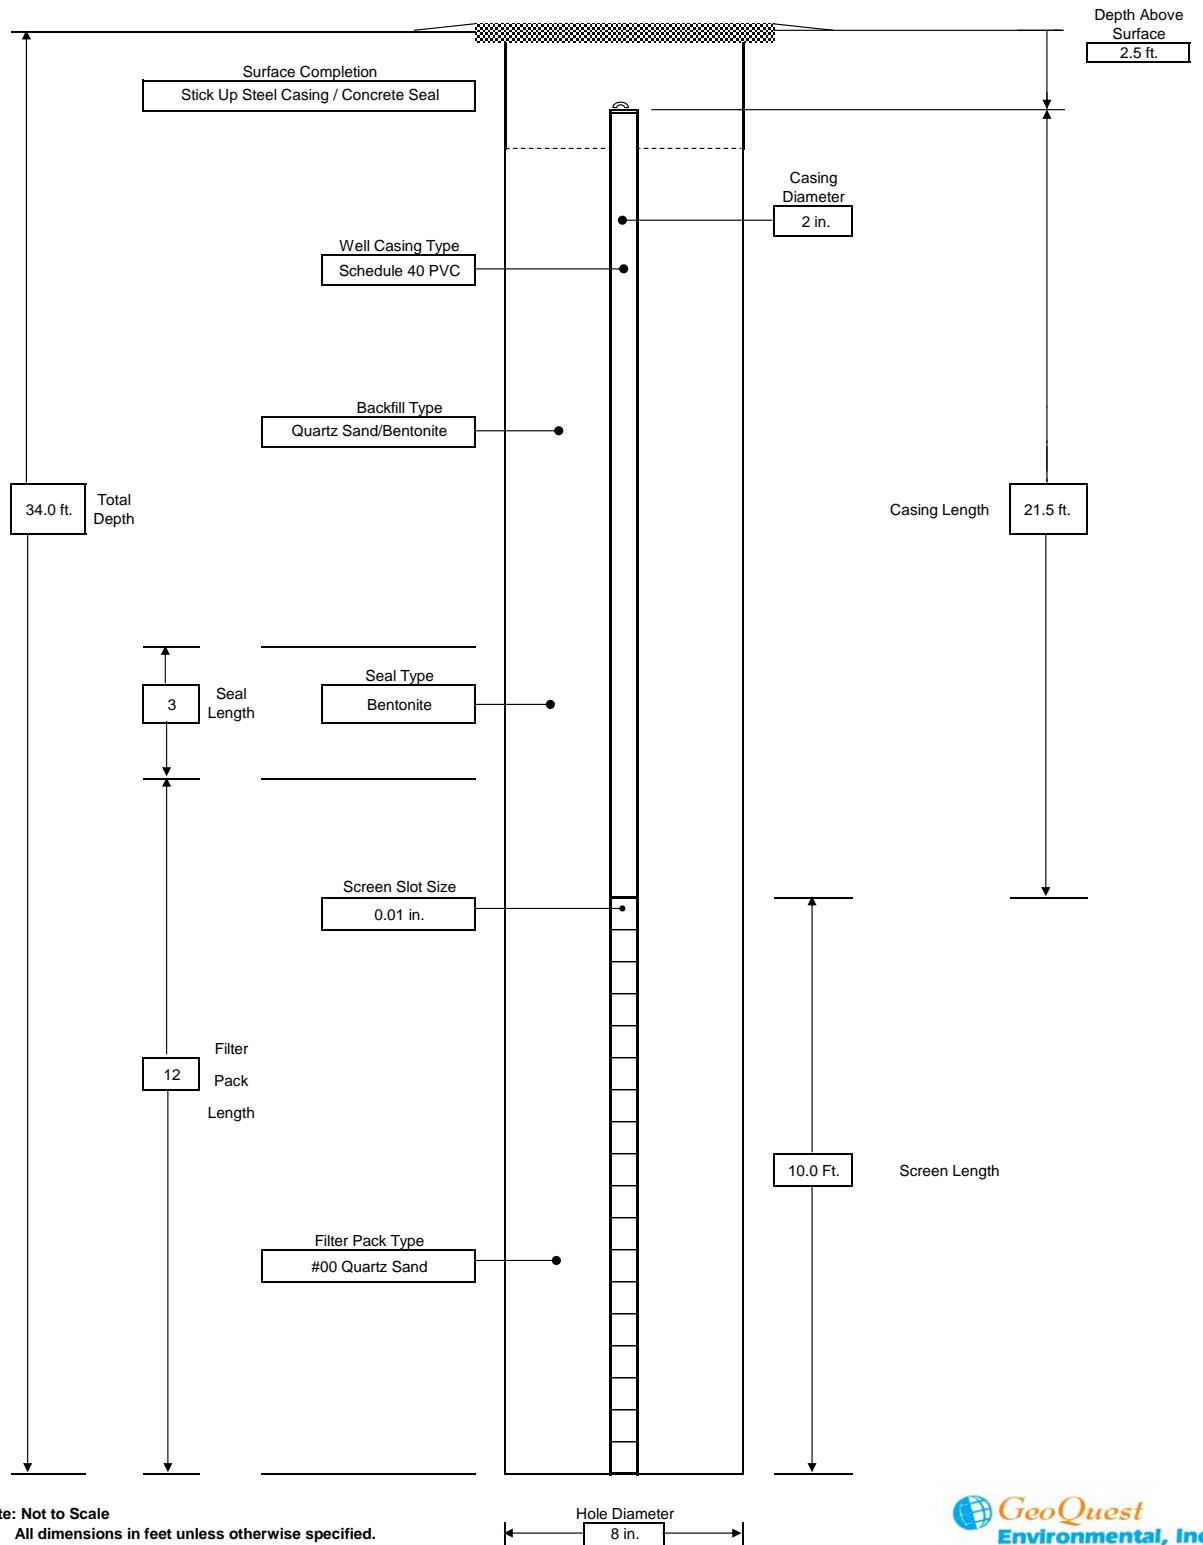
| Project: | Volunteers of America, 214 Lake Avenue, Rochester, NY | Well Name: | MW - 105 | WELL COMPLETION LOG |

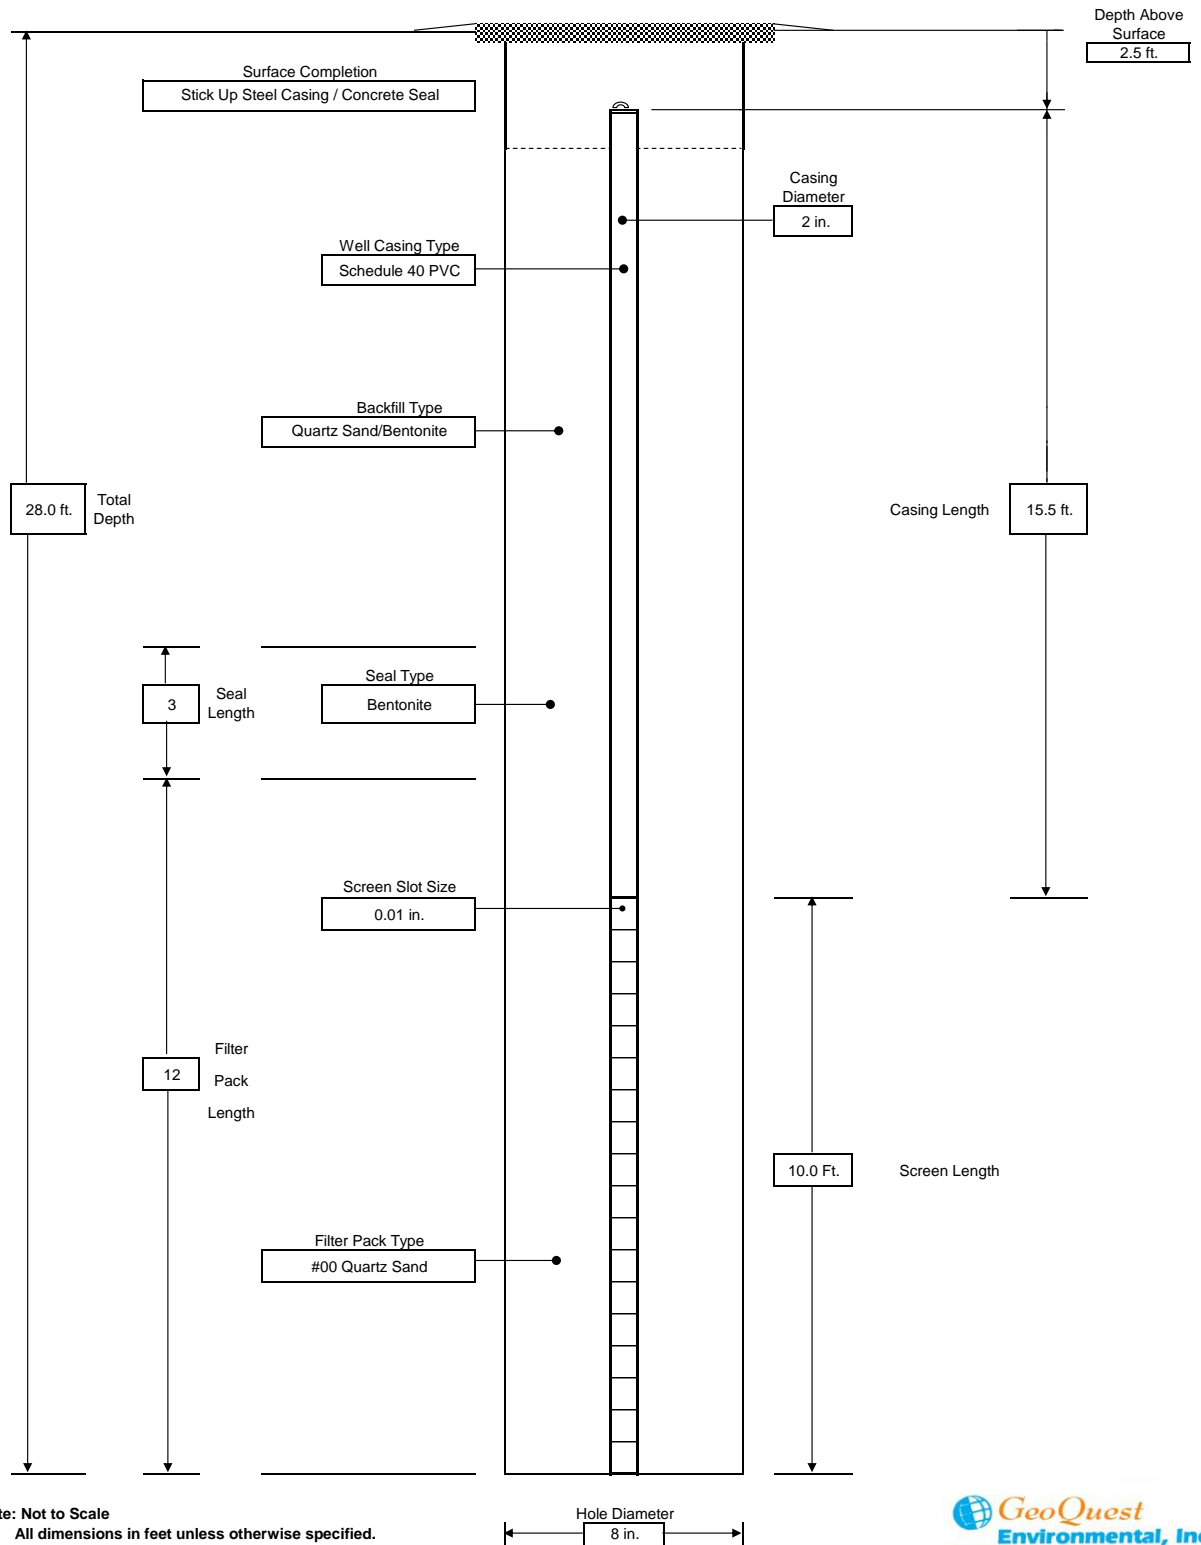
| Project: | Volunteers of America, 214 Lake Avenue, Rochester, NY | Well Name: | MW - 106 | WELL COMPLETION LOG |
