VOLUNTEERS OF AMERICA – BACK LOT REMEDIAL INVESTIGATION REPORT

**214 Lake Avenue – Back Lot
Rochester, NY
Site C828126**

Submitted to: New York State Department of Environmental Conservation

Prepared by: Bergmann Associates

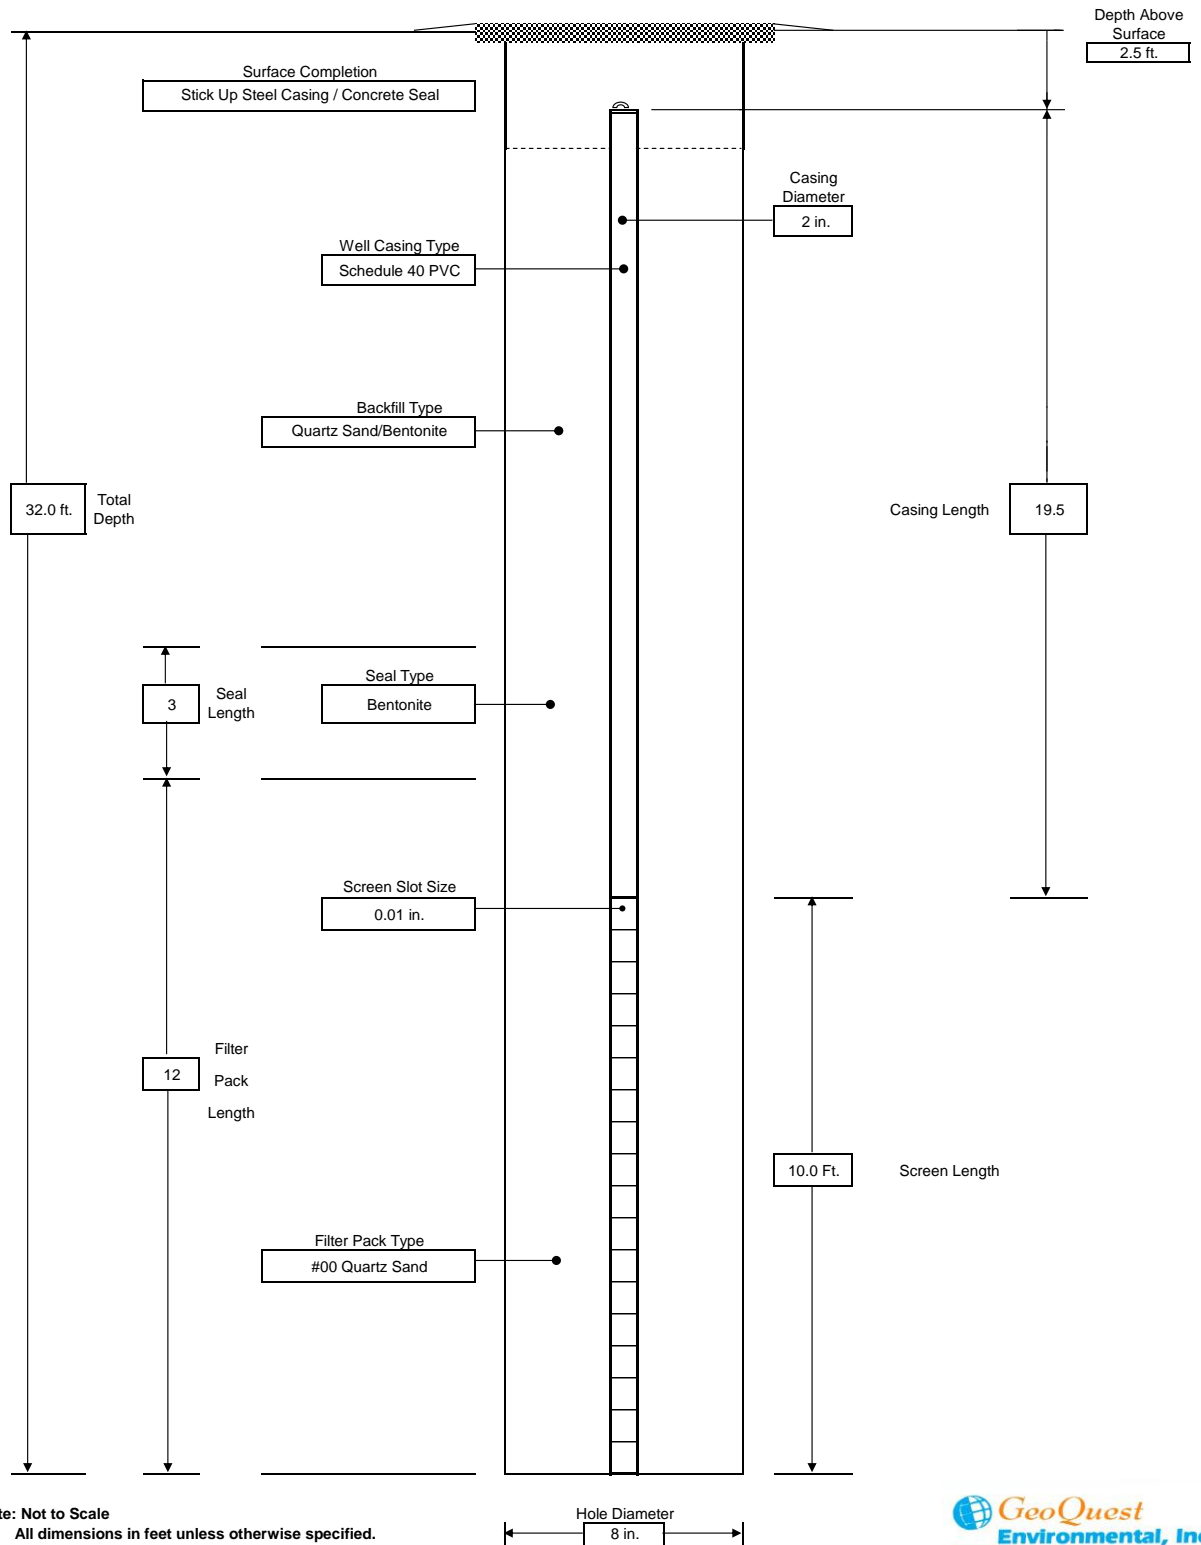
| Project: | Volunteers of America, 214 Lake Avenue, Rochester, NY | Well Name: | MW - 107 | WELL COMPLETION LOG | |

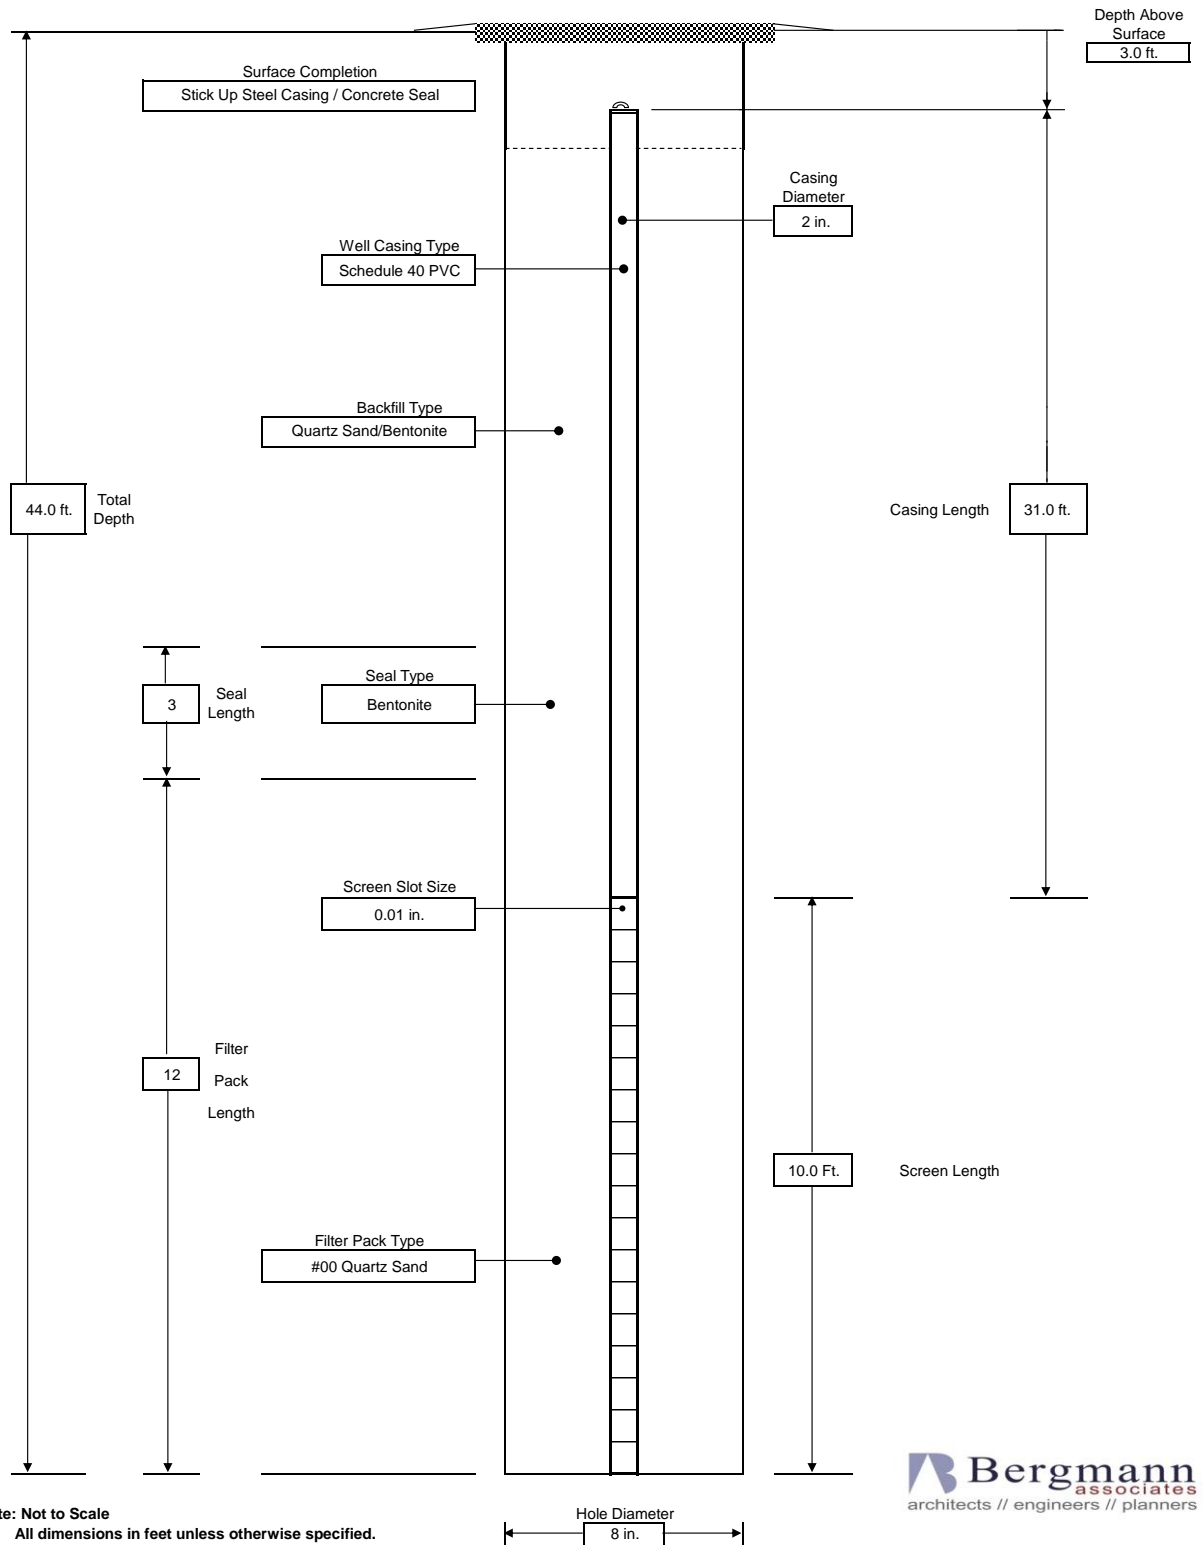
| Project: | Volunteers of America, 214 Lake Avenue, Rochester, NY | Well Name: | MWR - 101 | WELL COMPLETION LOG | |

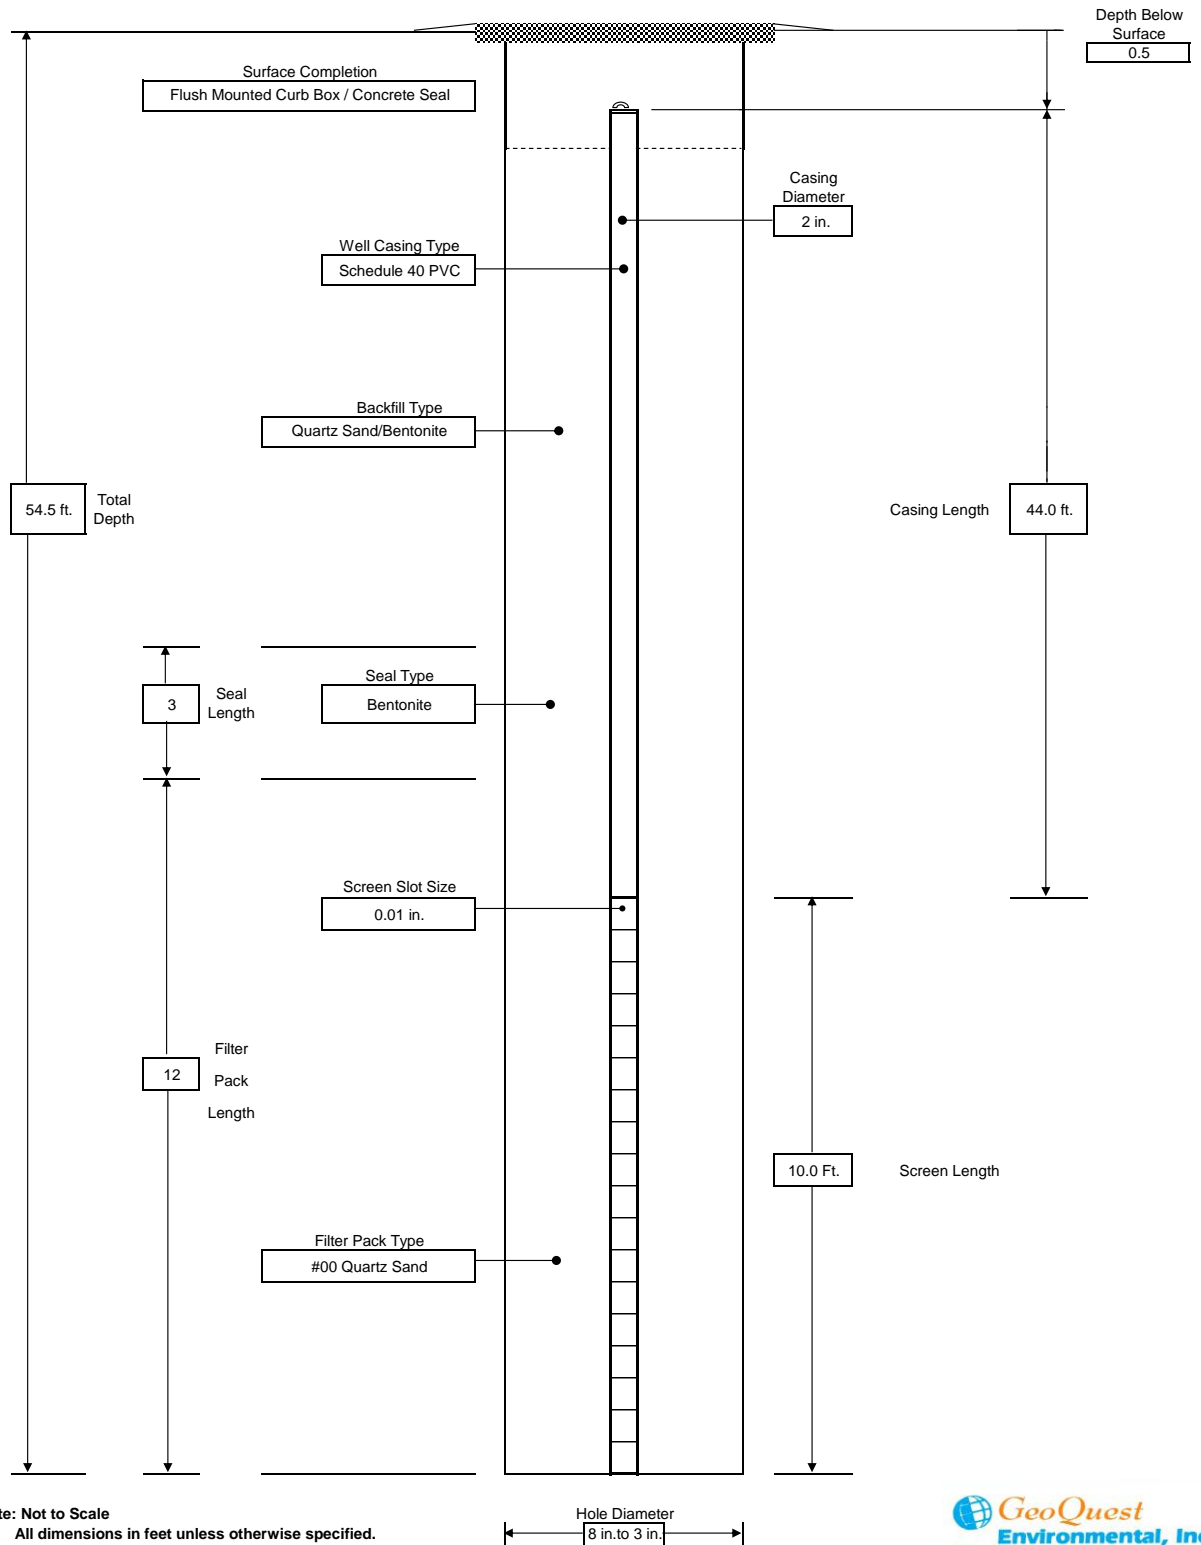
| Project: | Volunteers of America, 214 Lake Avenue, Rochester, NY | Well Name: | MWR - 102 | WELL COMPLETION LOG | |

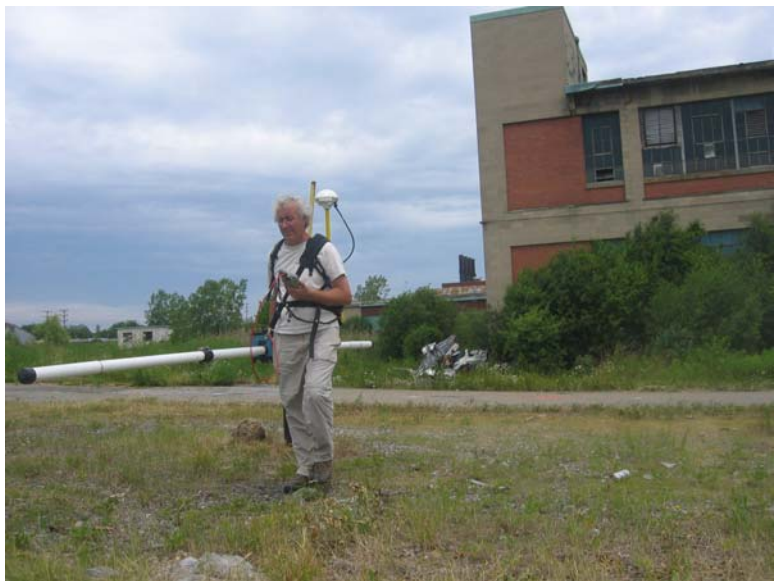
A Geonics EM31 Terrain Conductivity meter was used to measure and record the quadrature component (ground conductivity) and the inphase component of the EM field along the survey lines. The quadrature component of the EM field is a measurement of the apparent ground conductivity. The inphase component of the EM field is sensitive to metallic objects. Comparison of the quadrature component of the EM field data (expressed in units of milliSiemens per meter (mS/m)) and the inphase component data (expressed in units of parts per thousand (ppt)) results in increased anomaly definition. The character of the EM response, low or high, is partially dependent on the orientation of the buried target relative to the orientation of the EM31 device during data acquisition, and the survey direction. A buried metal pipe, for example, will exhibit a high valued response when the trend of the pipe is parallel to the survey direction. Alternatively, when a survey line crosses a

EM31 with GPS in use (photo not from this site)

buried metal pipe whose trend is perpendicular to the survey direction, it is characterized by a low response. Similarly, other complex buried metal anomalies are indicated by a coupling of a high and low response.

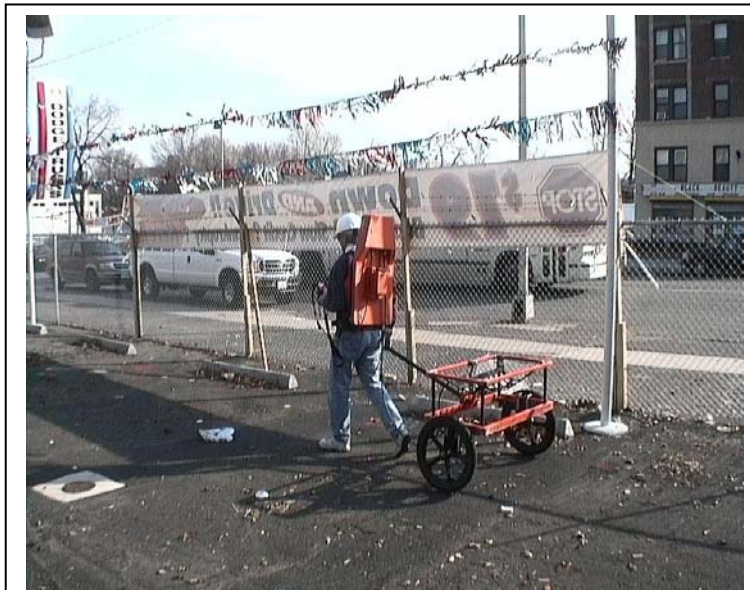
The device's transmitter coil generates a pulsed primary EM field at a rate of 150 pulses per second, inducing eddy currents into the subsurface. The decay rates of these eddy currents are measured by two, 3.28 foot by 1.64 foot (1 meter by ½ meter) rectangular receiver coils. By taking the measurements at a relatively long time frame after termination of the primary pulse,

EM equipment in use (photo not from this site)

the response is practically independent of the survey area's terrain conductivity. Specifically, the decay rates of the eddy currents are much longer for metals than for normal soils allowing the discrimination of the two.

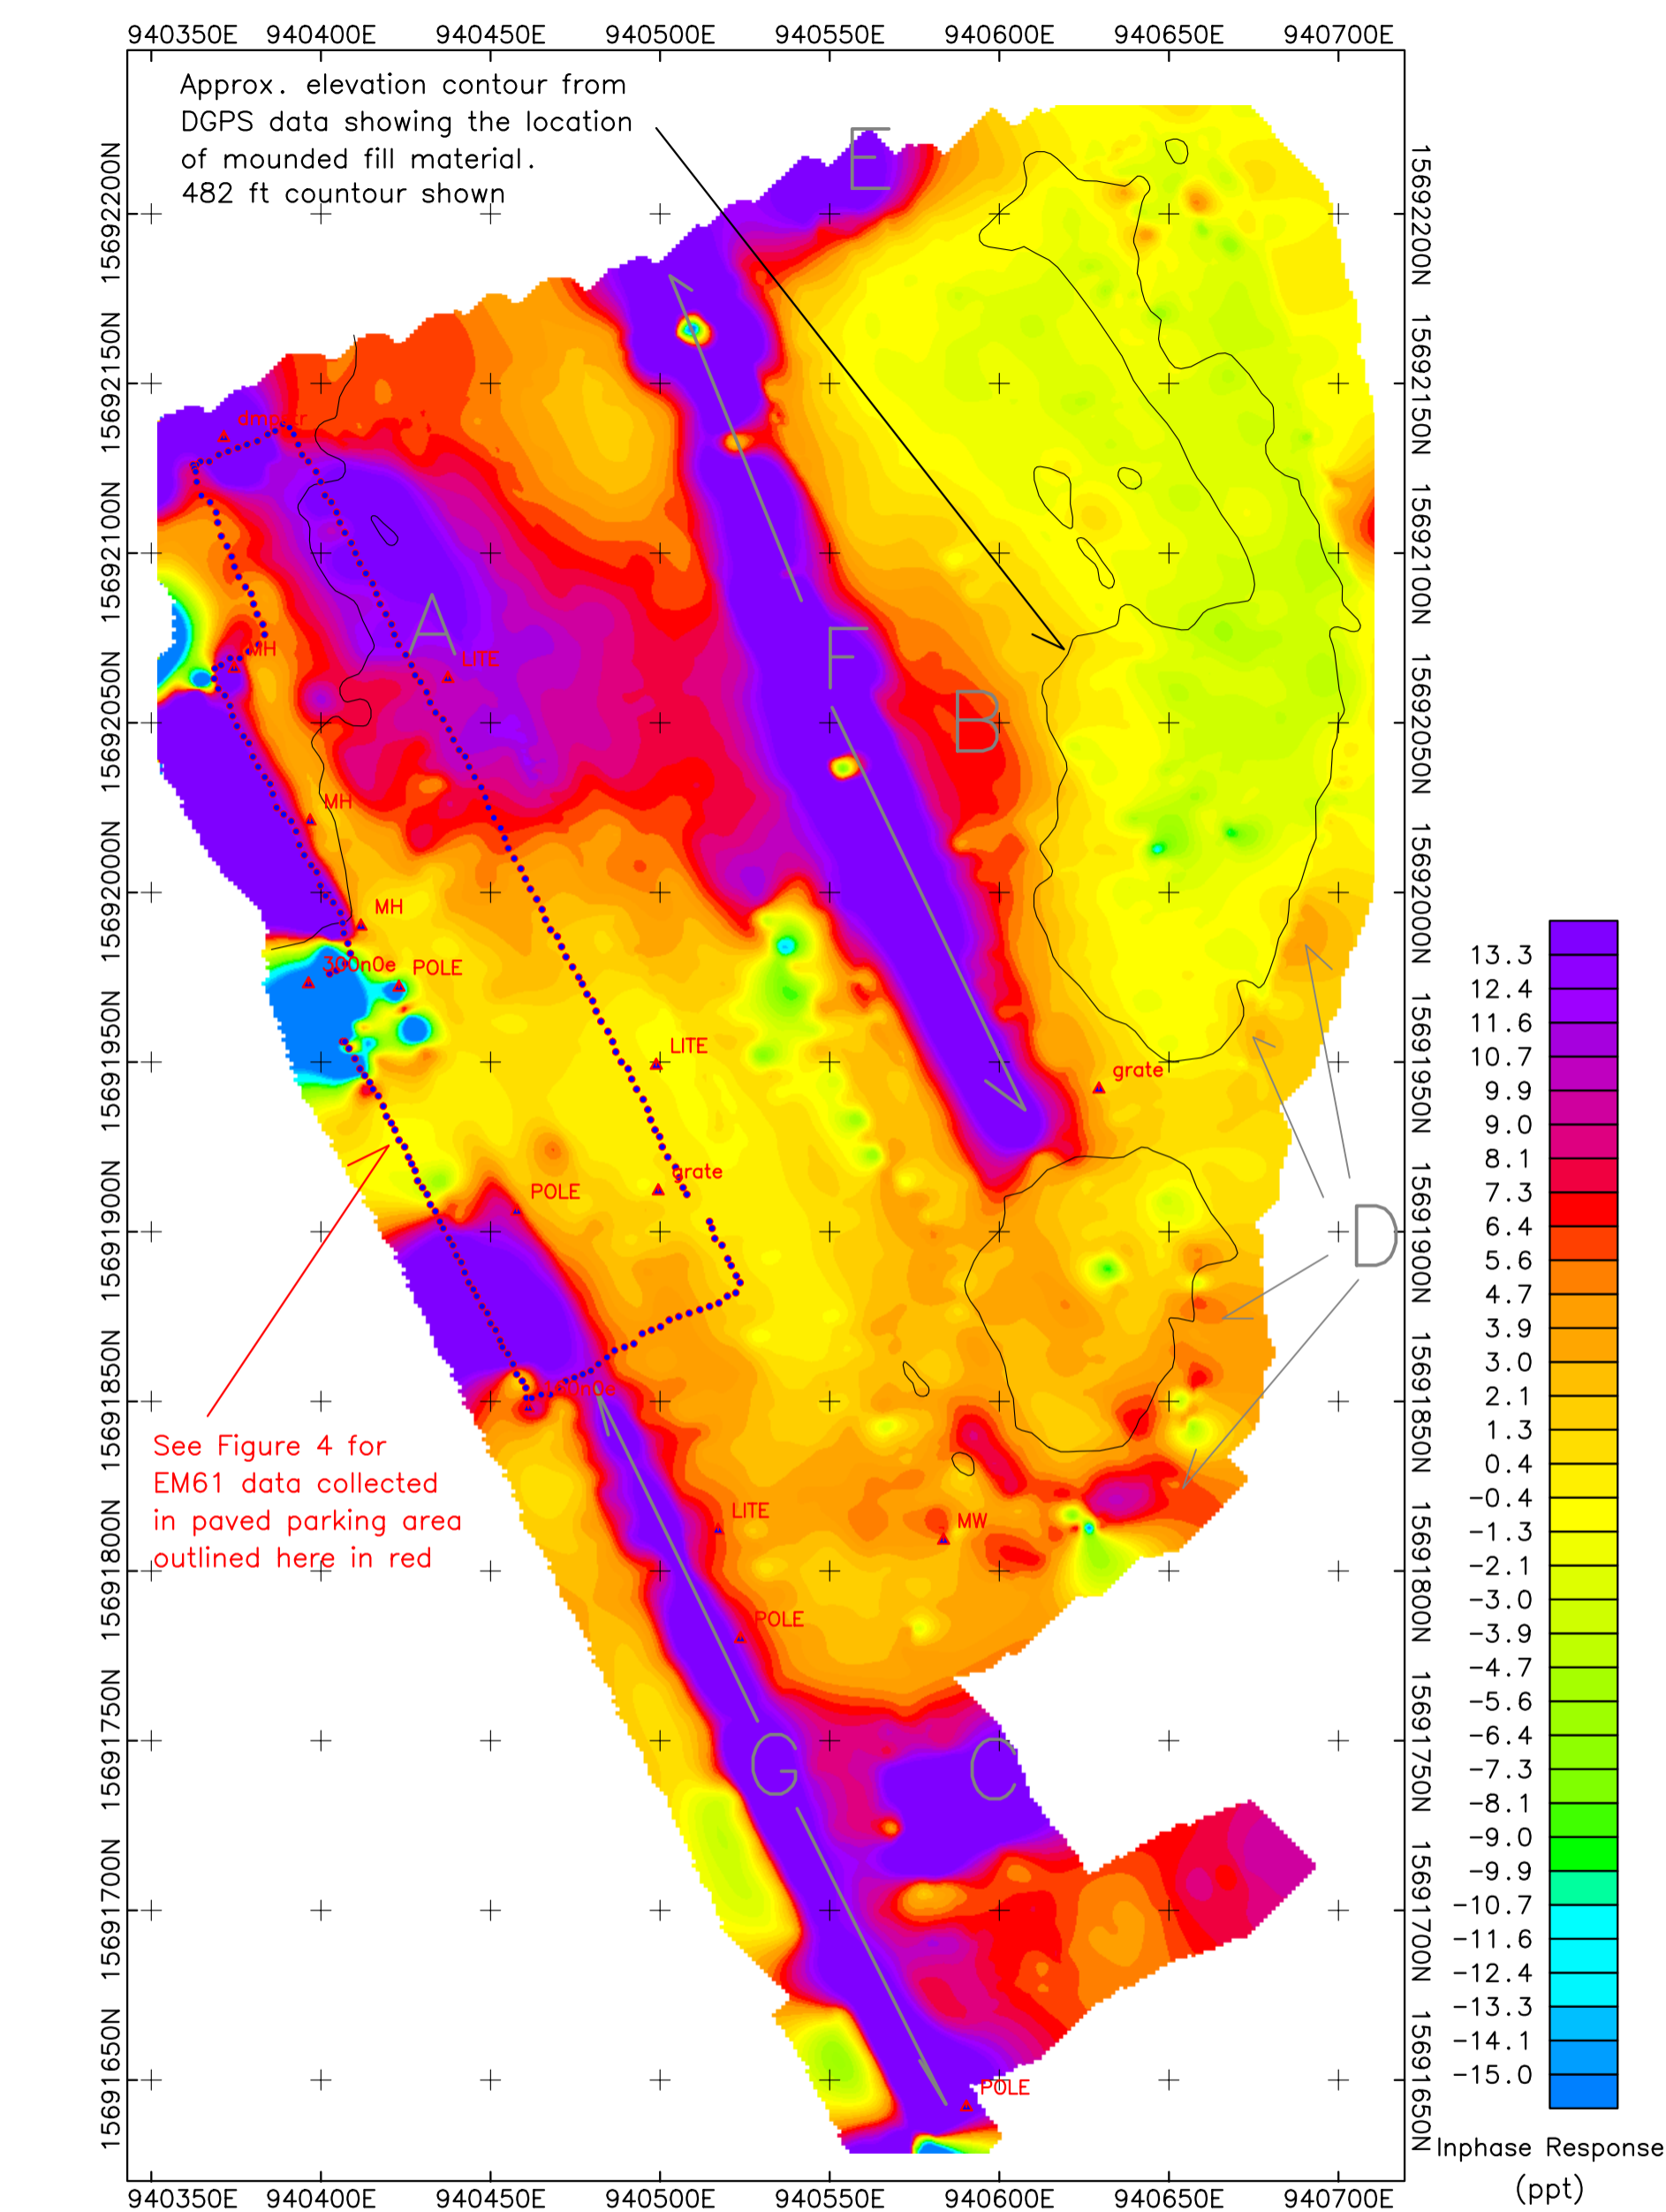
A Geophysical Anomaly discussed in report

Figure 2
Geophysical Survey Results
Color Contours of EM31 Data
Inphase Response (ppt)
Volunteers of America
214 Lake Ave
Rochester, NY
GeoQuest Environmental
Geomatrix (716) 565-0624

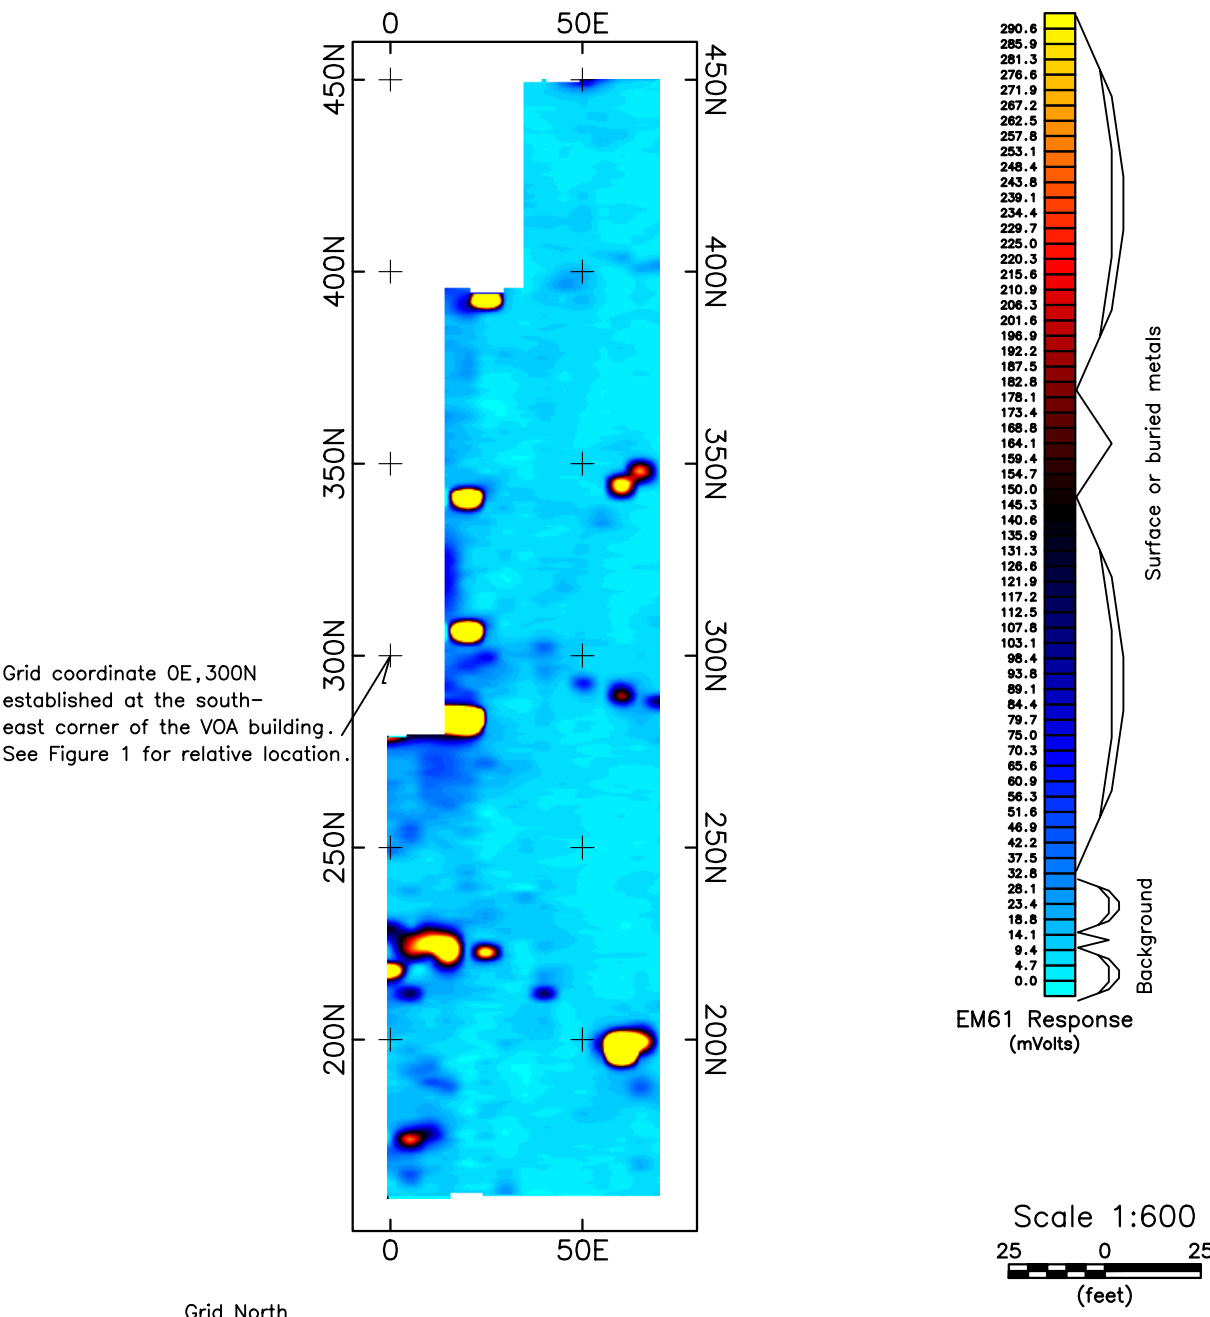
Figure 4

Geophysical Survey Results
Color Contours of EM61 Data
(mVolts)
