SUBJECT: Brownfield Cleanup Program Application
The Kirstein Building and Associated Parking Lot, C828127

Re: Brownfield Cleanup Application
The Kirstein Building and Associated Parking Lot
BCP No. C828127

The Kirstein Building

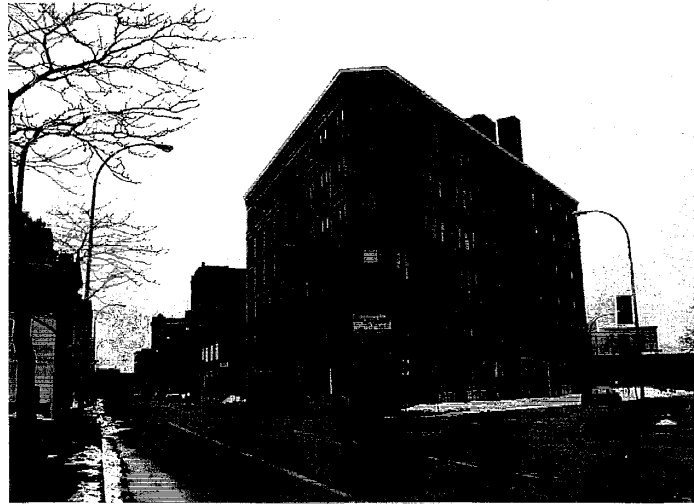
Looking west at subject Kirstein Building
