**REMEDIAL DESIGN INVESTIGATION – PHASE 2
FORMER UNDERGROUND STORAGE TANK AREA**

**BROWNFIELD CLEANUP PROGRAM
NYSDEC SITE ID C828130
118 PETTEN STREET
ROCHESTER, NEW YORK**

Prepared By: Day Environmental, Inc.
1563 Lyell Avenue
Rochester, New York 14609

Date: August 30, 2015
(Revised April 8, 2016)

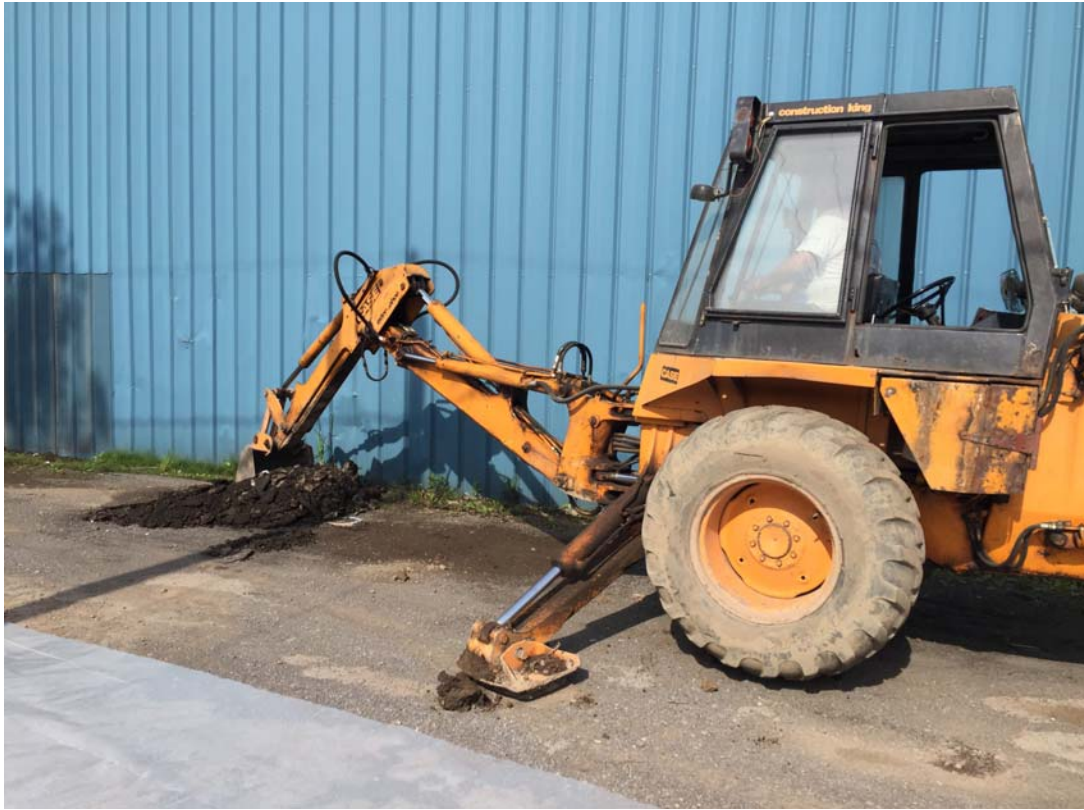
Test Pit TP1: Two apparent concrete-filled USTs were identified in Test Pit TP1, located on the eastern exterior side of Building 6 near a foundation footer for the building. The USTs appeared to be approximately 5 feet (ft.) long and 4 ft. in diameter. The tops of the USTs were located approximately 4.5 ft. below ground surface (bgs). The fill ports of the USTs were accessible. The USTs were determined to be concrete-filled by visual inspection and attempting to insert a metal pole into the fill ports of the USTs. A large concrete slab was located to the north of the USTs. An approximate 3 inch diameter steel pipe that was connected to the tops of both USTs entered the south wall of the large concrete slab (i.e., the steel pipe was oriented in a north-south direction). Also, two smaller, loose concrete slabs (each approximately 3 ft. by 2 ft. by 0.8 ft. thick) were located approximately 0.5 ft. above the steel pipe. During the excavation of Test Pit TP1, groundwater monitoring well GM-MW16 was destroyed due to its proximity to the USTs. Evidence of apparent contamination was noted in Test Pit TP1. Specifically, elevated PID readings ranging between 0.0 parts per million (ppm) to 681 ppm, stained sand fill and apparent petroleum-type odors were encountered. The evidence of apparent contamination appeared to be greatest in the location of the USTs and large concrete slab. The maximum depth of Test Pit TP1 was 6 ft. bgs. The test pit was not extended to a depth of 8 ft. bgs, as stated in the RAWP, due to saturated soil/fill encountered at an approximate depth of 5 ft. bgs. In addition, the area of the concrete-filled USTs was not excavated to the invert of the tanks as stated in the RAWP due to the saturated soil/fill. Following completion of Test Pit TP1, the excavated material removed

Test Pit 1, taken looking west against east wall of Building 6

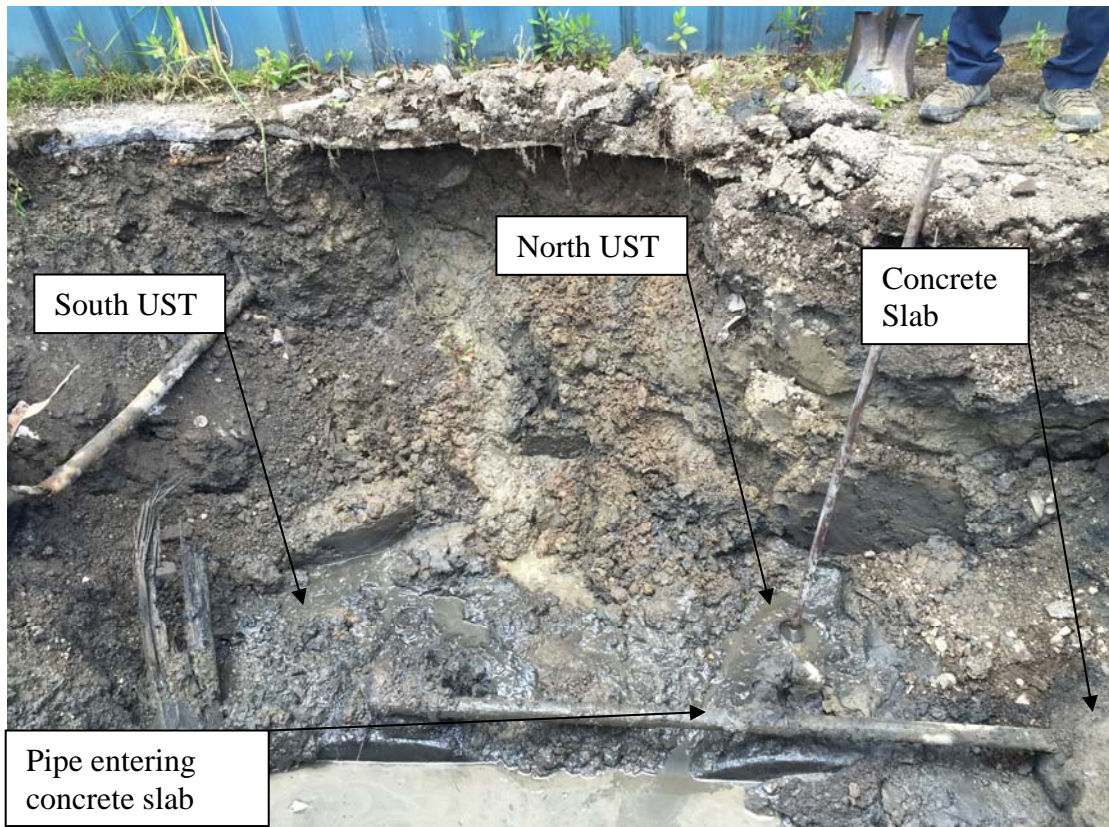
- Two concrete-filled USTs, each approximately 550-gallon in size, were identified in test pit TP1. These USTs are located approximately one foot east of Building 6 and in proximity to a foundation footer. A structural engineer concluded that removal of the concrete-filled USTs would compromise the structural integrity of the building, so with the concurrence of the NYSDEC, the USTs were not removed. A pipe was connected to the tops of both USTs and entered the south wall of a large concrete slab. Additional piping was present running from the large concrete slab to the east.

Concrete filled USTs and concrete slab located in Test Pit TP1, taken looking west

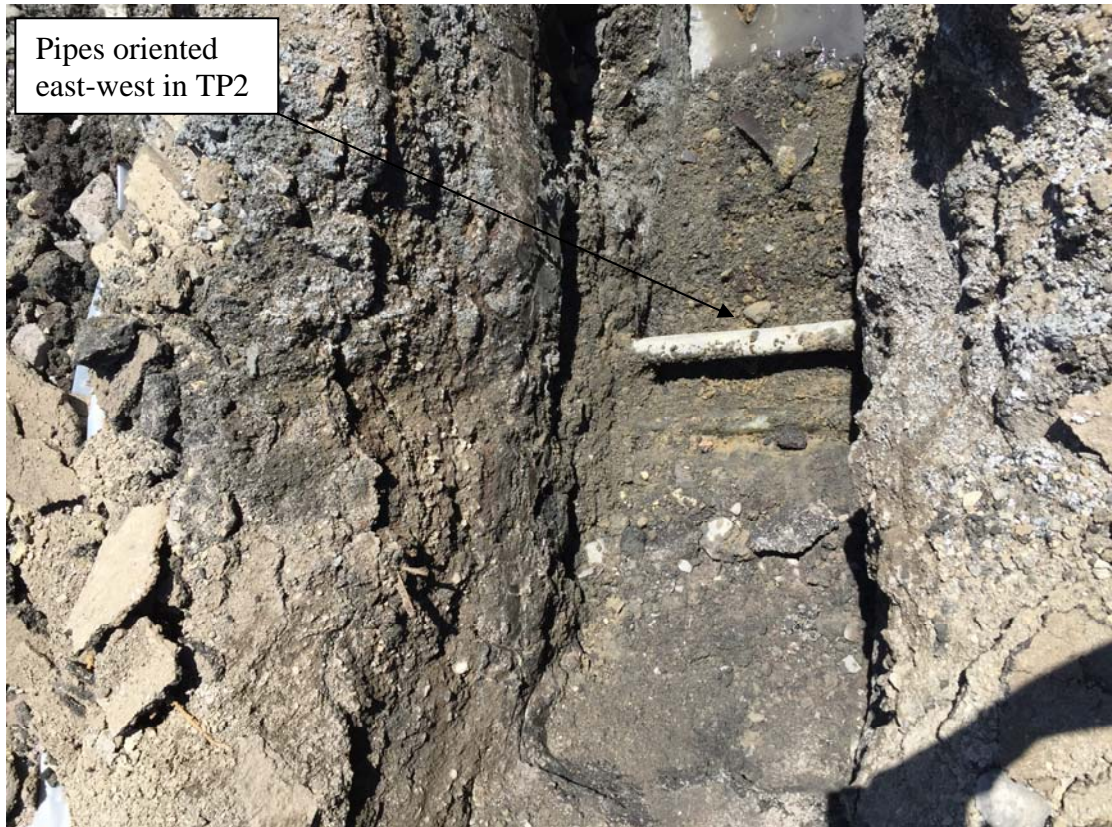
Test Pit TP2: Test Pit TP2 was located approximately 10 feet east of Test Pit TP1. Two steel pipes, each approximately 3 inches in diameter, were identified passing through Test Pit TP2. The pipes appeared to be in-line with the large concrete slab in Test Pit TP1 and were oriented in an east-west direction. Evidence of apparent contamination was noted in Test Pit TP2 (i.e., elevated PID readings ranging between 0.0 ppm to 53.5 ppm, stained soil, odors) but to a lesser degree than noted in Test Pit TP1. The maximum depth of Test Pit TP2 was approximately 5.2 ft. bgs due to the presence of saturated soil/fill at an approximate depth of 5 ft. bgs. Following completion of Test Pit TP2, the excavated material removed from Test Pit TP2 was used to backfill Test Pit TP2. Material was placed back into the excavation in the same general strata from which it was removed. Fill material was not imported to the Site for use as backfill.

Pipes oriented
east-west in TP2

Test Pit TP2 taken looking north

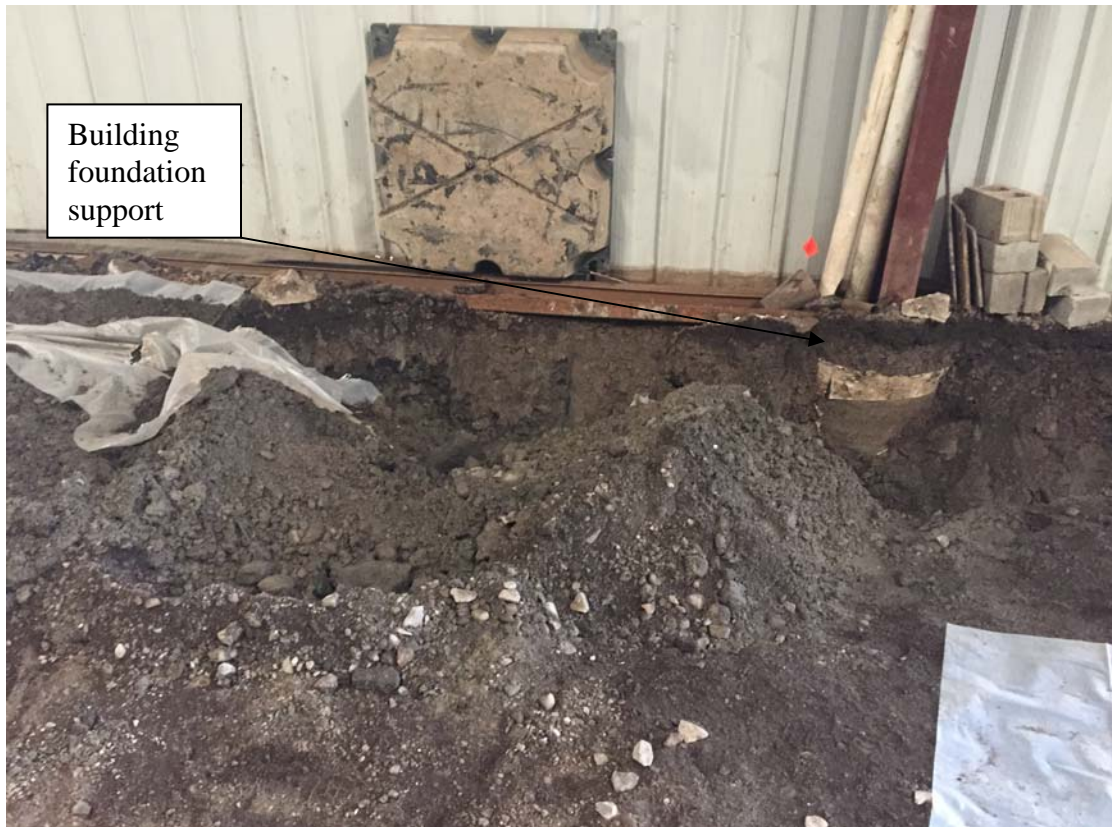
Test Pit TP3: Test Pit TP3 was located inside Building 6, approximately 3 feet west of Test Pit TP1. No tanks or piping were encountered in Test Pit TP3. Staining was not observed in Test Pit TP3. A petroleum odor and elevated PID readings, ranging between 0.8 ppm to 9.7 ppm, were noted in Test Pit TP3 in the vicinity of the large concrete slab that was observed in Test Pit TP1. Two small concrete slabs were observed in TP3, each approximately 5 ft. by 3.5 ft. and 1 ft. thick. The northern concrete slab was removed from the excavation. The southern concrete slab did not appear to be attached to the building or piping underneath, but was left in-place due to its proximity to the building wall. The maximum depth of Test Pit TP3 was approximately 5 ft. bgs due to the presence of saturated soil/fill at an approximate depth of 5 ft. bgs. Following completion of Test Pit TP3, the excavated material removed from Test Pit TP3 was used to backfill Test Pit TP3. Material was placed back into the excavation in the same general strata from which it was removed. Fill material was not imported to the Site for use as backfill.

Building
foundation
support

Test Pit TP3 taken looking east

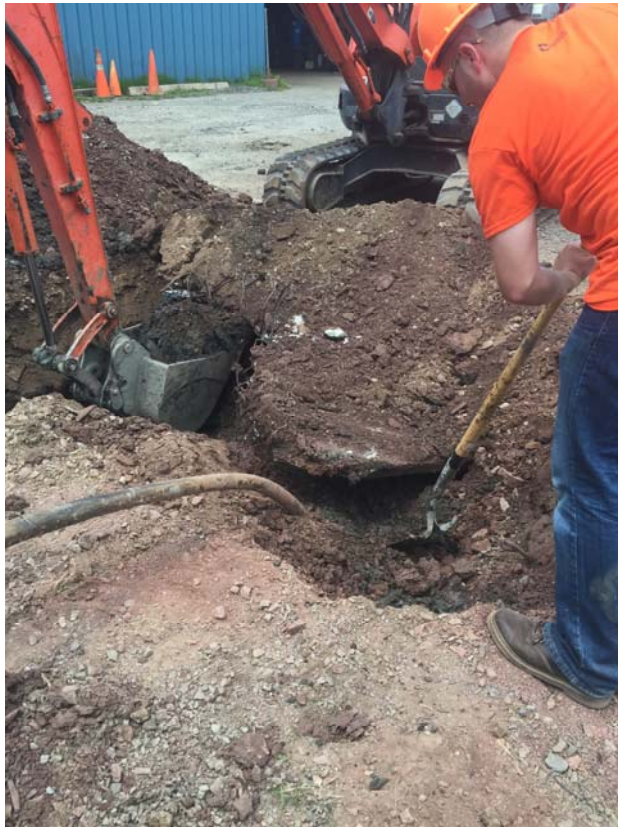
- During pipe removal work, an assumed former pump dispenser concrete pad was identified to the east of the concrete-filled USTs (refer to Figure 3).
- Evidence of petroleum contamination in soil (i.e., staining, odors, elevated PID readings) appeared to be greatest within the area of the two concrete-filled USTs, and in the location of the assumed former pump dispenser and pipe elbow located adjacent to test pit TP4. The majority of soil contamination is present within the saturated zone.

Assumed pipe dispenser location

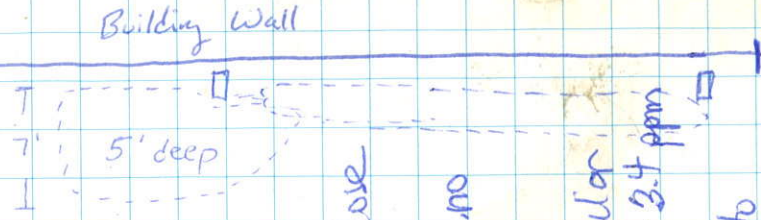
discussed w Rick - plan to sample 5' box in line w north UST + concrete slab (ext) i.e. location of highest PID reading - Rick needs to shift backfill.

13:40 obtained SP1 TP3-0622-205
5' bgs. adjoining east wall
located w 1.5 - 2' west of east
wall between concrete slab
and north UST (4.3 ppm) headspace
