# REMEDIAL ACTION REPORT

## ROCHESTER DRIVING PARK SITE

### 666 DRIVING PARK AVENUE

JULY 2014

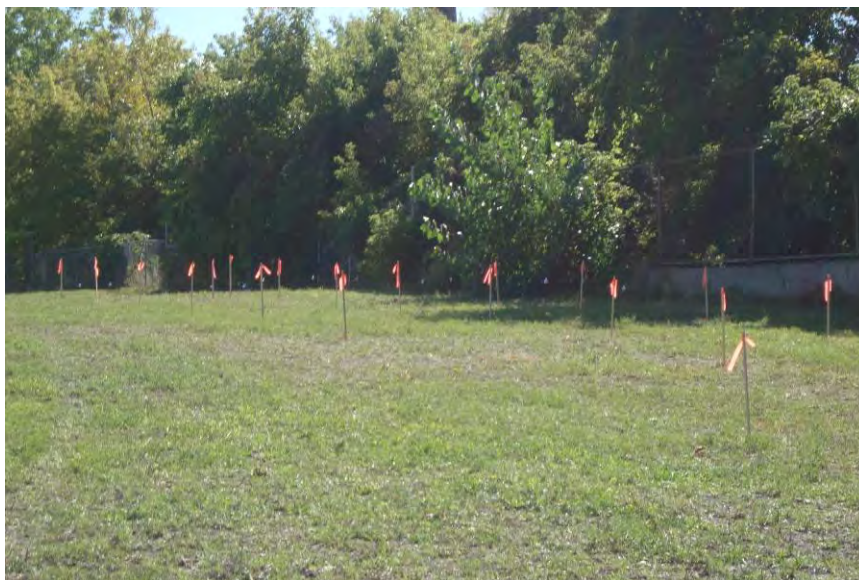
Description: Excavation areas RR1 through RR12 after location stakeout.

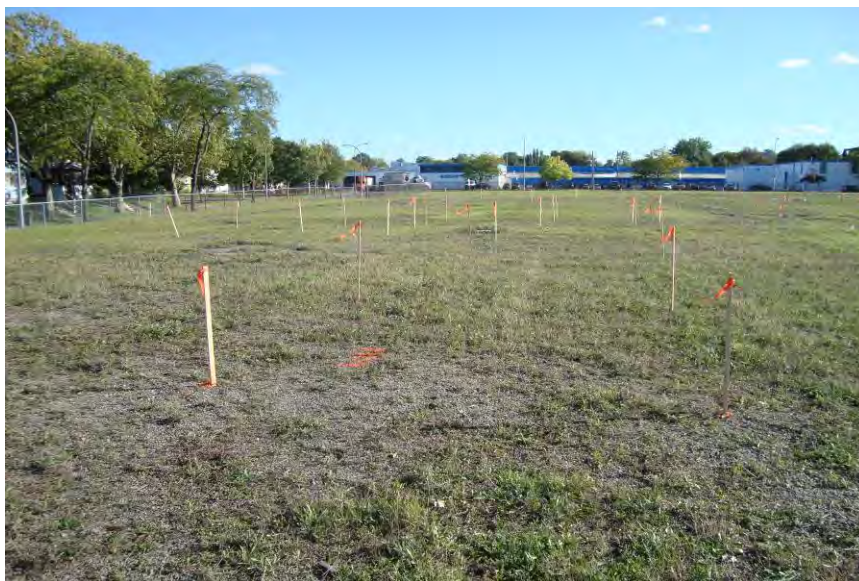
Description: Excavation areas RR13 through RR24 looking from the north end of the site to the south.

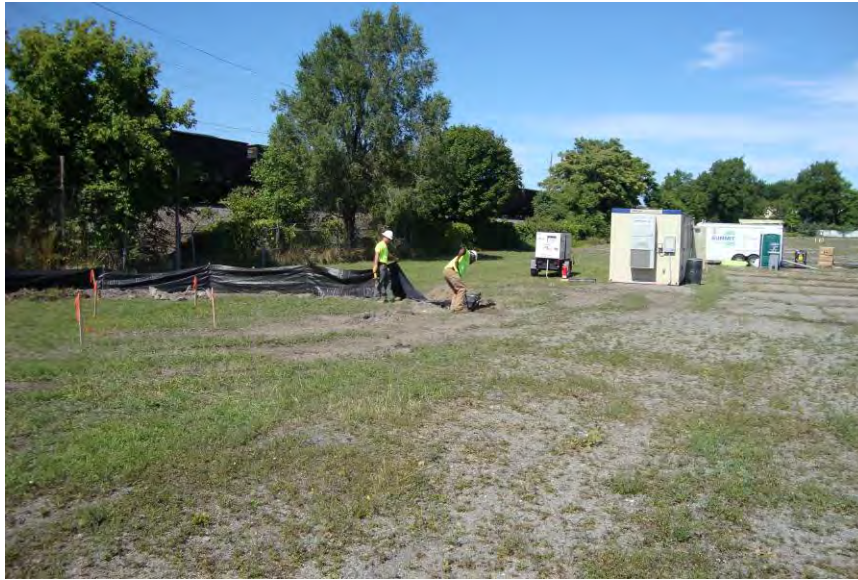
Description: Installation of silt fence around RR1 through RR12.

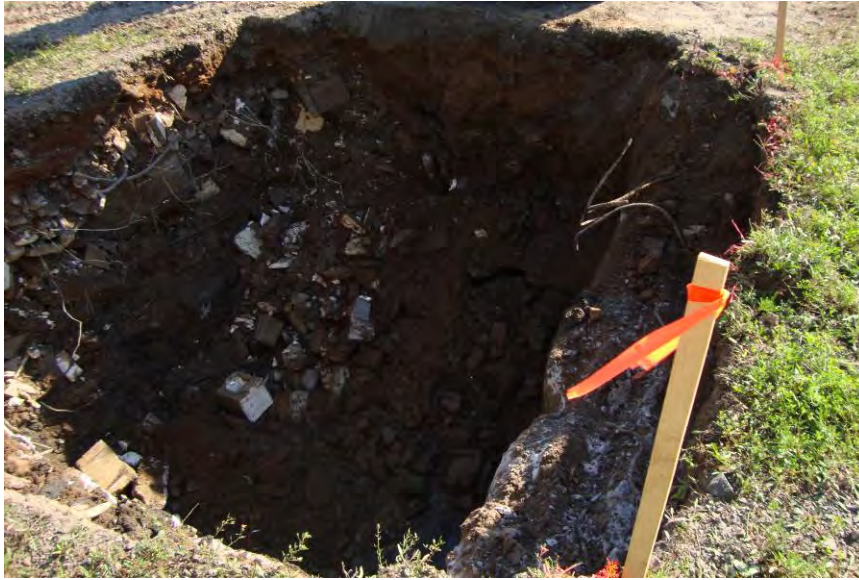
Description: Initial excavation at RR6, confirmatory samples determined additional excavation

At RR6, material along the eastern and bottom extents of the excavation remained above soil cleanup objectives. Bedrock was encountered at the bottom of this excavation (after an additional 4.5 feet of excavation), and foundation walls encountered on the eastern extent (after an additional 8 feet of excavation). Based on these results, a verification test pit was dug along the eastern side of the foundation wall that was encountered. A similar verification test pit was dug on the eastern extent of RR11 because concentrations prior to reaching a foundation wall remained above soil cleanup objectives. The test pits were dug to approximately 2 feet deep to verify that foundation walls had indeed been encountered and further excavation would have only yield building foundation remnants rather than impacted soil. A soil sample was collected from each of the verification test pits on the opposite side of the foundation wall, and results were below soil cleanup objectives (Table 2.2).

Assessed RR6 prior to continuing excavation and called client to discuss the conditions. Bedrock has been encountered at the bottom of RR6 and on the east side a concrete foundation wall has been reached, preventing sample collection. Team spoke and decided to dig two test pits, one on the east side of the foundation wall encountered at RR6 and a similar pit at RR11 since similar conditions encountered (large concrete block reached at bottom of RR11 and foundation wall on the east side). The two test pits were dug to approximately 2 feet along the length of the corresponding excavation area. At both test pits, building foundation material was encountered as well as remnants of pavement. Took composite samples of each of the test pits for confirmatory sampling. Continued additional excavations at RR9 and excavated around the large block at the bottom of RR11, RR10 and RR12. Confirmatory samples were collected from each of these excavations per the Remedial Work Plan.

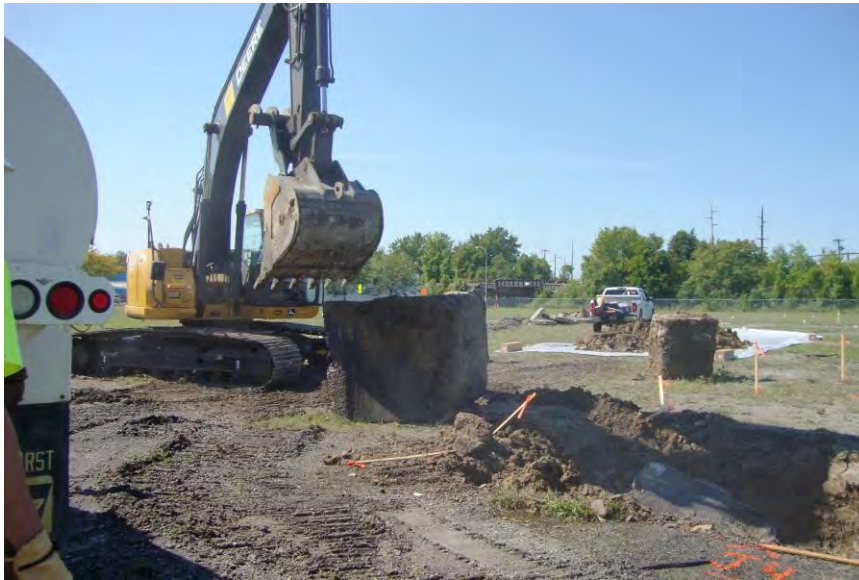
Description: Initial excavation at RR22/RR23. Large concrete block encountered during excavation.

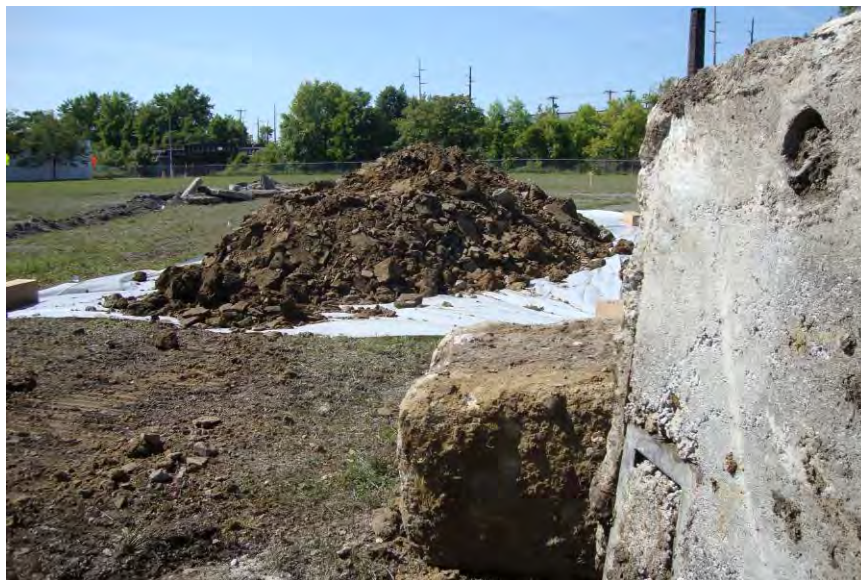
Description: Stockpiled hazardous waste and large block removed from RR22 and RR23.

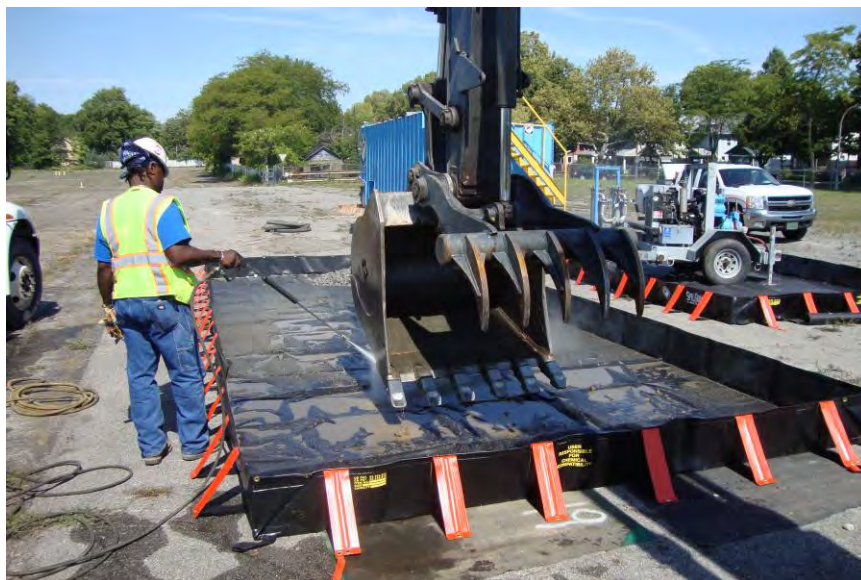
Description: Decontamination of equipment after excavations at locations with hazardous material.

Decontamination was conducted at a temporary pad constructed on-site as specified in the Remedial Work Plan. Following each excavation at the locations labeled as hazardous based on historical TCLP sampling, the excavator and all excavation and sampling equipment were thoroughly decontaminated at the pad using a power washer and dedicated brushes to ensure excavated material did not reach other excavation or work areas. Decontamination water was contained at the pad (see Section 2.5).

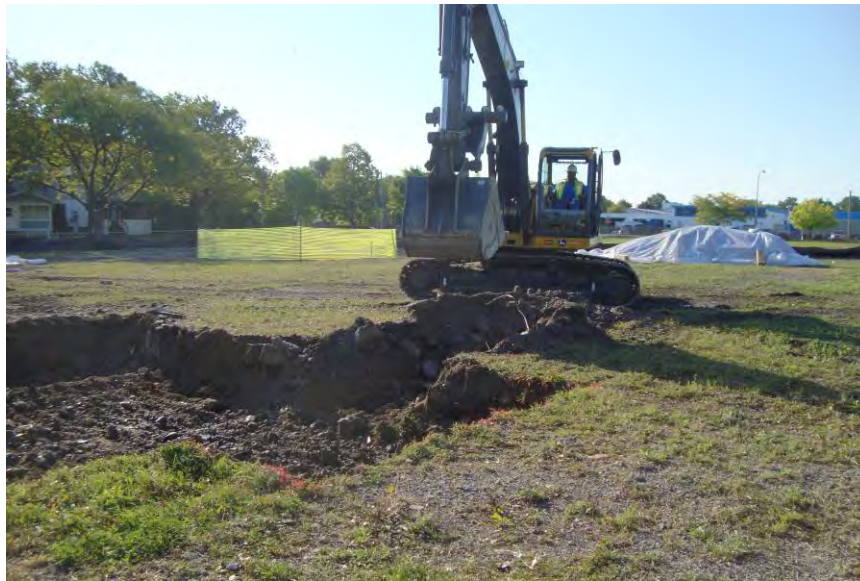
Description: Excavations at RR18, looking north to south.

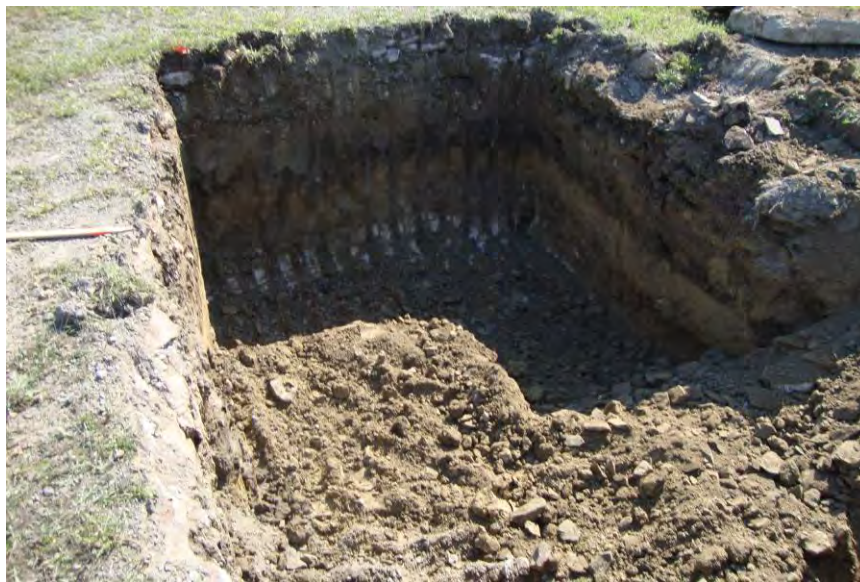
Description: Excavation locations RR16 and RR17, looking into the excavation South to North.

Moved to locations RR16 and RR17 and excavated together since their boundaries overlap. Sampled sidewalls and bottom of excavation. Material removed today stockpiled since final approval; from High Acres for non-hazardous disposal was not confirmed until end of the day. Stockpiles securely covered and excavation locations fenced off with high-vis construction fencing per the Remedial Work Plan.

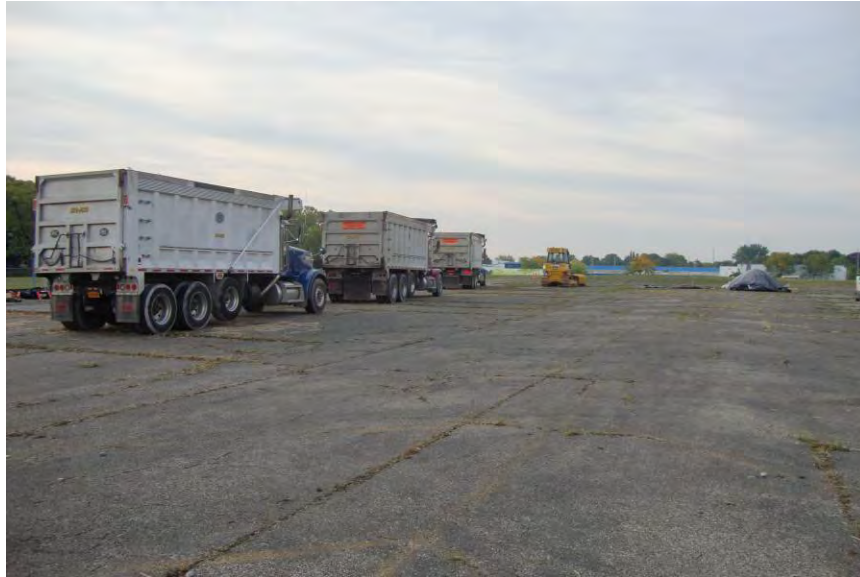
Description: Trucks lined on site ready to be loaded with non- hazardous material. Trucks facing South.

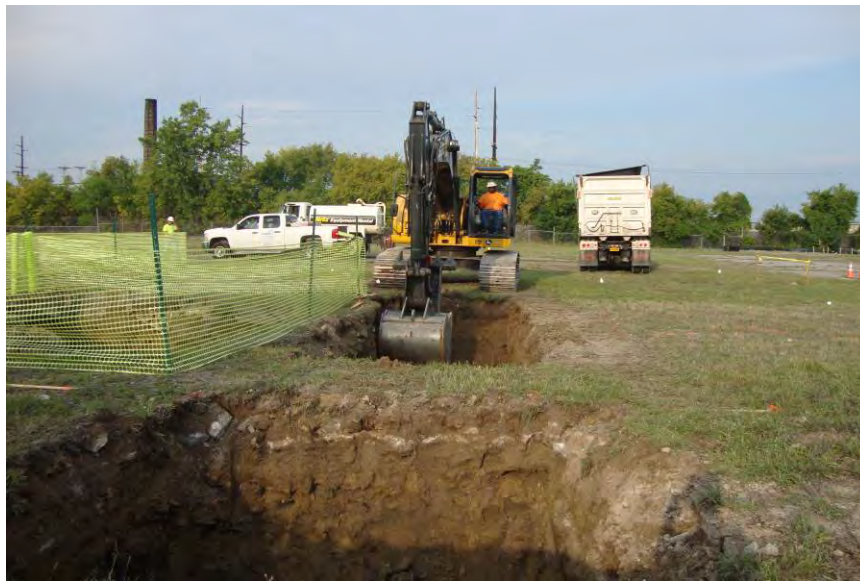
Description: Excavation locations RR15 (front) and RR25(back). Looking East to West.

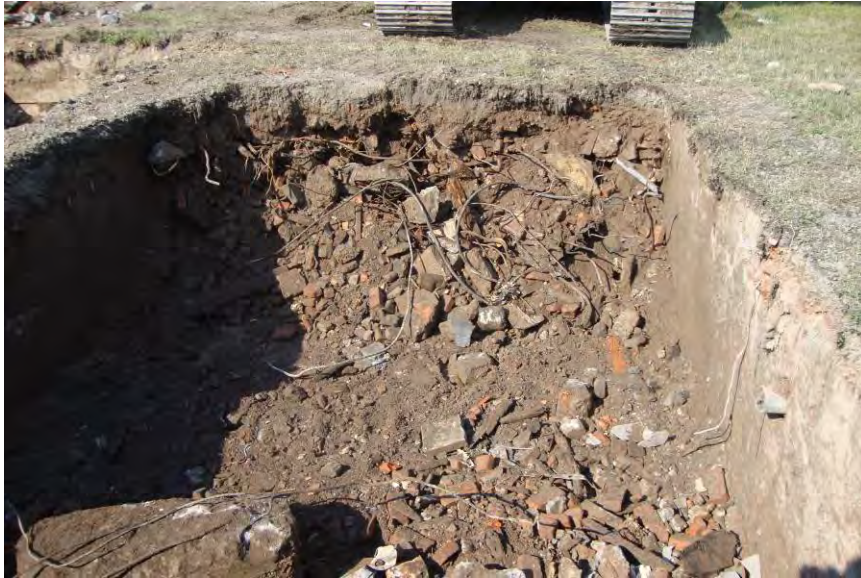
Description: Excavation location RR14, looking East to West. Location is entirely a pit of debris. No additional sampling or excavation.

further due to property boundaries; and (2) the western side of RR14 and the eastern side of RR24 because excavations at these locations revealed debris so continuing the excavations would not have yielded additional soil. While initial sample results at the RR14 and RR24 debris areas showed exceedances of the soil cleanup objective for silver and/or cadmium, further excavation revealed the pits contained debris.

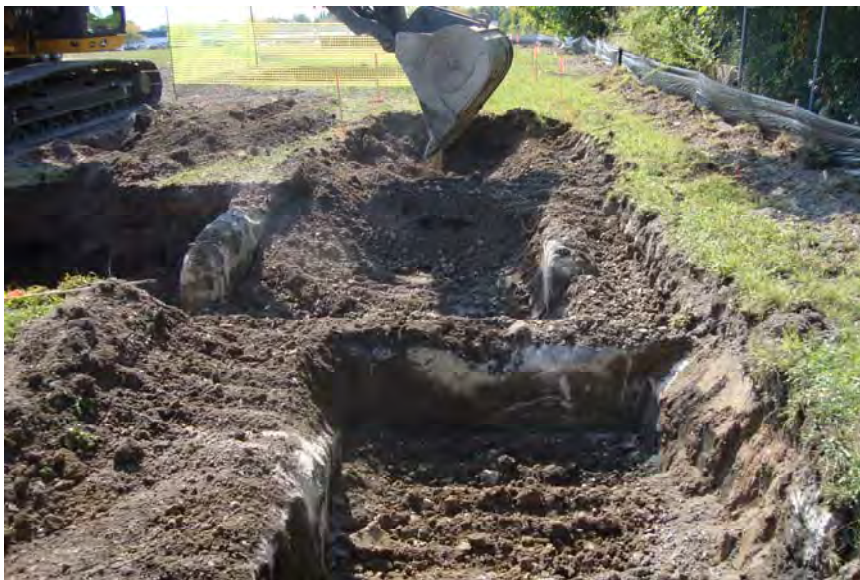
Description: Looking North to South at excavations RR1 through RR4. Visible foundation walls on multiple sides.

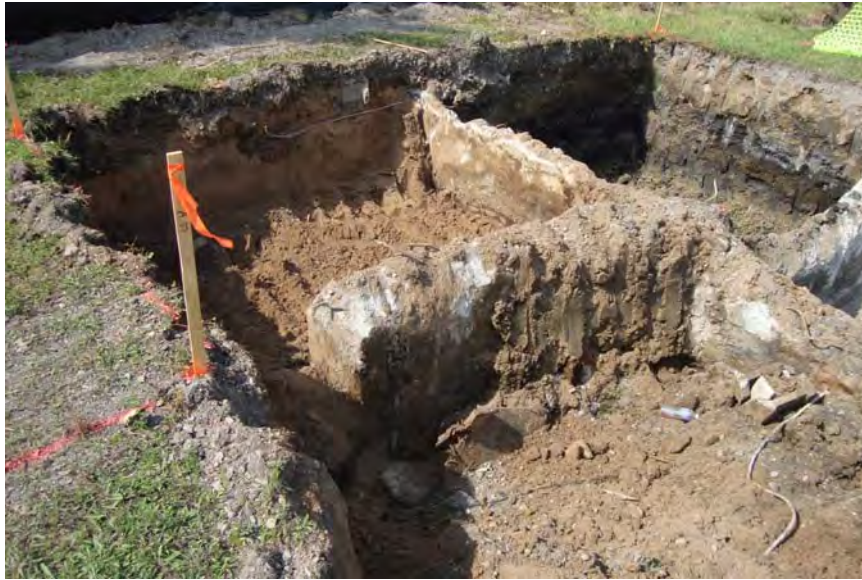
Description: Excavation areas RR5 through RR8 looking East to West.

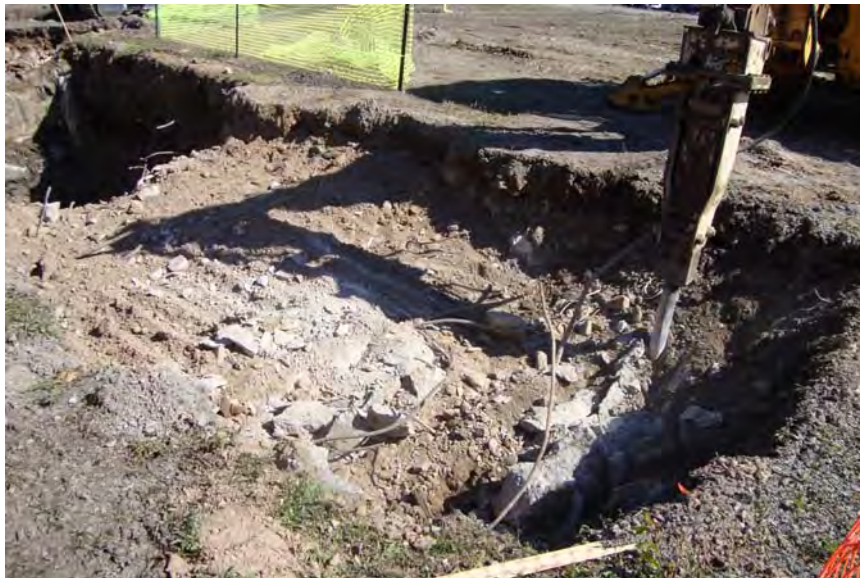
Description: Hoe ram used to attempt to break large concrete block at the bottom of RR10, RR11 and RR12.

| Location | Sample ID | Cadmium Result (mg/kg) | Silver Result (mg/kg) | Comments |
|---|---|---|---|---|
| RR10 | RR10Bot | 6.2 | 191 | Encountered large concrete foundation at ~2 ft, no further sampling. |
| RR11 | RR11Bot | 13 | 411 | Encountered large concrete foundation at ~2ft, no further sampling. |

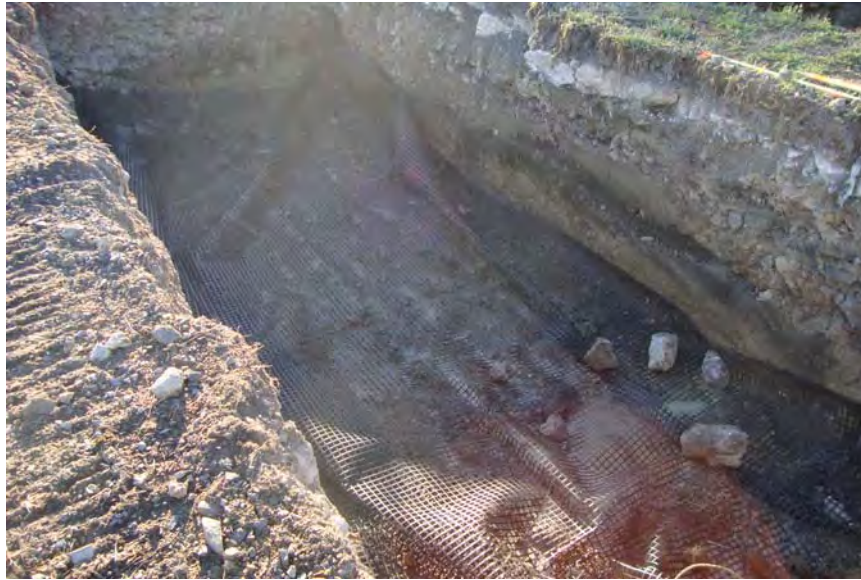
Description: Placement of geogrid in RR24 prior to backfilling.

Began additional excavations at RR15 and removed 5ft from the North and east sides. Found old drain pipe on east side. Started placing geogrid at the bottom of excavations and followed with clean backfill. Filled in RR13,14,16,17 & 24. Large blocks of concrete from excavations was placed back in these locations as additional fill. Ensured the geogrid was placed securely before any backfill operation started. Moved to RR3 and excavated 3.5ft from west sidewall. Could not remove additional material from west sidewall since property line and fencing reached. Used hoe ram to begin hammering out the thick concrete reached in RR12 Hammer could not break all of the concrete as some areas were over 3ft thick but were able to reach 6ft BGS in a majority of the location to collect samples. Removed the south sidewall on RR4 and excavated 1ft out of the bottom per confirmatory sampling results. Also removed at same time the north sidewall on RR5. There was approximately 5 to 6 feet between them. Moved to RR8 and excavated 5ft from east sidewall. All 24 locations have been excavated per the Work Plan at least once, awaiting additional confirmatory sampling results. Contacted DuPont, URS and High Acres regarding volume, requesting additional tonnage for disposal.

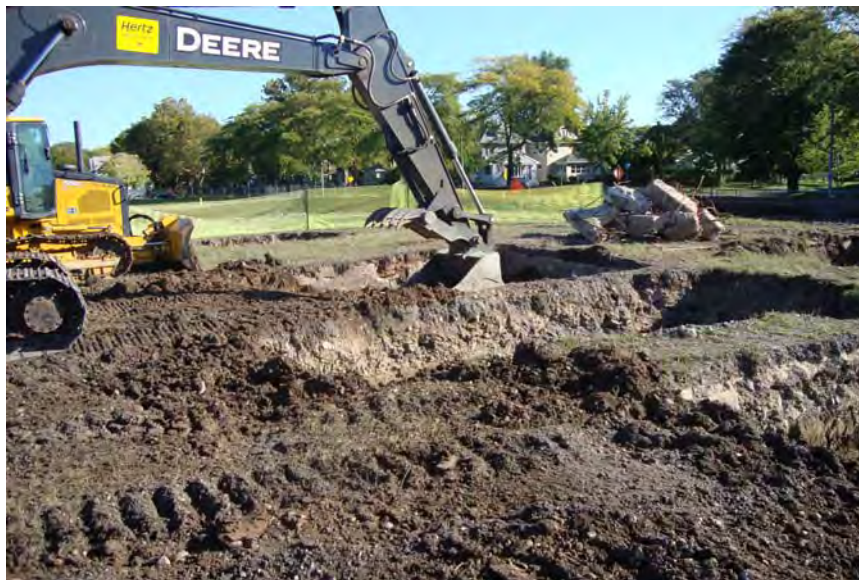
Description: Backfilling locations using excavator to tamp clean fill material.

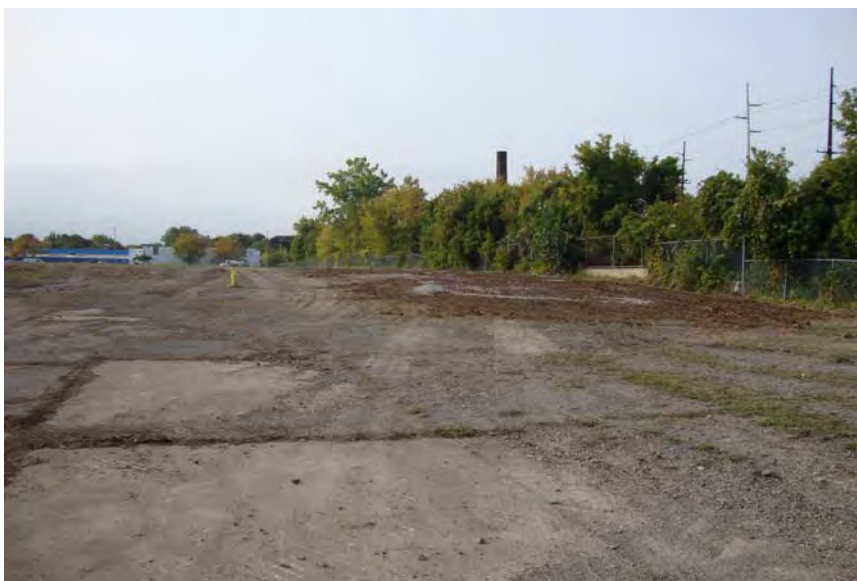
Description: Final grade after backfilling at locations RR1 through RR12.
