Brownfield Cleanup Program Application

**Former JML Optical, Inc.
678-690 Portland Avenue
City of Rochester, New York**

CHA Project Number: 17781.1001.1102

December 27, 2007

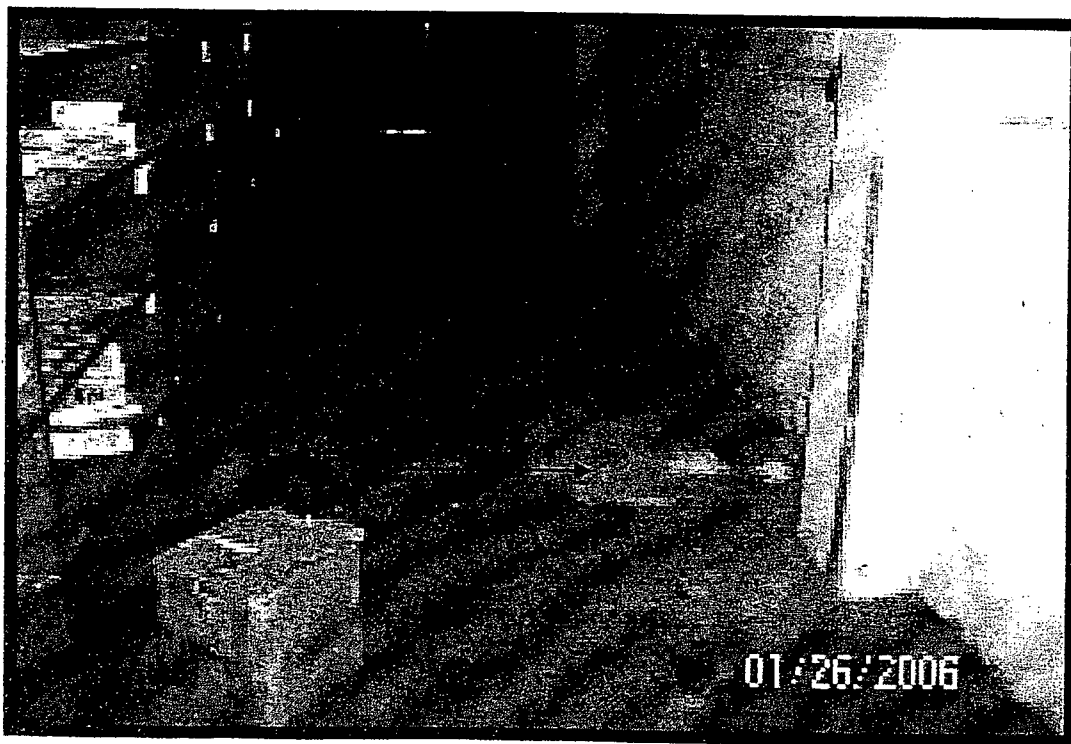
A sump is located at the Site next to the former maintenance shop. A Phase II ESA prepared for the Site by LaBella Associates, P.C. investigated the subsurface environmental conditions in the vicinity of this sump and found soil impacted with chlorinated solvents. This area of impairment at the Site is discussed in detail in Section 5.1.14.

Sump located next to maintenance shop at the Site.
