**Former JML Optical, Inc.**

**Interim Remedial Measure**

**Construction Completion Report**

**Sump Cleanup and LNAPL Recovery**

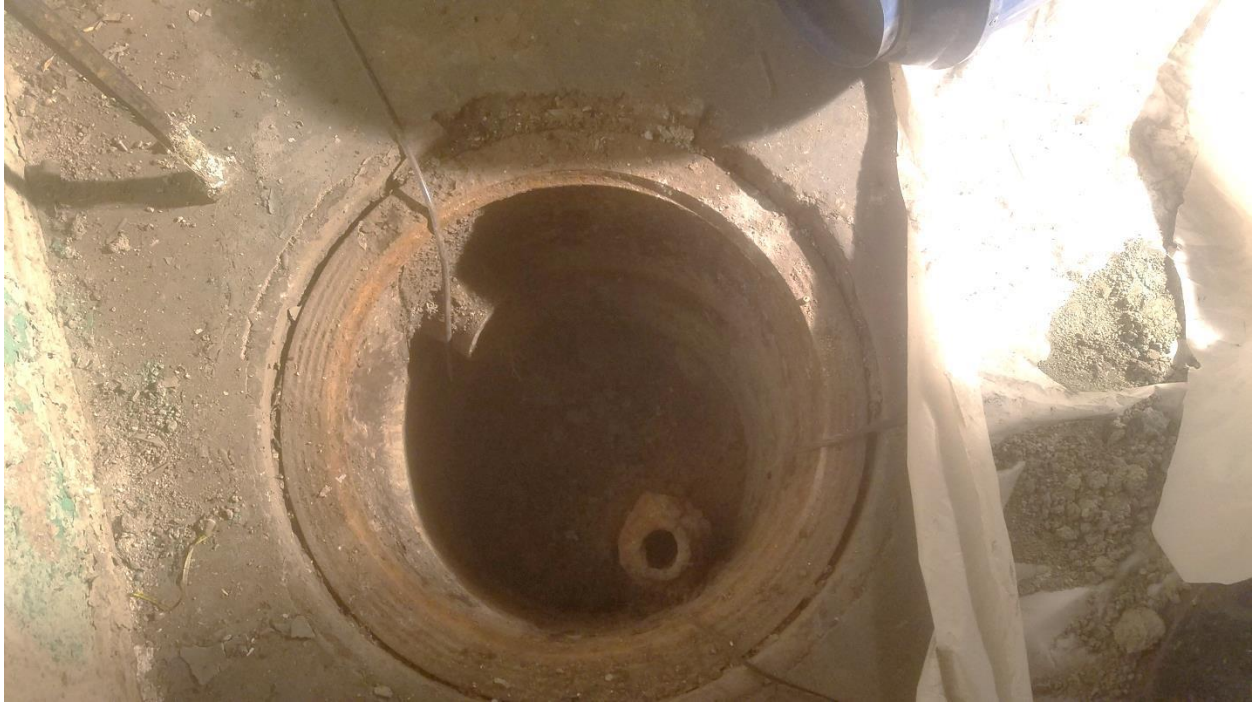
*Sump prior to sediment removal*

Two 55-gallon drums of TCE-containing sediments were manually removed from the sump. Hazardous levels of TCE (18,400 mg/Kg) were confirmed by laboratory analysis prior to IRM work activities. Toluene (404 mg/Kg) was also reported.

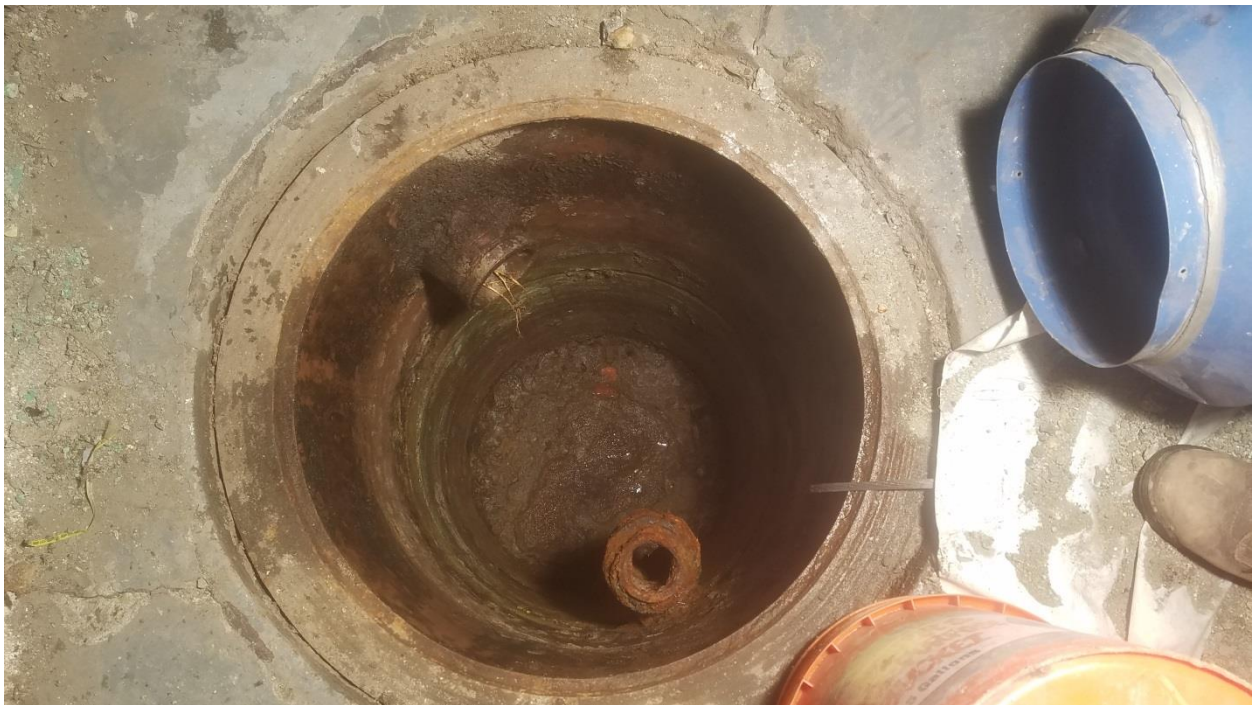
*Sump after sediment removal*

After cleanout, the sump was inspected to document its construction and condition, as well as its dimensions and the number, orientation, and location of openings, cracks, gaps or breaks. The sump was determined to be approximately 2.1 feet (ft.) in diameter and 4.4 ft. deep. It is constructed of two cylindrical concrete columns stacked vertically, with a grouted seam in between the two columns. The grout and columns appeared to be undamaged; no holes or cracks or missing grout were identified. Two pipe breeches were noted in the sump.

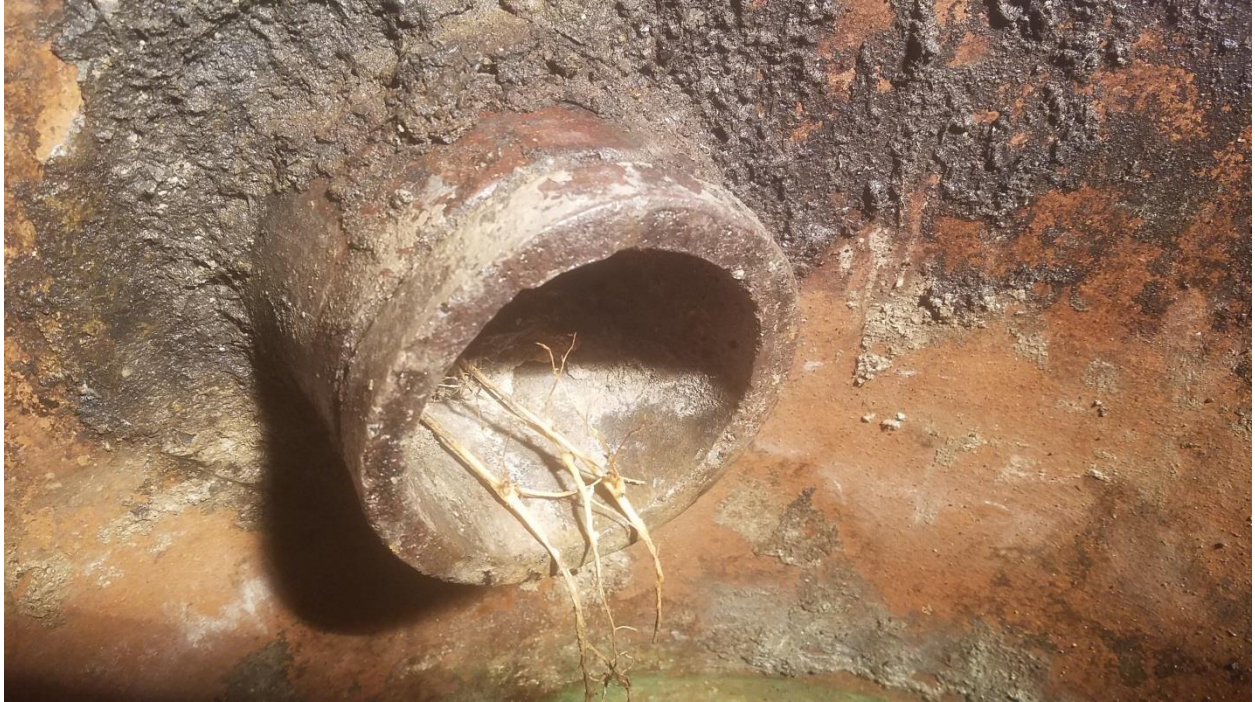
*Close up of pipe at southeast perimeter of sump*

Labella's Supplemental Site Characterization (SSC) report indicated that one pipe is the confluence of two floor drains from the maintenance shop, and the other is a discharge pipe. Based on Figure 6 of the CHA RIR, two floor drains discharge to the sump; there is no sump discharge pipe depicted. Neither Labella nor CHA were able to determine the discharge location of the sump in their floor drain investigations. Our investigation indicates that the sump does not have a discharge pipe. One of the pipes is equipped with a corroded metal fitting that may have at one time been connected to a pump.

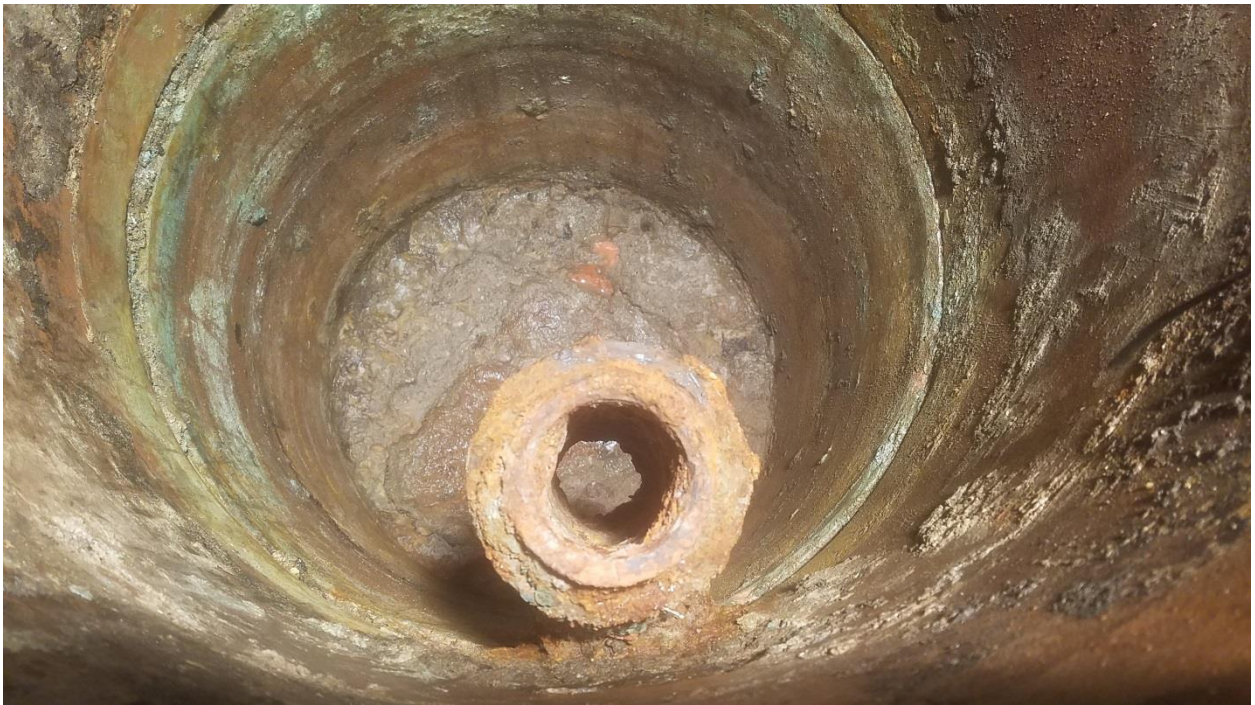
*Birds eye view of feature at northwest perimeter of sump*

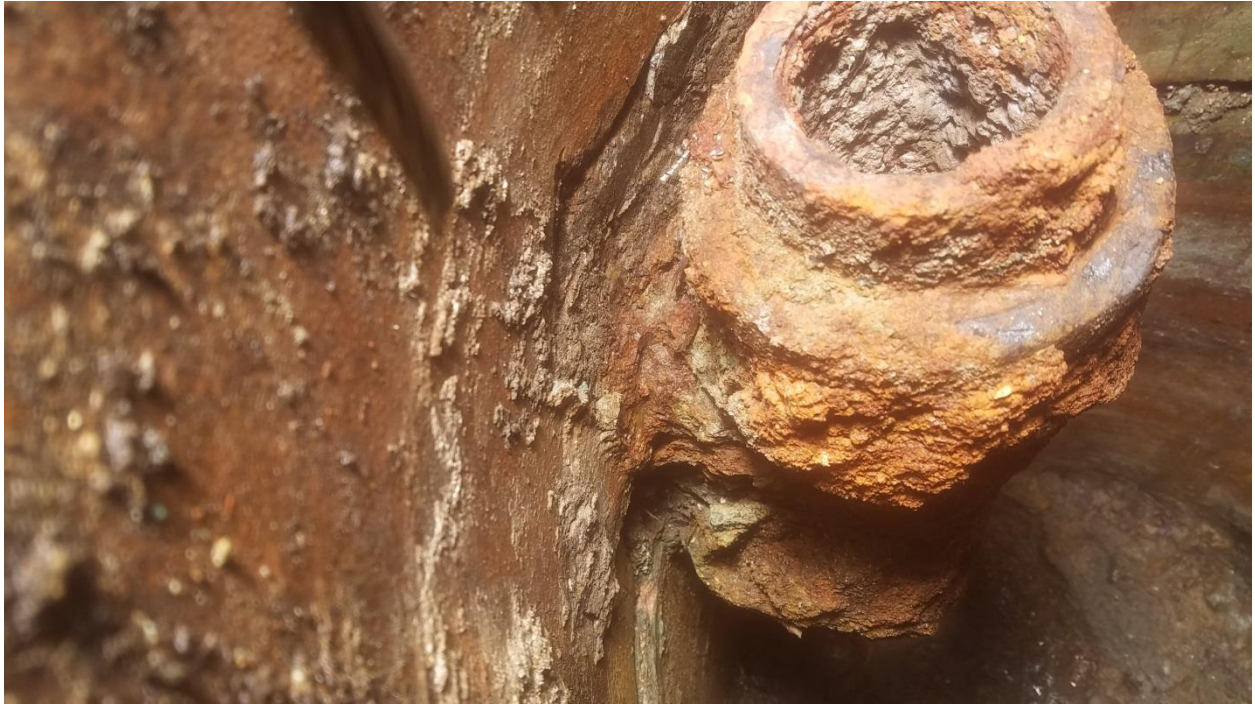
*Side view of feature at northwest perimeter*

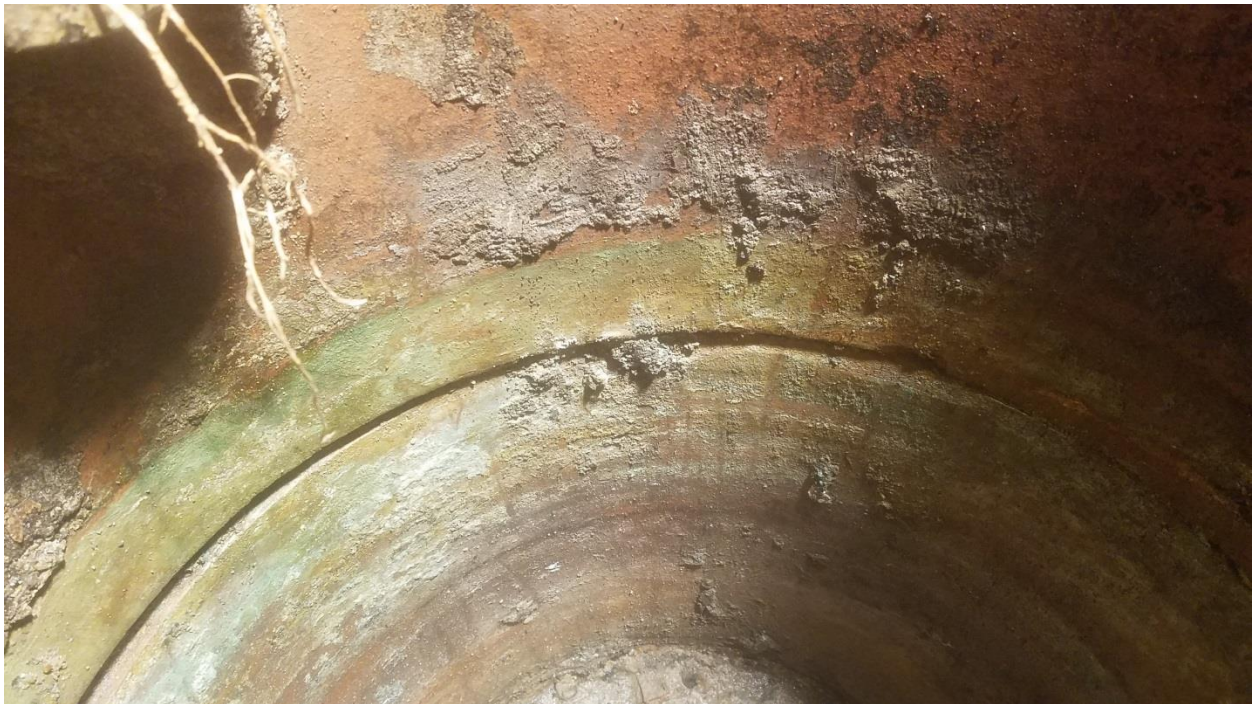
*Closeup of grouted seam between two stacked concrete columns*

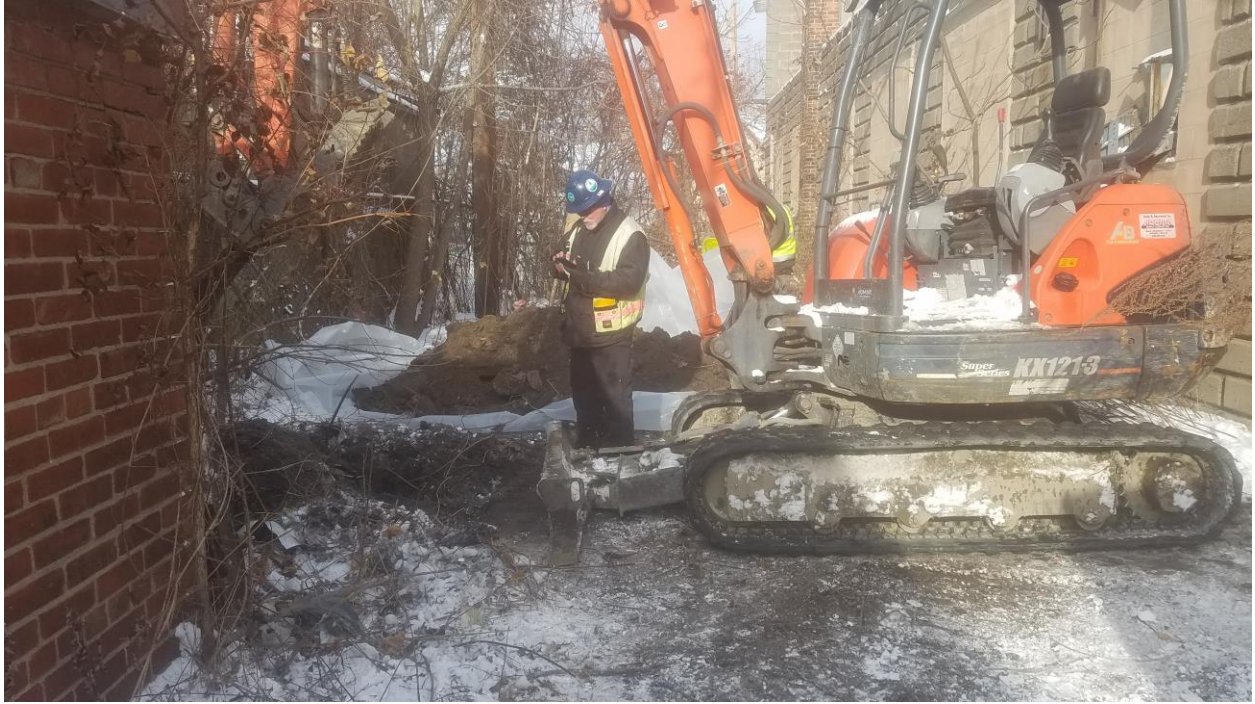
*Excavation of recovery well pit*

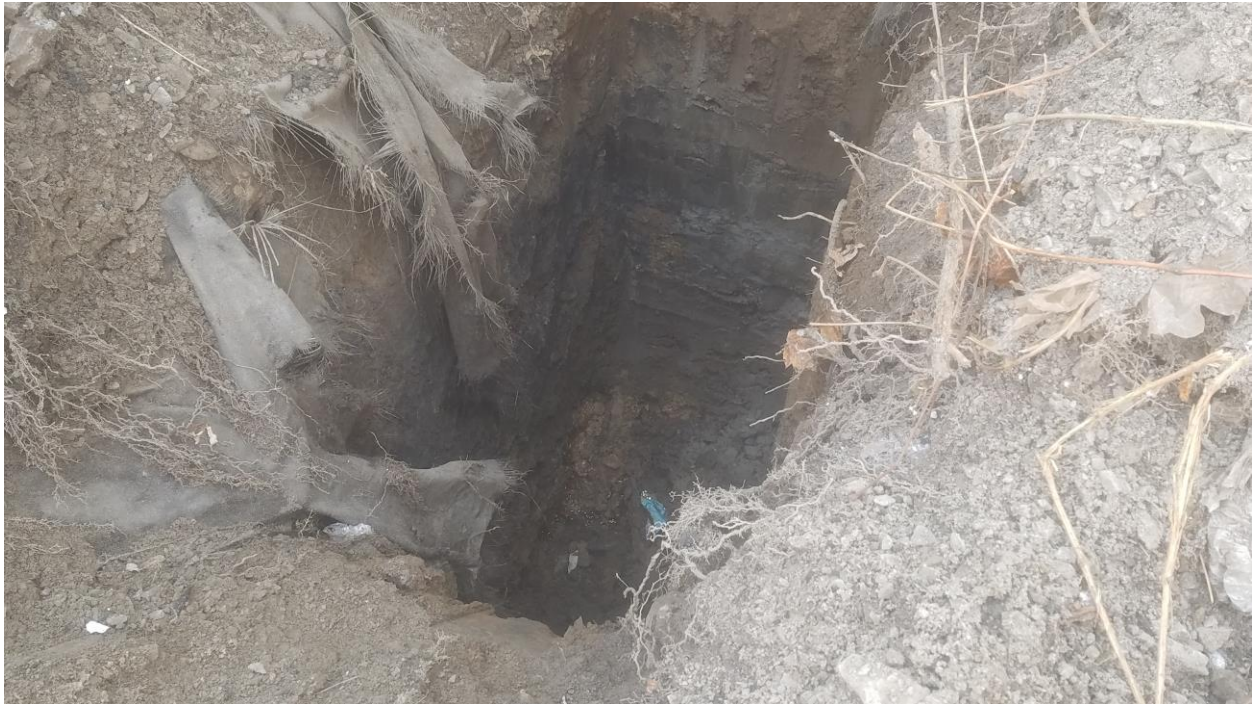
*Stained soils in recover well pit*

The recovery well was installed approximately 2.7 ft. from MW-3. Soils appeared to be clean and free of staining and odors from ground surface to approximately 4 ft. bgs. Soils were stained black from 4 to 8 ft. bgs. A small amount of LNAPL-saturated soil was removed during the excavation. LNAP-saturated soils were encountered at 8 ft. bgs. near the southwest corner of the excavation.

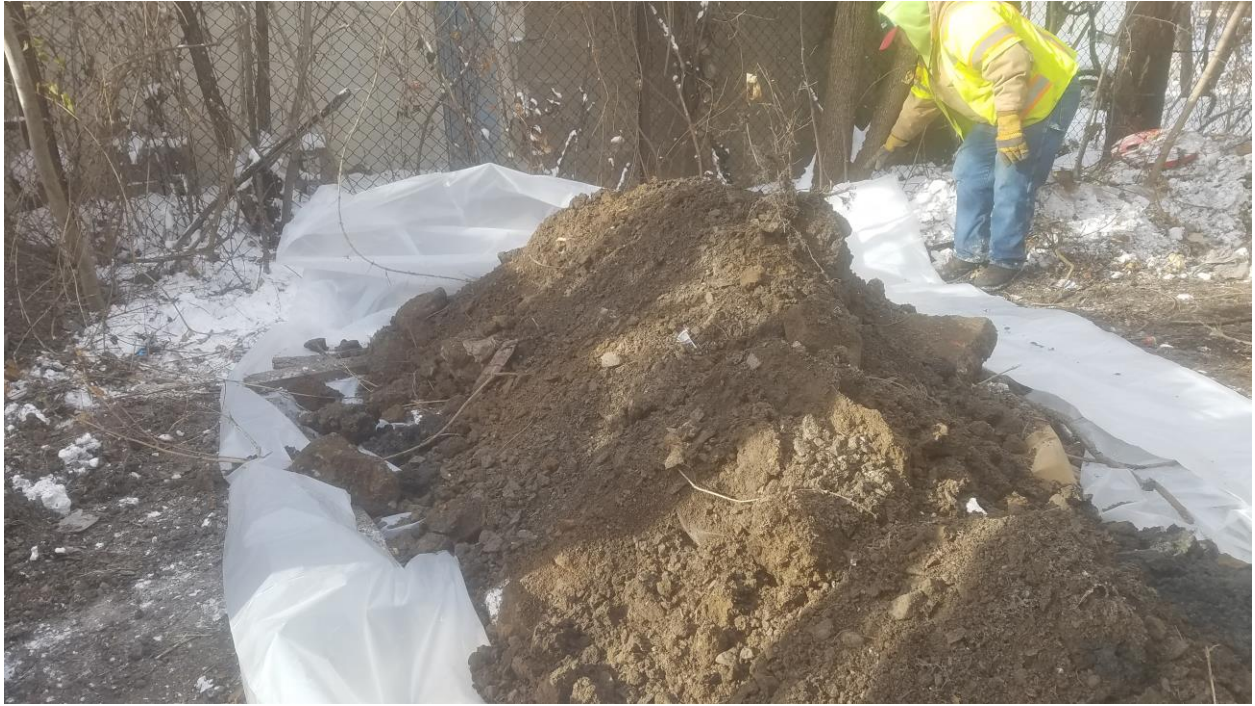
*Staging of excavated soils*

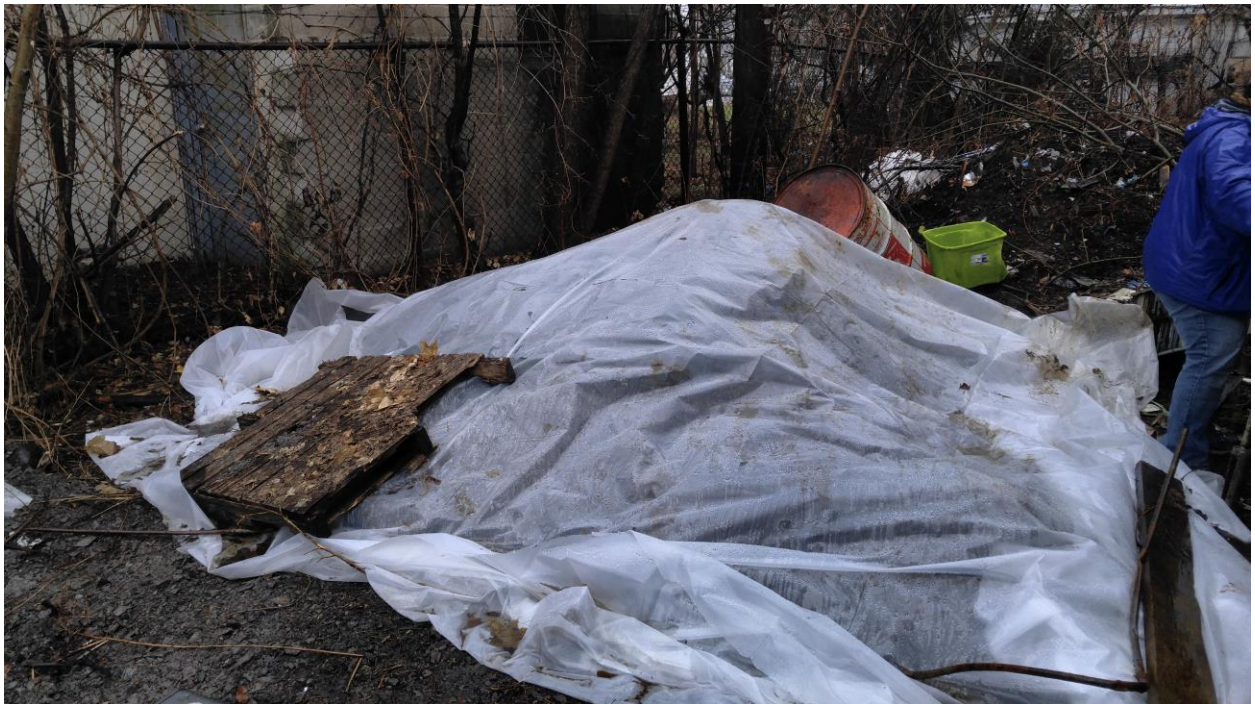
*Covered excavation soils*

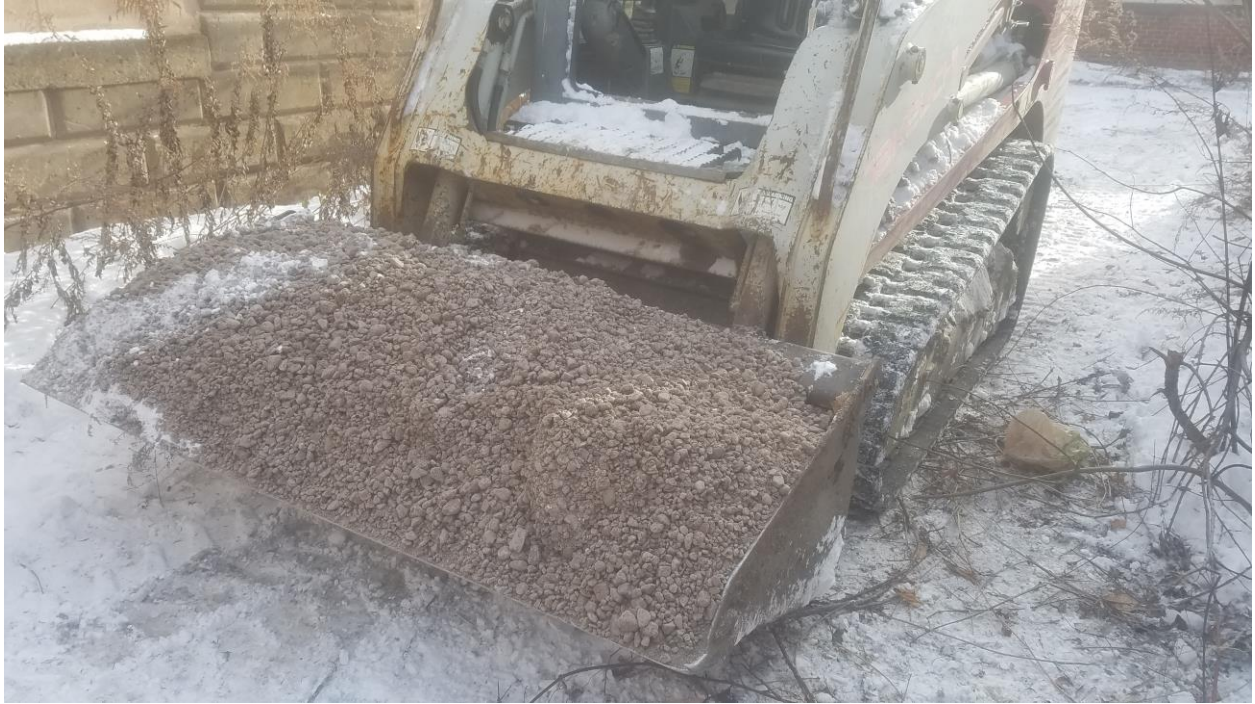
*1A gravel used as recovery well backfill*

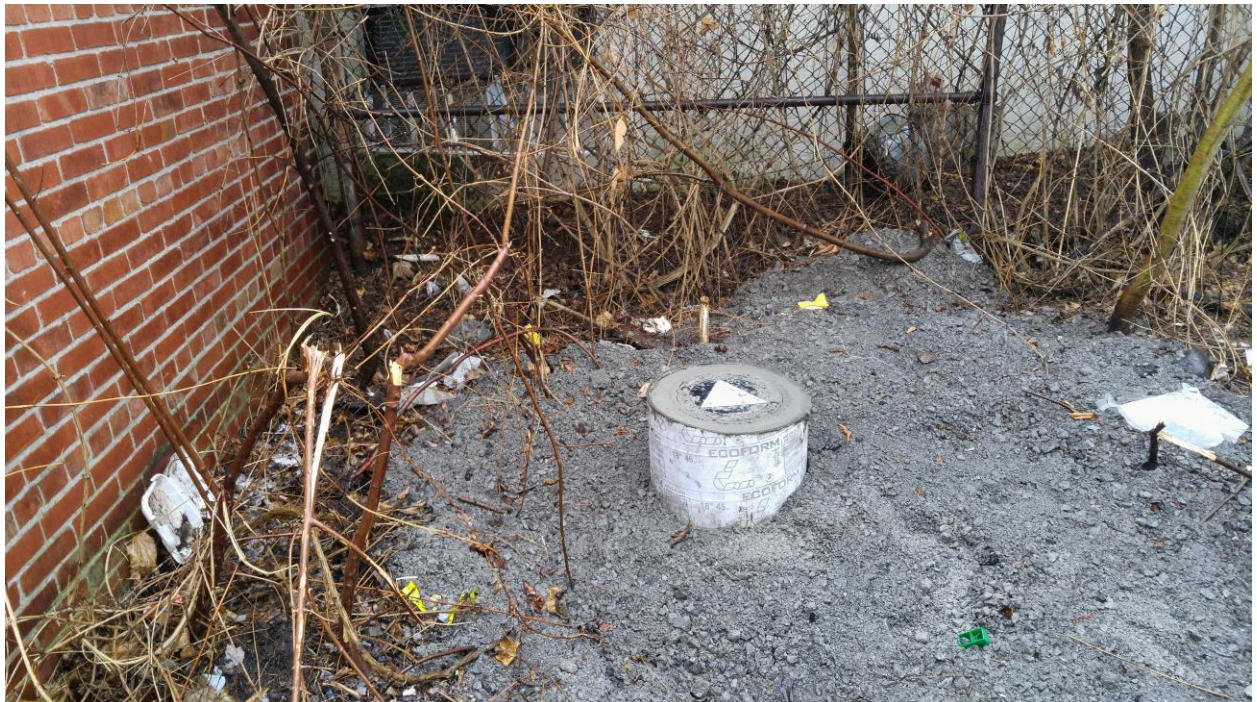
*The finished recovery well*

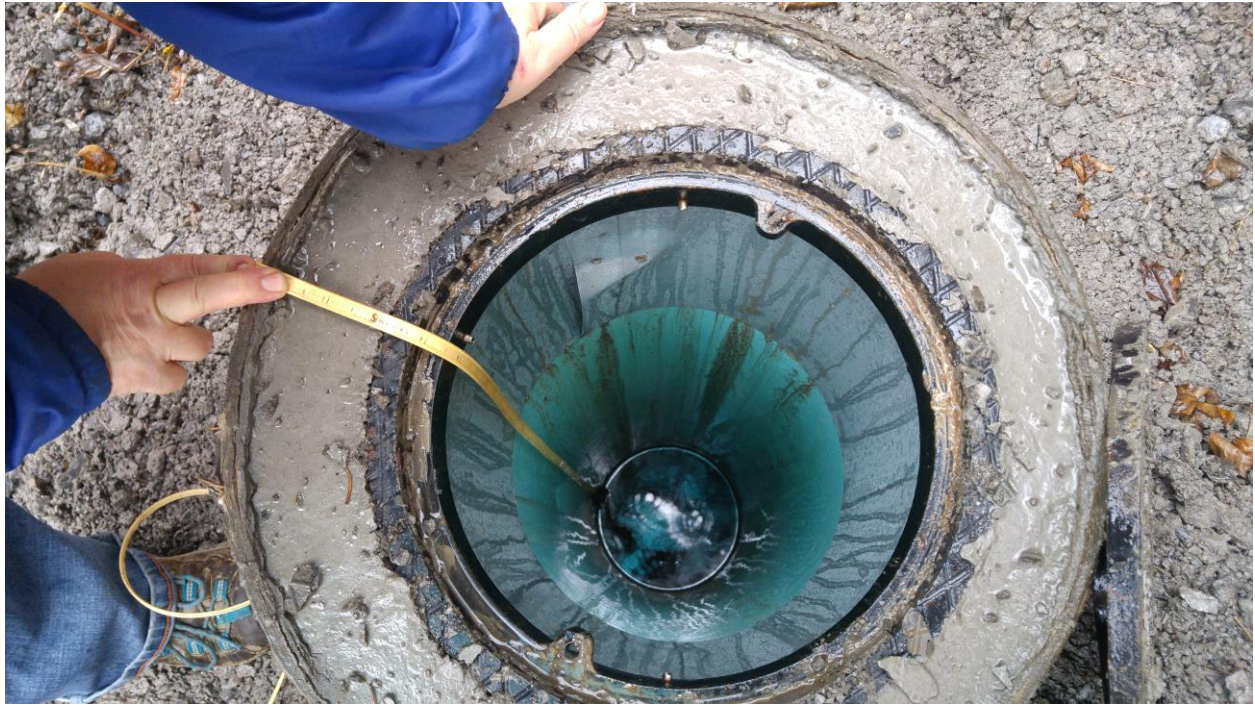
*Measuring LNAPL accumulation*
