Remedial Alternatives Analysis

NYSDEC BCP Site No. C828182

Eldre Corporation
1500 Jefferson Road & 55 Hofstra Road
Town of Henrietta
Monroe County, New York

LaBella Project No. 212721.02

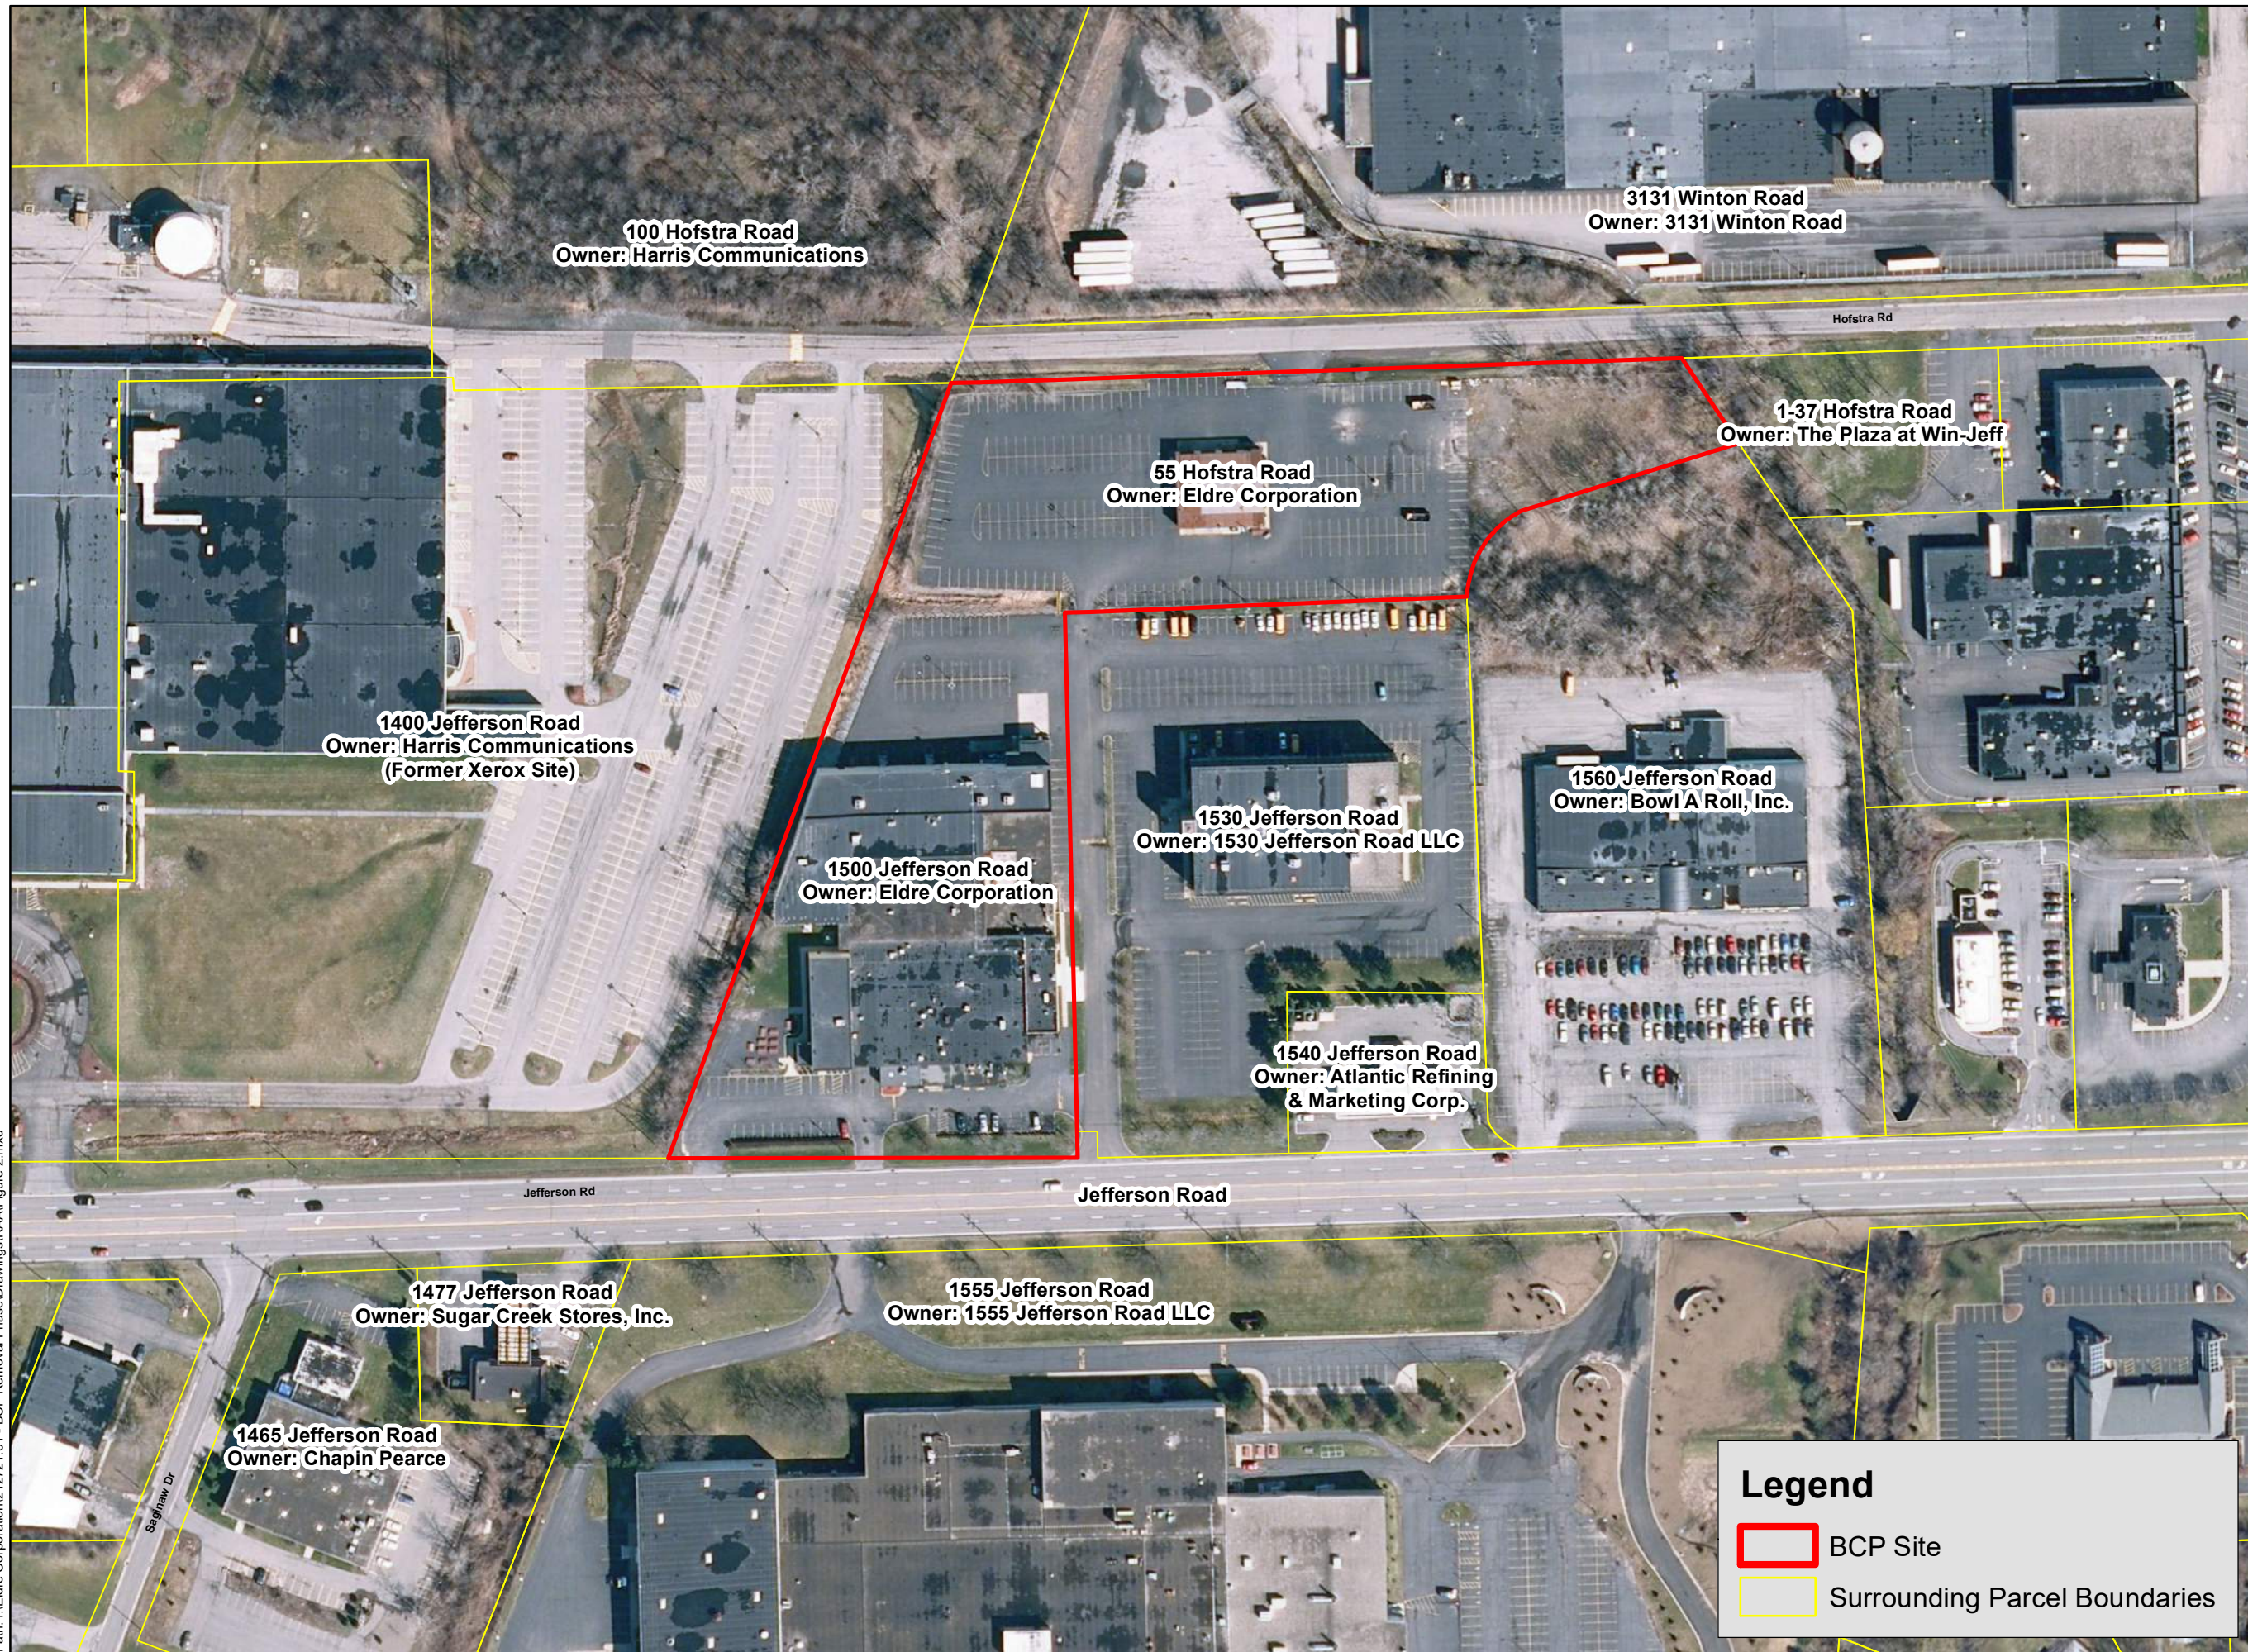
[FIGURE 2]

ELDRE CORPORATION
BCP SITE C828182

1500 JEFFERSON ROAD
AND 55 HOFSTRA ROAD

The Site consists of four (4) contiguous tax parcels totaling approximately 6.72 acres, as summarized in the following table and shown on Figure 2.
