Todd Caffoe, P.E
New York State Department of Environmental Conservation
Division of Environmental Remediation
6274 East Avon-Lima Road
Avon, NY 14414
**Reference: Brownfield Cleanup Program
Monthly Progress Report #10
Site #C828184
Former Carriage Factory
33 Litchfield Street
Rochester, Monroe County, New York**

On behalf of Carriage Factory Special Needs Apartments, LP (CFSNA), Stantec Consulting Services Inc. (Stantec) has prepared this Monthly Progress Report #10 for the Brownfield Cleanup Program (BCP) at the Former Carriage Factory located at 33 Litchfield Street in the City of Rochester, Monroe County, New York (Site). This report covers activities that took place during the month of December 2013.

BROWNFIELD CLEANUP PROGRAM
FORMER CARRIAGE FACTORY
33 LITCHFIELD STREET, ROCHESTER, NY

UTILITY EXCAVATIONS

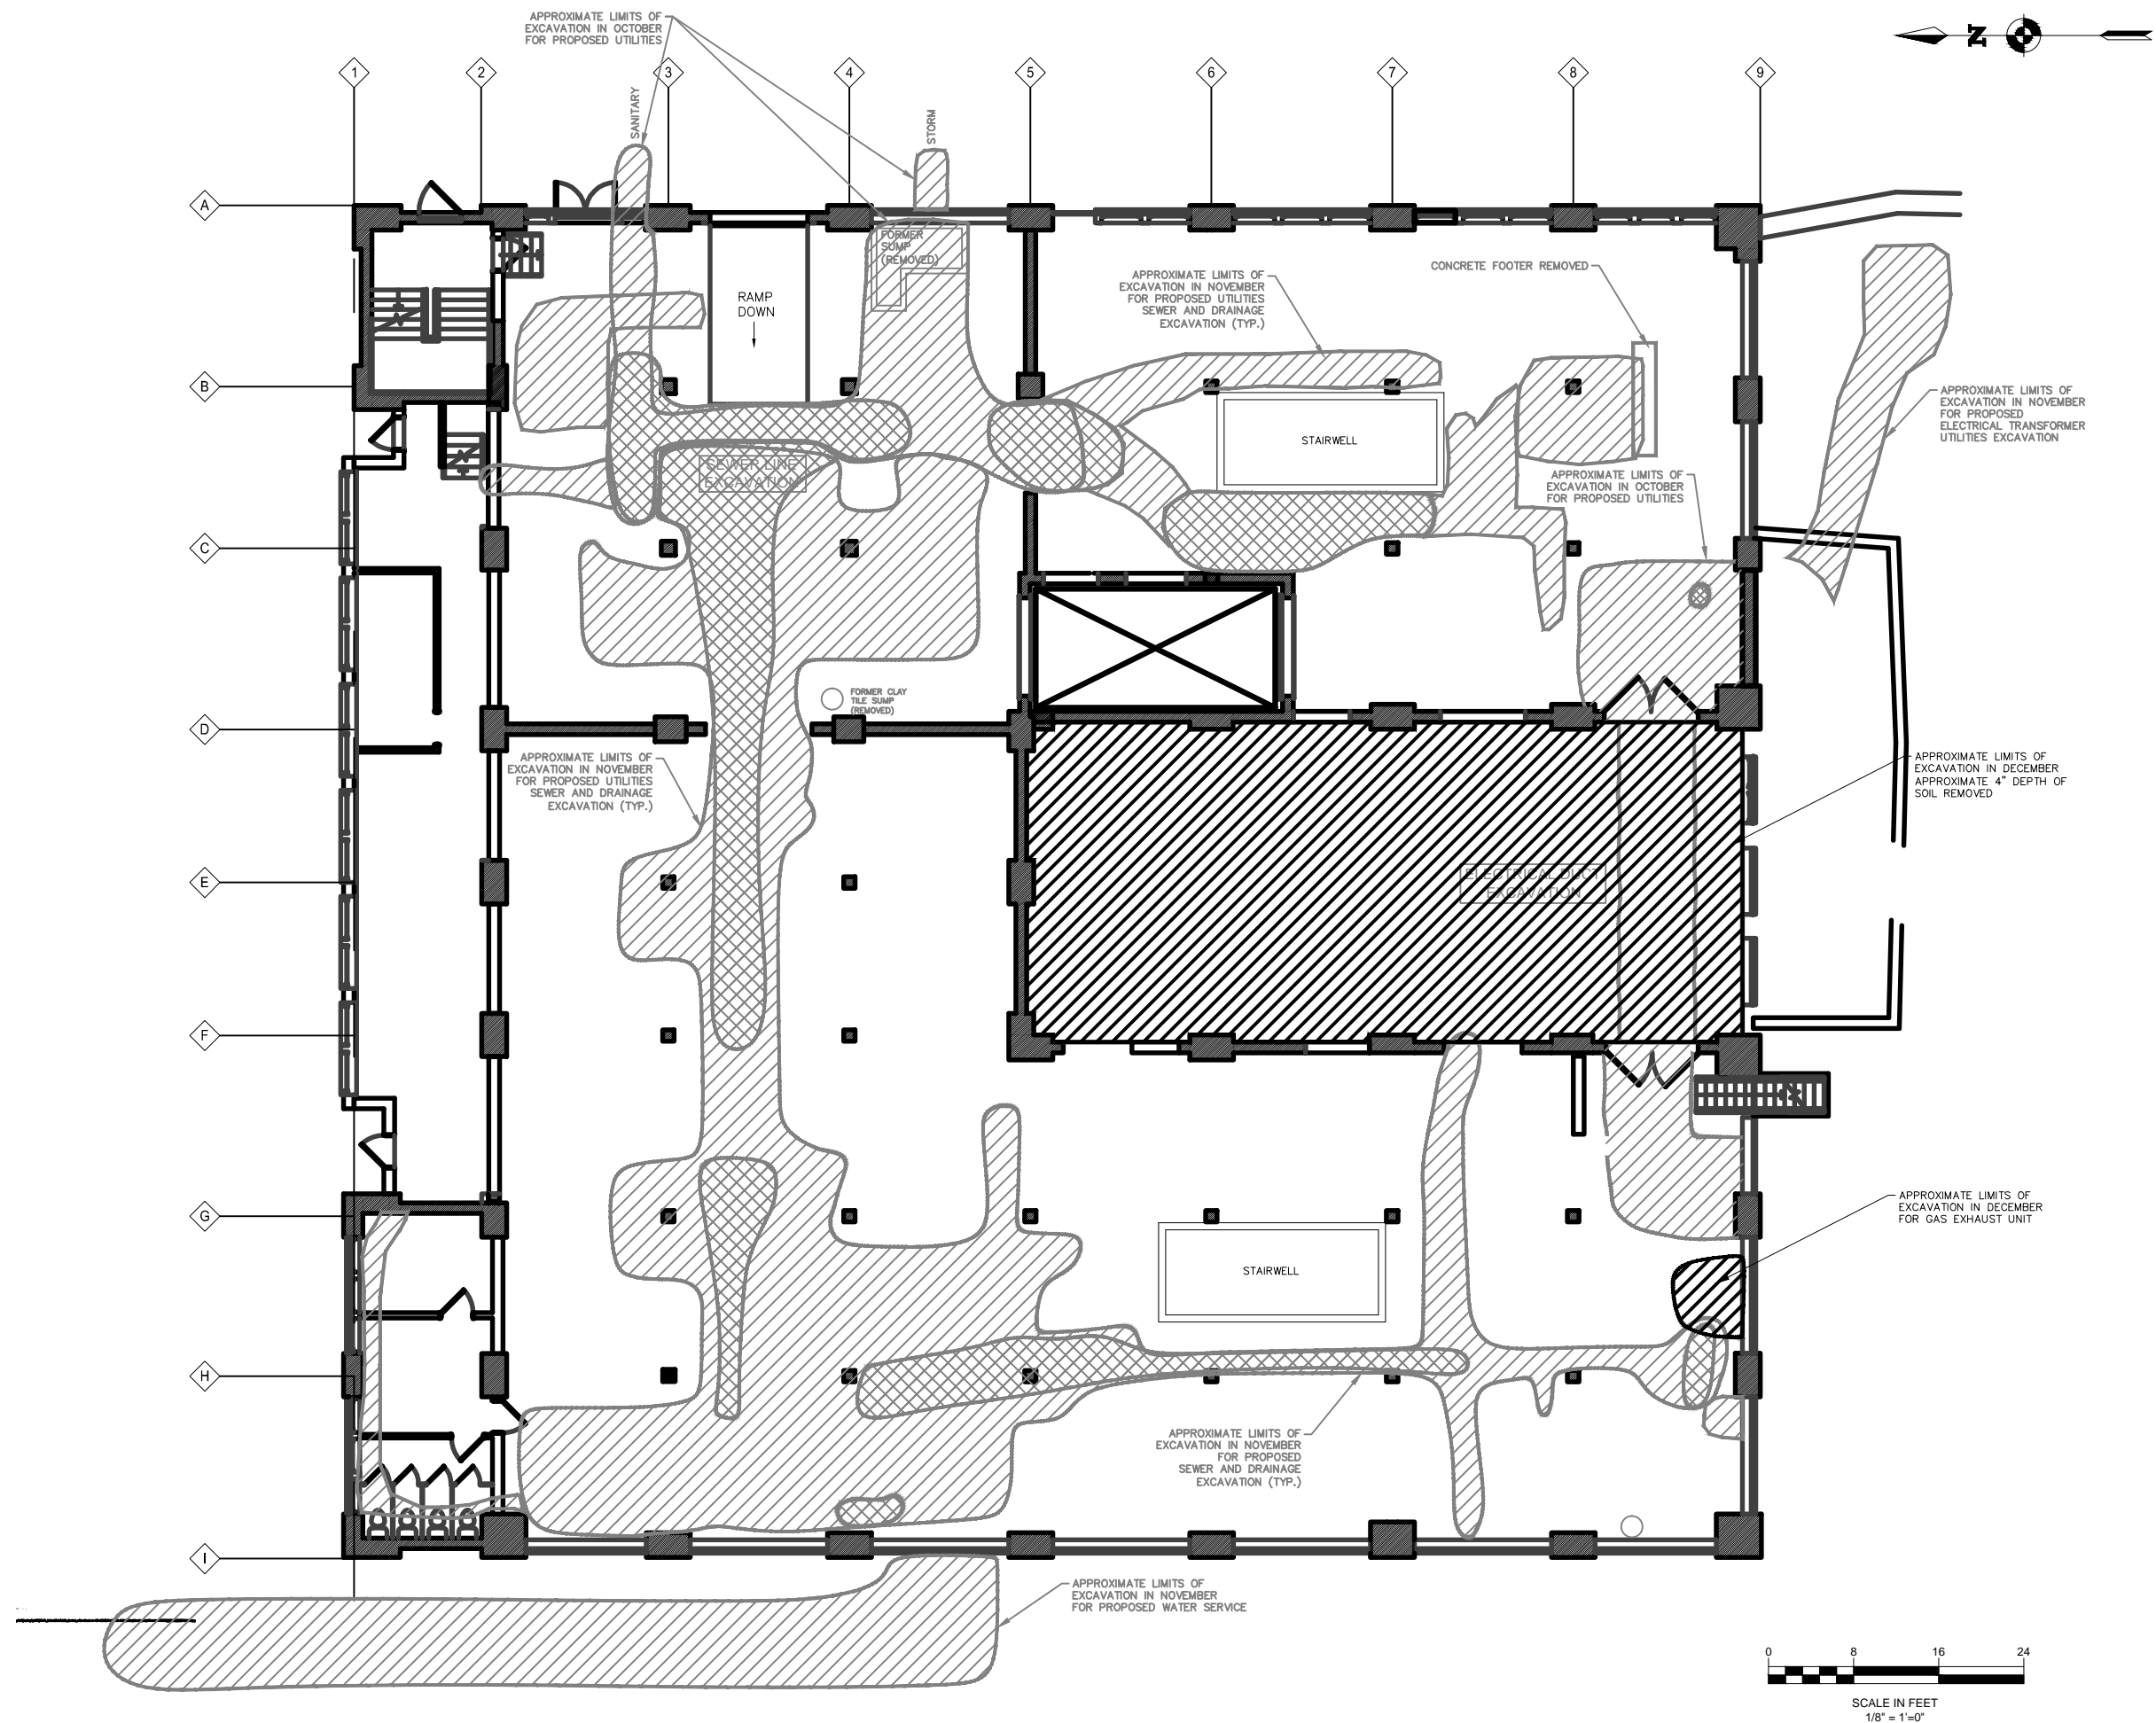
FIGURE 1 of 0

GENERAL/ UTILITY EXCAVATION IN DECEMBER 2013

PREVIOUS EXCAVATION (OCTOBER)

BEDROCK EXCAVATION (NOVEMBER)

1. EXCAVATION LIMITS APPROXIMATE ONLY.
2. AREAS EXCAVATED PRIMARILY FOR STORM AND SANITARY PIPES AND CONNECTIONS TO SEWER.

- On December 12 approximately 20 cy of soil was excavated and removed from the atrium to meet sub-grade elevation. This soil comprised the top 4 to 6 inches of material across the entire atrium (Figure 1). The soil consisted largely of brick and cinder material and in most locations had a strong petroleum-like odor. PID readings of this soil ranged from 1 to 2 ppm. The material was removed using a skid-steer and was added to the stockpile outside that contains other contaminated soils from the basement as shown on Figure 2.
