3750 Monroe Avenue
MONROE COUNTY
TOWN OF PITTSFORD, NEW YORK

INTERIM SITE MANAGEMENT

Sub-Slab Depressurization System

NYSDEC Site Number: C828187

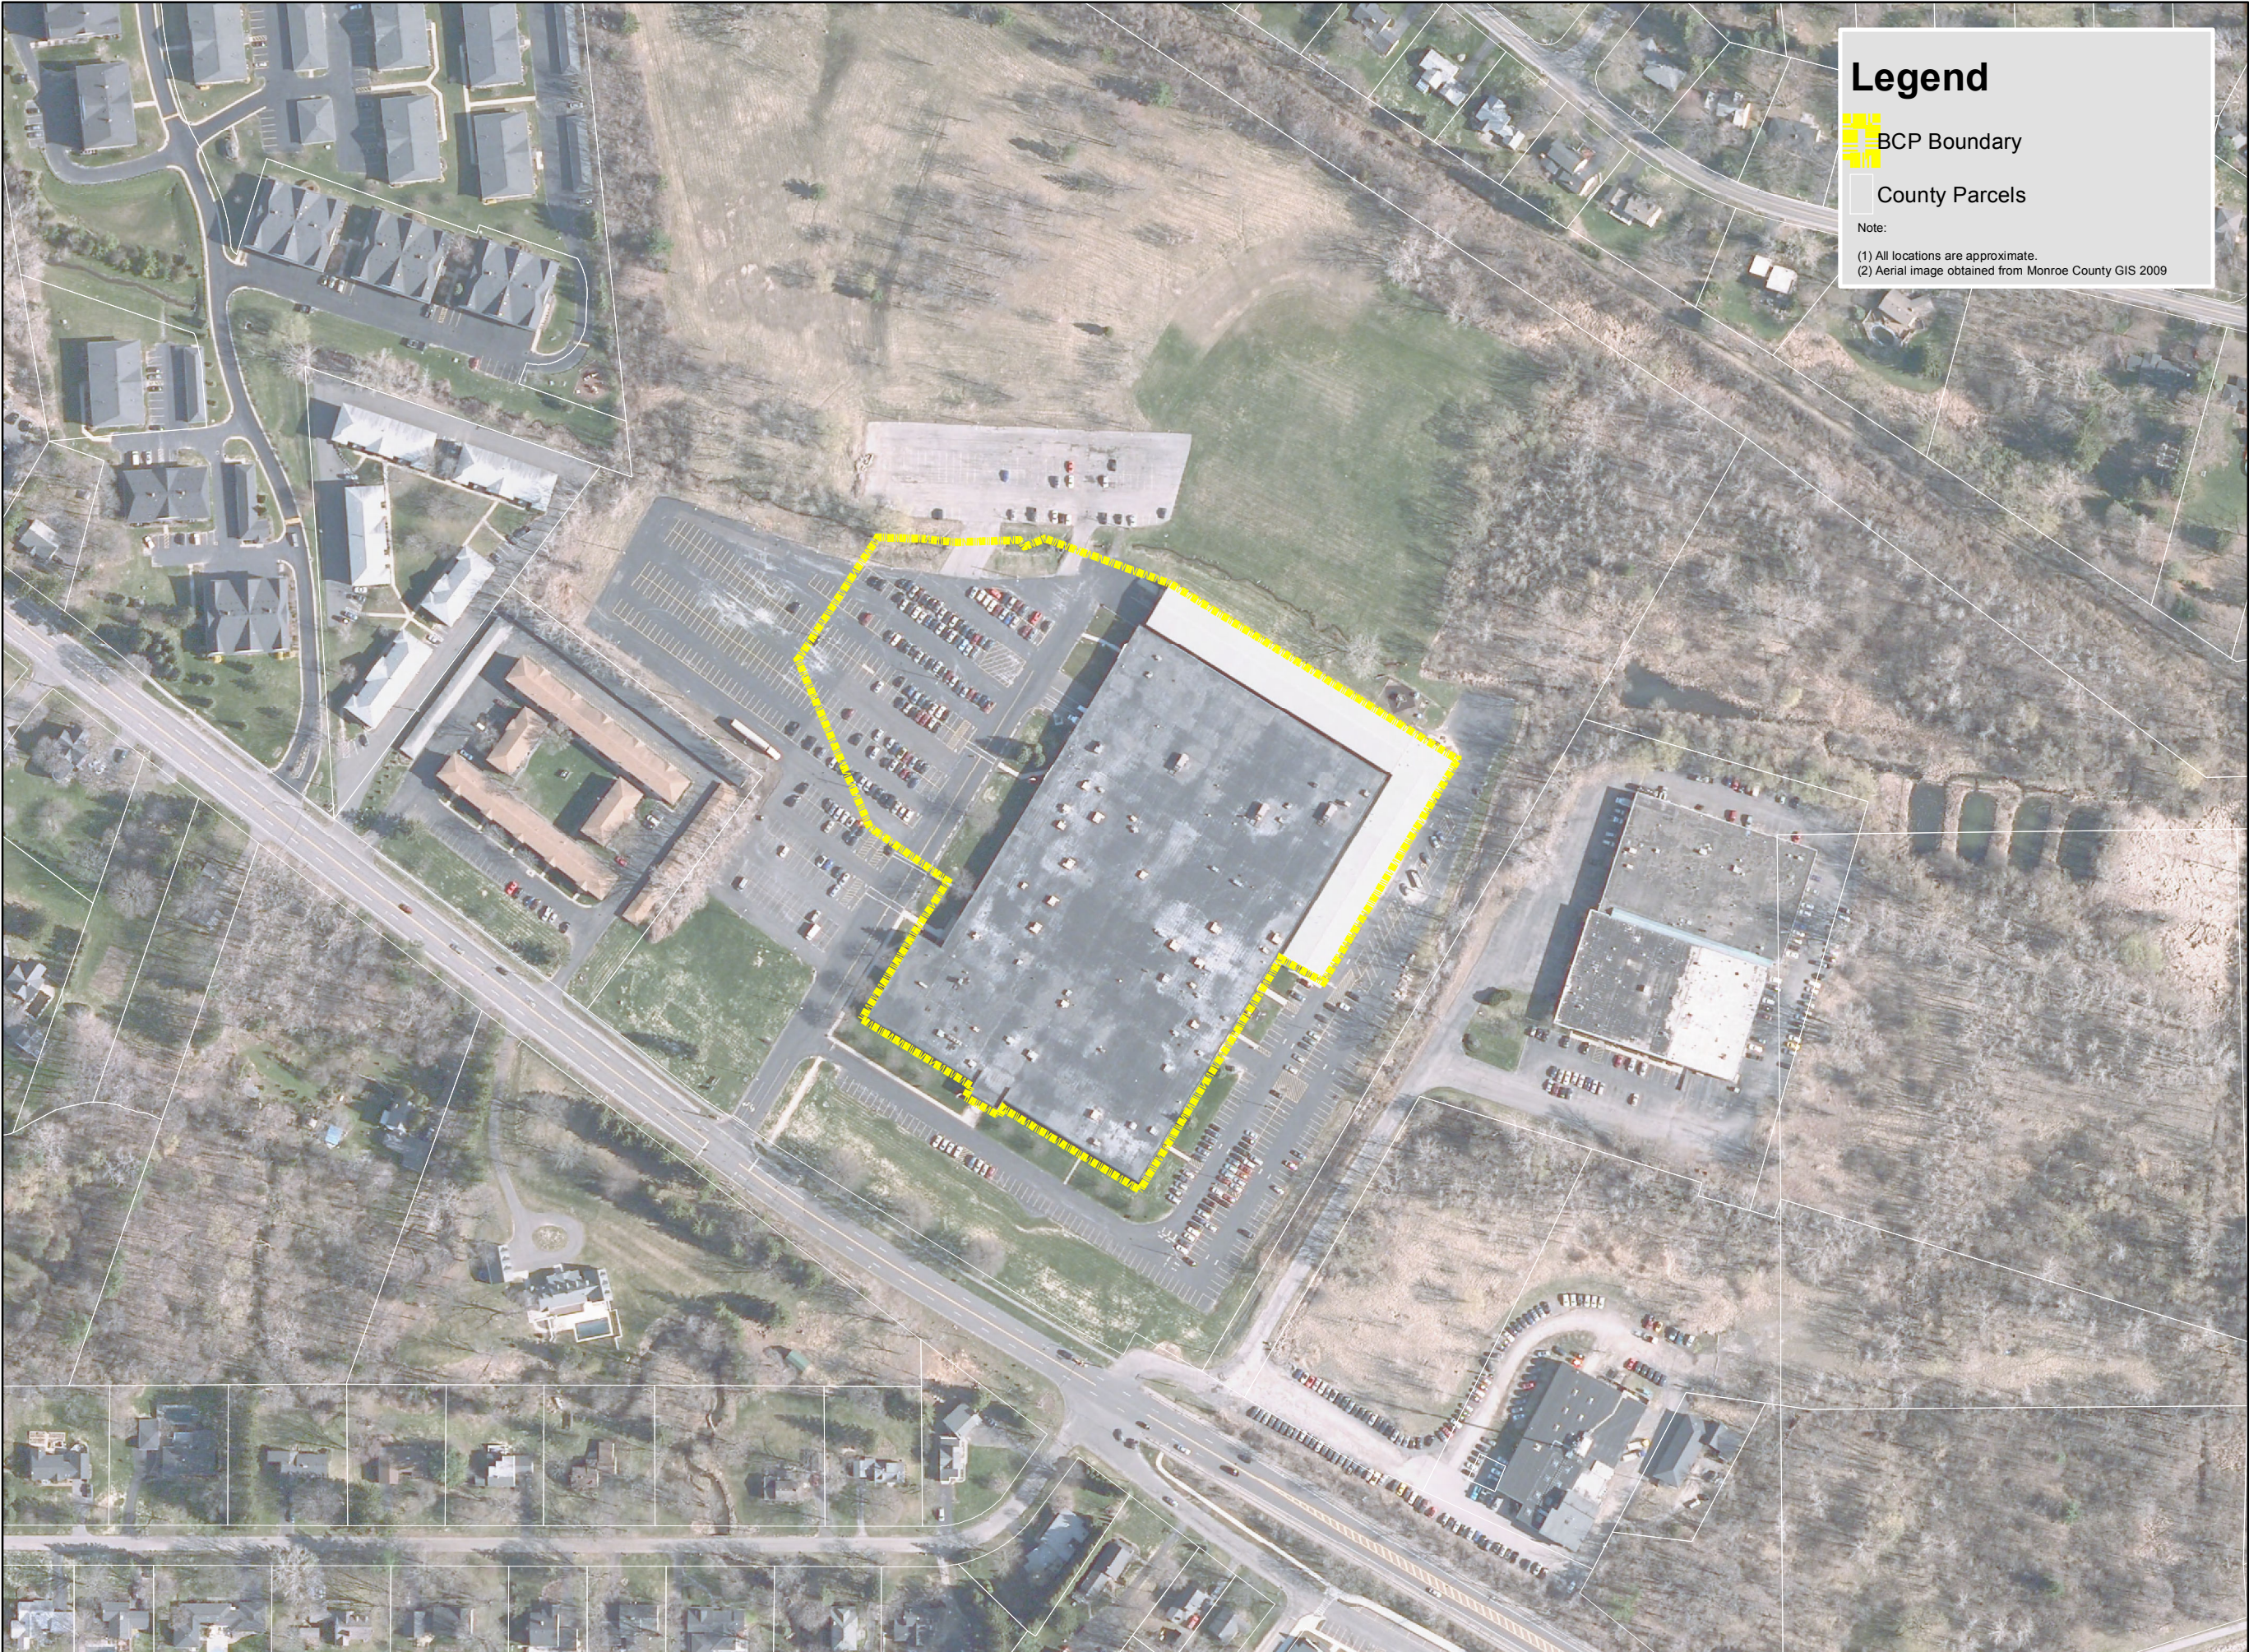
[FIGURE 2]

Figure 2 – BCP Site Boundary

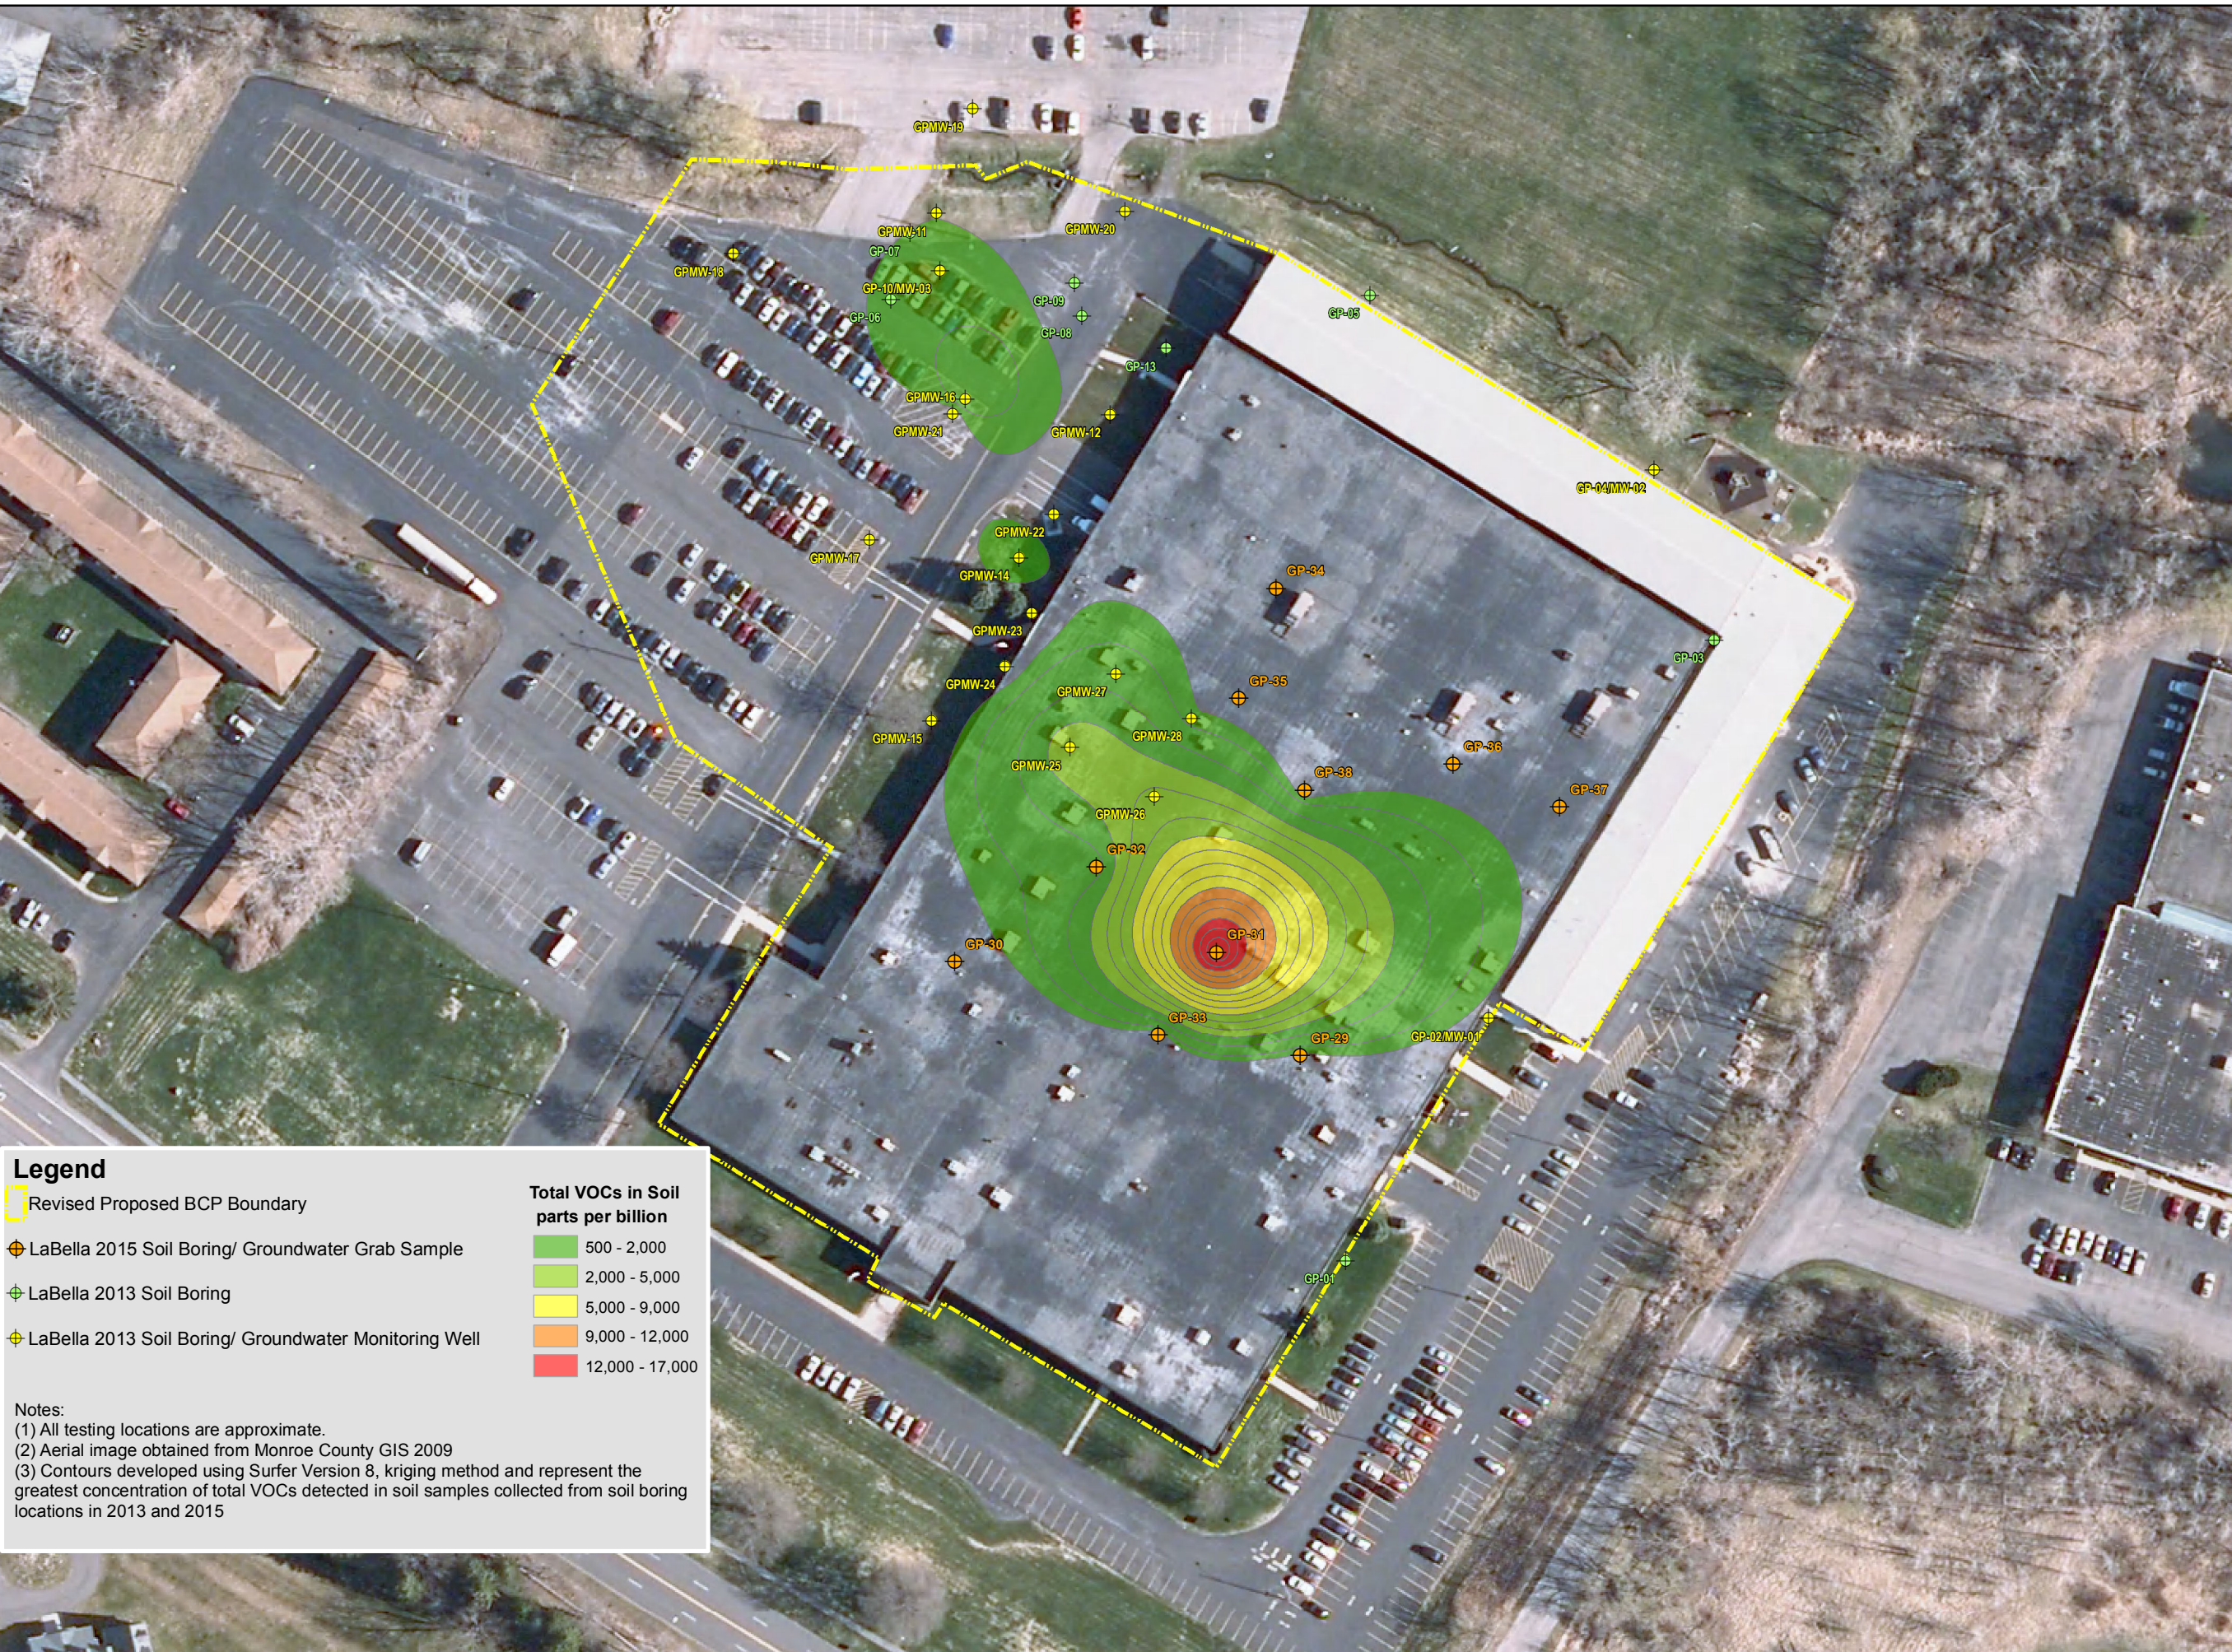
[FIGURE 3]

Figure 3 – VOCs in Soil Contour Map (Source: Remedial Investigation Work Plan, Figure 5)

TCI/Graflex plating area and GRAB GP-36 was advanced in the location of the Graflex degreasing and oil storage area (see Figure 3 for the locations of these soil borings and associated groundwater monitoring wells).

Remedial actions under the NYSDEC BCP have not yet been performed at the Site, however subsurface contamination has been documented at the Site during prior investigations. Section 2.3 provides additional information regarding the findings of these prior investigations (also see Figure 3). This section discusses air sampling activities performed prior to and after the IRM addressed by this ISMP (i.e., the installation of an SSDS within the Site building).

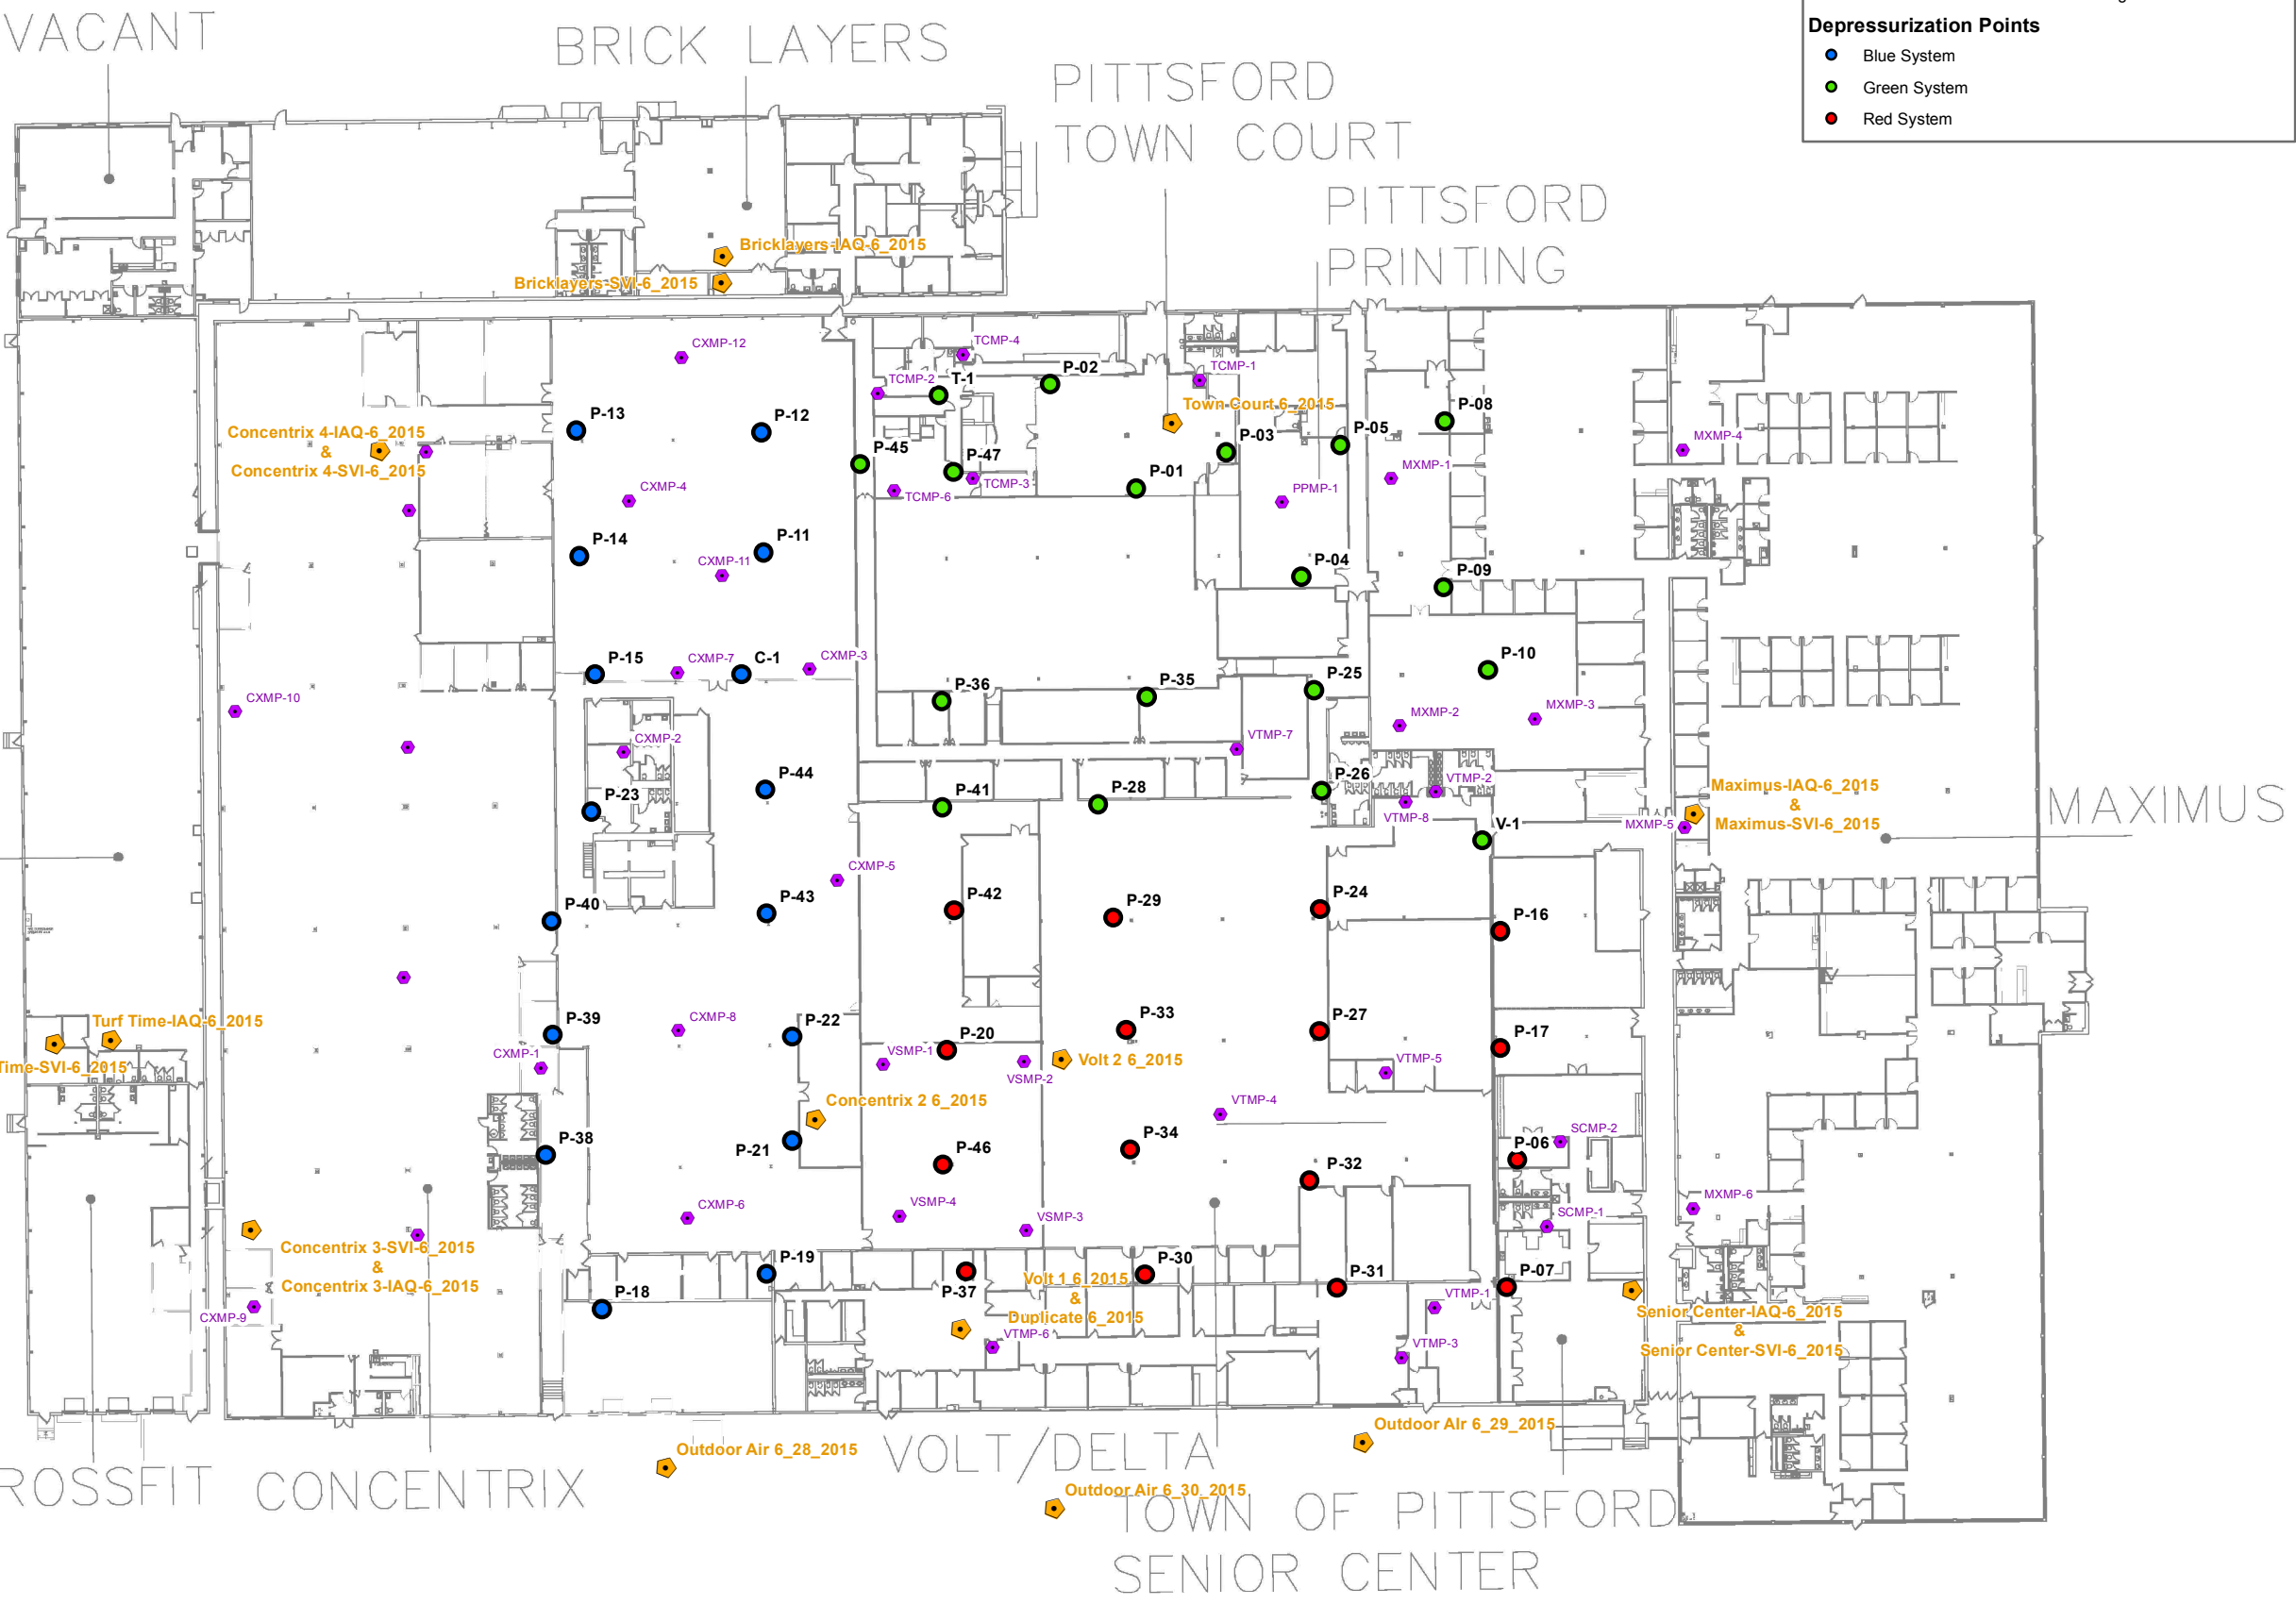
[FIGURE 4]

Figure 4 – Sub-Slab Depressurization System Layout and Indoor/Sub-slab & Outdoor Air Sampling Locations - June 2015

- Indoor Air/ Sub-slab & Outdoor Sample Locations (6-2015)
- Pressure Field Extension Monitoring Points
- Depressurization Points**
 - Blue System
 - Green System
 - Red System

On June 28, 29, and 30, 2015 (more than forty-five days after the installation and full startup of the three-fan SSDS, per the IRM WP), indoor air samples were collected from the same locations in which previous indoor air samples were collected within the SSDS mitigation area. Specifically, sample locations “Town Court”, “Volt 1”, “Volt 2” and “Concentrix 2” were retested. Six (6) additional indoor air samples and six (6) associated sub-slab vapor samples were also collected from locations selected outside of the SSDS mitigation area. A total of three (3) outdoor air samples (one for each day of sampling) were also collected as part of this sampling event. QA/QC samples (i.e., blind duplicate and MS/MSD) were also collected. The June 2015 sampling locations are included on Figure 4.

Per the IRM WP, indoor air sampling and soil vapor intrusion (SVI) sampling were required post SSDS start-up. Due to the timing of the installation being completed, it was agreed that an initial round of sampling would be completed outside of the heating season and a follow up round of sampling, within the heating season, would be completed at a later date. The initial round of indoor air and sub-slab sampling was performed in late June 2015, and the associated laboratory analytical results indicated that the indoor air in the northern portion of the Site building appeared to require further mitigation. Refer to Section 2.5.1 of this report for a discussion of the June 2015 Indoor Air, Outdoor Air, and Sub-Slab Vapor Sampling event. June 2015 SVI sampling locations are depicted on Figure 4.

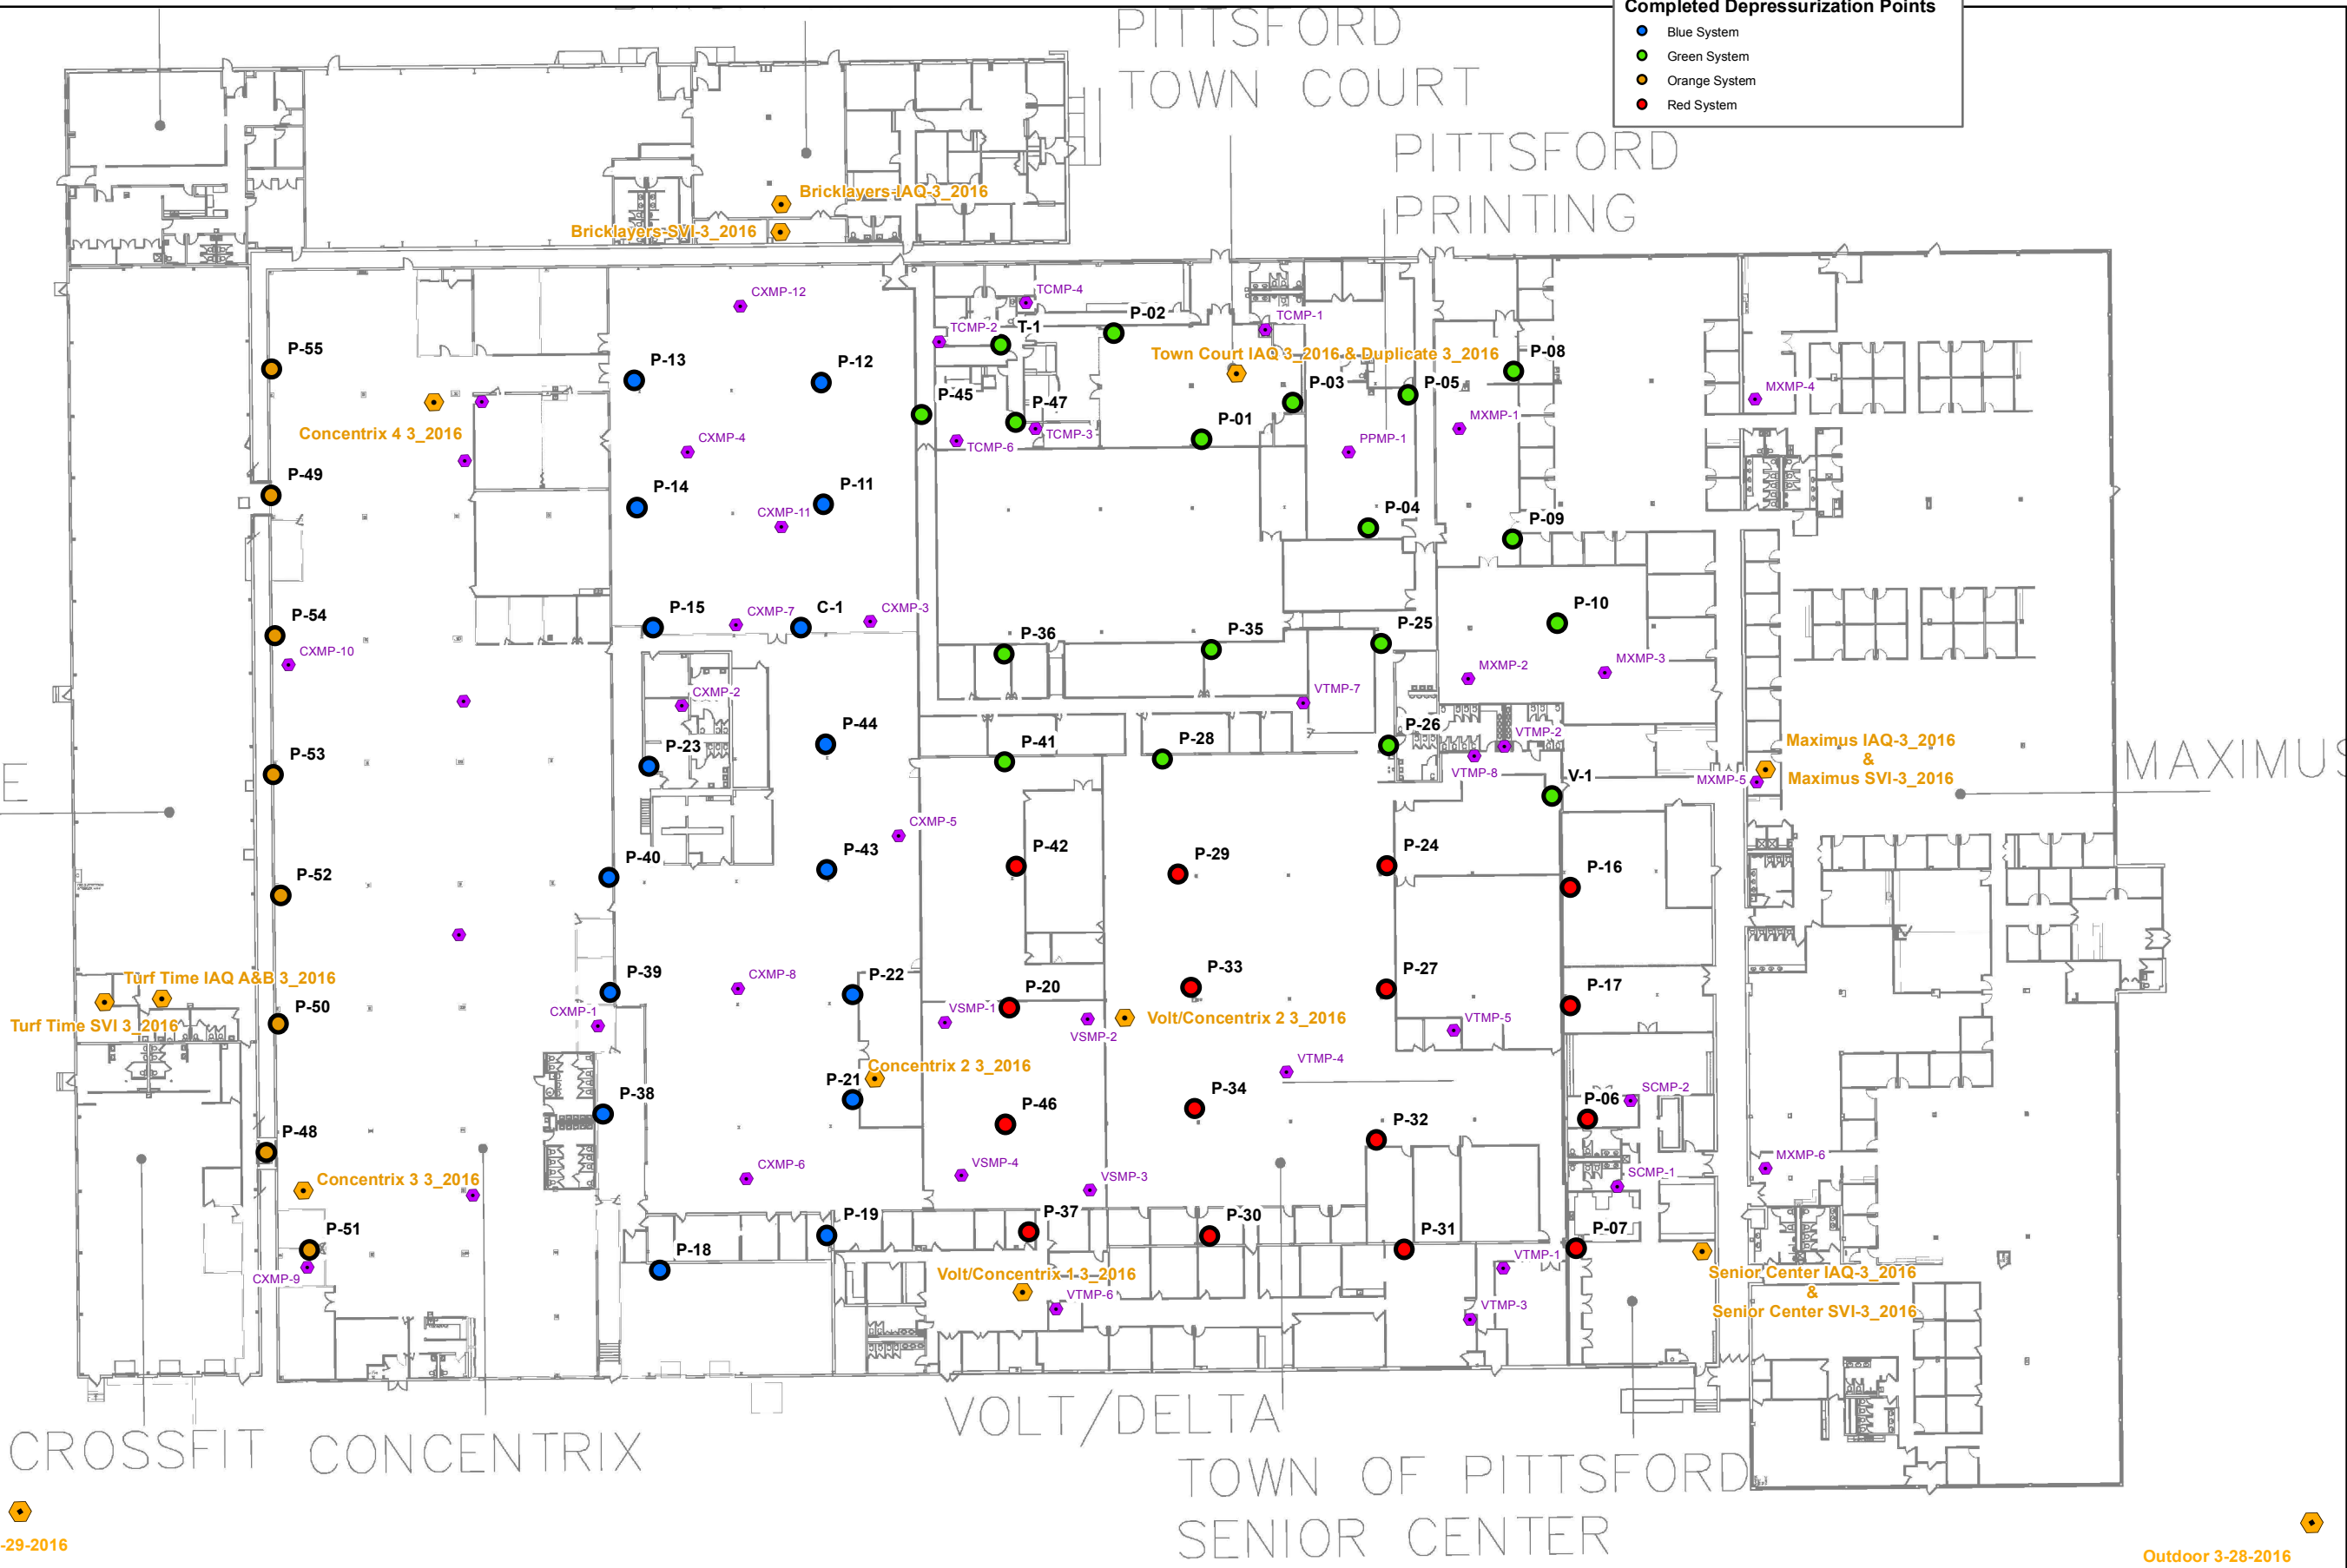
[FIGURE 6]

It is understood the Site building's various heating, ventilation, and air-conditioning (HVAC) systems are located on the roof. Figure 6 depicts the rooftop locations of the SSDS exhaust fans and the locations of rooftop HVAC units that have air intakes. "As-built" drawings for the SSDS are included in Appendix B.

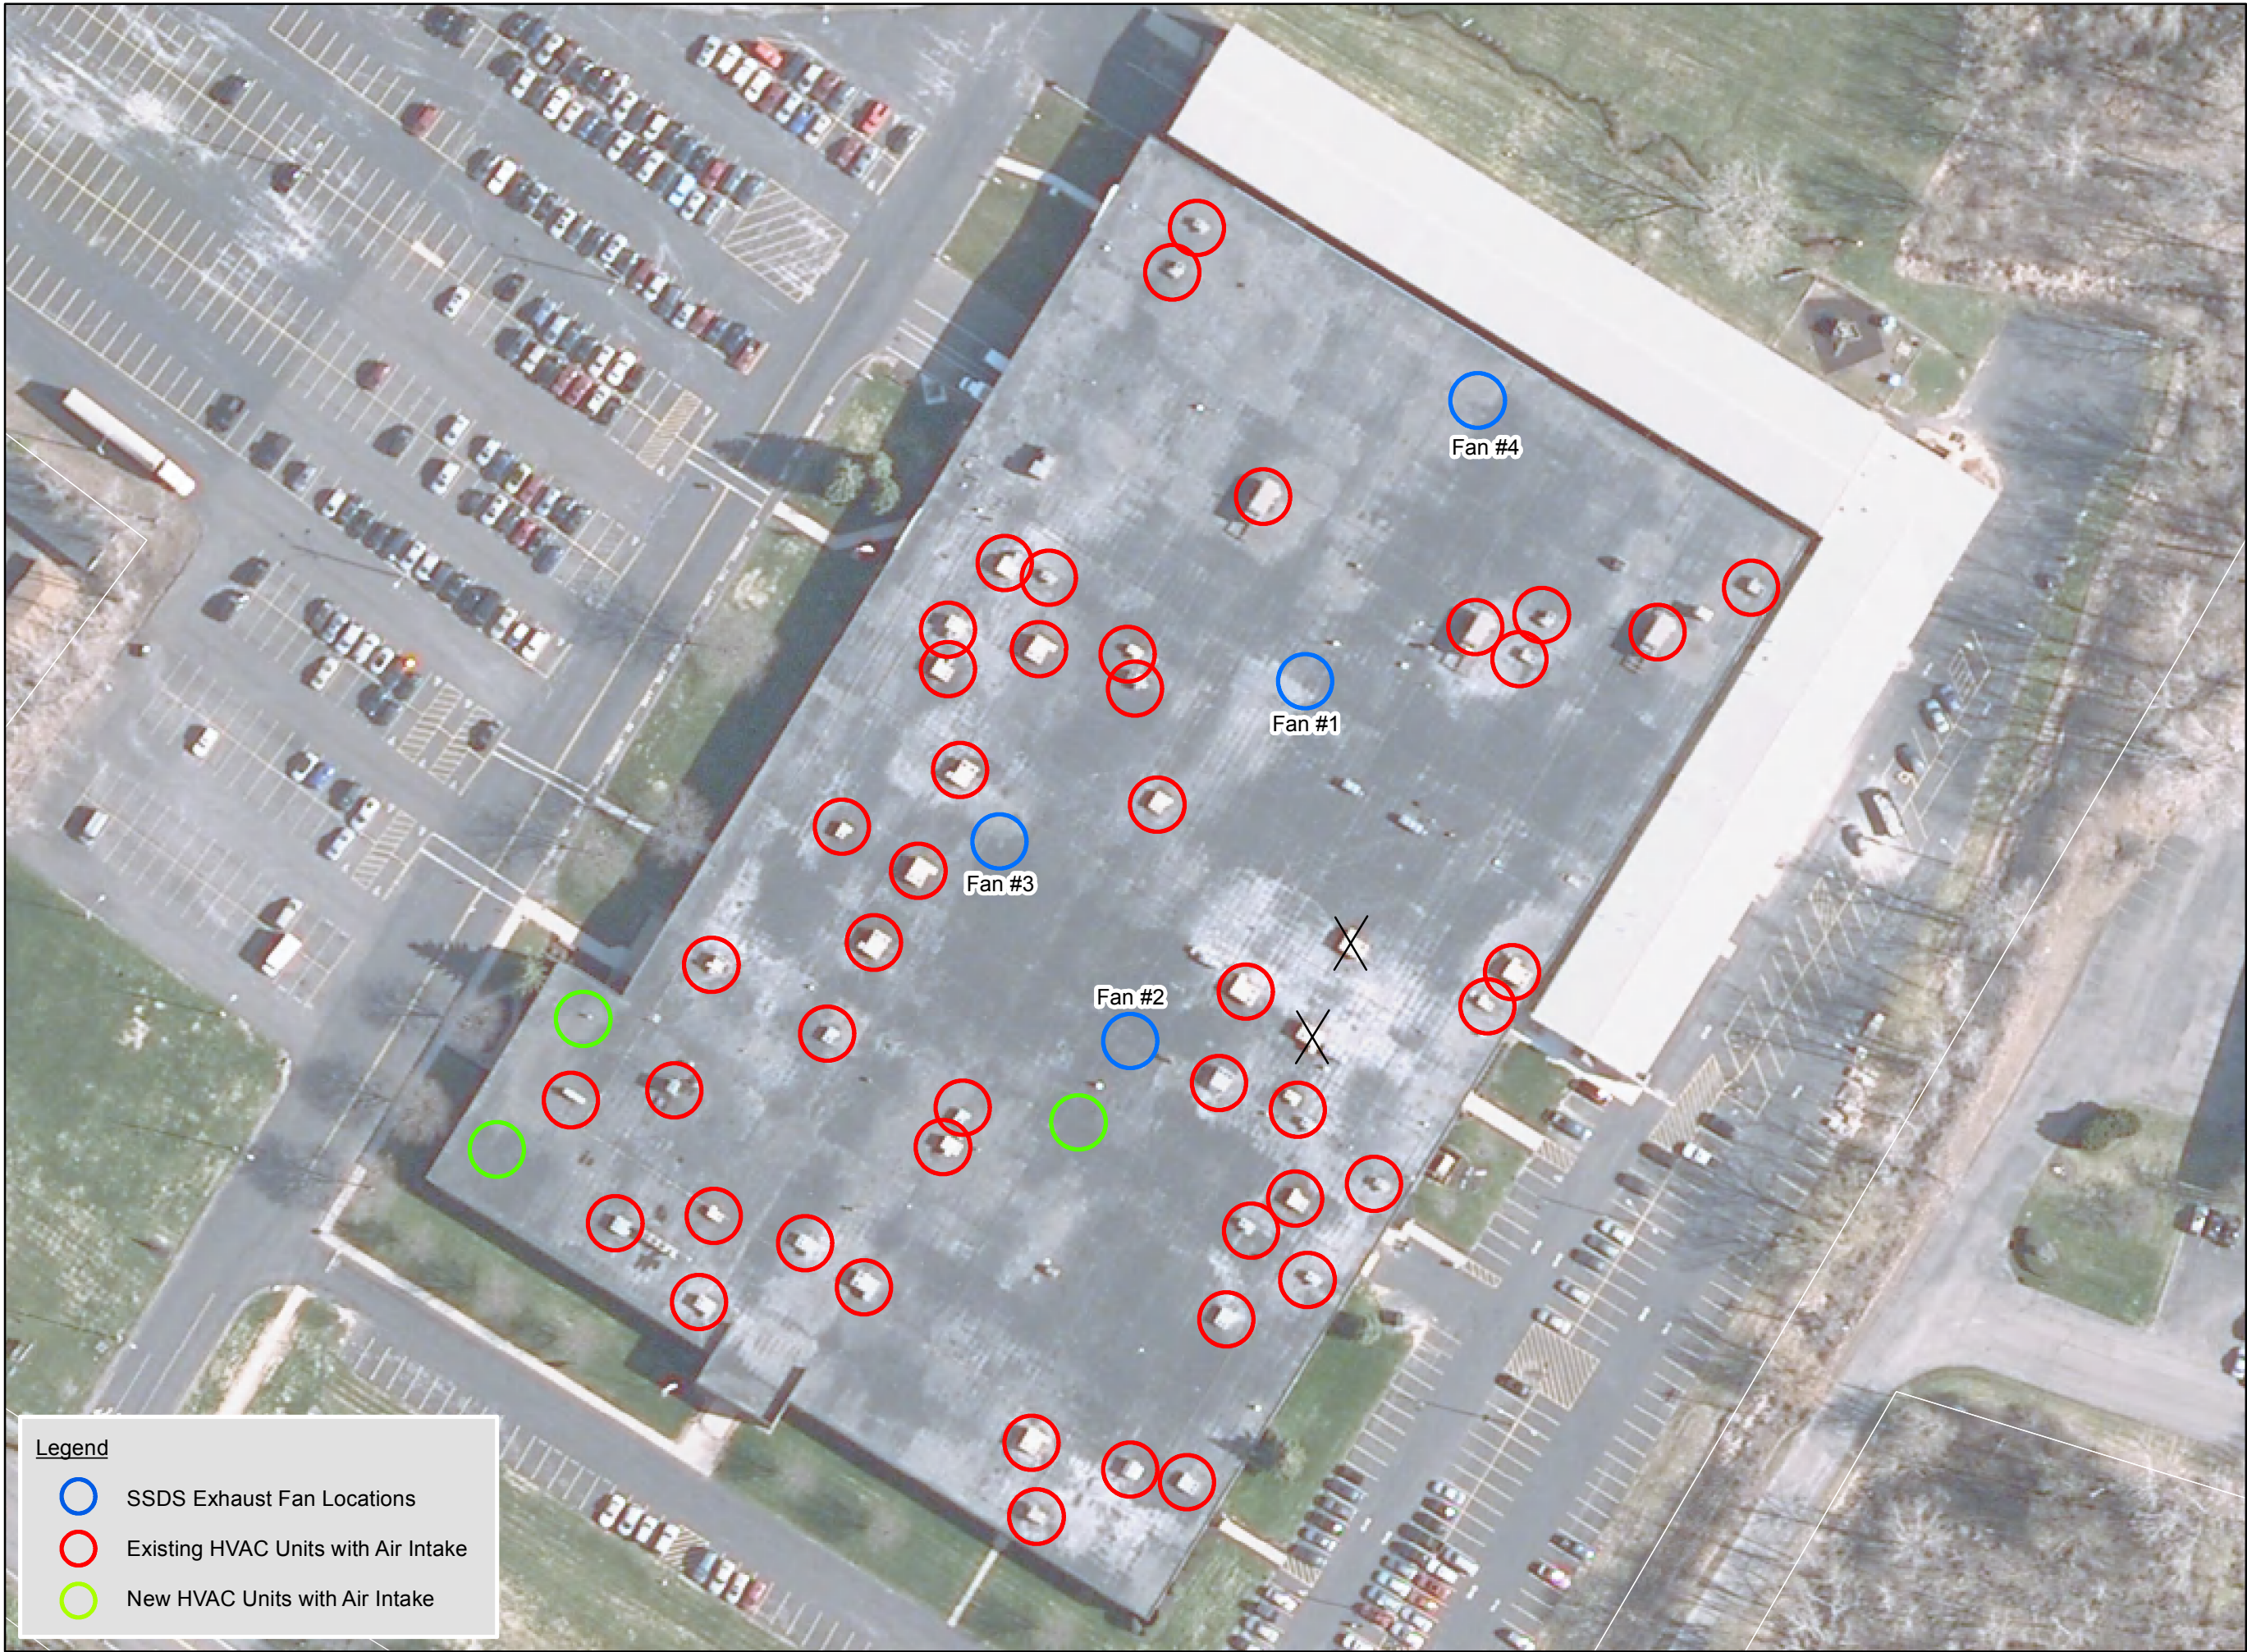
Figure 6 – Rooftop Exhaust Fans and HVAC Air Intake Locations

Information regarding the four (4) rooftop exhaust fans, including electrical information, is summarized in the attached Table 10 and the approximate locations of system components are depicted on Figure 6 and on the as-built drawings included in Appendix B.
