3750 Monroe Avenue
MONROE COUNTY
TOWN OF PITTSFORD, NEW YORK

INTERIM SITE MANAGEMENT

Sub-Slab Depressurization System

NYSDEC Site Number: C828187

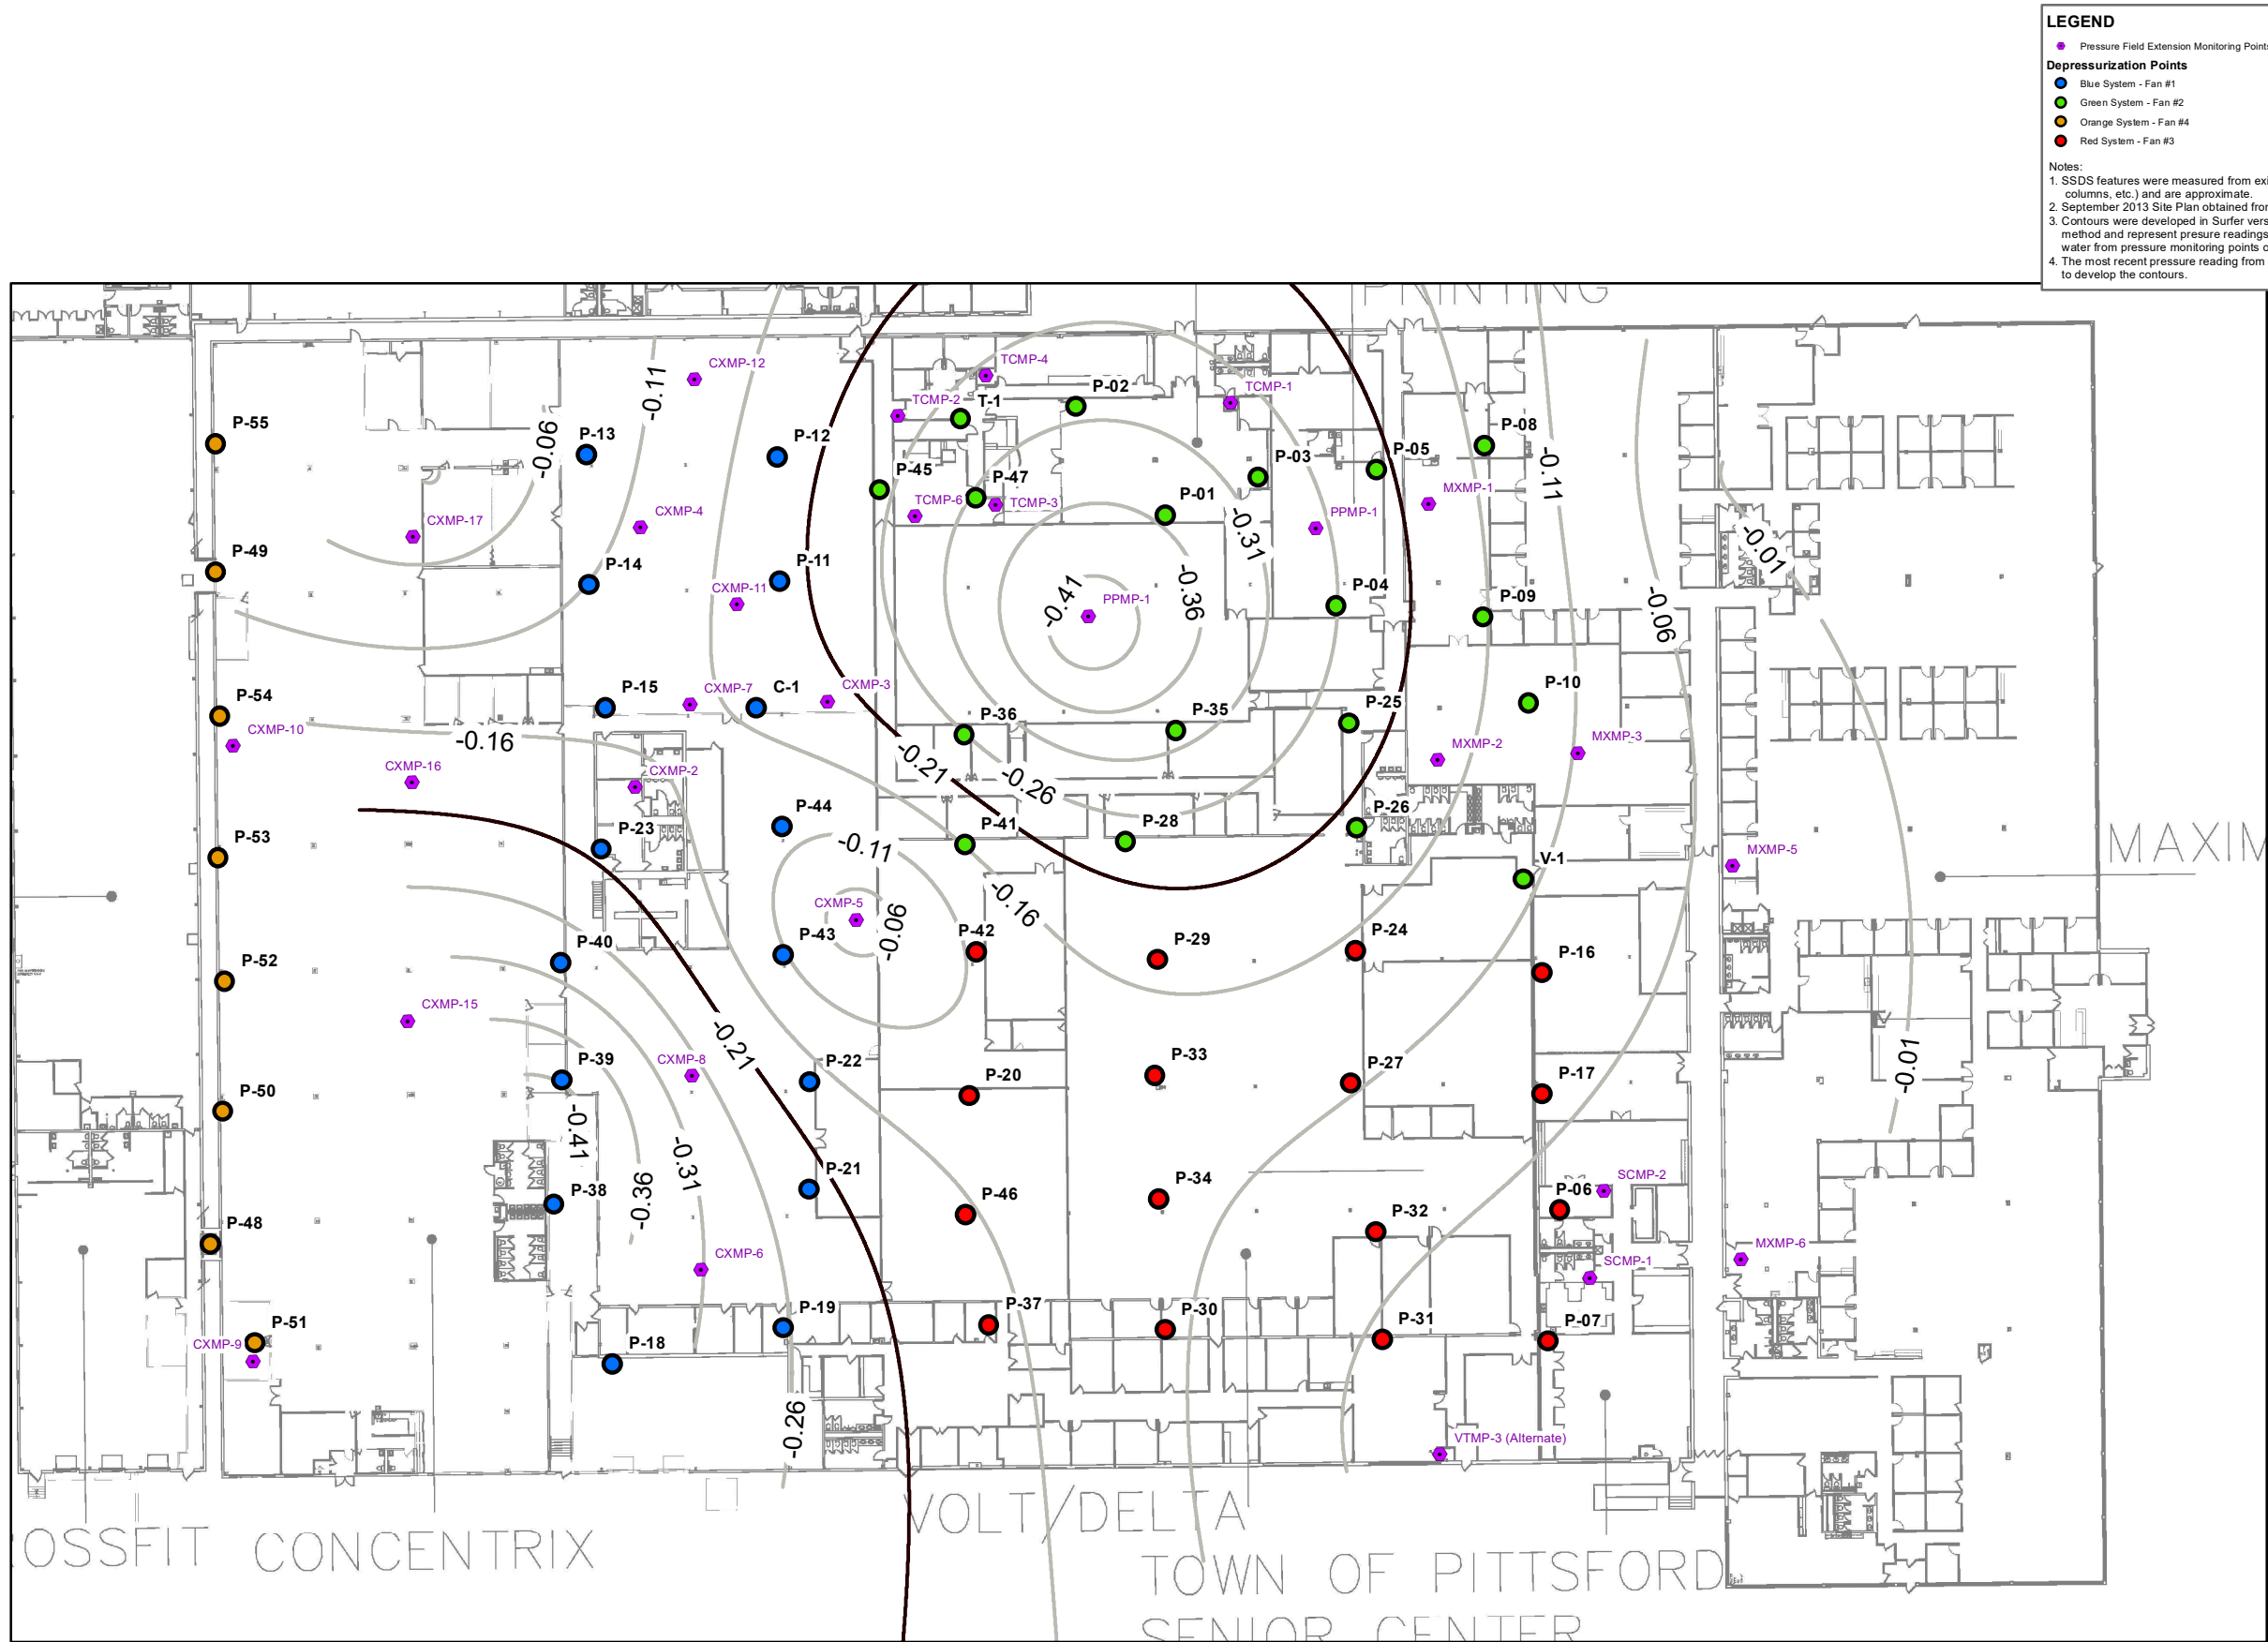
FIGURE 7

Figure 7 – Interior Layout with Sub Slab Depressurization System Pressure Field Extension Testing Radius of Influence

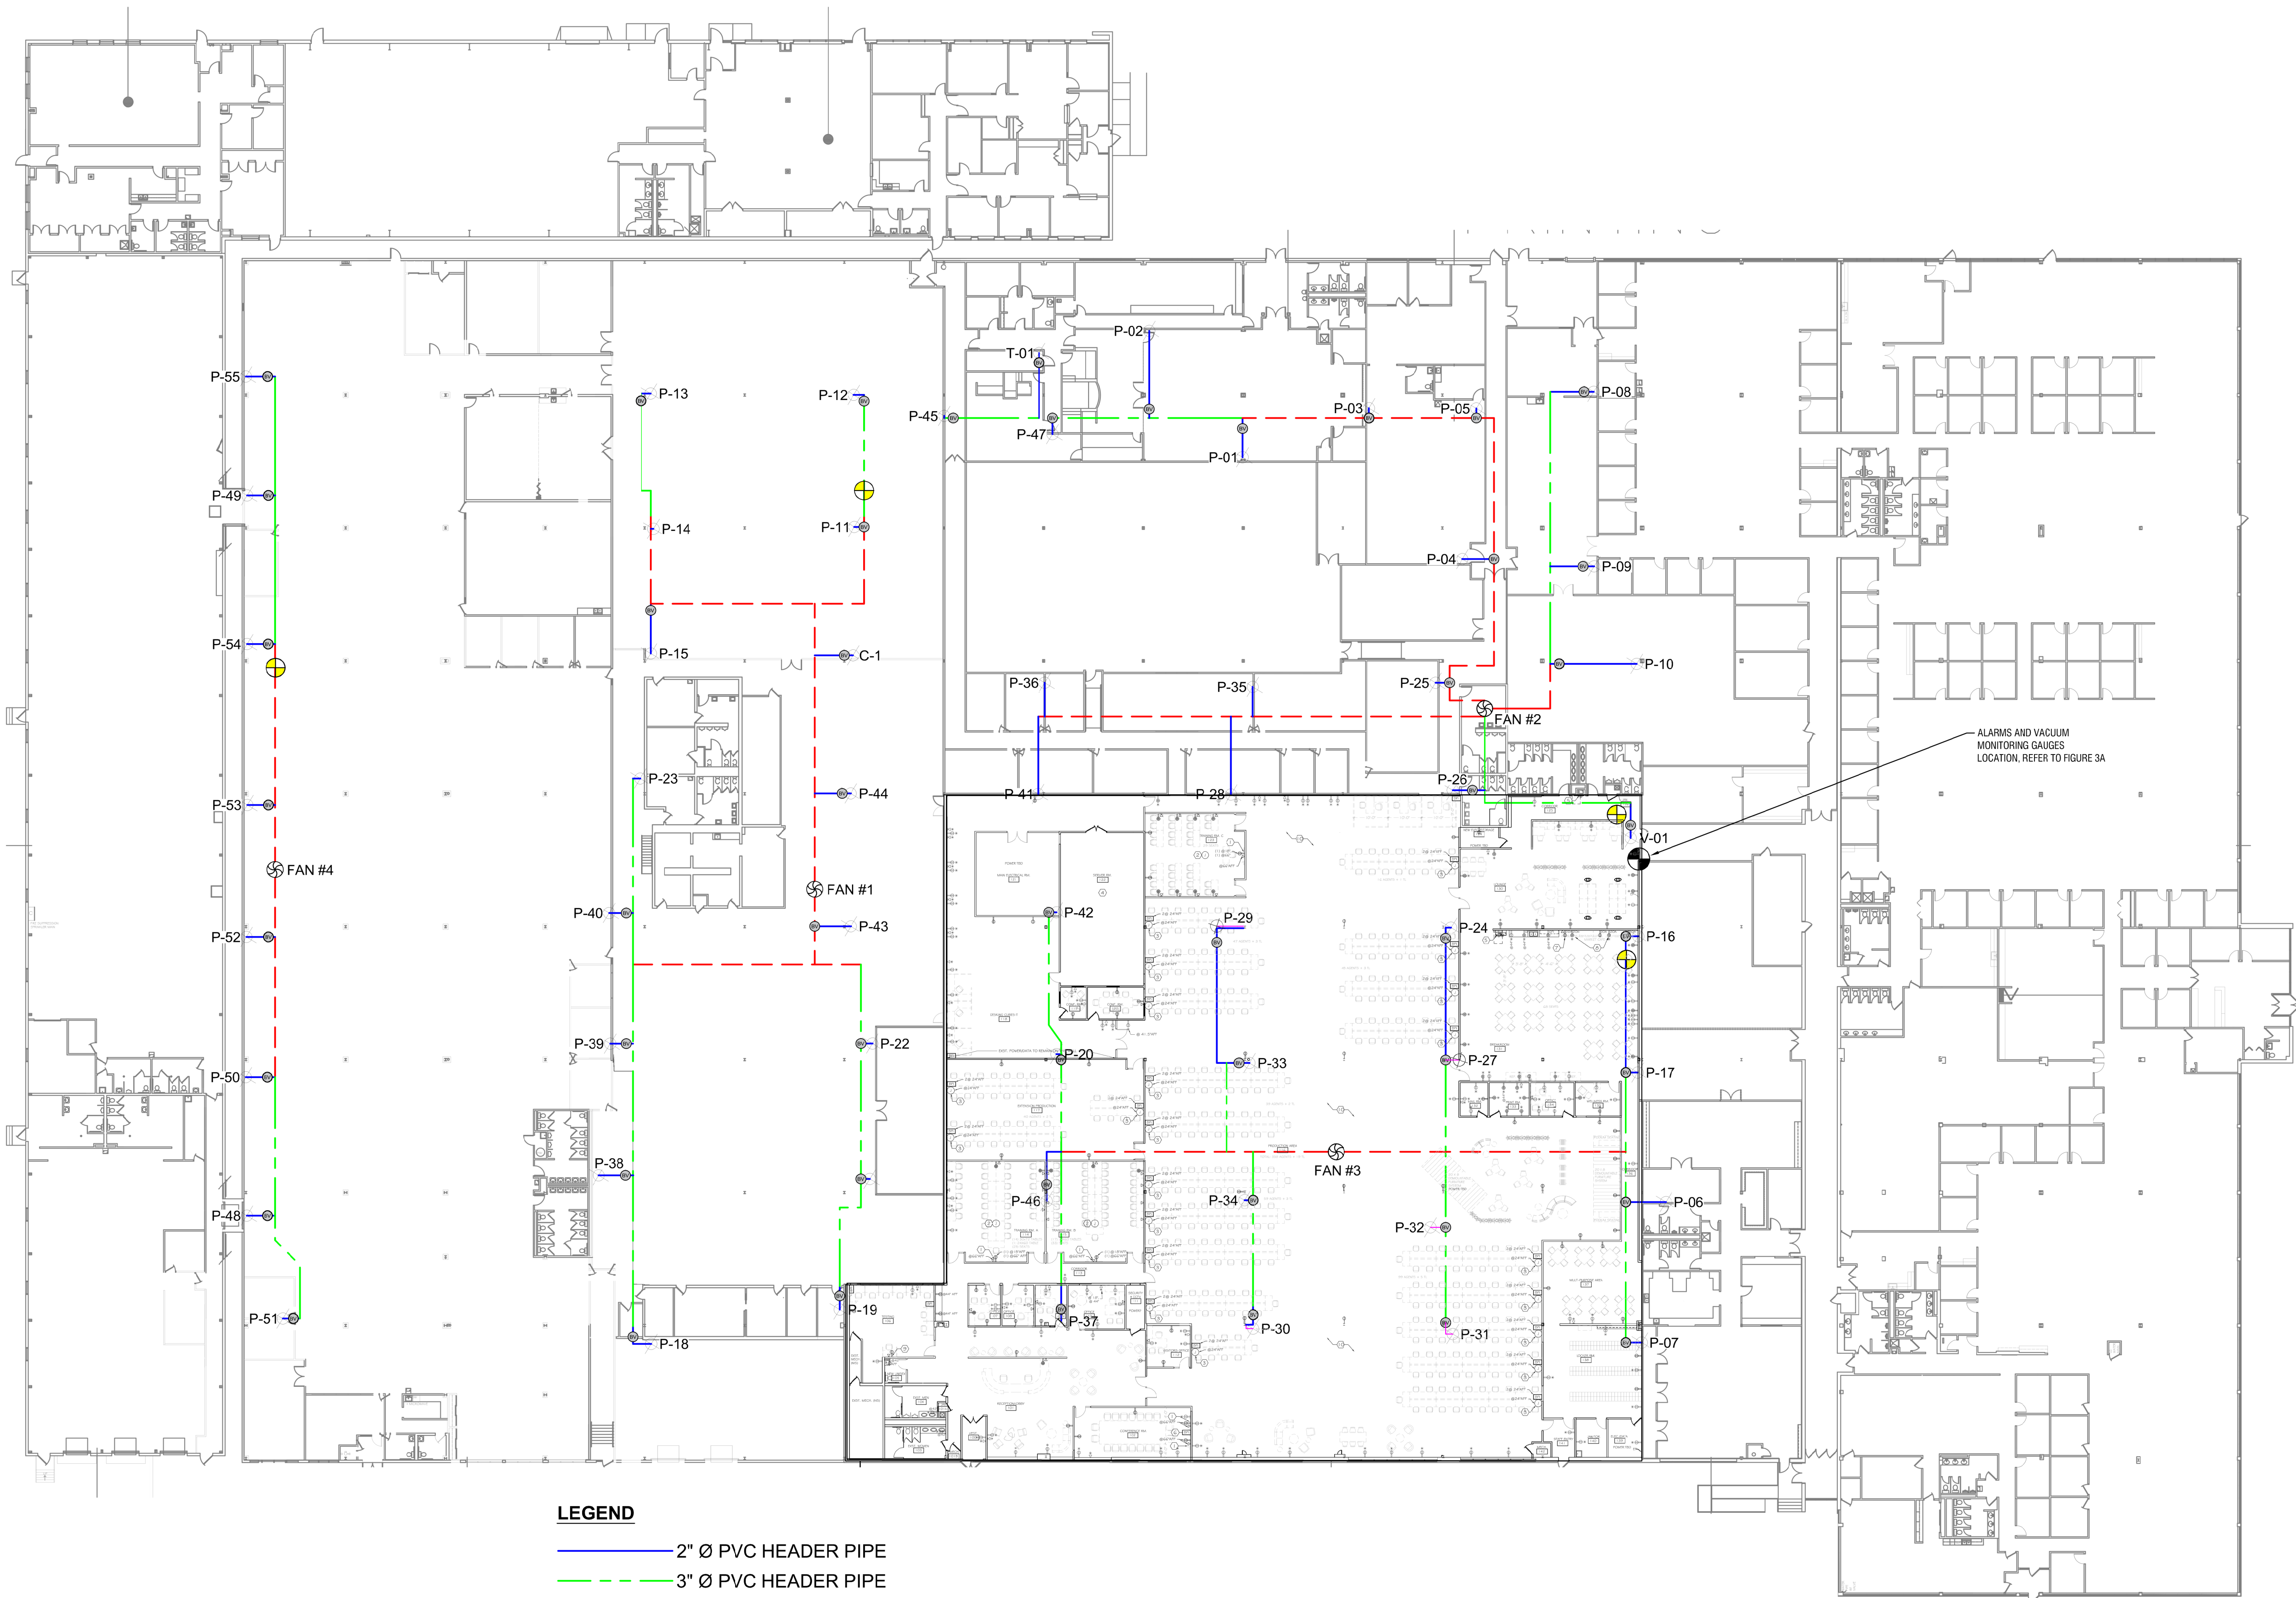
SSDS Operation and Maintenance (O&M) Manual and As-Built

- LEGEND**
- 2" Ø PVC HEADER PIPE
 - 3" Ø PVC HEADER PIPE
 - 4" Ø PVC HEADER PIPE
 - PVC PIPING IN SUBGRADE TRENCH
 - 2" PVC BALL VALVE
 - SUB-SLAB DEPRESSURIZATION FAN (LOCATED ON ROOF)
 - 2" PVC VERTICAL DEPRESSURIZATION POINTS
 - SSDS ALARM/GAUGE PANEL
 - SSDS ALARM VACUUM TUBING CONNECTION

The approximate locations of the 58 SSDS depressurization points are summarized in the attached Table 9 and depicted on the as-built drawings included in Appendix B. As anticipated, due to building conditions, tenant requirements, and vacuum requirements, the installed locations of some SSDS depressurization points varied slightly from the locations proposed in the IRM WP and the IRM WP Amendment dated August 7, 2015. However, the final locations of the SSDS components have still resulted in mitigation of IAQ impacts within the Site building.

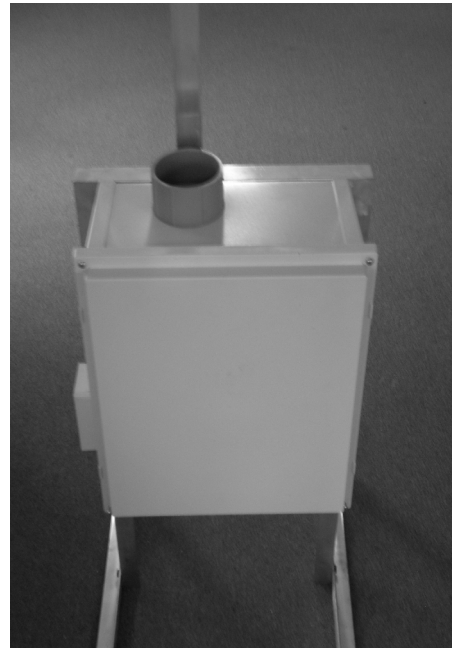
GBR89 WITH ROOF MOUNT

- GBR89 HA 14" WC at 100CFM max flow 500 CFM.
- Built in speed control to customize performance.
- Condensate bypass built in.
- 12 month warranty 40,000 hr sealed bearings.

- Our modular design means the blower and manifold assembly can be removed and replaced as a unit. This makes repairs cost effective and easy and allows contractors to upgrade systems simply by swapping assemblies.
- The GBR series is based on a bypass blower designed to handle combustible materials.
- The housing is not required to be air tight so you can add gauges and alarms without compromising the system.
- Built in condensate bypass.
- Built in speed control.
- Quick disconnect electrical harness.
- All UL listed components including UL listed enclosure for outside use.
- Wall fastening lugs included.
- GBR series roof and wall mounts available to quickly configure the blowers for your installation while providing a custom built look.
- Compact design 18"x 16"x 10" weighing only 18 lbs.
- 4" schedule 40 inlet and 6" schedule 40 exhaust.

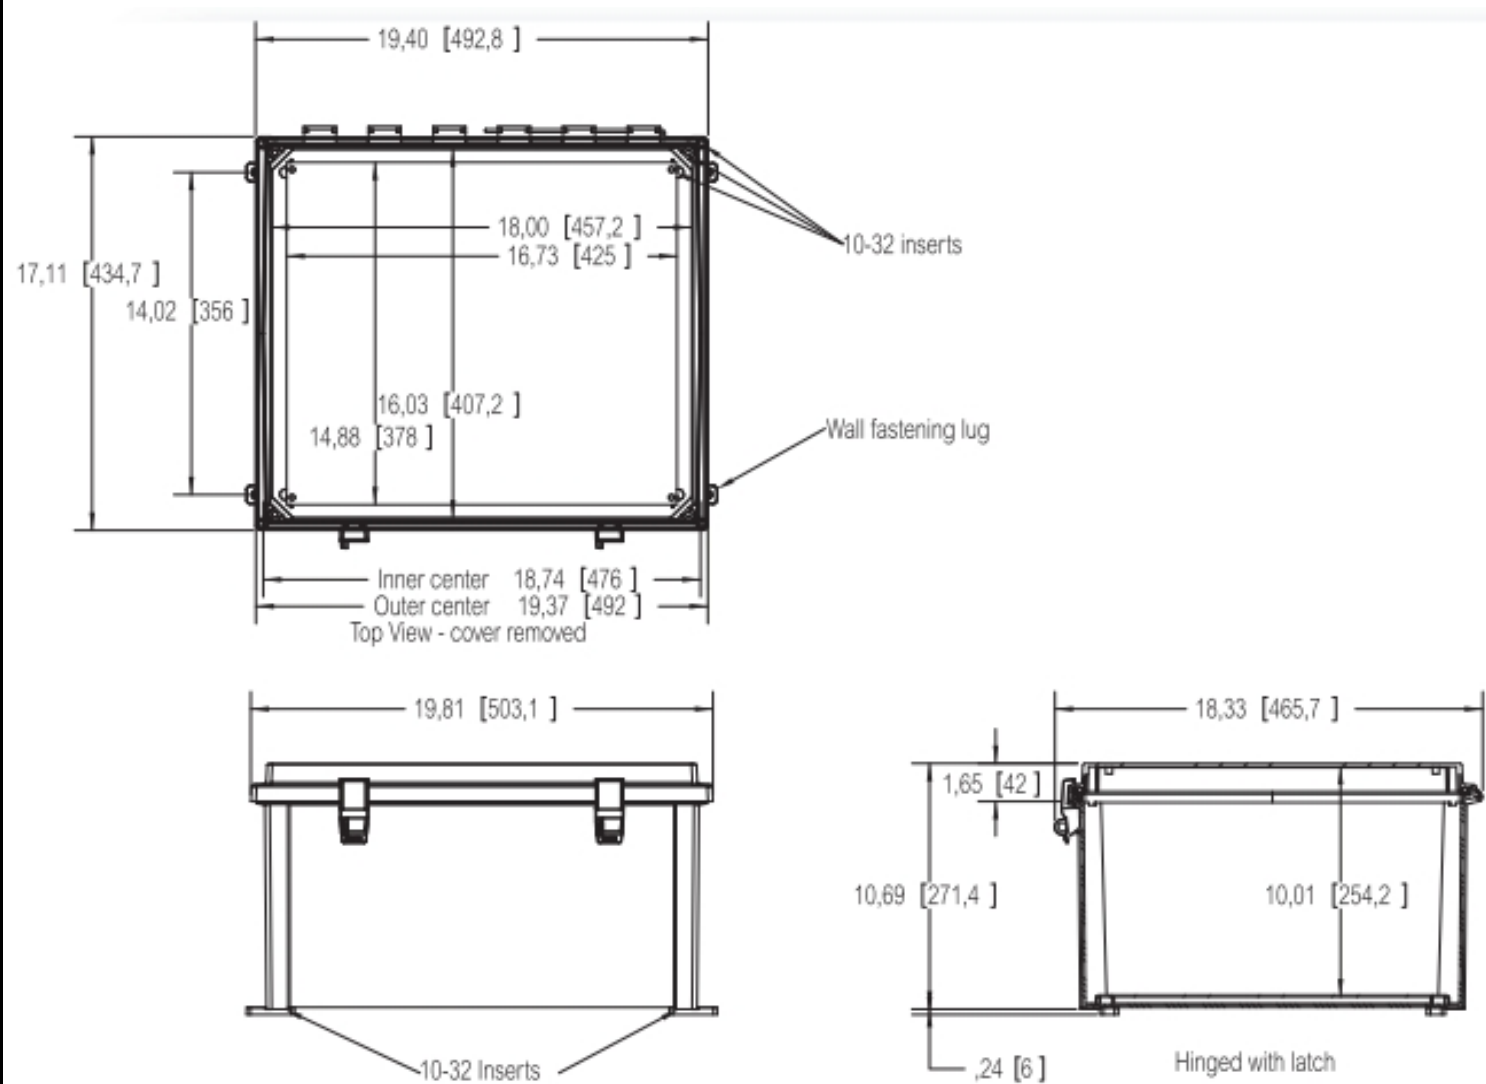
High Voltage Brushless DC Blowers

Nautilair (TM) 8.9" (226mm) Variable Speed Blower

240 Volt AC Input, Single Phase, High Output

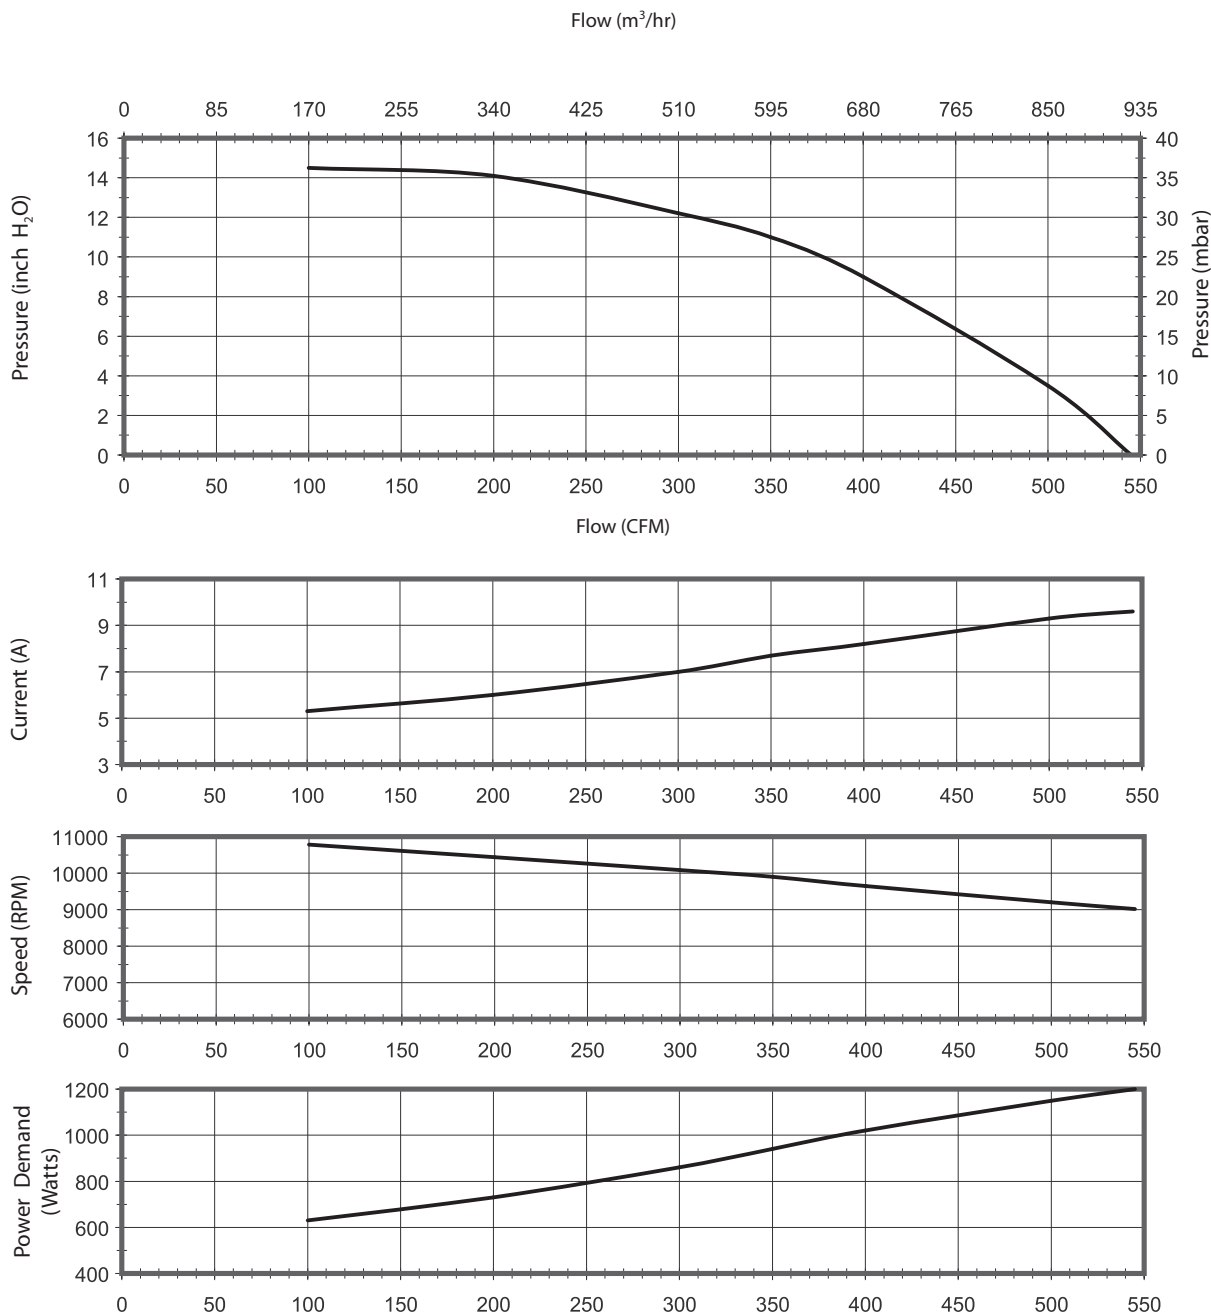
Typical Performance

Data presented represents blower performance at STANDARD AIR DENSITY, .075 lb/ft³ (29.92" Hg, Sea Level, 68° F)
Vacuum performance available upon request.

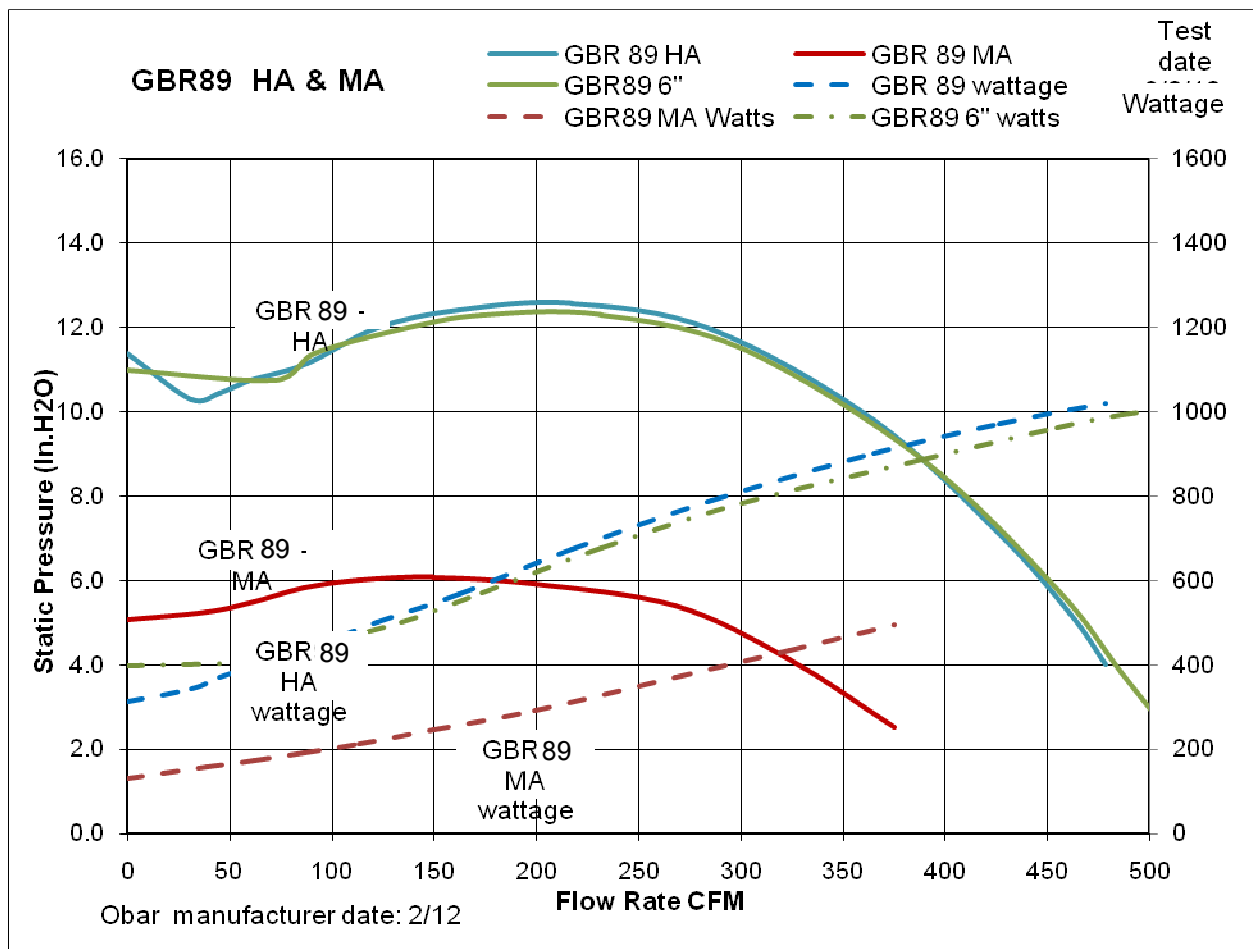
Maximum airflow with no exhaust piping and 8' of 6" piping is 529 CFM

GBR89 MA tested with speed control set to half the wattage consumption (Red Line)

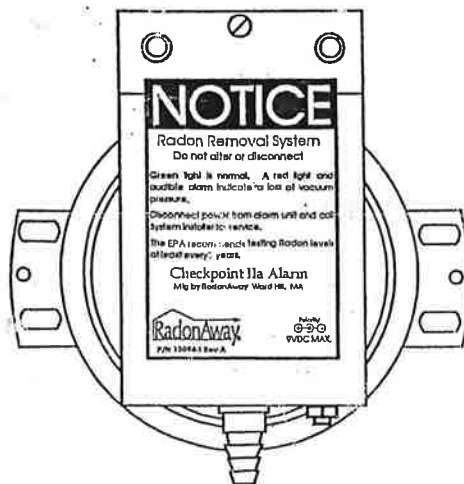
Drill a 5/16" hole into the side of the vent pipe about 6" higher than the top of the unit.

Insert the vinyl tubing provided about 1" inside the suction pipe.

Cut a suitable length of vinyl tubing and attach it to the pressure switch connector on the CHECKPOINT IIa.

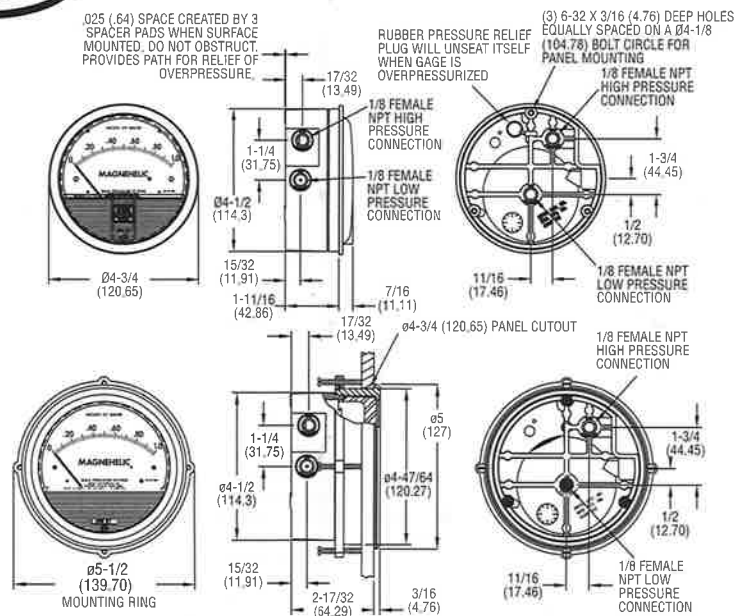
Magnehelic® Differential Pressure Gage

*The blowout plug is not used on models above 180 inches of water pressure, medium or high pressure models, or on gages which require an elastomer other than silicone for the diaphragm.

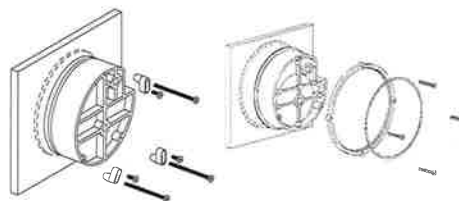
FLUSH MOUNTING

Provide a 4-9/16" dia. (116 mm) opening in panel. Provide a 4-3/4" dia. (120 mm) opening for MP and HP models. Insert gage and secure in place with No. 6-32 machine screws of appropriate length, with adapters, firmly secured in place.

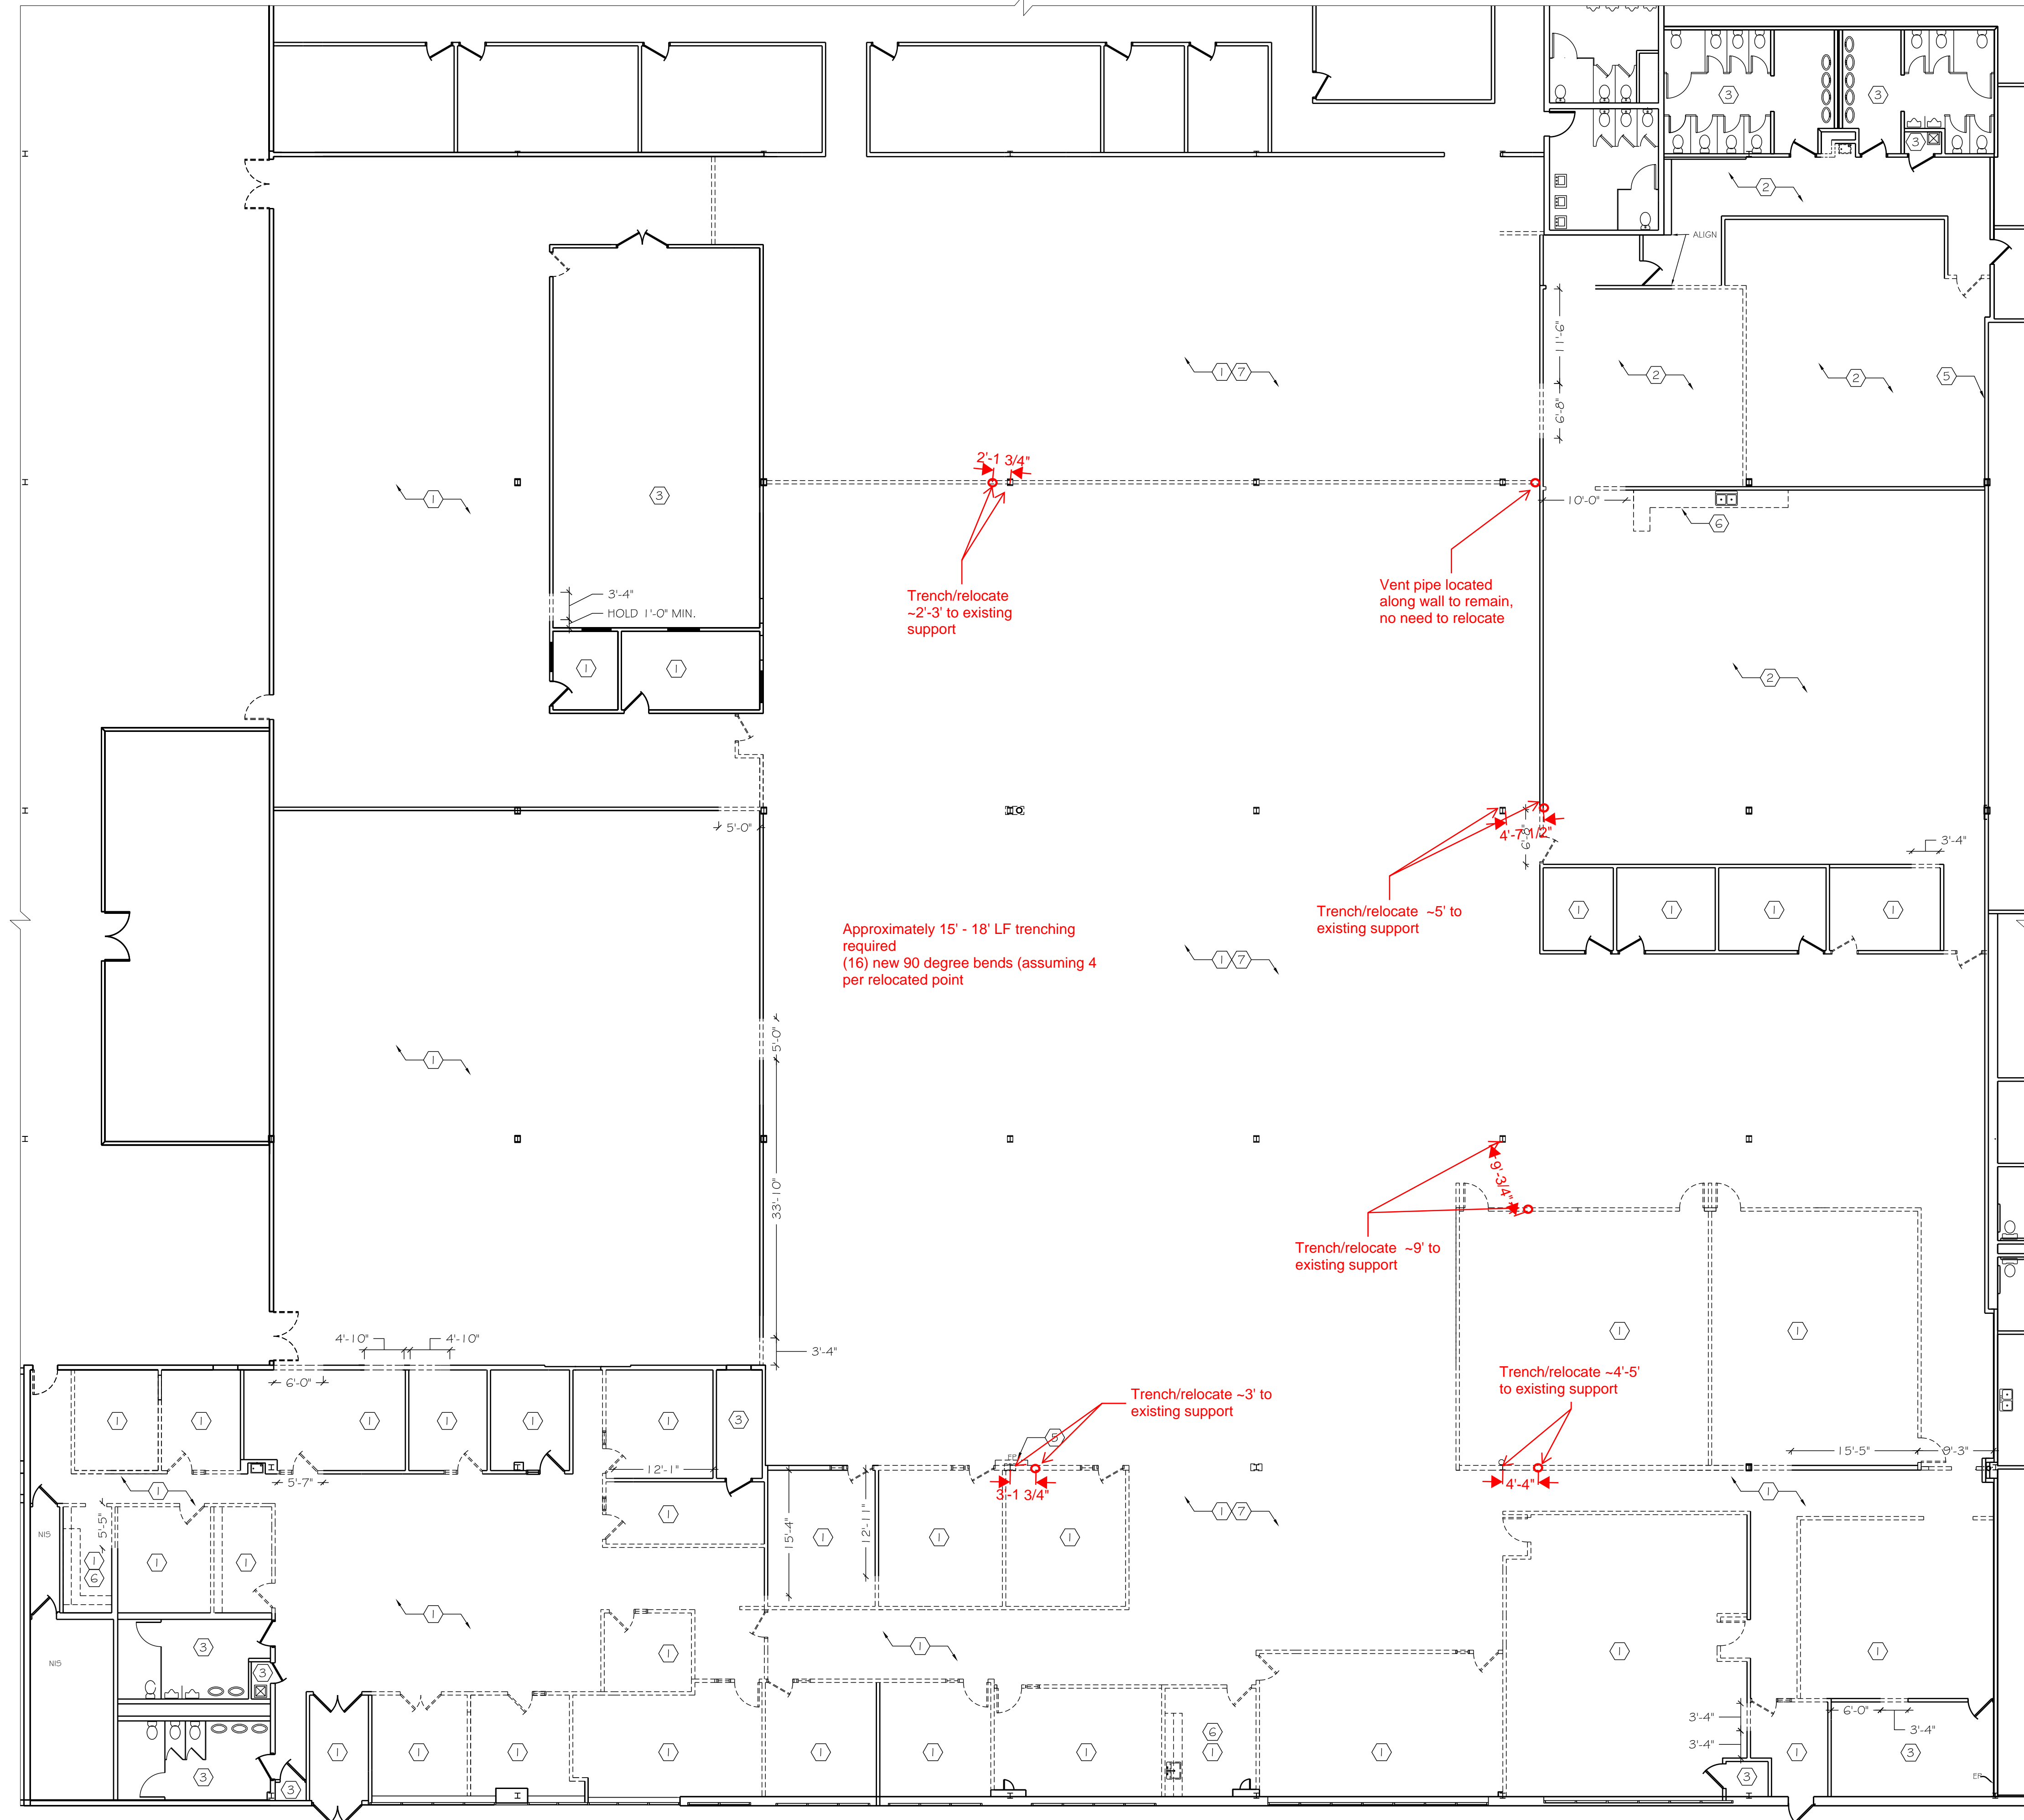
DEMOLITION FLOOR PLAN

- ① REMOVE EXISTING CARPET AND PREPARE FOR NEW FLOOR FINISH
- ② EXISTING FLOOR TO REMAIN; PREPARE FOR NEW FLOORING TO BE INSTALLED OVER EXISTING FLOOR
- ③ EXISTING FLOOR TO REMAIN
- ④ NOT USED
- ⑤ RELOCATE EXISTING ELECTRICAL PANEL
- ⑥ REMOVE EXISTING MILLWORK, COUNTERTOP, REUSE EXISTING CABINETRY.
- ⑦ REMOVE DRYWALL ON COLUMNS TO EXPOSE I-BEAM
