# 2016 Periodic Review Report

## Reporting Period: 12/11/2015 to 03/31/2017

### NYSDEC BCP Site No. C828189

Former Michelsen Furniture Co. Site  
182 Avenue D and 374 Conkey Avenue  
City of Rochester, New York

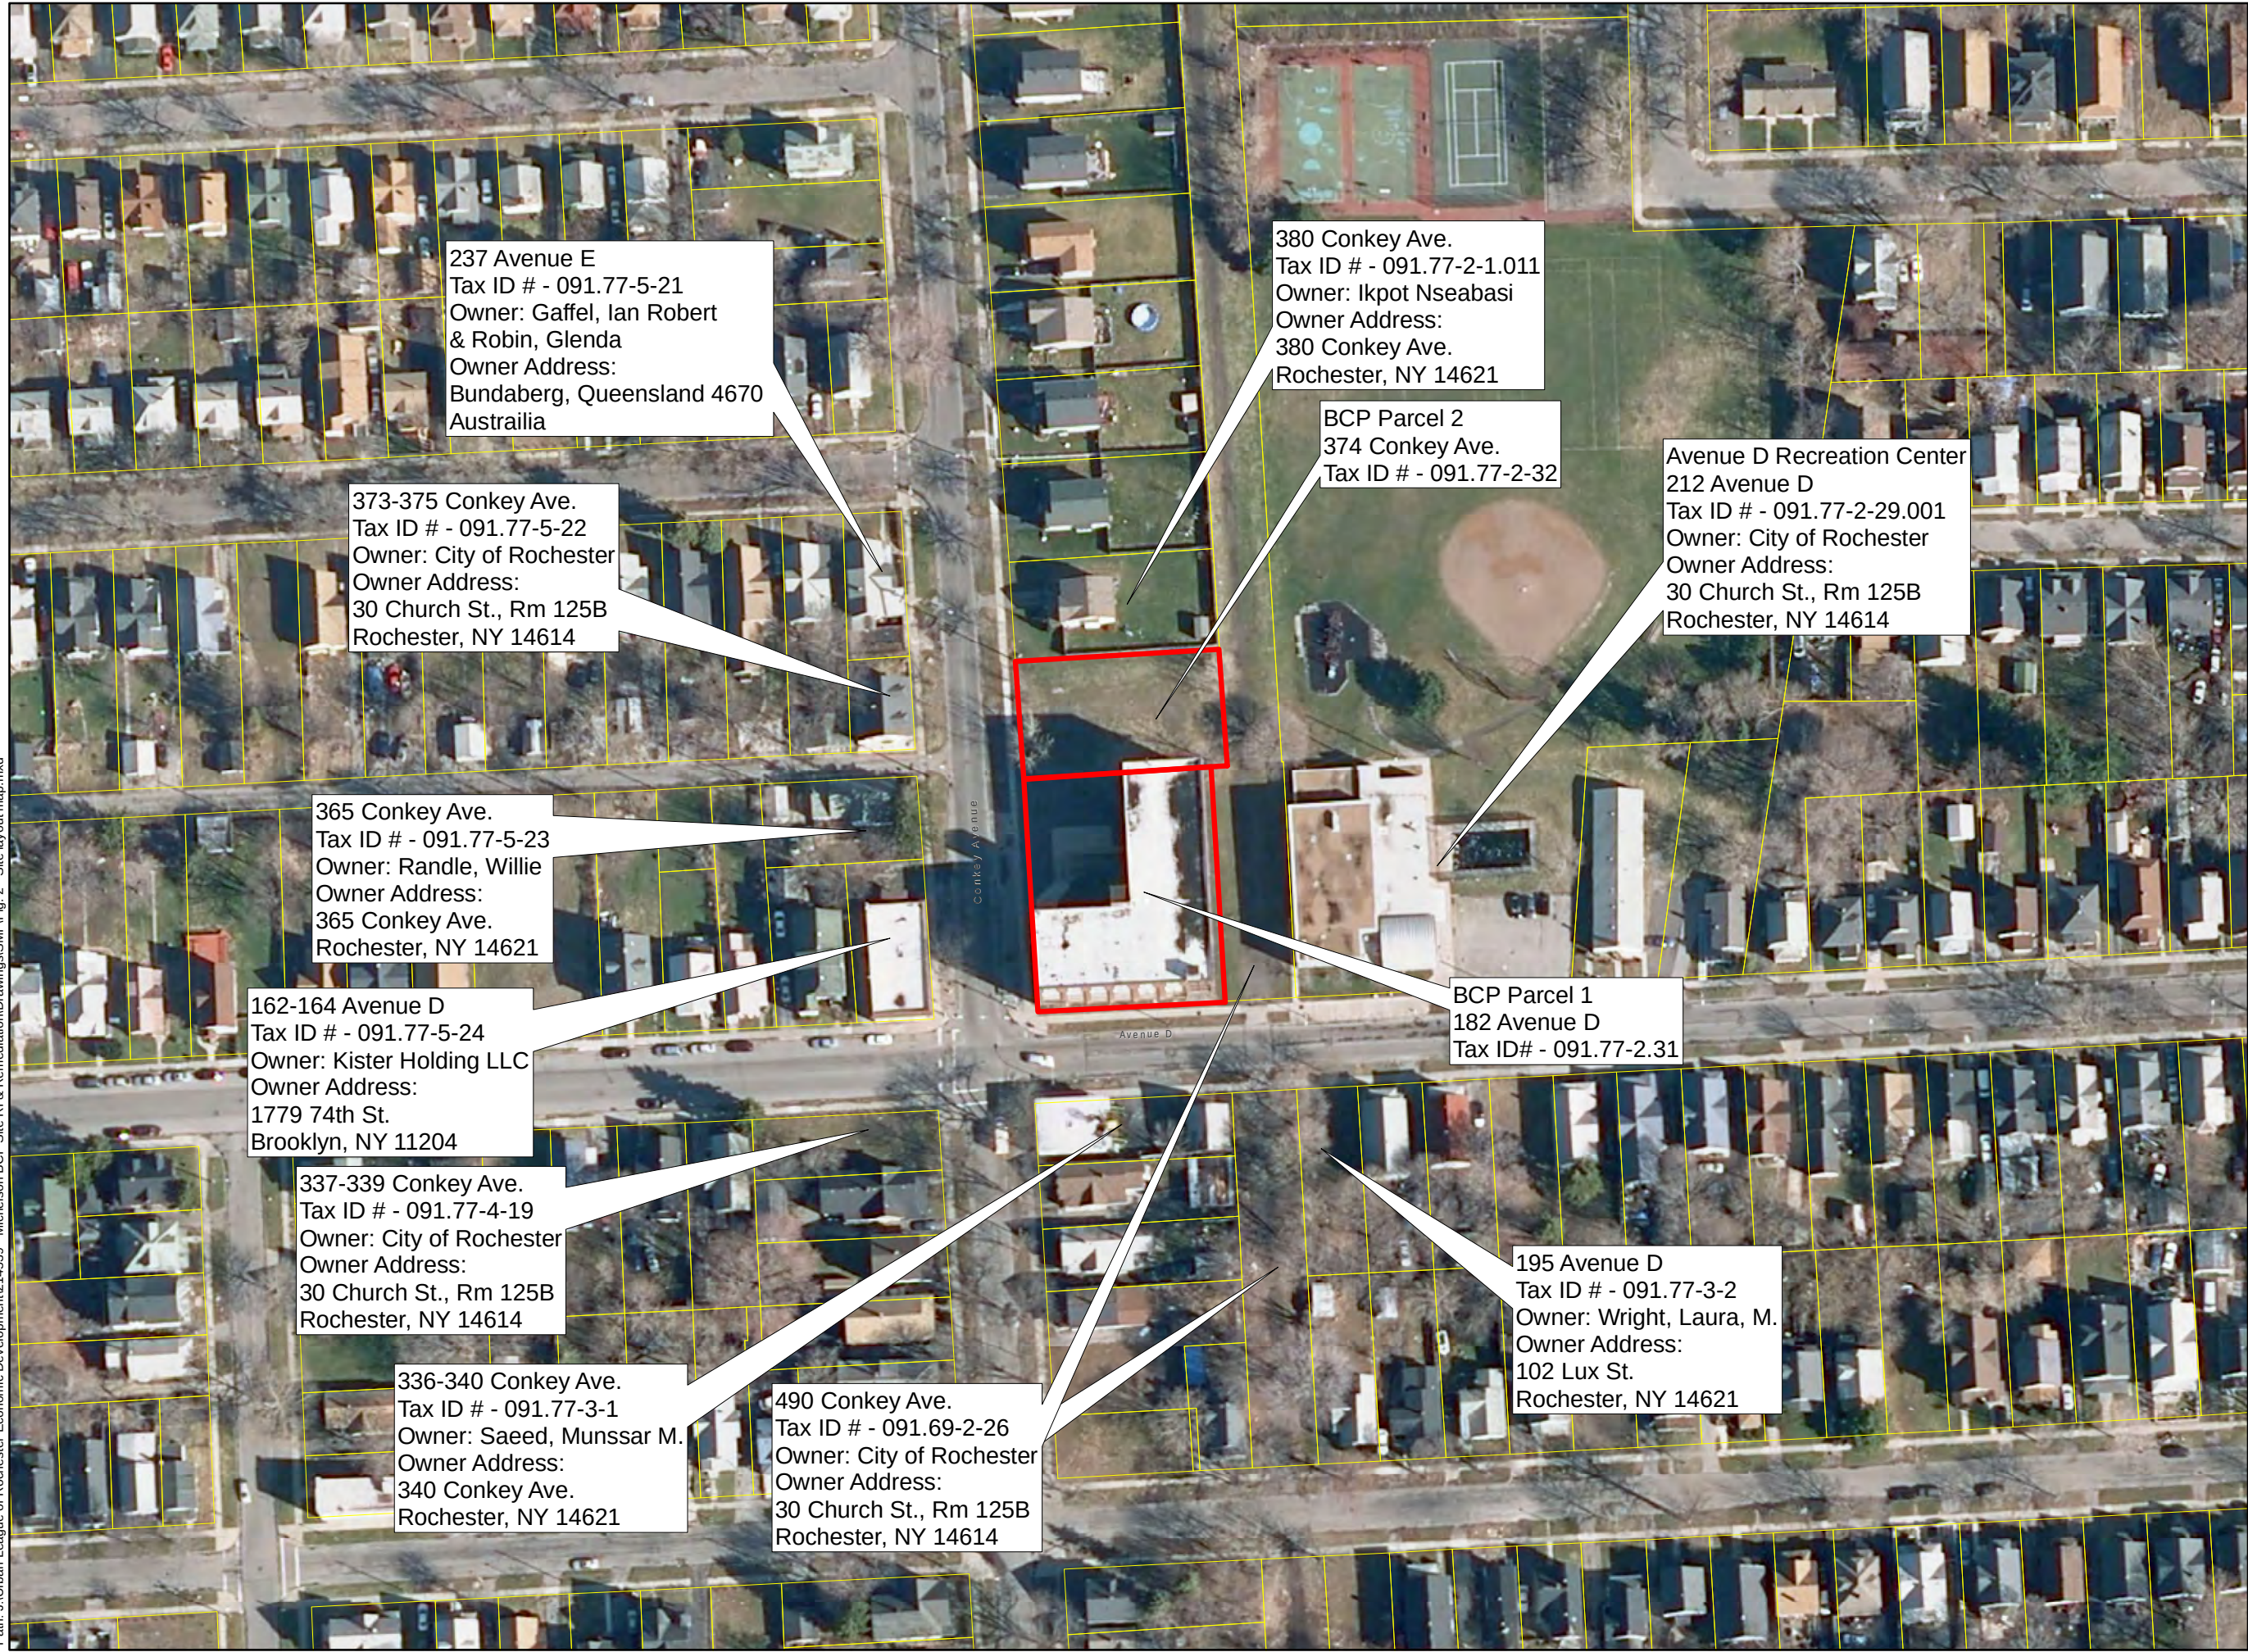
[ 2161282 ]  
[ Figure 2 ]

A Site Plan (included as Figure 2), illustrates the Site boundaries and the adjacent properties.

Title:  
Adjacent Property Information

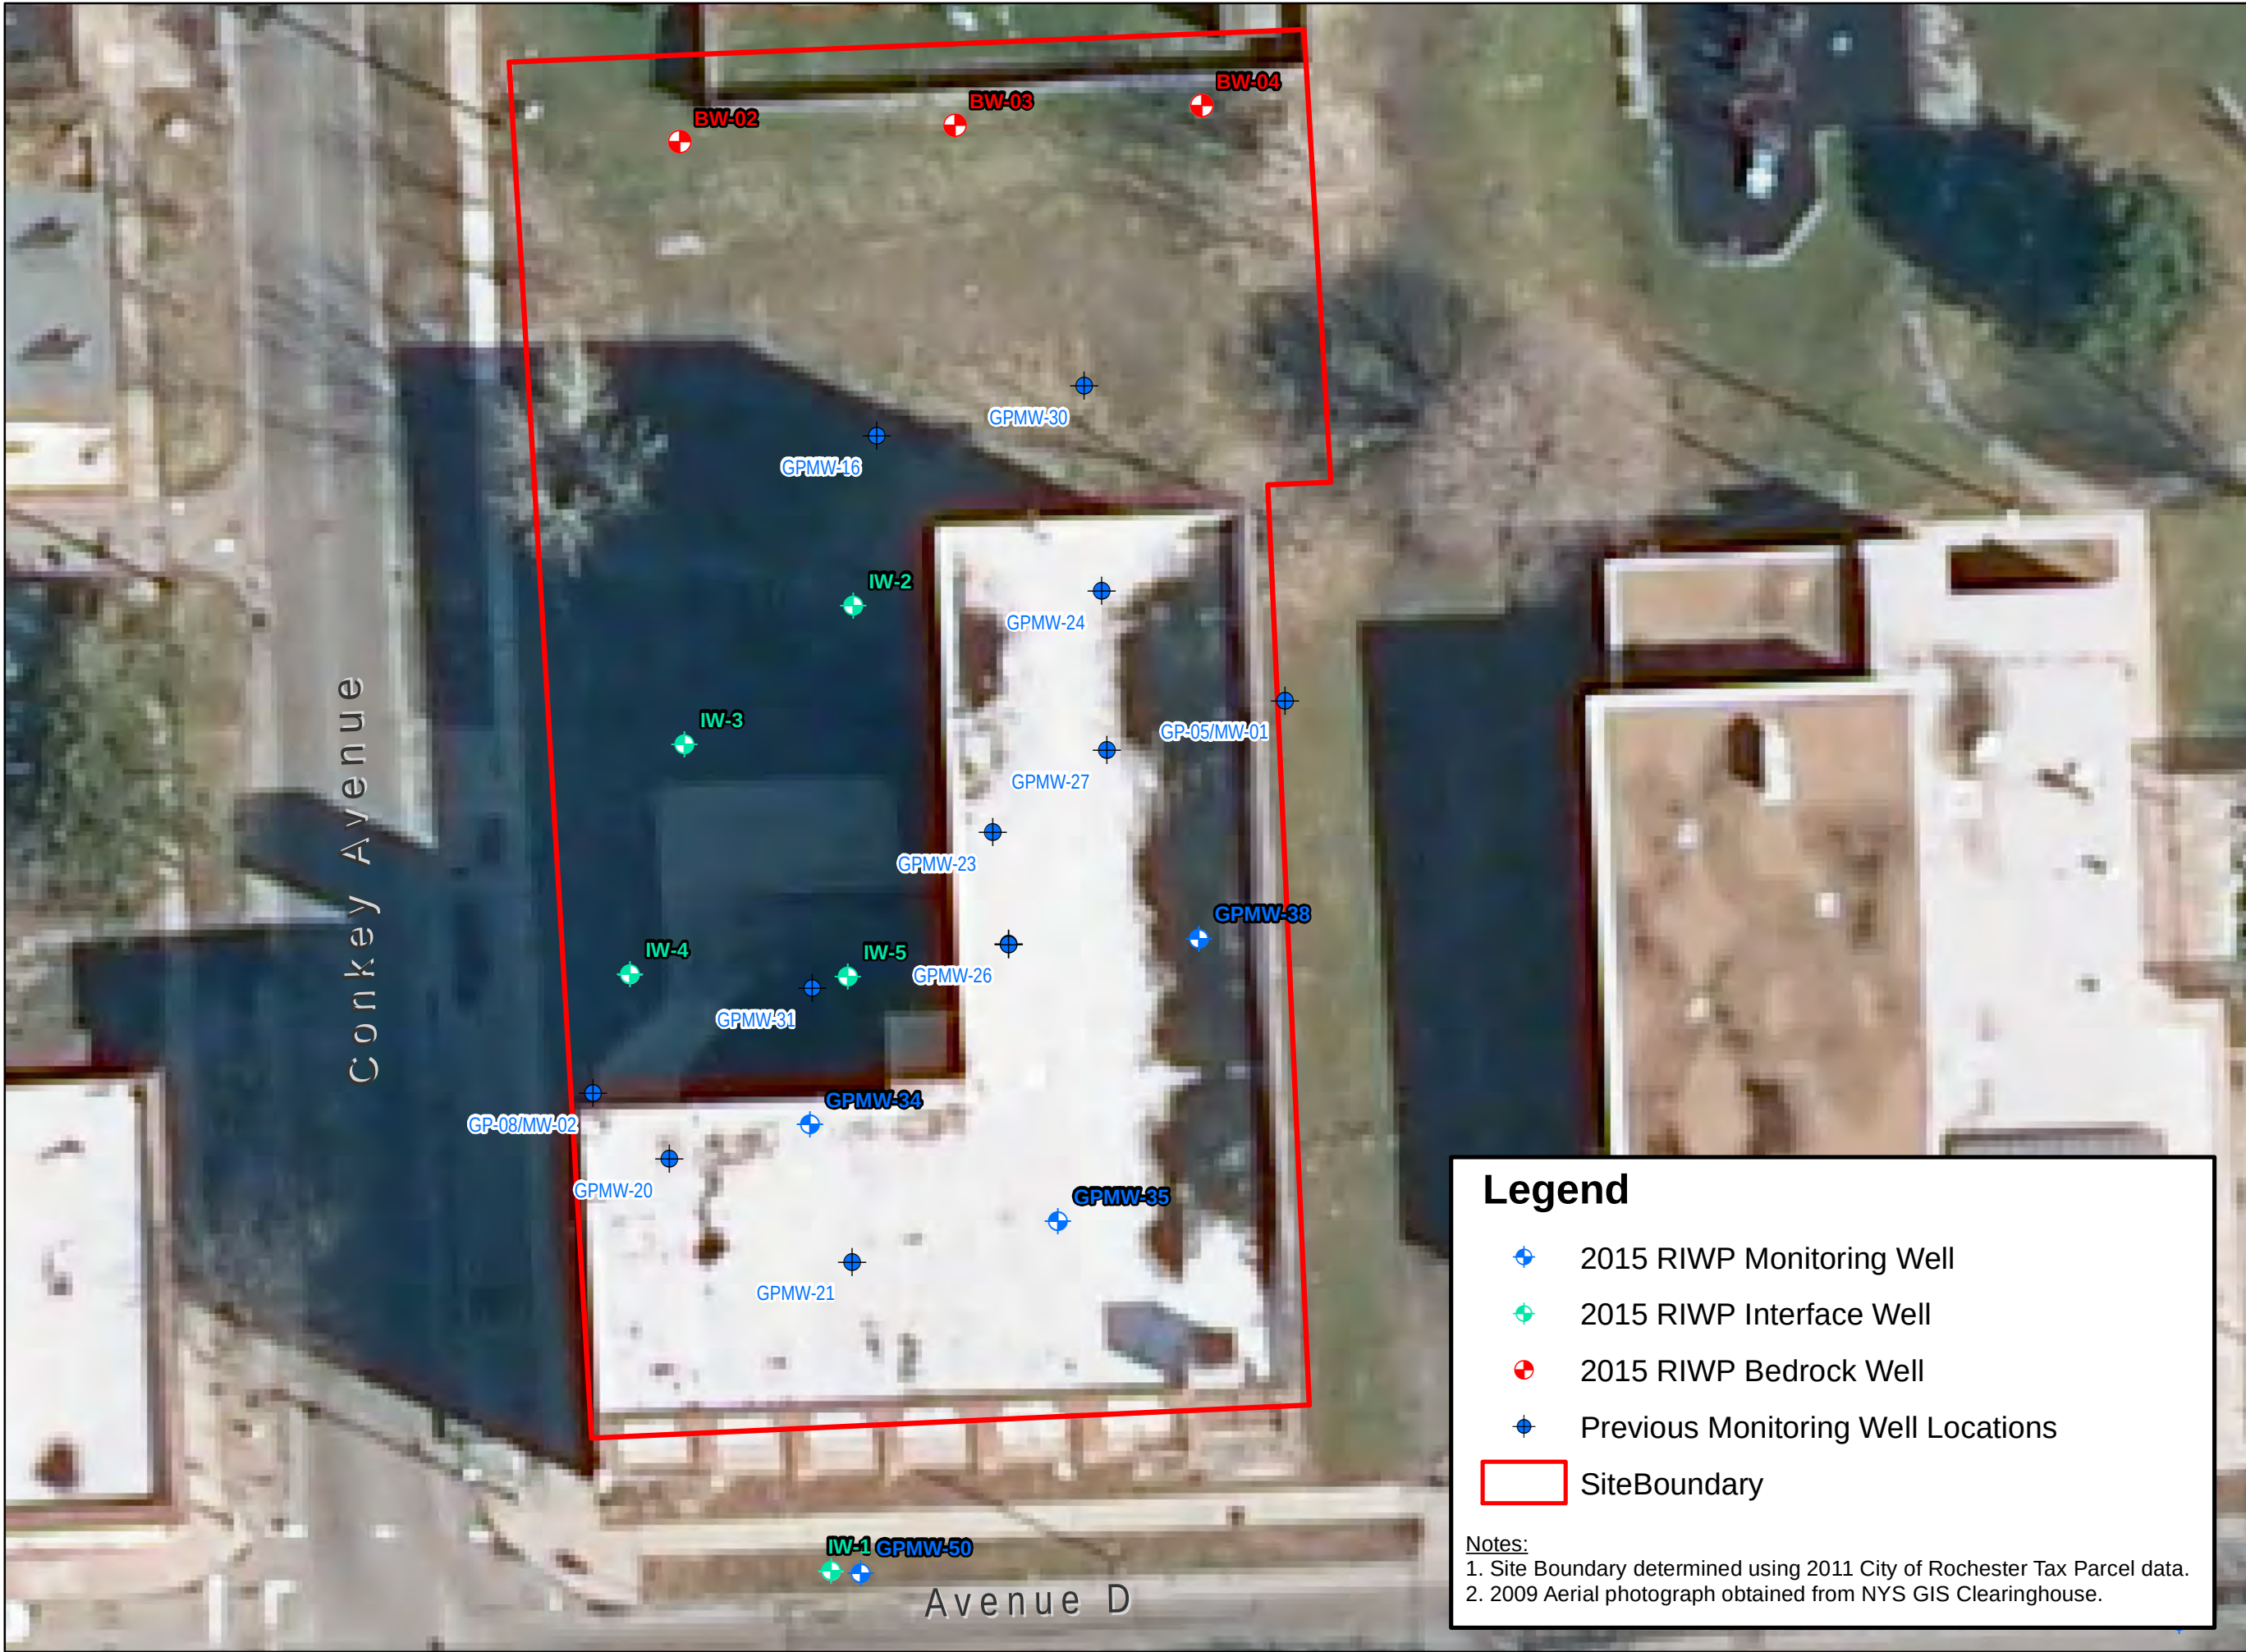
[ Figure 3 ]

| <b>Figure 3</b> | Annual Sampling Locations |

Title:  
Groundwater Monitoring  
Locations

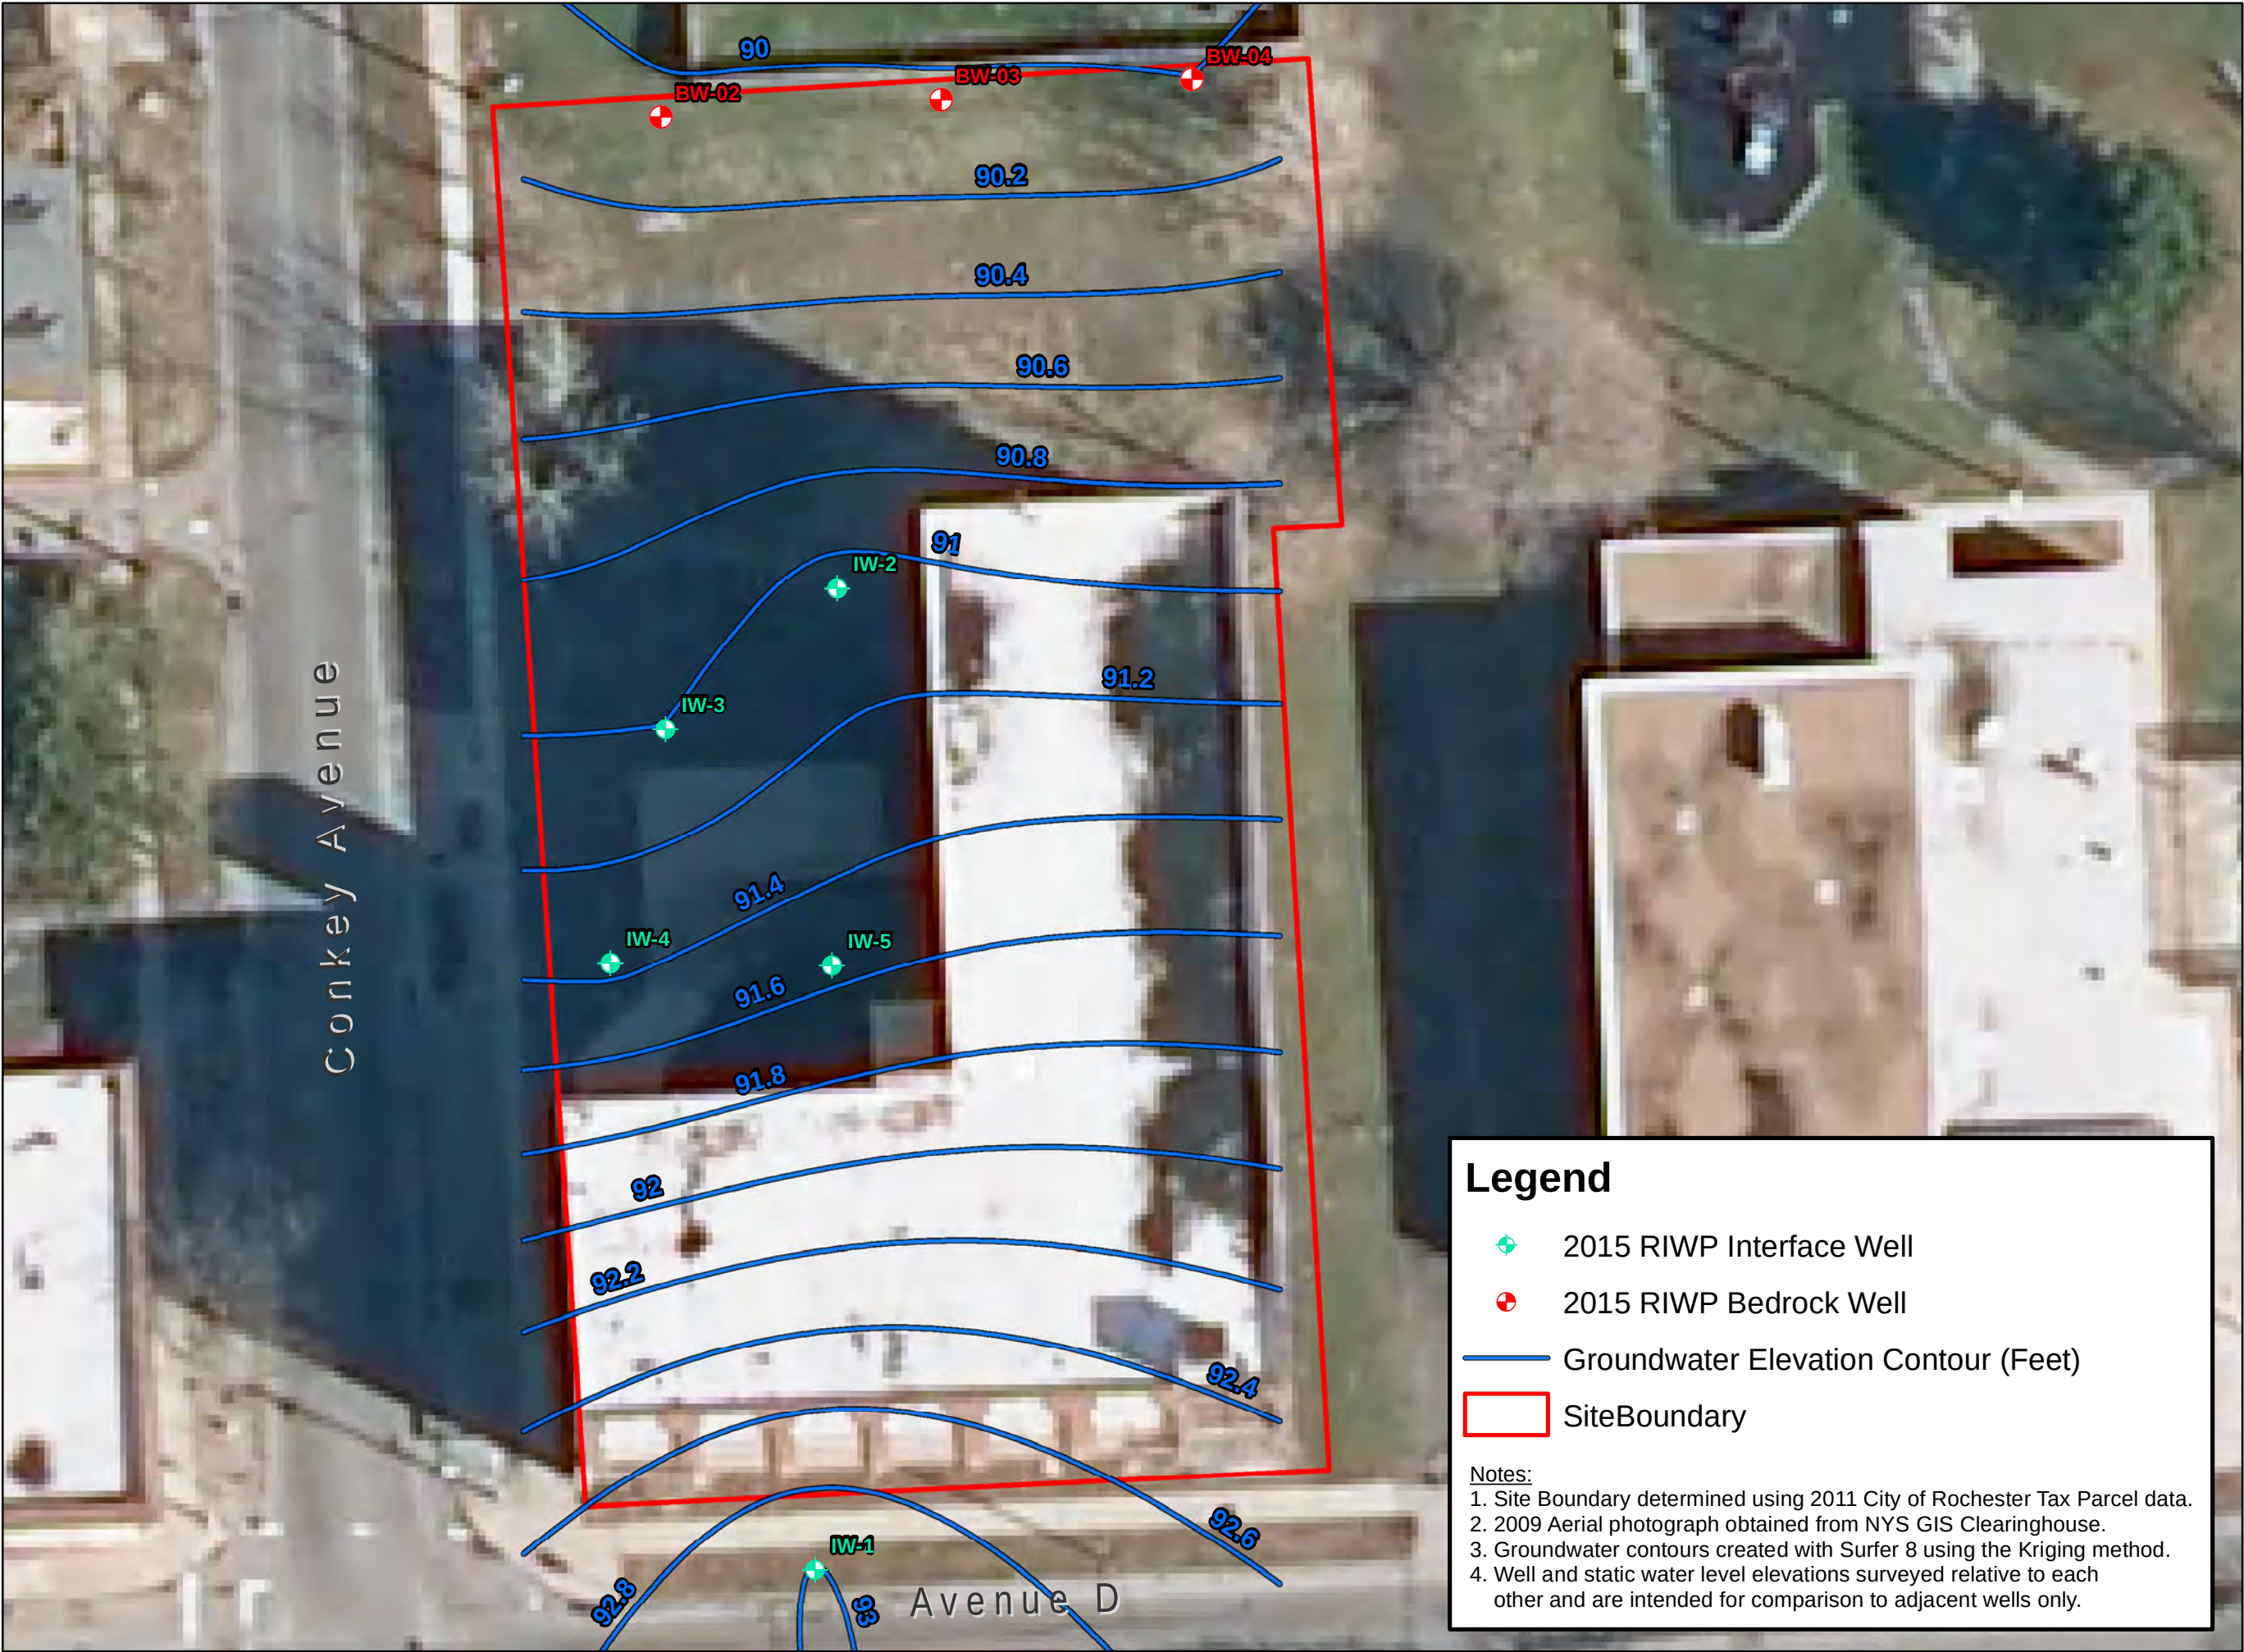
[ Figure 4 ]

Historic monitoring information previously presented to the NYSDEC describes a direction of groundwater flow that is to the north. For informational purposes, a groundwater contour map from June 2015 is included as Figure 4.

Title:  
Groundwater Elevation  
Contouring

Bedrock & Interface  
Monitoring Wells  
(6/1/2015)
