# PHASE I ENVIRONMENTAL SITE ASSESSMENT

**22 Flint Street  
City of Rochester  
Monroe County, New York**

**March 2005**

**22 FLINT STREET  
CITY OF ROCHESTER  
MONROE COUNTY, NEW YORK 14608**

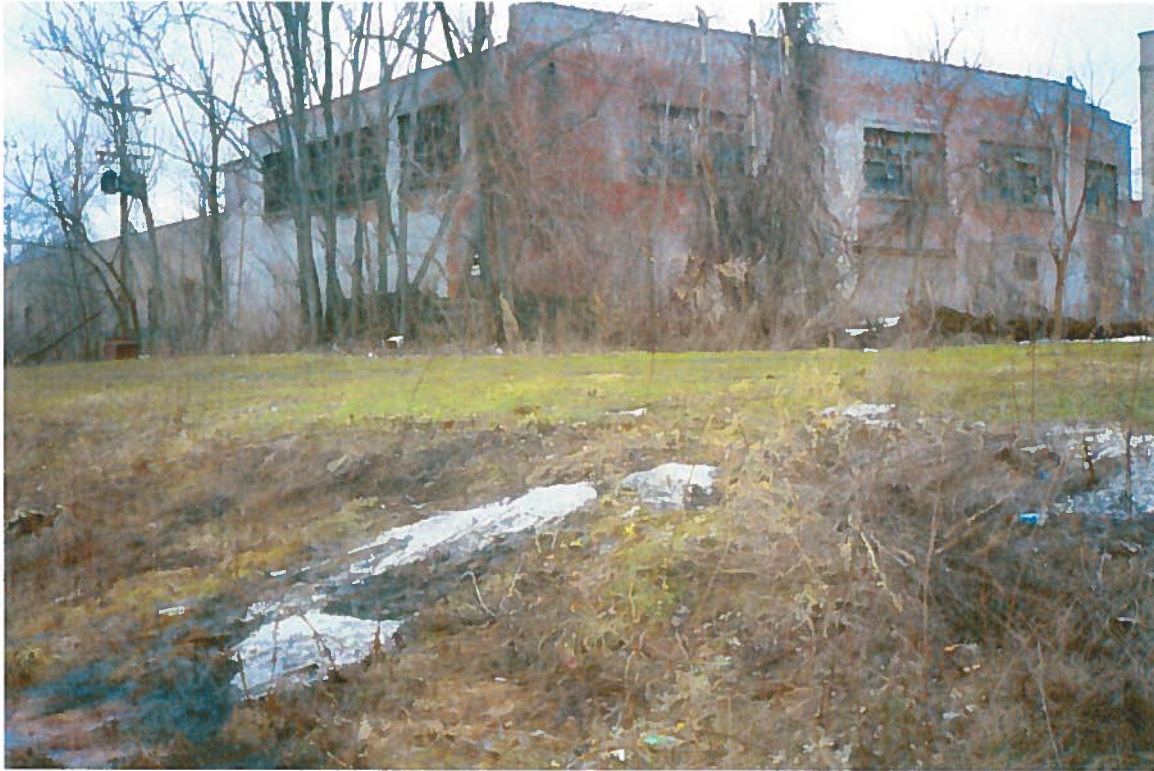
**Photo No. 1.** Site Overview North.

At the time of our Site visit, 1 pole-mounted transformer observed on-Site, along the East side of the Site building (see Photograph 1). This transformer is presumed to be owned by Rochester Gas and Electric, appeared to be in good condition and was not leaking.

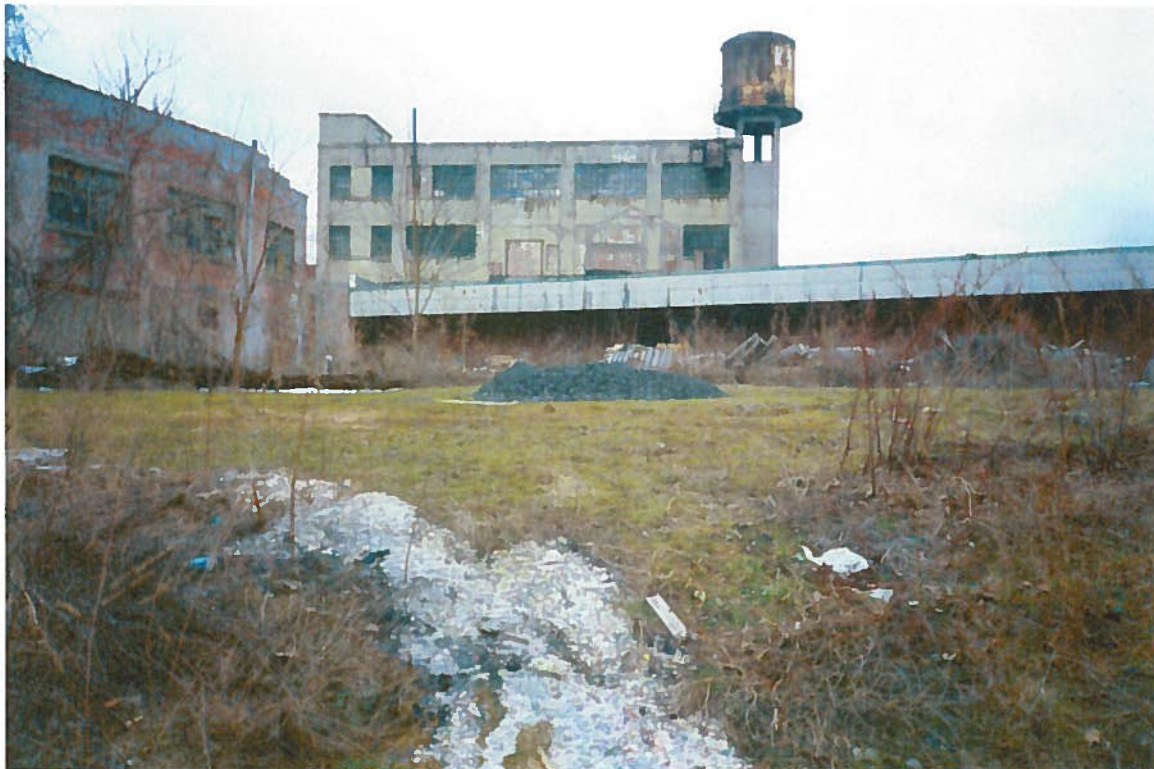
**Photo No. 2.** Surrounding Area North (Old Sears Warehouse).

The Site is bounded on the East by the Genesee River (see Photograph 11); on the West by FOODLINK (see Photographs 7 and 8); on the North by the old Sears Building (see Photograph 2); and on the South by Flint Street, a commercial/residential building, a junk yard and XLI where sheet metal operations are conducted (see Photographs 6, 4 and 5, respectively).

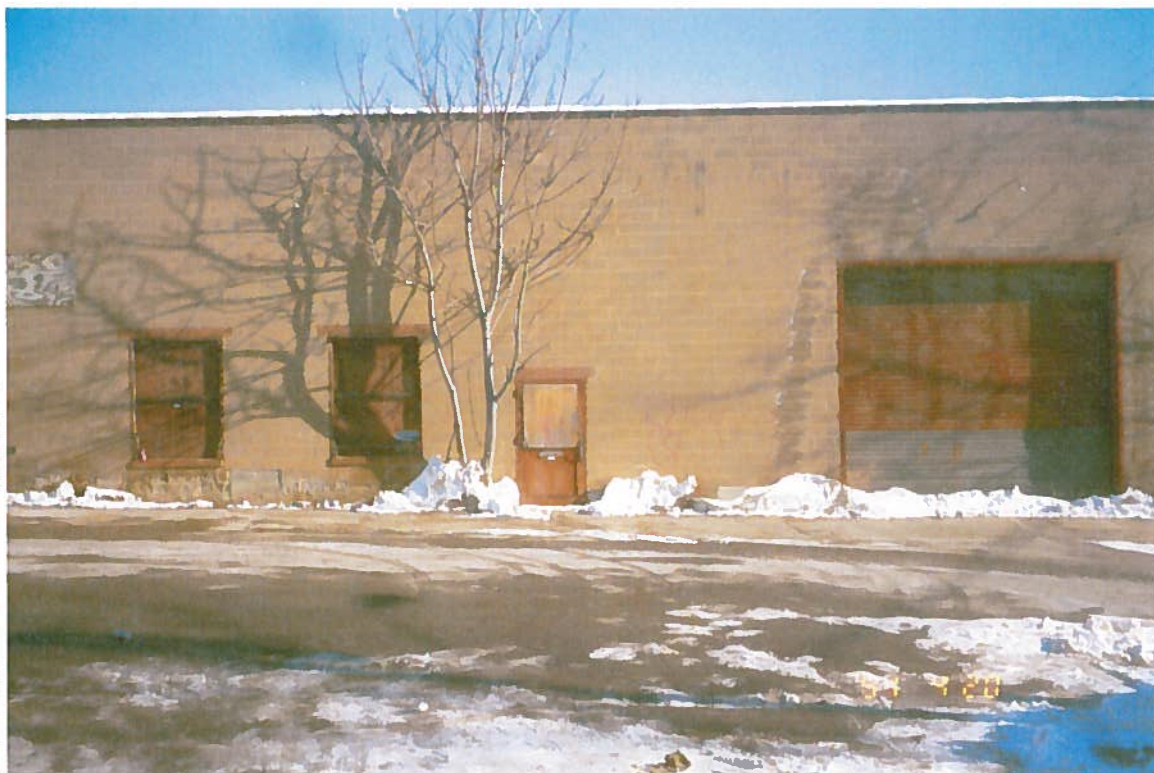
**Photo No. 3. Site Overview South**

The Site is paved on the West, South and part of the East side of the Site building (see Photographs 3, 7, 9 and 10).

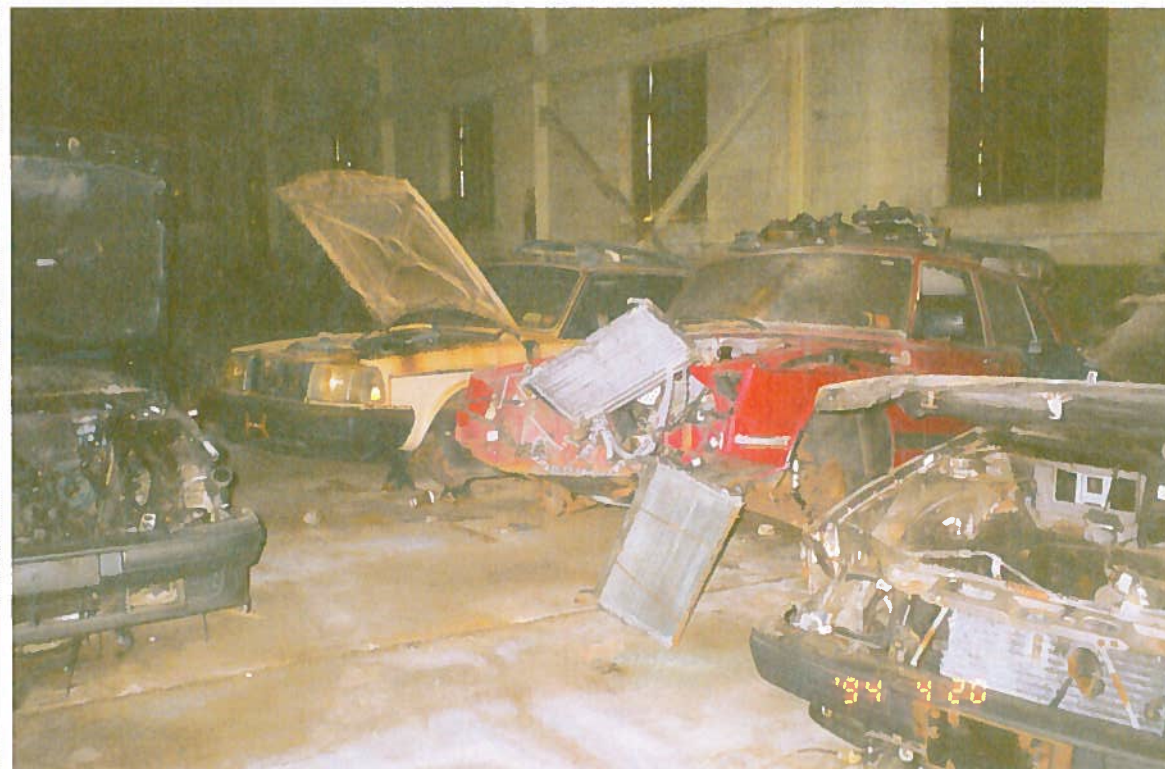
**Photo No. 12.** First Floor Main Warehouse (Vehicle Storage).

The Site is currently being leased by Impact Motors for warehouse storage of vehicles and associated parts (see Photographs 12, 13, 14 and 20).

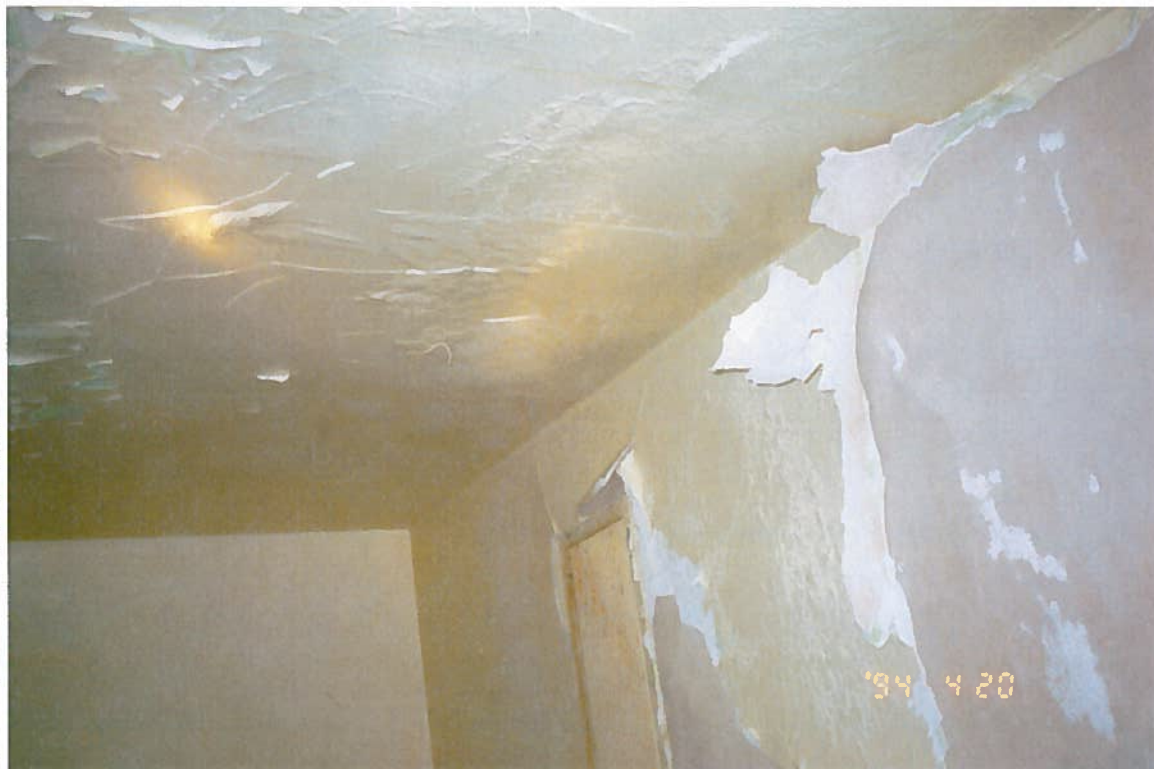
Based upon the age of the Site building (ie, 1800's), there is significant potential that paint on building surfaces is lead-based. Paint on interior surfaces was observed to be in poor condition (ie, peeling, see Photographs 16 and 17).

**Photo No. 16. Second Floor Bathroom (Peeling Paint).**

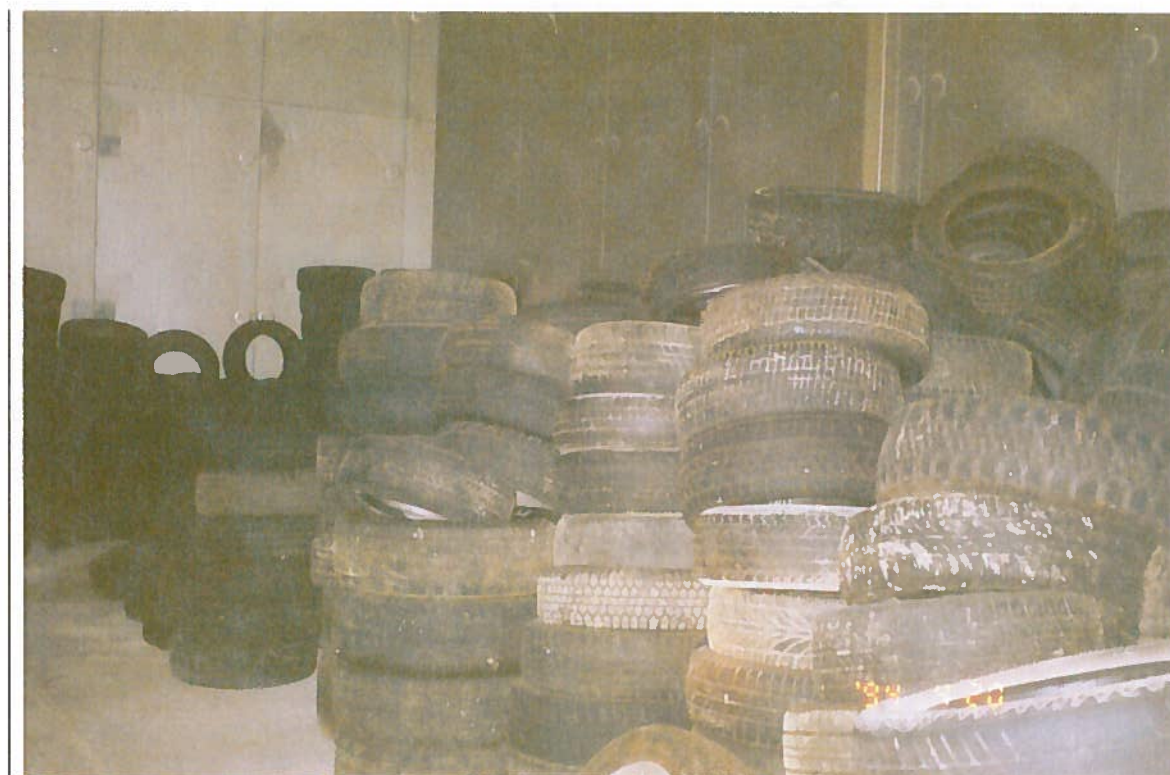
**Photo No. 22. Main Warehouse (Tire Storage).**

Small amounts of hazardous substances and petroleum products are used by Impact Motors as part of warehouse storage of vehicles and associated parts. At the time of our Site visit, paints and tires were observed inside the warehouse (see Photographs 21 and 22). Waste paint was observed near and in the former canal bed (see Photograph 35) and is assumed to be associated with current operation of the Site. This condition represents a **recognized environmental condition** at the Site.

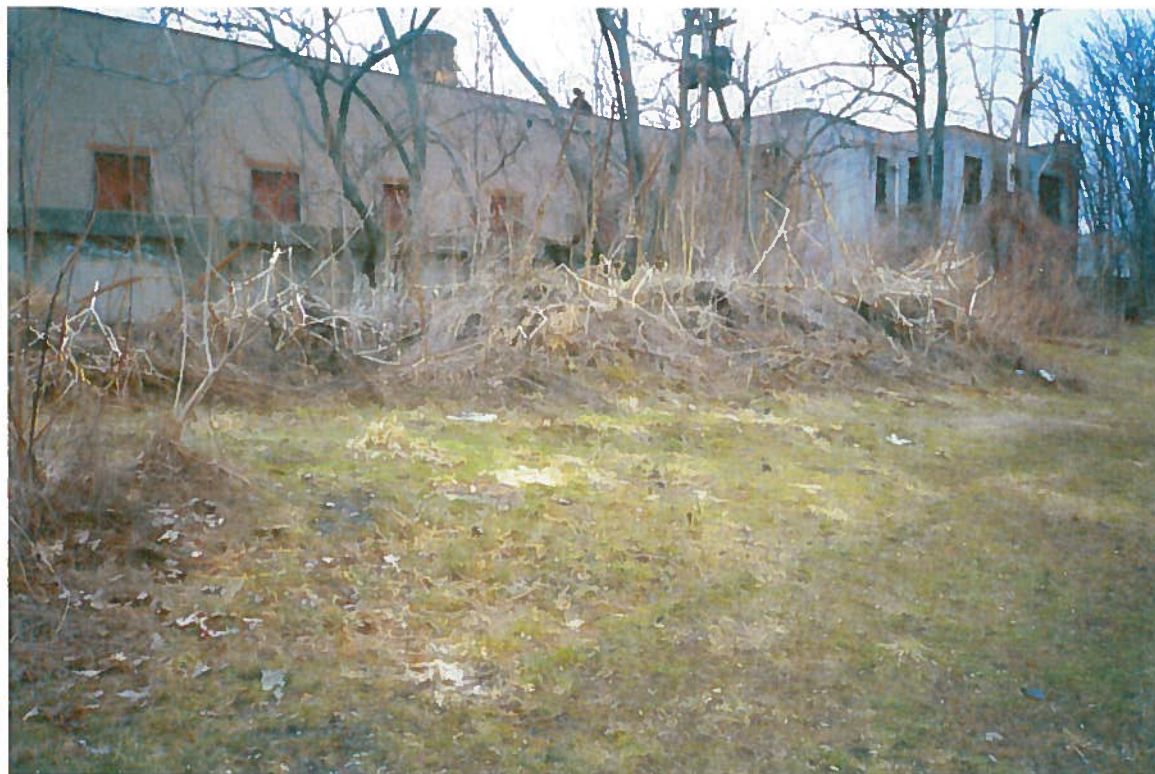
**Photo No. 23.** Soil Pile (East Side of Site Building).

During our Site visit, a former pump house, underground piping, debris piles and a soil pile were observed (see Photographs 25, 30, 24, 27 and 23, respectively). No information was available indicating the origination of this soil or whether this soil contains petroleum contaminants. This soil may be associated with the soil removal completed in this area by the NYSDEC in 1992. This condition represents a **recognized environmental condition** at the Site.

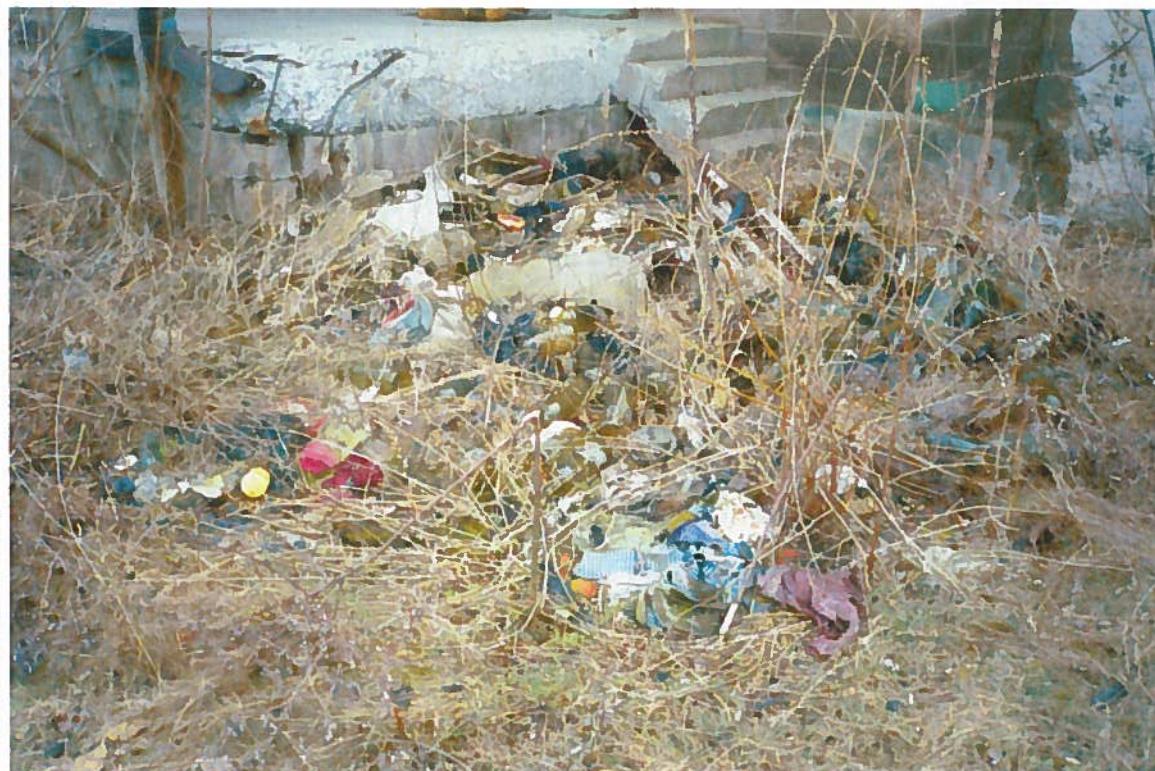
**Photo No. 24.** Debris Pile (Southeast Side of Site Building; Glass and Garbage).

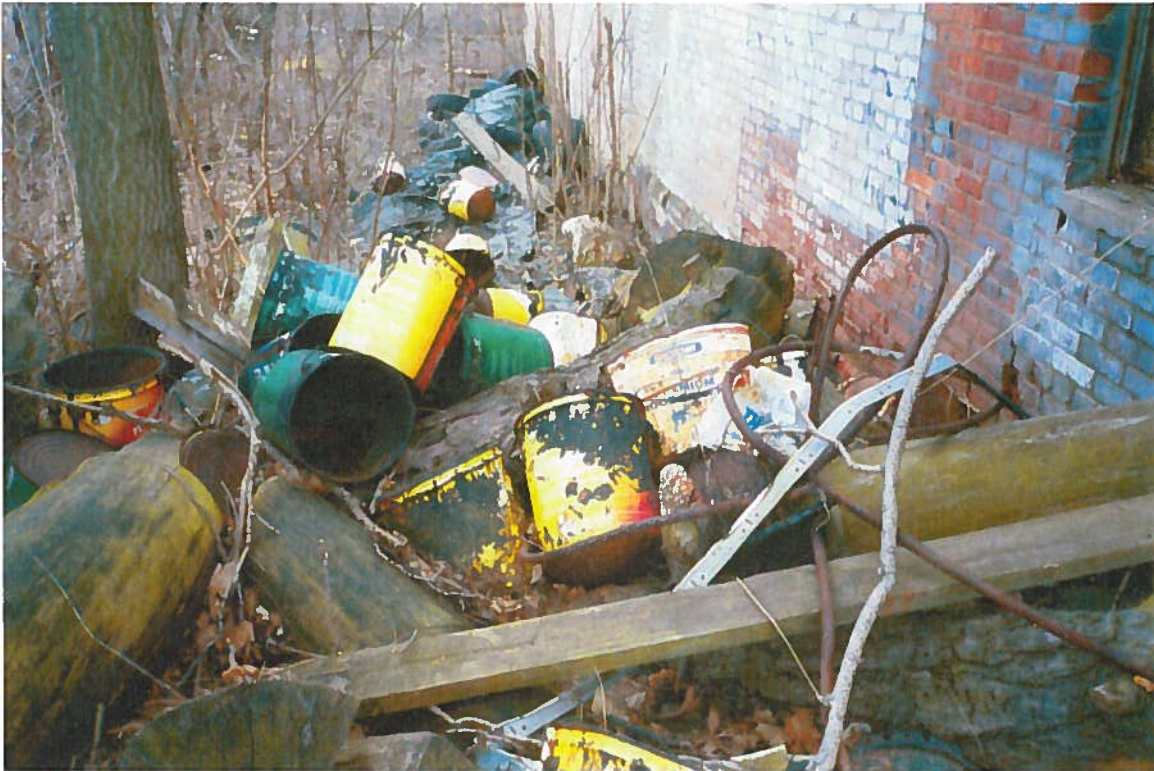
**Photo No. 27.** Debris Pile North Side of Site Building  
(Empty Asphalt Containers and Garbage).

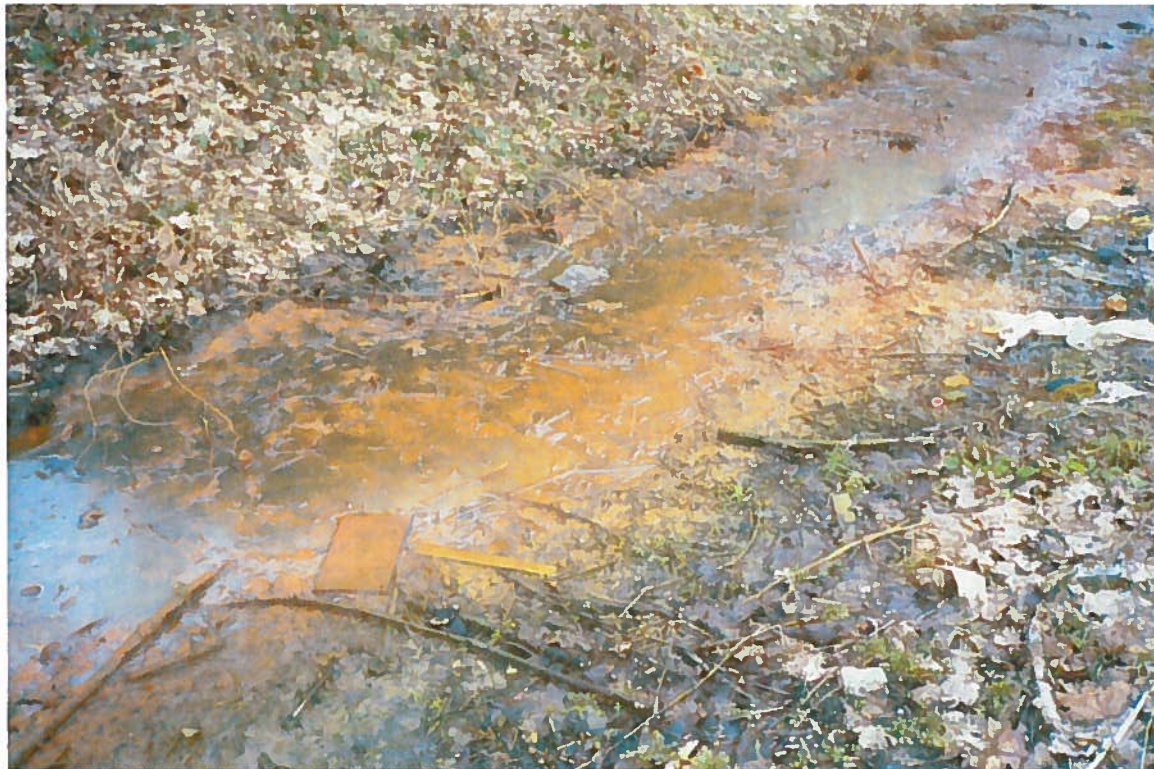
**Photo No. 32.** Oil and Sheen on Water in Canal Bed.

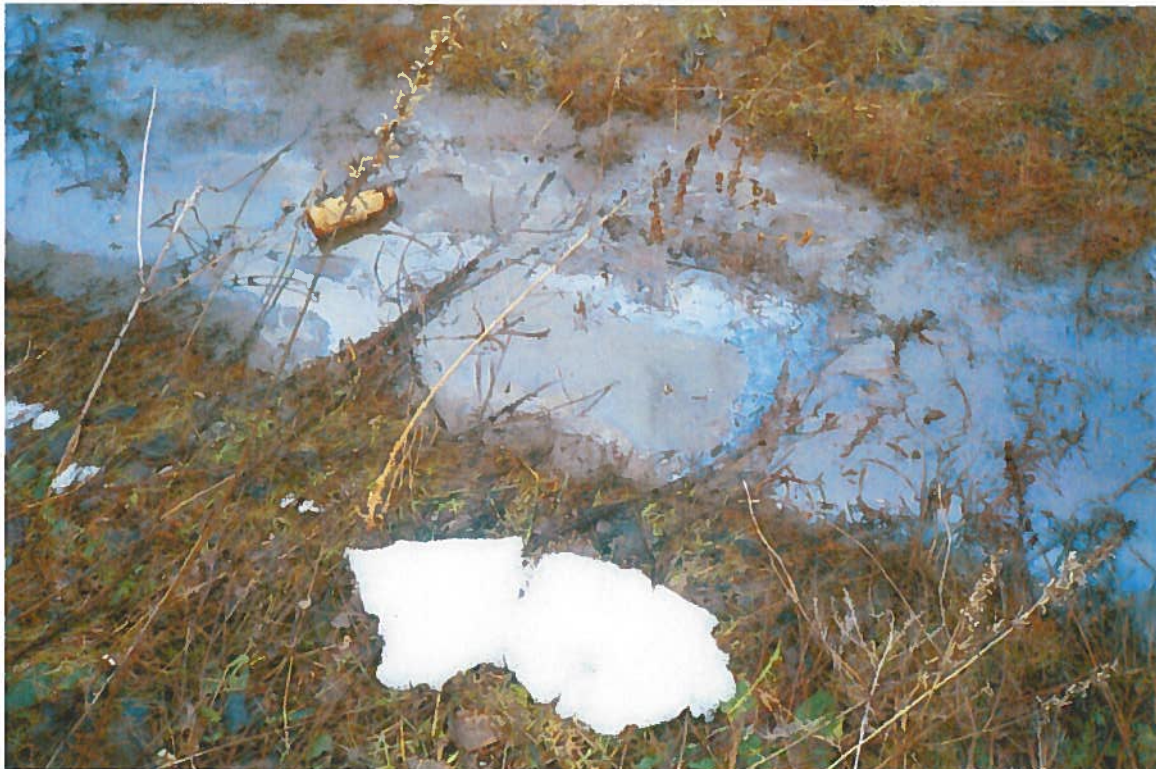
**Photo No. 34.** Sheen on Water in Canal Bed.

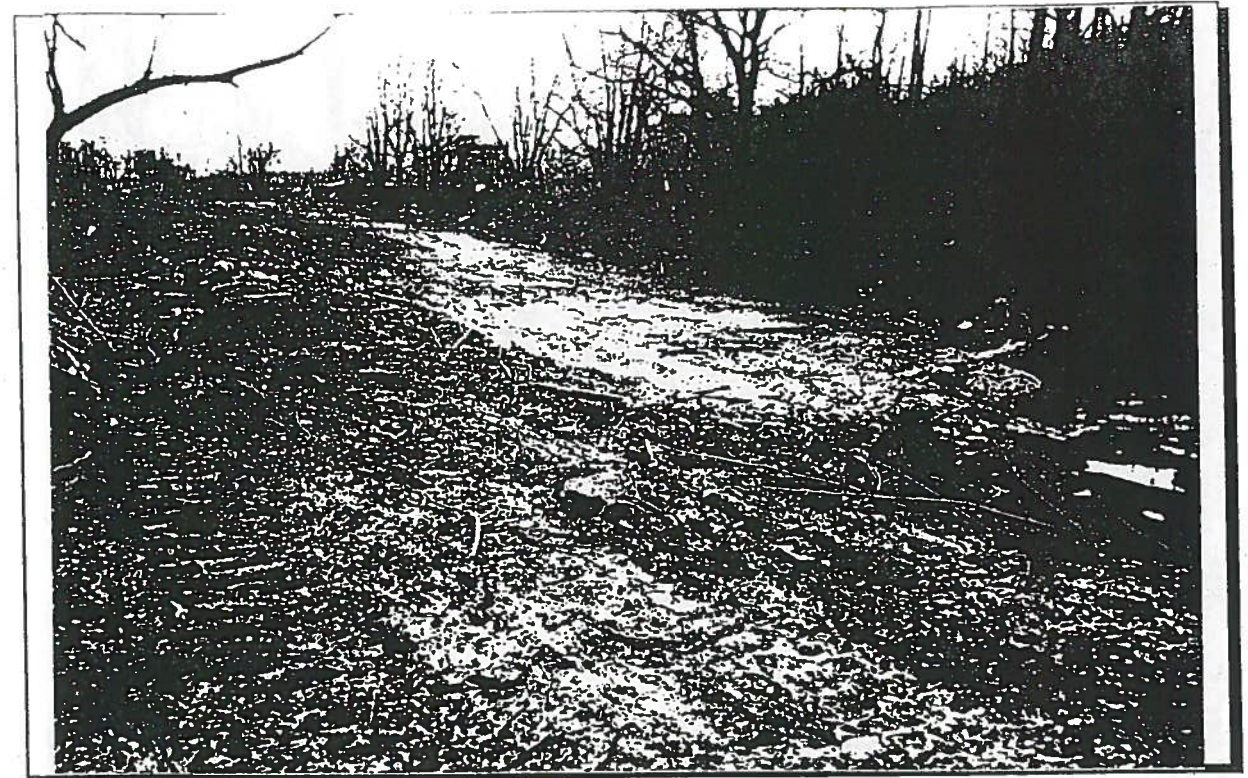
PHOTO 9: View to the north of the former canal behind 22 Flint Street. As can be seen, the canal is being actively filled.
