## 113-117 Clinton North MONROE COUNTY, NEW YORK

## **Construction Completion Report**

**NYSDEC Site Number: C828195**

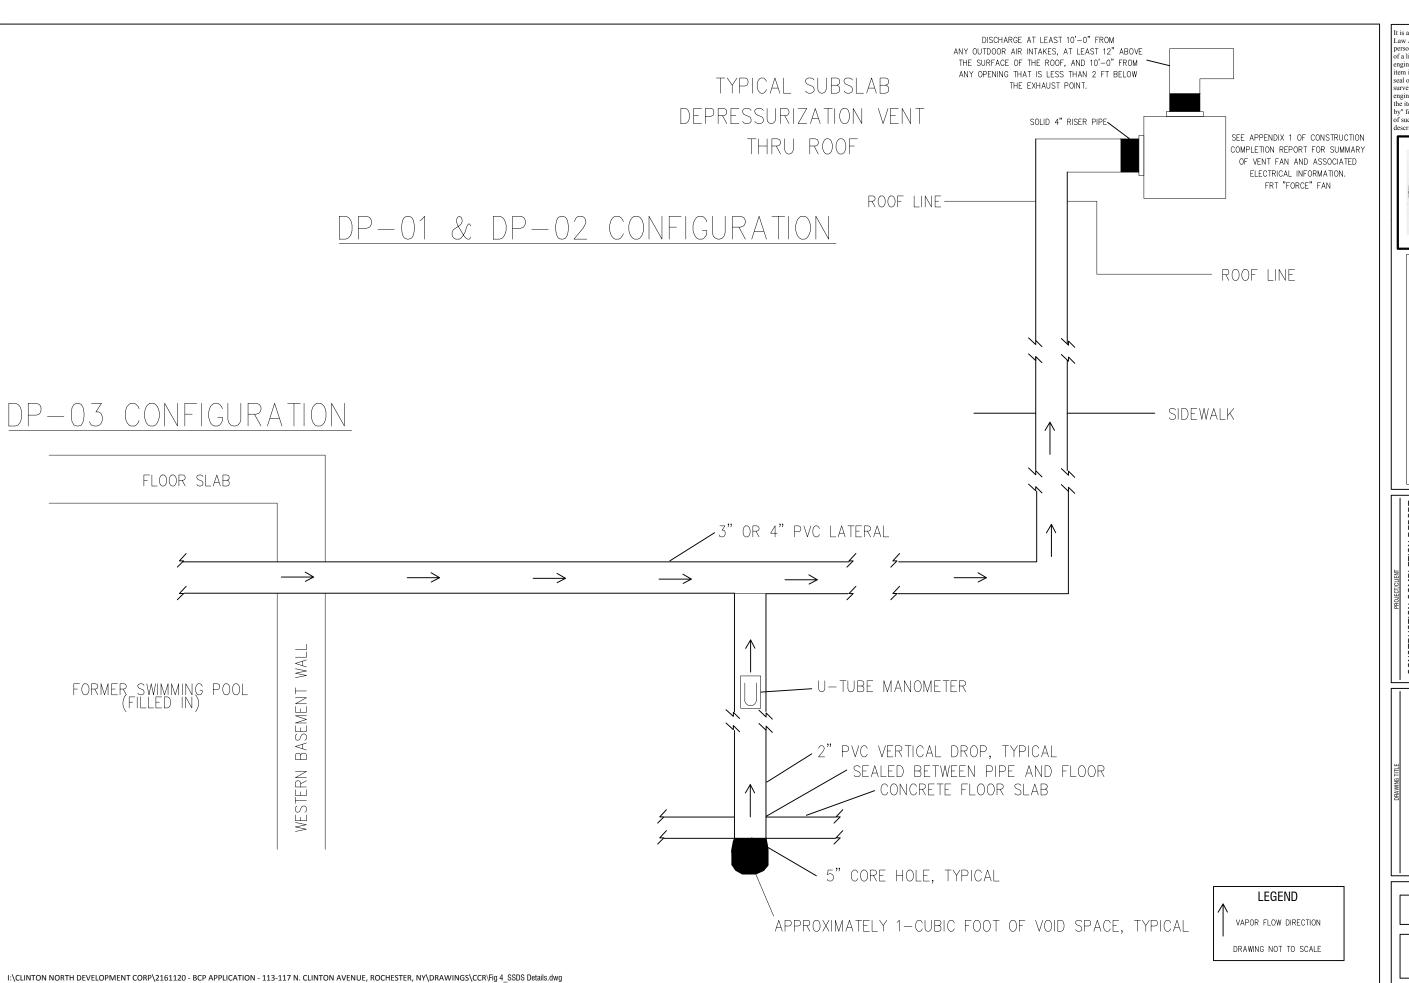
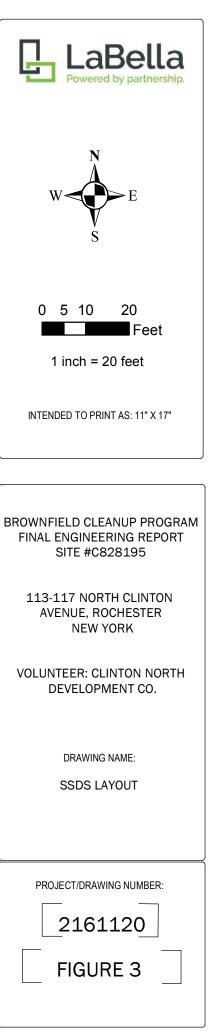
2161120
FIGURE 4

SUB-SLAB DEPRESSURIZATION
SYSTEM DETAILS
ISSUED FOR ISSUED FOR AS-BUILT
DATE: JANUARY, 2019 REVENED BY: JG
DATE: JANUARY, 2019 REVENED BY: JG

Between October 10, 2018 and November 30, 2018, three (3) depressurization points (designated DP-01 through DP-03) and one (1) rooftop fan (Festa Radon Technologies FRT "Force") were installed at the Site. Refer to Appendix 1 for fan specifications and Appendix 5 for a photographic log. Points DP-01 and DP-02 were installed vertically through the building's basement floor slab while DP-03 was installed horizontally through the western wall of the basement into a partial void space which underlies the western-most portion of the building's first floor (refer to Figure 3). A swimming pool was reportedly previously located in this area but was filled and a concrete floor slab (i.e., the first floor slab in this portion of the building) was poured over it.

U-Tube manometers were installed on each of the depressurization points to measure pressure differentials and thus system effectiveness. System components are depicted on Figure 4.

The final SSDS configuration reflects the proposed layout in the IRAWP Amendment with the exception of the path of the horizontal piping in the basement due to the ceiling configuration. Another minor deviation was the use of a more powerful fan, the Festa Radon Technologies FRT "Force", instead of the RadonAway® RP-265. Refer to Figure 3 for the locations of SSDS components and Figure 4 for an as-built drawing.

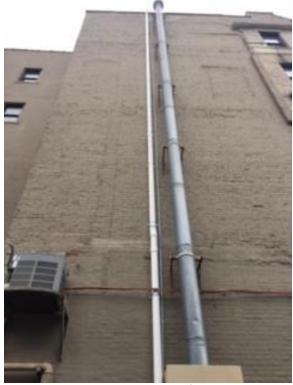
Exterior riser (PVC).

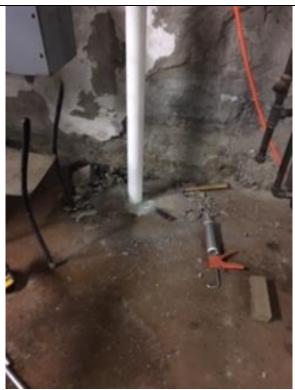
**DP-01** – Vertical depressurization point during installation.

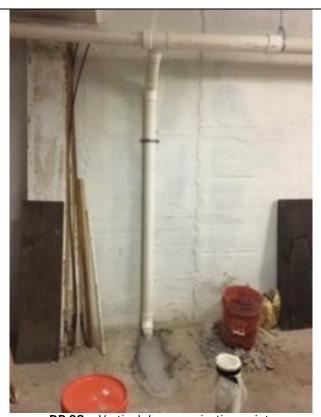
**DP-02** – Vertical depressurization point.

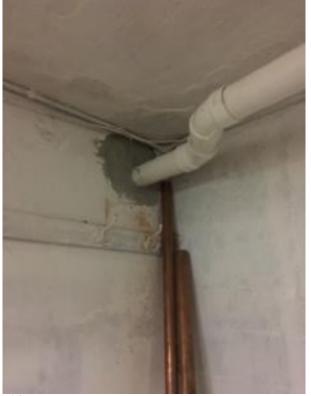
**DP-03** – Horizontal depressurization point extending below the western portion of the Site building where no basement is present.

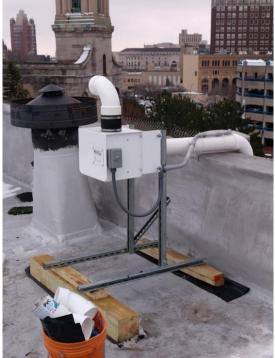
Festa Radon Technologies Company FRT Force fan, located on the roof of the Site building.

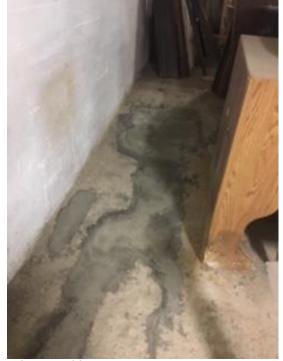
Sealing of floor cracks in building basement.

As part of system installation, several cracks in the basement floor slab were sealed to prevent loss of vacuum during system operation.

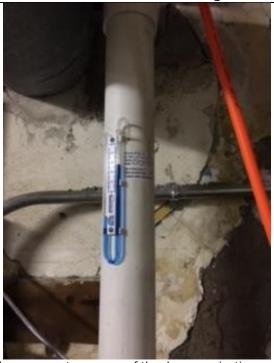
U-tube manometer on one of the depressurization points.
