**Reference: Monthly Progress Report #8  
Brownfield Cleanup Program Site # C828200  
820 Linden Avenue  
Pittsford, Monroe County, New York**

On behalf of Ridgecrest Associates, Stantec Consulting Services Inc. (Stantec) has prepared this Monthly Progress Report #8 for the Brownfield Cleanup Program at the 820 Linden Ave Site located at 820 Linden Avenue, Monroe County, New York (Site). This report covers the period from January 10, 2019 through February 8, 2019.

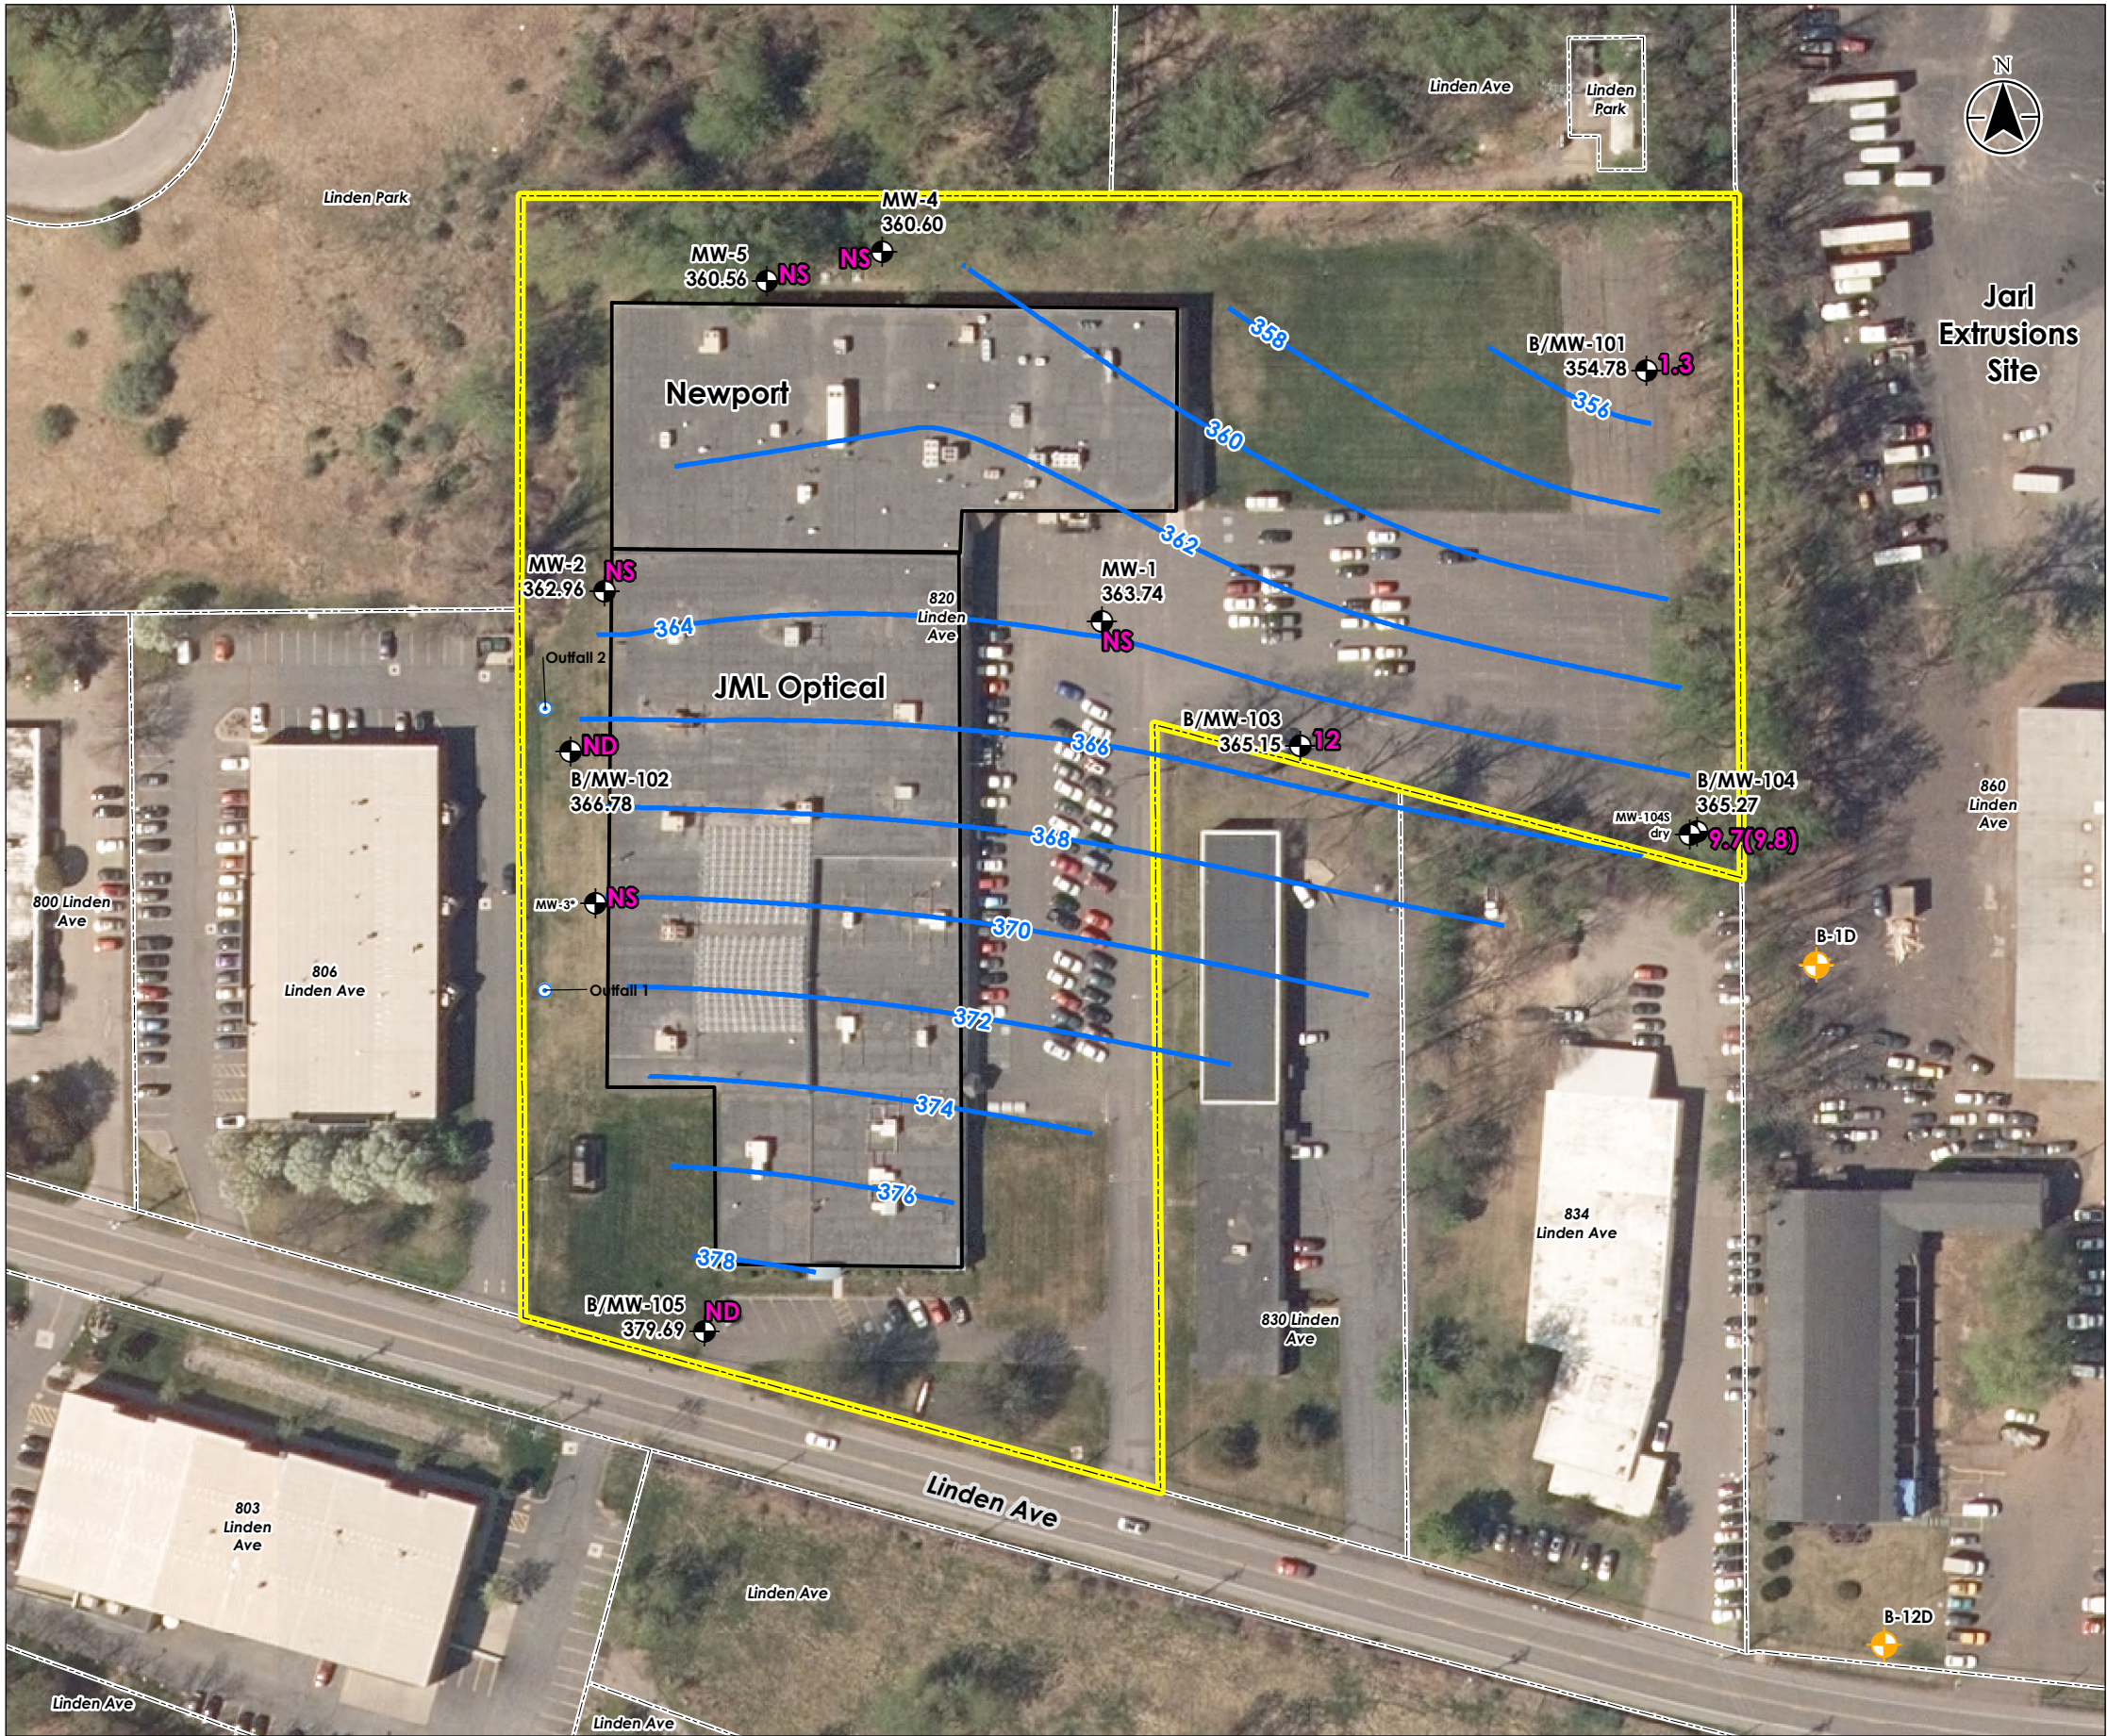
Figure No.  
1

- Groundwater elevations were calculated from water level gauging data collected on January 23. The groundwater elevations were used to generate groundwater elevation contours to confirm suspected flow direction across the Site. Figure 1 provides the draft groundwater elevation contour map based on the January gauging data. The water table was slightly lower than observed during the first round of gauging, but the groundwater flow direction and gradient remained consistent.

- The primary item of note in the January 23 data is the detection of trichloroethene (TCE) in the same three monitoring wells where it was reported in the October 2018 sampling event: monitoring wells MW-101, MW-103, and MW-104 located in the eastern parking lot area. The attached Figure 2 depicts the groundwater elevation contour map with TCE concentrations from both sampling events. The TCE concentration reported in monitoring wells MW-103 (12 µg/L) and MW-104 (9.7 µg/L) exceed the NYSDEC standard of 5 µg/L. Downgradient monitoring well MW-101 exhibited a low-level concentration of TCE (1.3 µg/L) below the standard. See Figures 1 and 2 for groundwater elevation contours and TCE plotting.

Groundwater Elevation Contours and  
TCE Concentrations (January 2019)

Figure 1 – Groundwater Elevation Contours and TCE Concentrations (January 2019)

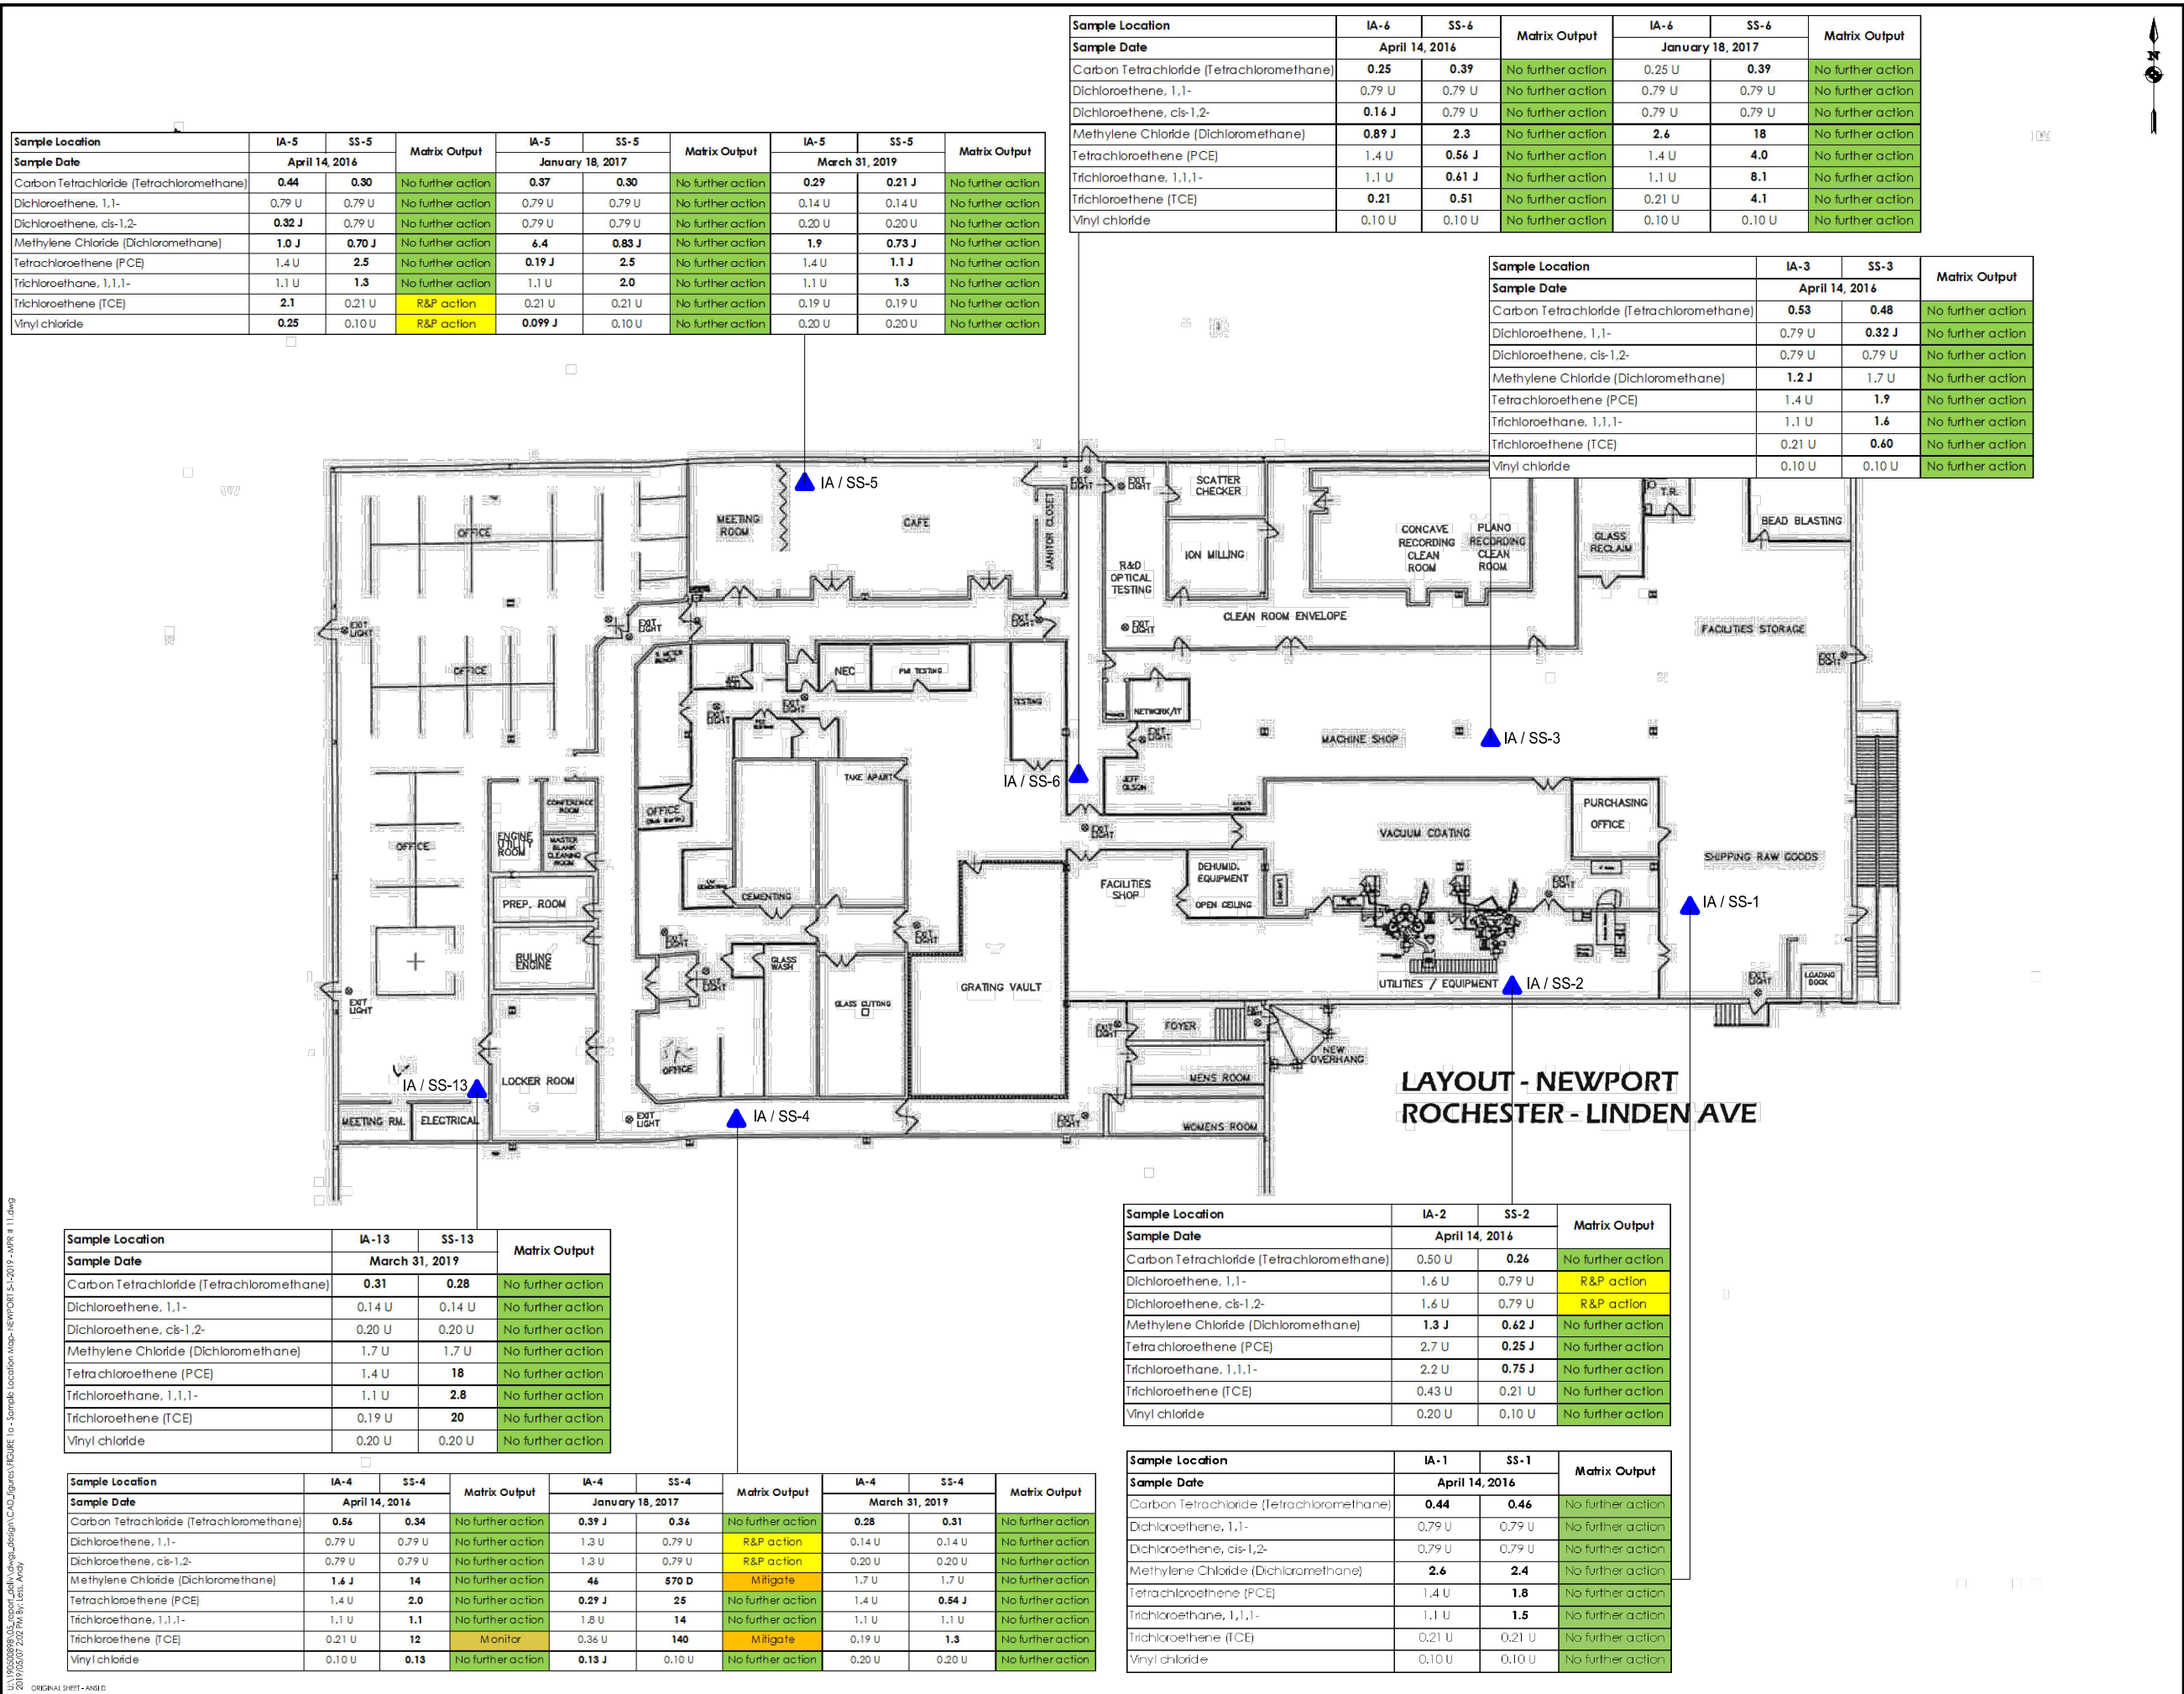
| Figure 1a | Newport Tenant Space Interior Building Plan and SVI Sampling Results with NYSDOH Matrix Recommendations |

Analytical data from the post-SSDS installation SVI sampling event performed on March 31, 2019 were received on April 12, 2019. Figures 1a and 1b present a summary of the data and the resultant NYSDOH matrix guidance recommendations for Newport and JML, respectively. Laboratory data are tabulated in

- All three sampling locations in Newport (IA/SS-4, IA/SS-5, and IA/SS-13) demonstrated *No Further Action* matrix outcomes.
- One of the two JML sample locations (IA/SS-14) demonstrated *No Further Action* matrix outcomes.
- The second JML sample location (IA/SS-7) demonstrated *No Further Action* matrix outcomes for the compounds assessed except TCE. No concentration of TCE was reported in the indoor air sample, but the sub-slab vapor concentration was 80 µg/m<sup>3</sup> resulting in a *Mitigate* matrix recommendation. Both the indoor air and sub-slab vapor samples previously collected at IA/SS-7 during the April 2016 event were non-detect for TCE. As shown on Figure 1b, IA/SS-7 is in the 1954 building construction area. This area was not included in the original SSDS construction because of the previous sampling results.

NEWPORT TENANT SPACE INTERIOR BUILDING PLAN AND SVI SAMPLING RESULTS WITH NYSDOH MATRIX RECOMMENDATIONS (NEWPORT)
