**Subject: 820 Linden Ave Site (#C828200)  
820 Linden Ave, Pittsford, NY 14625  
Remedial Alternatives Analysis,  
August 2020**

820 Linden Ave Site  
Brownfield Cleanup Program  
Pittsford, Monroe County  
Site No. C828200  
October 2020

### Remedial Alternatives Analysis Report

Client/Project  
820 Linden Ave Site  
BCP Site #C828200  
Alternatives Analysis Report

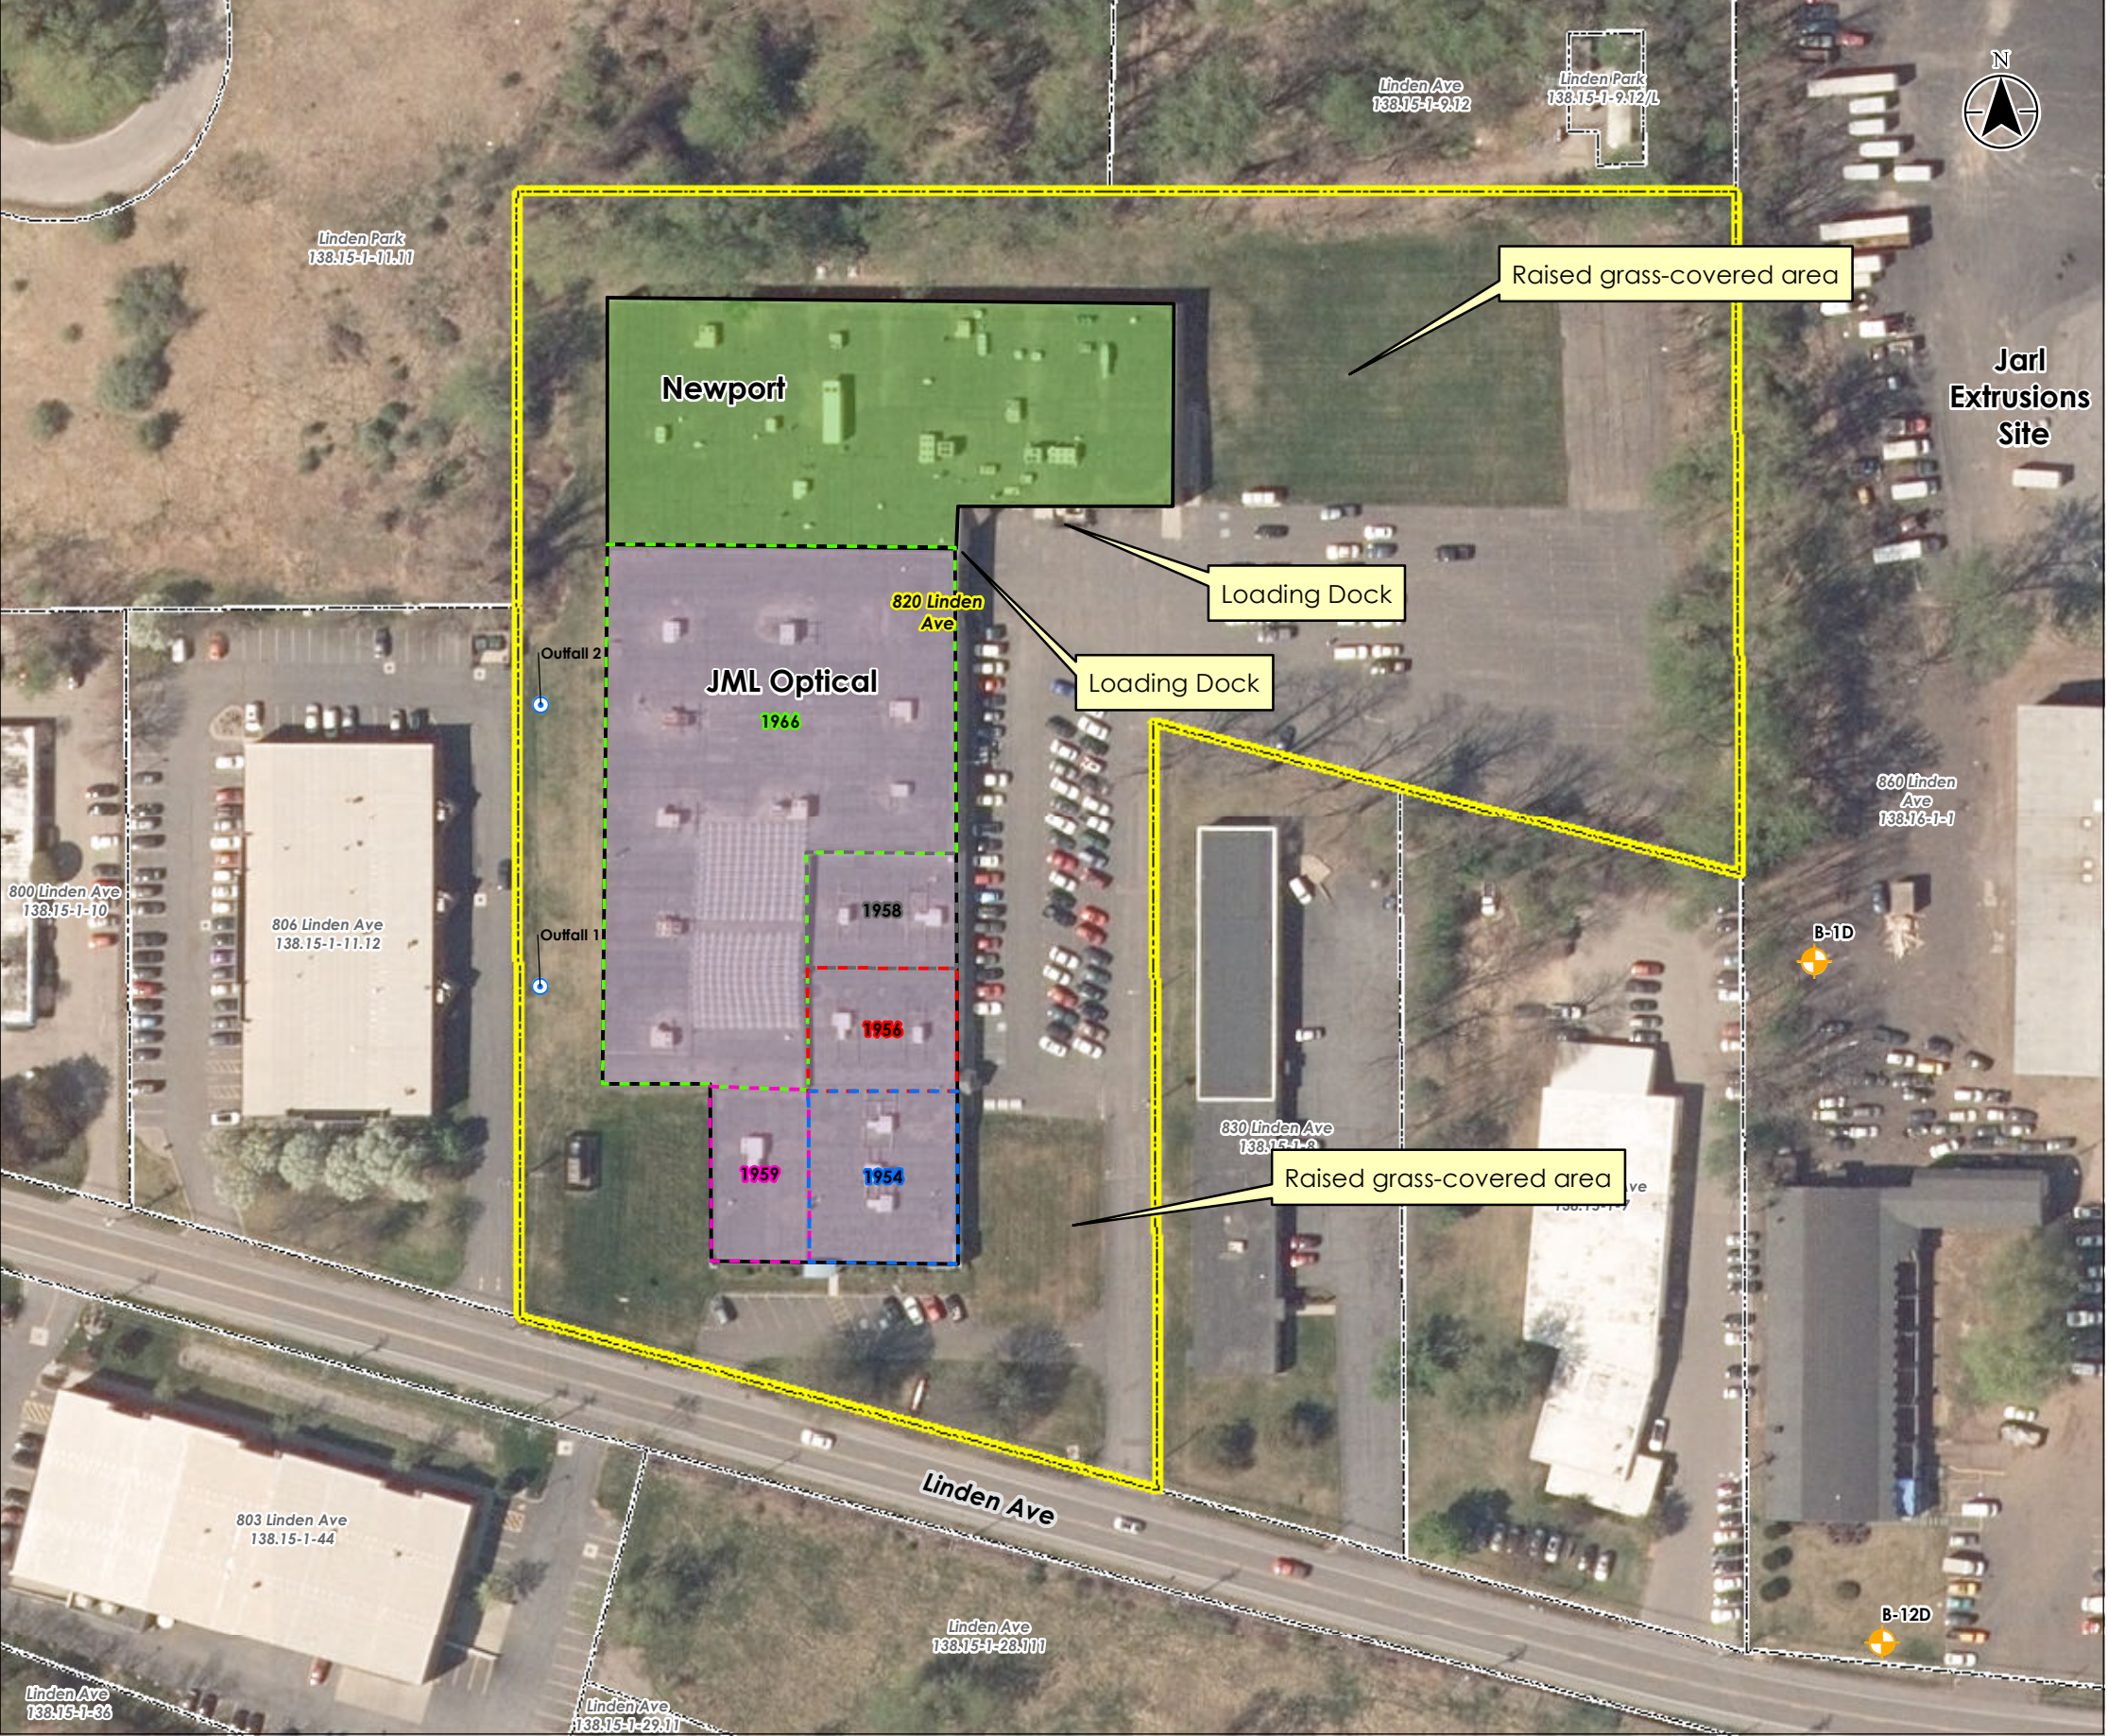
**Site Layout Map**

- Site Property Outline
- Building Outline
- Newport tenant space (permitted addition 1967)
- JML Optical tenant space (five construction phases, see below)
- Year of Building Permits for Construction Phases of Southern Tenant Space
  - 1954
  - 1956
  - 1958
  - 1959
  - 1966
- Nearby Parcel Boundaries
- Jarl Extrusions Monitoring Well
- Roof Drain Outfall Locations

- Notes**
- Coordinate System: NAD 1983 StatePlane New York West FIPS 3103 Feet
  - Orthoimagery (2015) downloaded from gis.ny.gov.
  - Site building is occupied by two tenants: JML Optical in the southern building section and Newport Corporation in the northern building section. Both current tenants are optics manufacturing facilities.

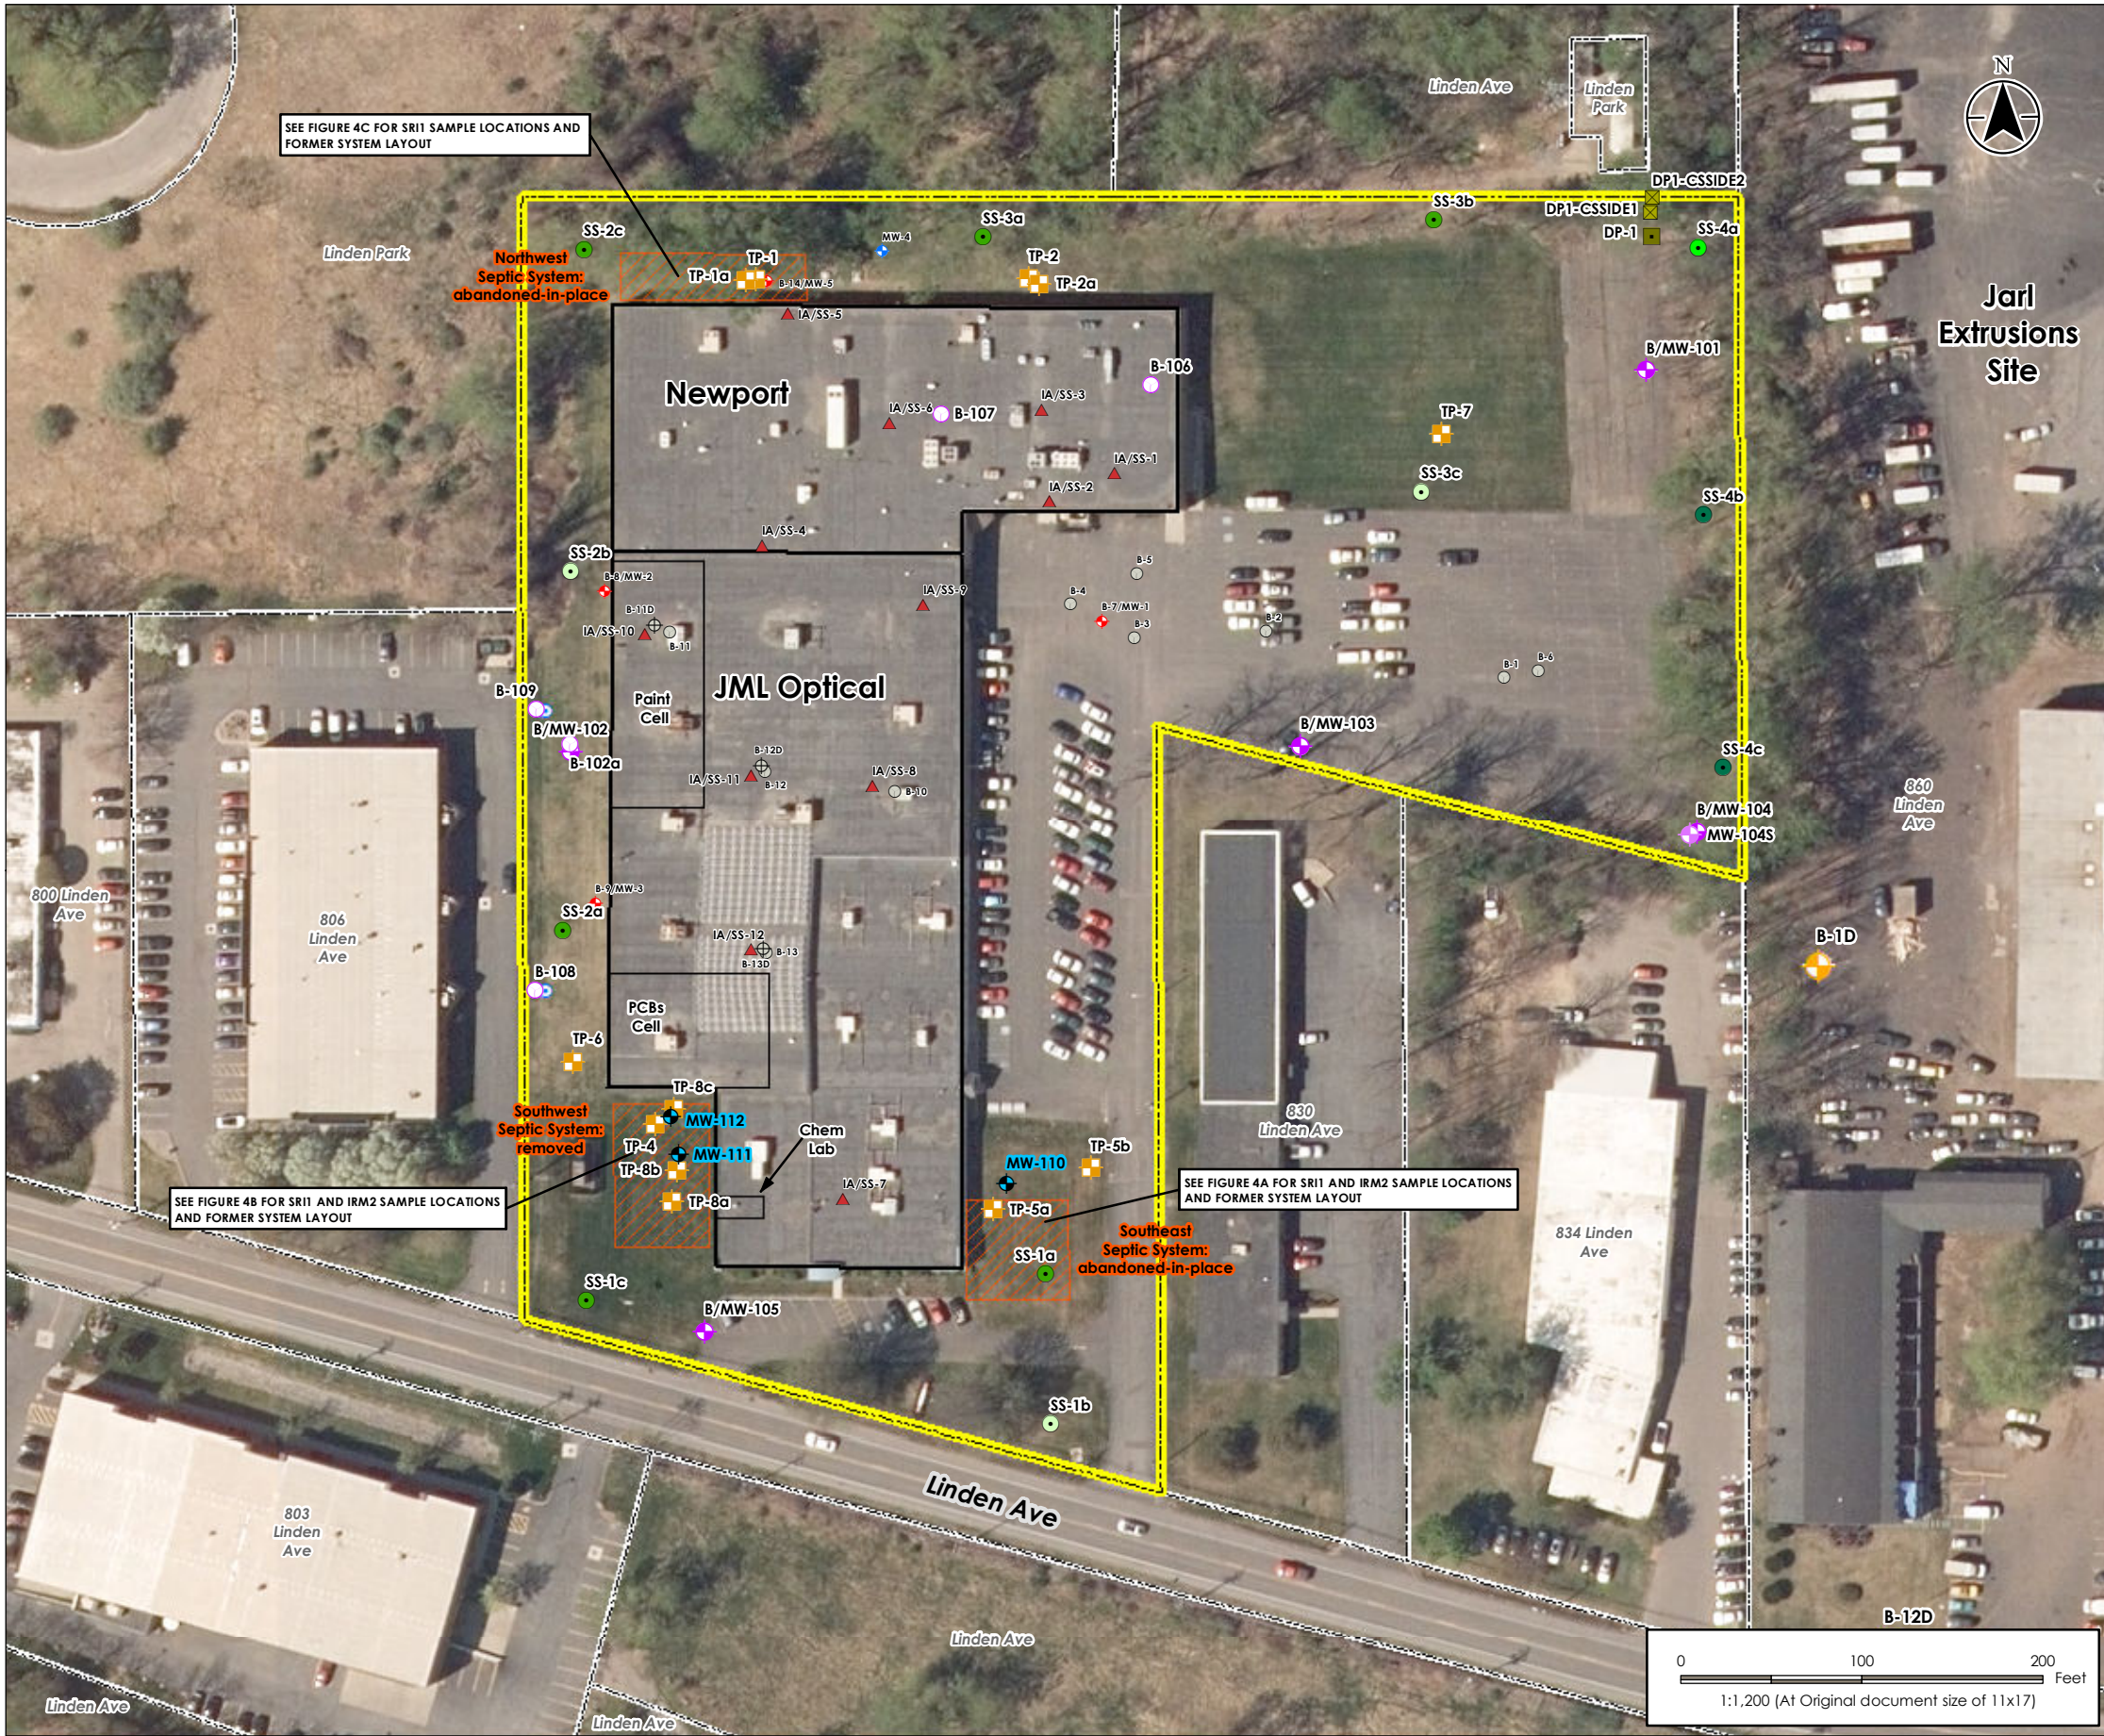
Investigation and Sample Locations

- 2020 IRM2 Septic System Monitoring Well
- 2020 IRM2 Debris Pile Removal Sidewall Samples
- 2018 RI Soil Boring/Monitoring Well
- 2018 RI Shallow Monitoring Well

- Interior boring/well locations and sub-slab vapor/indoor air sample locations are estimated based on building structure tie-offs. The exterior locations are based on handheld GPS (Trimble) unit measurements and/or field measurements.

- Well locations surveyed for vertical and horizontal coordinates by a Stantec surveyor.
- \*Surface soil sample locations were selected based on NYSDEC's Draft Soil Screening Guidance. Soil was collected from two depths at each sample location. Of the twelve discrete sample locations, eight included the collection of additional soil for VOC analysis (in addition to the soil collected for a composite analysis of other parameters). Each of the eight composite samples (4 groups at two depths) were comprised of three discrete samples. The discrete surface soil sample locations SS-4a, SS-4b, and SS-4c were re-sampled in April 2020 as part of SRI2. Samples from 0-2" below ground cover were each analyzed for benzo(a)pyrene to delineate PAH impacts to surface soil.
