## DRAFT PHASE II ENVIRONMENTAL SITE ASSESSMENT

Providence Housing – Lot I Wambach Farms 2590 Culver Road  
Town of Irondequoit, Monroe County, New York

December 23, 2020

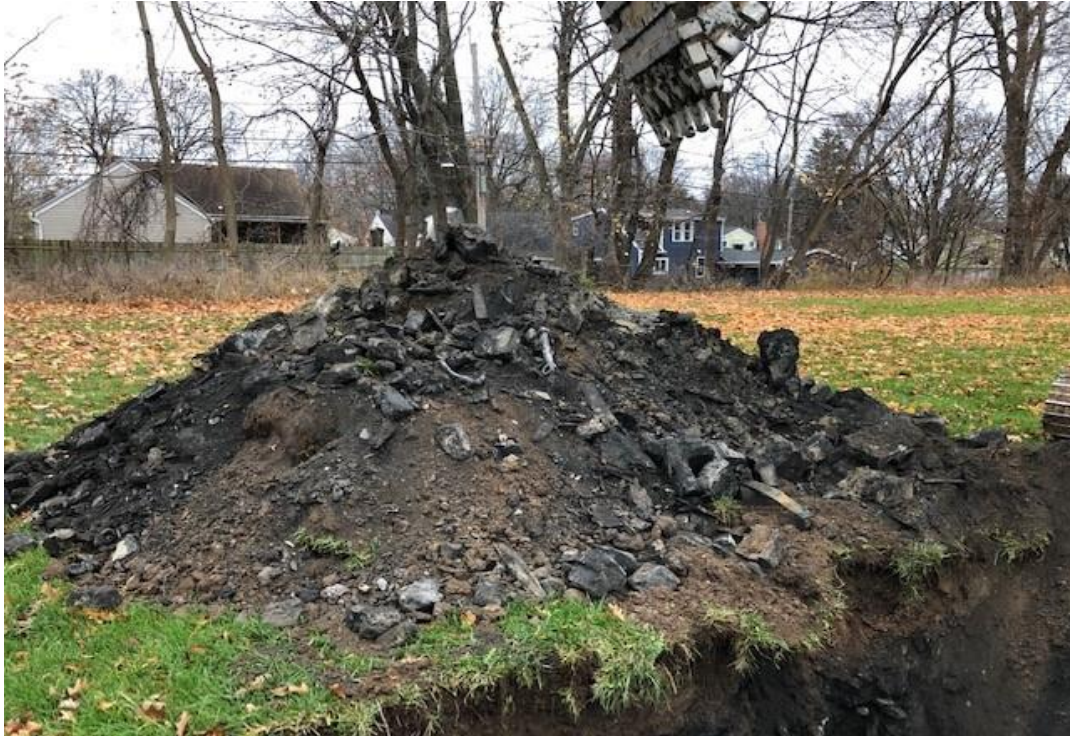
| Depth (FT) | Sample Depth (FT) | Sampler Blows Per 6 Inches | Head Space (PPM) | Sample Number and Recovery | Strata Change (FT) | Visual Classification and Remarks |
|---|---|---|---|---|---|---|
| 4 | | | ND | | | Building debris, cinder blocks, brick, wood, metal pipe, black stained fill matrials with petroluem odors, moist. |

Test Pit TP20-2 fill soils and fill materials

However, petroleum nuisance odors were noted by olfactory senses during the excavation of test pits TP-20-2 (petroleum odor) and TP20-14 (potential petroleum). Therefore, soil cleanup levels for a nuisance condition appear to be exceeded as presented in NYSDEC CP-51/ Soil Cleanup guidance. Based on our field observations, it appears that VOCs have been released to the subsurface soils at these sample locations and there is a potential for vapor intrusion and vapor encroachment conditions from the fill soils into future buildings that are proposed for restricted residential use. The laboratory reports are presented in Appendix 2 – Laboratory Analytical Reports. Sample locations are shown on Figure EX-1.

The laboratory SVOCs results from samples are TP20-2 (6.0-7.0 ft.) and TP20-14 (8.5-9.0 ft.) indicate detection of six (6) individual SVOCs at concentrations below UUSCO in sample TP20-2 that include, Benzo (a) anthracene (0.334 ppm), Benzo (a) pyrene (0.331 ppm), Chrysene (0.377 ppm), Fluoranthene (0.622 ppm), Phenanthrene (0.455 ppm), and Pyrene (0.502 ppm). The sample results from TP20-14 (8.5-9.0 ft.) indicate detections of two (2) SVOCs that exceed UUSCOs and three (3) exceeded RRUSCOs as listed below:

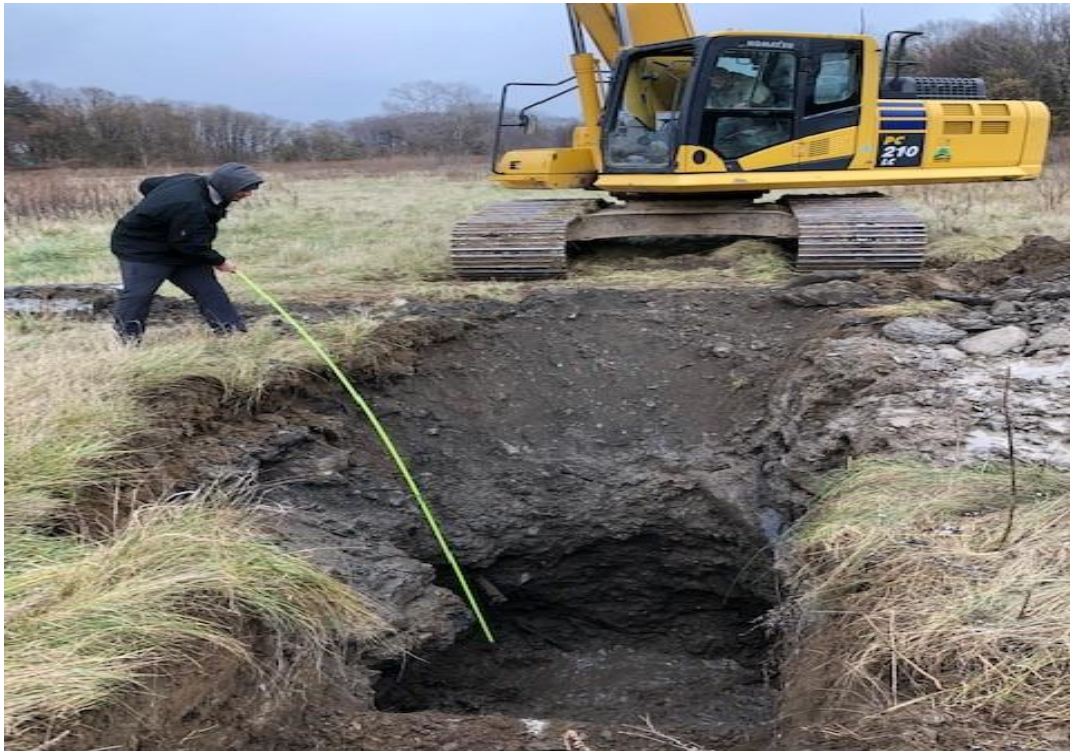
TP20-6 view looking east

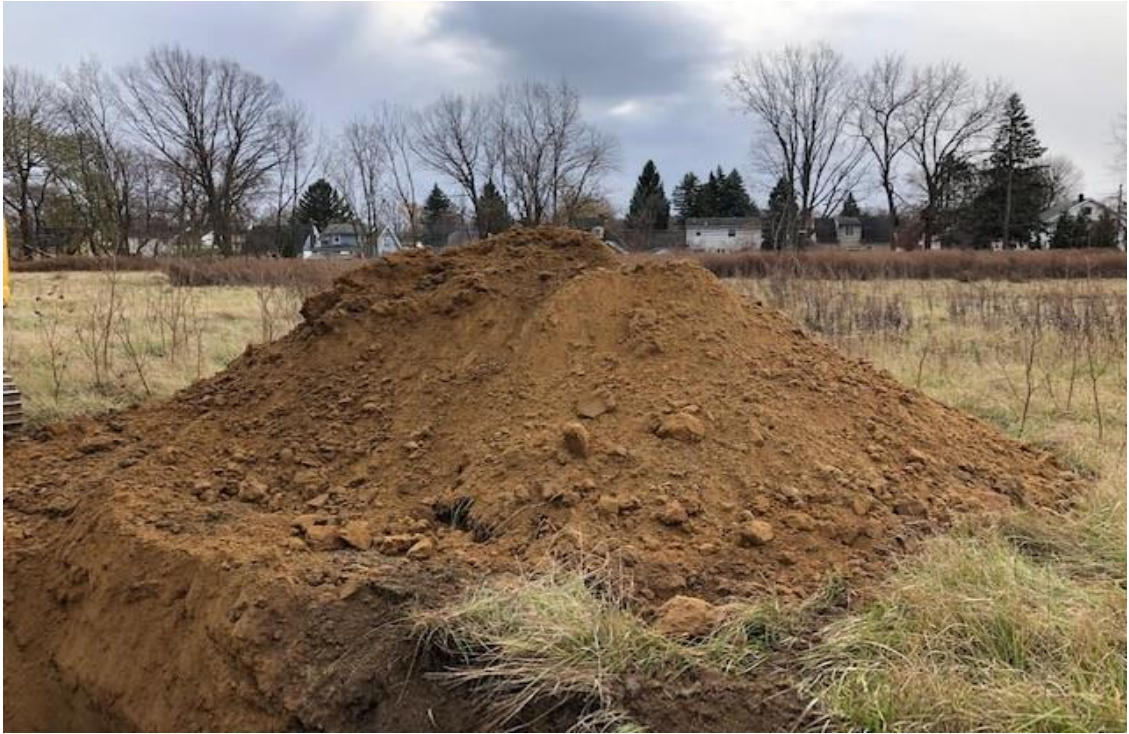
TP20-17 native Lacustrine sand

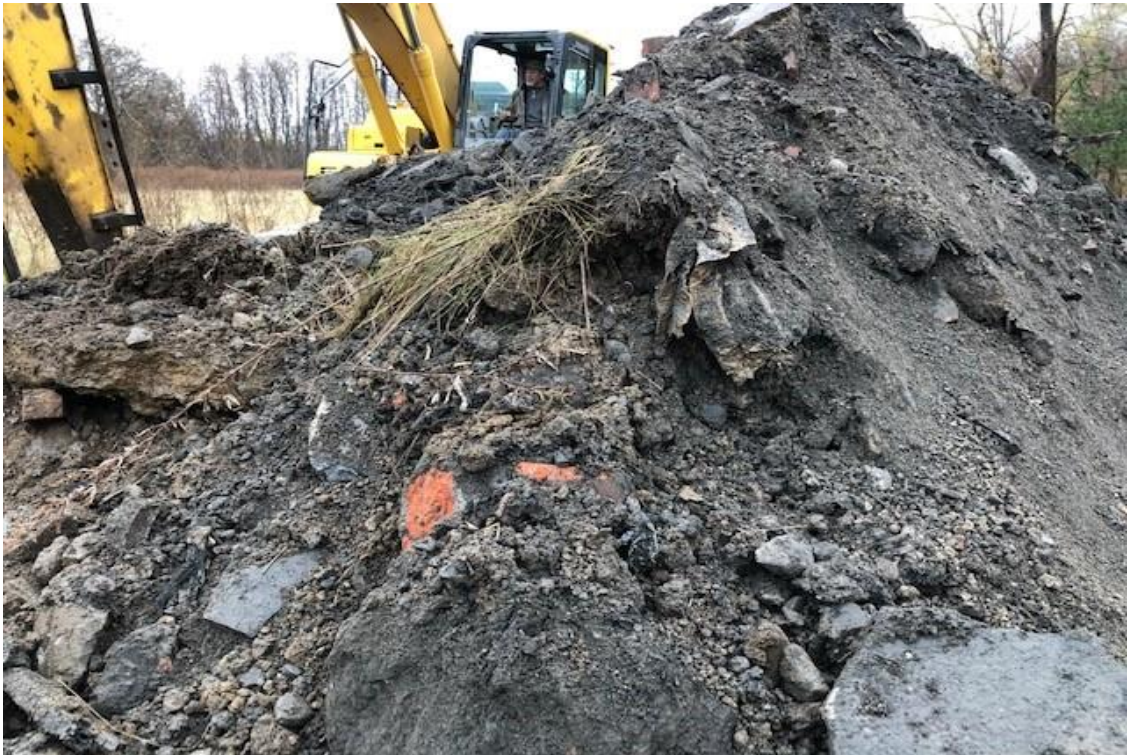
TP20-23 landfilled fill soils/fill materials

1. Additional subsurface investigation is recommended to characterize the nature and extent of the landfilled materials and their impacts on soil, groundwater, and soil gas quality. The results would be used to evaluate remedial alternatives with subsequent preparation of a site management plan/site excavation plan.
2. Future subsurface investigations should be coordinated with New York State Department of Environmental Conservation (NYSDEC), New York State Department of Health (NYSDOH) and other agencies typically
