Remedial Investigation Work Plan

80 Lyndon Road

Brownfield Cleanup Program Site

NYSDEC Site No. C828230

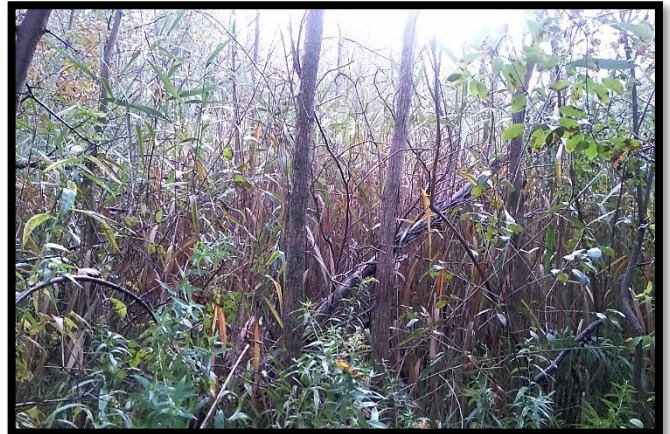
Photo 2: Facing east. Depicts the scrub-shrub swamp community of W1 data point D2. 10/17/23

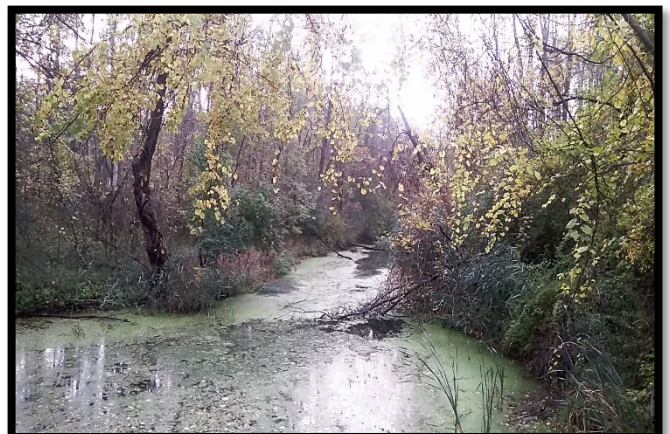
Photo 4: Facing southeast. Depicts Stream 1. 10/17/23

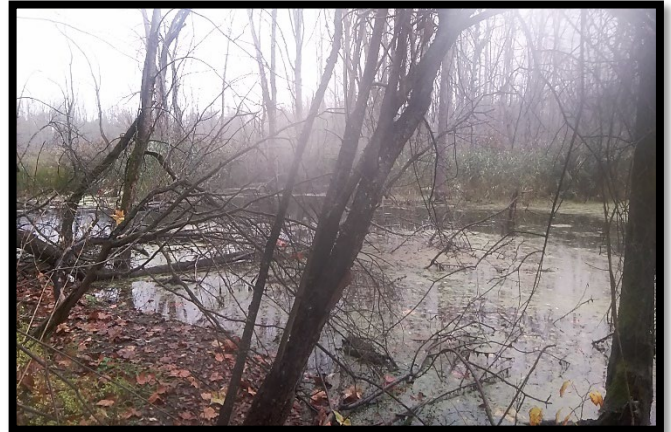
Photo 8: Facing east. Depicts the deep emergent marsh community of W1 at data point D7. 10/17/23

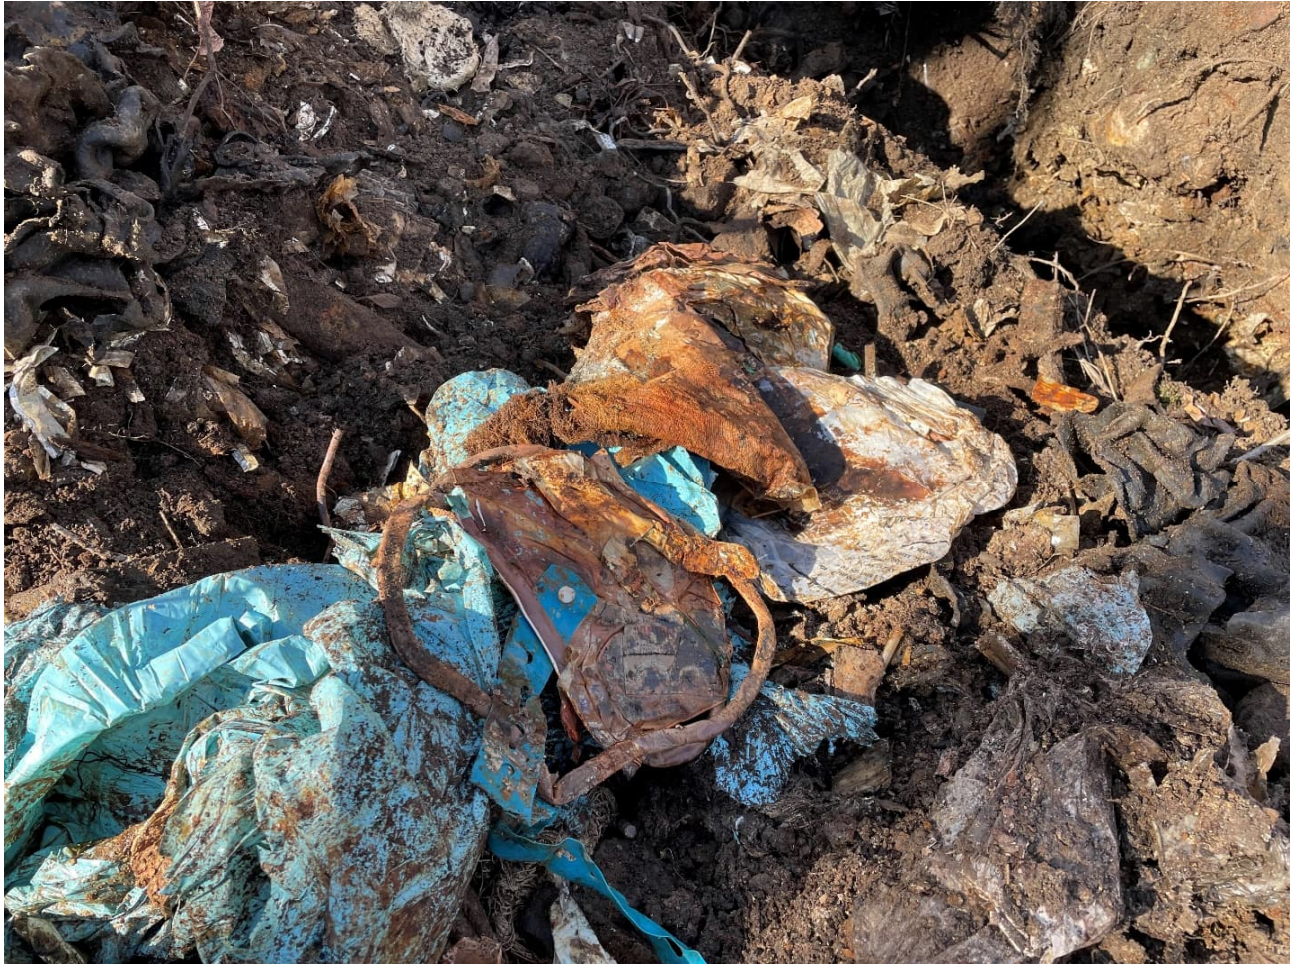
Photograph No. 1: Observed medical waste in Test Pit #3 (March 03, 2023).
Note: what appears to be, tubing, IV bag, and stained bedding or gauze.

During the test pitting, several red and blue plastic bags containing what appeared to be medical waste³, were unearthed in two locations and observed during the geotechnical test pitting conducted by 80 Lyndon Rd., LLC. The location of the observed medical waste are shown on Figure 3. In a third location, a semi-intact 55-gallon steel drum was discovered. The drum contained unknown material, solids, and liquids, which were sampled and contained elevated levels of VOCs and SVOCs. These discoveries indicate the landfill was used for disposal of other waste besides the intended use of disposal of boards, wooded debris, and rubble. A sample from the drum contained 2-Butanone (MEK), Ethylbenzene, Toluene, m,p-Xylene, o-Xylene, Xylene, Benzo(a)anthracene, Benzo(a)pyrene, Benzo(b)fluoranthene above industrial SCOs and Benzo(b)fluoranthene, Chrysene, and Indeno(1,2,3-cd) pyrene at above restricted residential SCOs (Table 5, Table 5A, and Table 5B). Based on the information provided to Inventum, the materials did not exhibit the characteristics of toxicity, and therefore were not a hazardous waste.

- Potential medical waste⁶ consisting of medical tubing, bedding, baby bottles, IV bags, bandages, and stained bedding and gauze have been identified buried on the property and the source and potential influence of those materials is unknown. No potential medical waste is exposed at the ground surface.

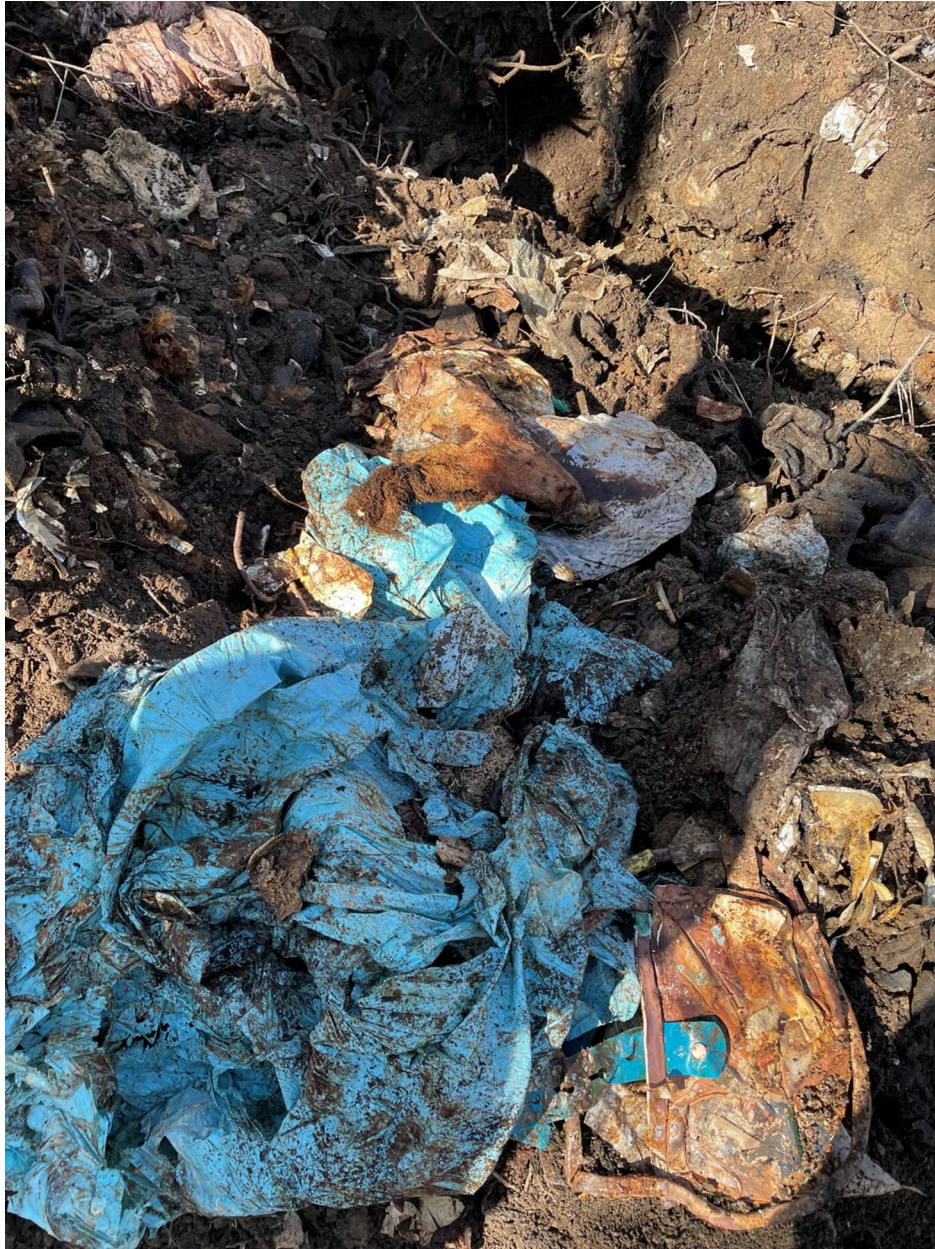
Photograph No. 2: Observed medical waste at Test Pit #3 (March 03, 2023).
Note: what appears to be blue linens/medical waste bag, bedding or gauze material, tubing and IV bag.

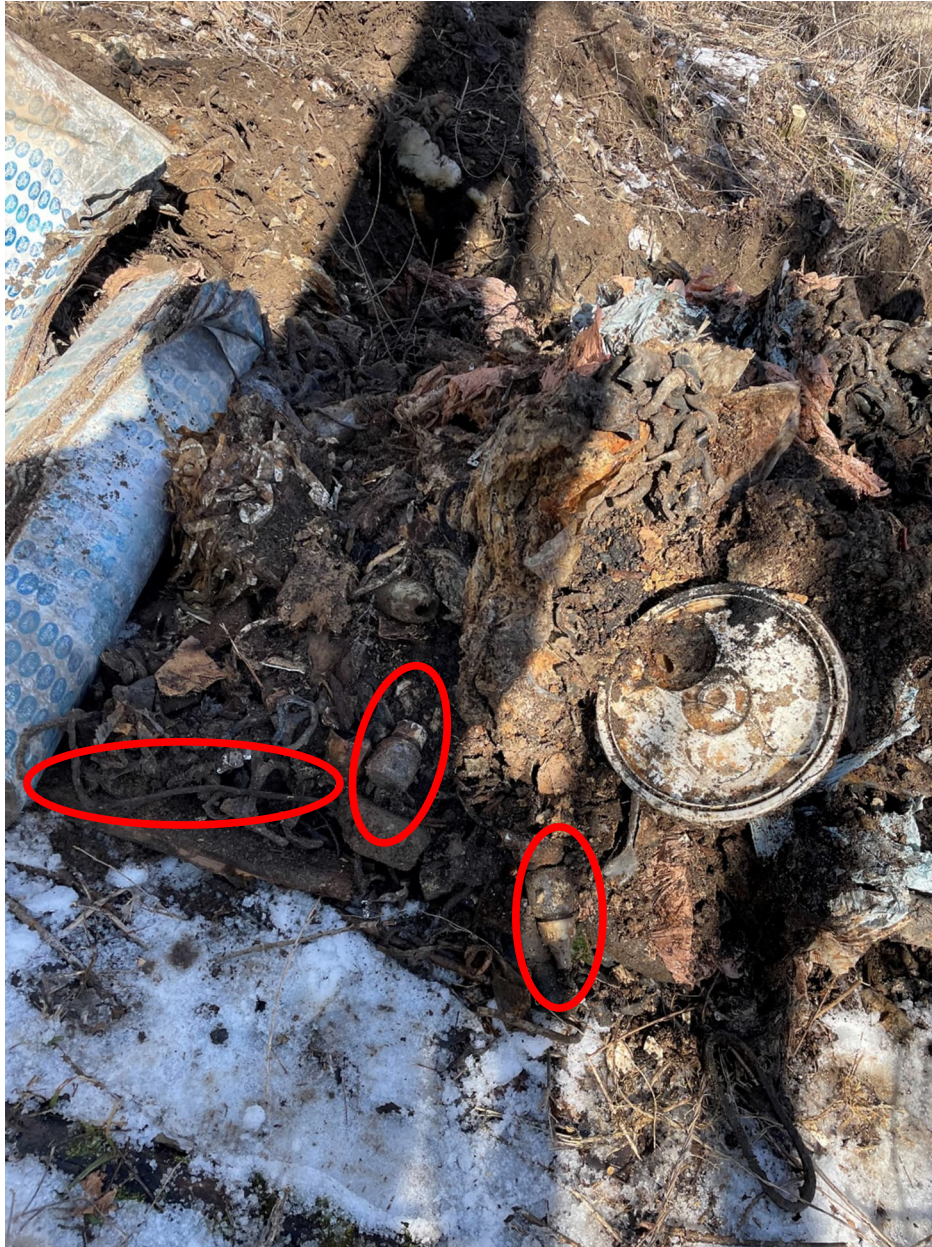
Photograph No. 3: Observed medical waste at Test Pit #3 (March 03, 2023).
Note: Observed baby bottles and medical type tubing circled in red.

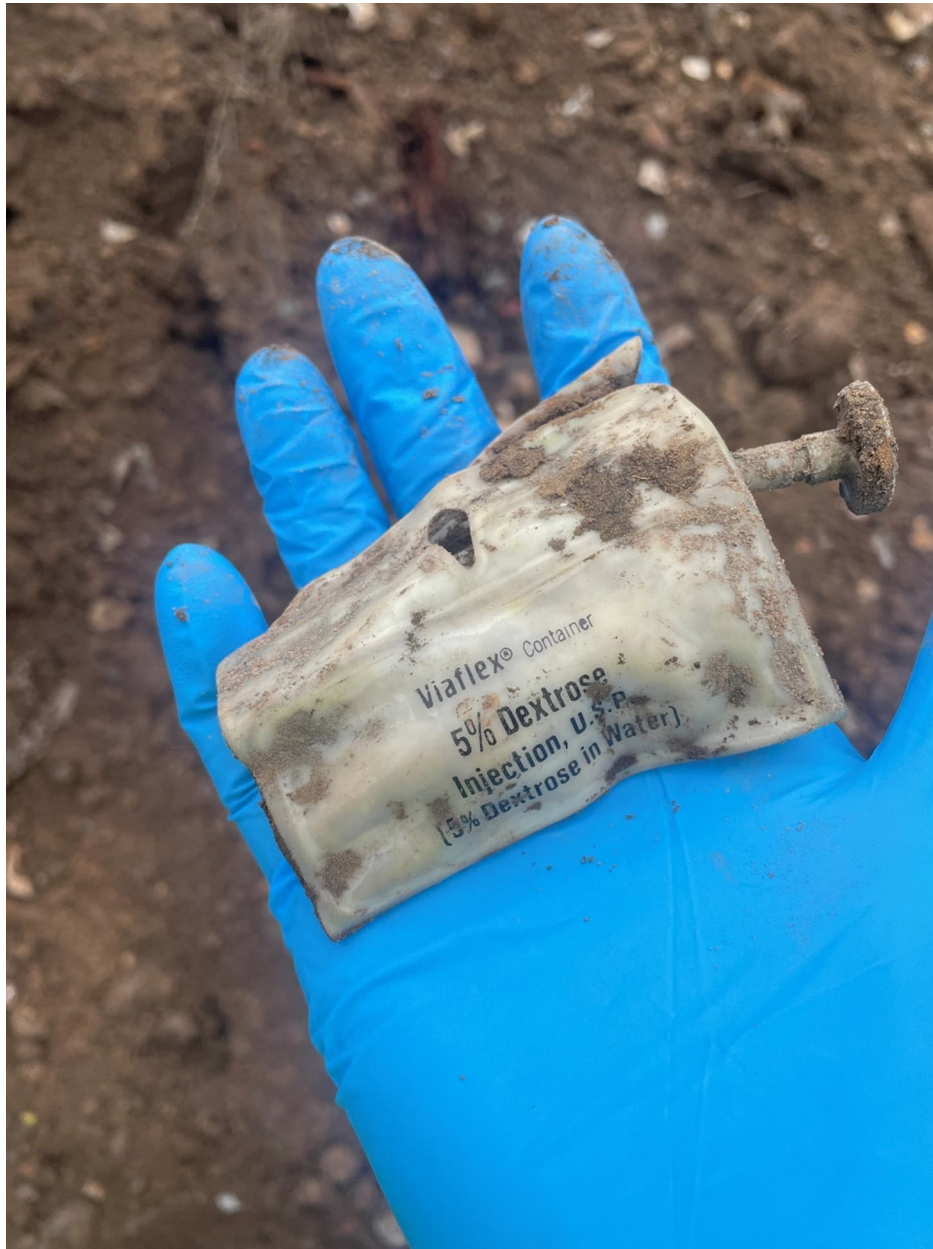
Photograph No. 4: Observed medical material in vicinity of Test Pit GEO-TP-02 (January 29, 2024).

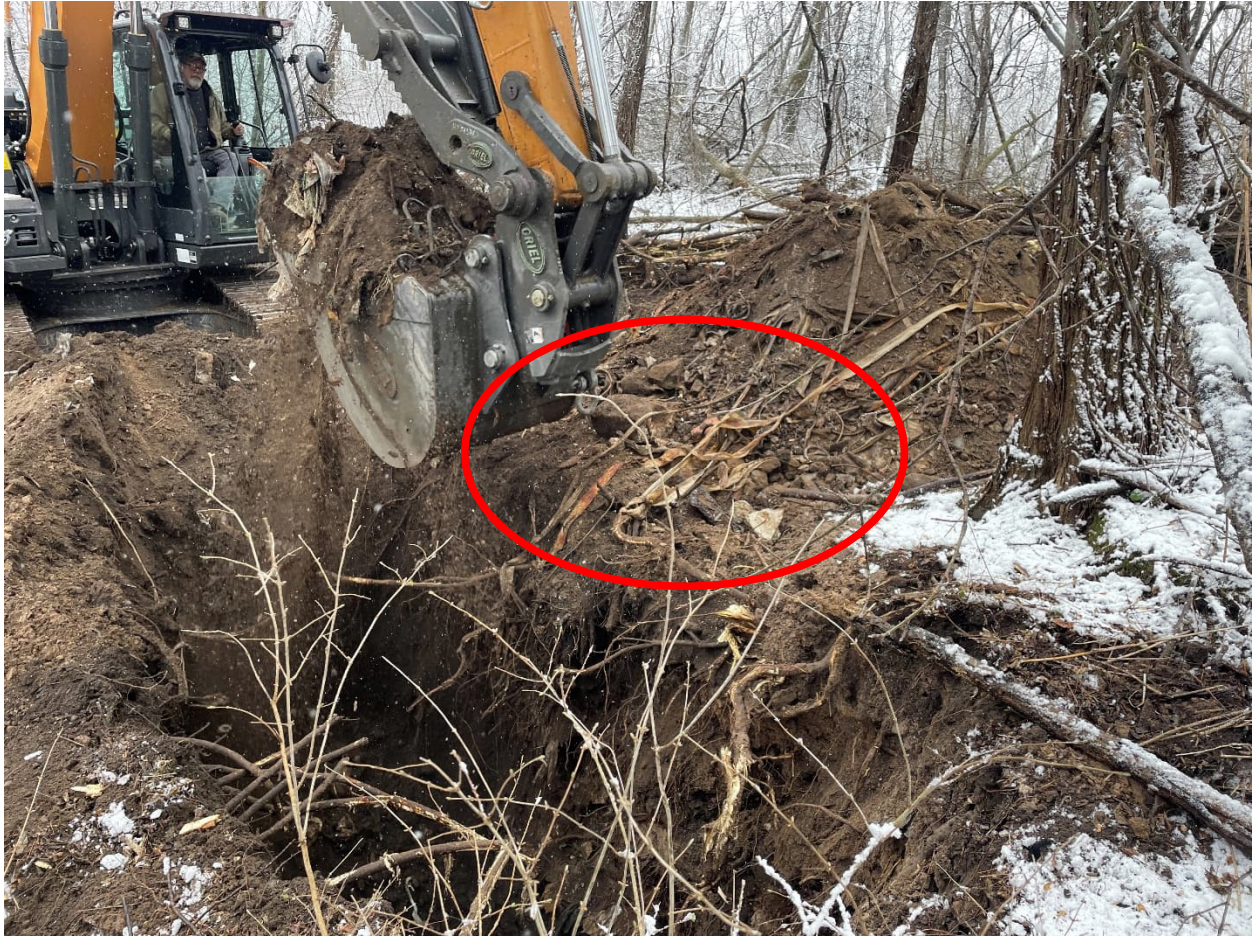
Photograph No. 5: Observed medical waste in Test Pit GEO-TP-04 (January 29, 2024).
Note: Observed what appears to be several feet of stained gauze or bandage wrappings.
