**PERIODIC REVIEW REPORT
FORMER GRIFFIN TECHNOLOGY SITE
BCP SITE # C835008
DECEMBER 2011**

SECTION I - INTRODUCTION

The Former Griffin Technology property is located at 6132 Victor-Manchester Road, Ontario County, Farmington, New York. Griffin Technologies released small quantities of trichloroethene (TCE) on the ground surface near the west side of their manufacturing facility. Over time these releases impacted groundwater.

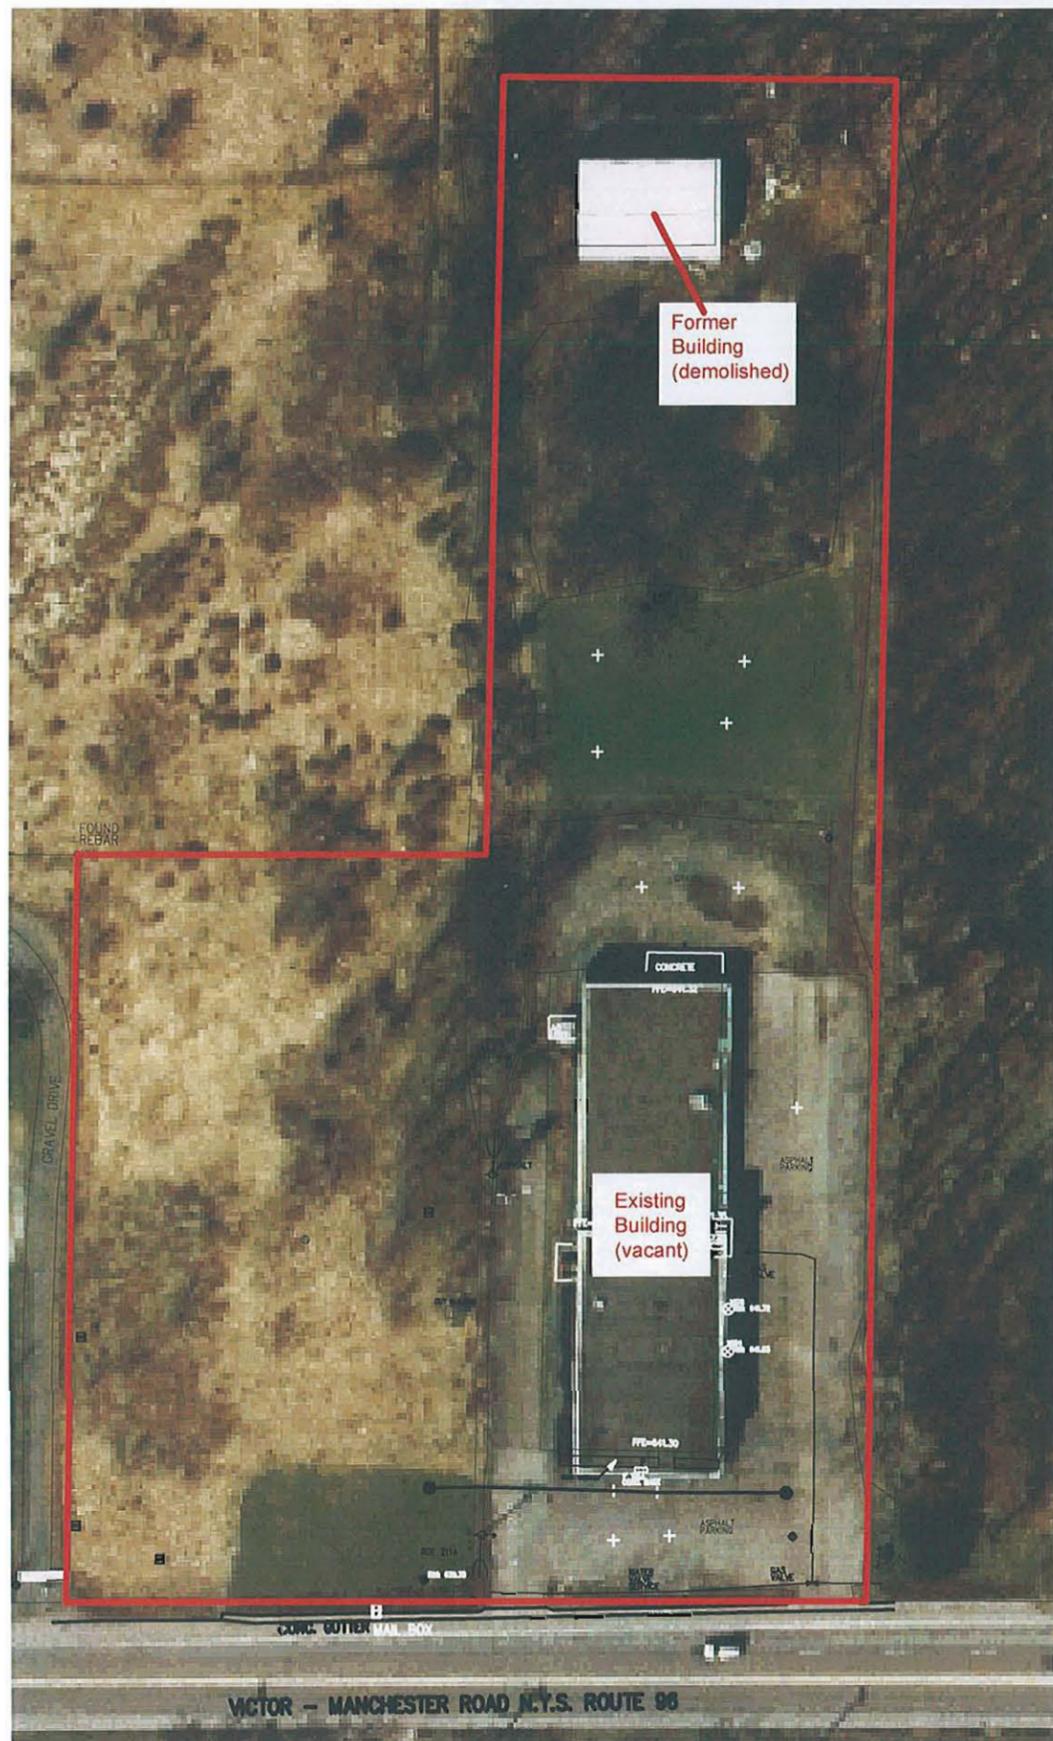
S&W Redevelopment of North America, LLC. Syracuse, New York DATE: 12/2011 JOB No: B6003	Periodic Review Report Former Griffin Technology Site, BCP # C835008 6132 Victor Manchester Road Farmington (T), Ontario (C), New York
	Figure 1 Site Plan

The Former Griffin Technology BCP site consists of 3.64 acres and historically included two (2) abandoned buildings consisting of a former manufacturing building encompassing a footprint of approximately 12,000 ft² and a separate storage building encompassing a footprint of approximately 2,400 ft². The 2,400 ft² storage building has been demolished and only the concrete slab on grade remains. The Brownfield Cleanup Agreement (BCA) describes the site as consisting of Tax Parcel 29.00-1-12 and the southern quarter of parcel 29.00-1-76-1. The site is immediately bordered by a wooded area to the north, Victor-Manchester Road to the south, a wooded area to the east, and an auto repair facility to the west (Figure 1). Griffin Technology operated on the site from 1975 until the mid-1990s performing photocopying (laminating) operations.
