**G.W. Lisk Facility**  
**2 SOUTH STREET, VILLAGE OF CLIFTON SPRINGS,**  
**ONTARIO COUNTY, NEW YORK**

**Final Soil Vapor Intrusion**  
**Interim Remedial Measure**  
**Construction Completion Report**

**NYSDEC Site Number: C835026**

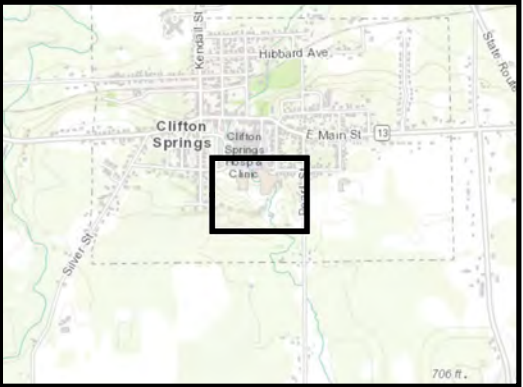
**Figure 3-1A: Soil Vapor Pre-Mitigation Sampling Results**  
G.W. Lisk  
2 South Street, Clifton Springs, NY

ERM completed sub-slab soil vapor and indoor air samples during the SC effort in May of 2017. Additional AOPCs were identified, and a supplemental sampling effort was undertaken in August of 2018. These samples were used as the basis to determine which areas of the building were most likely to be impacted by SVI due to sub-slab soil vapor CVOC concentrations and to inform any potential IRM undertaken. G.W. Lisk, ERM, NYSDEC, and NYSDOH met on 6 September 2018 to present and discuss the results. At this meeting, it was proposed that mitigation would be performed in Buildings 4C, 7B, and the Vacuum Furnace Room (i.e., the location of AOPC-05). Additionally, it was agreed that further indoor air sampling would be helpful to evaluate a potential need for mitigation at locations Building 4A and Building 4D. Further sub-slab sampling was also to be performed at two locations, specifically Building 4M and Building 5. Data from the sub-slab and indoor air from these events are shown Figure 3-1A and 3-1B respectively.

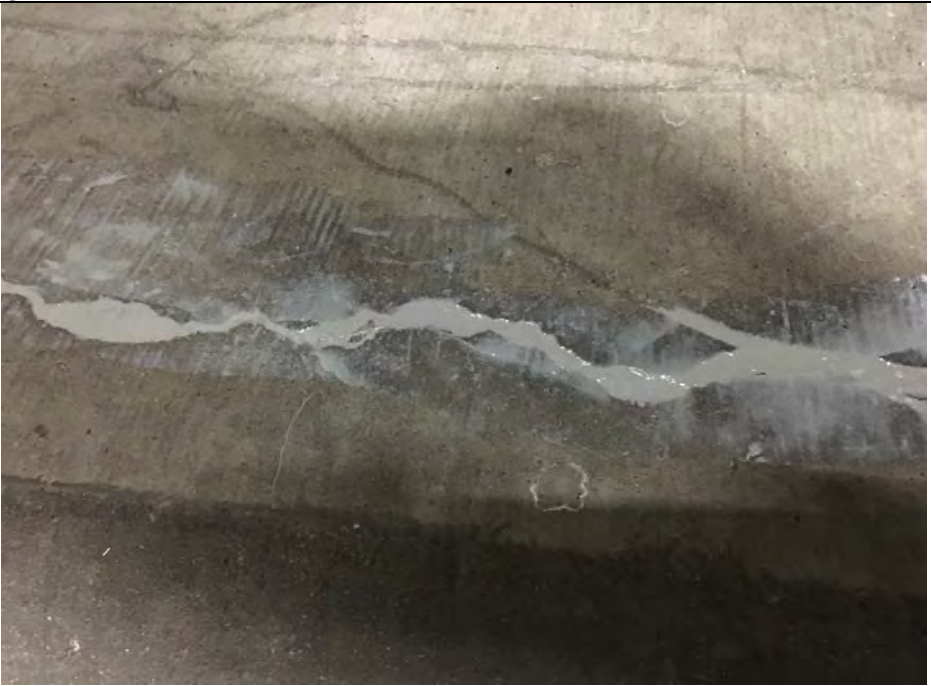
| <b>Photo #:</b> 1 | <b>Date:</b> 3/4/2019 | |

| <b>Description:</b><br><br>Example of sealed floor crack. | | |

Perimeter gaps were sealed with RadonAway® Radon Pro Hybrid Sealant up to the floor grade. The edge of the wall was also coated with the same product to provide continuous coverage from the floor to at least 3 inches up the wall. Gaps at mechanical equipment were sealed similar to perimeter gaps. Utility pits open to the subsurface soil were sealed RadonAway® Radon Pro Hybrid Sealant product. All sealing was performed in accordance with manufacturer's recommendations and was overseen by ERM.

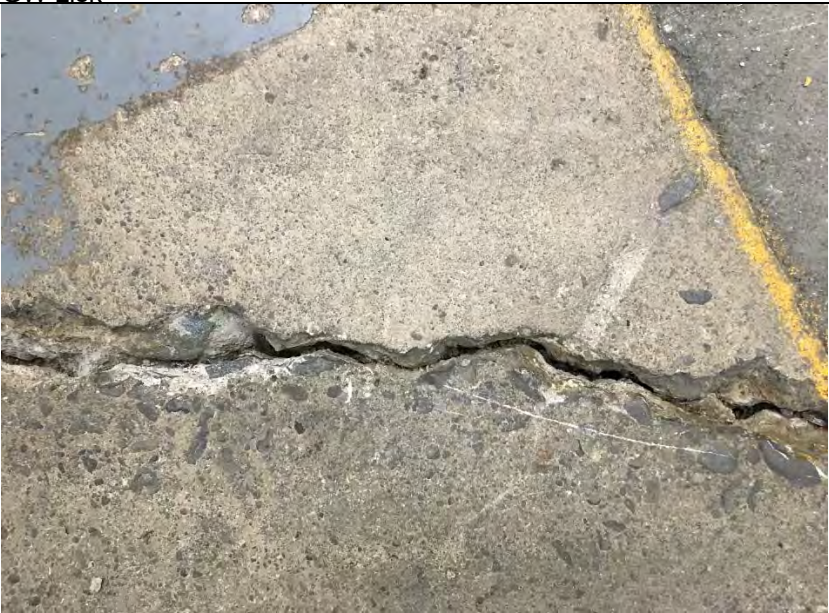
| <b>Photo #:</b> 2 | <b>Date:</b> 3/4/2019 | |

| <b>Description:</b><br><br>Floor crack prior to sealing. | | |

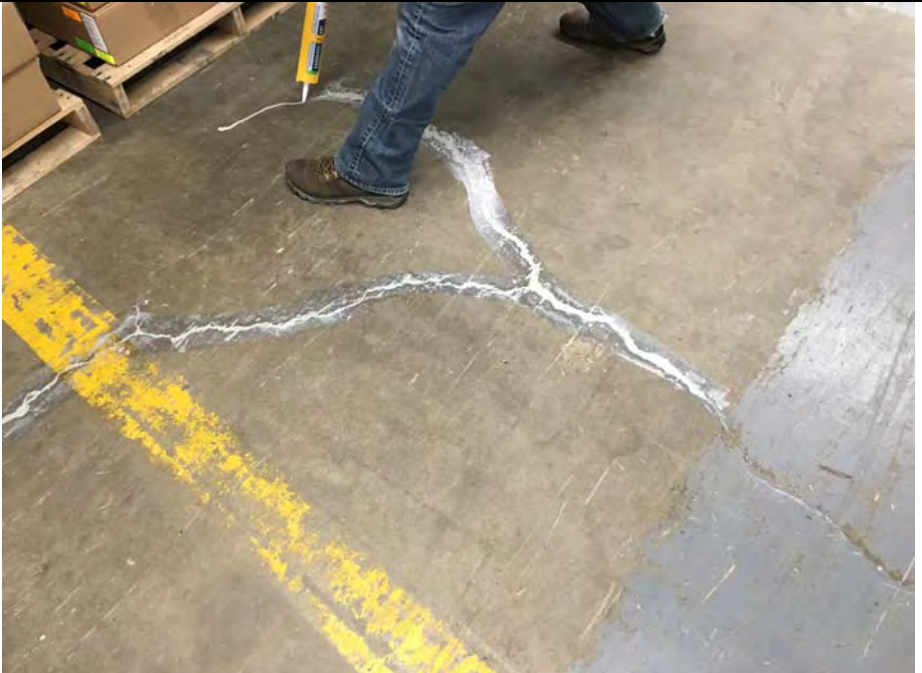
| <b>Photo #:</b> 5 | <b>Date:</b> 3/4/2019 | |

| <b>Description:</b><br><br>Sealing floor cracks in Building 7. | | |

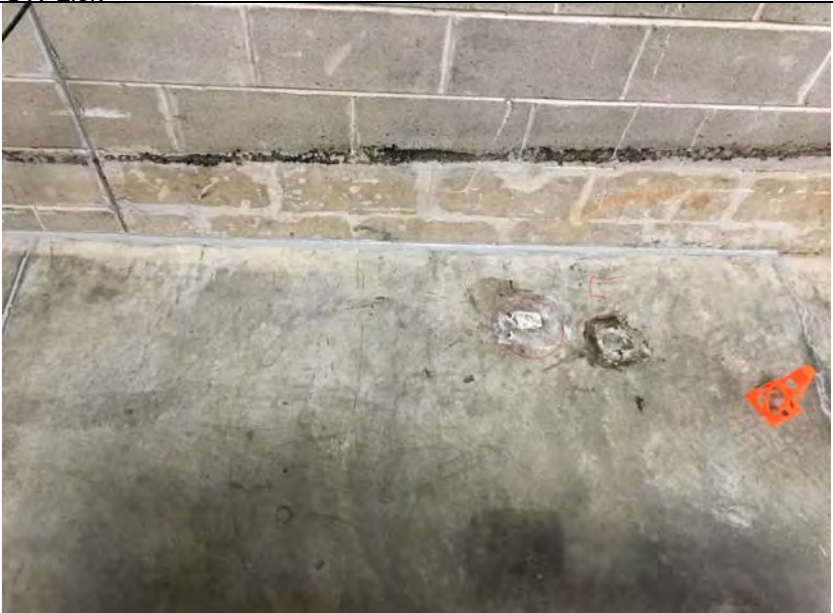
| <b>Photo #:</b> 6 | <b>Date:</b> 3/4/2019 | |

| <b>Description:</b><br><br>Sealed wall joint in Building 7. | | |

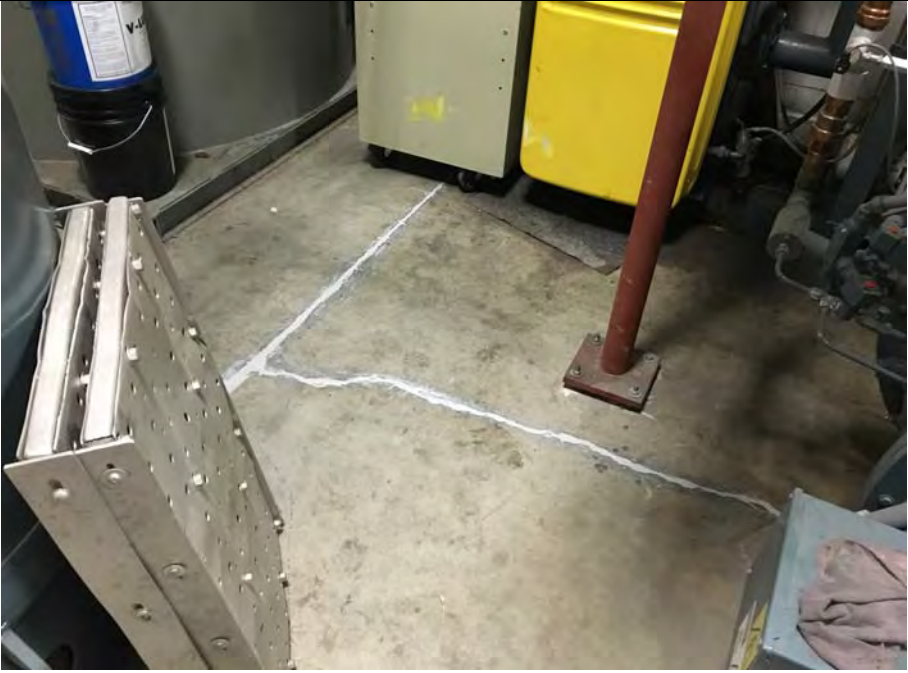
| <b>Photo #:</b> 8 | <b>Date:</b> 3/4/2019 | |

| <b>Description:</b><br><br>Sealed cracks and floor joints in Building 7A. | | |

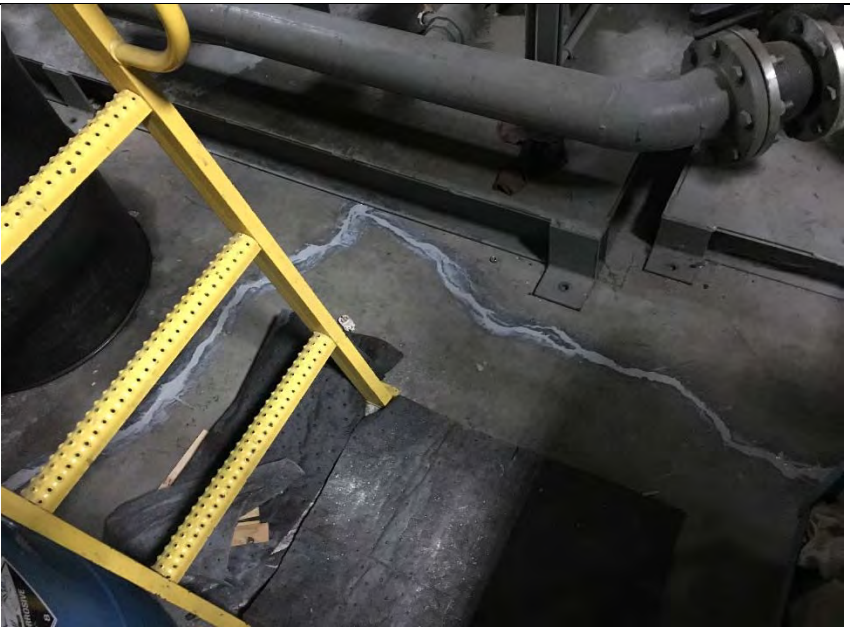
| <b>Photo #:</b> 9 | <b>Date:</b> 3/4/2019 | |

| <b>Description:</b><br><br>Sealed cracks in vacuum furnace room. | | |

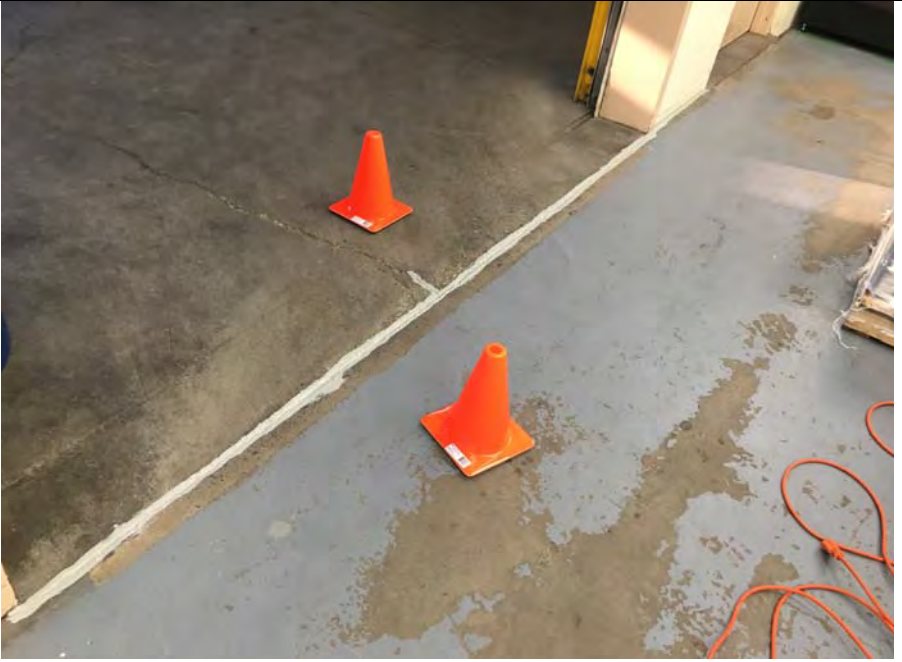
| <b>Photo #:</b> 11 | <b>Date:</b> 3/4/2019 | |

| <b>Description:</b><br><br>Sealed cracks in Building 6. | | |

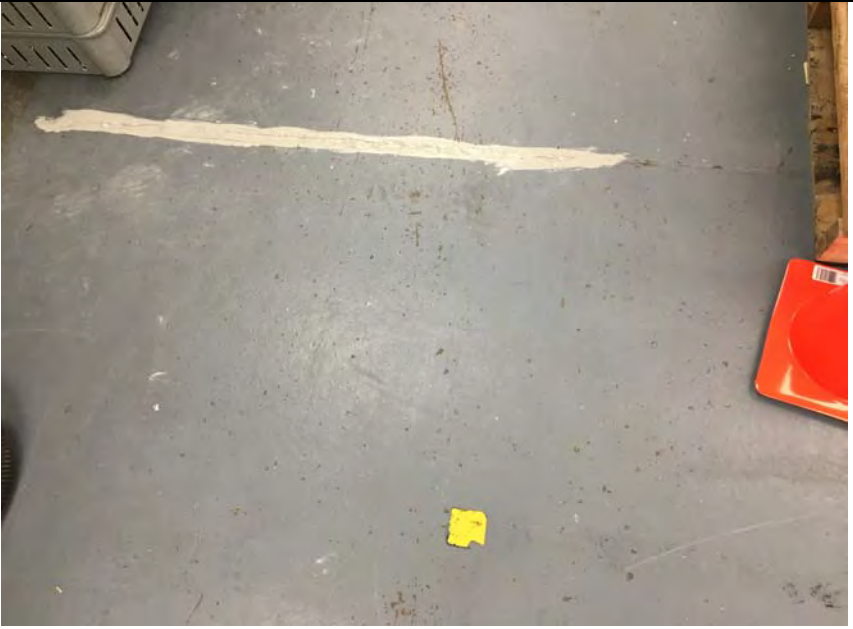
| <b>Photo #:</b> 12 | <b>Date:</b> 3/4/2019 | |

| <b>Description:</b><br><br>Sealed cracks in Building 6. | | |

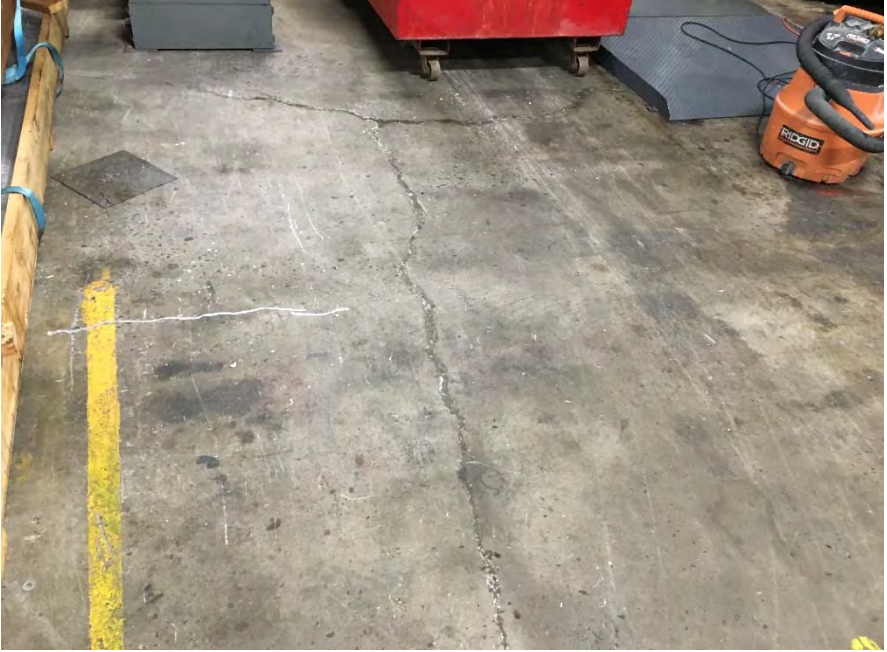
| <b>Photo #:</b> 5 | <b>Date:</b> 3/5/2019 | |

| <b>Description:</b><br><br>Floor crack in Building 7 during sealing activities. | | |

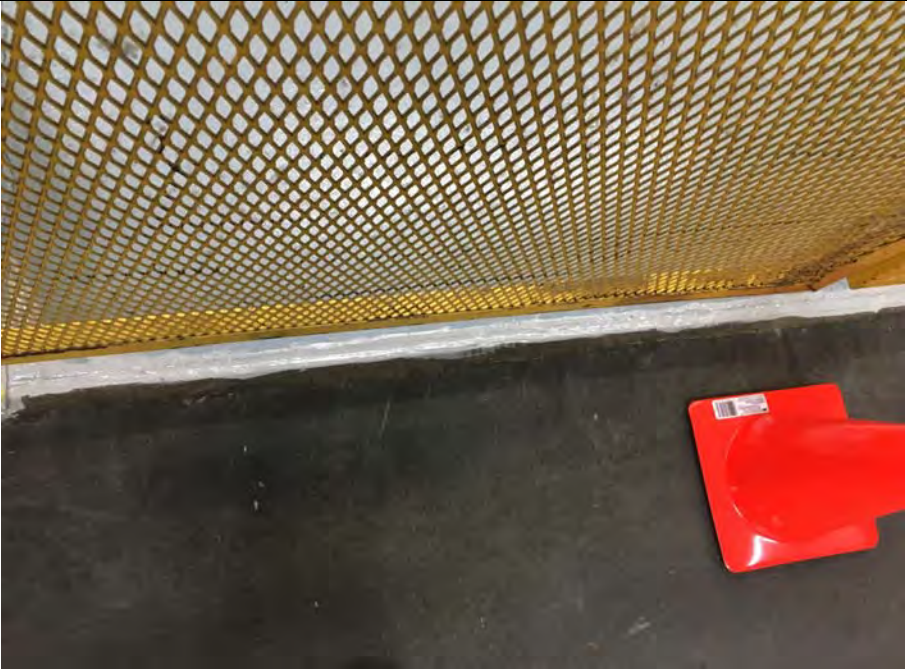
| <b>Photo #:</b> 6 | <b>Date:</b> 3/5/2019 | |

| <b>Description:</b><br><br>Floor joint in Building 6 after sealing.. | | |

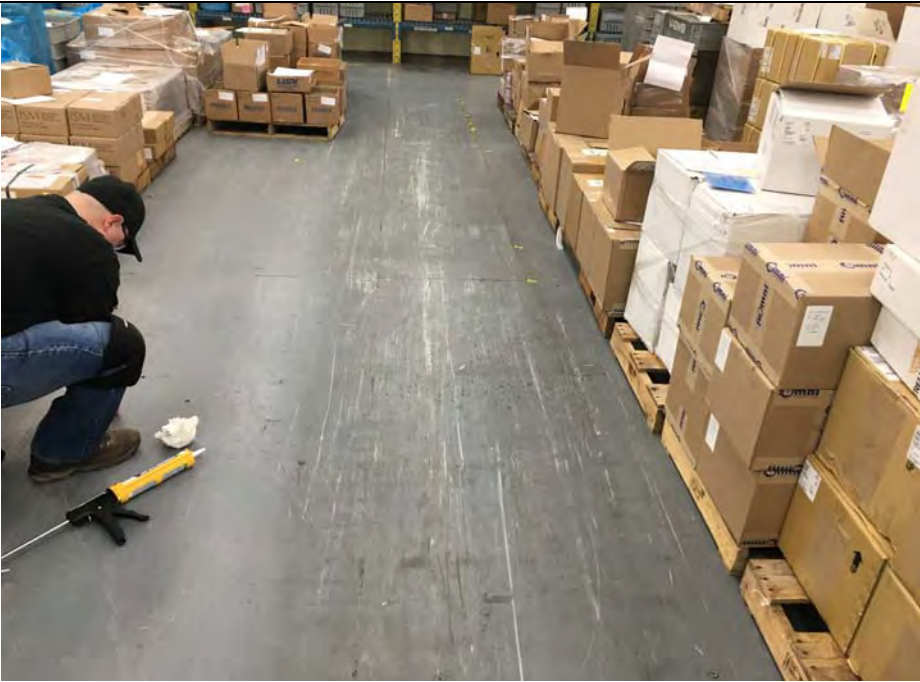
| <b>Description:</b><br>Sealing floor joints and cracks in Building 7. | | |

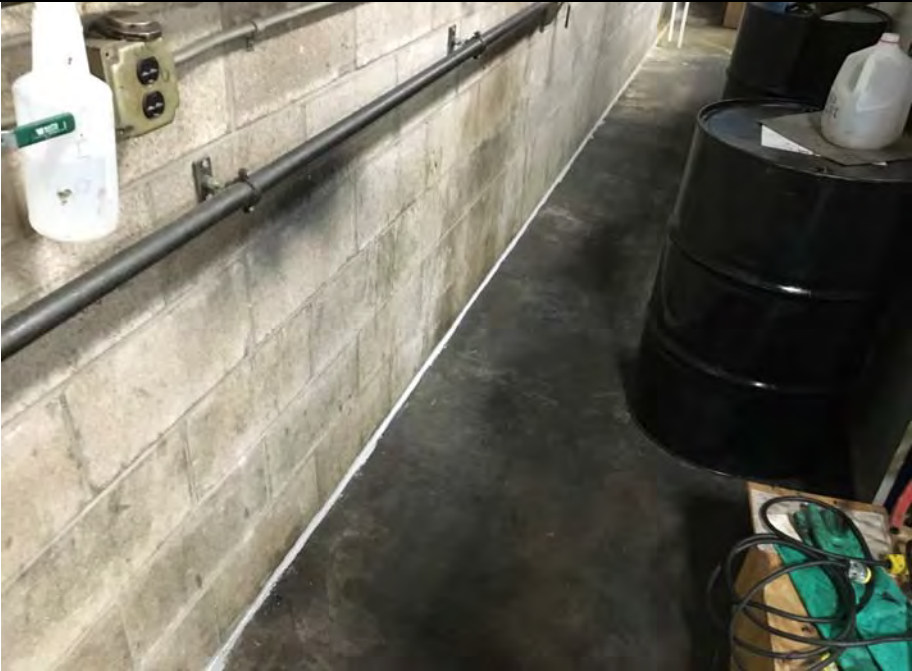
| <b>Description:</b><br>Sealed wall joint in Building 7. | | |

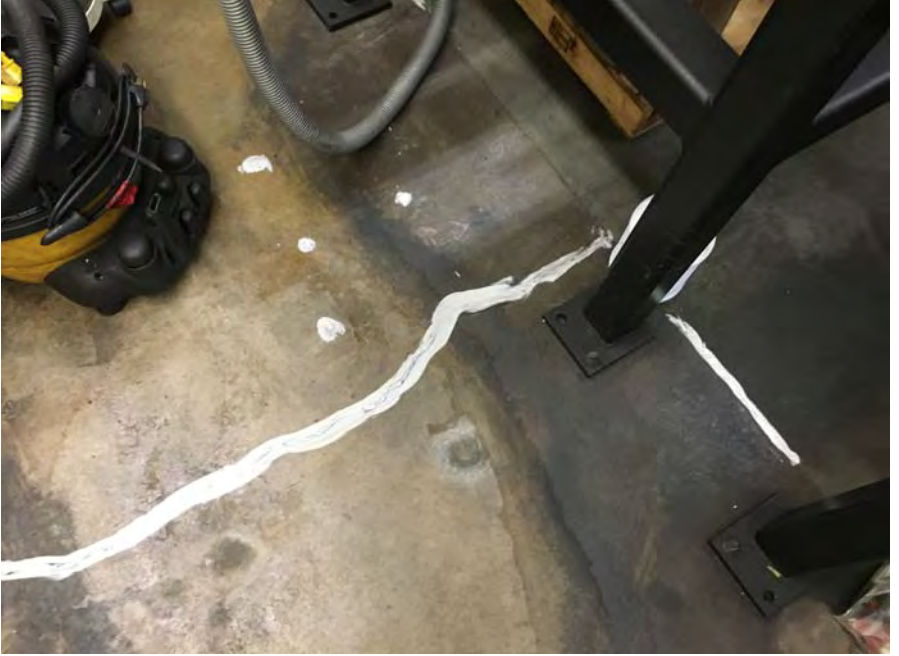
| <b>Photo #:</b> 9 | <b>Date:</b> 3/5/2019 | |

| <b>Description:</b><br><br>Sealed floor cracks in Building 7. | | |

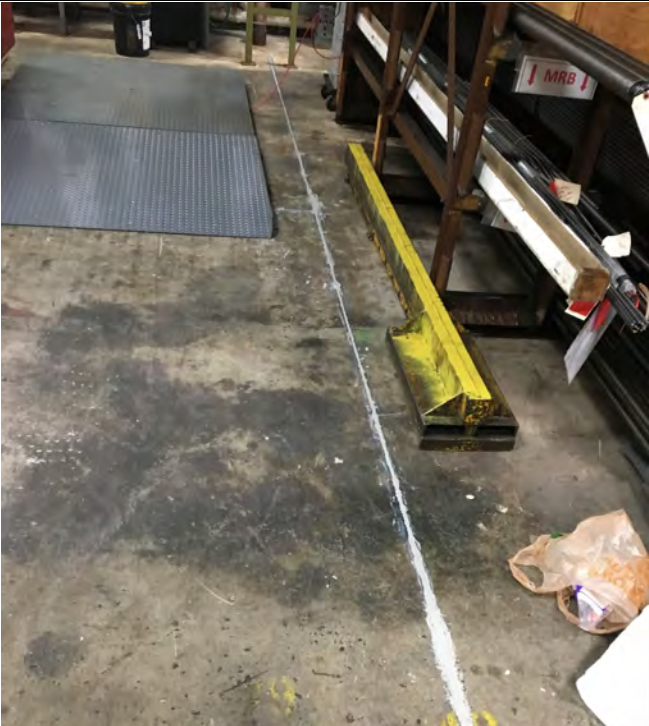
| <b>Photo #:</b> 10 | <b>Date:</b> 3/5/2019 | |

| <b>Description:</b><br><br>Sealed floor joint in Building 7. | | |

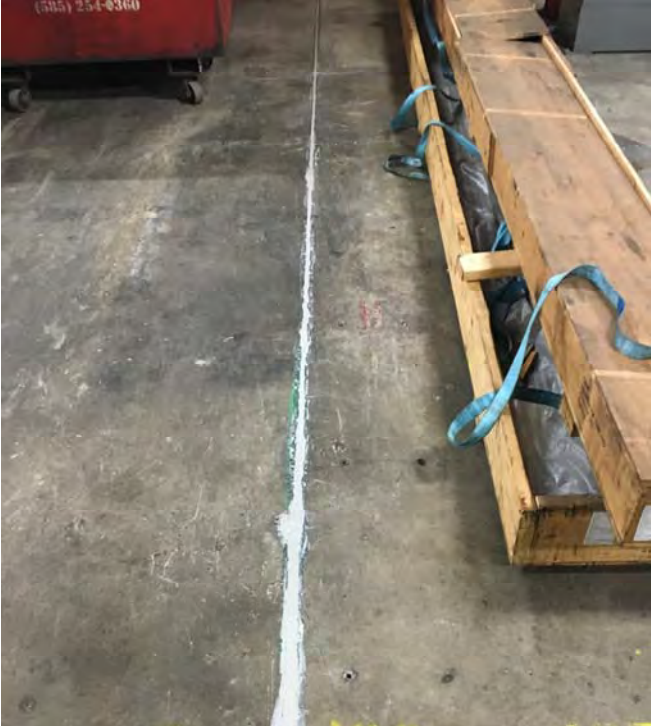
### Soil Vapor

*Mitigate impacts to public health resulting from existing, or the potential for, soil vapor intrusion into buildings at a site.*

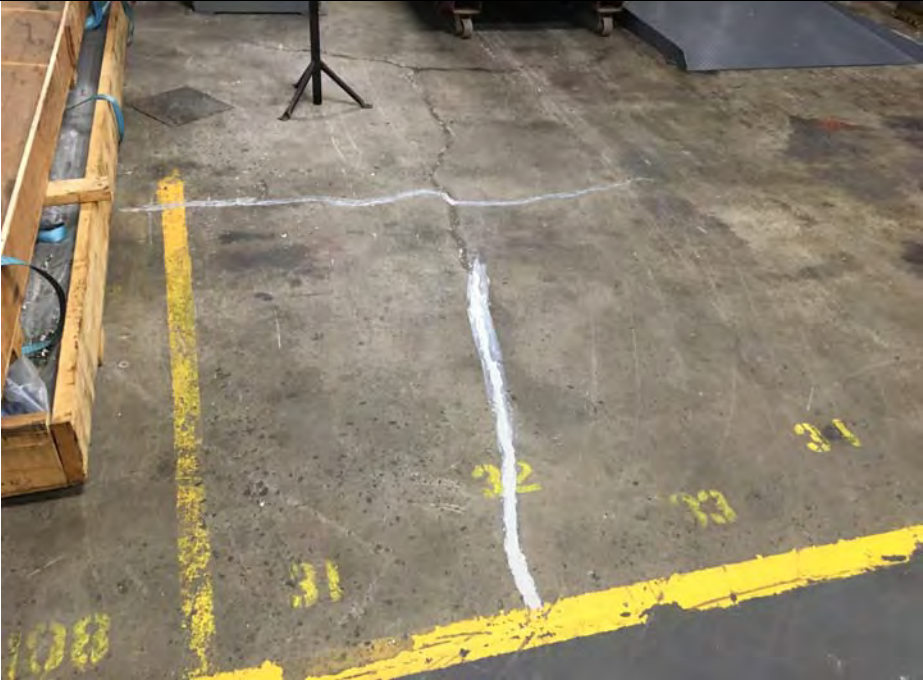
| <b>Photo #:</b> 12 | <b>Date:</b> 3/5/2019 | | |

| <b>Description:</b><br><br>Sealed floor cracks in Building 7. | | | |

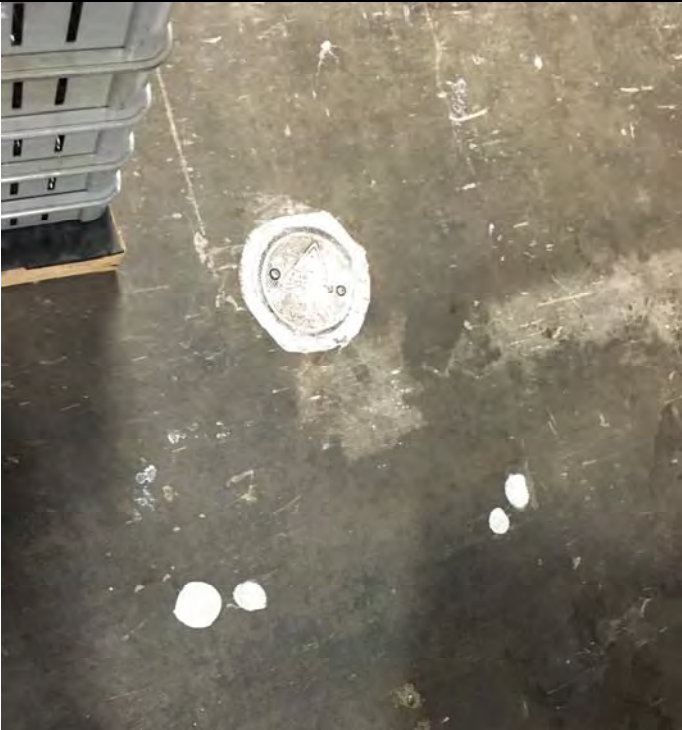
On 7 September 2018, ERM conducted a Site walk with potential mitigation contractors at the Site, and supplemental pre-design sub-slab and indoor air samples were collected in October 2018.

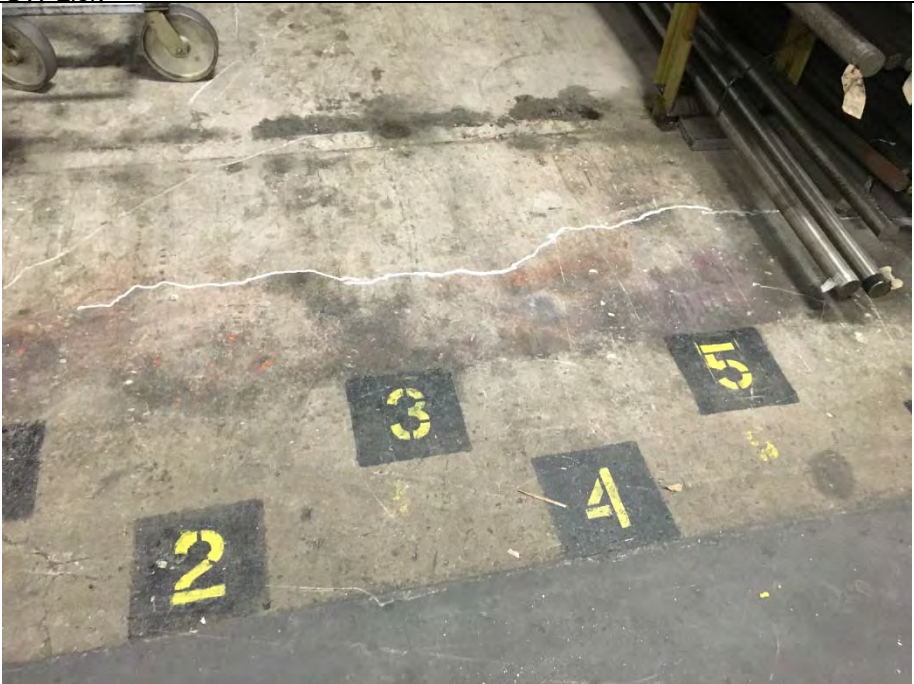
As of June 2020, a total of the following floor cracks and wall joints were filled (approximately) as follows:

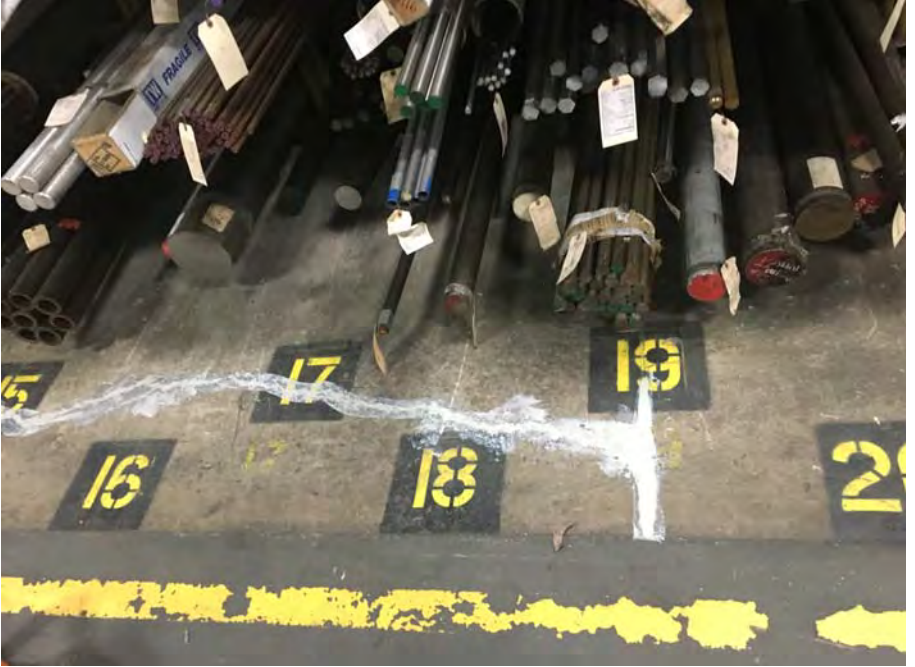
| <b>Photo #:</b> 17 | <b>Date:</b> 3/5/2019 | |

| <b>Description:</b><br><br>Sealed floor cracks in Building 4A. | | |

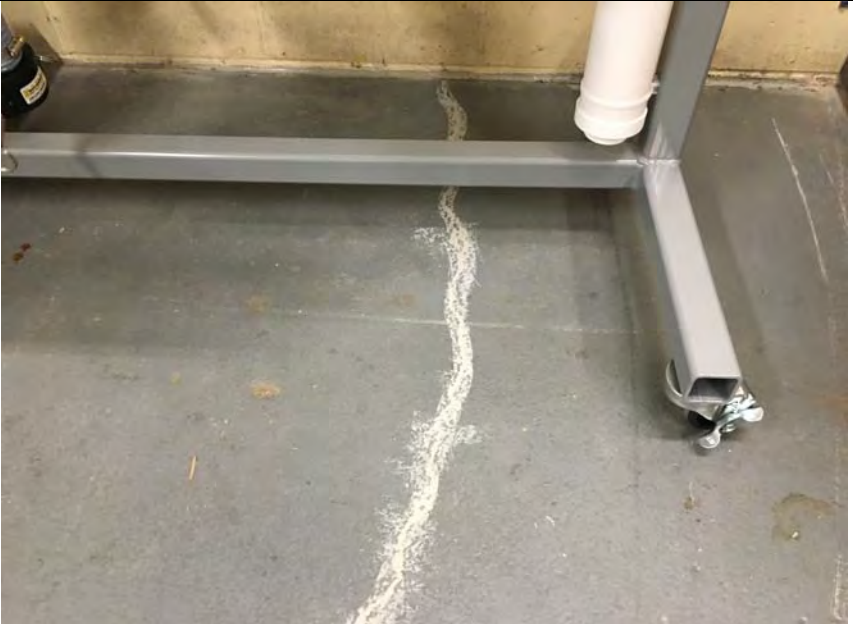
| <b>Photo #:</b> 18 | <b>Date:</b> 3/5/2019 | |

| <b>Description:</b><br><br>Sealed floor cracks in Building 4A. | | |

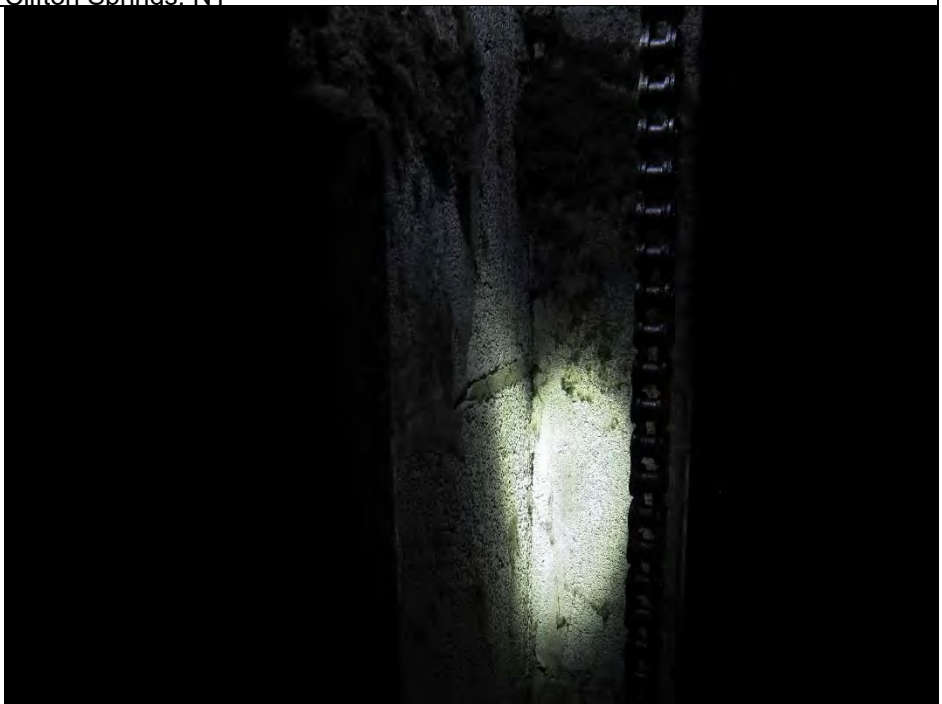
| <b>Photo #:</b> 2 | <b>Date:</b> 19-May-2019 | |

| <b>Description:</b><br><br>Interior wall of Building 7B elevator shaft. | | |

In May 2019, additional mitigation of cracks and floor penetrations was completed in Buildings 6, 7A, and 7B. At this time, the elevator shaft in Building 7B was inspected and additional cracks and floor penetrations were identified. In June and July of 2019, the elevator shaft sump was sealed in the same manner as the building slab in other areas of the building. Subsequently, a second round of post-mitigation indoor air samples were collected only from Buildings 7A and 7B in August 2019. Table 4-5 shows indoor air concentrations remained above  $2 \mu\text{g}/\text{m}^3$  in Buildings 7, 7A, and 7B.

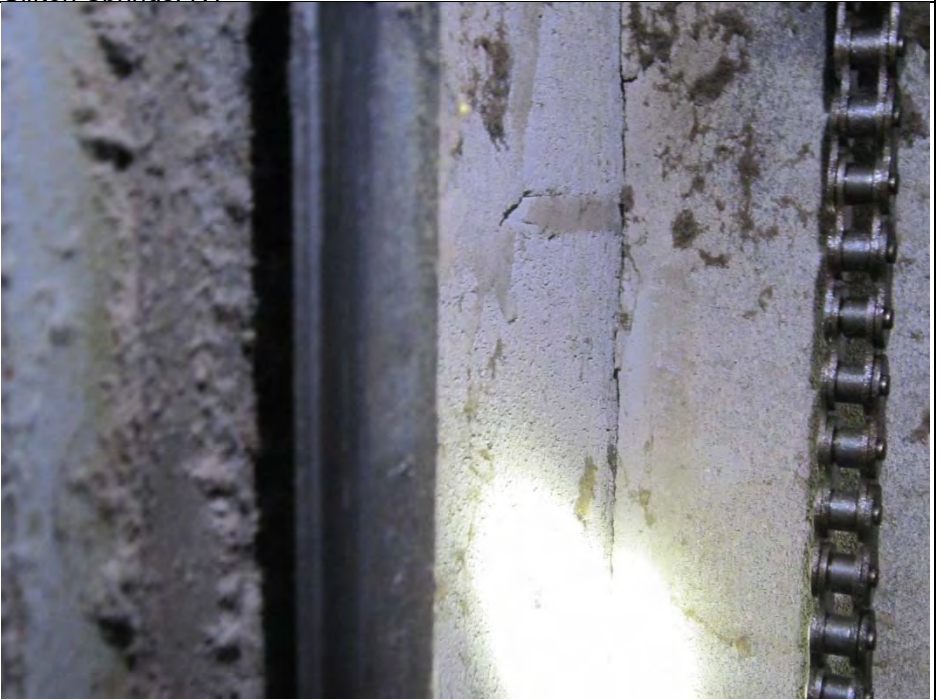
# 4.1 Remedial Program Elements

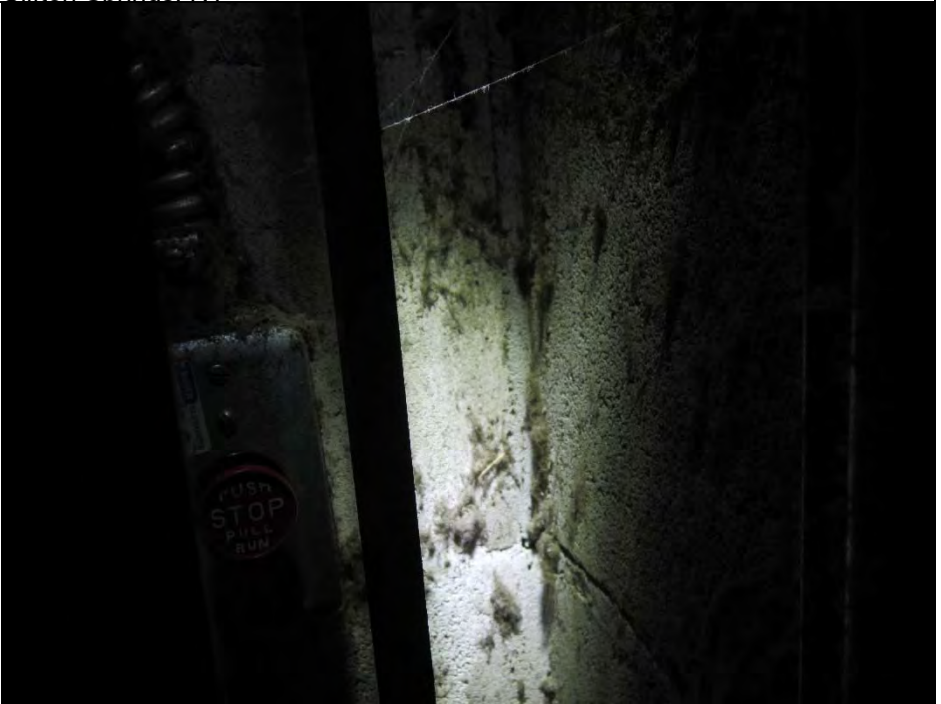
| <b>Photo #:</b> 4 | <b>Date:</b> 19-May-2019 | | |

| <b>Description:</b><br><br>Interior wall of Building 7B elevator shaft. | | | |

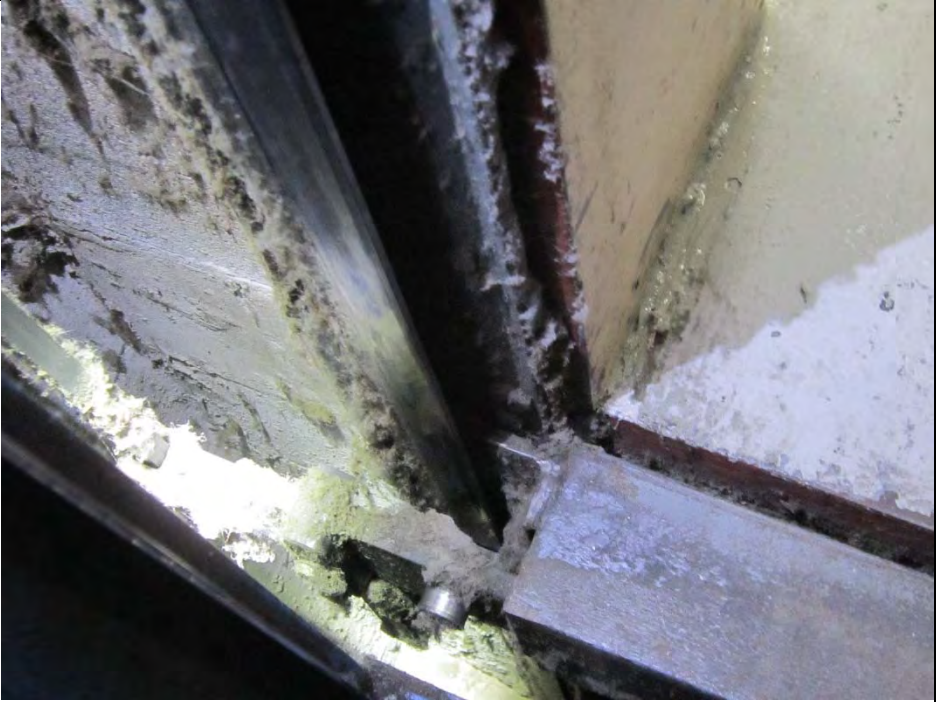
#### 4.1.3 General Site Controls

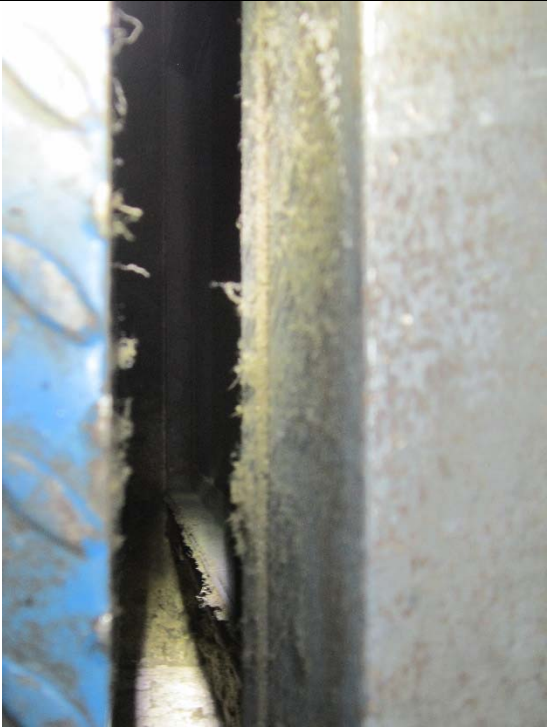
#### 4.1.4 Project Recordkeeping and Reporting

All air sampling information, questionnaires, and building inventories are included in Appendix A. All data has been loaded into an electronic data deliverable for submission to NYSDEC's Electronic Information Management System website. Additionally, all laboratory reports are included in Appendix C. Select photographs taken by ERM personnel have been loaded into photologs and included in Appendix D to assist in visualization of site work and conditions.

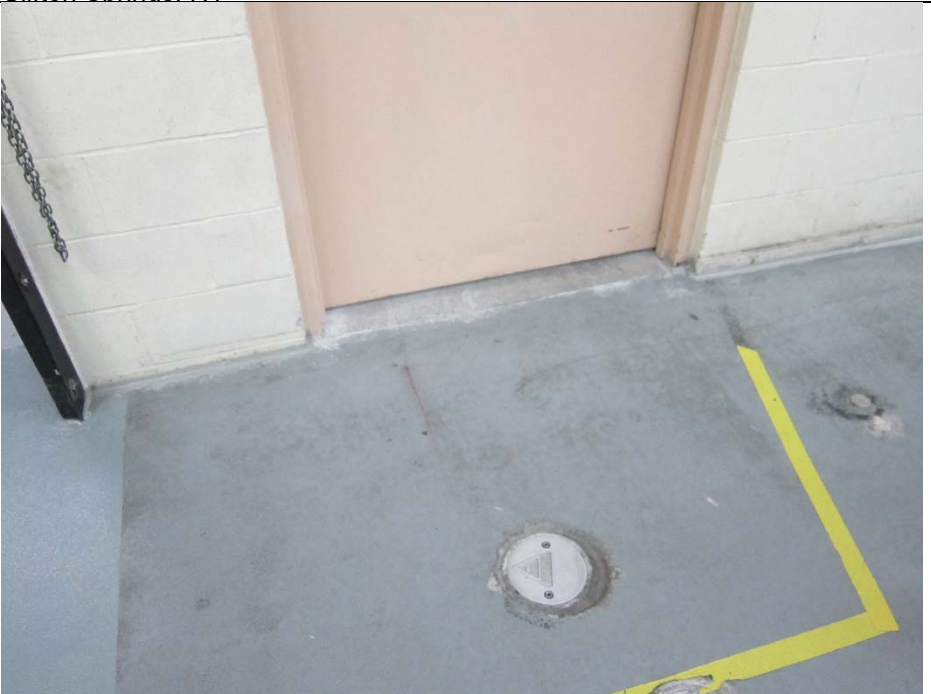
### 5.0.1 First Round Vapor Sampling

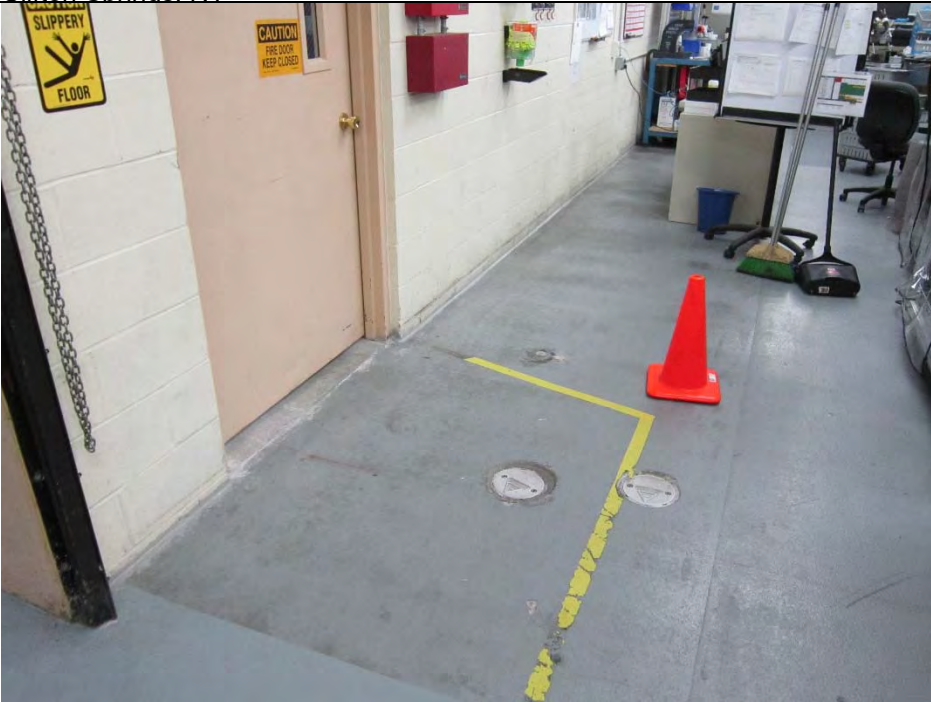
| Environmental Media | Number of Samples | Laboratory Analytical Parameters |

| Environmental Media | Number of Samples | Laboratory Analytical Parameters |
|---|---|---|
| Sub-Slab Vapor | 12 | VOCs by TO-15 |

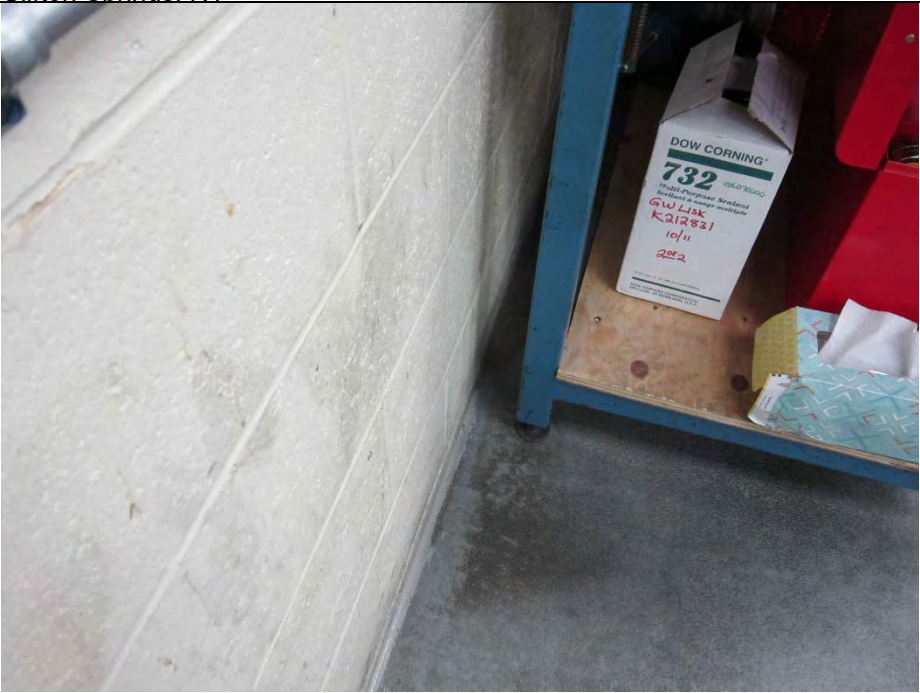
### 5.0.4 Product Sampling and Analysis

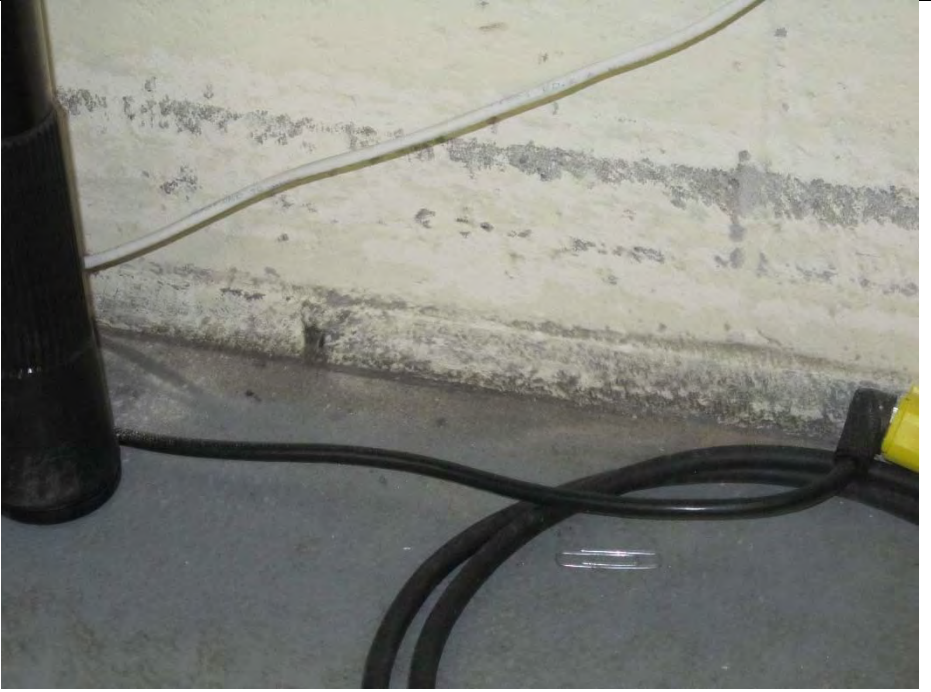
Based upon the detection of TCE and other VOCs in the flux cleaners, OSHA permissible exposure level standards may be used for comparison of indoor air concentrations for TCE and other VOCs used within the facilities.

ERM and G.W. Lisk presented the results of the sampling, along with a description of the mitigation measures completed to date, to NYSDEC and NYSDOC on a conference call on 31 March 2020. Both regulatory agencies were in agreement that SVI IRM sampling and mitigation activities appear to be complete and agreed to proceed towards the preparation of a Draft Construction Completion Report (CCR) and Draft Interim Site Management Plan (ISMP) for NYSDEC and NYSDOH review. A summary of project milestones is included in Table 4-8.

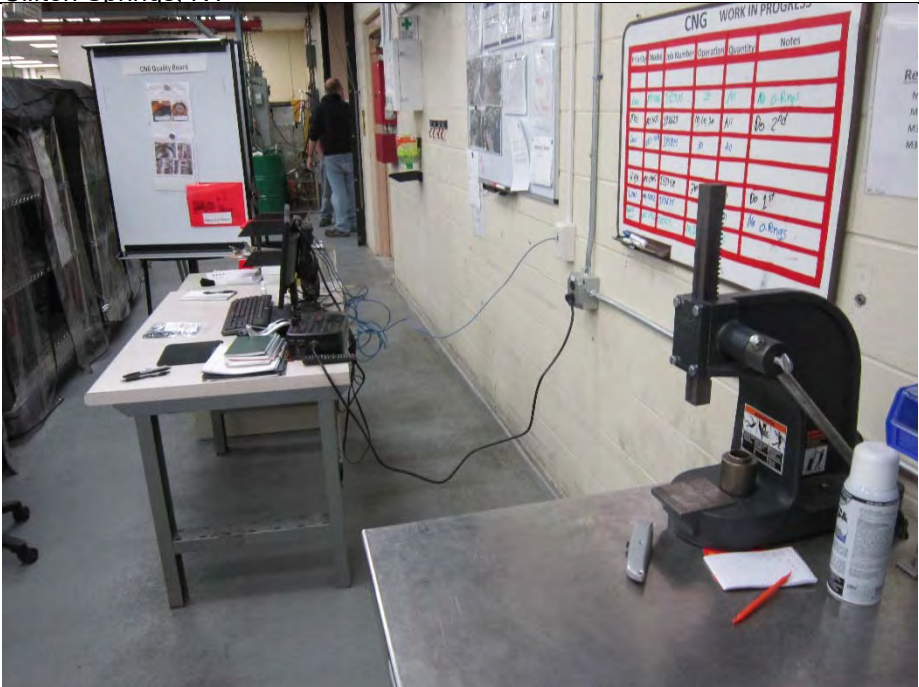
guidance or the associated decision matrices, but rather to industrial worker safety guidance, including the OSHA permissible exposure levels.

- The surficial sealing product DRYLOK was utilized within the elevator shaft in 7B. This product is low VOC, and a catalog cutsheet is included in Appendix F.

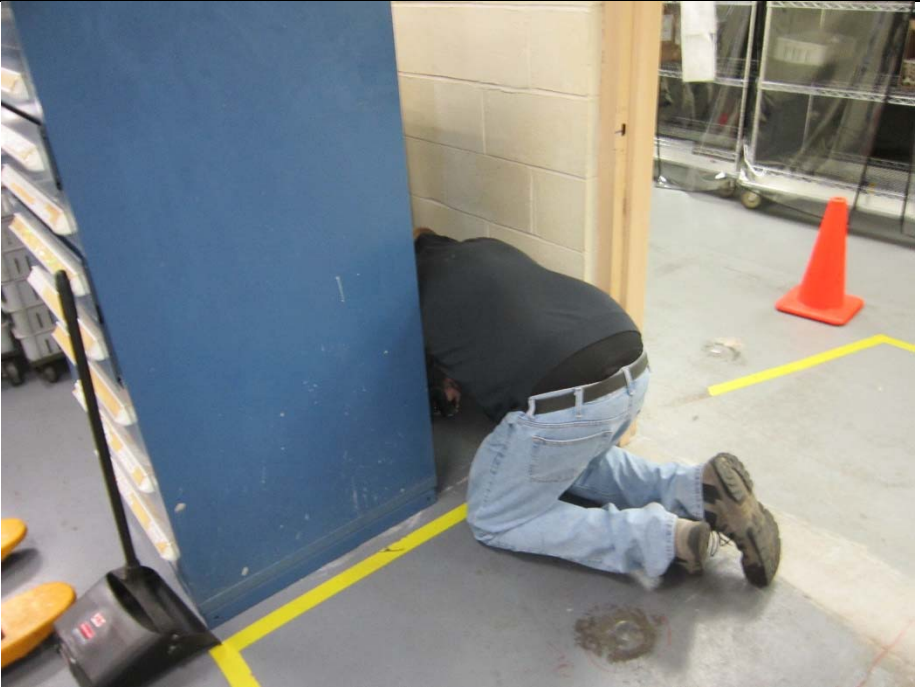
## 10.0 REFERENCES CITED

- ERM, 2016. *Final Site Characterization Work Plan, G.W Lisk Facility – 2 South Street, Village of Clifton Springs, Ontario County, New York. NYSDEC Site Number 835026.* ERM Consulting & Engineering, Inc. Syracuse, January 2016.

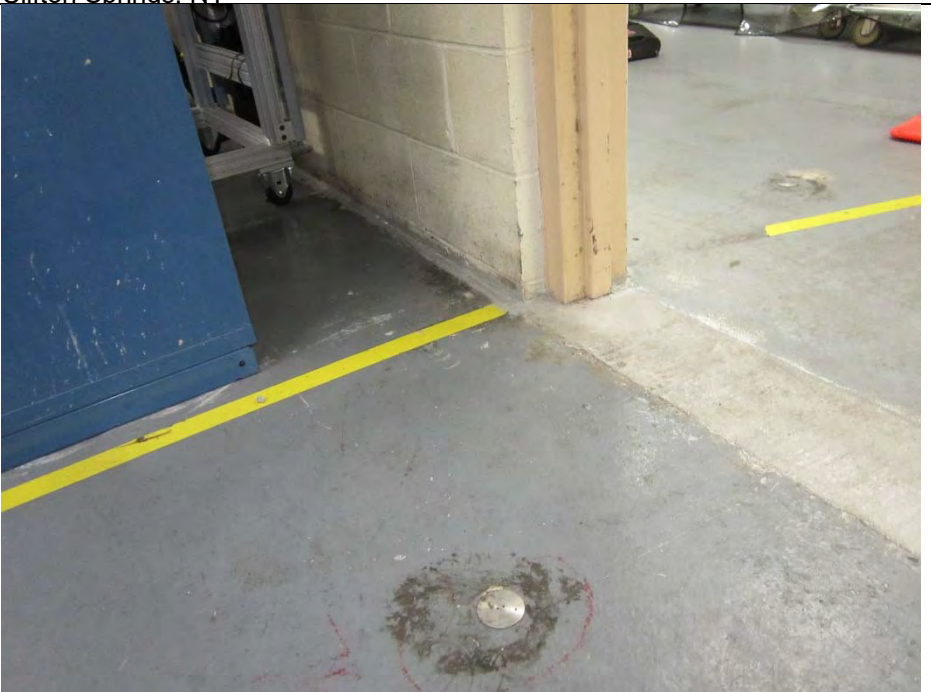
| Analyte | Location ID | GWL-AA | VI-01 - IA | VI-01 - SS | VI-02 - IA | VI-02 - SS | VI-03 - IA | VI-03 - SS | VI-04 - IA | VI-04 - SS | VI-04 - IA | VI-05 - IA | VI-05 - SS |
|---|---|---|---|---|---|---|---|---|---|---|---|---|---|
| | Sample Date | 10-May-17 | 10-May-17 | 10-May-17 | 10-May-17 | 10-May-17 | 10-May-17 | 10-May-17 | 10-May-17 | 10-May-17 | 10-May-17 | 10-May-17 | 10-May-17 |

| Analyte | Location ID | GWL-AA | VI-01 - IA | VI-01 - SS | VI-02 - IA | VI-02 - SS | VI-03 - IA | VI-03 - SS | VI-04 - IA | VI-04 - SS | VI-04 - IA | VI-05 - IA | VI-05 - SS |
|---|---|---|---|---|---|---|---|---|---|---|---|---|---|
| | Sample Type | N | N | N | N | N | N | N | N | N | FD | N | N |

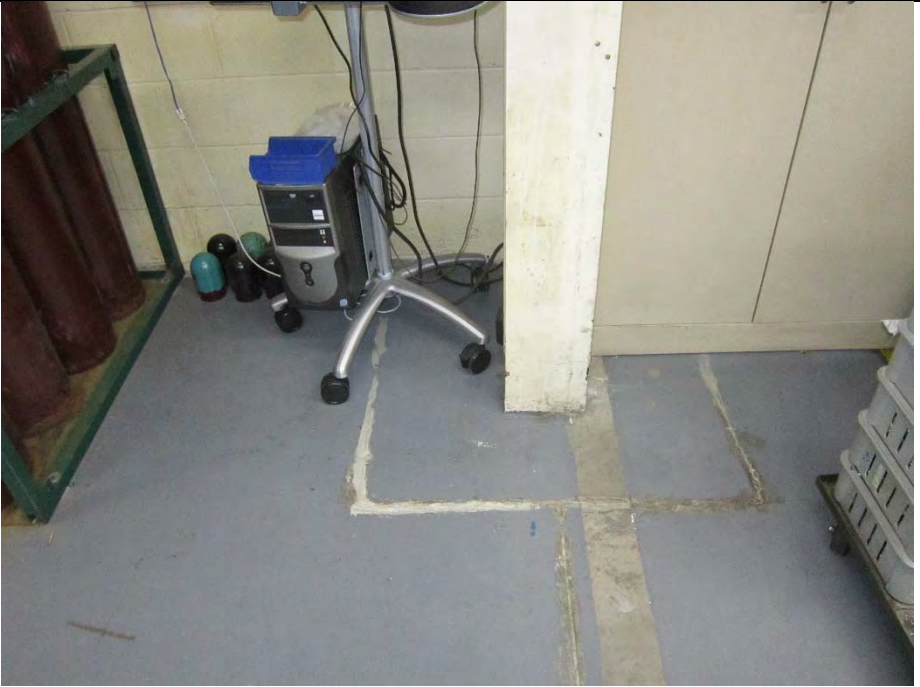
| <b>Photo #:</b> 29 | <b>Date:</b> 19-May-2019 | |

| <b>Description:</b><br><br>Sealed floor joints in Building 7B. | | |

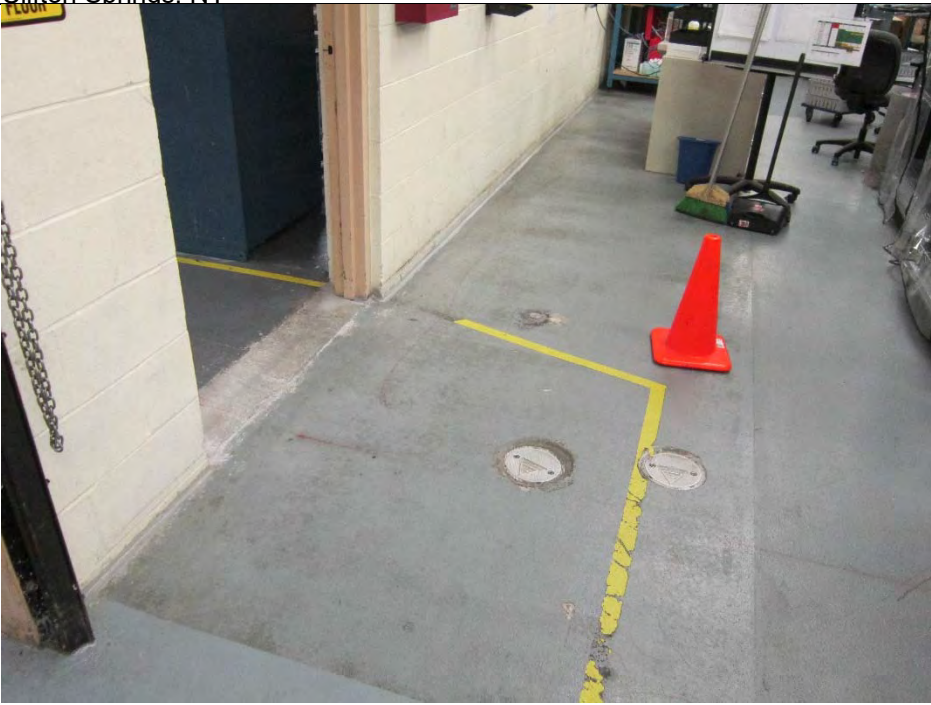
| <b>Photo #:</b> 30 | <b>Date:</b> 19-May-2019 | |

| <b>Description:</b><br><br>Vapor point and monitoring wells in Building 7A. | | |
