**G.W. Lisk Facility**  
**2 SOUTH STREET, VILLAGE OF CLIFTON SPRINGS,**  
**ONTARIO COUNTY, NEW YORK**

**Final Soil Vapor Intrusion**  
**Interim Remedial Measure**  
**Construction Completion Report**

**NYSDEC Site Number: C835026**

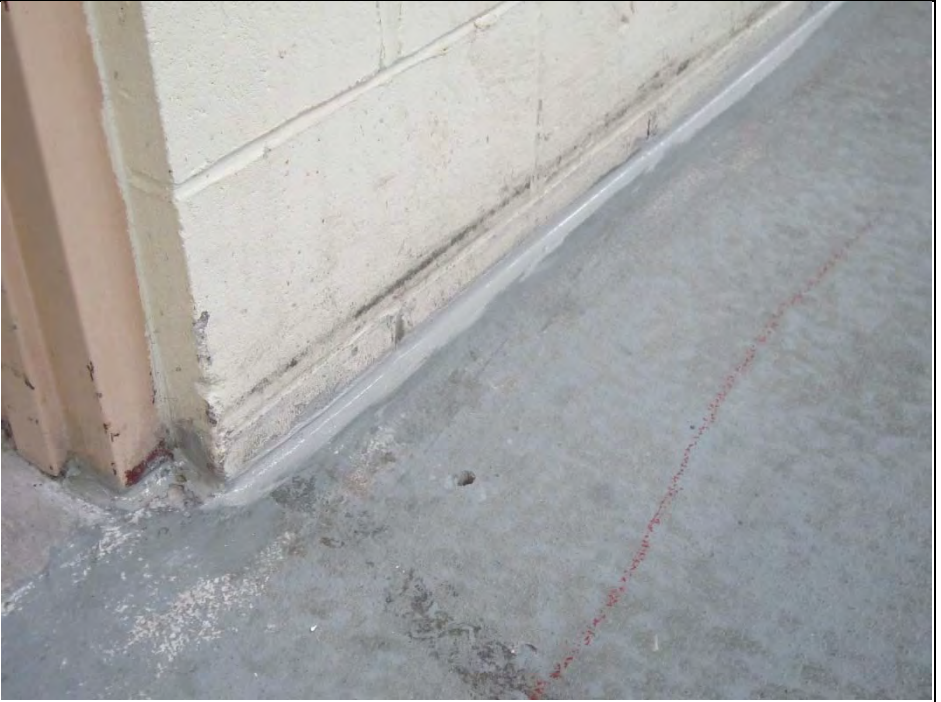
| <b>Photo #:</b> 31 | <b>Date:</b> 19-May-2019 | |

| <b>Description:</b><br><br>Sealed wall joint in Building 7A. | | |

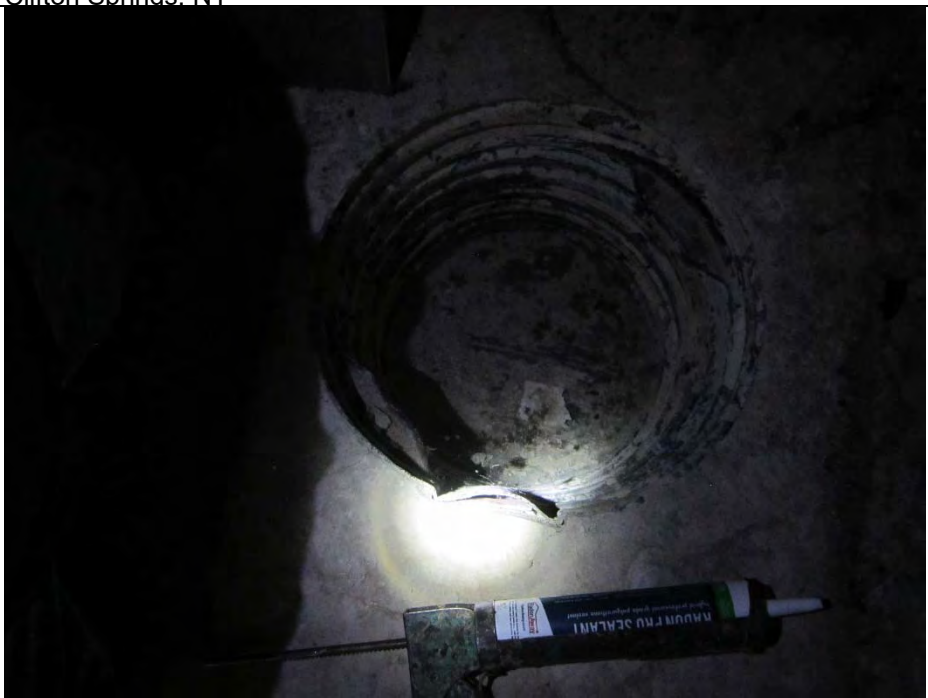
| <b>Photo #:</b> 2 | <b>Date:</b> 21-Jun-2019 | | |

| <b>Description:</b><br><br>Sump in Building 7B elevator shaft. | | | |

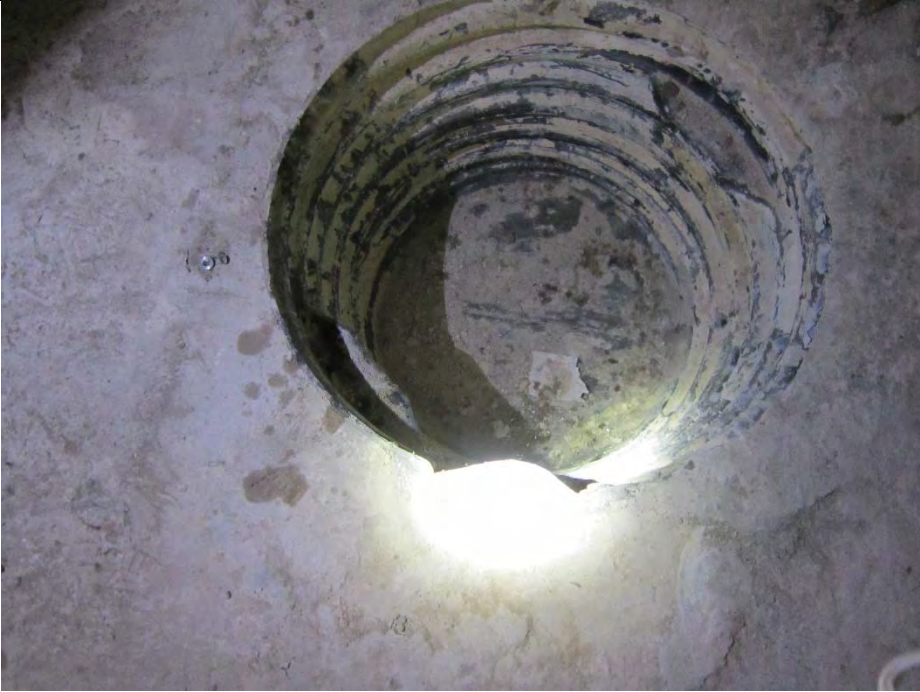
| <b>Photo #:</b> 3 | <b>Date:</b> 21-Jun-2019 | | |

| <b>Description:</b><br><br>Sump in Building 7B elevator shaft. | | | |

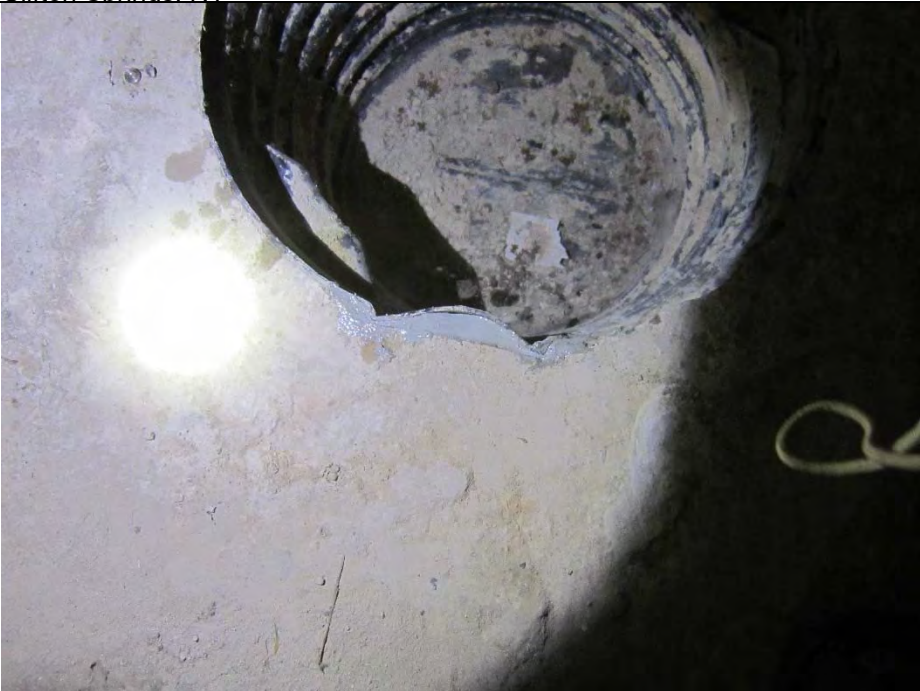
| <b>Photo #:</b> 4 | <b>Date:</b> 21-Jun-2019 | | |

| <b>Description:</b><br><br>Sump in Building 7B elevator shaft. | | | |

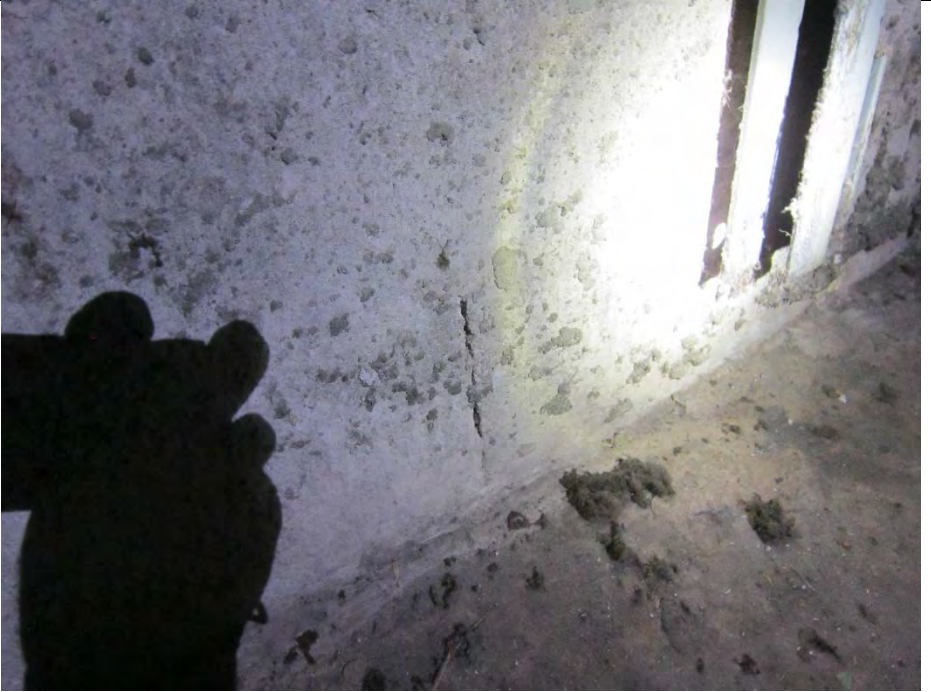
| <b>Photo #:</b> 5 | <b>Date:</b> 21-Jun-2019 | | |

| <b>Description:</b><br><br>Building 7B elevator shaft. | | | |

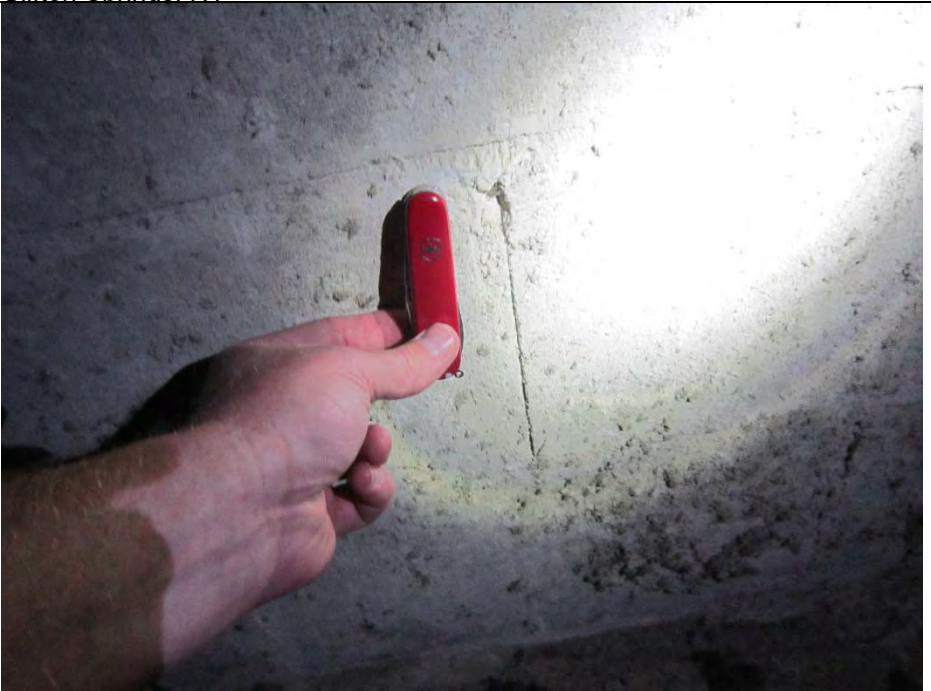
| <b>Photo #:</b> 6 | <b>Date:</b> 21-Jun-2019 | | |

| <b>Description:</b><br><br>Wall crack in Building 7B elevator shaft. | | | |

In May 2019, additional mitigation of cracks and floor penetrations was completed in Buildings 6, 7A, and 7B. At this time, the elevator shaft in Building 7B was inspected and additional cracks and floor penetrations were identified. In June and July of 2019, the elevator shaft sump was sealed in the same manner as the building slab in other areas of the building. Subsequently, a second round of post-mitigation indoor air samples were collected only from Buildings 7A and 7B in August 2019. Table 4-5 shows indoor air concentrations remained above  $2 \mu\text{g}/\text{m}^3$  in Buildings 7, 7A, and 7B.

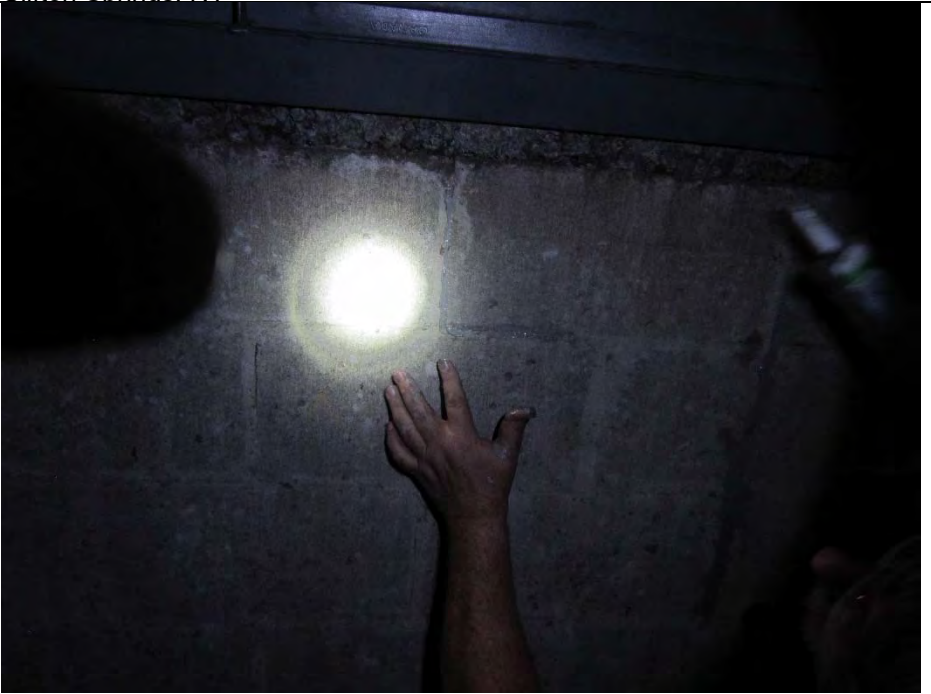
| <b>Photo #:</b> 7 | <b>Date:</b> 21-Jun-2019 | | |

| <b>Description:</b><br><br>Interior of Building 7B elevator shaft. | | | |

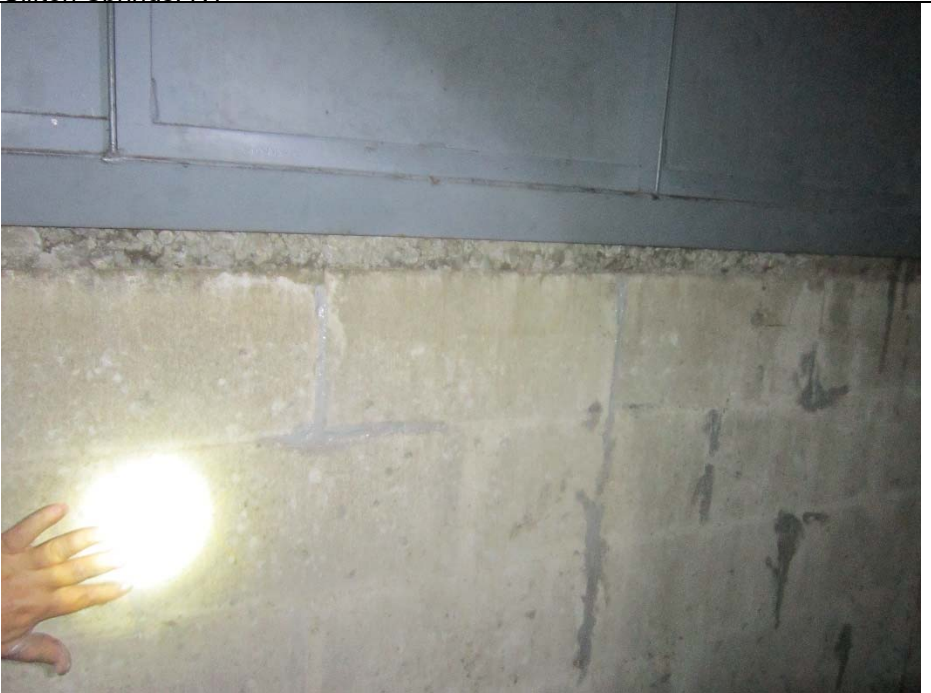
| <b>Photo #:</b> 8 | <b>Date:</b> 21-Jun-2019 | | |

| <b>Description:</b><br><br>Interior of Building 7B elevator shaft. | | | |

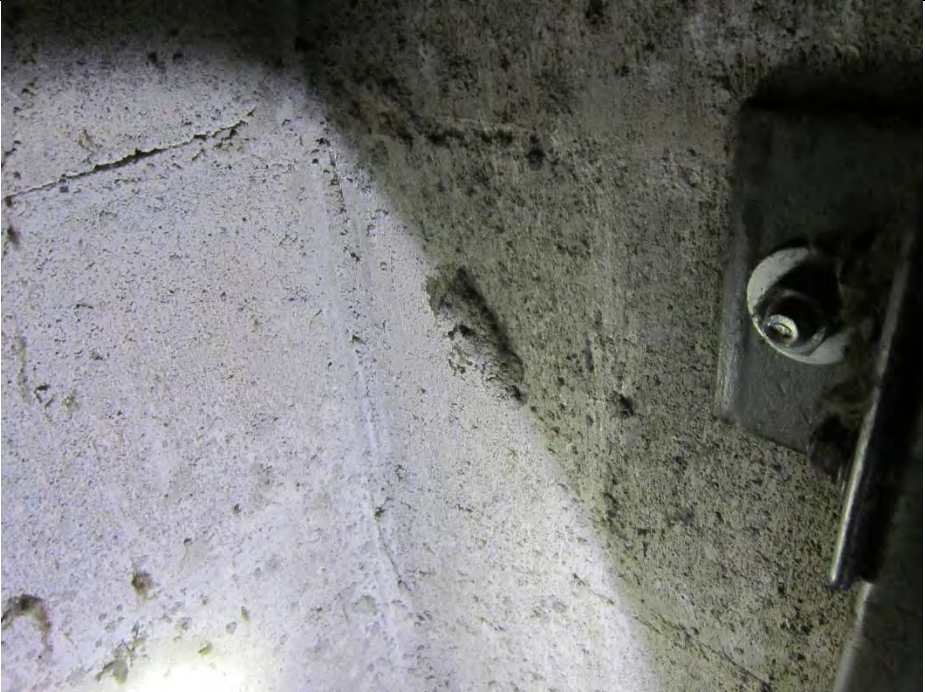
| <b>Photo #:</b> 9 | <b>Date:</b> 21-Jun-2019 | | |

| <b>Description:</b><br><br>Interior of Building 7B elevator shaft. | | | |

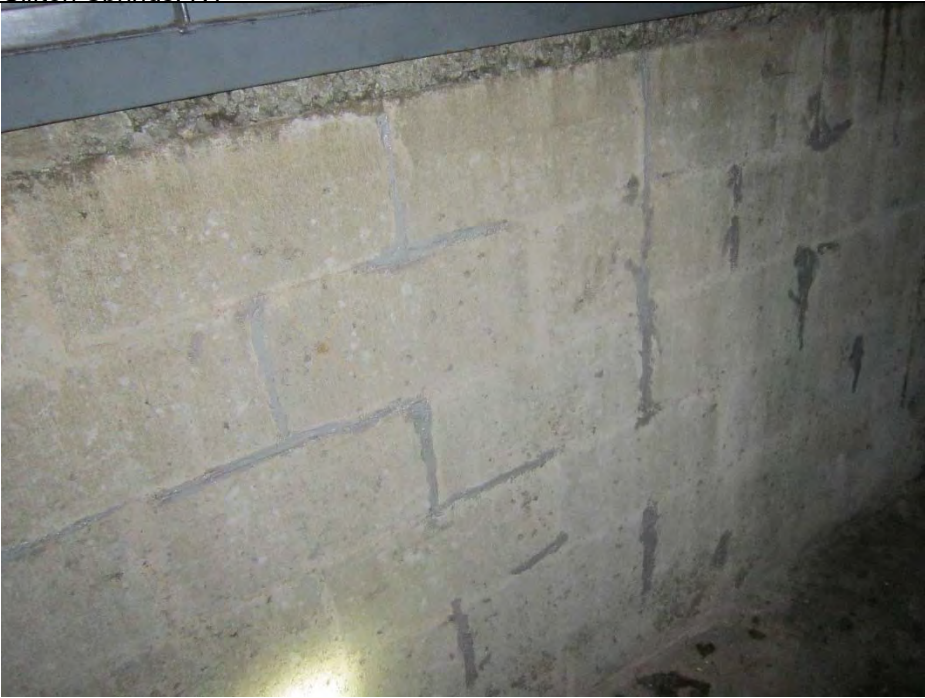
| <b>Photo #:</b> 10 | <b>Date:</b> 21-Jun-2019 | | |

| <b>Description:</b><br><br>Interior of Building 7B elevator shaft after sealing of wall cracks. | | | |

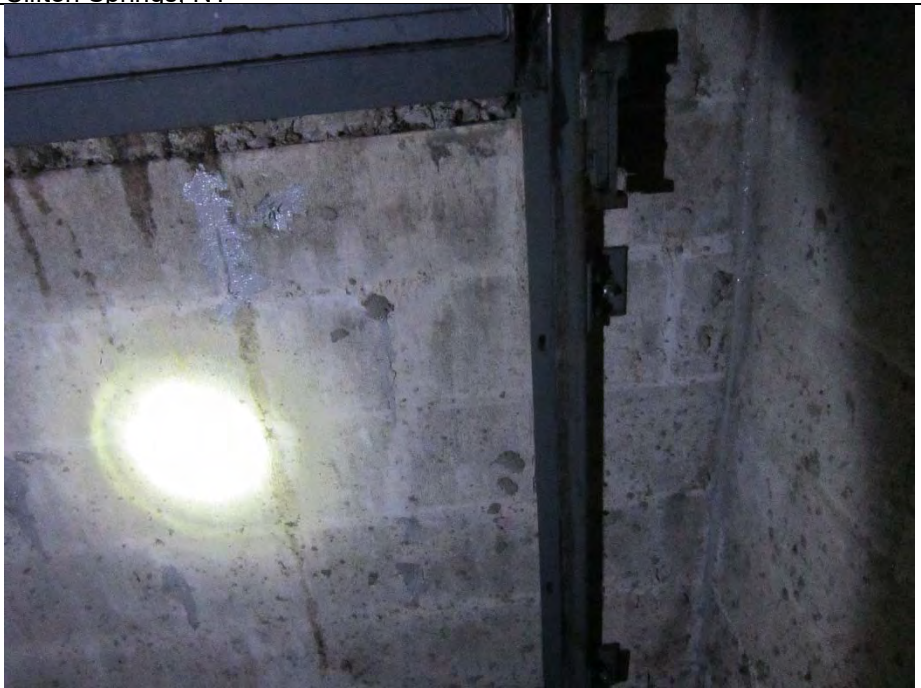
| <b>Photo #:</b> 11 | <b>Date:</b> 21-Jun-2019 | | |

| <b>Description:</b><br><br>Sealed cracks in Building 7B elevator shaft. | | | |

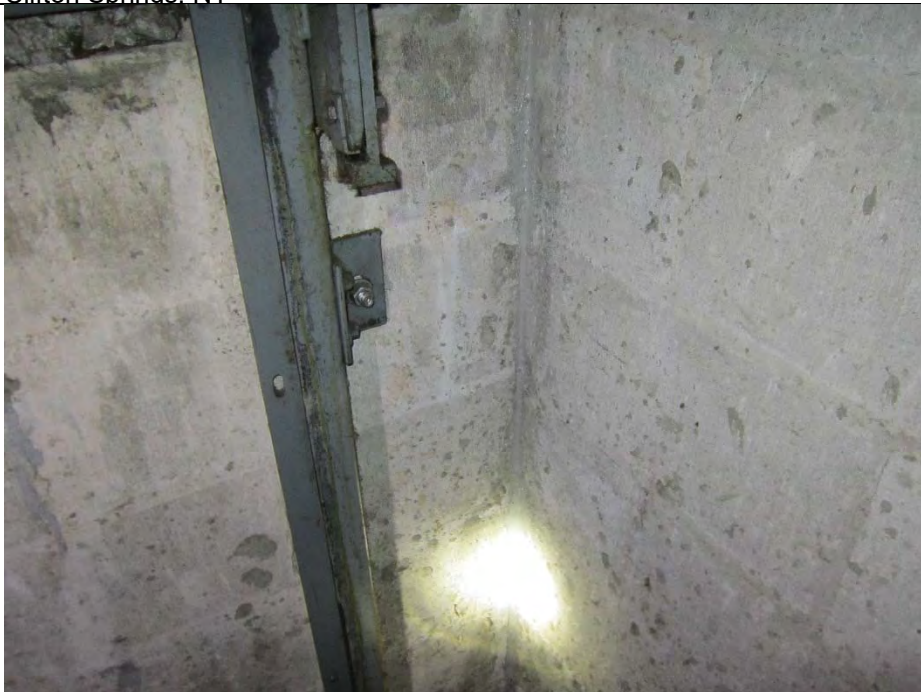
| <b>Photo #:</b> 12 | <b>Date:</b> 21-Jun-2019 | | |

| <b>Description:</b><br><br>Sealed cracks in Building 7B elevator shaft. | | | |

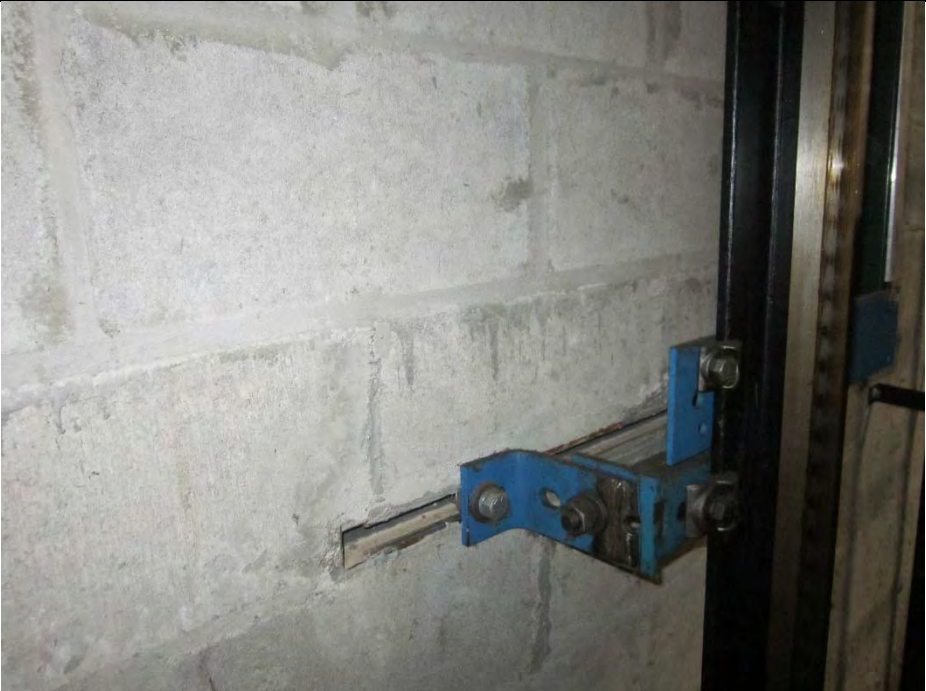
| <b>Photo #:</b> 13 | <b>Date:</b> 21-Jun-2019 | |

| <b>Description:</b><br><br>Sealed cracks in Building 7B elevator shaft. | | |

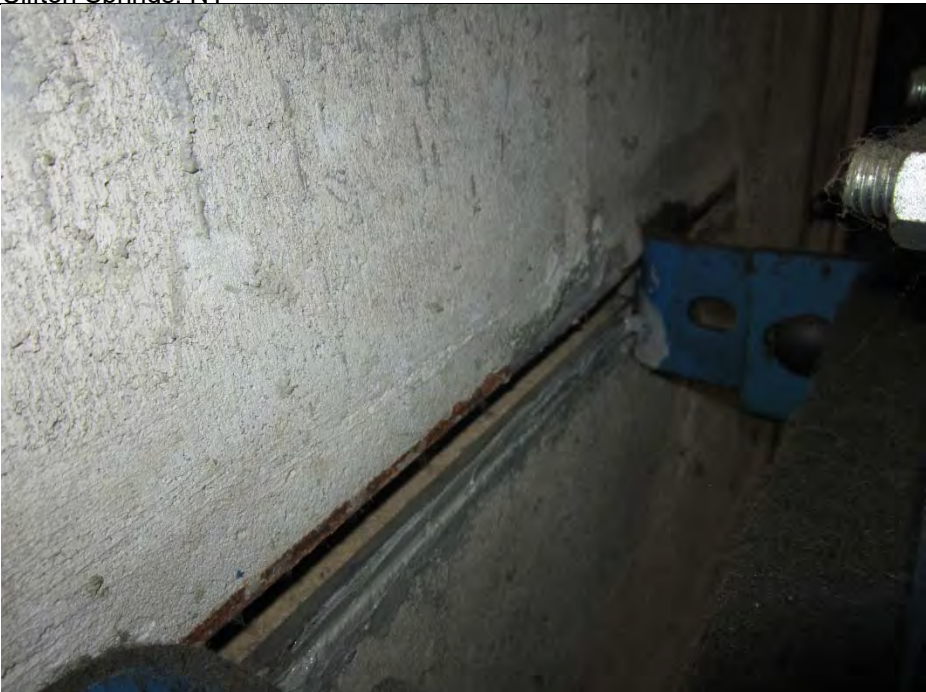
| <b>Photo #:</b> 14 | <b>Date:</b> 21-Jun-2019 | |

| <b>Description:</b><br><br>Sealed cracks in Building 7B elevator shaft. | | |

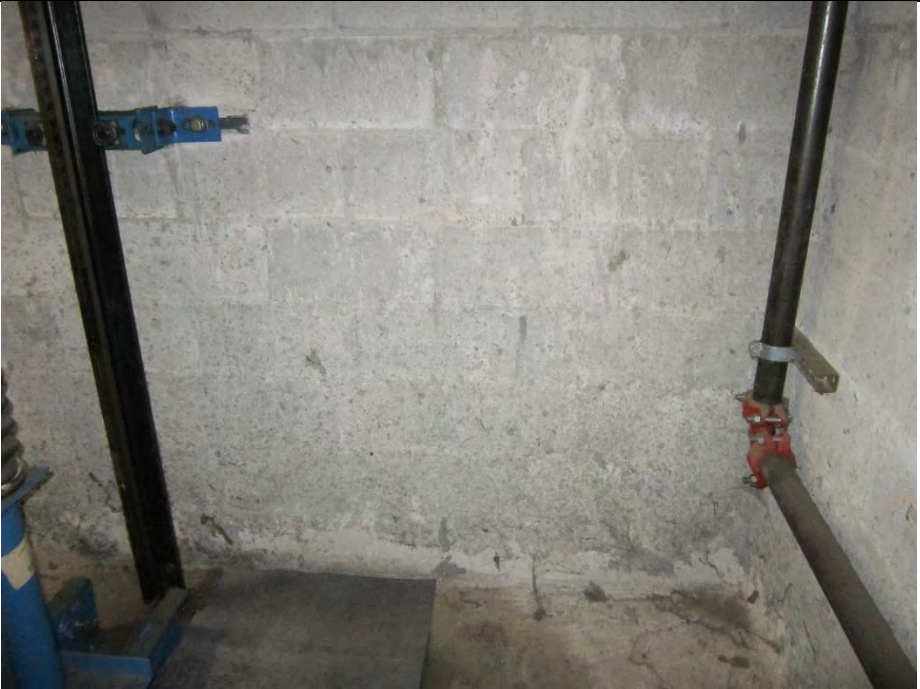
| <b>Photo #:</b> 15 | <b>Date:</b> 21-Jun-2019 | |

| <b>Description:</b><br><br>Sealed cracks in Building 7B elevator shaft. | | |

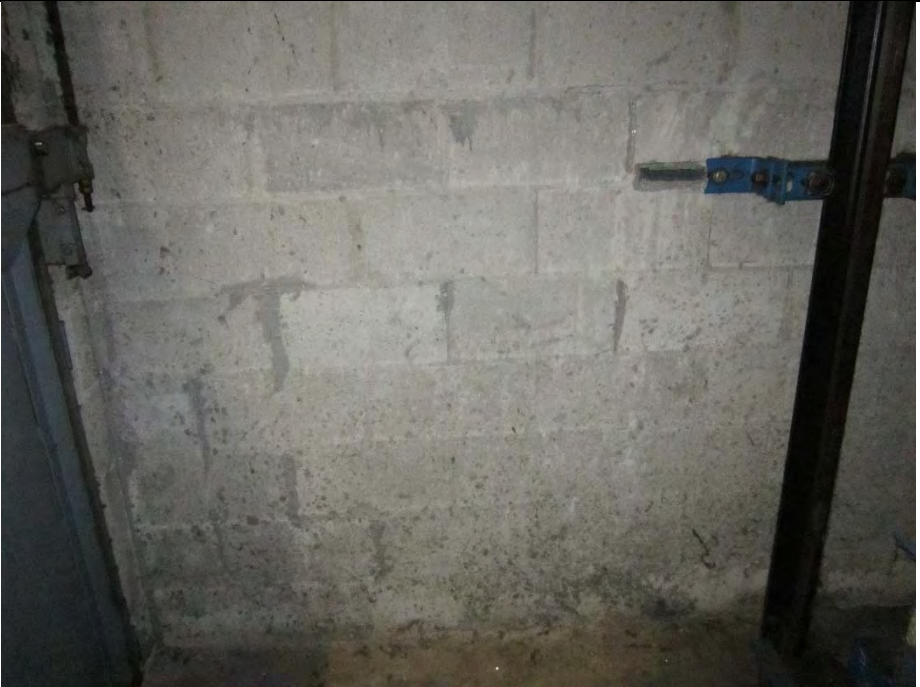
| <b>Photo #:</b> 17 | <b>Date:</b> 21-Jun-2019 | |

| <b>Description:</b><br><br>Sealed cracks in Building 7B elevator shaft. | | |

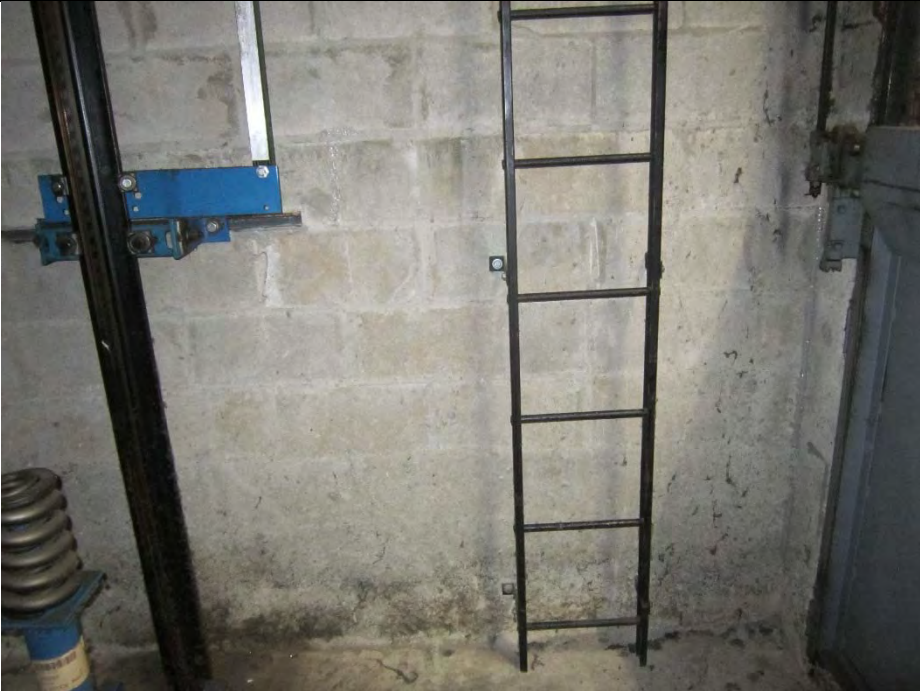
| <b>Photo #:</b> 19 | <b>Date:</b> 21-Jun-2019 | |

| <b>Description:</b><br><br>Sealed cracks in Building 7B elevator shaft. | | |

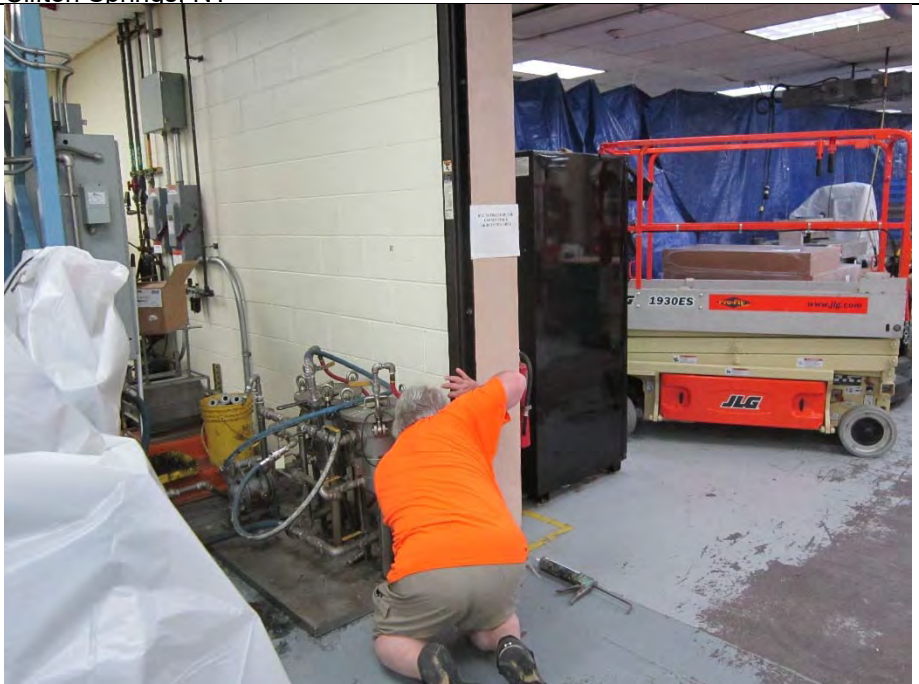
| <b>Photo #:</b> 1 | <b>Date:</b> 02-Jul-2019 | | |

| <b>Description:</b><br><br>GW Lisk personnel sealing additional floor and wall joints in Building 7B. | | | |

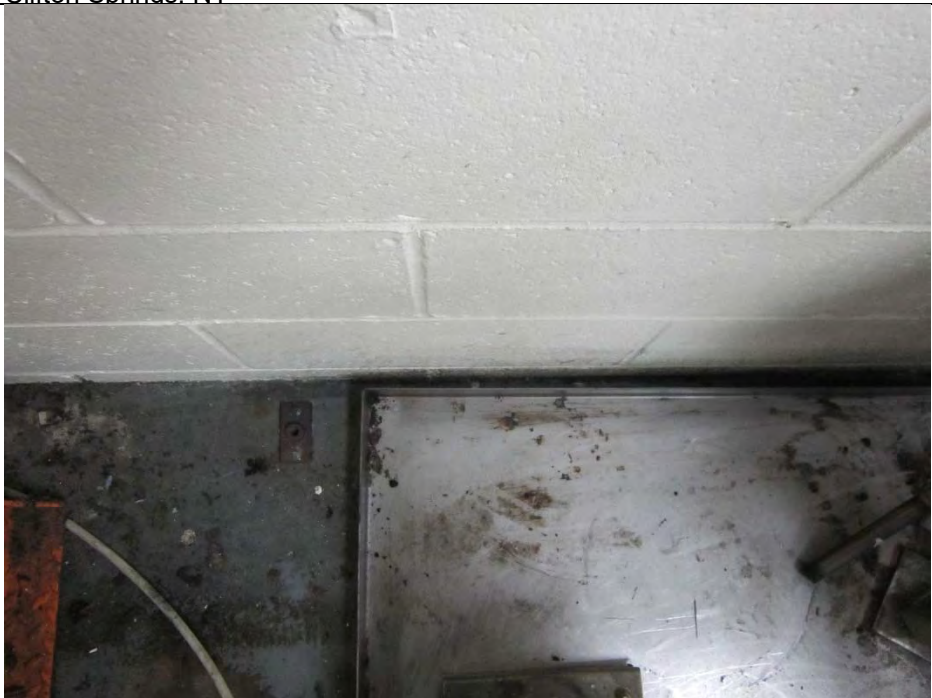
| <b>Photo #:</b> 2 | <b>Date:</b> 02-Jul-2019 | | |

| <b>Description:</b><br><br>View of sealed wall joint in Building 7B. | | | |

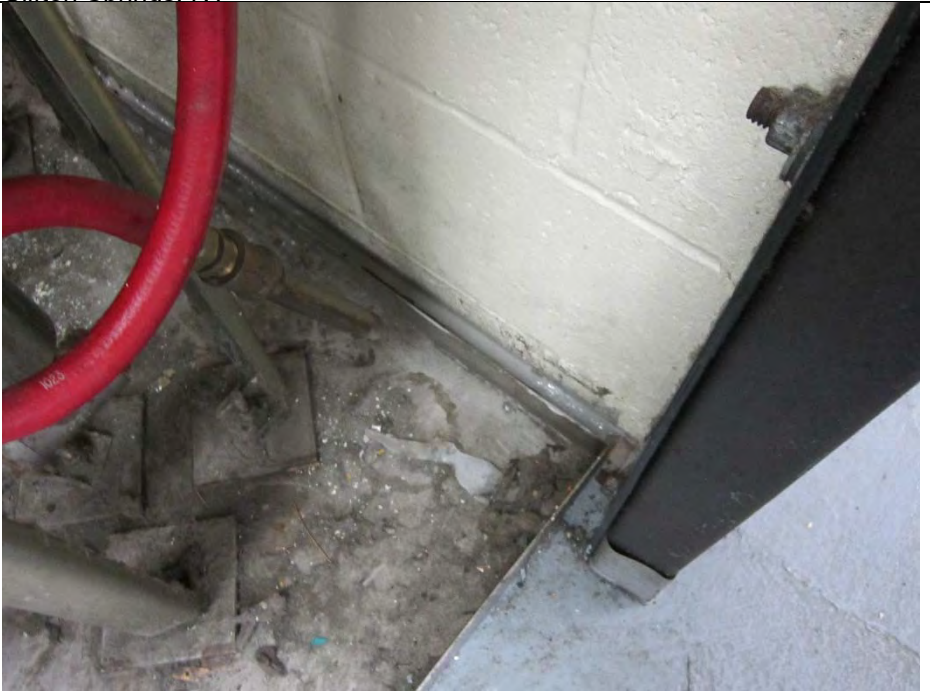
| <b>Photo #:</b> 3 | <b>Date:</b> 02-Jul-2019 | | |

| <b>Description:</b><br><br>Close up of sealed wall joint in Building 7B. | | | |

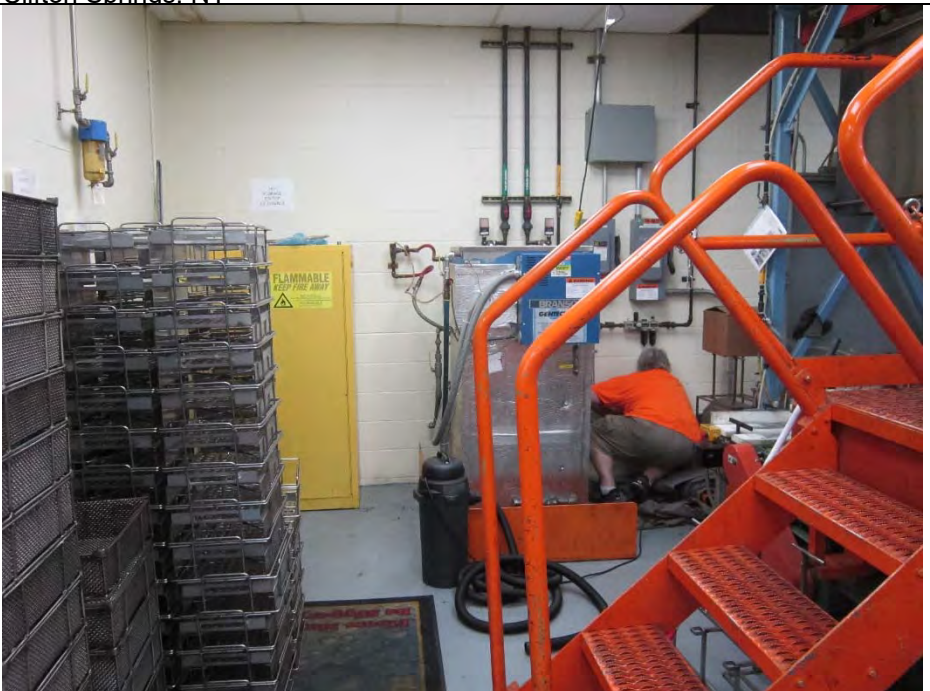
| <b>Photo #:</b> 4 | <b>Date:</b> 02-Jul-2019 | |

| <b>Description:</b><br><br>GW Lisk personnel sealing additional wall joints in Building 7B. | | |

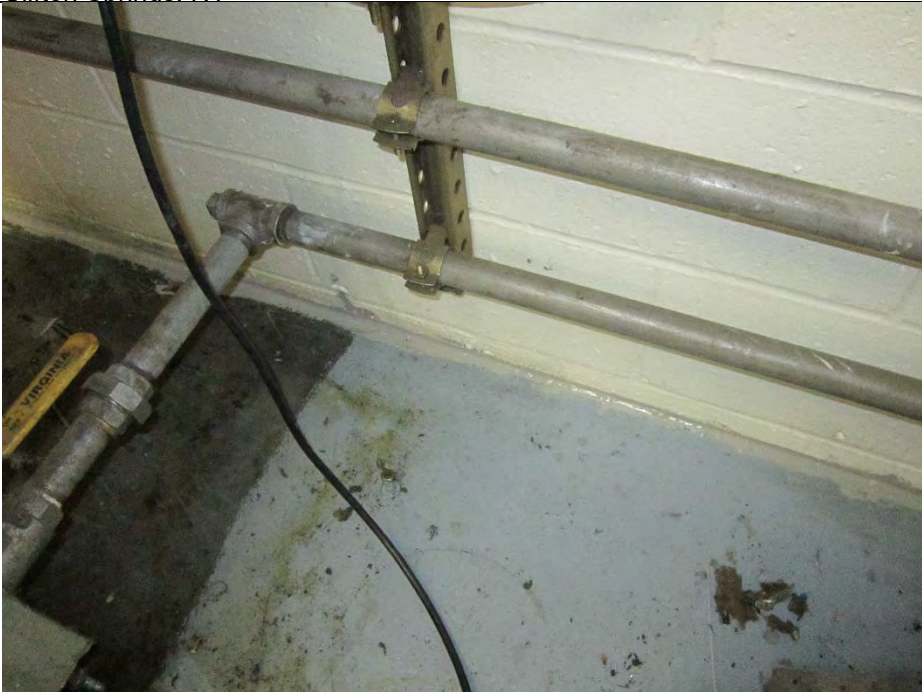
| <b>Photo #:</b> 5 | <b>Date:</b> 02-Jul-2019 | | |

| <b>Description:</b><br><br>Sealed wall joint in Building 7B. | | | |

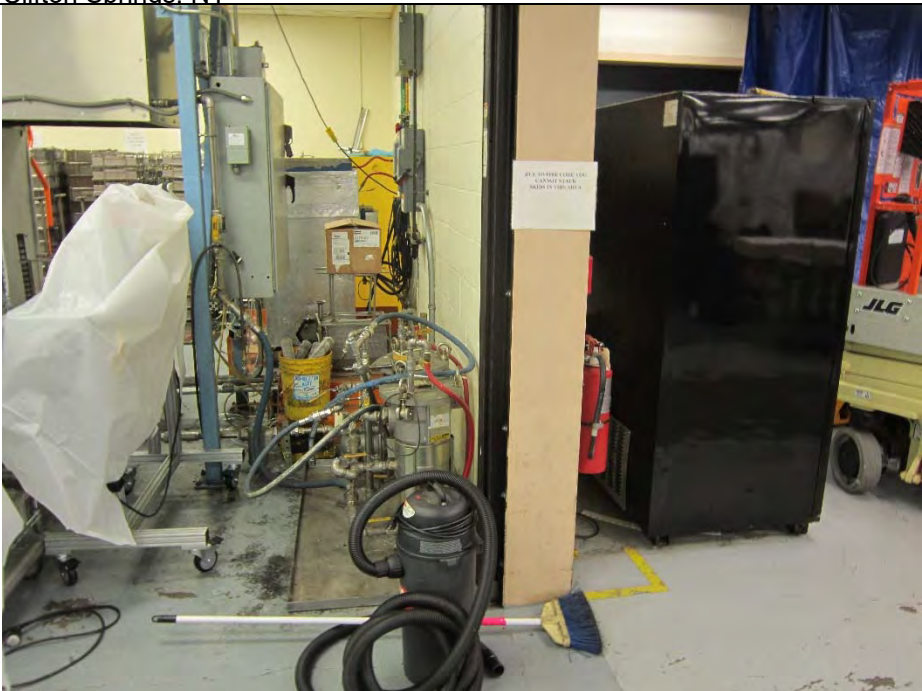
| <b>Photo #:</b> 6 | <b>Date:</b> 02-Jul-2019 | | |

| <b>Description:</b><br><br>Boundary between Building 7A and Building 7B. | | | |

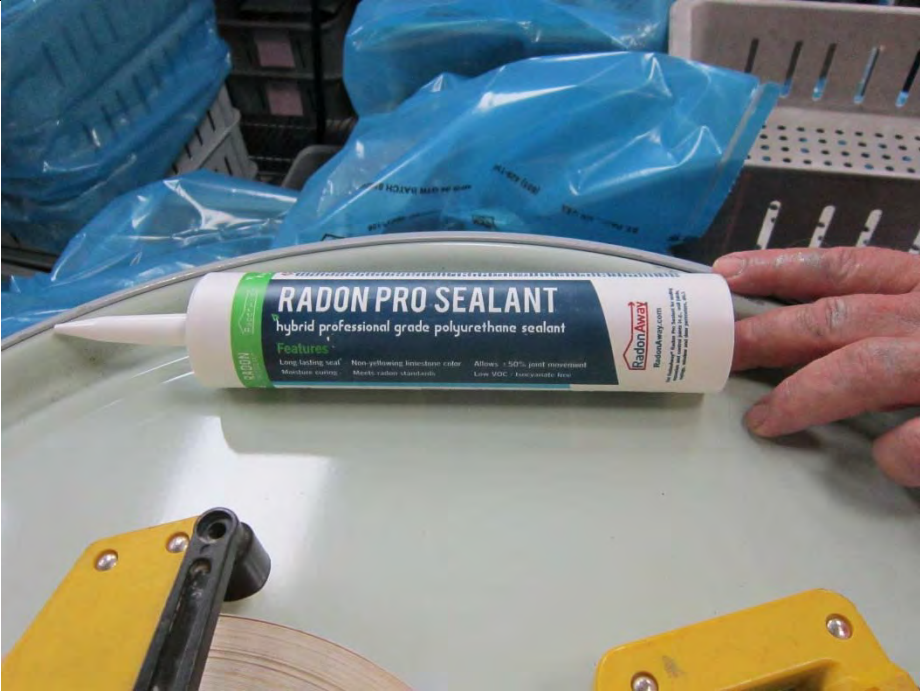
| <b>Photo #:</b> 7 | <b>Date:</b> 02-Jul-2019 | | |

| <b>Description:</b><br><br>Tube of sealing agent used for mitigation of cracks and joints. | | | |

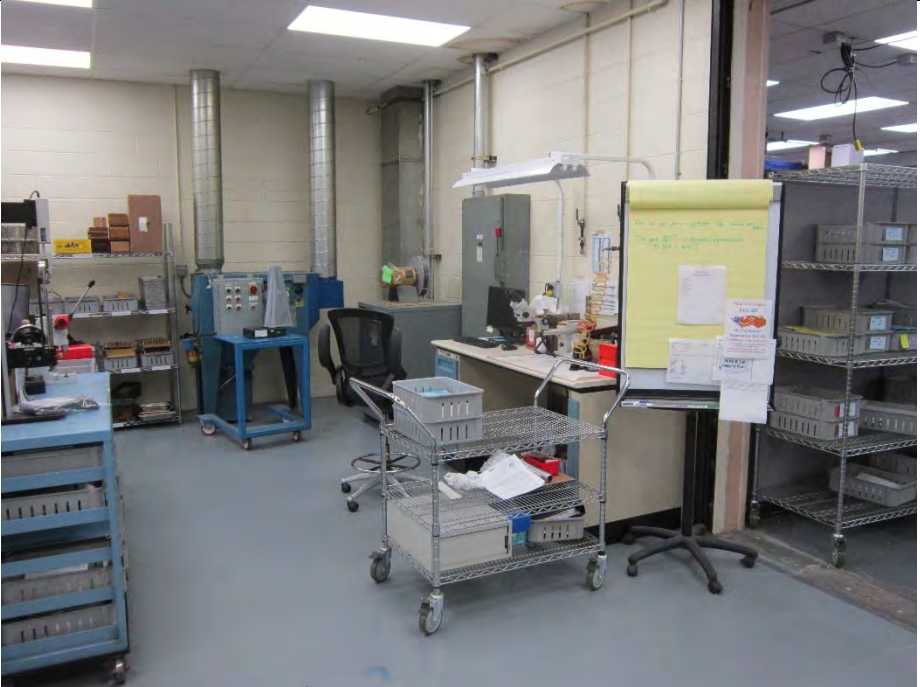
| <b>Photo #:</b> 9 | <b>Date:</b> 02-Jul-2019 | |

| <b>Description:</b><br><br>Boundary between Building 6 and Building 7A. | | |

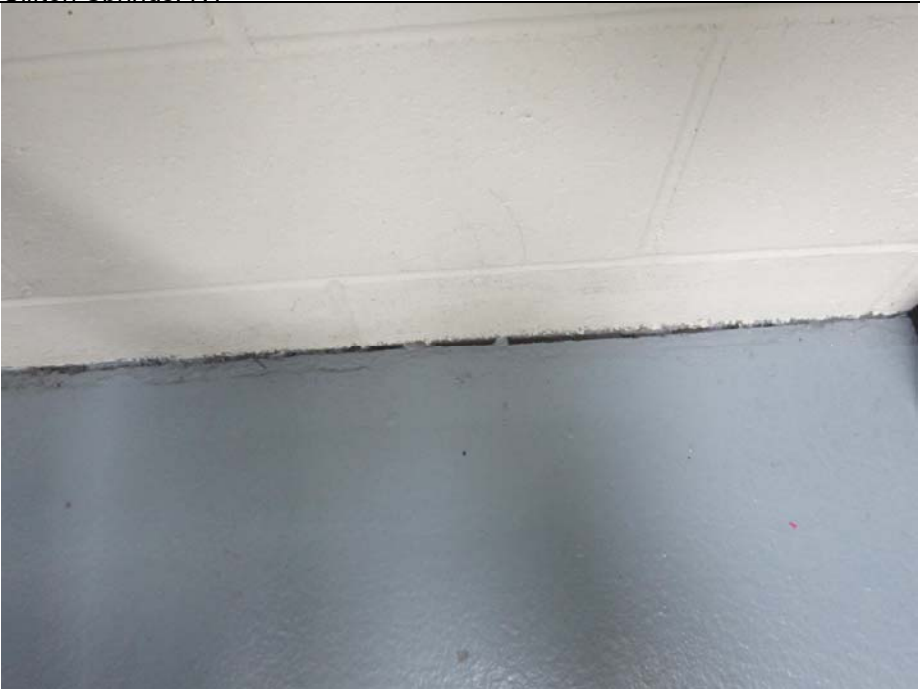
| <b>Photo #:</b> 10 | <b>Date:</b> 02-Jul-2019 | |

| <b>Description:</b><br><br>Gap in wall joint prior to sealing. | | |

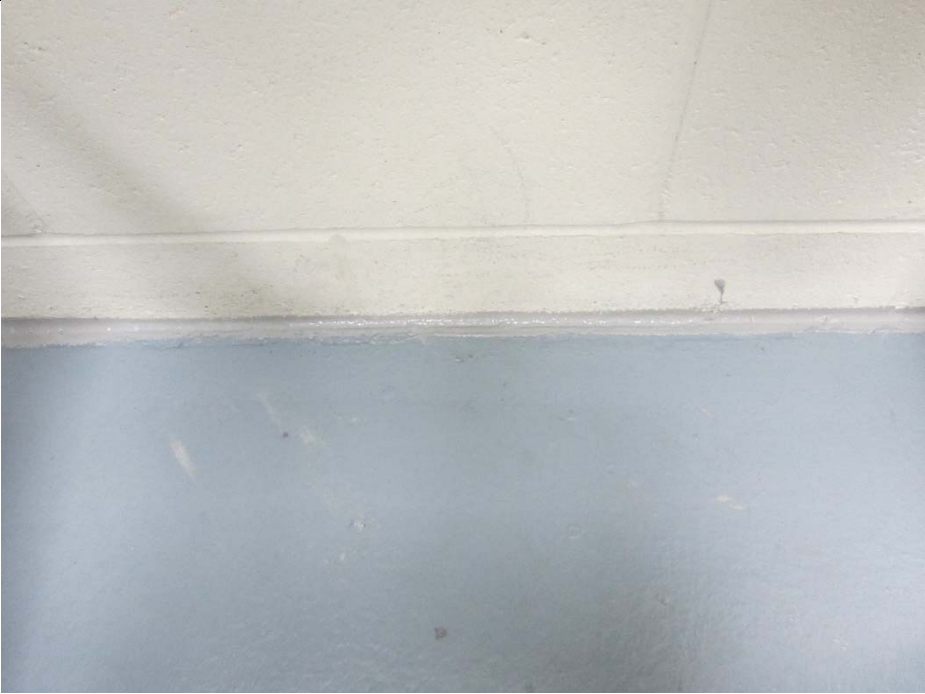
| <b>Photo #:</b> 11 | <b>Date:</b> 02-Jul-2019 | |

| <b>Description:</b><br><br>View of wall joint in Photo #10 after sealing. | | |

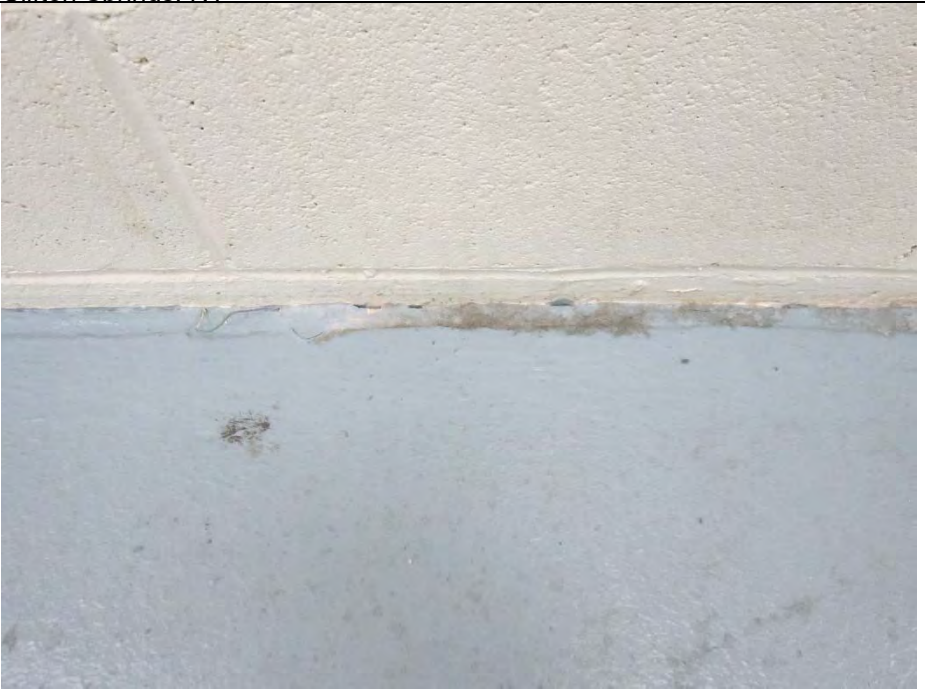
| <b>Photo #:</b> 12 | <b>Date:</b> 02-Jul-2019 | |

| <b>Description:</b><br><br>Close-up view of wall joint after sealing. | | |

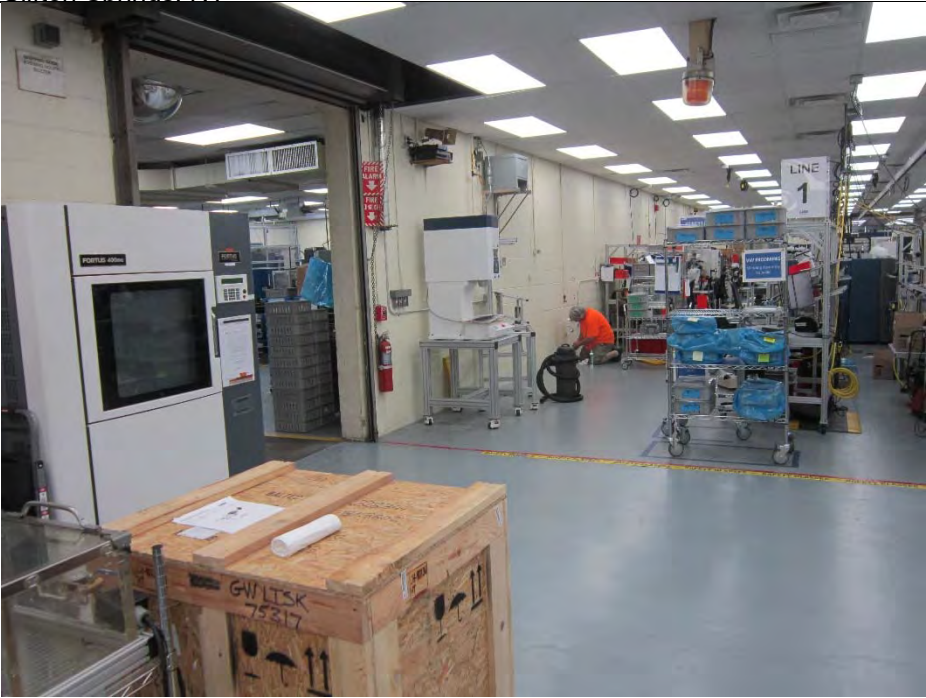
| <b>Photo #:</b> 13 | <b>Date:</b> 02-Jul-2019 | |

| <b>Description:</b><br><br>Boundary between Building 7A and Building 7B. | | |

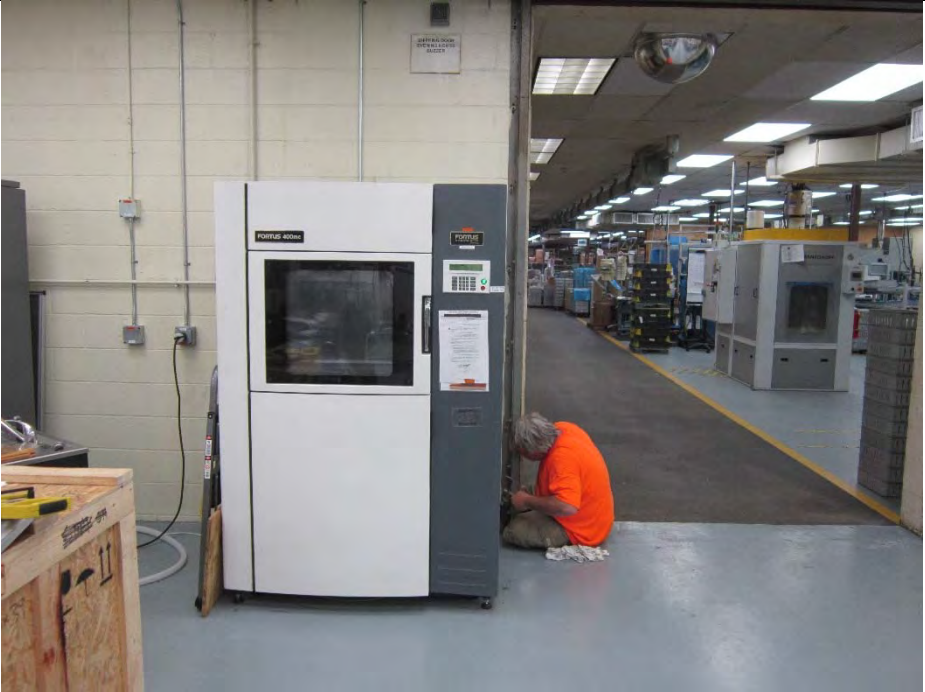
| <b>Photo #:</b> 15 | <b>Date:</b> 02-Jul-2019 | |

| <b>Description:</b><br><br>GW Lisk personnel sealing wall joint in Building 7B. | | |

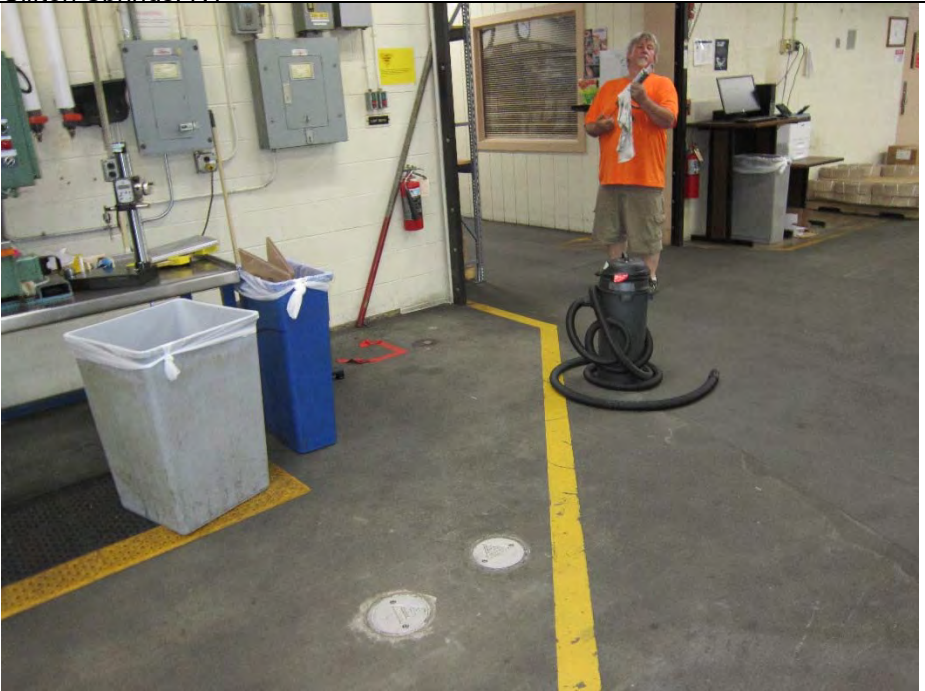
| <b>Photo #:</b> 16 | <b>Date:</b> 02-Jul-2019 | |

| <b>Description:</b><br><br>Sealed well covers in Building 7A. | | |

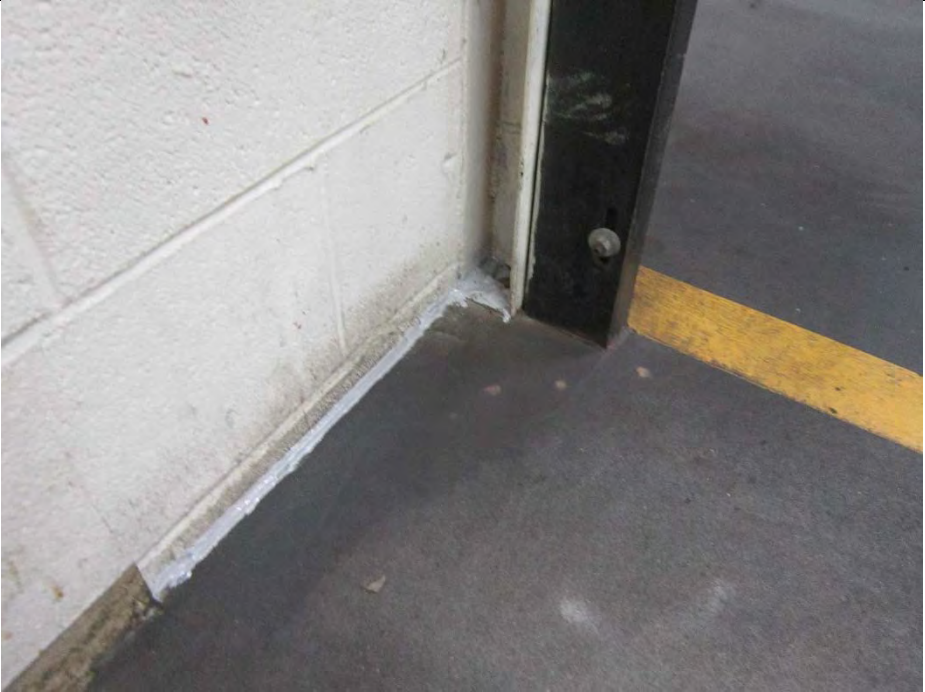
| <b>Photo #:</b> 17 | <b>Date:</b> 02-Jul-2019 | |

| <b>Description:</b><br><br>Wall joint sealed in Building 7A. | | |

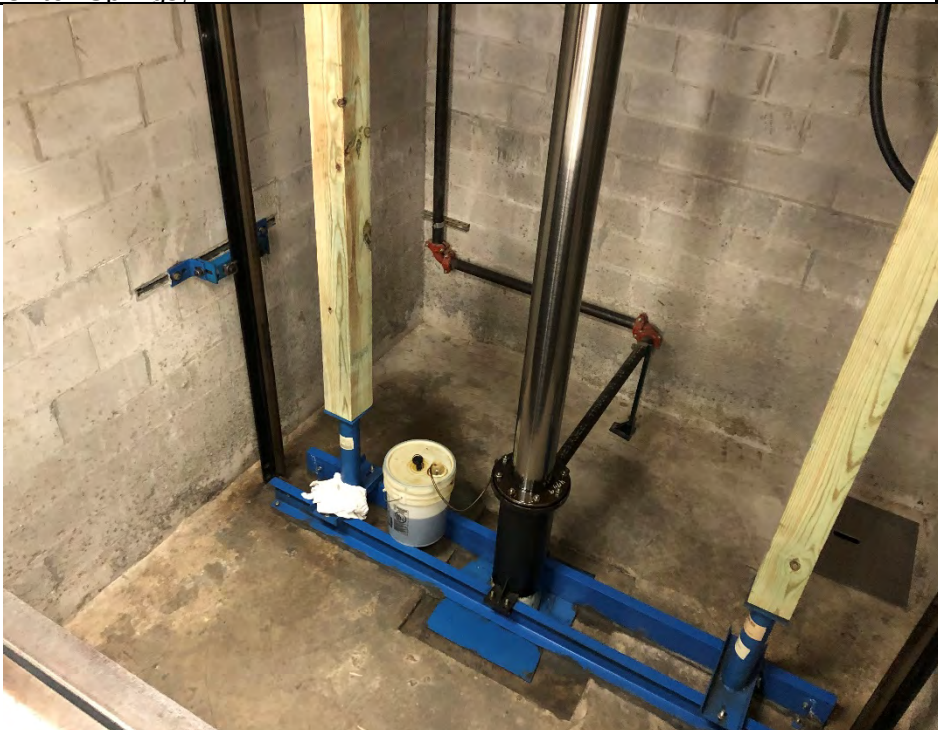
| <b>Photo #:</b> 1 | <b>Date:</b> 25-<br>January-2020 | |

| <b>Description:</b><br>View of Building 7B elevator shaft sump prior to sealing with DRYLOK™. | | |
