**G.W. Lisk Facility**  
**2 SOUTH STREET, VILLAGE OF CLIFTON SPRINGS,**  
**ONTARIO COUNTY, NEW YORK**

**Final Soil Vapor Intrusion**  
**Interim Remedial Measure**  
**Construction Completion Report**

**NYSDEC Site Number: C835026**

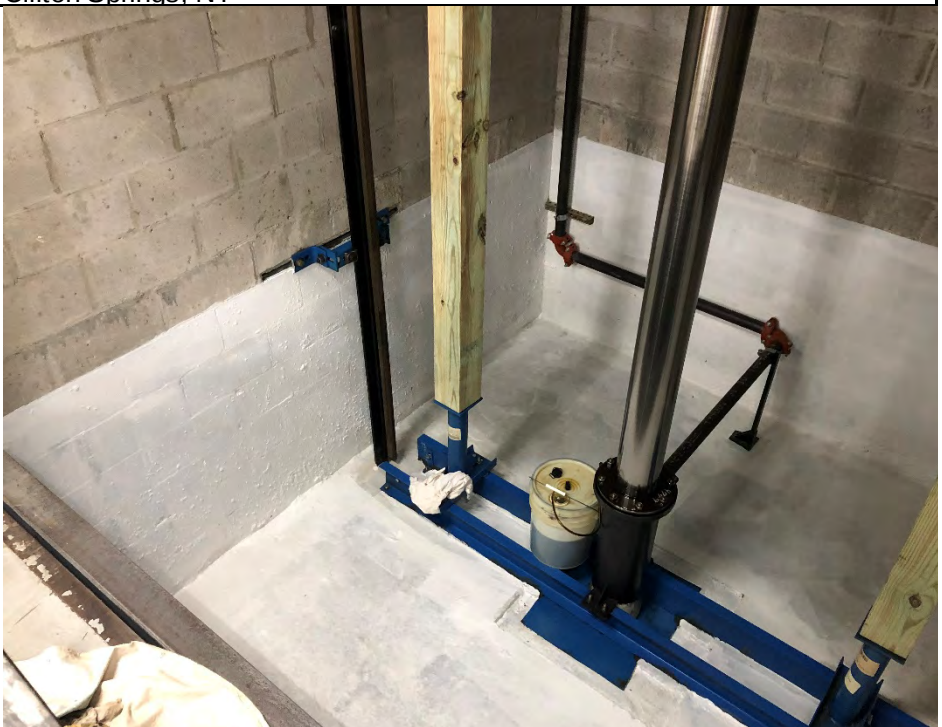
| <b>Photo #:</b> 2 | <b>Date:</b> 25-<br>January-2020 | |

| <b>Description:</b><br>View of Building 7B elevator shaft sump following application of first coat of DRYLOK™. | | |

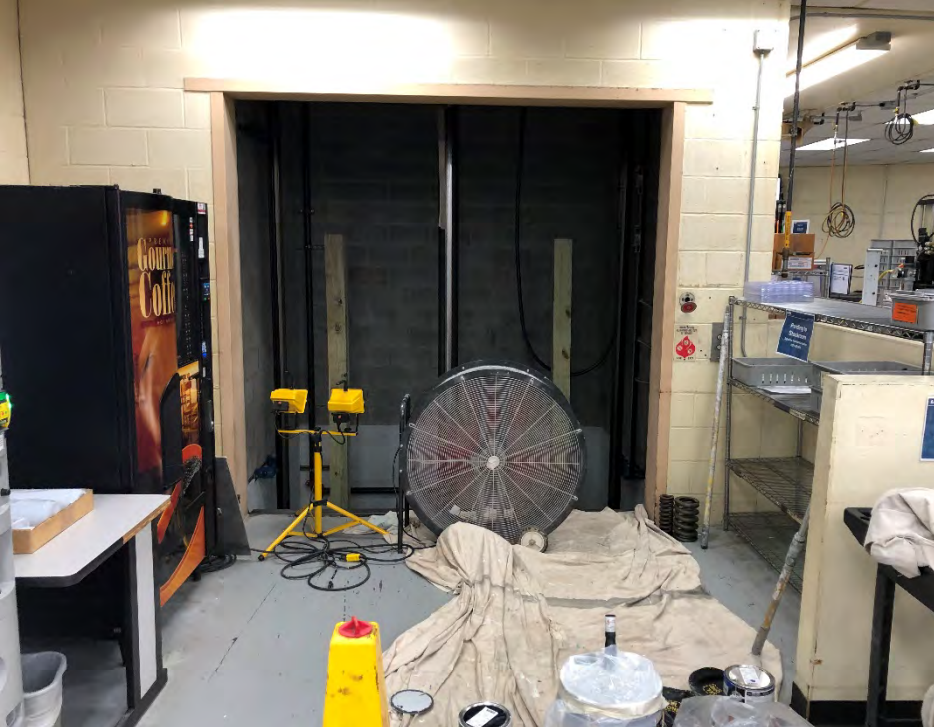
| <b>Photo #:</b> 3 | <b>Date:</b> 25-January-2020 | |

| <b>Description:</b><br>View of Building 7B elevator shaft sump following application of first coat of DRYLOK™ during drying/curing time. | | |

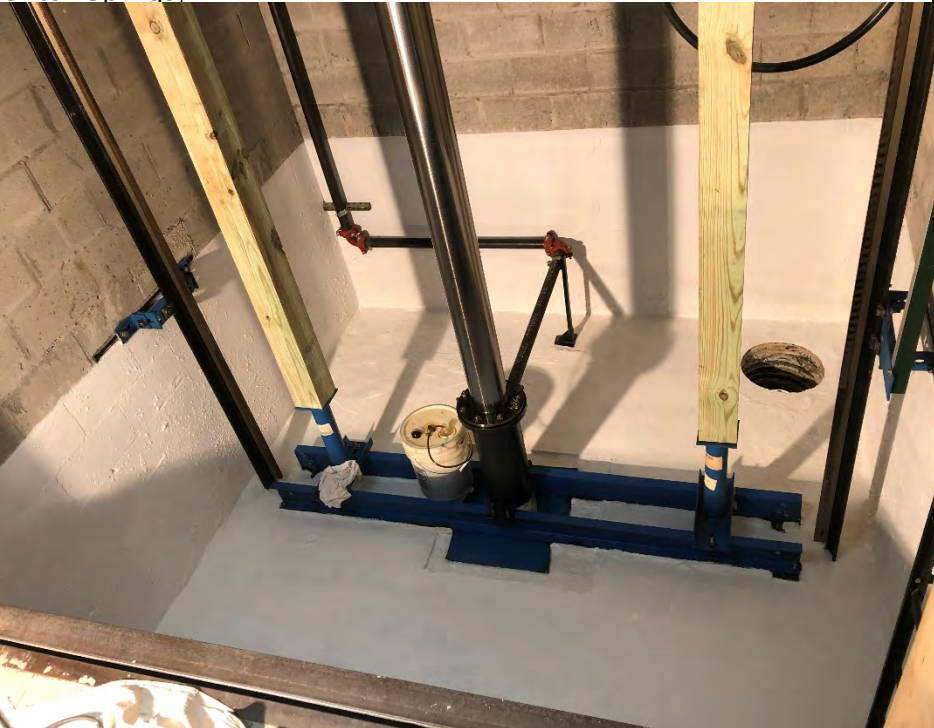
| <b>Photo #:</b> 4 | <b>Date:</b> 25-January-2020 | |

| <b>Description:</b><br>View of Building 7B elevator shaft sump following application of second coat of DRYLOK™. | | |

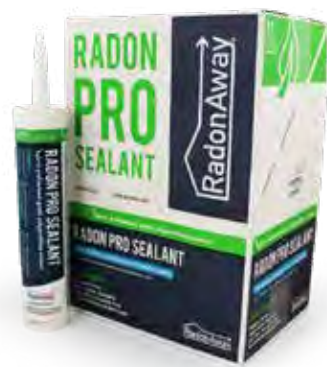
RadonAway® Radon Pro Hybrid Sealant (P/N 28523) meets most basement and crawlspace needs. Use our hybrid sealant for sealing expansion and control joints (i.e., wall joints, copings, window and door perimeters, etc.). This easy-to-use, professional grade sealant is long-lasting, self-leveling, non-sag and moisture curing. It contains little to no solvent and is virtually odor free.

- Professional grade polyurethane\*
- Non-yellowing limestone color
- Moisture-curing
- Elastomeric (non-sag)
- Allows  $\pm 50\%$  joint movement
- Long-lasting seal
- Low VOC content
- Meets radon standards
