2022 Annual Report

G.W. Lisk. Facility

2 South Street, Village of Clifton Springs, Ontario County, New
York
NYSDEC Site Number C835026

Annual Report

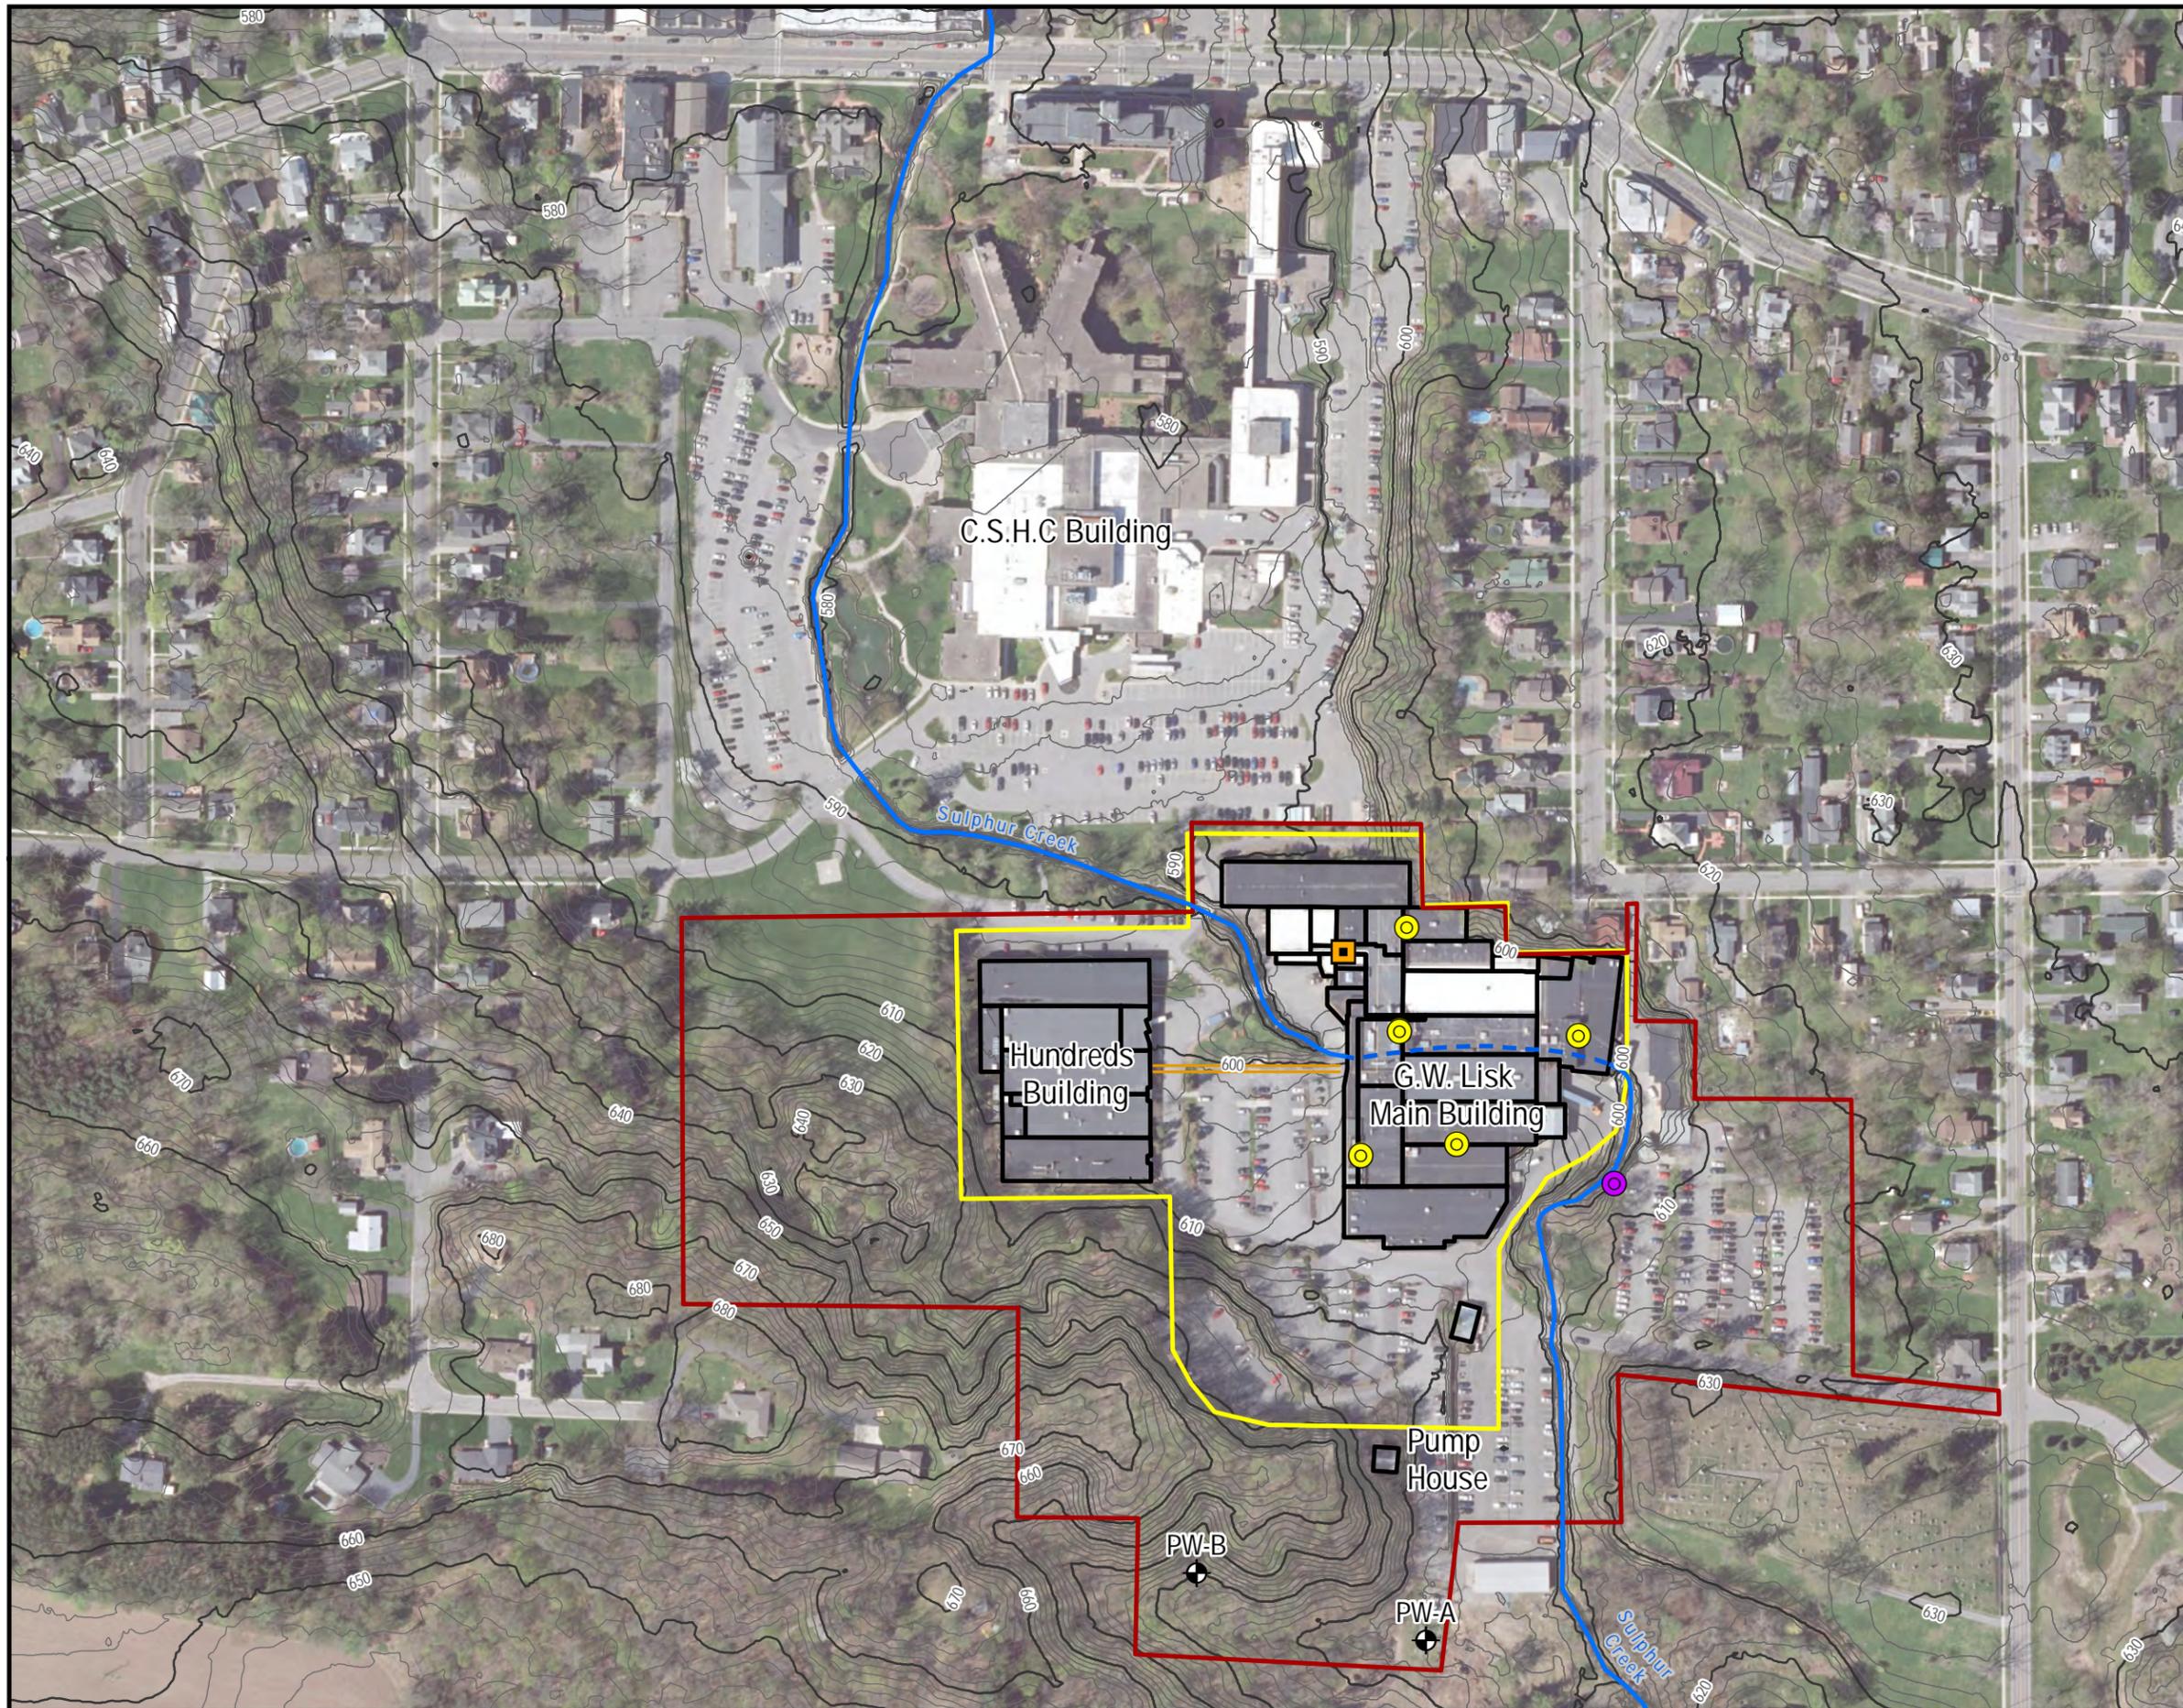
Figure 2: Site Layout Map
 G.W. Lisk Company, Inc.
 2 South Street, Clifton Springs, NY

The Site is located in the south-central portion of the Village of Clifton Springs in Ontario County, New York. Figure 1 shows the location of the Site and adjacent areas. Figure 2 shows the layout and land use of the Site including the parcel boundary and surrounding areas.

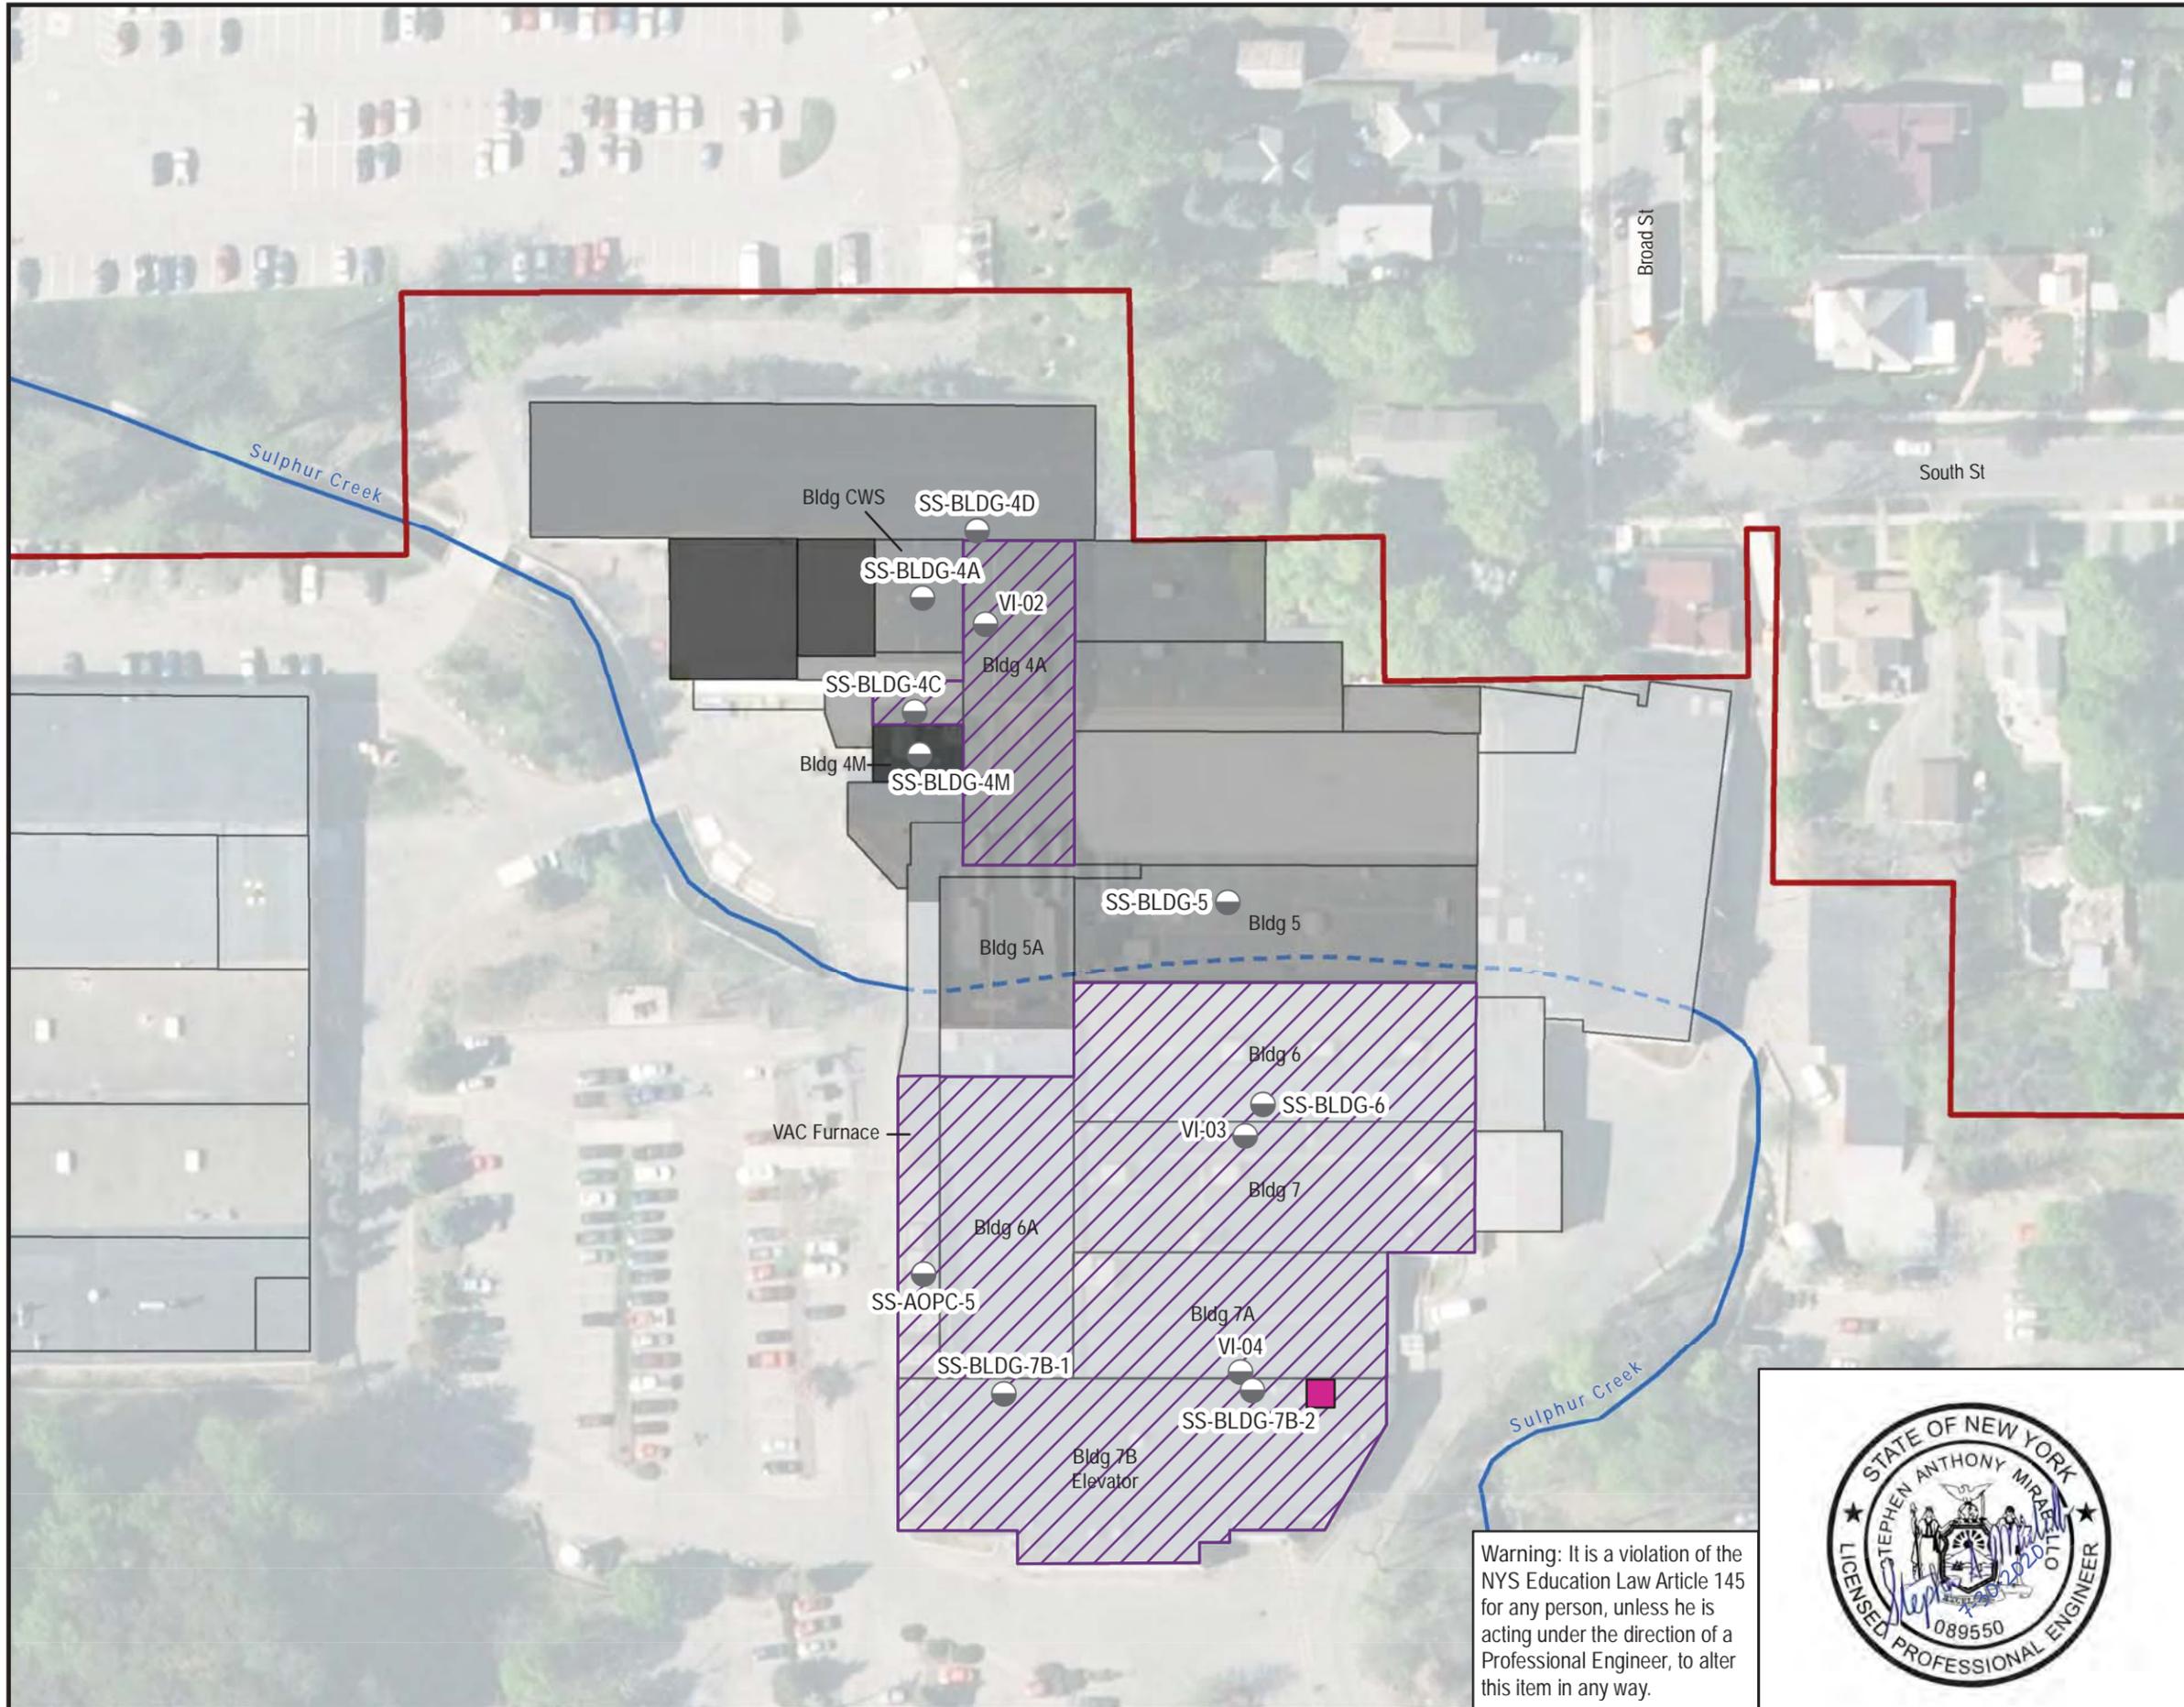
Figure 3	Institutional and Engineering Control Map Main Building		
Prepared For	G. W. Lisk		
Drawn By ORB	Scale 1:900	Date 11 May 2020	Job Number 0500166.05

A series of ICs is provided to (1) implement, maintain, and monitor Engineering Control systems; (2) prevent future exposure to remaining contamination; and (3) limit the use and development of the Site to Industrial uses only. Adherence to these ICs on the Site is required by the BCP has been and will continue to be implemented under the ISMP. ICs identified in the ISMP may not be discontinued without a corresponding NYSDEC-approved amendment to the ISMP. The IC boundaries are shown on Figure 3. These ICs are:

- *The potential for vapor intrusion must be evaluated for any buildings developed in the area within the IC boundaries noted on Figure 3, and any potential impacts that are identified must be monitored or mitigated.*

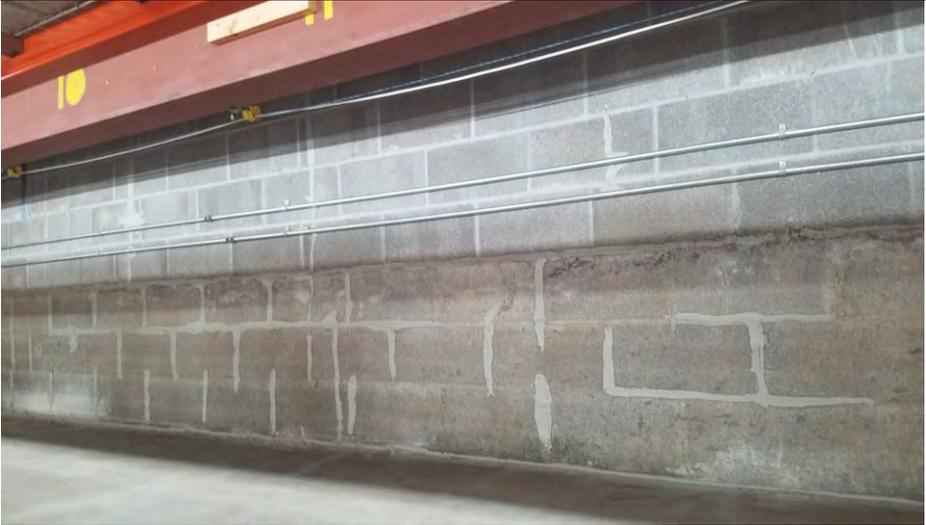
Property ID: G.W. Lisk Company Inc.		Property Location: Clifton Springs, NY	
Photo #: 1	Date: 2/28/2022

Description: Sealed Walls in Building 104

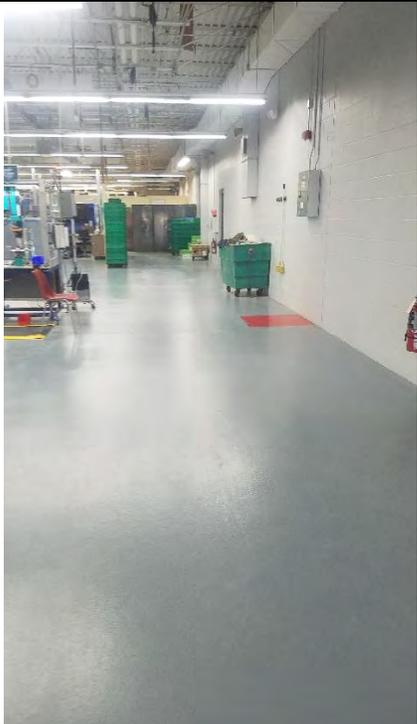
Property ID: G.W. Lisk Company Inc.		Property Location: Clifton Springs, NY	
Photo #: 2	Date: 2/28/2022

Description: Building 101 – New Epoxy Sealed Floor

Continue to seal cracks as new areas are exposed.
Notify ERM of sealing activities and for inspection.
Discuss plans with facility staff to seal stock area in Building 101 - previously inaccessible. Touch up sealing in areas Buildings 102, 103, 103 Loading dock, and 232

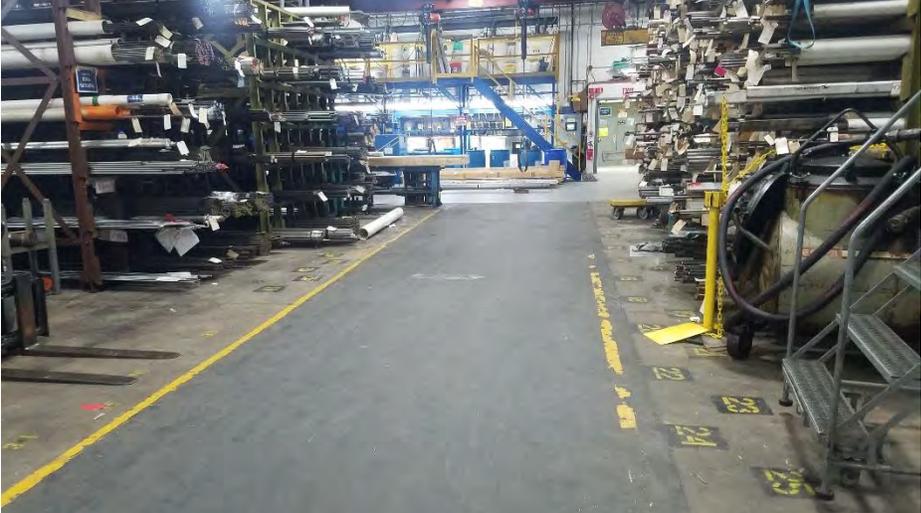
Property ID: G.W. Lisk Company Inc.		Property Location: Clifton Springs, NY	
Photo #: 3	Date: 2/28/2022

Description: Building 4A - Floor

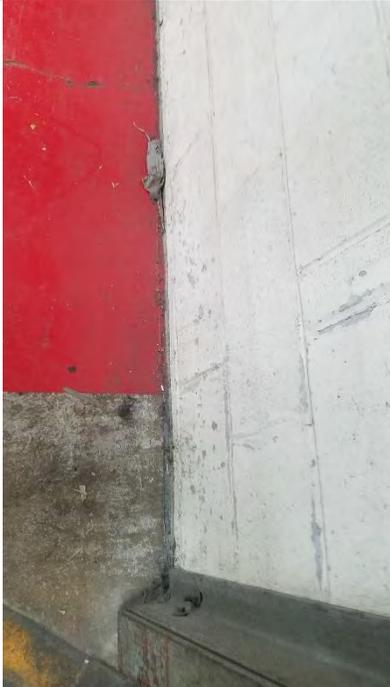
Property ID: G.W. Lisk Company Inc.		Property Location: Clifton Springs, NY	
Photo #: 4	Date: 2/28/2022

Description: Building 6 – Perimeter Gap - Sealed
