PERIODIC REVIEW REPORT

**SENECA MARKET I, LLC SITE
(BCP SITE No. C849004)**

WATKINS GLEN, NEW YORK

May 2010

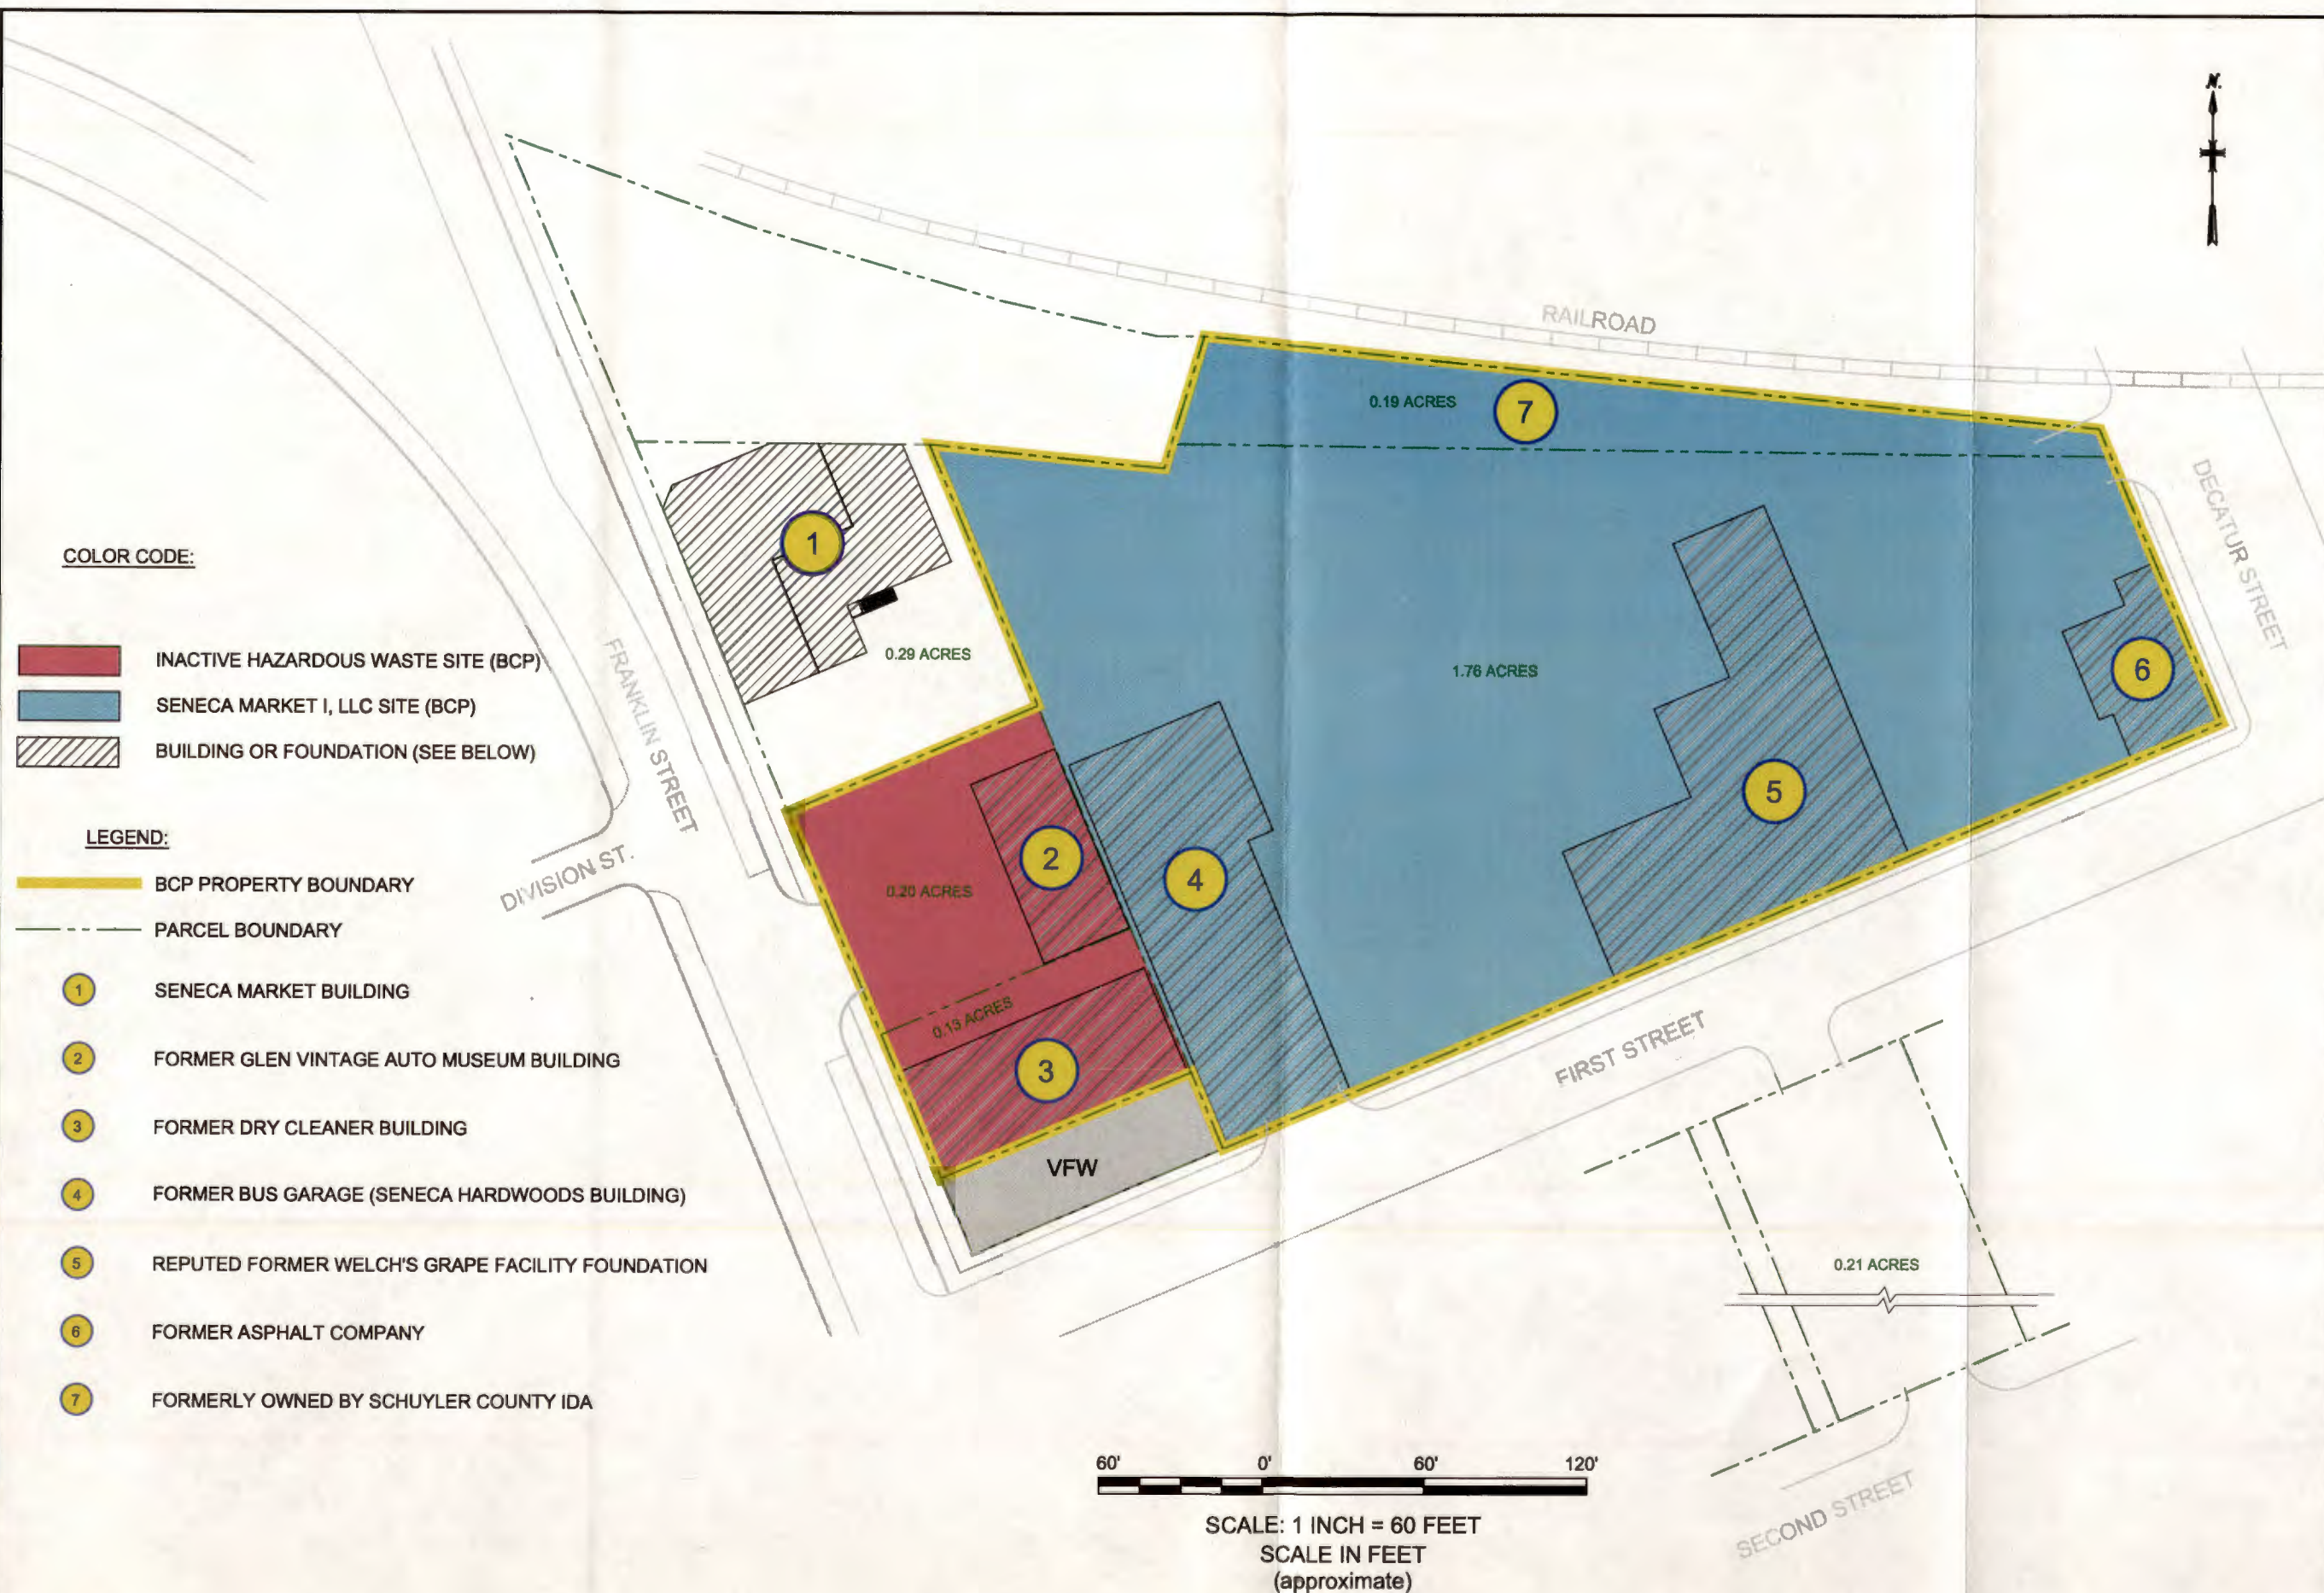
FIGURE 2

The Seneca Market I, LLC Site encompasses approximately 2.3-acres of land which was redeveloped as a hotel complex in Watkins Glen, New York (see Figure 1). The Site was formerly comprised of four separate adjoining tax parcels which were historically used as a dry cleaning facility, a bus garage, an automobile museum, a grape processing facility, and an asphalt company. Figure 2 shows the former parcels and buildings prior to remediation.

SITE PLAN (PRE-REMEDIATION)

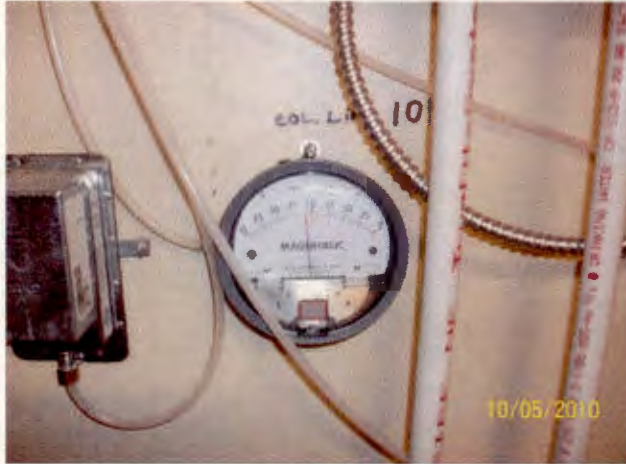
Photo 1: Magnahelic gauge (0.9 inches WC indicated – line 10)

During the annual Site Inspection, the inspector verified that the ASD system was operating properly, as indicated by the readings on both of the magnahelic vacuum gauges (0.75 and 0.90 inches water column (WC), respectively), and an alarm response of the indicator lights when the system was manually tripped. Copies of the ASD periodic visual inspection logs are included in Appendix C.

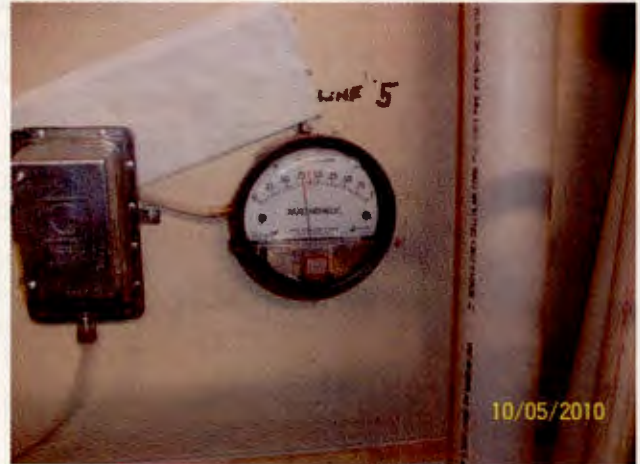
Photo 2: Magnahelic gauge (0.75 inches WC indicated – line 5)

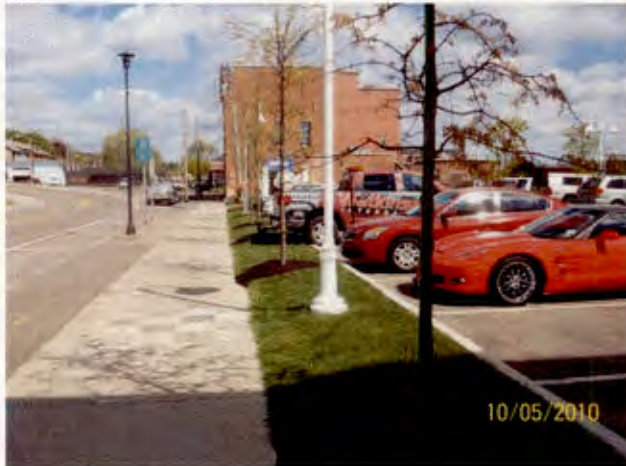
- Photo 5: Site conditions parking area (looking west adjacent to First St.)
- Photo 6: Site conditions parking area (looking north)
- Photo 7: Site conditions (looking southeast adjacent to Seneca Market bldg.)
- Photo 8: Landscaping (adjacent to Franklin St.)

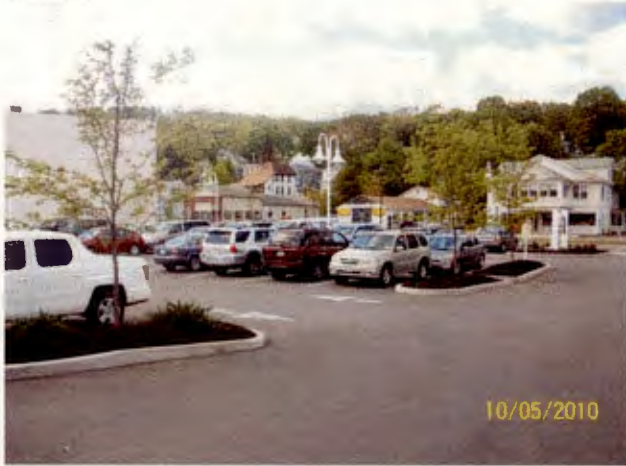
Photo 9: Condition of asphalt parking area (looking south toward First St.)

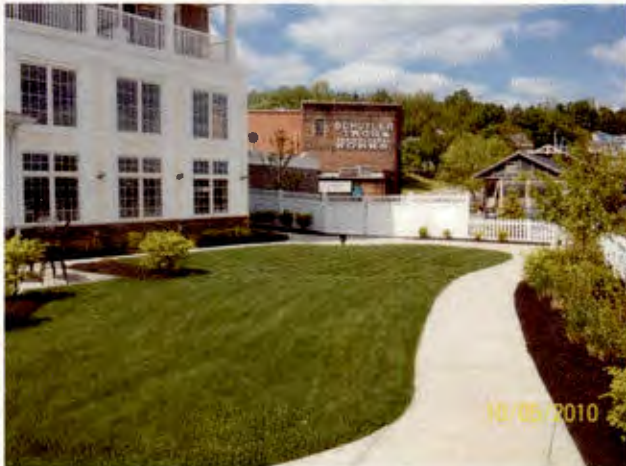
Photo 11: Exterior site conditions (north side of building looking west at Seneca Market Building)

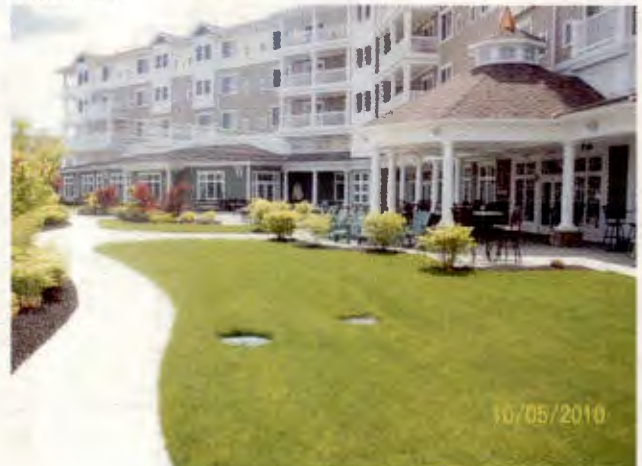
Photo 12: Exterior site conditions (north side of building looking east)
