# Periodic Review Report

**Site No. 3 BCP Site (BCP Site #C859028)  
Reporting Period: April 21, 2022 to April  
21, 2023**

Garlock Sealing Technologies

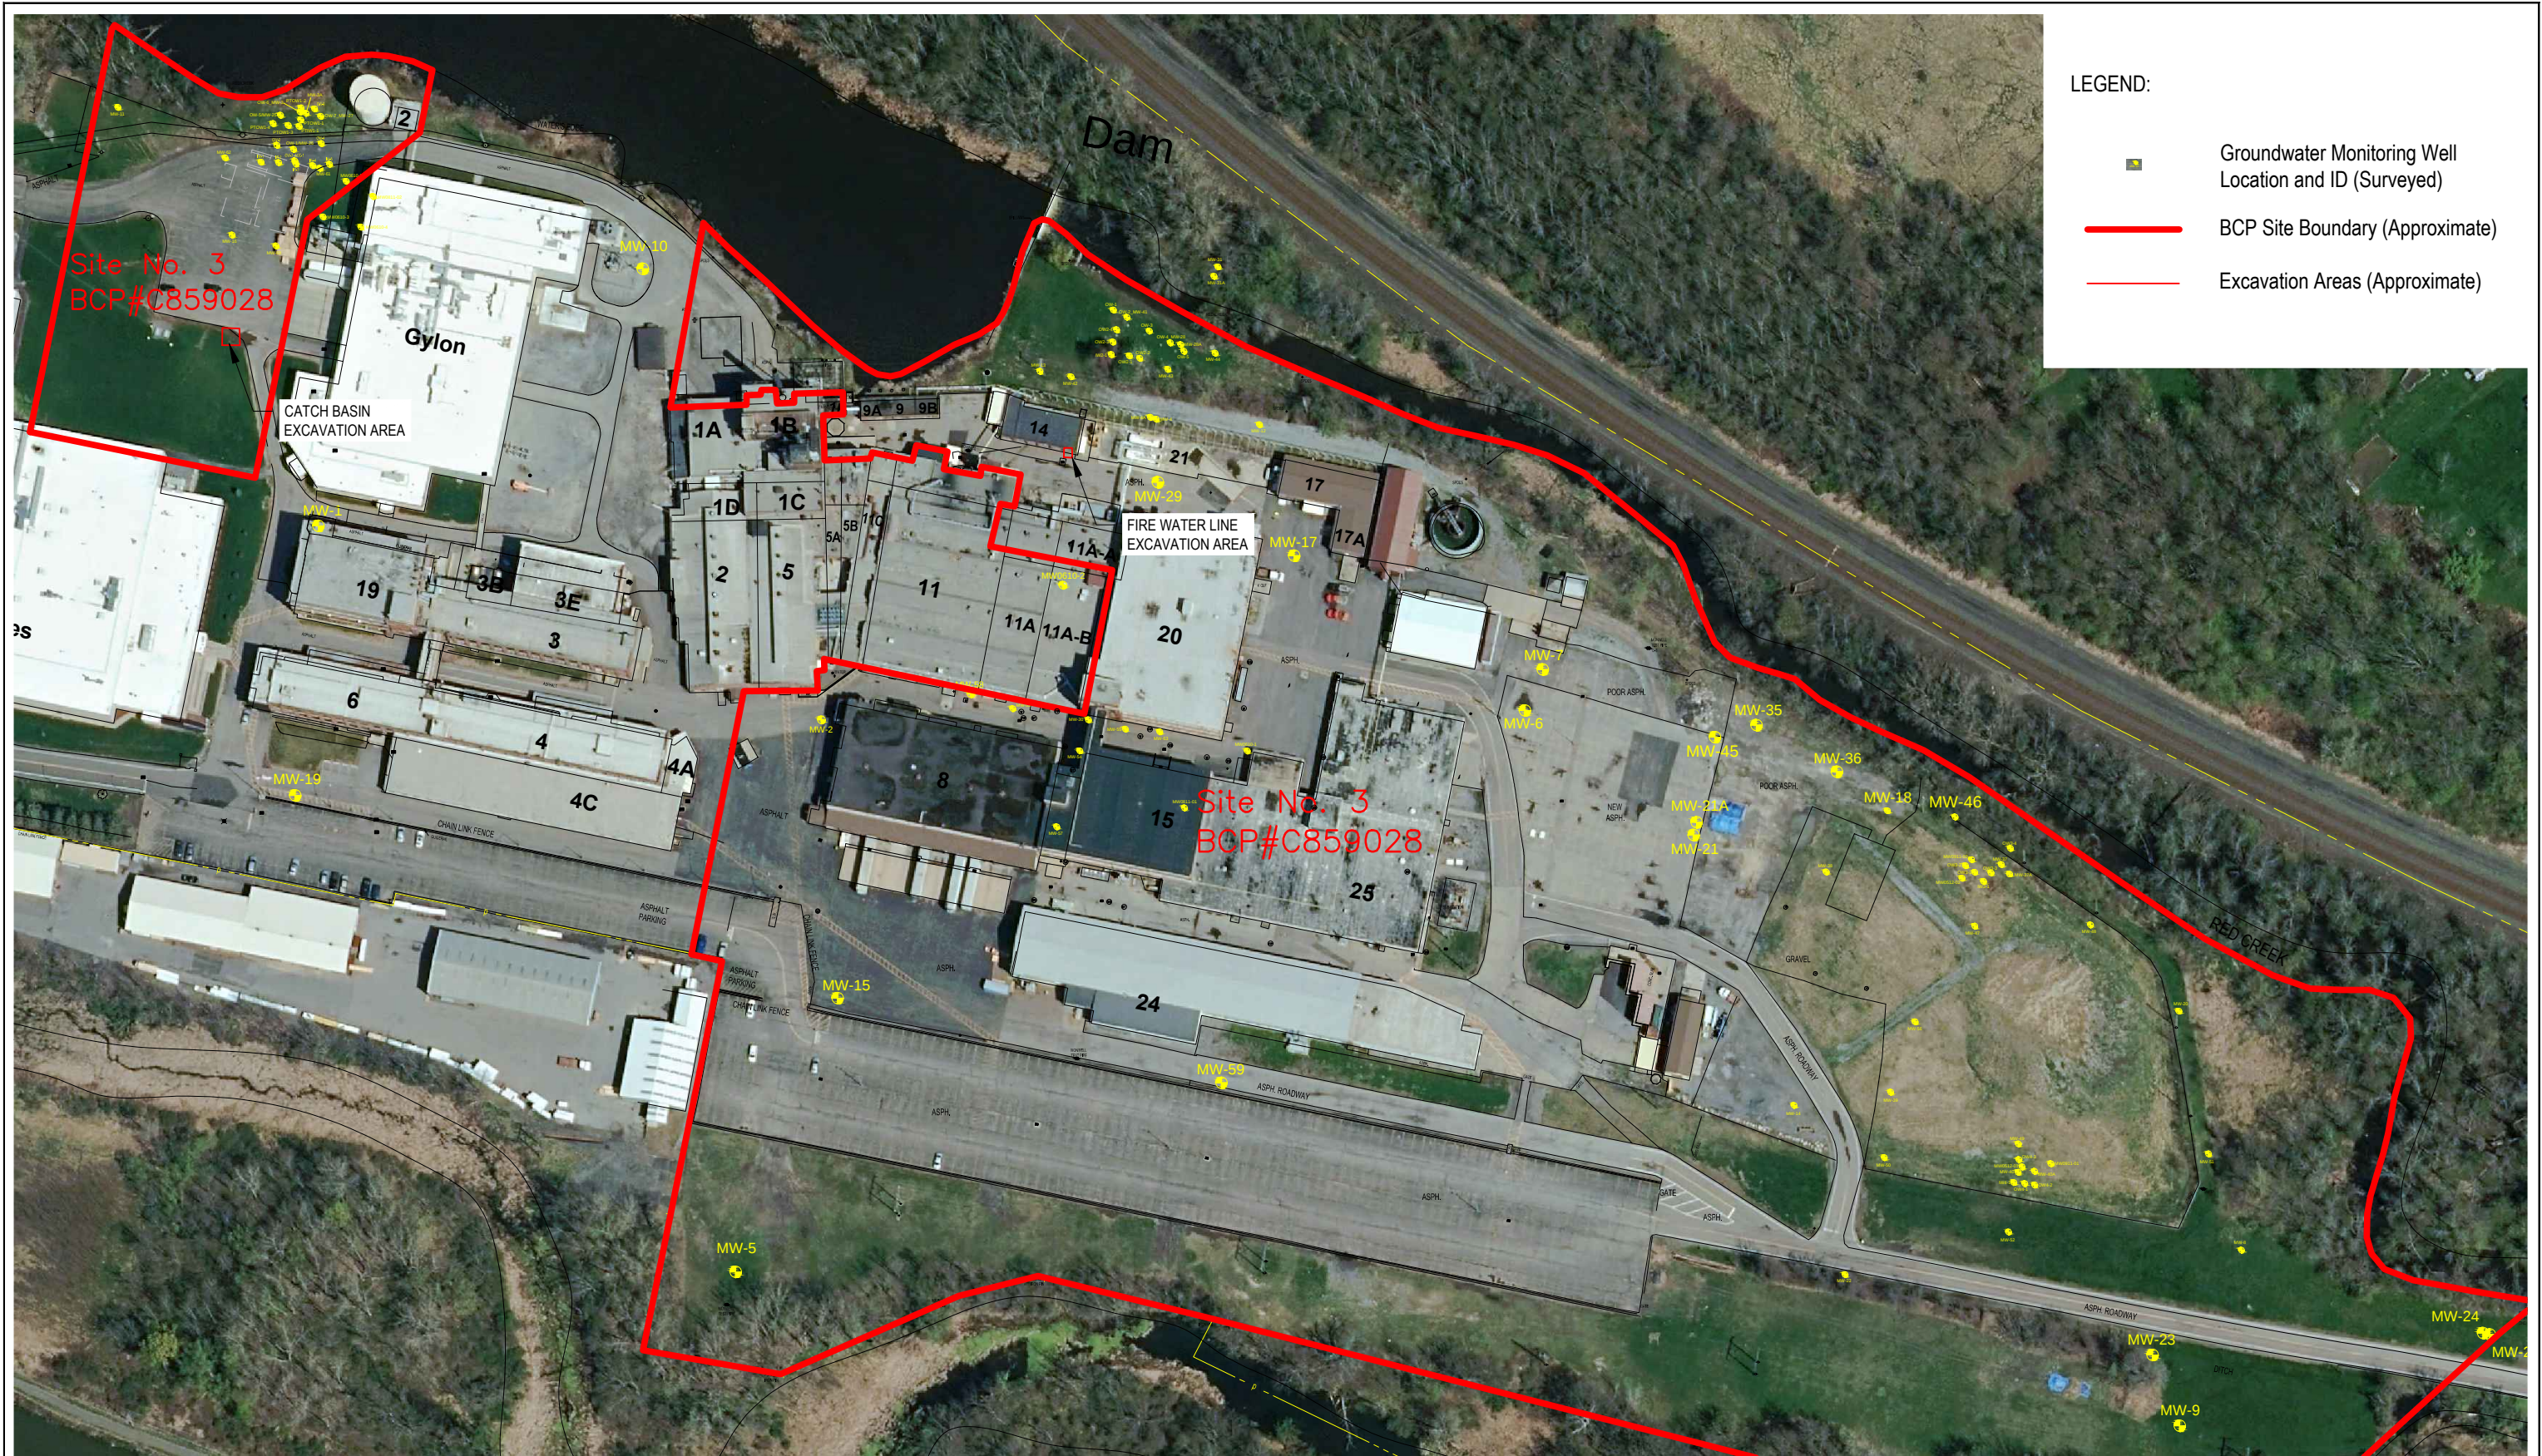
FIGURE 2

SITE LAYOUT

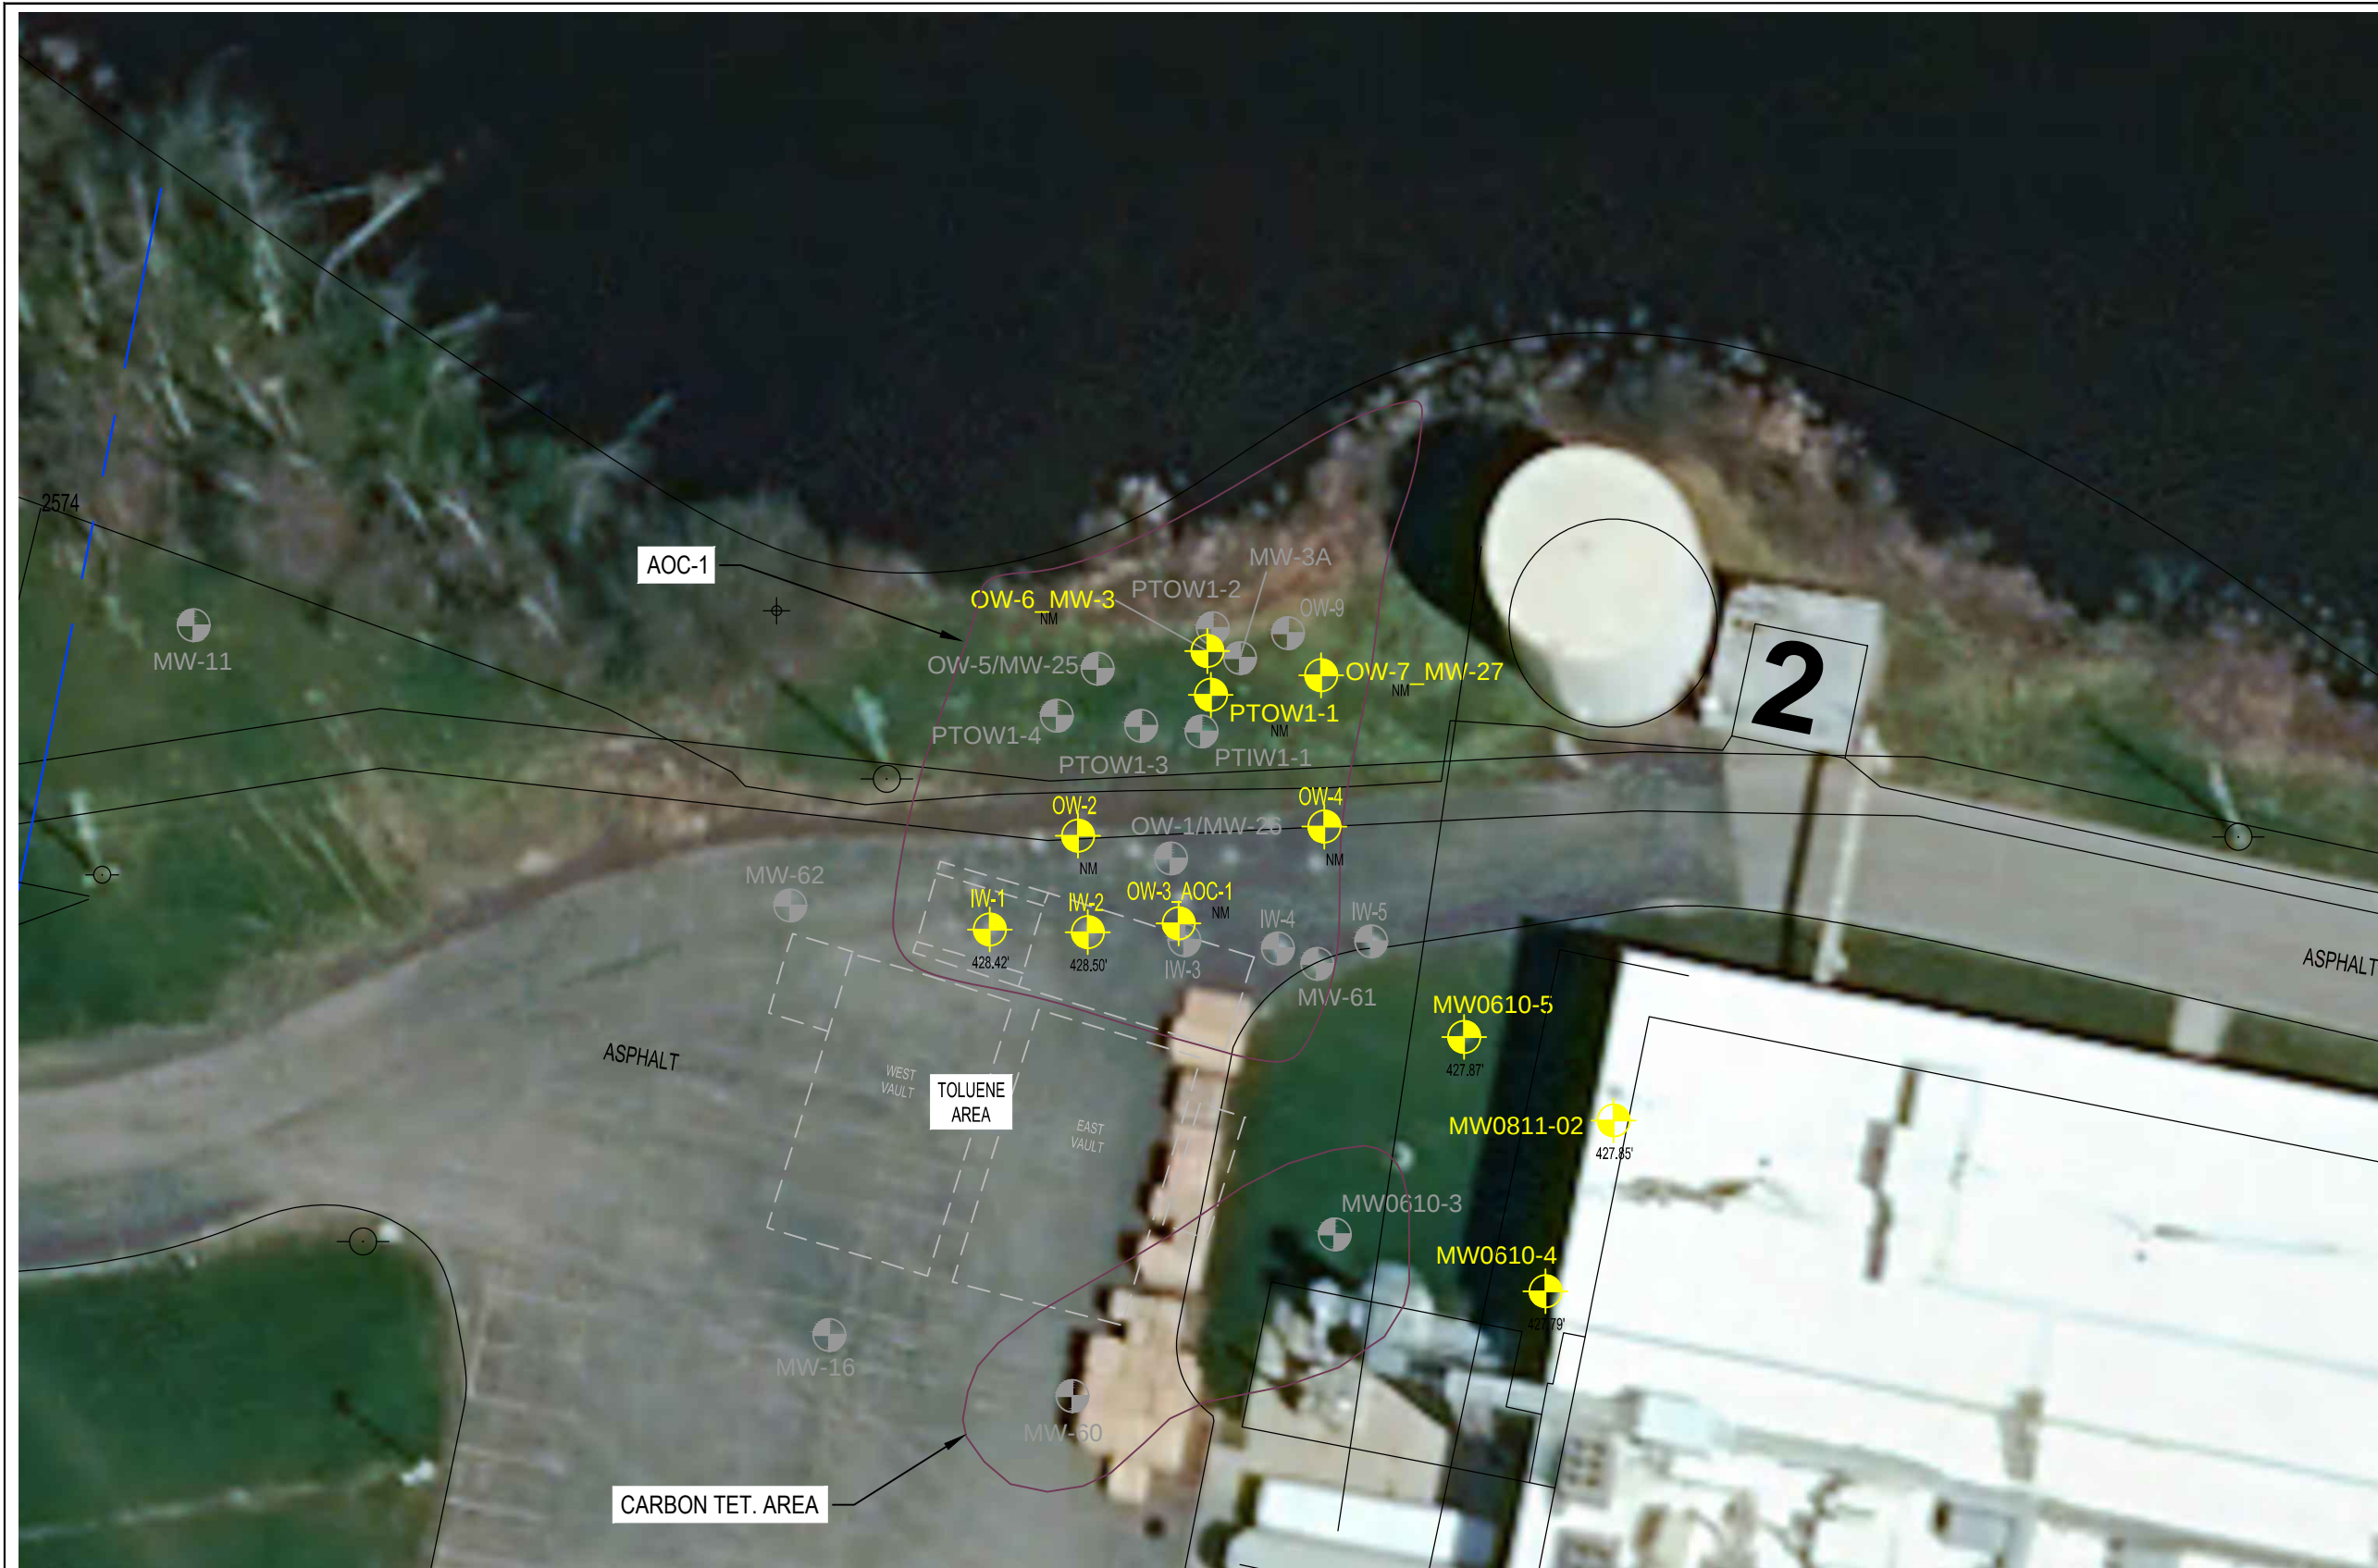
FIGURE 1

SITE LAYOUT

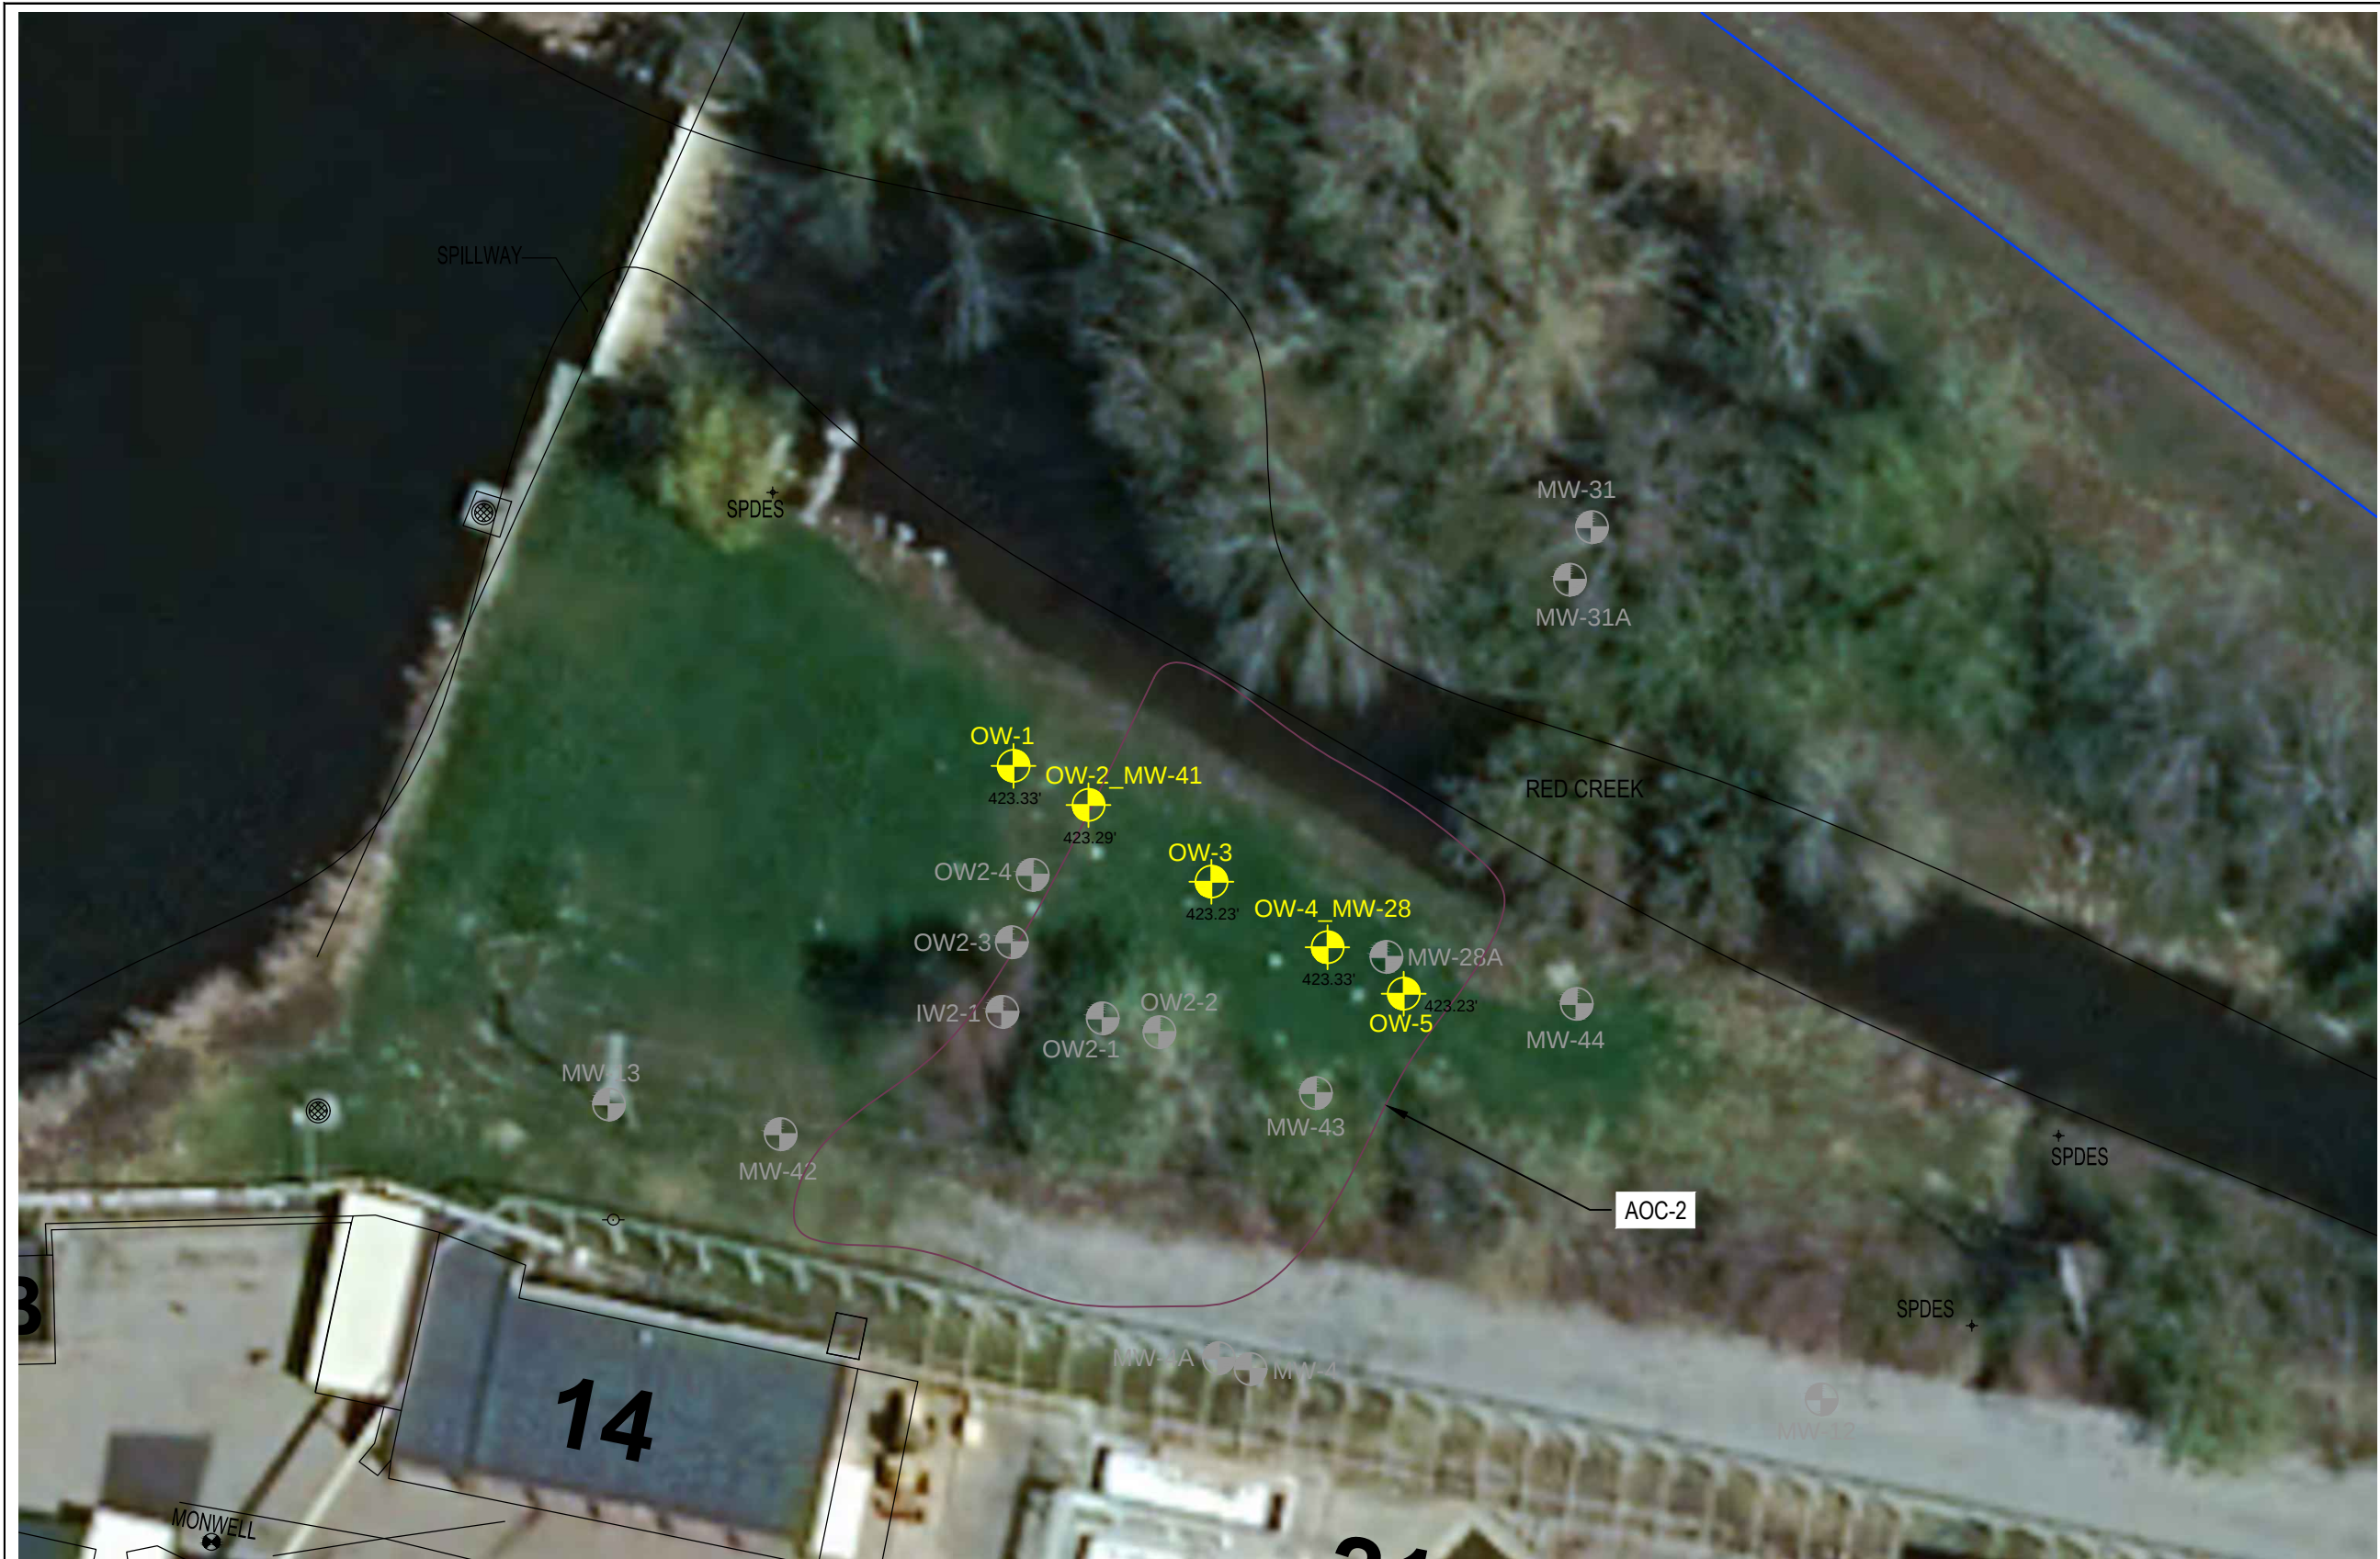
| 7620 | 0.005 | 9:52 AM |

- OW-1**  
Effectiveness Groundwater Monitoring Well Location and ID (Surveyed)
- MW-43**  
Other Groundwater Monitoring Well Location and ID (Surveyed)
- 423.23'  
Groundwater Elevation (March 30, 2023)

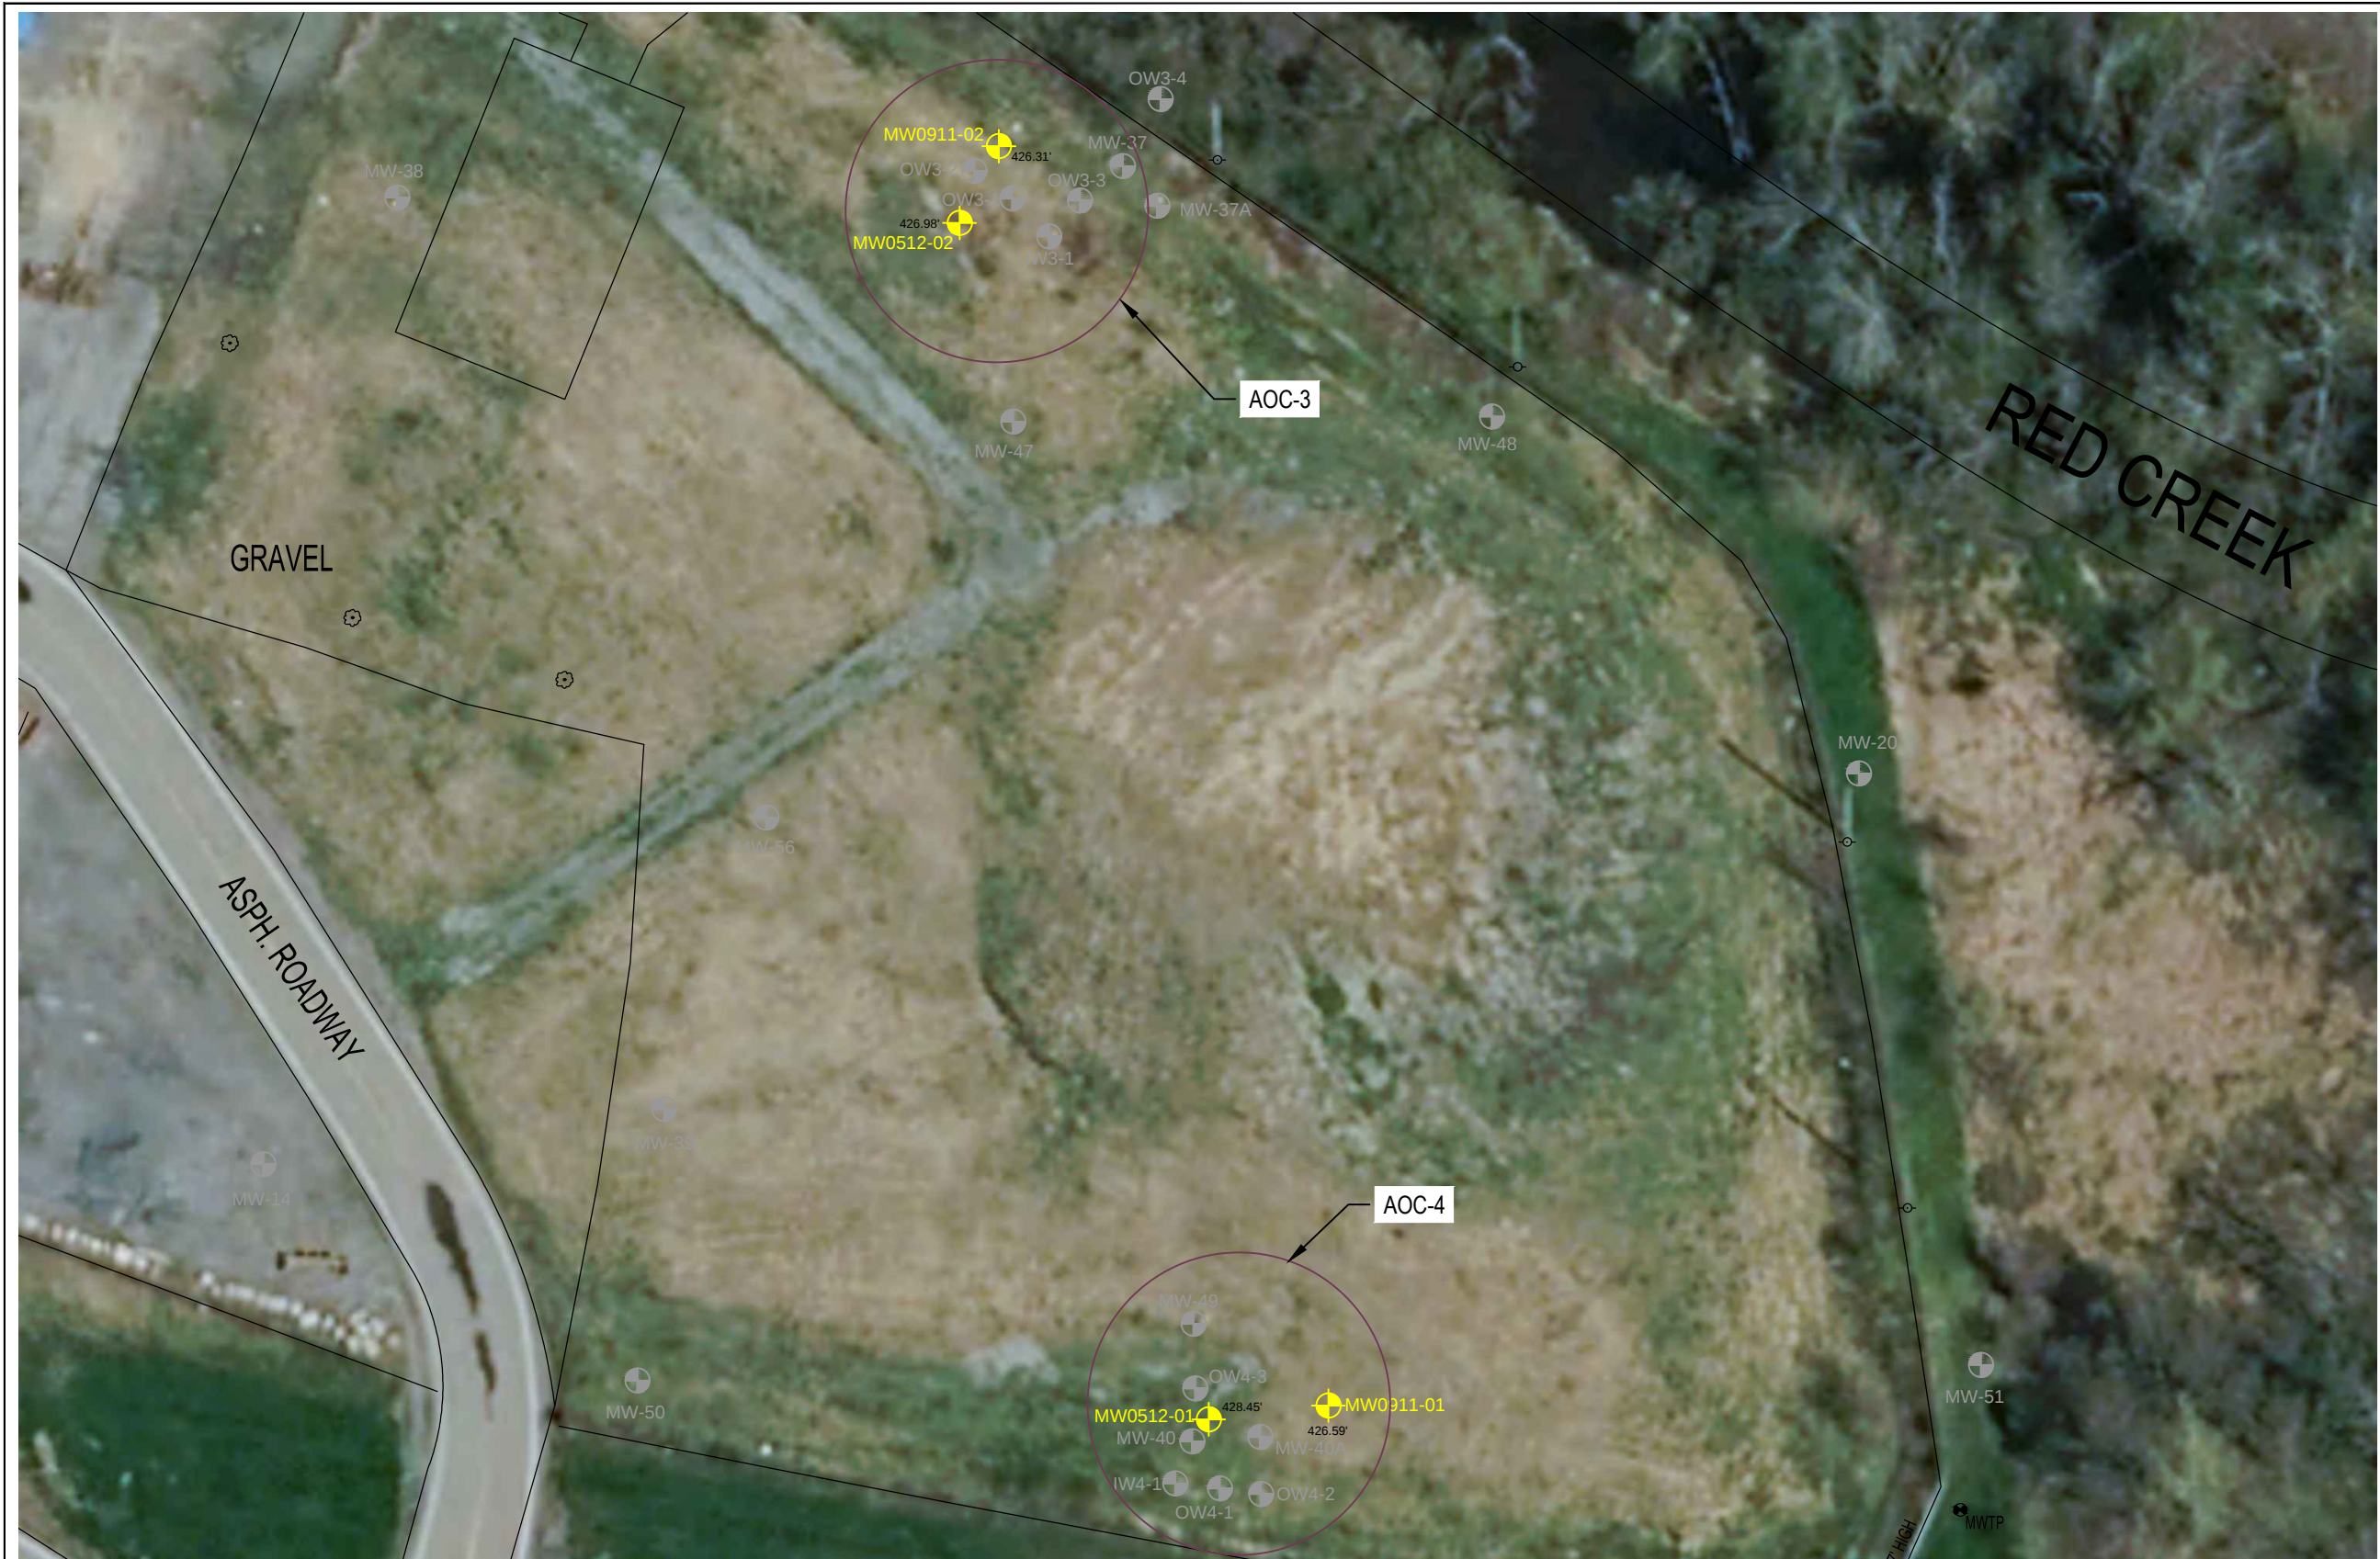
FIGURE 3

AOC-2

Quarterly groundwater monitoring for AOC-2 includes taking samples from five (5) groundwater monitoring wells: OW-1, OW-2\_MW-41, OW-3, OW-4\_MW-28, and OW-5 (Figure 3 and Table 4 in Appendix B). Each groundwater sample is analyzed for TCL VOCs, TOC, COD, and field parameters.

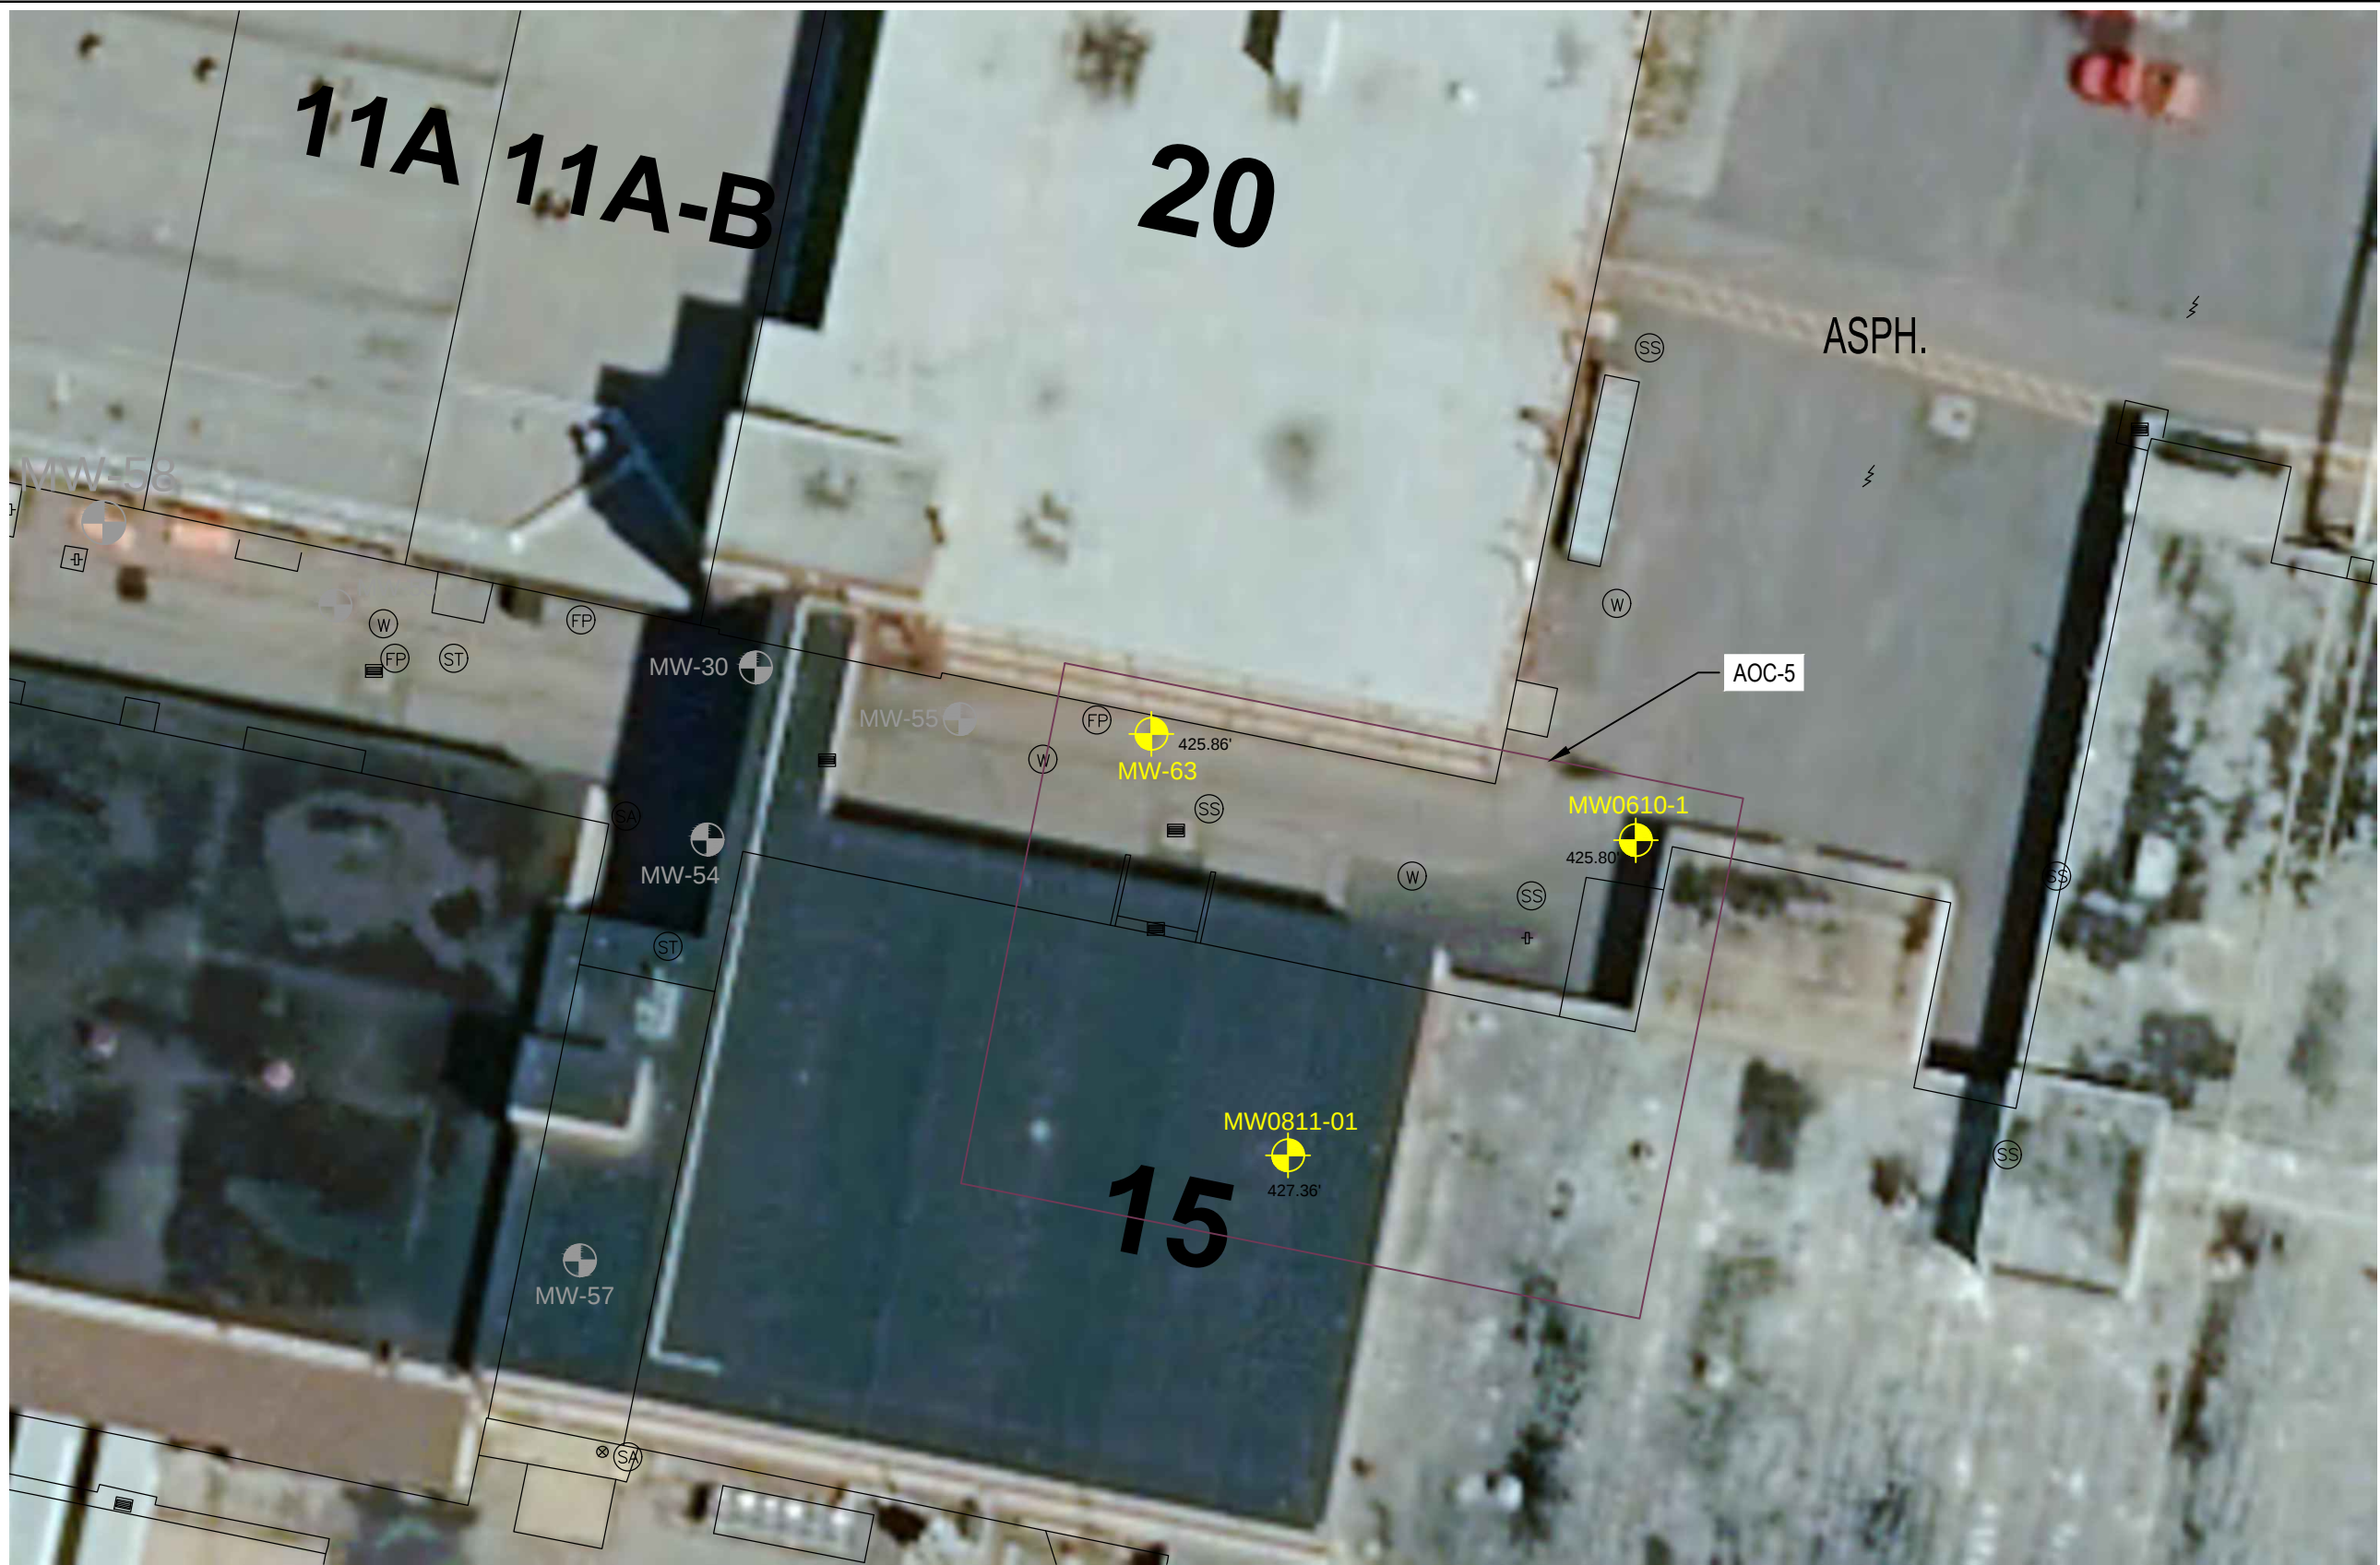
FIGURE 4

AOC-3 AND AOC-4

Quarterly groundwater monitoring for AOC-3 includes taking samples from two (2) groundwater monitoring wells, MW0512-02 and MW0911-02 (Figure 4 and Table 5 in Appendix B). Each sample is analyzed for TCL VOCs and field parameters.

Quarterly groundwater monitoring for AOC-4 includes taking samples from two (2) groundwater monitoring wells: MW0512-01 and MW0911-01 (Figure 4 and Table 6 in Appendix B). Each sample is analyzed for TCL VOCs and field parameters.

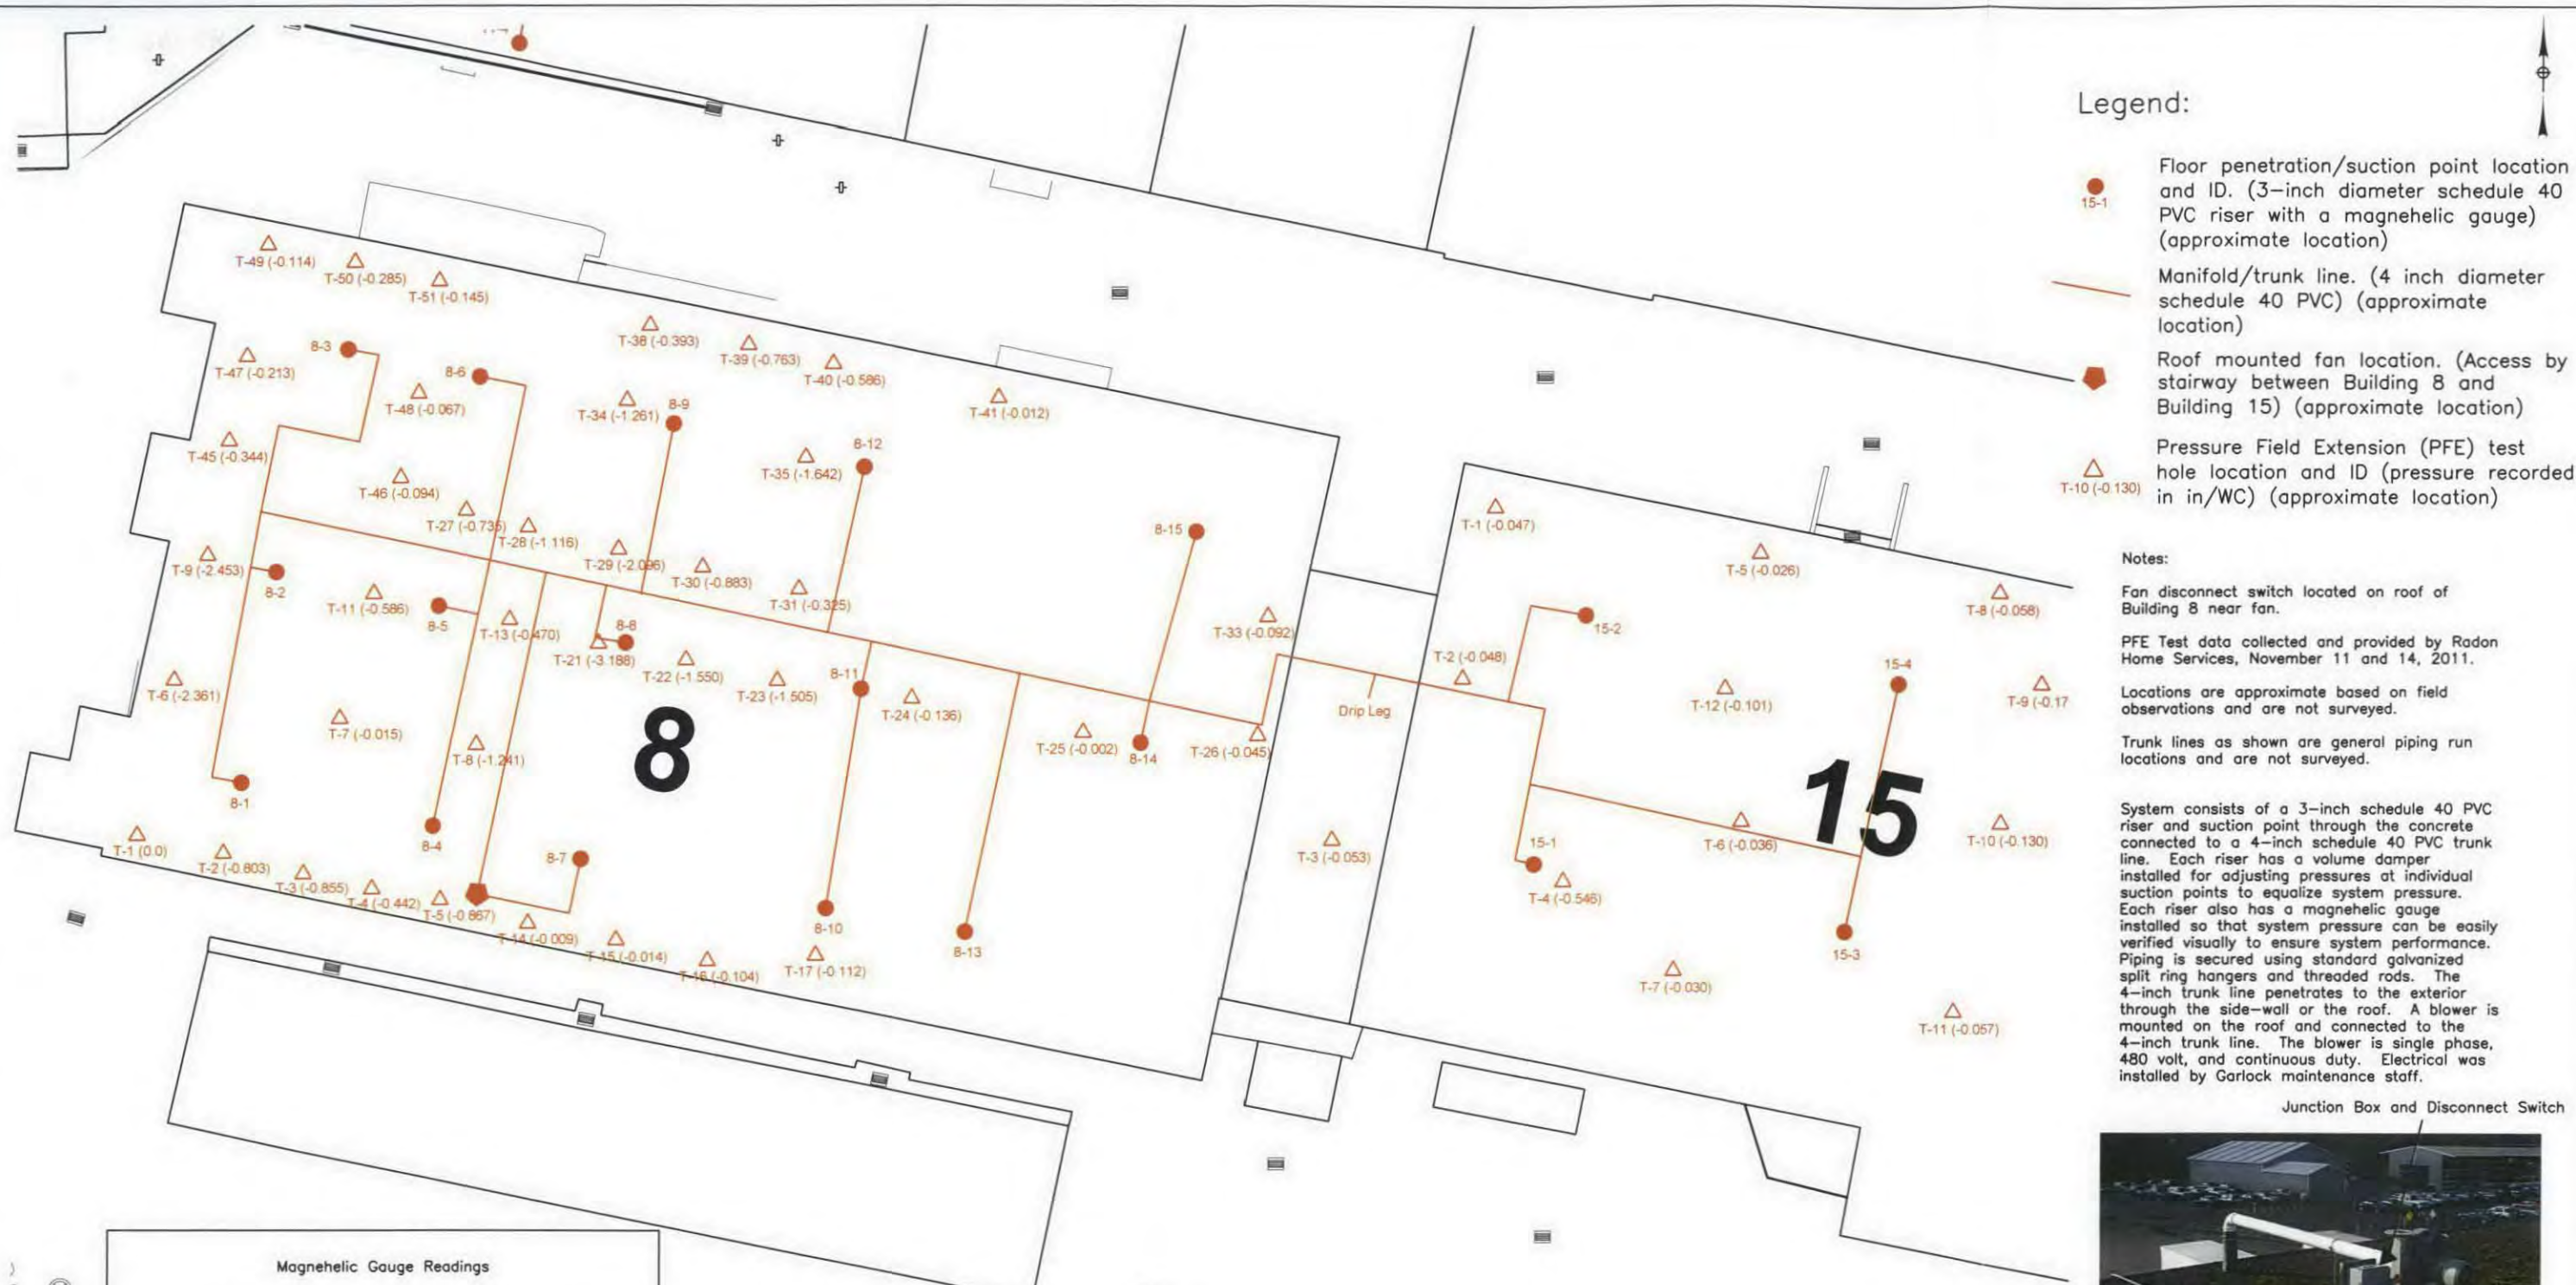
Figure 16 – Buildings 8 and 15 SSDS  
Layout and PFE Test Results

- Legend:**
- Floor penetration/suction point location and ID. (3-inch diameter schedule 40 PVC riser with a magnehelic gauge) (approximate location)
  - Manifold/trunk line. (4 inch diameter schedule 40 PVC) (approximate location)
  - Roof mounted fan location. (Access by stairway between Building 8 and Building 15) (approximate location)
  - Pressure Field Extension (PFE) test hole location and ID (pressure recorded in in/WC) (approximate location)

System consists of a 3-inch schedule 40 PVC riser and suction point through the concrete connected to a 4-inch schedule 40 PVC trunk line. Each riser has a volume damper installed for adjusting pressures at individual suction points to equalize system pressure. Each riser also has a magnehelic gauge installed so that system pressure can be easily verified visually to ensure system performance. Piping is secured using standard galvanized split ring hangers and threaded rods. The 4-inch trunk line penetrates to the exterior through the side-wall or the roof. A blower is mounted on the roof and connected to the 4-inch trunk line. The blower is single phase, 480 volt, and continuous duty. Electrical was installed by Garlock maintenance staff.

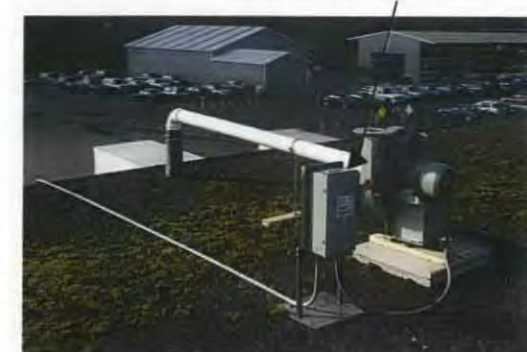
Junction Box and Disconnect Switch

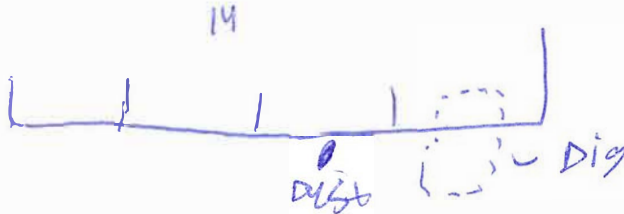
Sketch:

Description of Job: Fire line Dig
