# Periodic Review Report

**Site No. 3 BCP Site (BCP Site #C859028)  
Reporting Period: April 21, 2022 to April  
21, 2023**

Garlock Sealing Technologies

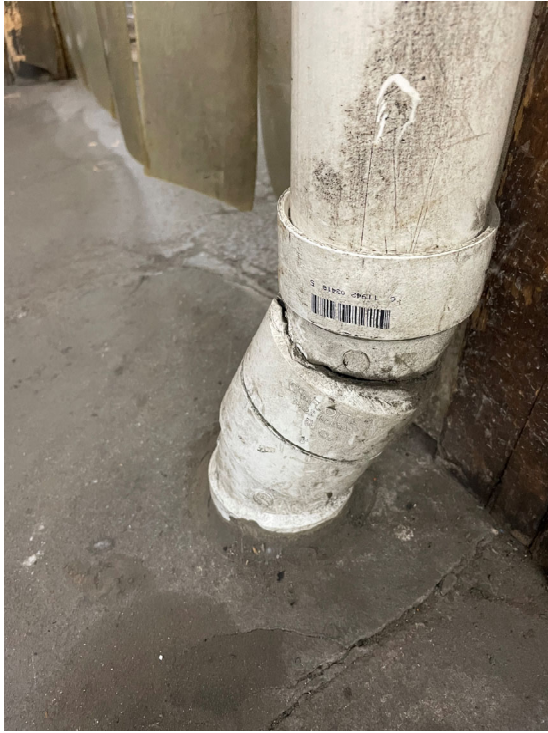
- Riser 20-4 in building 20 appeared to be broken at the base and should be repaired.

**Photo 1** Broken riser pipe 20-4.

- Minor surface soil repairs are required for the disturbed soil surface adjacent to roadways. Repairs should include regrading and/or filling as needed and reseeding to re-establish grass cover, which has been initiated by Garlock under Work Order #124033 on May 22, 2023.
- Based on SSDS gauge readings recorded by Garlock personnel during the monthly inspections, it appears that the SSDSs are functioning as intended and should continue to be operated in their current configurations. The following noted repair should be completed, and documentation retained for inclusion in the next PRR:
  - The base of riser pipe 20-4 in building 20 should be repaired.
- The fan exhaust piping from Building 31 should have a “T” or gooseneck fitting installed at the outlet to reduce rainwater entering the piping.

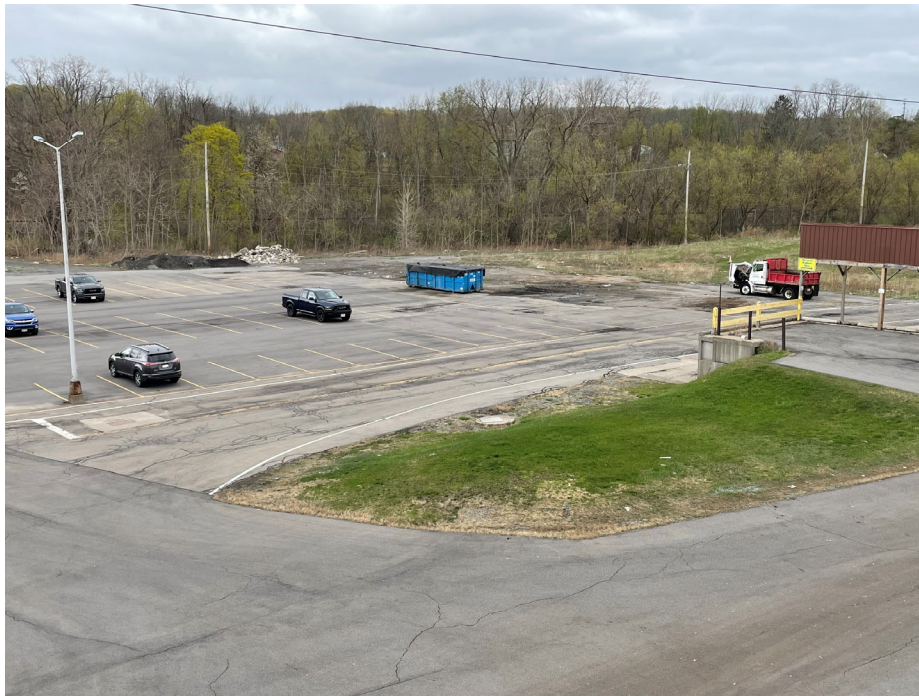
- In general, the soil/grassed landscape areas were intact; however, several areas adjacent to the asphalt pavement appeared to be disturbed at the surface, likely as a result of snow removal activities. The surface disturbance did not appear to constitute a breach of the soil cover system or have the potential to expose remaining contamination in subsurface soils.
- In general, the lower levels of the building floors appear to have minor cracks in them, the cracks do not appear to constitute a breach of the soil cover system or have the potential to expose remaining contamination and should be monitored to mitigate future concerns.

**Photo 2** Example of snow removal surface soil disturbance seen at various locations at the Site adjacent to roadways.
