**Remedial Investigation Report and
Interim Remedial Measures
Construction Completion Report
Former Allegany Bitumens Belmont
Asphalt Plant
Brownfield Cleanup Program
Site # C902019
5392 State Route 19
Amity, Allegany County, New York**

**RE: Remedial Investigation Report and
Interim Remedial Measures Construction Completion Report
Brownfield Cleanup Program Site # C902019
Former Allegany Bitumens Belmont Asphalt Plant
5392 State Route 19, Amity, New York**

**REMEDIAL INVESTIGATION REPORT AND
INTERIM REMEDIAL MEASURES CONSTRUCTION COMPLETION REPORT
FORMER ALLEGANY BITUMENS BELMONT ASPHALT PLANT****Executive Summary**

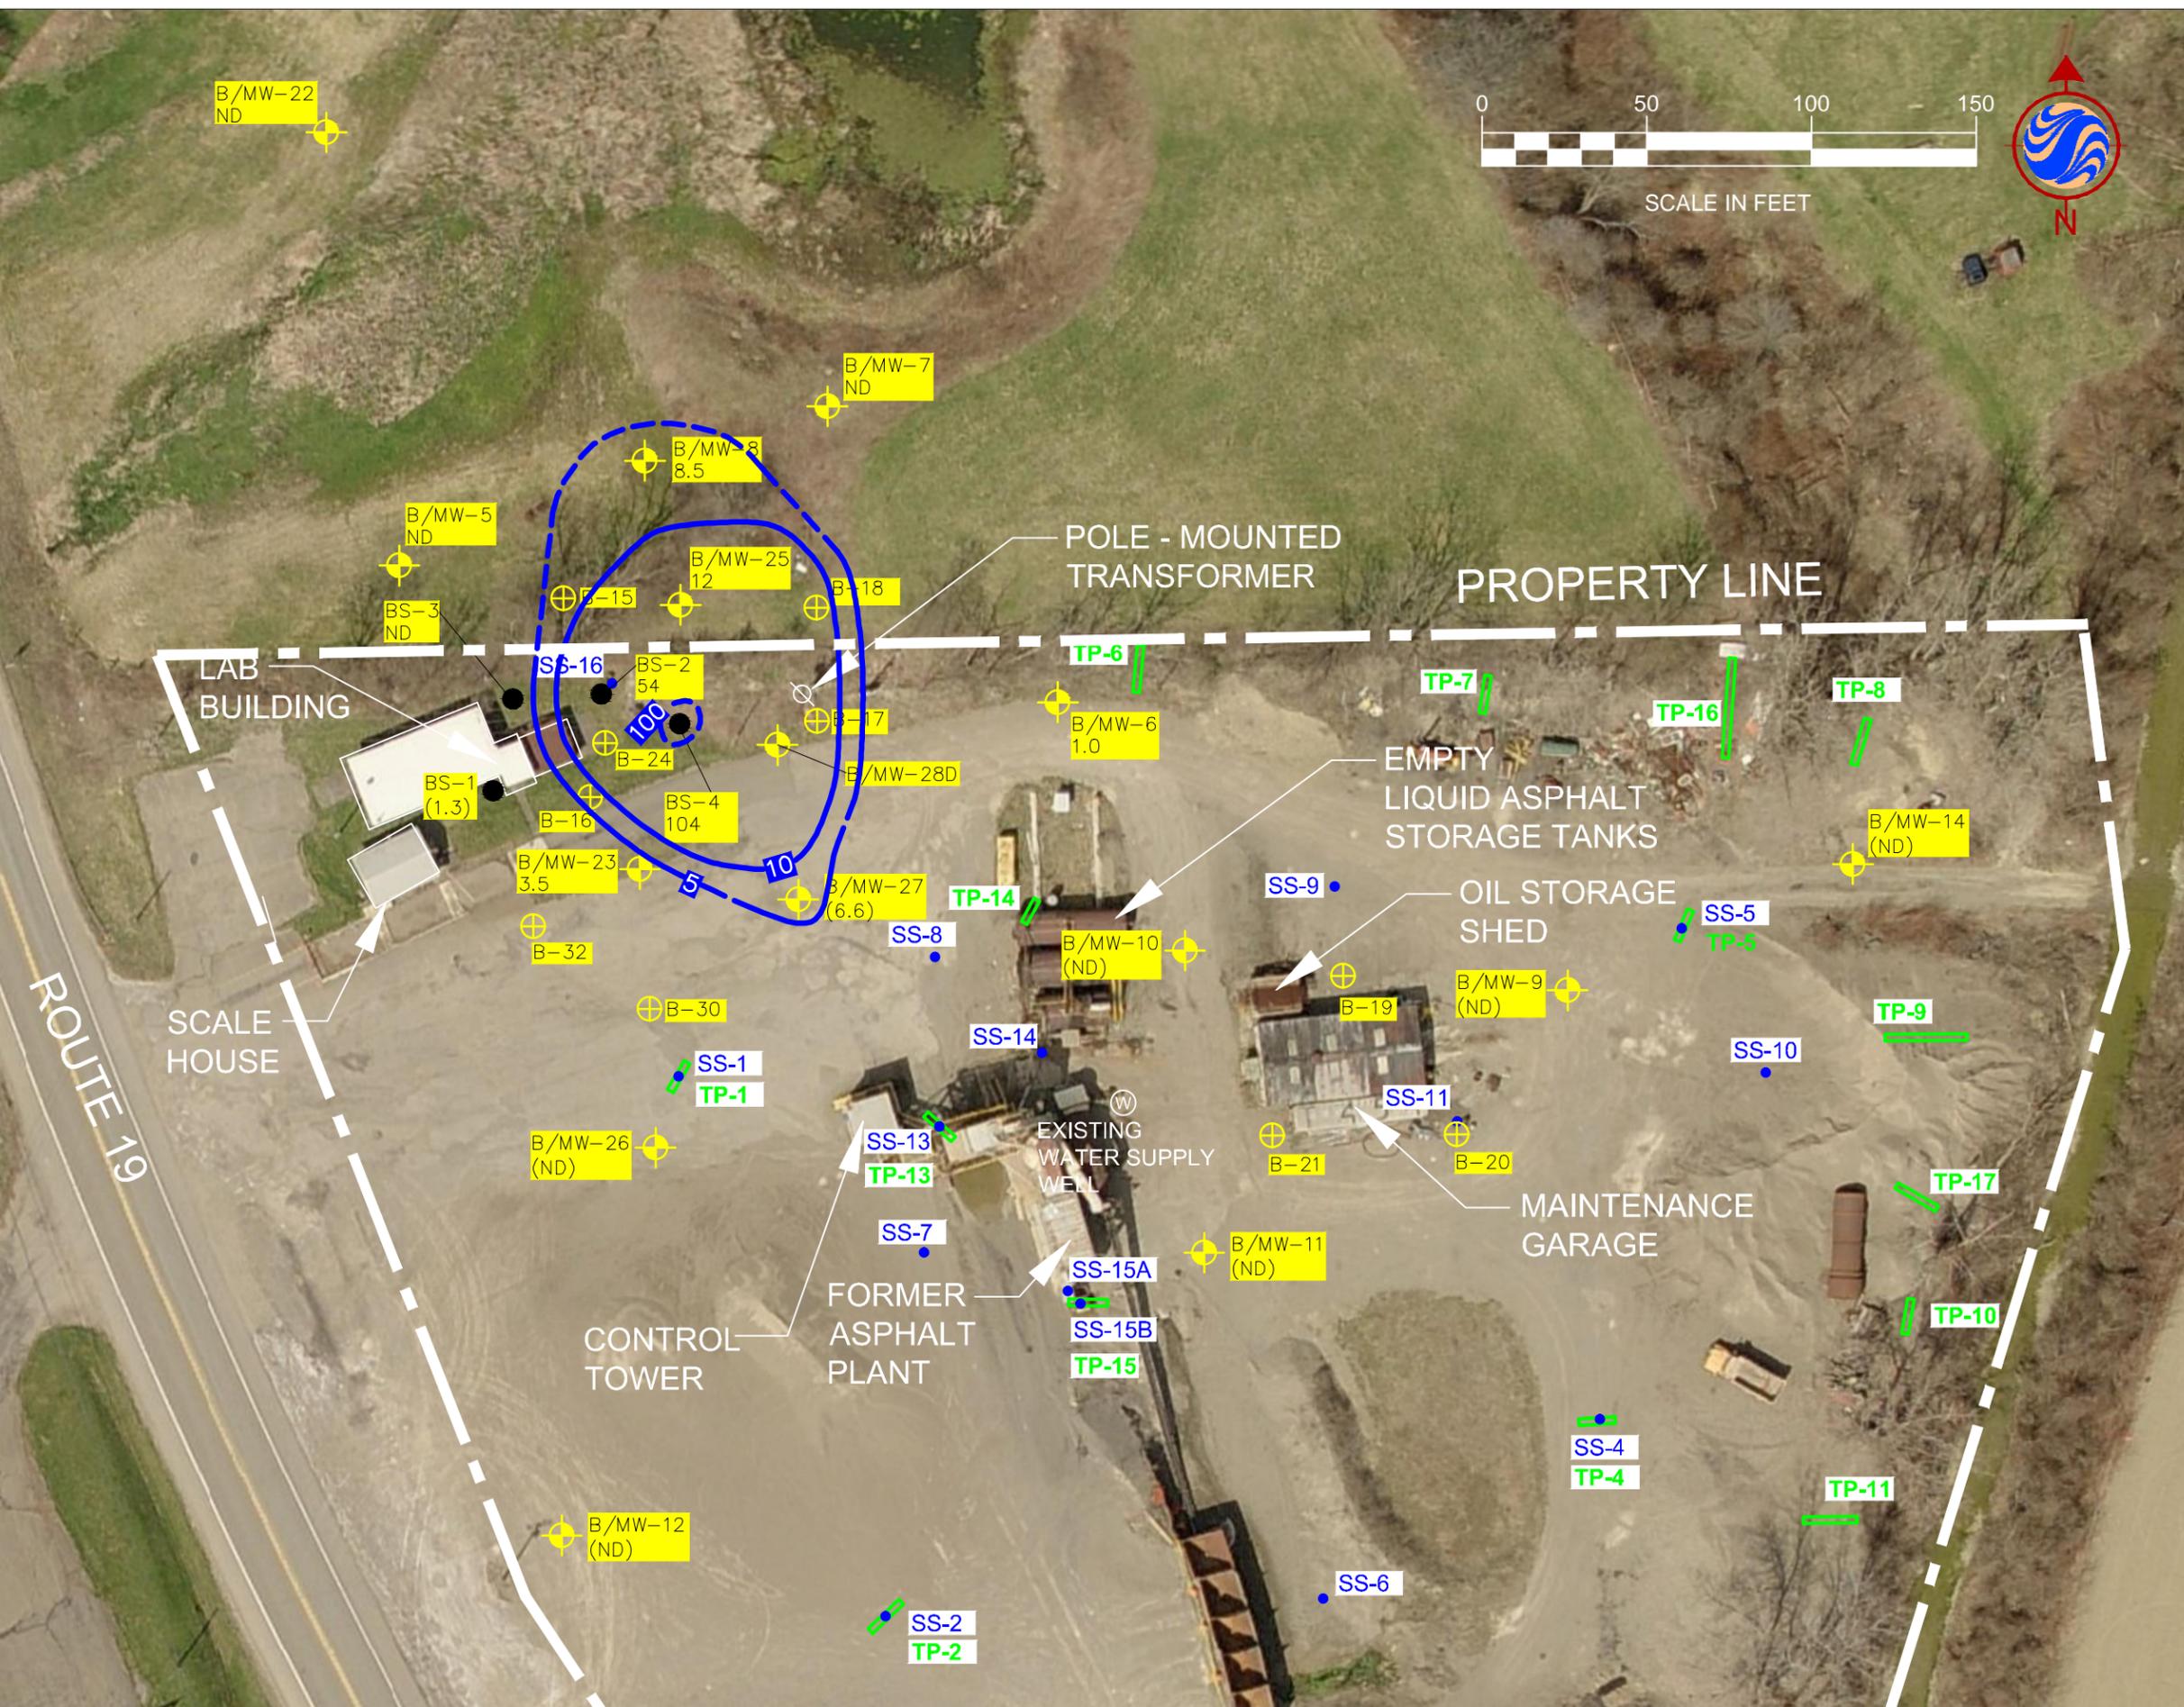
FIG. 12

The second RI round of groundwater sampling was conducted on April 20-21, 2011. Ten shallow overburden wells were sampled. Chlorinated VOCs were detected in six of the wells, with exceedances at four of these locations (BS-2, BS-4, MW-8, and MW-25). Total chlorinated ethene and ethane concentrations ranged up to 0.1 ppm, with TCE comprising the majority of this total at 0.091 ppm. Figure 12 presents interpolated contours of the chlorinated VOCs in shallow overburden wells. As with the first round of sampling, concentrations were highest east and southeast of the laboratory building. Downgradient concentrations in the area to the north and to the east diminish rapidly. VOC concentrations during the second round of sampling were generally lower than those observed during the first round of sampling. It is presumed that the reduction of VOC concentrations was related to the high water table at the time of sampling. During the weeks prior to sampling precipitation levels were well above average levels. In March the average precipitation at nearby Wellsville, NY is 2.24 inches and the actual precipitation was 3.15 inches, thus the actual was 41% higher than the average. From April 1st to 21st, the average precipitation is 1.77 inches and the actual precipitation was 3.75 inches, thus the actual was more than twice the average amount. Thus, the changes in VOC concentrations represent seasonal variation in concentrations which may have been more extreme due to the particularly high levels of precipitation and the resulting high groundwater levels that caused dilution of the contaminant concentrations.

File Name: Figure 12 Total Chlorinated VOC in Groundwater April 2011-RB11

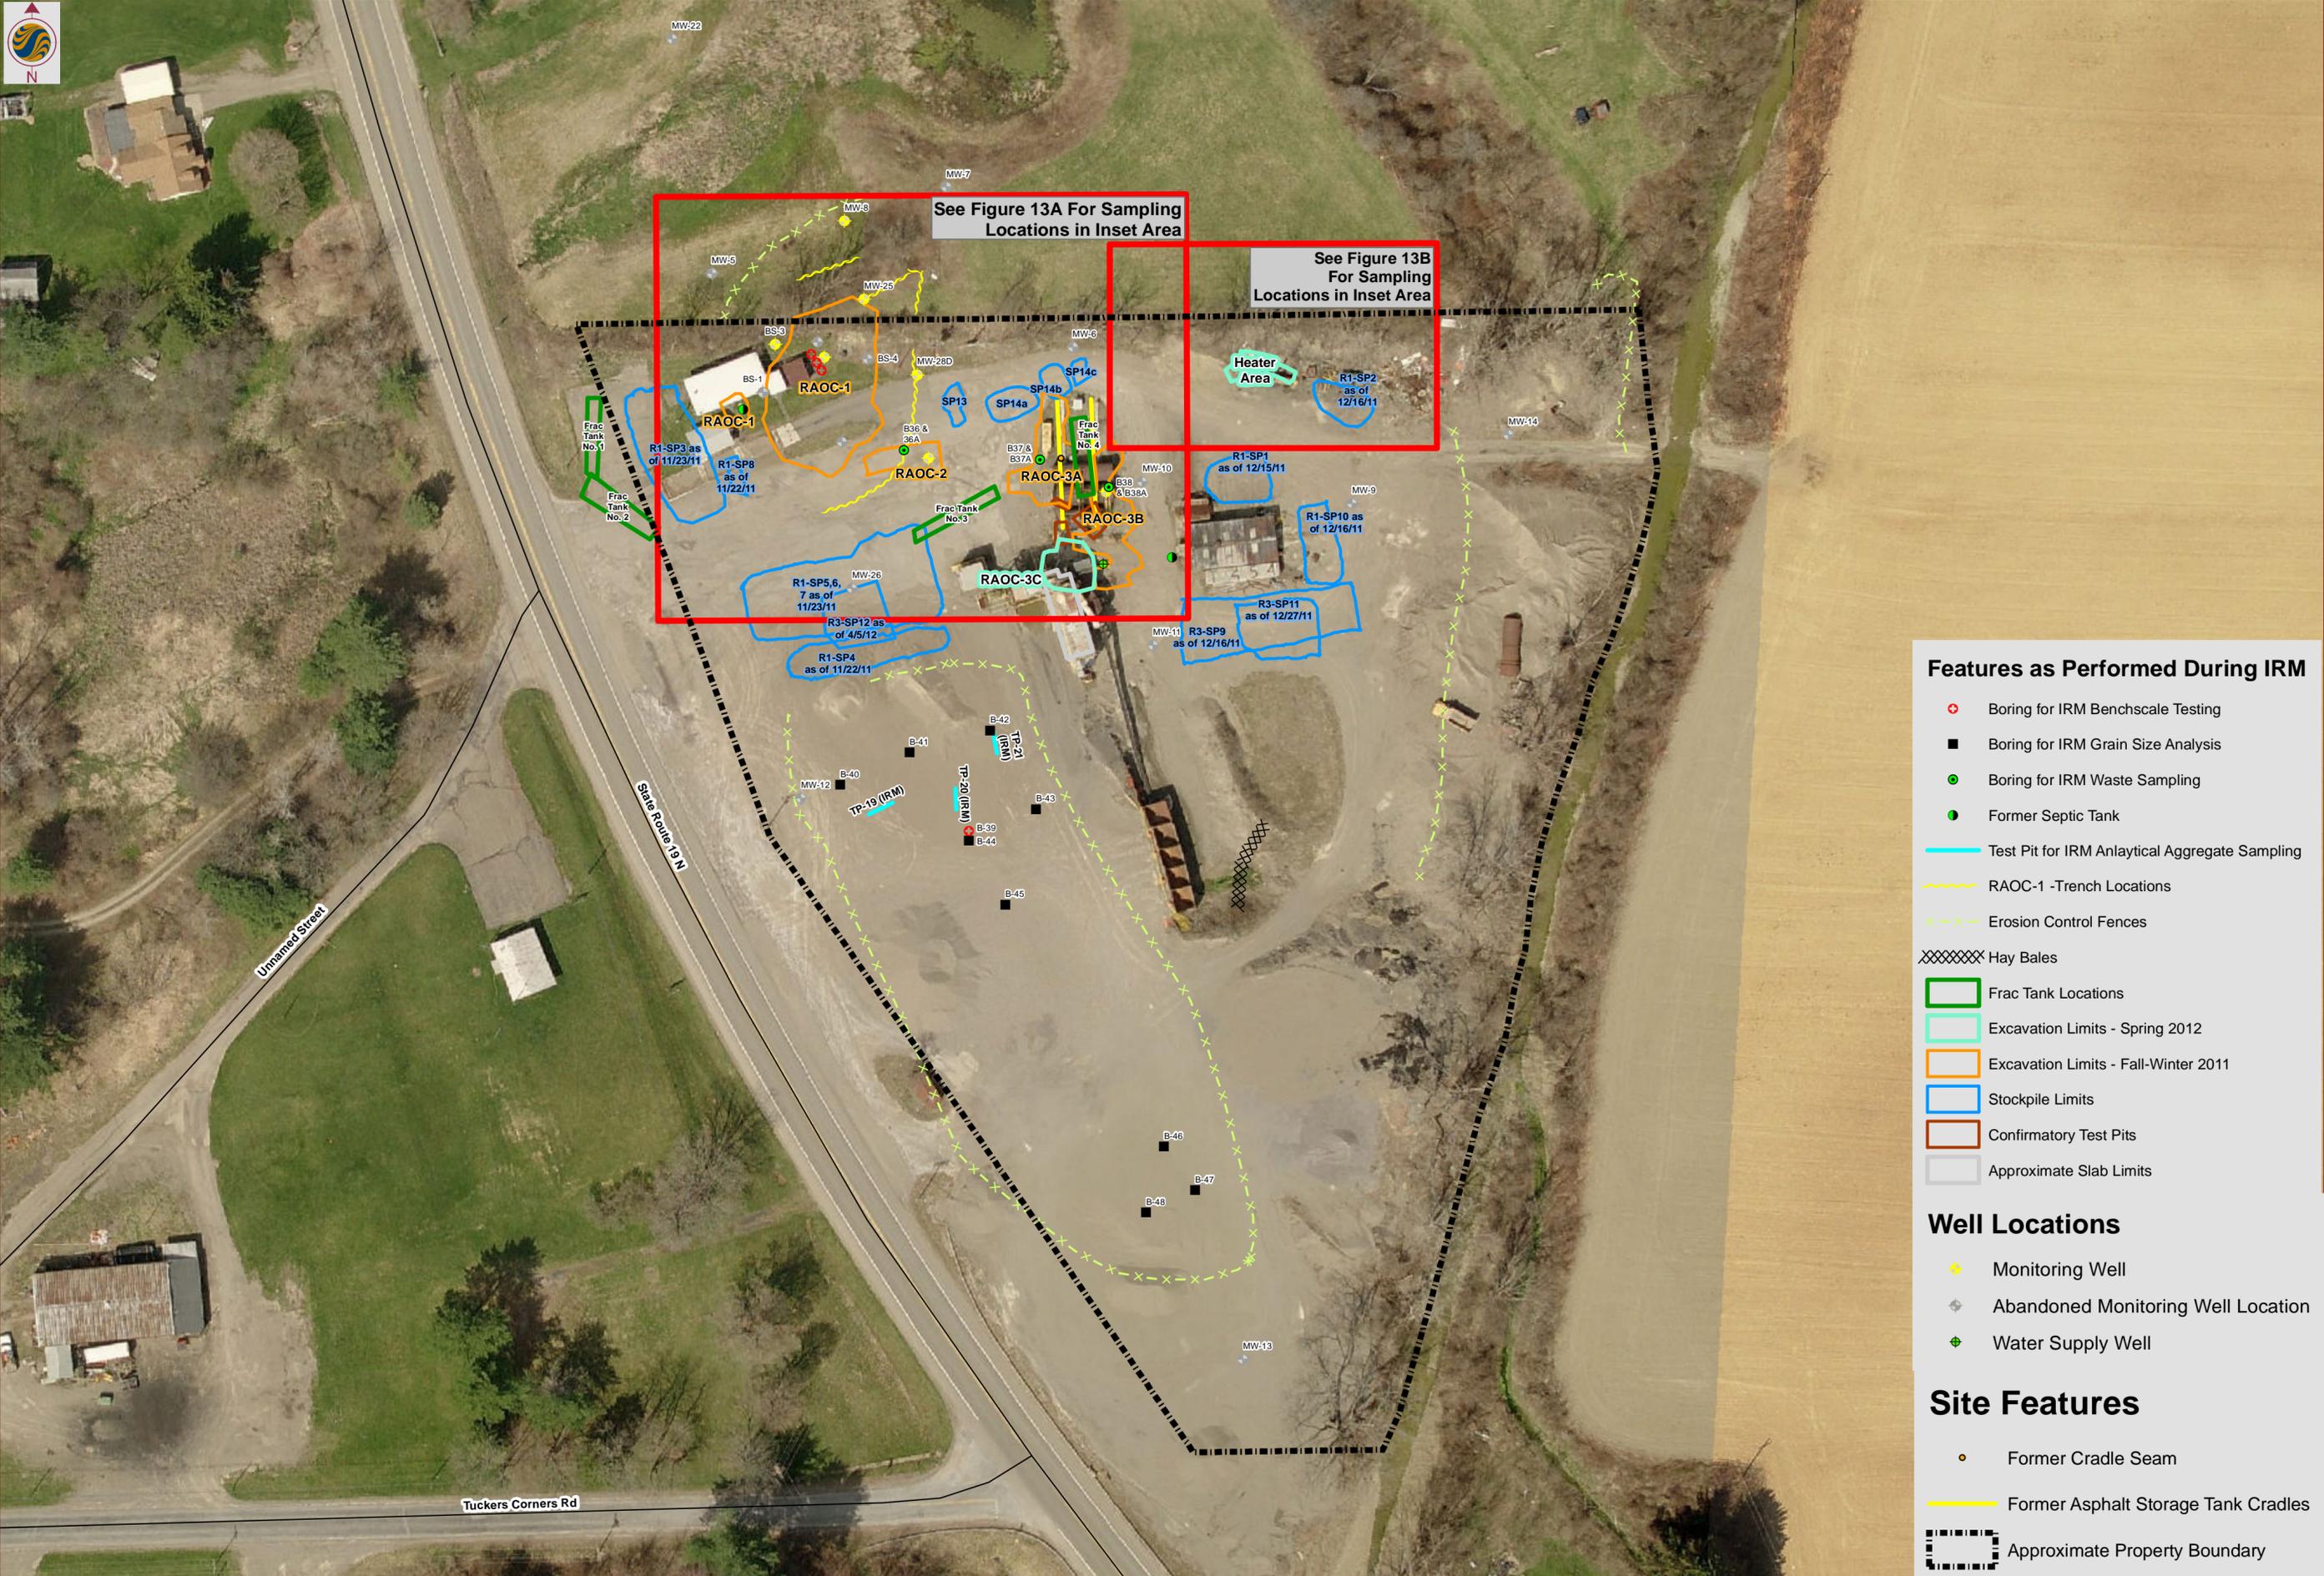
Figure 13: IRM Site Map
 Former Allegany Bitumens Belmont Asphalt Plant Site

RAOC	Approximate Tonnage of Contaminated Soil Removed
1	1,635
2	75
3	1,205

Approximately 1,635 tons of chlorinated VOC-impacted soil was excavated from the source area and disposed offsite. The excavation was 4,800 sq ft with a total sidewall length of 274 ft. Excavation sidewall and bottom confirmatory samples indicated that the excavation sufficiently removed impacted soil, i.e. no exceedences of POGW or Commercial and Industrial Use SCOs were observed in the analyzed samples.

During excavation of the impacted soil in RAOC-3, it became evident that two sub-areas of impacted soil existed: a western portion (RAOC-3A) and an eastern portion (RAOC-3B). Impacts in the western portion included those originally observed at TP-14. Elevated PID readings, staining and petroleum product odors were observed at depths ranging down to approximately 4.5 ft bgs. Groundwater was not encountered within this excavation.

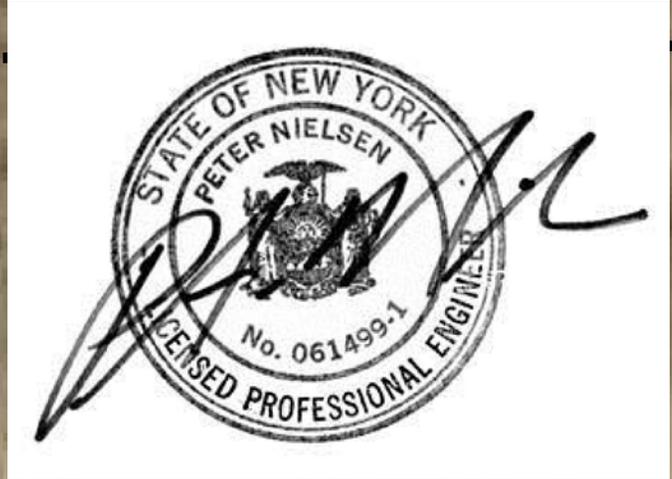
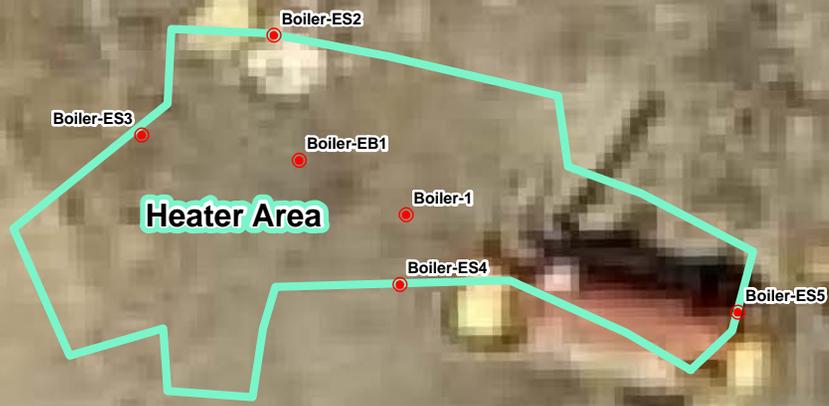
- Excav. Bottom/Sidewall Confirm Samp. Loc.
- Relocated Berm Materials
- ▣ Approximate Property Boundary
- Stockpile Limits
- Excavation Limits - Spring 2012

Remedial Area	Approximate Tonnage of Contaminated Soil Removed
Heater Area	87

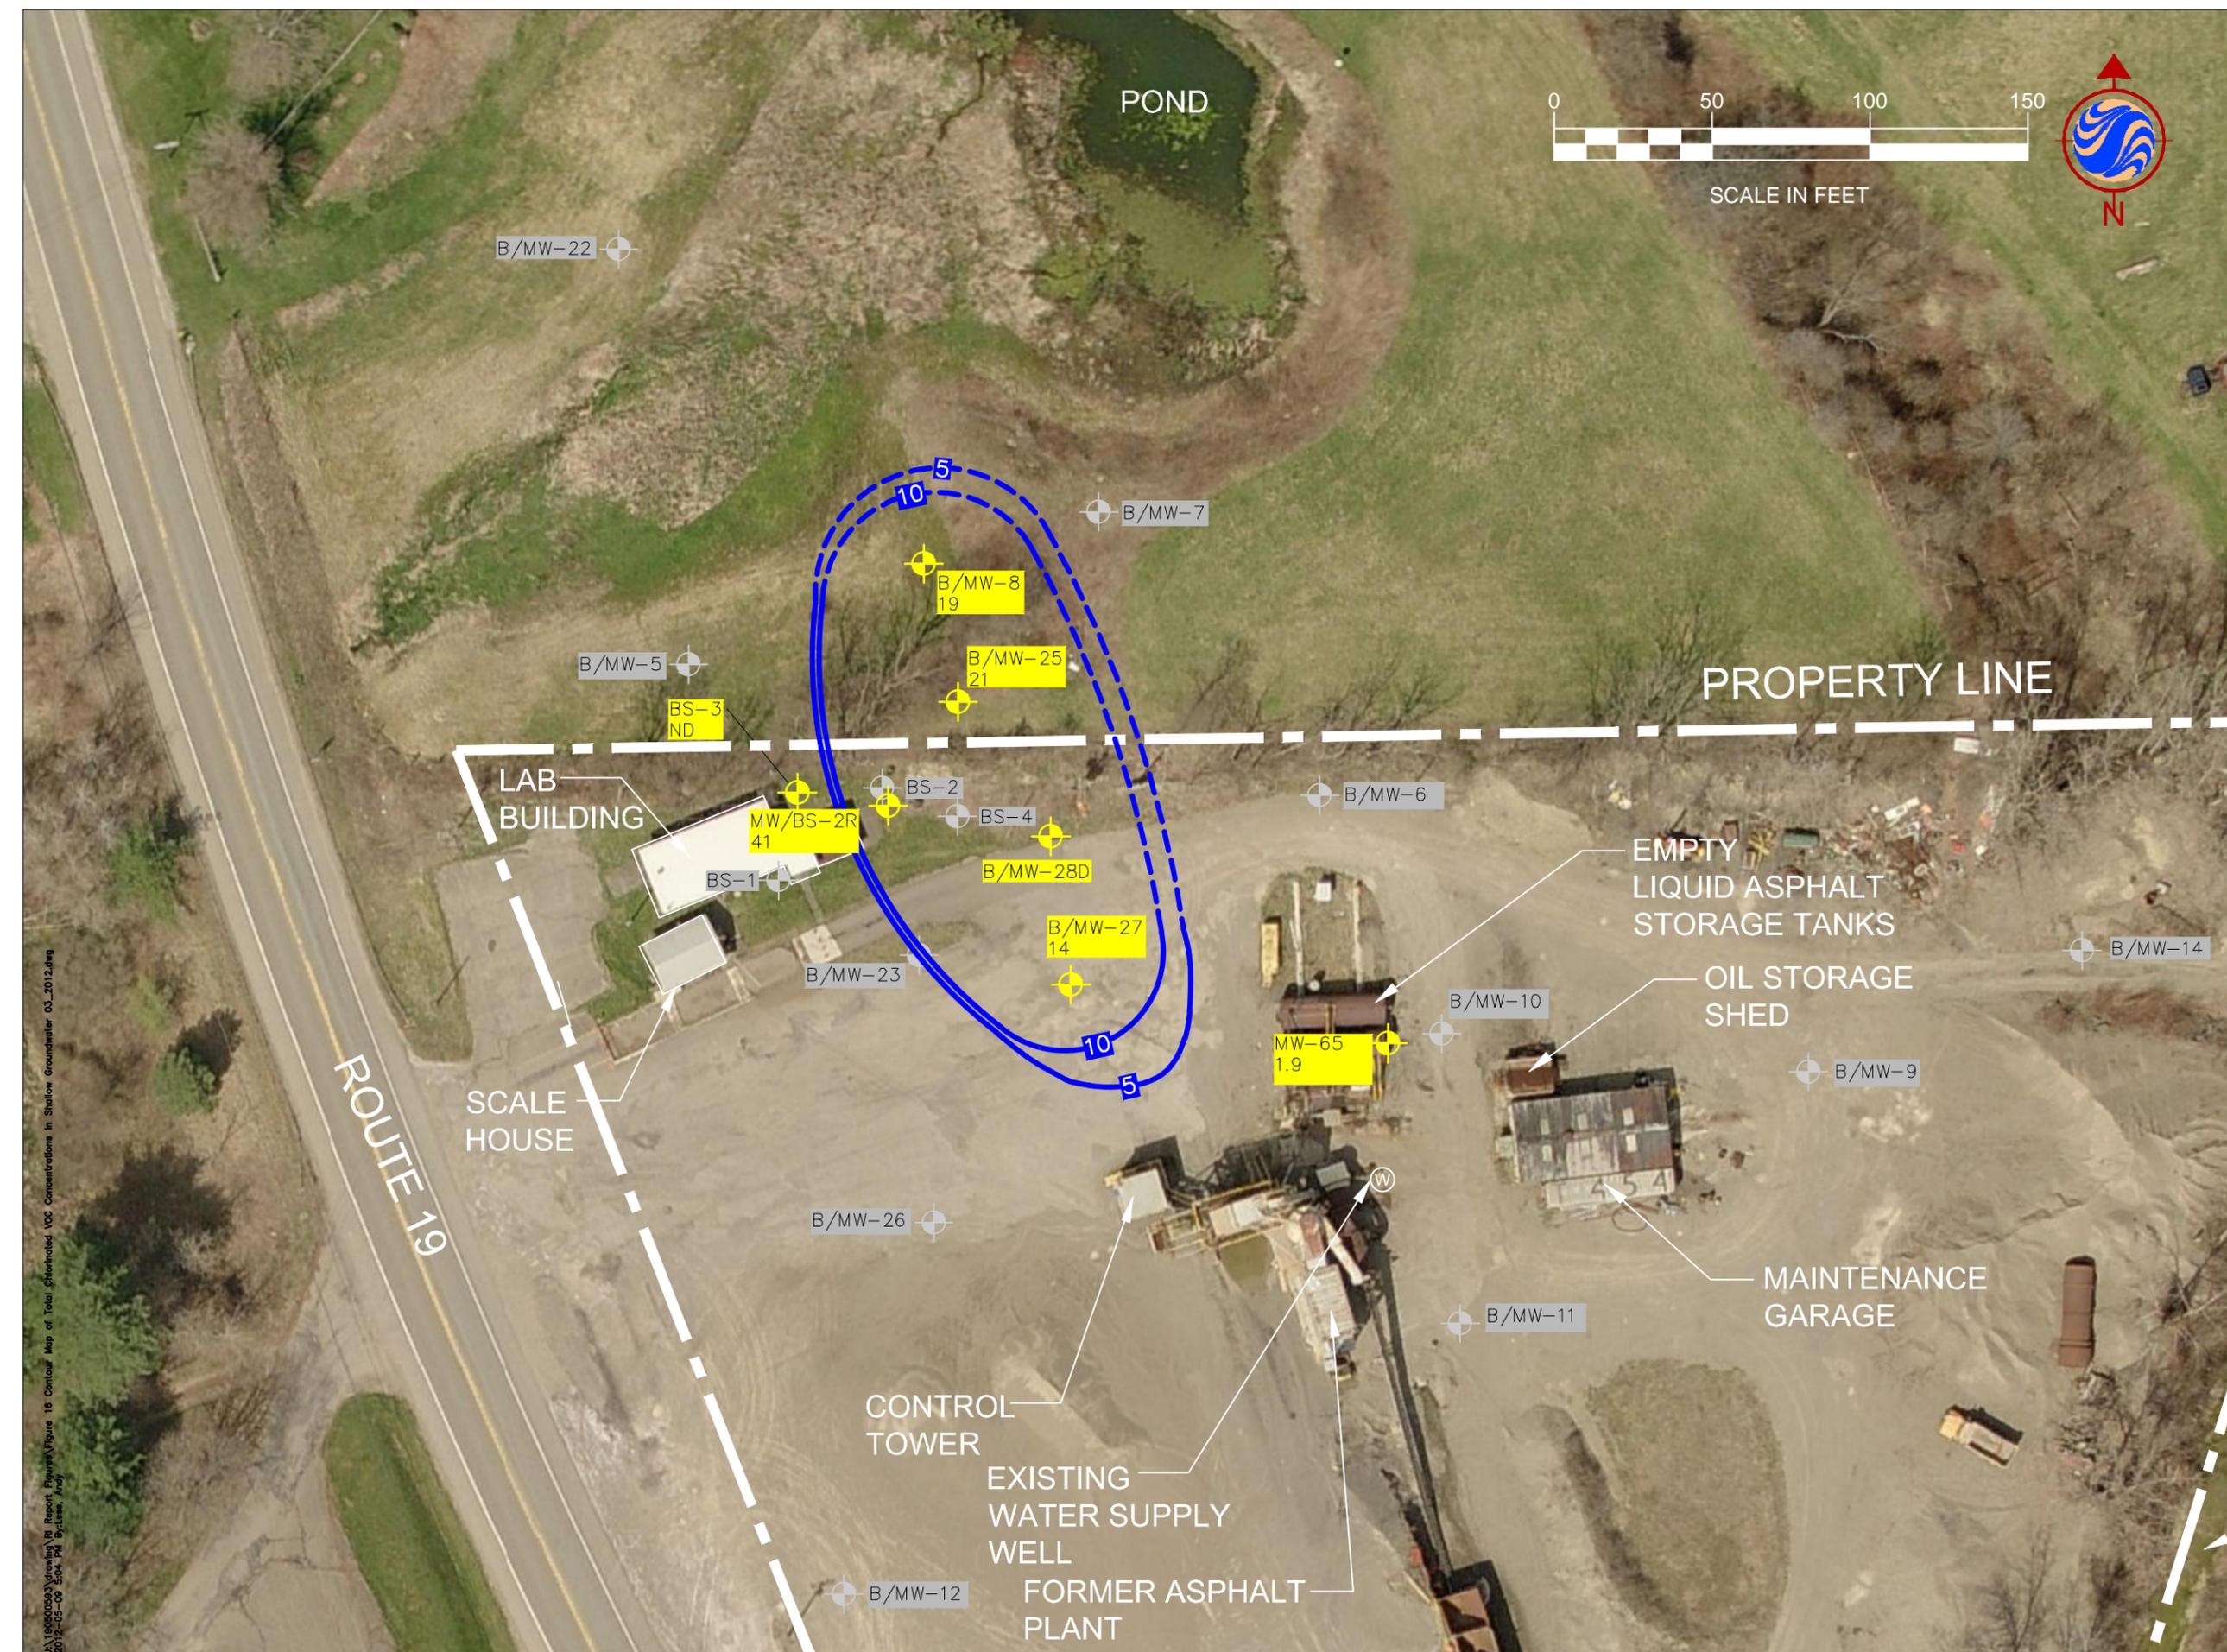
FIG. 16

U:\190500593\Drawing\RI Report\Figures\Figure 16 Contour Map of Total Chlorinated VOC Concentrations in Shallow Groundwater 03_2012.dwg
 2012-05-08 5:04 PM By: [unreadable]

Replacement well BS-2R was installed and developed subsequent to excavation backfill. Water levels were measured at all existing monitoring wells. Monitoring wells BS-2R, BS-3, MW-8, MW-25, MW-27, and MW-28D were sampled in late March 2012. The March 2012 source area concentration of 54 µg/L total VOCs in BS-2R are significantly lower than the 3,947 - 12,401

µg/L total VOC concentrations that were reported in source area wells in January 2011. VOCs were generally found at low levels that are near or below standards outside the source area. However, at downgradient well MW-8, the concentration of total VOCs increased from 8.5 to 19 µg/L, with most of the increase accounted for by the detection of cis-1,2-DCE at 9.9 µg/L. The increase in concentration of cis-1,2-DCE, which is a breakdown product of TCE, likely indicates that the sodium lactate has been successful at enhancing reductive dechlorination of TCE downgradient of the source area. Over time as the reductive dechlorination progresses, it is expected that total VOC concentrations will decrease.
