Periodic Review Report

Scott Rotary Seals Site
Olean, New York
BCP Site No. C905036

June 2017

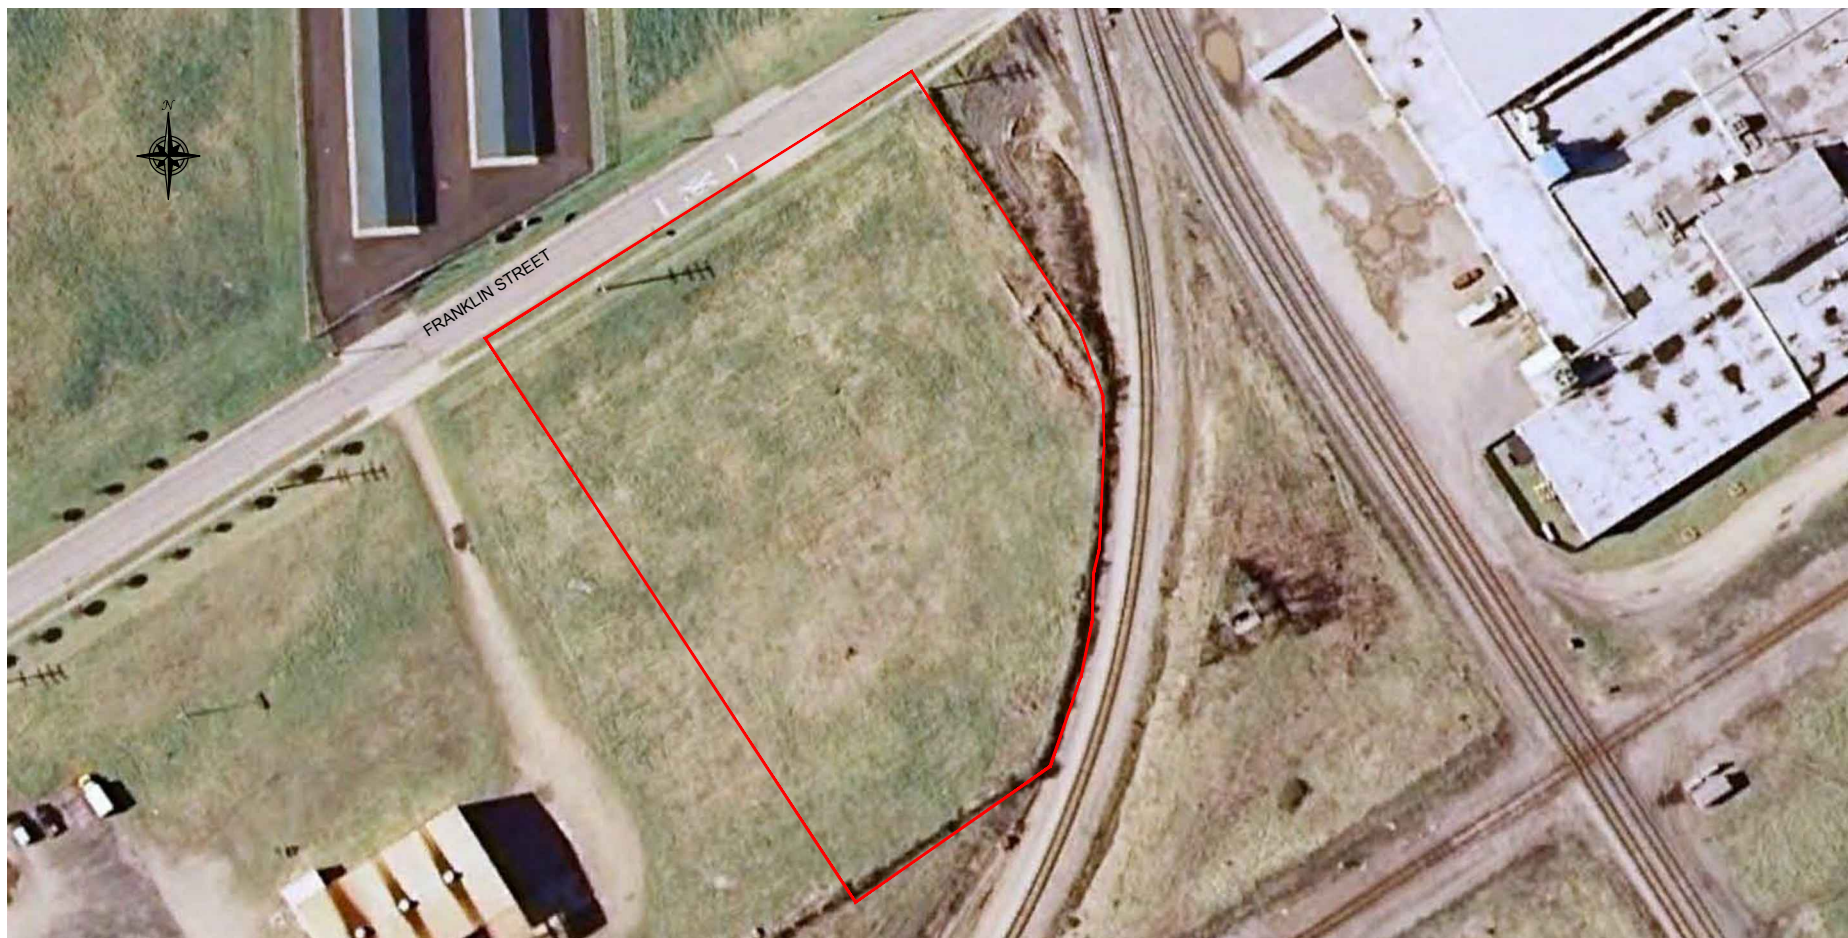
FIGURE 2

SITE PLAN PRE-REMEDATION

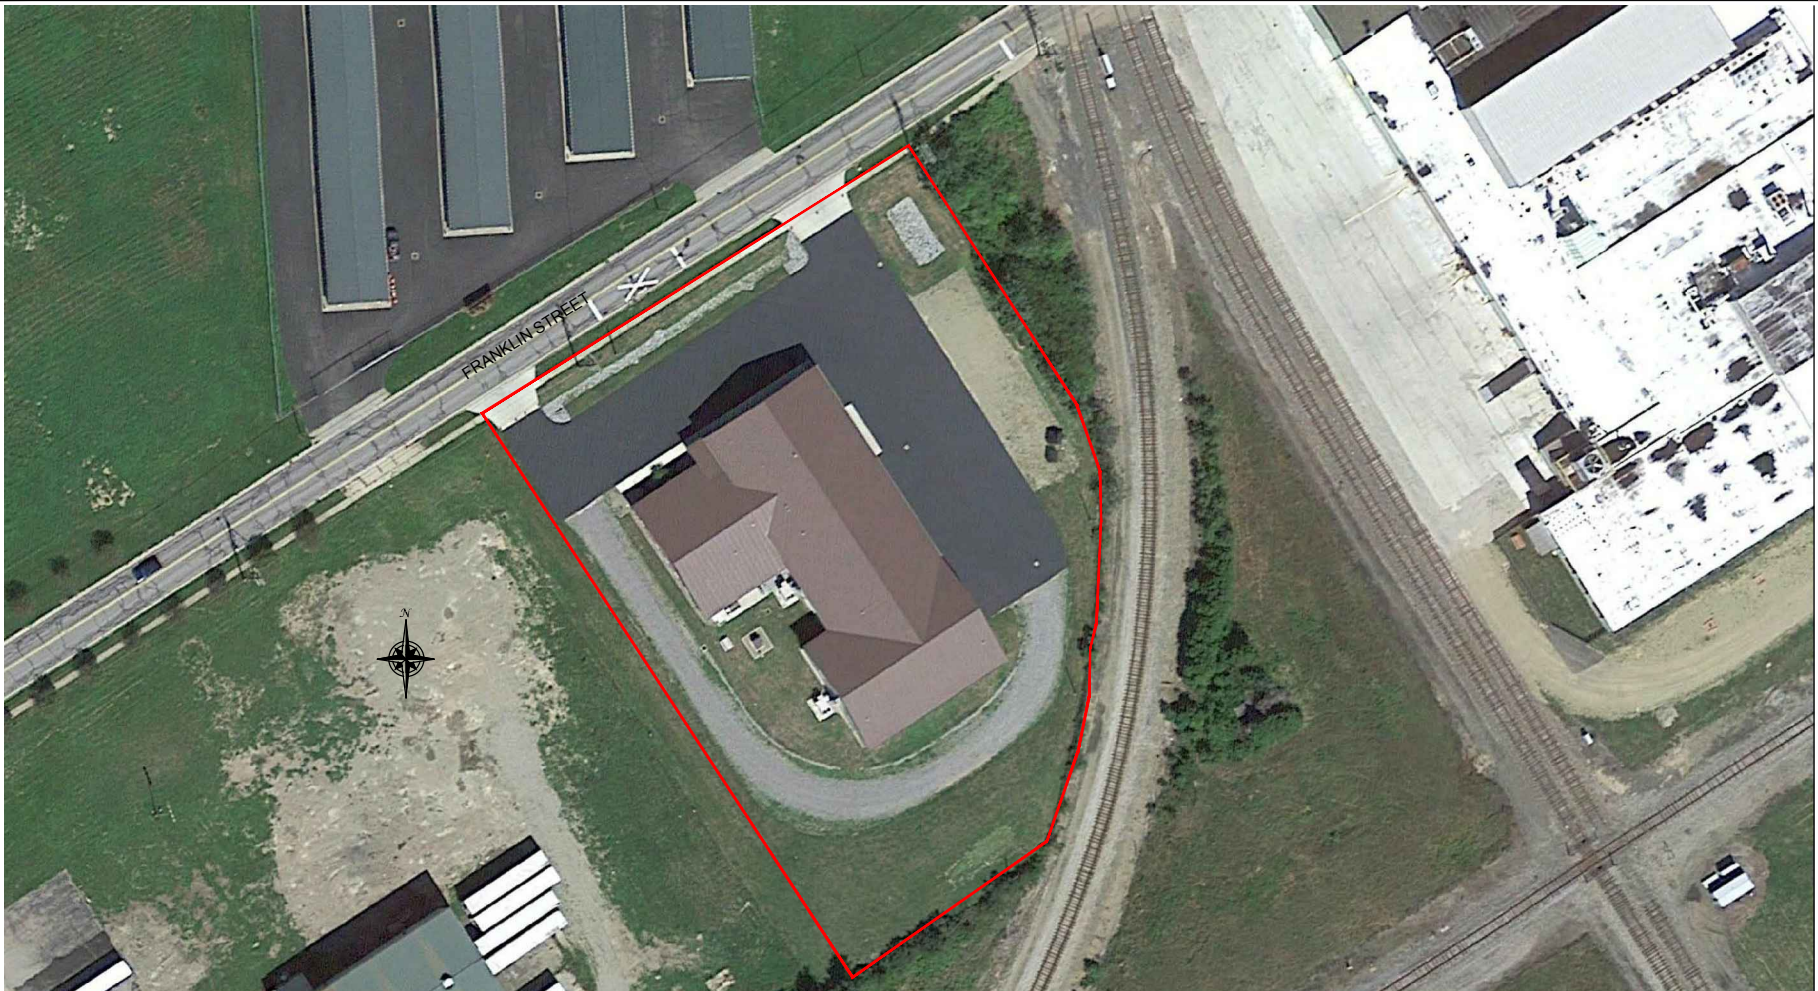
FIGURE 3

SITE PLAN POST-REMEDIATION

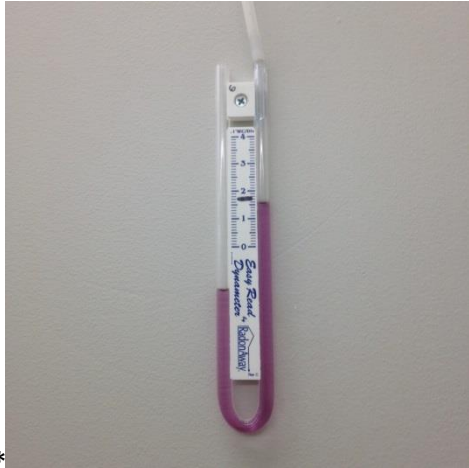
Photo 1: Manometer gauge (1.6 inches WC indicated – Fan 6)

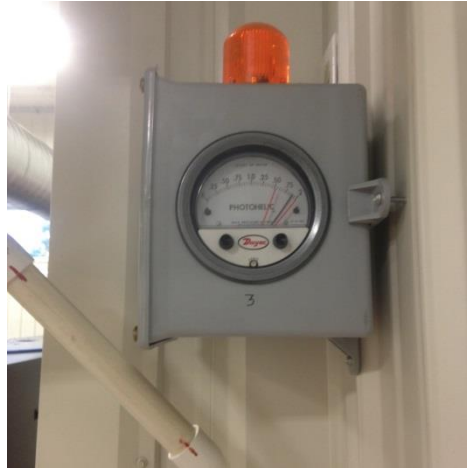
Photo 2: Photohelic gauge (1.85 inches WC indicated – Fan 3)

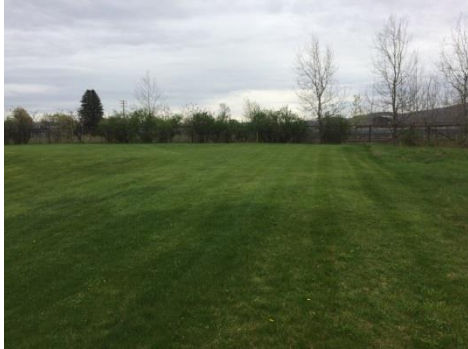
Photo 5: Rear Side (south) of SRS Building; (looking east).

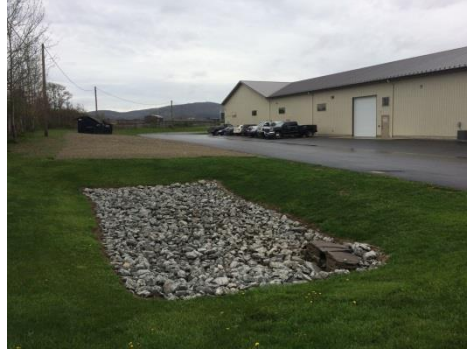
Photo 6: East side of site detention basin (looking south).

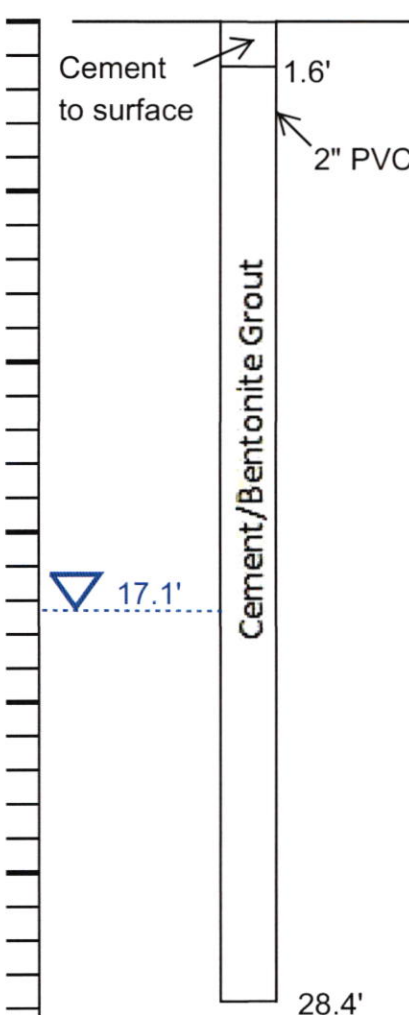
Site Name: Scott Rotary Seal	Well I.D.: MW 2
Site Location: Olean, NY	Driller: Dale Gramza
Drilling Co.: Nature's Way Environmental	Inspector:
	Date: 10/18/16

<u>CASING PULLING</u> Method employed <input type="text"/> Casing retrieved (feet) <input type="text"/> Casing type/dia. (in.) <input type="text"/>			
<u>CASING PERFORATING</u> Equipment used <input type="text"/> Number of perforations/foot <input type="text"/> Size of perforations <input type="text"/> Interval perforated <input type="text"/>			
<u>GROUTING</u> Interval grouted (FBLs) <input type="text"/> 0 to 28.0 # of batches prepared <input type="text"/> 1 For each batch record: Quantity of water used (gal.) <input type="text"/> 7.8 Quantity of cement used (lbs.) <input type="text"/> 94 Cement type <input type="text"/> Type I & II Quantity of bentonite used (lbs.) <input type="text"/> 3.9 lbs Quantity of calcium chloride used (lbs.) <input type="text"/> Volume of grout prepared (gal.) <input type="text"/> 10 Volume of grout used (gal.) <input type="text"/> 5.1

COMMENTS: Grouted in place. Displace and remove 1.9 gallons of water.

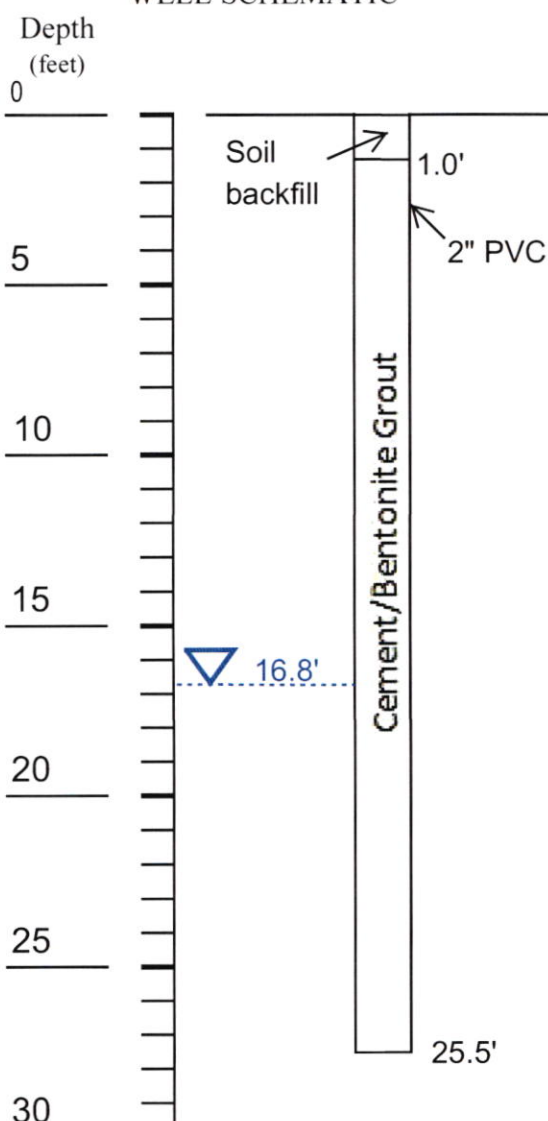
Site Name: Scott Rotary Seal	Well I.D.: MW 4
Site Location: Olean, NY	Driller: Dale Gramza
Drilling Co.: Nature's Way Environmental	Inspector:
	Date: 10/17/16

Interval Drilled			
Drilling Method(s)			
Borehole Dia. (in.)			
Temporary Casing Installed? (y/n)			
Depth temporary casing installed			
Casing type/dia. (in.)			
Method of installing			
<u>CASING PULLING</u>			
Method employed	Pull & Remove		
Casing retrieved (feet)	3.5'		
Casing type/dia. (in.)	2"		
<u>CASING PERFORATING</u>			
Equipment used			
Number of perforations/foot			
Size of perforations			
Interval perforated			
<u>GROUTING</u>			
Interval grouted (FBLS)	0 to 25.5		
# of batches prepared	1		
For each batch record:			
Quantity of water used (gal.)	7.8		
Quantity of cement used (lbs.)	94		
Cement type	Type I & II		
Quantity of bentonite used (lbs.)	3.9 lbs		
Quantity of calcium chloride used (lbs.)			
Volume of grout prepared (gal.)	10		
Volume of grout used (gal.)	4.8

COMMENTS: Grouted in place. Displace and remove 1.5 gallons of water.

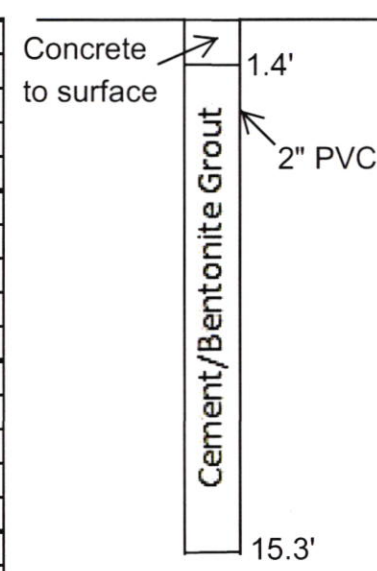
Site Name: Scott Rotary Seal	Well I.D.: SVE 2
Site Location: Olean, NY	Driller: Dale Gramza
Drilling Co.: Nature's Way Environmental	Inspector:
	Date: 10/18/16

Interval Drilled			
Drilling Method(s)			
Borehole Dia. (in.)			
Temporary Casing Installed? (y/n)			
Depth temporary casing installed			
Casing type/dia. (in.)			
Method of installing			
<u>CASING PULLING</u>			
Method employed			
Casing retrieved (feet)			
Casing type/dia. (in)			
<u>CASING PERFORATING</u>			
Equipment used			
Number of perforations/foot			
Size of perforations			
Interval perforated			
<u>GROUTING</u>			
Interval grouted (FBLS)	0 to 15.3

# of batches prepared	1		
For each batch record:			
Quantity of water used (gal.)	7.8		
Quantity of cement used (lbs.)	94		
Cement type	Type I & II		
Quantity of bentonite used (lbs.)	3.9 lbs		
Quantity of calcium chloride used (lbs.)			
Volume of grout prepared (gal.)	10		
Volume of grout used (gal.)	2.9

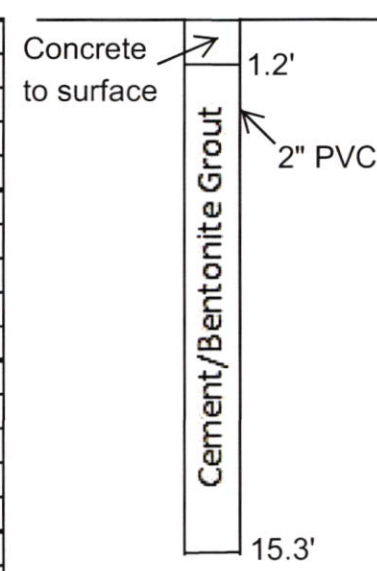
Site Name: Scott Rotary Seal	Well I.D.: SVE 3
Site Location: Olean, NY	Driller: Dale Gramza
Drilling Co.: Nature's Way Environmental	Inspector:
	Date: 10/18/16

Interval Drilled			
Drilling Method(s)			
Borehole Dia. (in.)			
Temporary Casing Installed? (y/n)			
Depth temporary casing installed			
Casing type/dia. (in.)			
Method of installing			
<u>CASING PULLING</u>			
Method employed			
Casing retrieved (feet)			
Casing type/dia. (in)			
<u>CASING PERFORATING</u>			
Equipment used			
Number of perforations/foot			
Size of perforations			
Interval perforated			
<u>GROUTING</u>			
Interval grouted (FBLS)	0 to 15.3

# of batches prepared	1		
For each batch record:			
Quantity of water used (gal.)	7.8		
Quantity of cement used (lbs.)	94		
Cement type	Type I & II		
Quantity of bentonite used (lbs.)	3.9 lbs		
Quantity of calcium chloride used (lbs.)			
Volume of grout prepared (gal.)	10		
Volume of grout used (gal.)	2.8

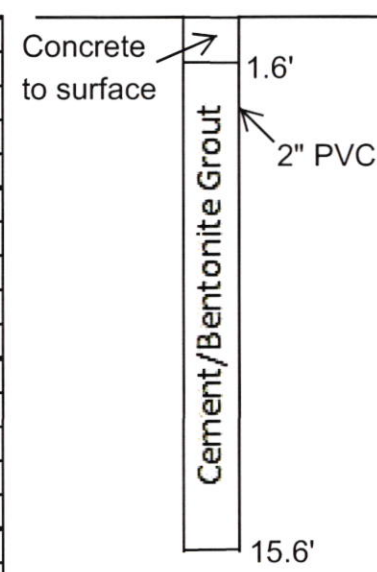
Site Name: Scott Rotary Seal	Well I.D.: SVE 4
Site Location: Olean, NY	Driller: Dale Gramza
Drilling Co.: Nature's Way Environmental	Inspector:
	Date: 10/18/16

Interval Drilled			
Drilling Method(s)			
Borehole Dia. (in.)			
Temporary Casing Installed? (y/n)			
Depth temporary casing installed			
Casing type/dia. (in.)			
Method of installing			
<u>CASING PULLING</u>			
Method employed			
Casing retrieved (feet)			
Casing type/dia. (in)			
<u>CASING PERFORATING</u>			
Equipment used			
Number of perforations/foot			
Size of perforations			
Interval perforated			
<u>GROUTING</u>			
Interval grouted (FBLs)	0 to 15.6

# of batches prepared	1		
For each batch record:			
Quantity of water used (gal.)	7.8		
Quantity of cement used (lbs.)	94		
Cement type	Type I & II		
Quantity of bentonite used (lbs.)	3.9 lbs		
Quantity of calcium chloride used (lbs.)			
Volume of grout prepared (gal.)	10		
Volume of grout used (gal.)	2.8

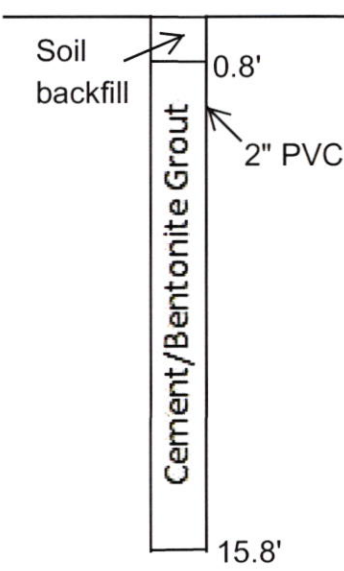
Site Name: Scott Rotary Seal	Well I.D.: SVE 5
Site Location: Olean, NY	Driller: Dale Gramza
Drilling Co.: Nature's Way Environmental	Inspector:
	Date: 10/17/16

Interval Drilled			
Drilling Method(s)			
Borehole Dia. (in.)			
Temporary Casing Installed? (y/n)			
Depth temporary casing installed			
Casing type/dia. (in.)			
Method of installing			
<u>CASING PULLING</u>			
Method employed			
Casing retrieved (feet)			
Casing type/dia. (in)			
<u>CASING PERFORATING</u>			
Equipment used			
Number of perforations/foot			
Size of perforations			
Interval perforated			
<u>GROUTING</u>			
Interval grouted (FBLs)	0 to 15.8

# of batches prepared	1		
For each batch record:			
Quantity of water used (gal.)	7.8		
Quantity of cement used (lbs.)	94		
Cement type	Type I & II		
Quantity of bentonite used (lbs.)	3.9 lbs		
Quantity of calcium chloride used (lbs.)			
Volume of grout prepared (gal.)	10		
Volume of grout used (gal.)	3

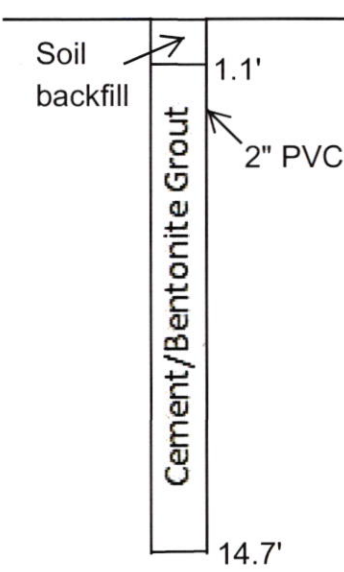
Site Name: Scott Rotary Seal	Well I.D.: SVE 6
Site Location: Olean, NY	Driller: Dale Gramza
Drilling Co.: Nature's Way Environmental	Inspector:
	Date: 10/17/16

Interval Drilled			
Drilling Method(s)			
Borehole Dia. (in.)			
Temporary Casing Installed? (y/n)			
Depth temporary casing installed			
Casing type/dia. (in.)			
Method of installing			
<u>CASING PULLING</u>			
Method employed			
Casing retrieved (feet)			
Casing type/dia. (in)			
<u>CASING PERFORATING</u>			
Equipment used			
Number of perforations/foot			
Size of perforations			
Interval perforated			
<u>GROUTING</u>			
Interval grouted (FBLs)	0 to 14.7

# of batches prepared	1		
<u>For each batch record:</u>			
Quantity of water used (gal.)	7.8		
Quantity of cement used (lbs.)	94		
Cement type	Type I & II		
Quantity of bentonite used (lbs.)	3.9 lbs		
Quantity of calcium chloride used (lbs.)			
Volume of grout prepared (gal.)	10		
Volume of grout used (gal.)	2.5

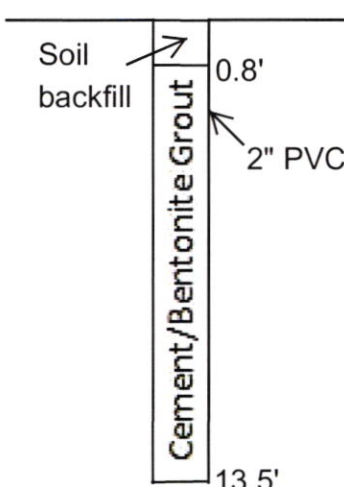
Site Name: Scott Rotary Seal	Well I.D.: SVE 7
Site Location: Olean, NY	Driller: Dale Gramza
Drilling Co.: Nature's Way Environmental	Inspector:
	Date: 10/17/16

Interval Drilled			
Drilling Method(s)			
Borehole Dia. (in.)			
Temporary Casing Installed? (y/n)			
Depth temporary casing installed			
Casing type/dia. (in.)			
Method of installing			
<u>CASING PULLING</u>			
Method employed			
Casing retrieved (feet)			
Casing type/dia. (in.)			
<u>CASING PERFORATING</u>			
Equipment used			
Number of perforations/foot			
Size of perforations			
Interval perforated			
<u>GROUTING</u>			
Interval grouted (FBS)	0 to 13.5		
# of batches prepared	1		
For each batch record:			
Quantity of water used (gal.)	7.8		
Quantity of cement used (lbs.)	94		
Cement type	Type I & II		
Quantity of bentonite used (lbs.)	3.9 lbs		
Quantity of calcium chloride used (lbs.)			
Volume of grout prepared (gal.)	10		
Volume of grout used (gal.)	2.6

COMMENTS: Grouted in place. SVE well. Dry. No water.

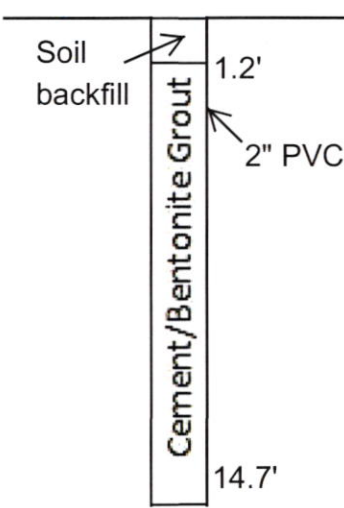
Site Name: Scott Rotary Seal	Well I.D.: SVE 8
Site Location: Olean, NY	Driller: Dale Gramza
Drilling Co.: Nature's Way Environmental	Inspector:
	Date: 10/18/16

Interval Drilled			
Drilling Method(s)			
Borehole Dia. (in.)			
Temporary Casing Installed? (y/n)			
Depth temporary casing installed			
Casing type/dia. (in.)			
Method of installing			
<u>CASING PULLING</u>			
Method employed			
Casing retrieved (feet)			
Casing type/dia. (in)			
<u>CASING PERFORATING</u>			
Equipment used			
Number of perforations/foot			
Size of perforations			
Interval perforated			
<u>GROUTING</u>			
Interval grouted (FBLs)	0 to 14.7		
# of batches prepared	1		
For each batch record:			
Quantity of water used (gal.)	7.8		
Quantity of cement used (lbs.)	94		
Cement type	Type I & II		
Quantity of bentonite used (lbs.)	3.9 lbs		
Quantity of calcium chloride used (lbs.)			
Volume of grout prepared (gal.)	10		
Volume of grout used (gal.)	2.6

COMMENTS: **Grouted in place. SVE well. Dry. No water.**

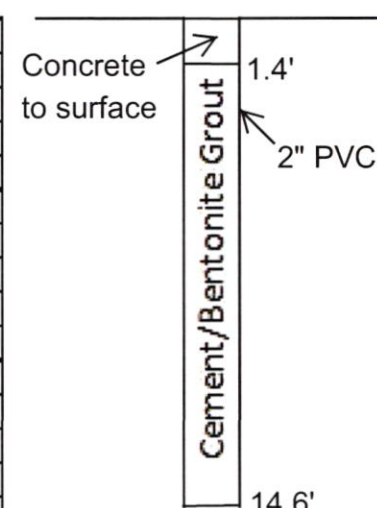
Site Name: Scott Rotary Seal	Well I.D.: SVE 9
Site Location: Olean, NY	Driller: Dale Gramza
Drilling Co.: Nature's Way Environmental	Inspector:
	Date: 10/18/16

Interval Drilled			
Drilling Method(s)			
Borehole Dia. (in.)			
Temporary Casing Installed? (y/n)			
Depth temporary casing installed			
Casing type/dia. (in.)			
Method of installing			
<u>CASING PULLING</u>			
Method employed			
Casing retrieved (feet)			
Casing type/dia. (in)			
<u>CASING PERFORATING</u>			
Equipment used			
Number of perforations/foot			
Size of perforations			
Interval perforated			
<u>GROUTING</u>			
Interval grouted (FBLS)	0 to 14.6		
# of batches prepared	1		
For each batch record:			
Quantity of water used (gal.)	7.8		
Quantity of cement used (lbs.)	94		
Cement type	Type I & II		
Quantity of bentonite used (lbs.)	3.9 lbs		
Quantity of calcium chloride used (lbs.)			
Volume of grout prepared (gal.)	10		
Volume of grout used (gal.)	2.9

COMMENTS: **Grouted in place. SVE well. Dry. No water.**
