PERIODIC REVIEW REPORT
REPORTING PERIOD: FEBRUARY 11, 2020 THROUGH FEBRUARY 10, 2021

211 FRANKLIN STREET
OLEAN, NEW YORK
NYSDEC SITE NO. C905038

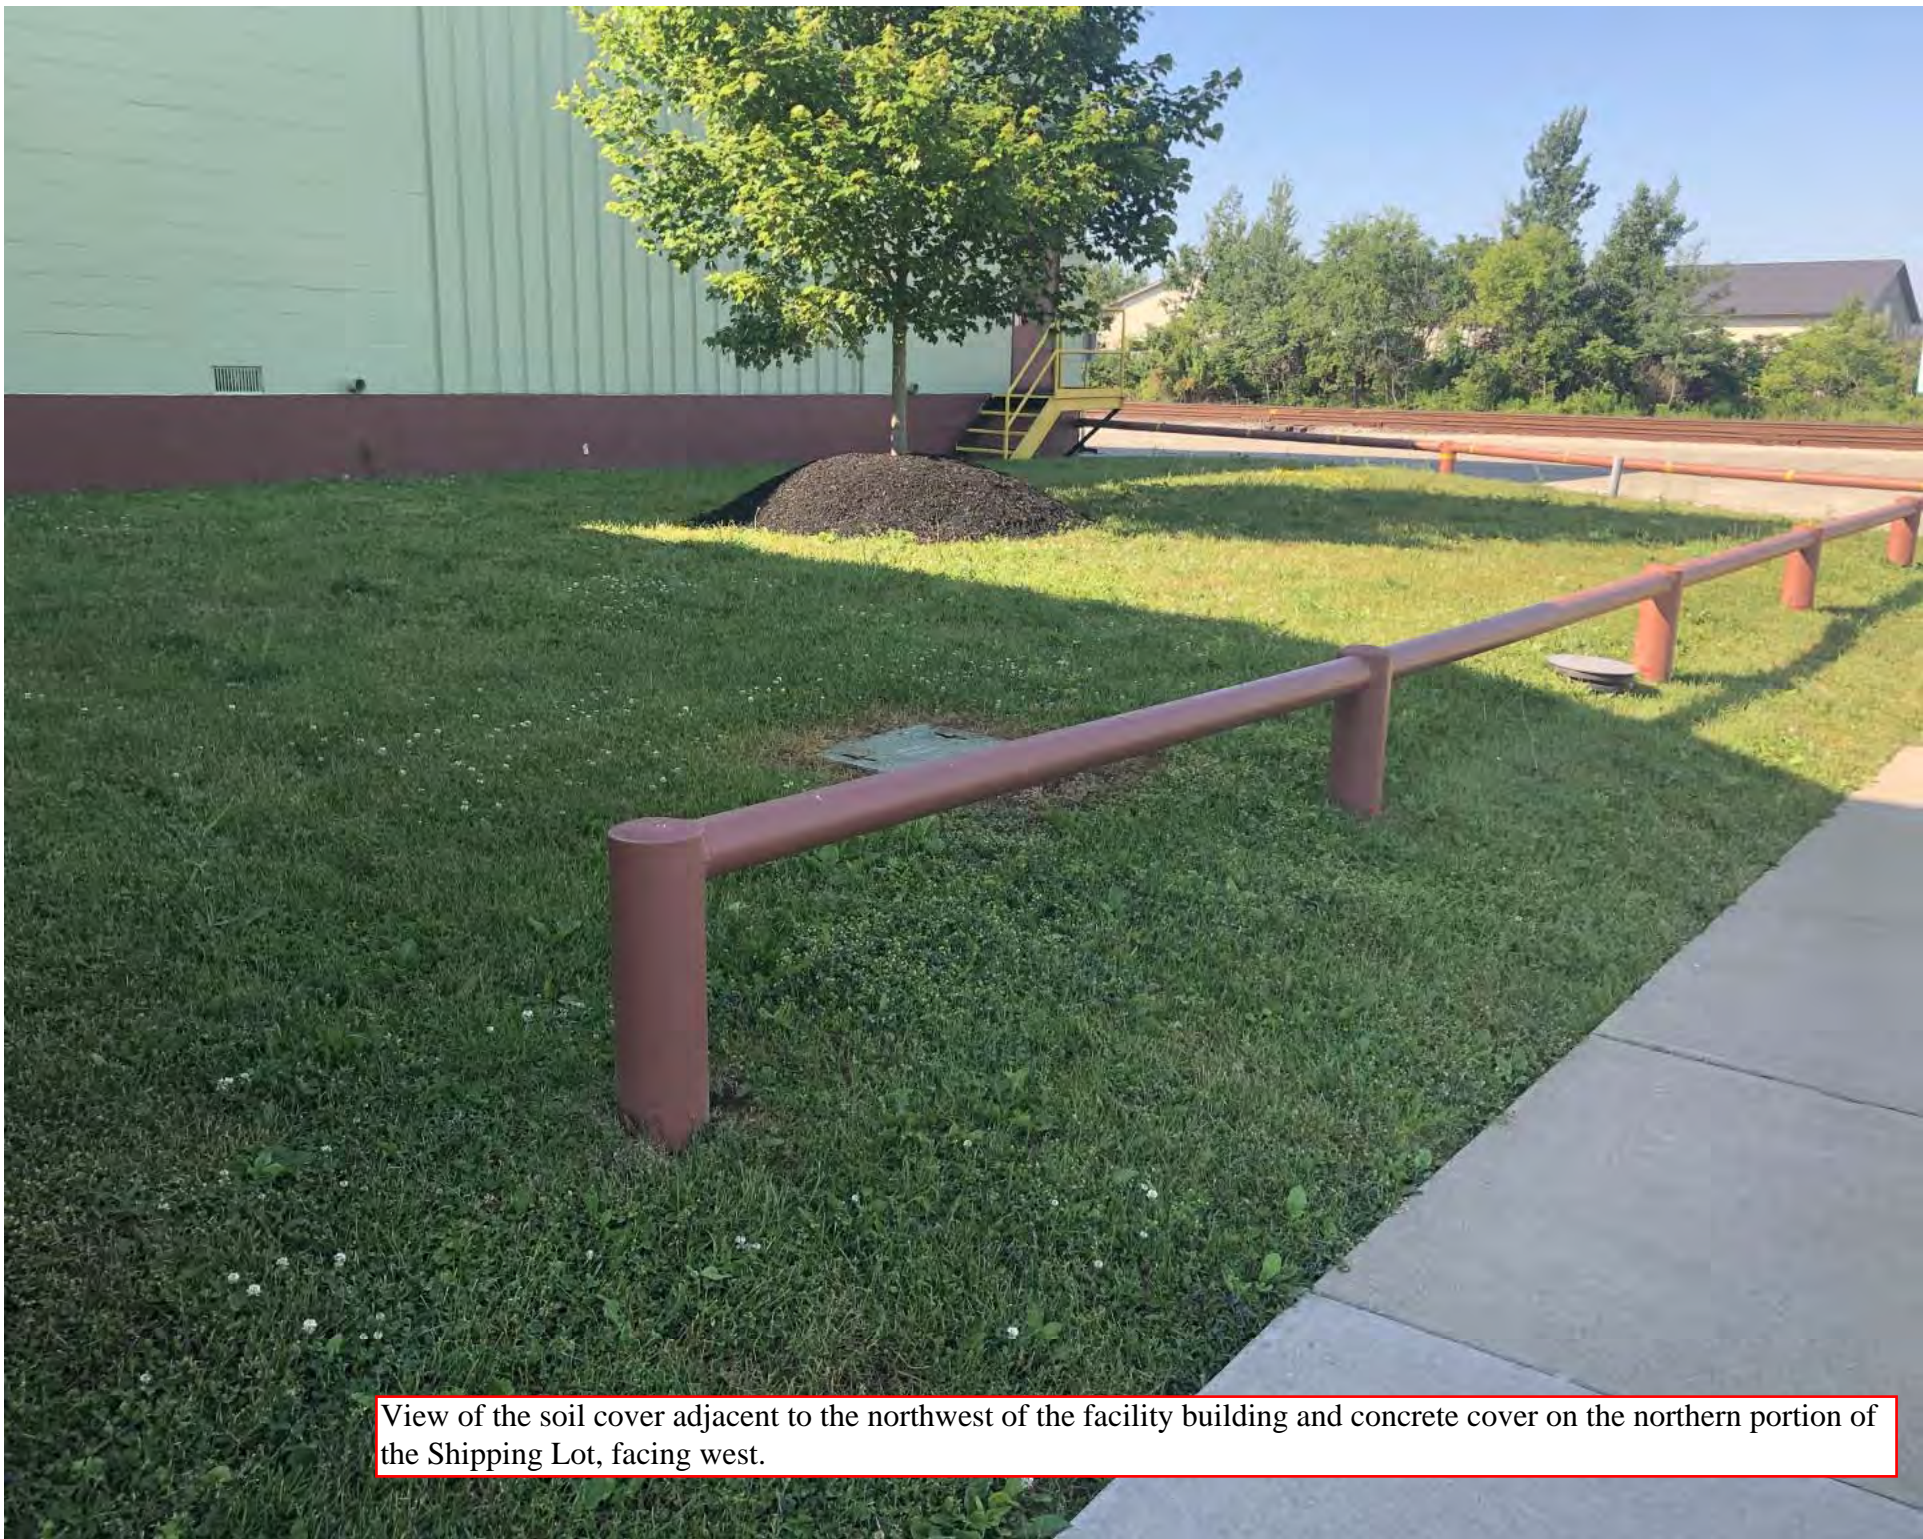
View of the soil cover adjacent to the northwest of the facility building and concrete cover on the northern portion of the Shipping Lot, facing west.

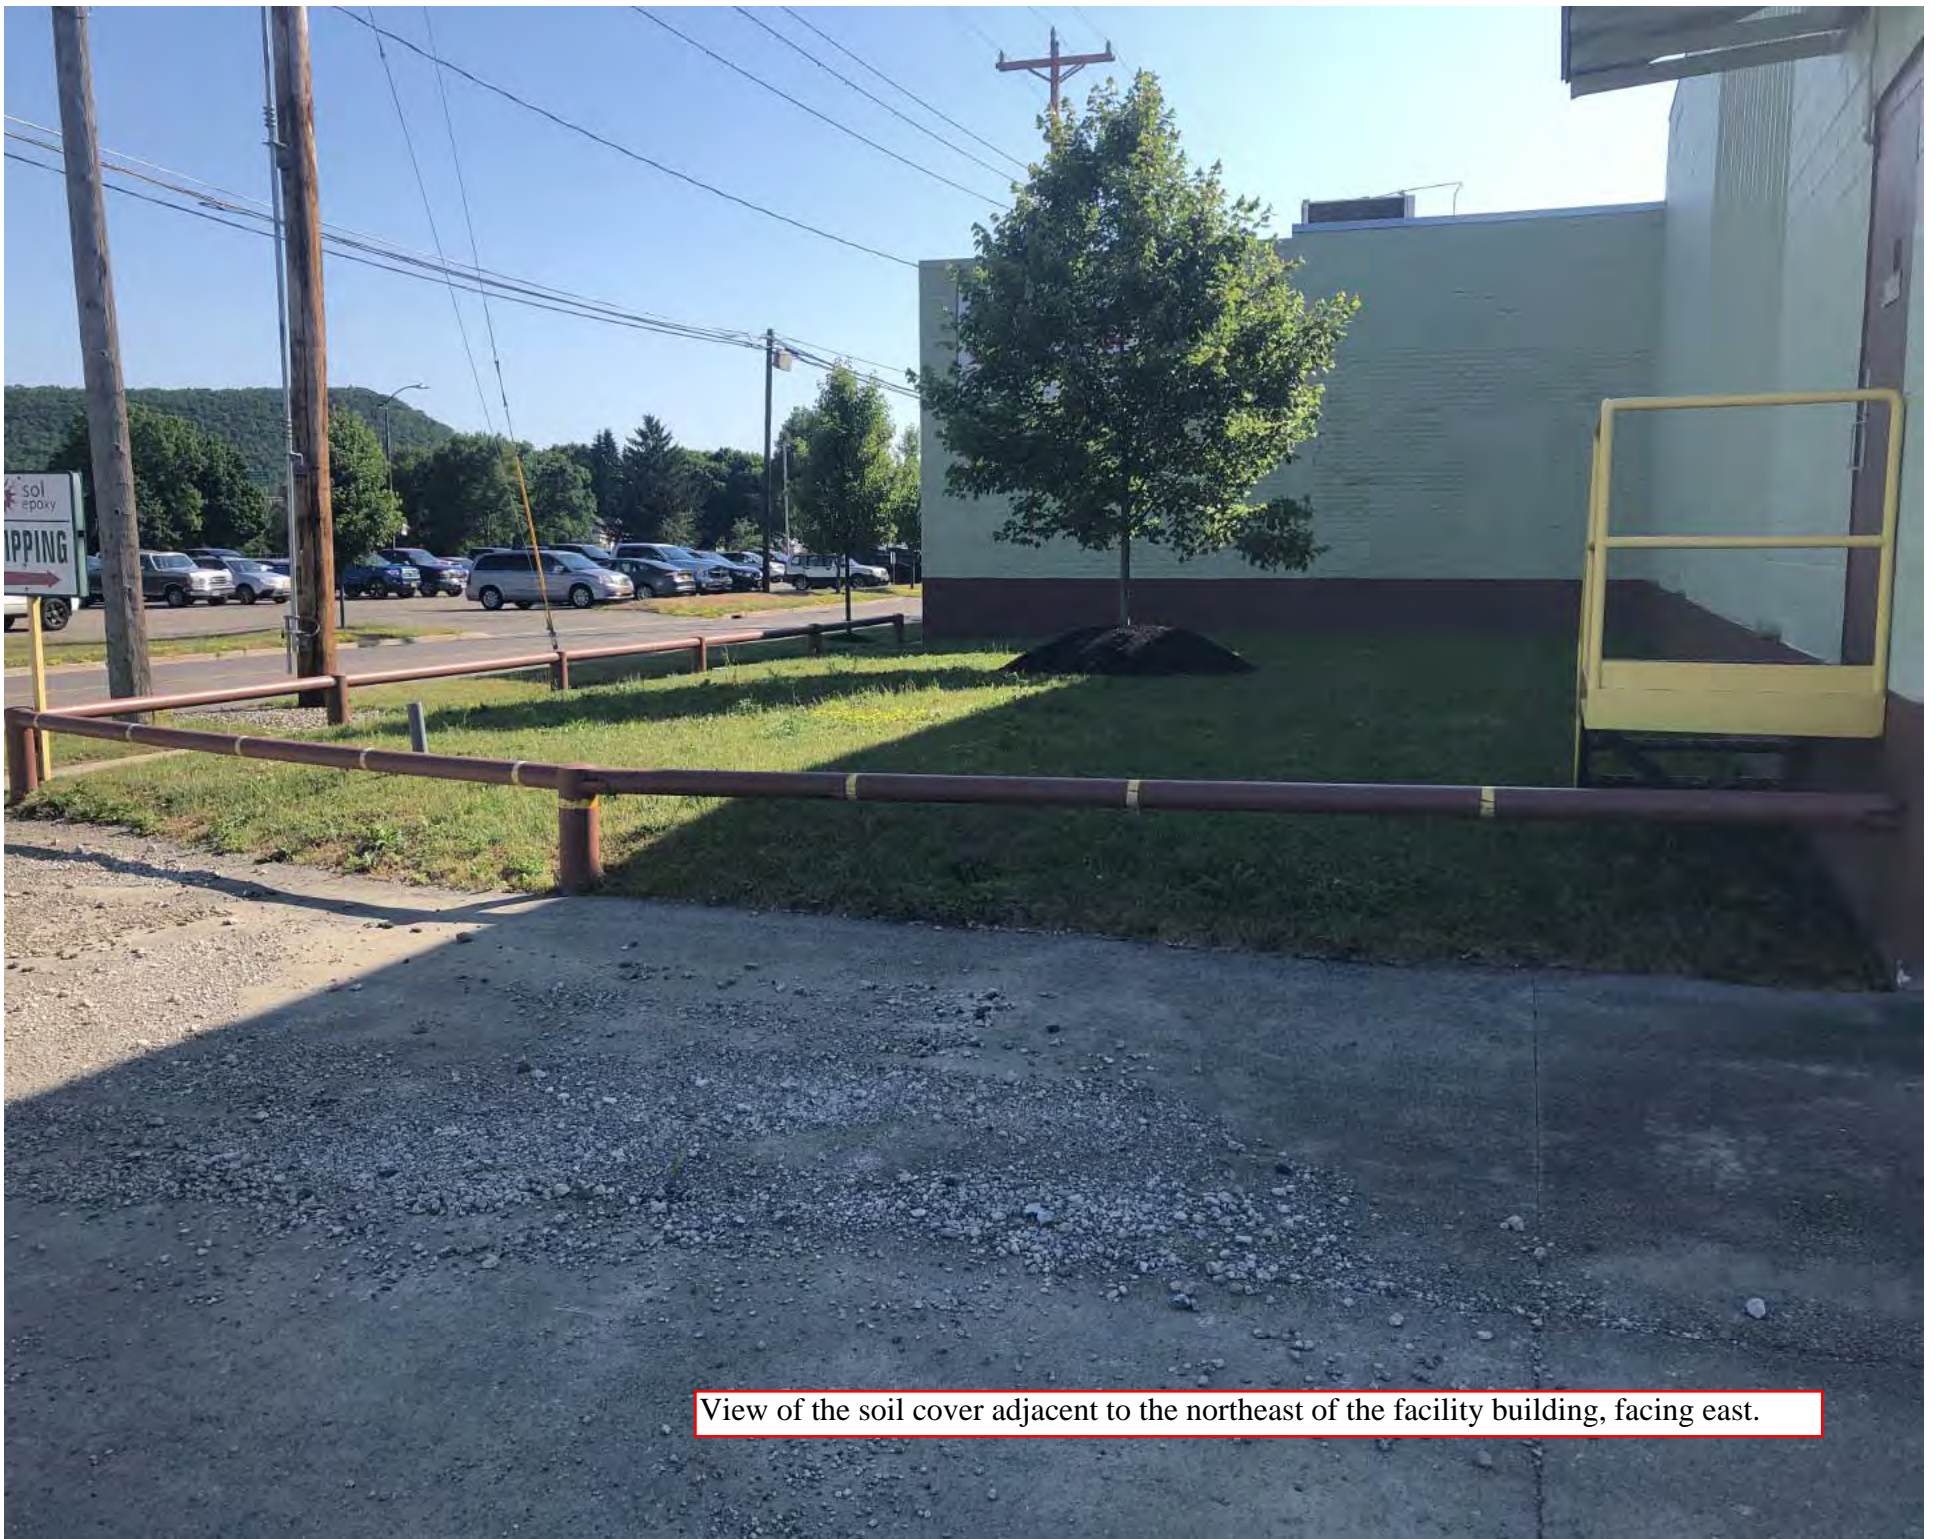
View of the soil cover adjacent to the northeast of the facility building, facing east.

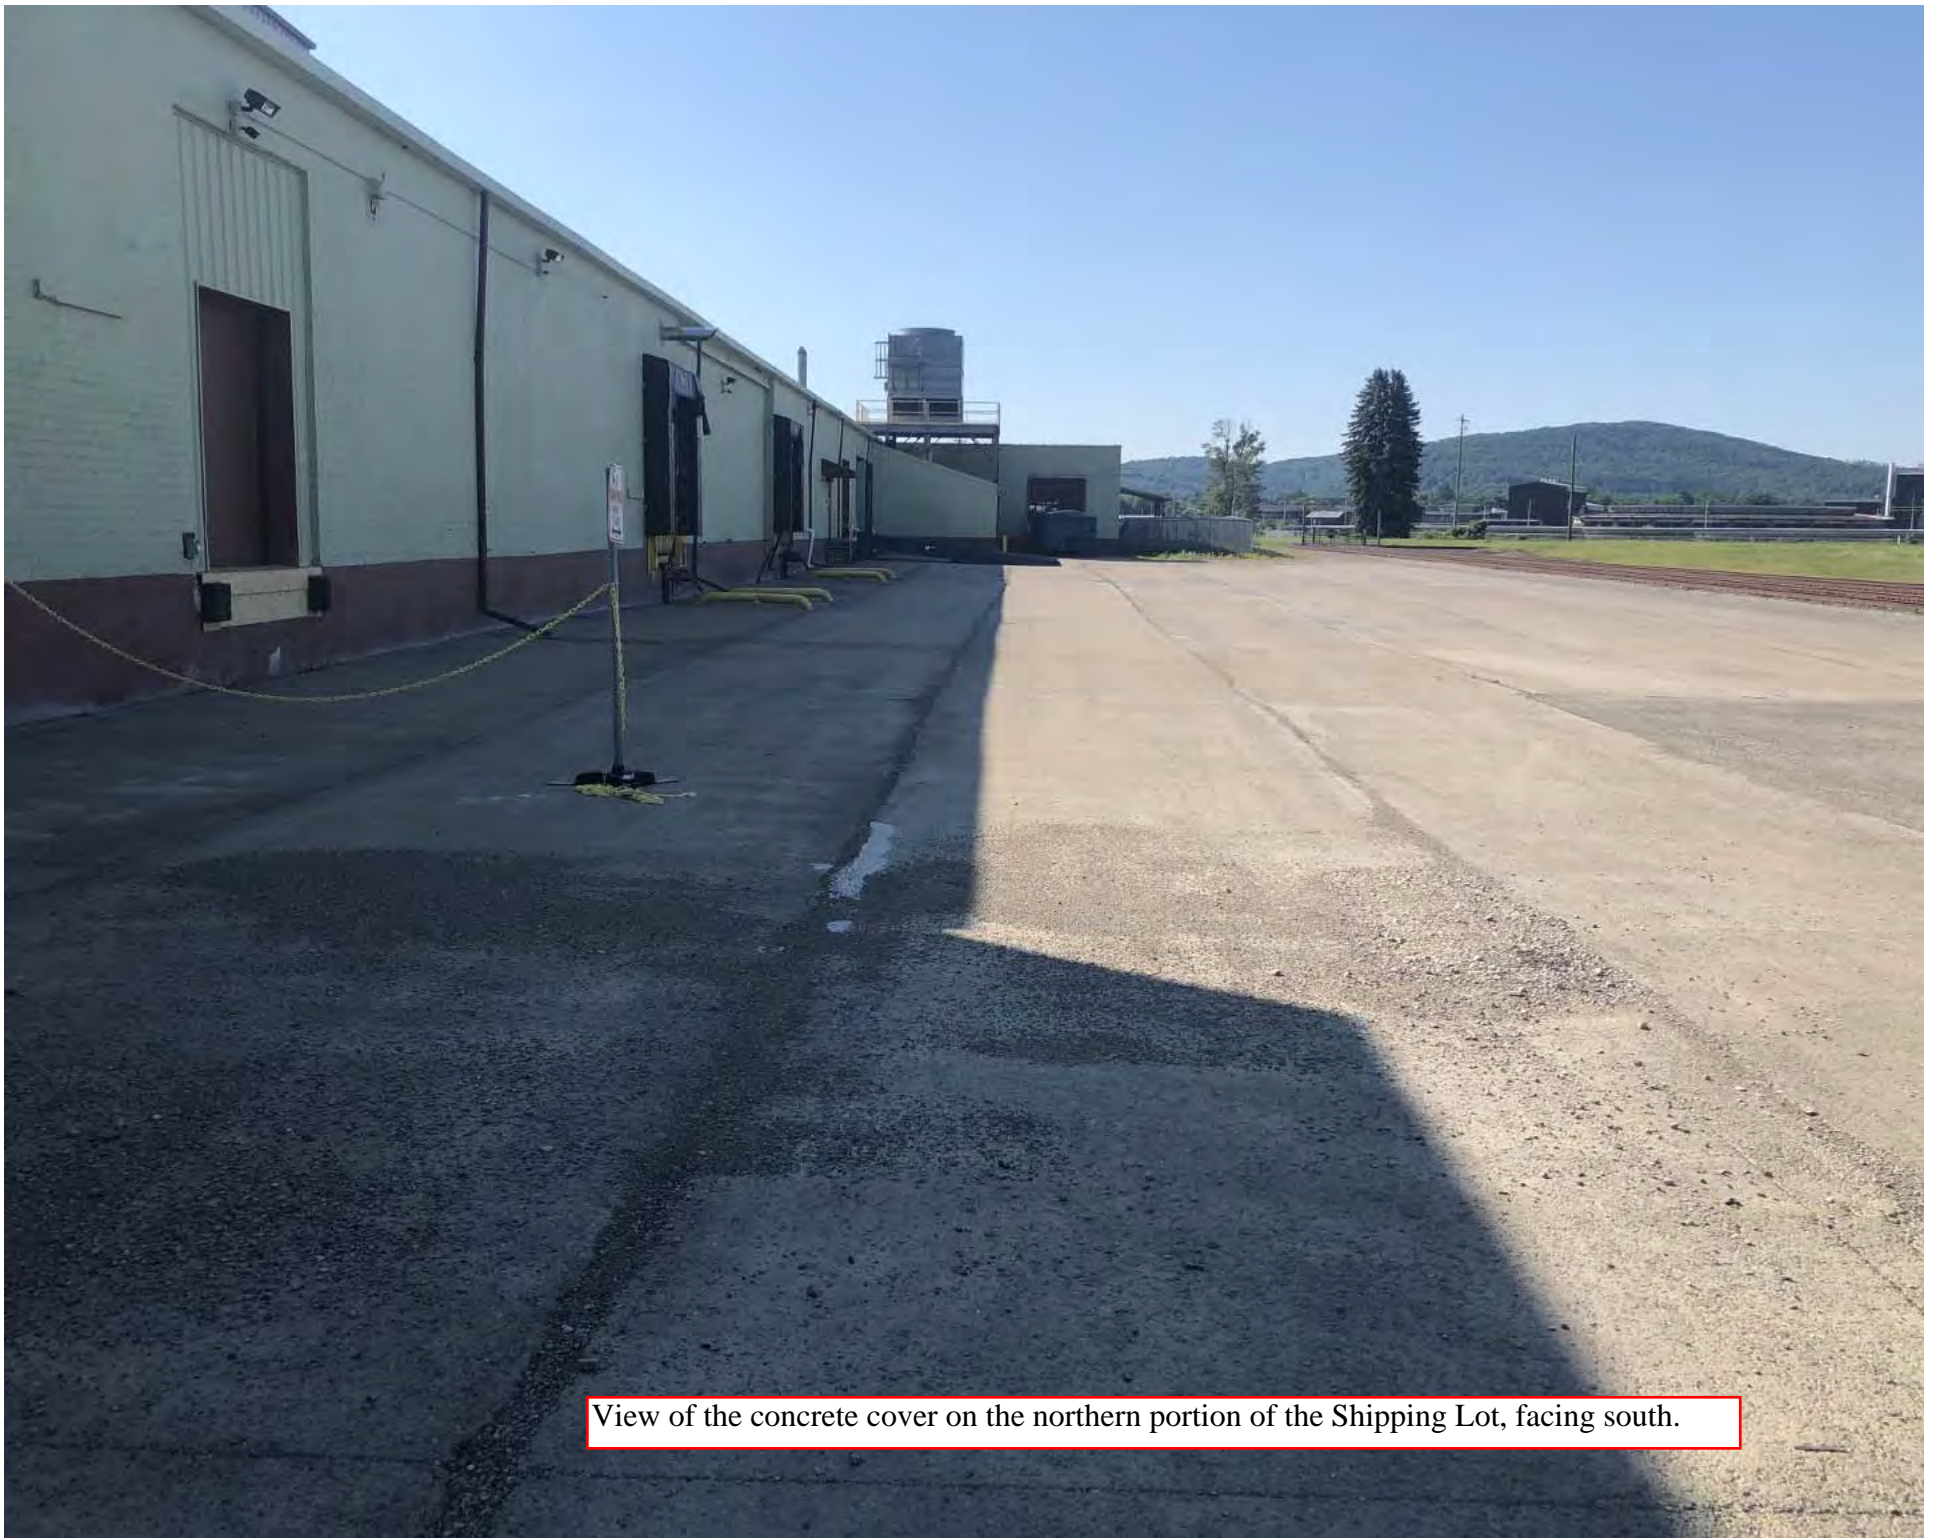
View of the concrete cover on the northern portion of the Shipping Lot, facing south.

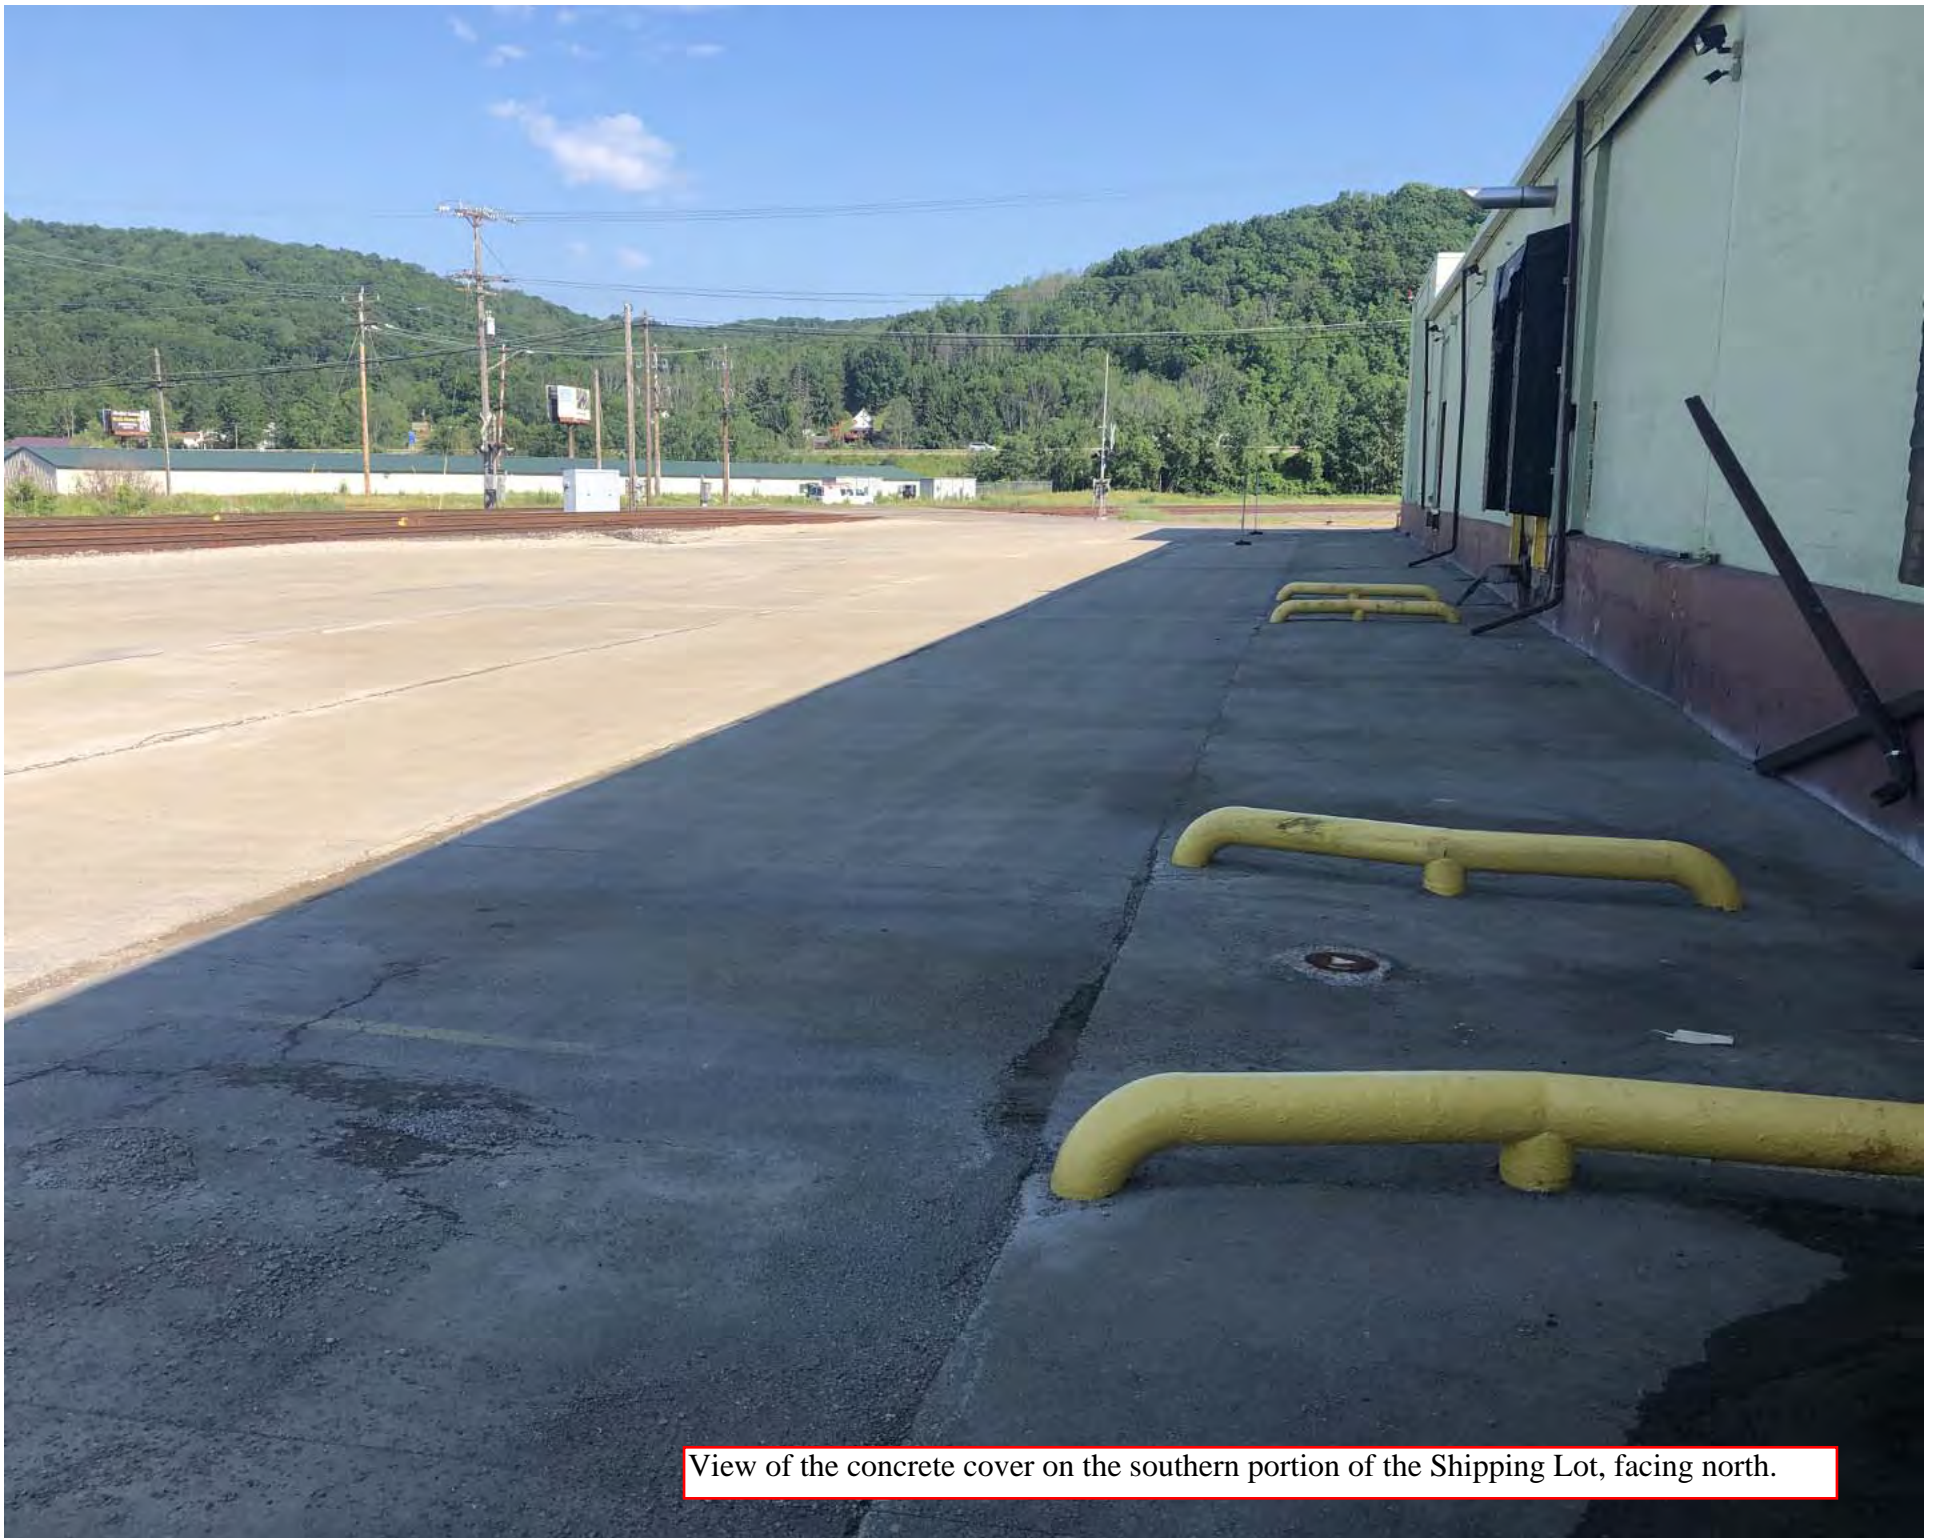
View of the concrete cover on the southern portion of the Shipping Lot, facing north.

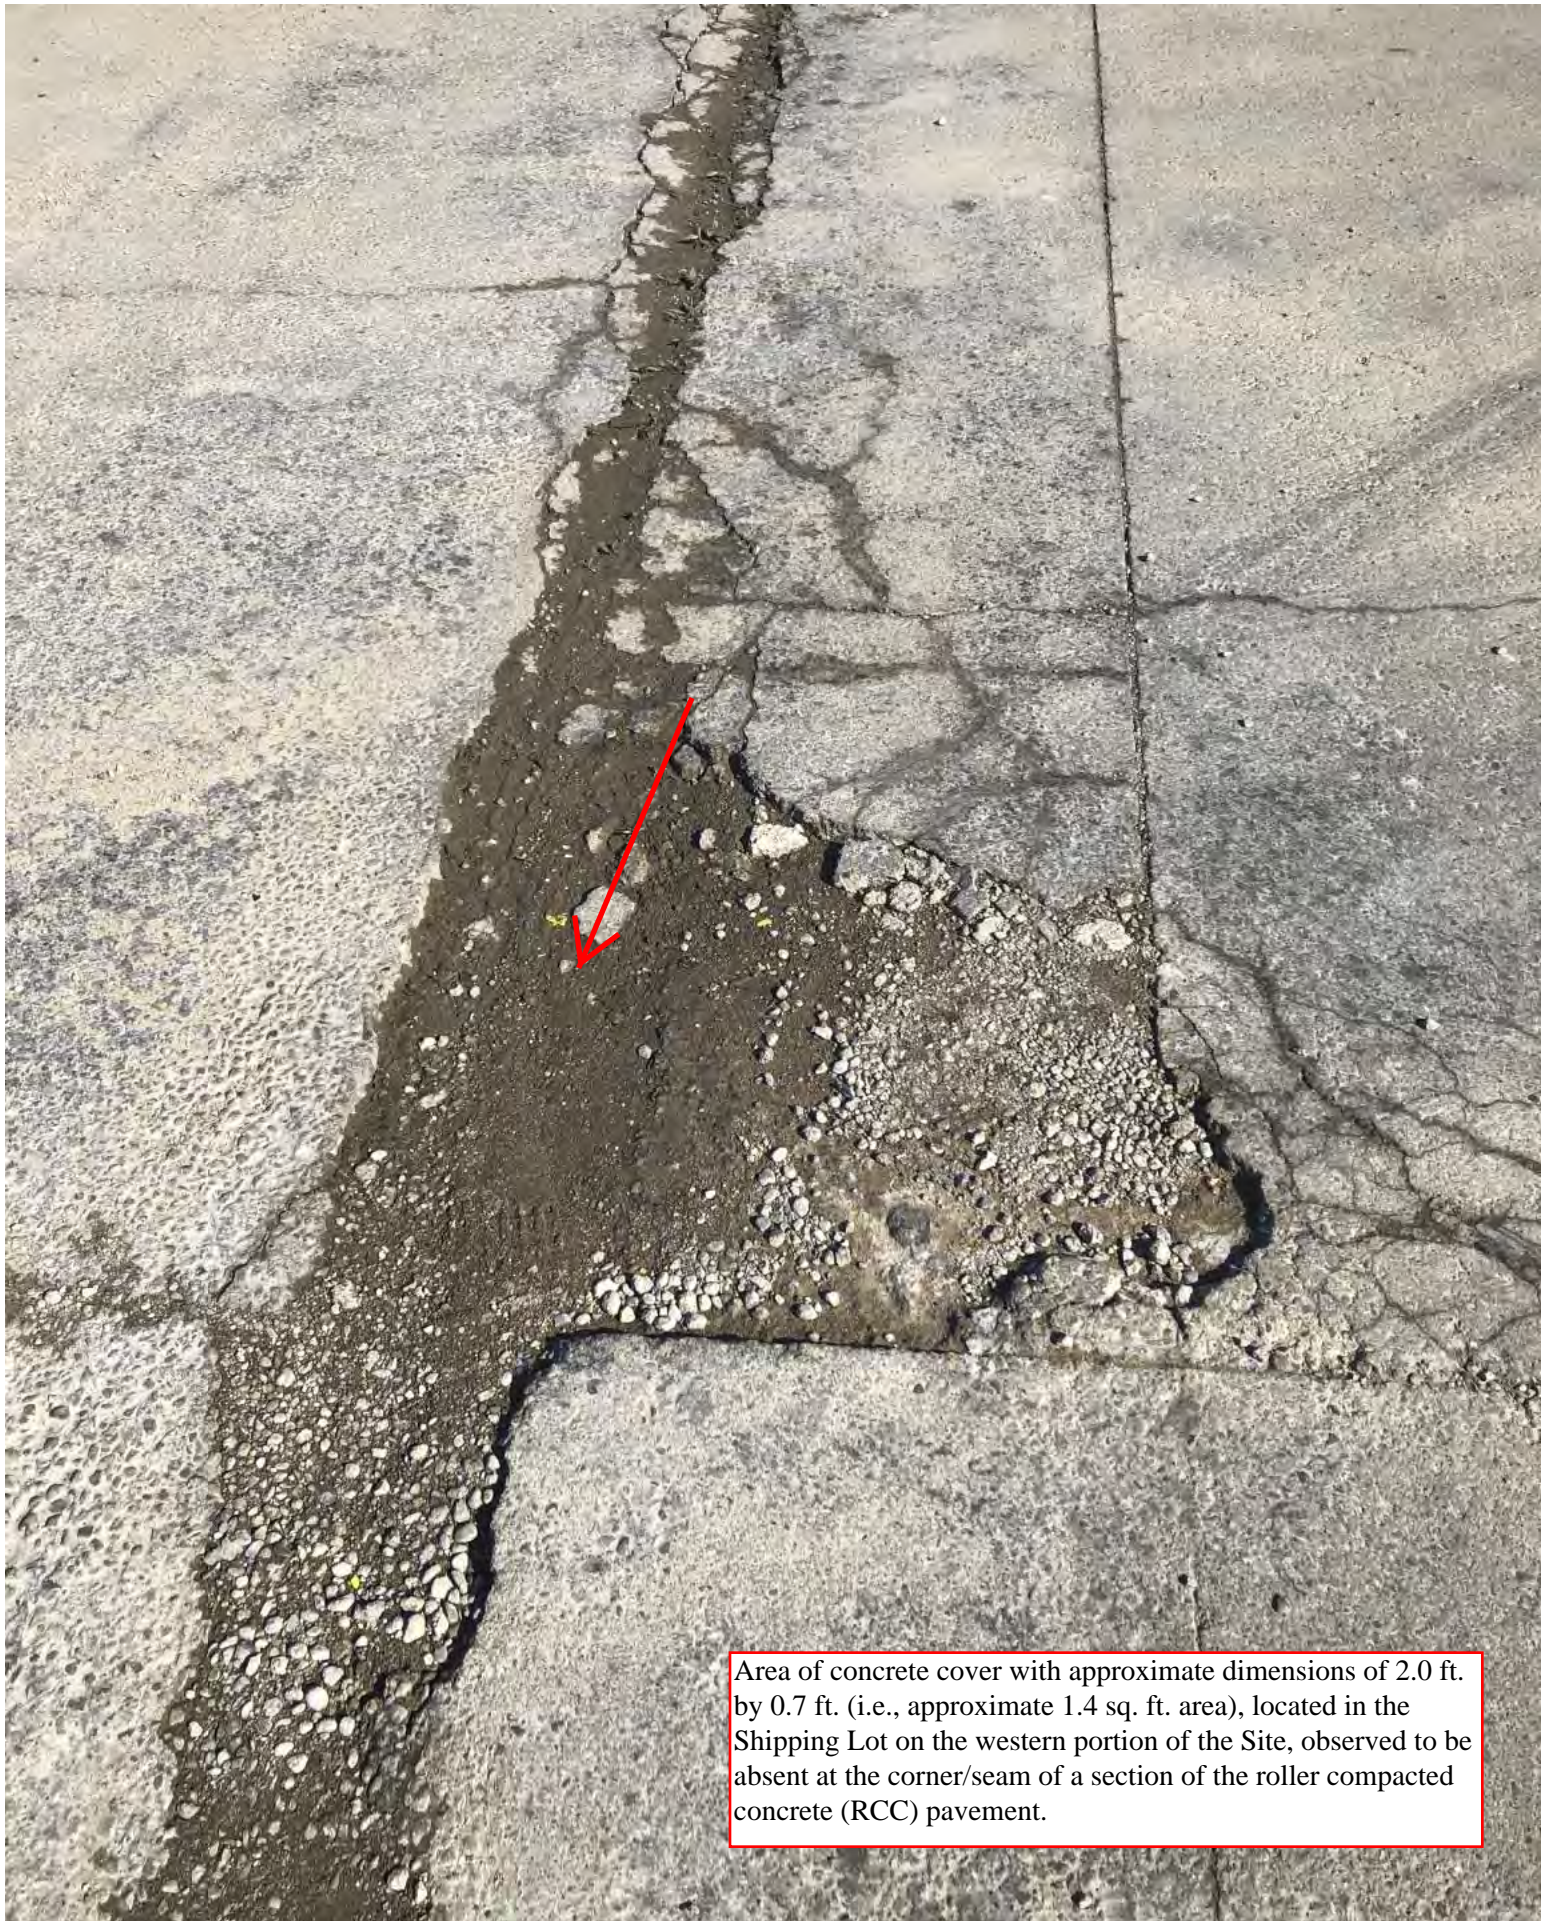
An area of concrete cover with approximate dimensions of 2.0 ft. by 0.7 ft. (i.e., approximate 1.4 sq. ft. area), located in the Shipping Lot on the western portion of the Site, was observed to be absent at the corner/seam of a section of the roller compacted concrete (RCC) pavement (refer to the photograph included in Attachment B). The area of missing concrete was probed, and a layer of imported base material at least 0.4 ft. thick was observed to be present (i.e., continuing to provide a barrier to the soil, present below the base material). The facility indicated that, as of the end of the reporting period, the approximate 1.4 sq. ft. area had not been patched, but would be patched in the Spring of 2021 (i.e., during paving season).

Shipping lot @ West edge of site - ~2' L x 0.7' W area where concrete has sloughed and is missing - base material is present and at least 20.4" thick - recommending patching area to prevent further erosion/sloughing

Area of concrete cover with approximate dimensions of 2.0 ft. by 0.7 ft. (i.e., approximate 1.4 sq. ft. area), located in the Shipping Lot on the western portion of the Site, observed to be absent at the corner/seam of a section of the roller compacted concrete (RCC) pavement.

1. The area of degraded/missing concrete cover with approximate dimensions of 2.0 ft. by 0.7 ft. (i.e., approximate 1.4 sq. ft. area) located in the Shipping Lot should be patched to prevent further degradation of the cover system in this area.
2. It is recommended that the frequency of future PRRs be modified from annually, as identified in the SMP Revision 2, to every three years (i.e., submitted such that the next PRR covers the reporting period February 11, 2021 through February 10, 2024).
3. Since residual contamination remains at the Site, it is recommended that site management requirements be continued to document the on-going effectiveness of the ICs and ECs implemented.

The area of degraded/missing concrete cover with approximate dimensions of 2.0 ft. by 0.7 ft. (i.e., approximate 1.4 sq. ft. area) located in the Shipping Lot should be patched to prevent further degradation of the cover system in this area. As of the end of the current reporting period, this repair was outstanding.

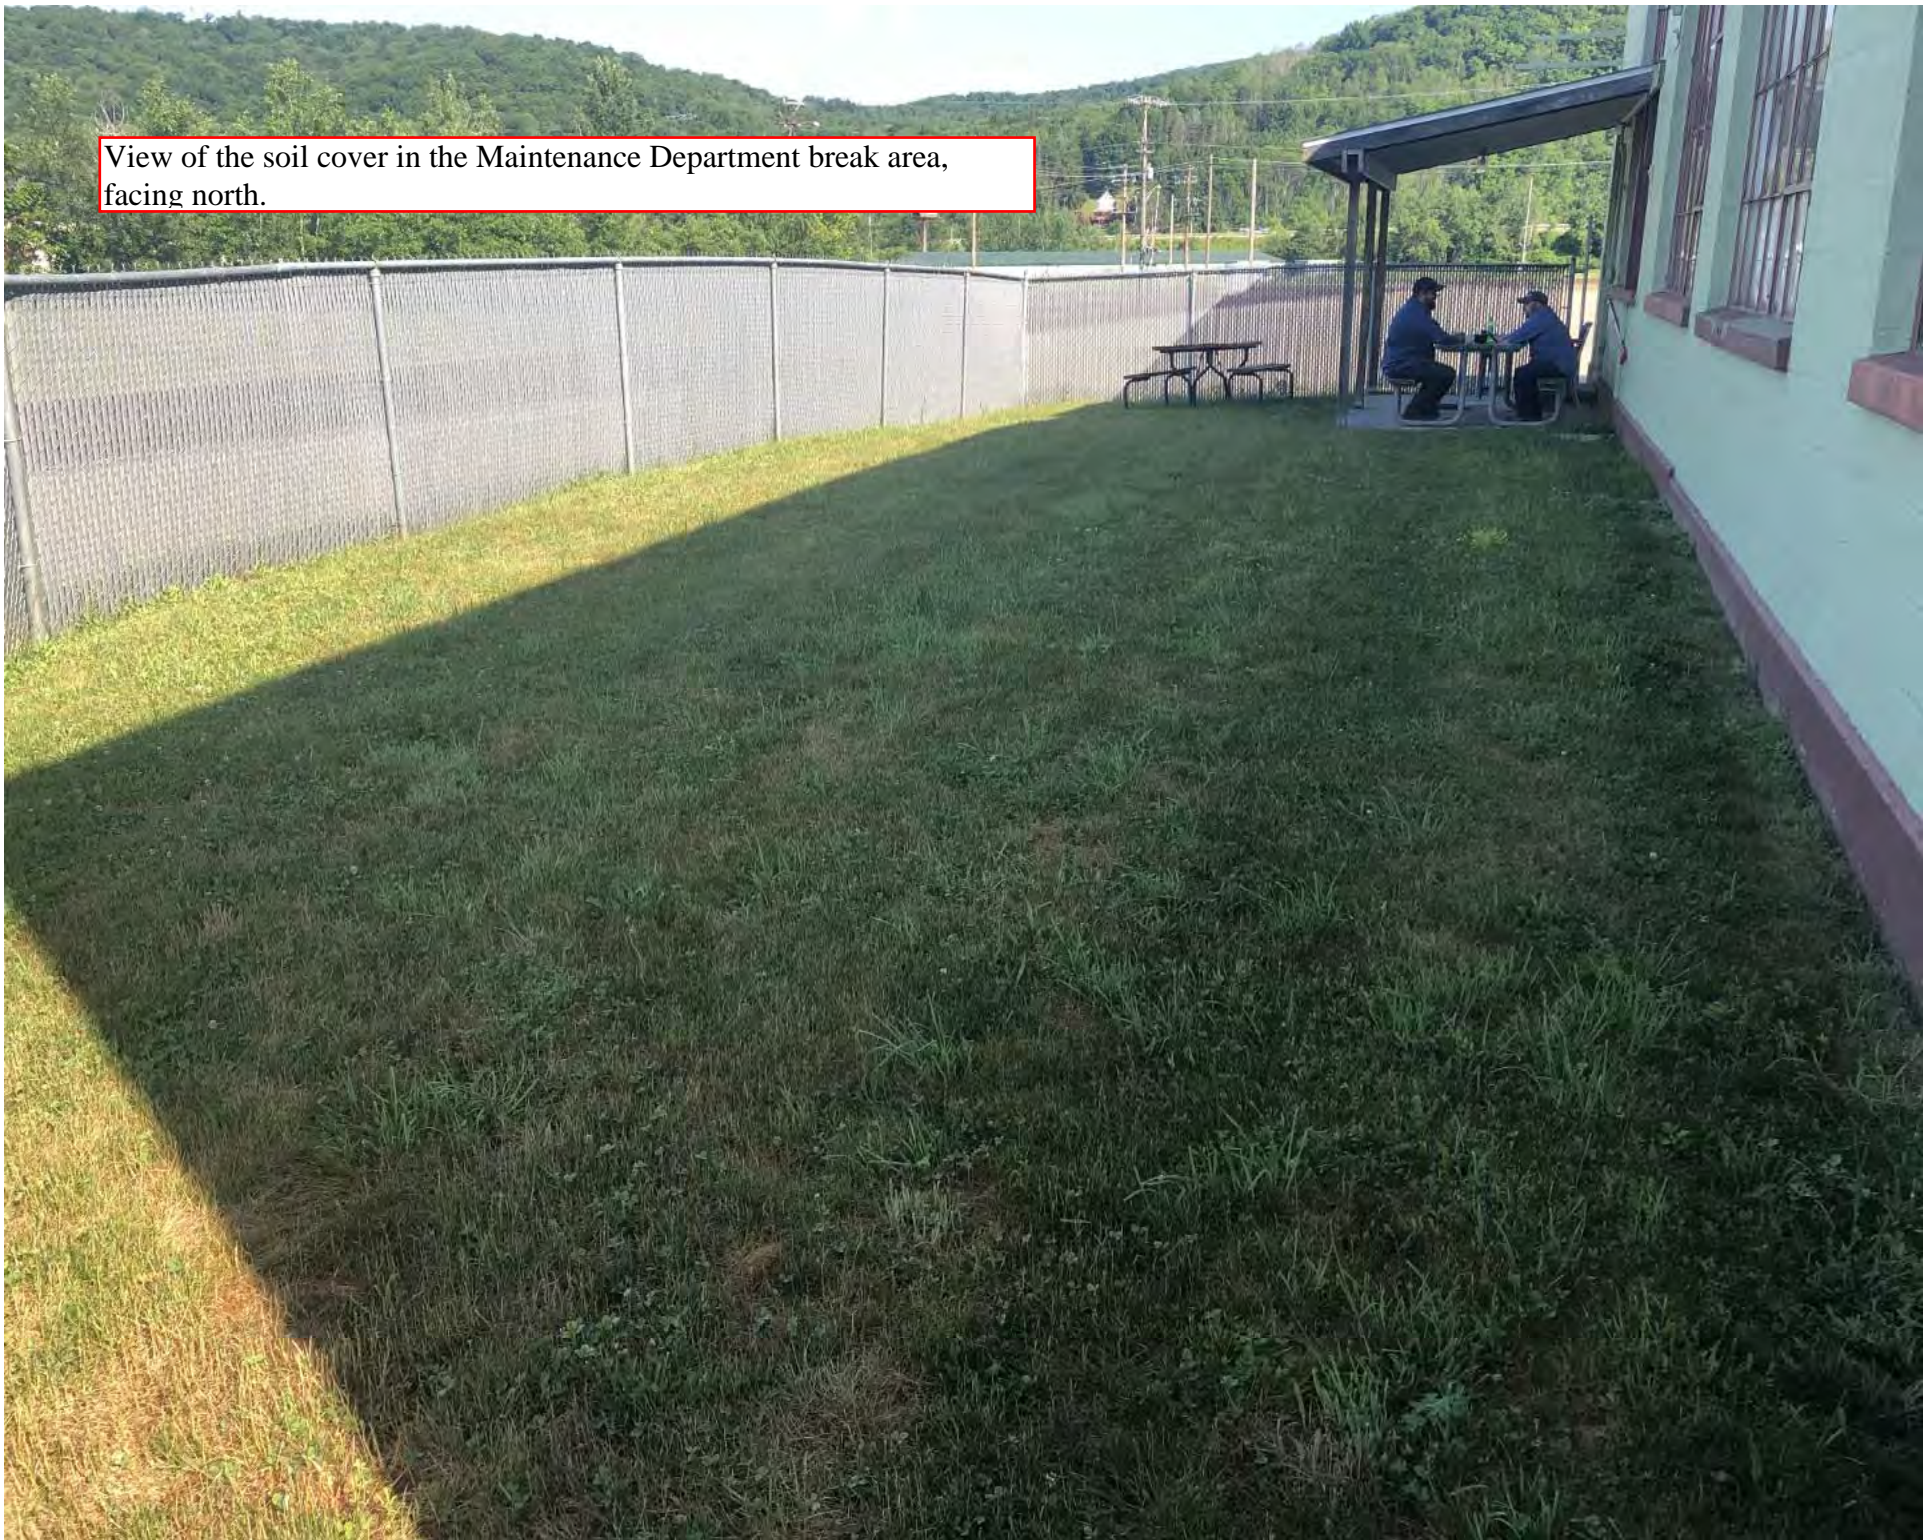
View of the soil cover in the Maintenance Department break area, facing north.

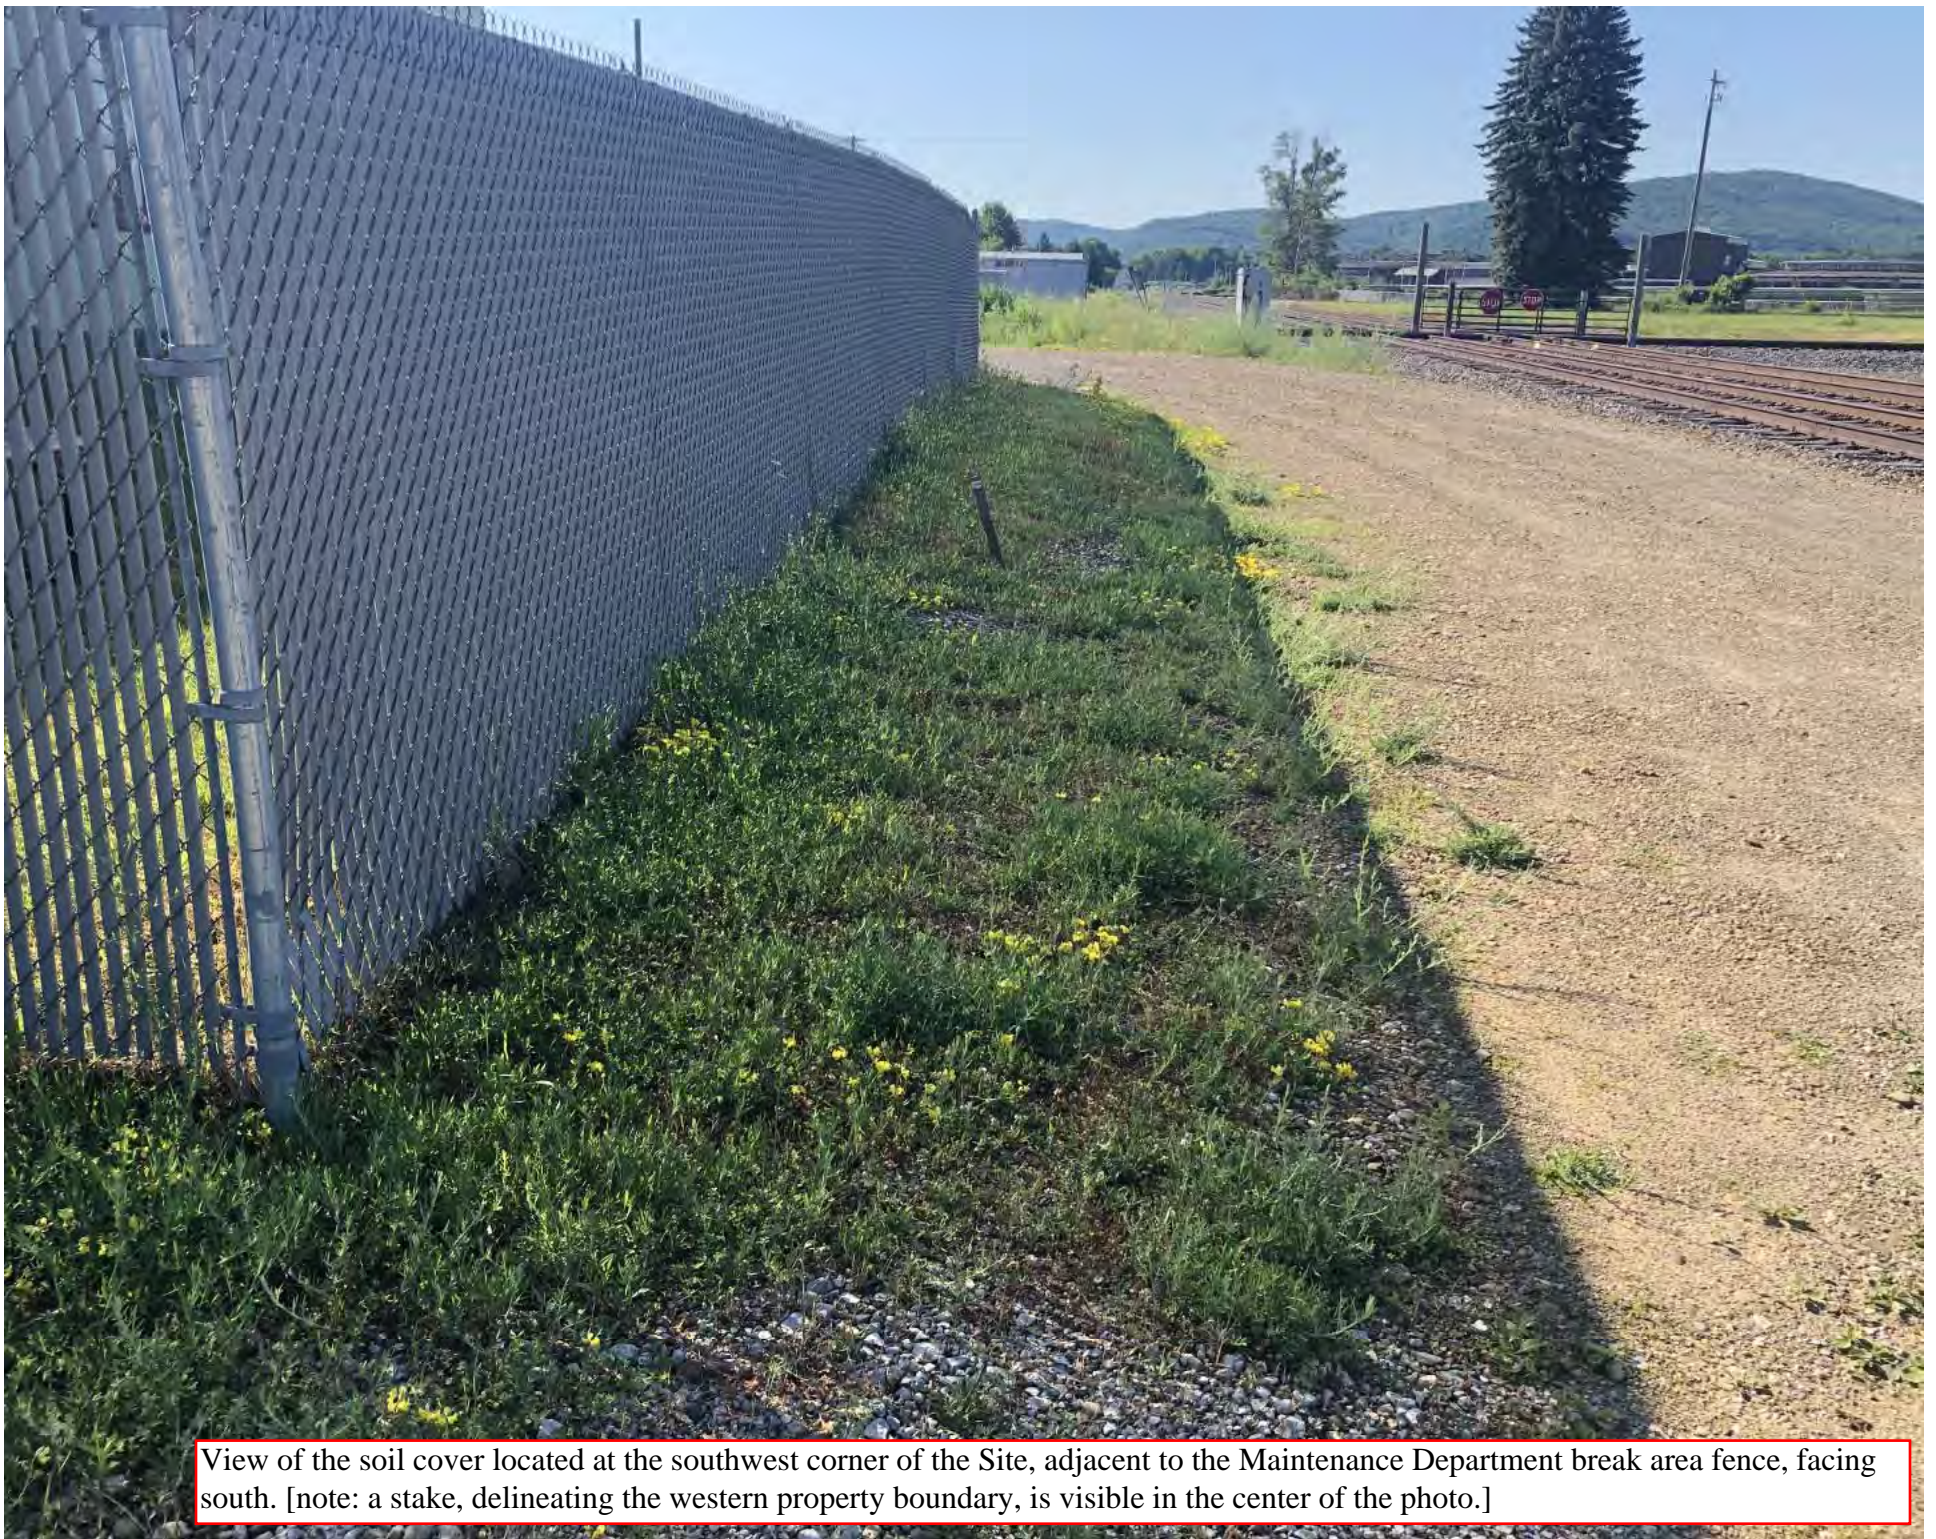
View of the soil cover located at the southwest corner of the Site, adjacent to the Maintenance Department break area fence, facing south. [note: a stake, delineating the western property boundary, is visible in the center of the photo.]
