PERIODIC REVIEW REPORT
REPORTING PERIOD: FEBRUARY 11, 2020 THROUGH FEBRUARY 10, 2021

211 FRANKLIN STREET
OLEAN, NEW YORK
NYSDEC SITE NO. C905038

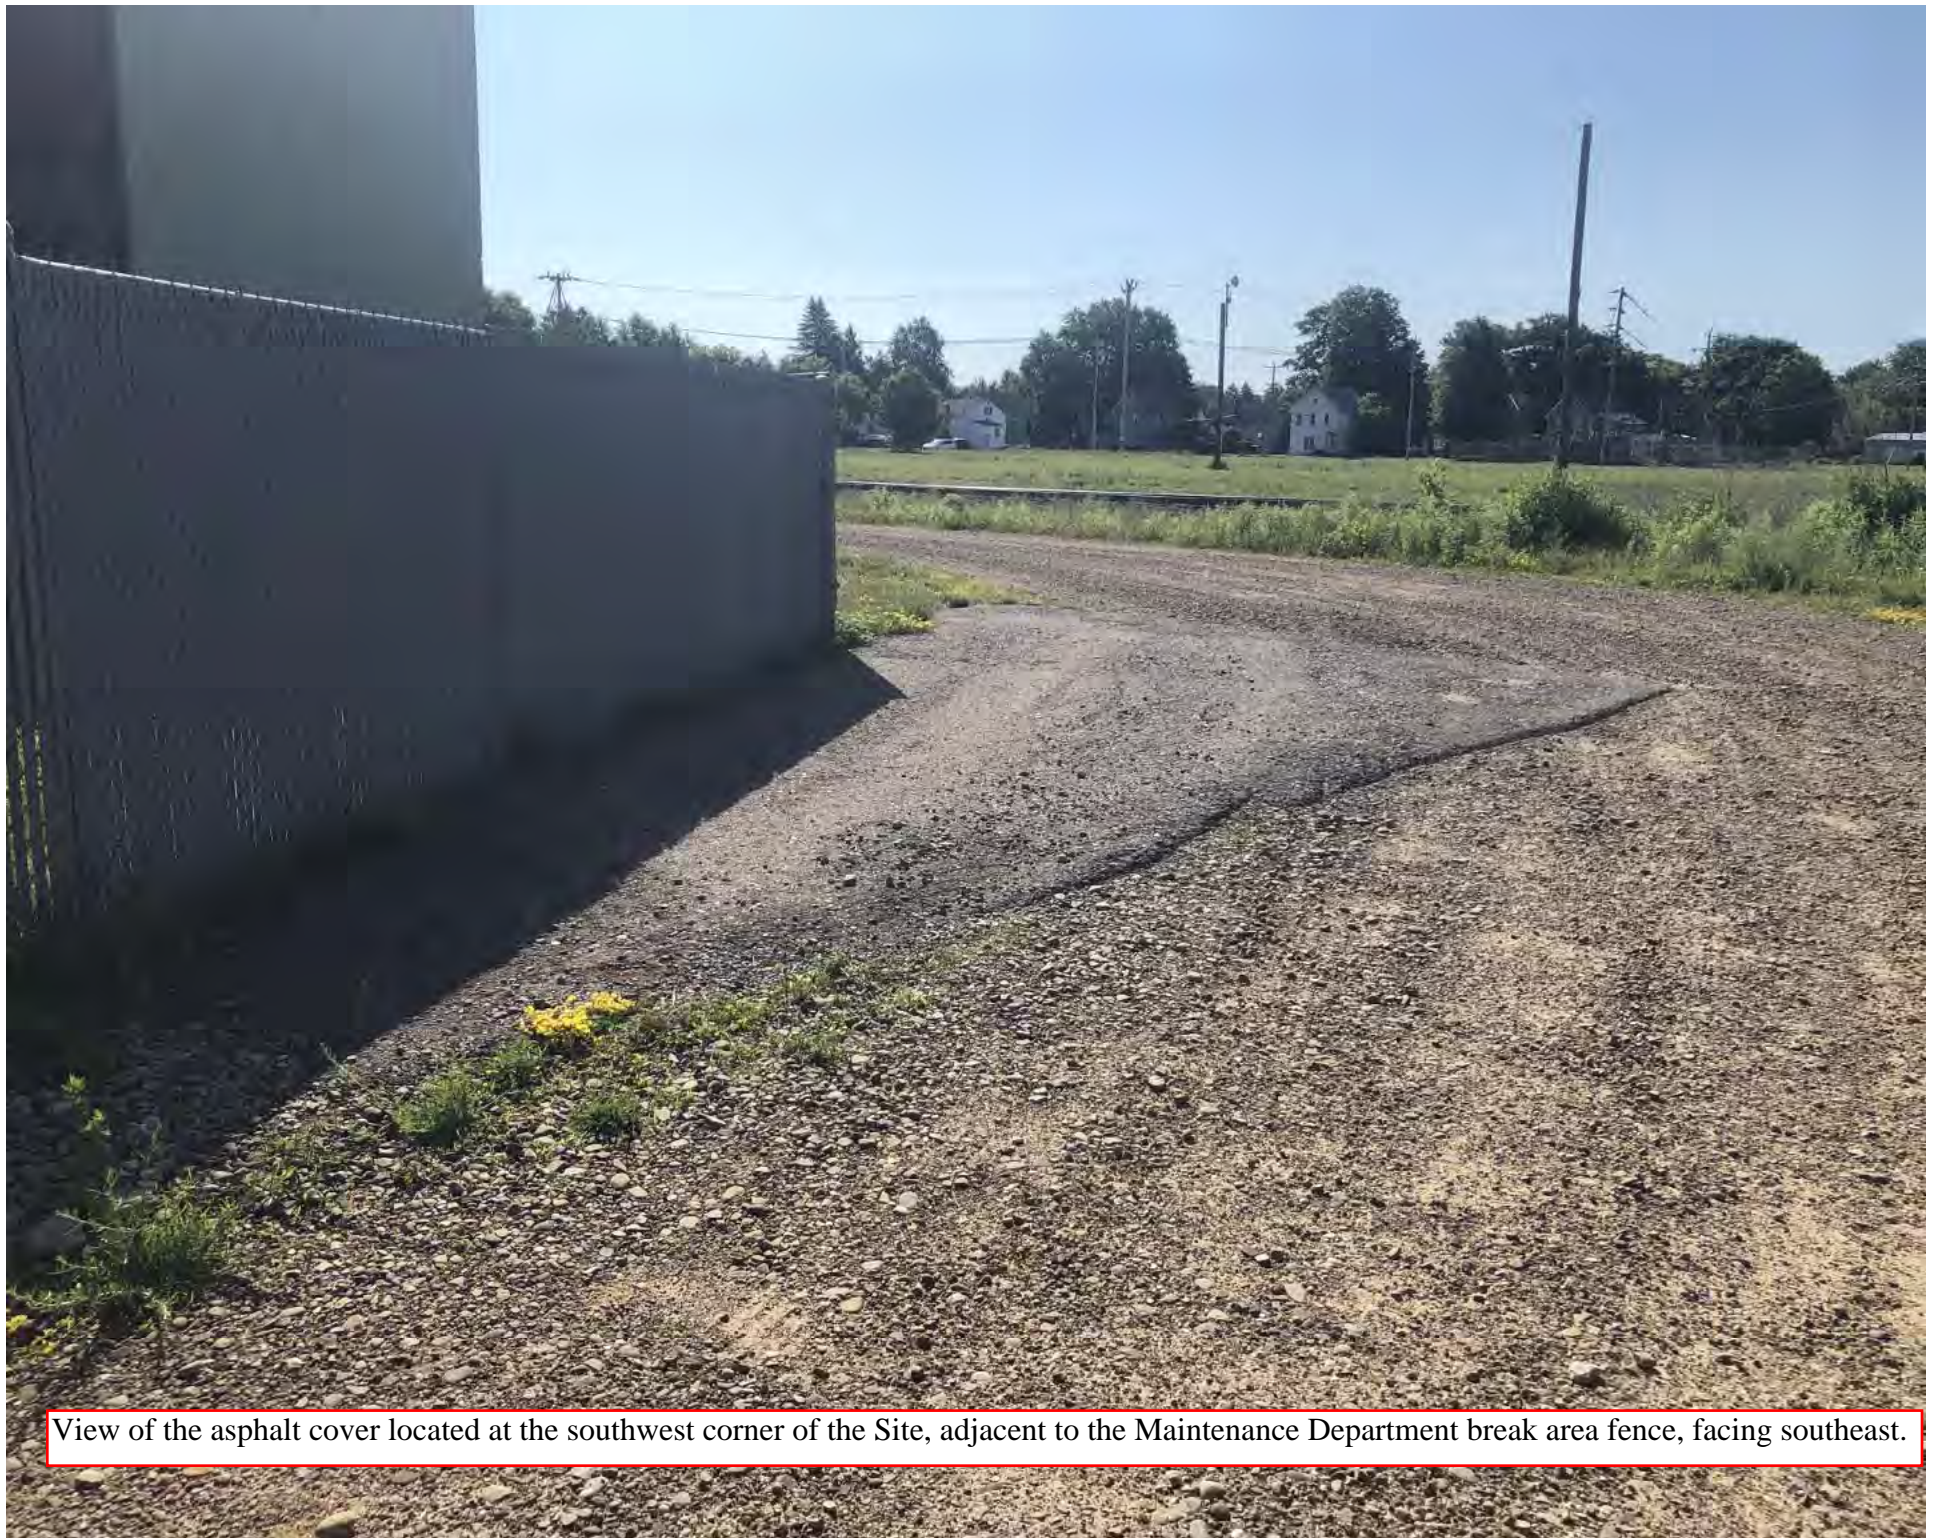
View of the asphalt cover located at the southwest corner of the Site, adjacent to the Maintenance Department break area fence, facing southeast.

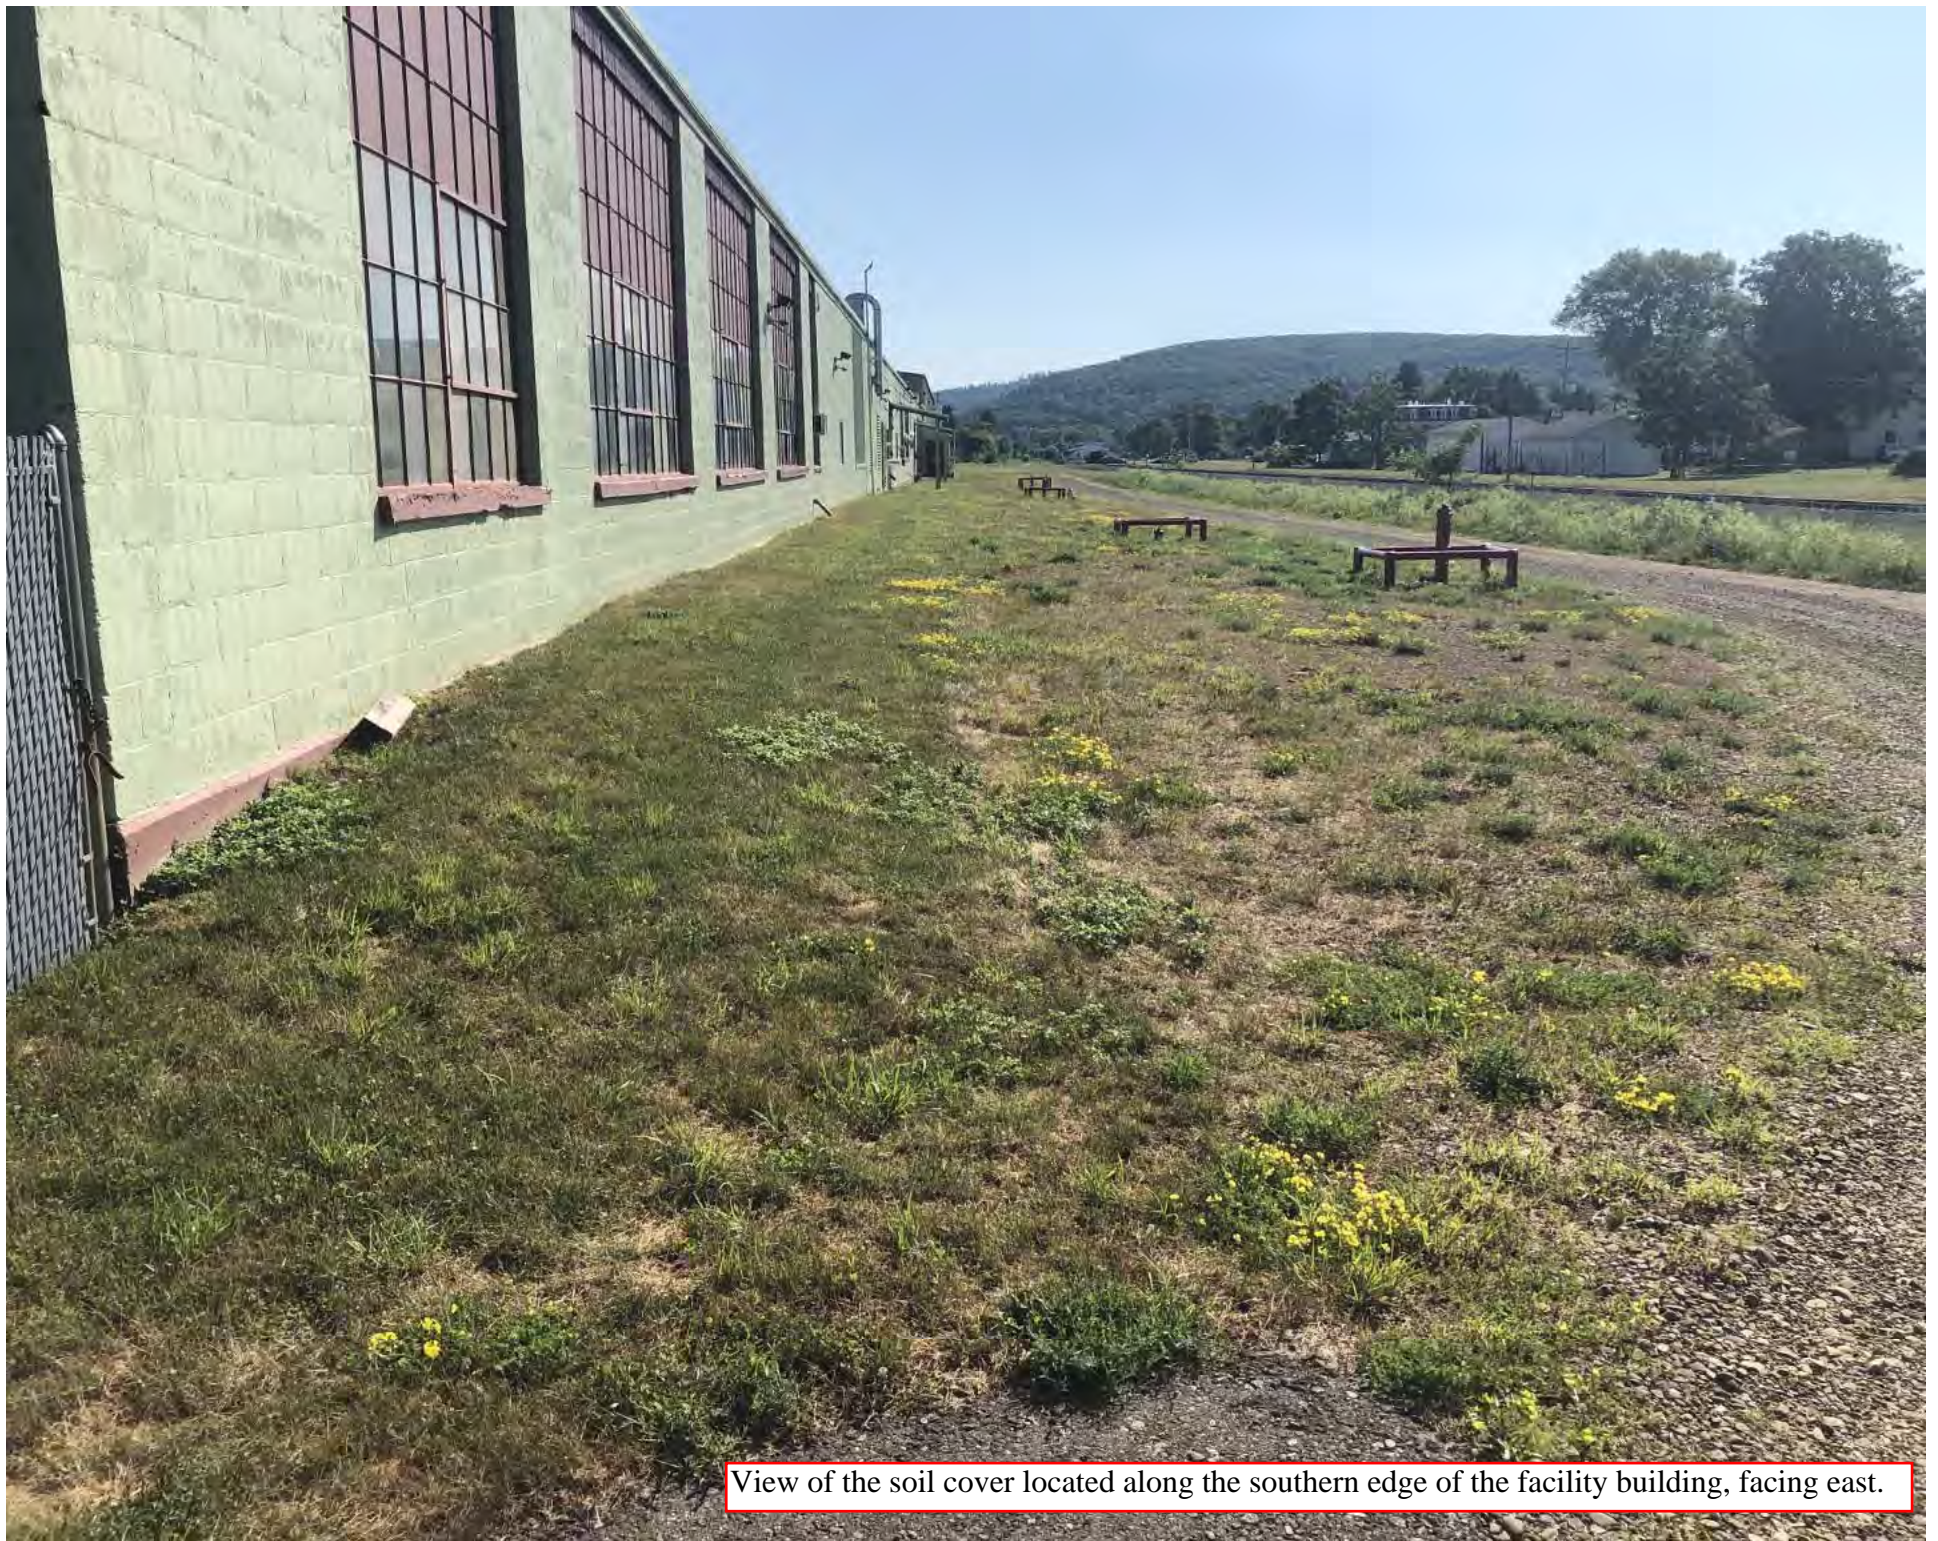
View of the soil cover located along the southern edge of the facility building, facing east.

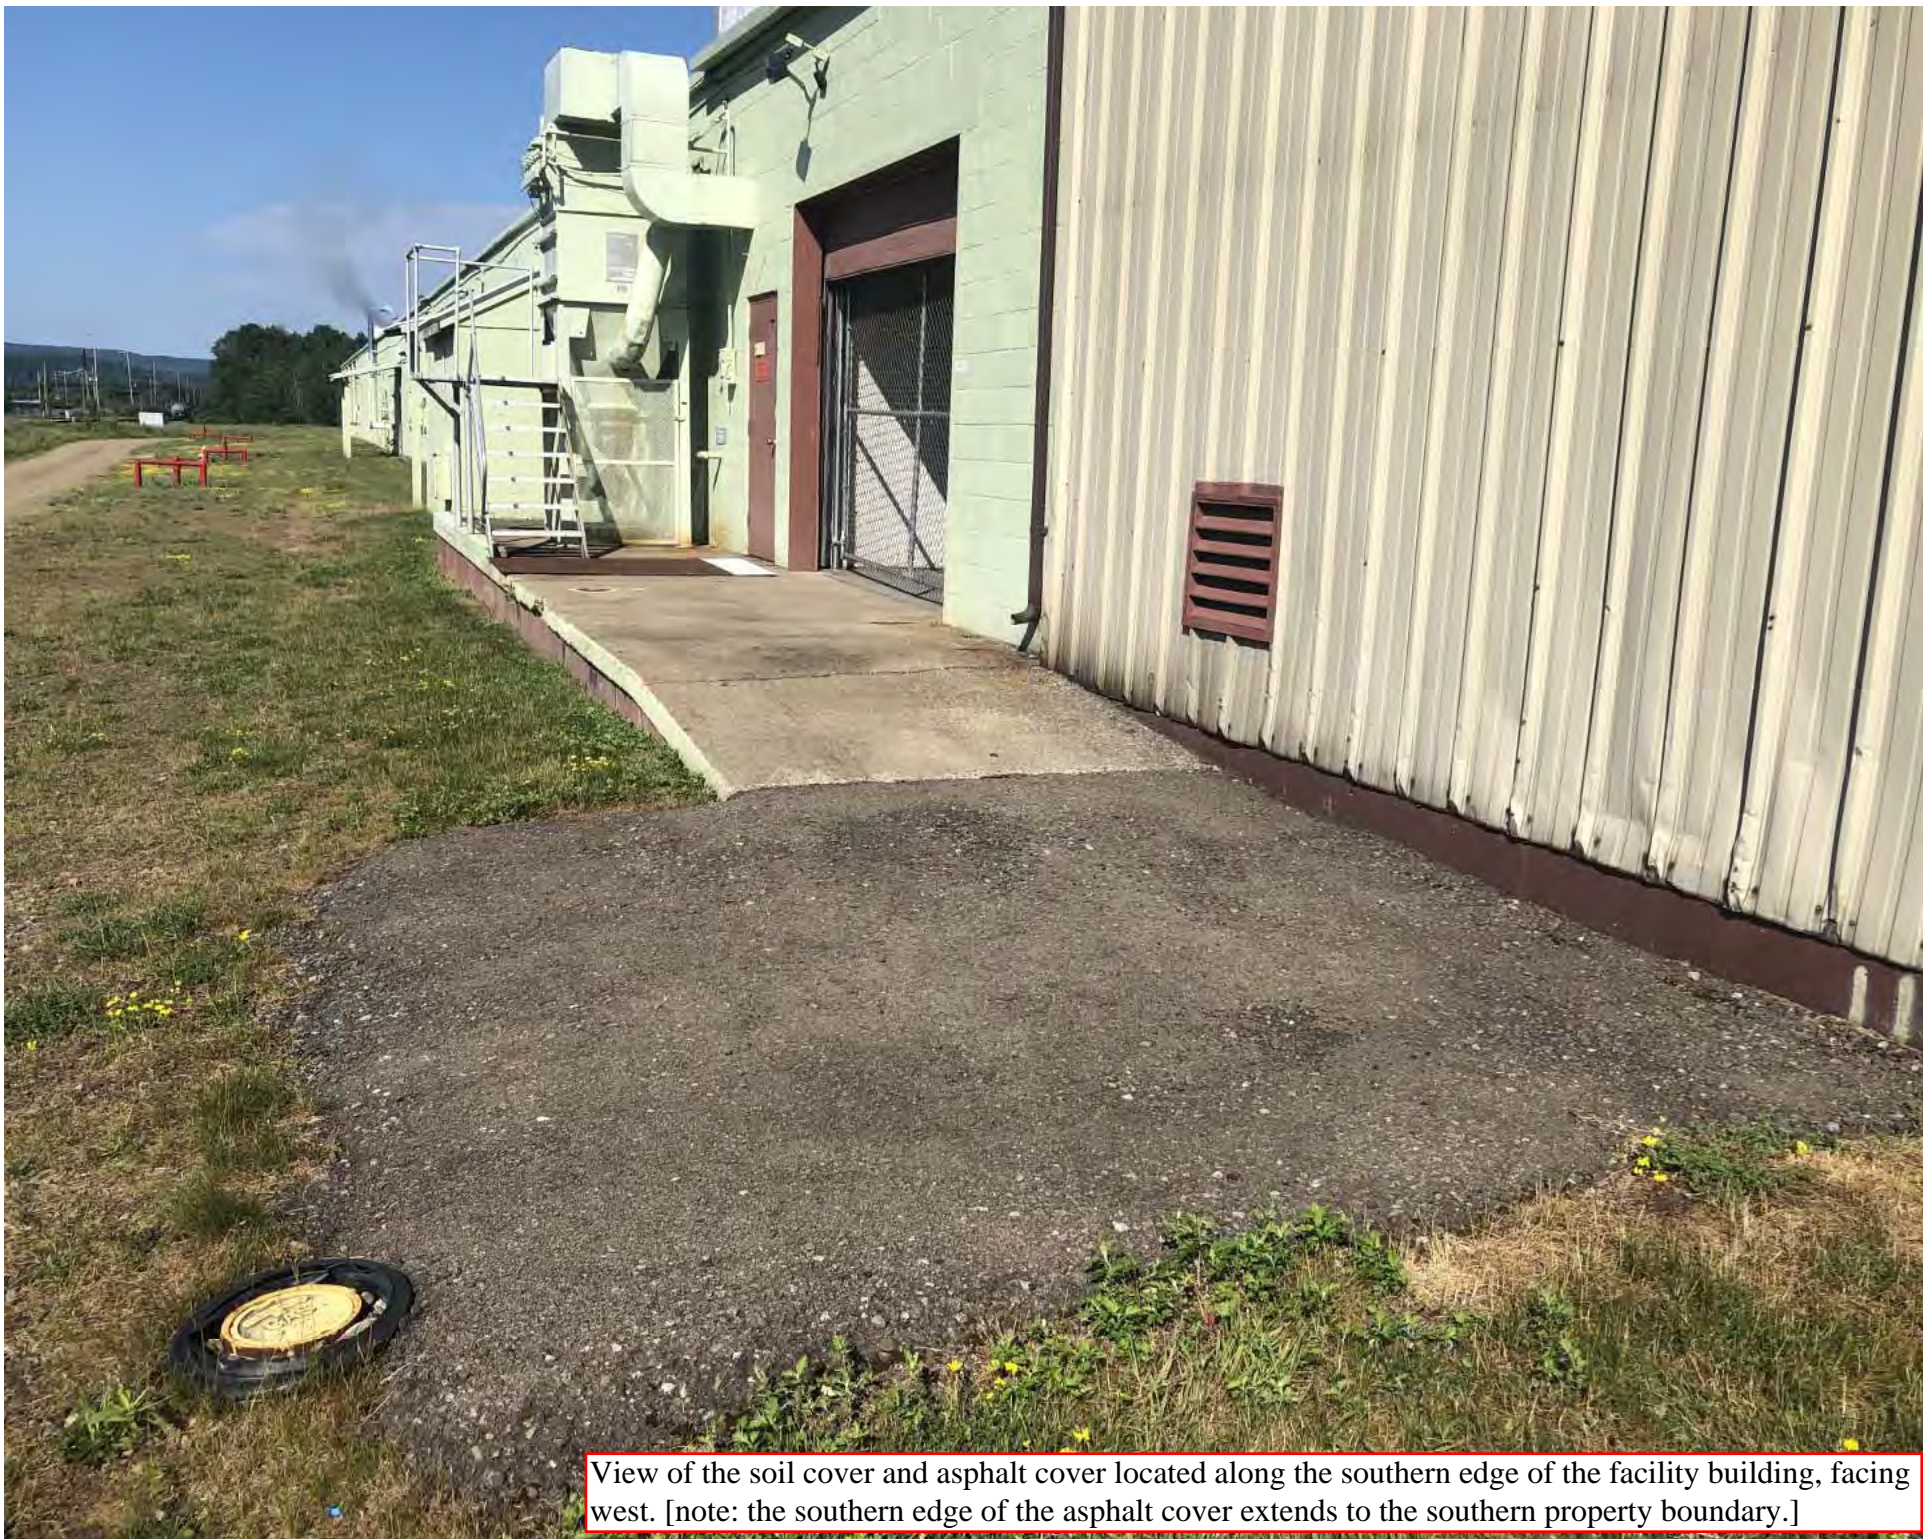
View of the soil cover and asphalt cover located along the southern edge of the facility building, facing west. [note: the southern edge of the asphalt cover extends to the southern property boundary.]

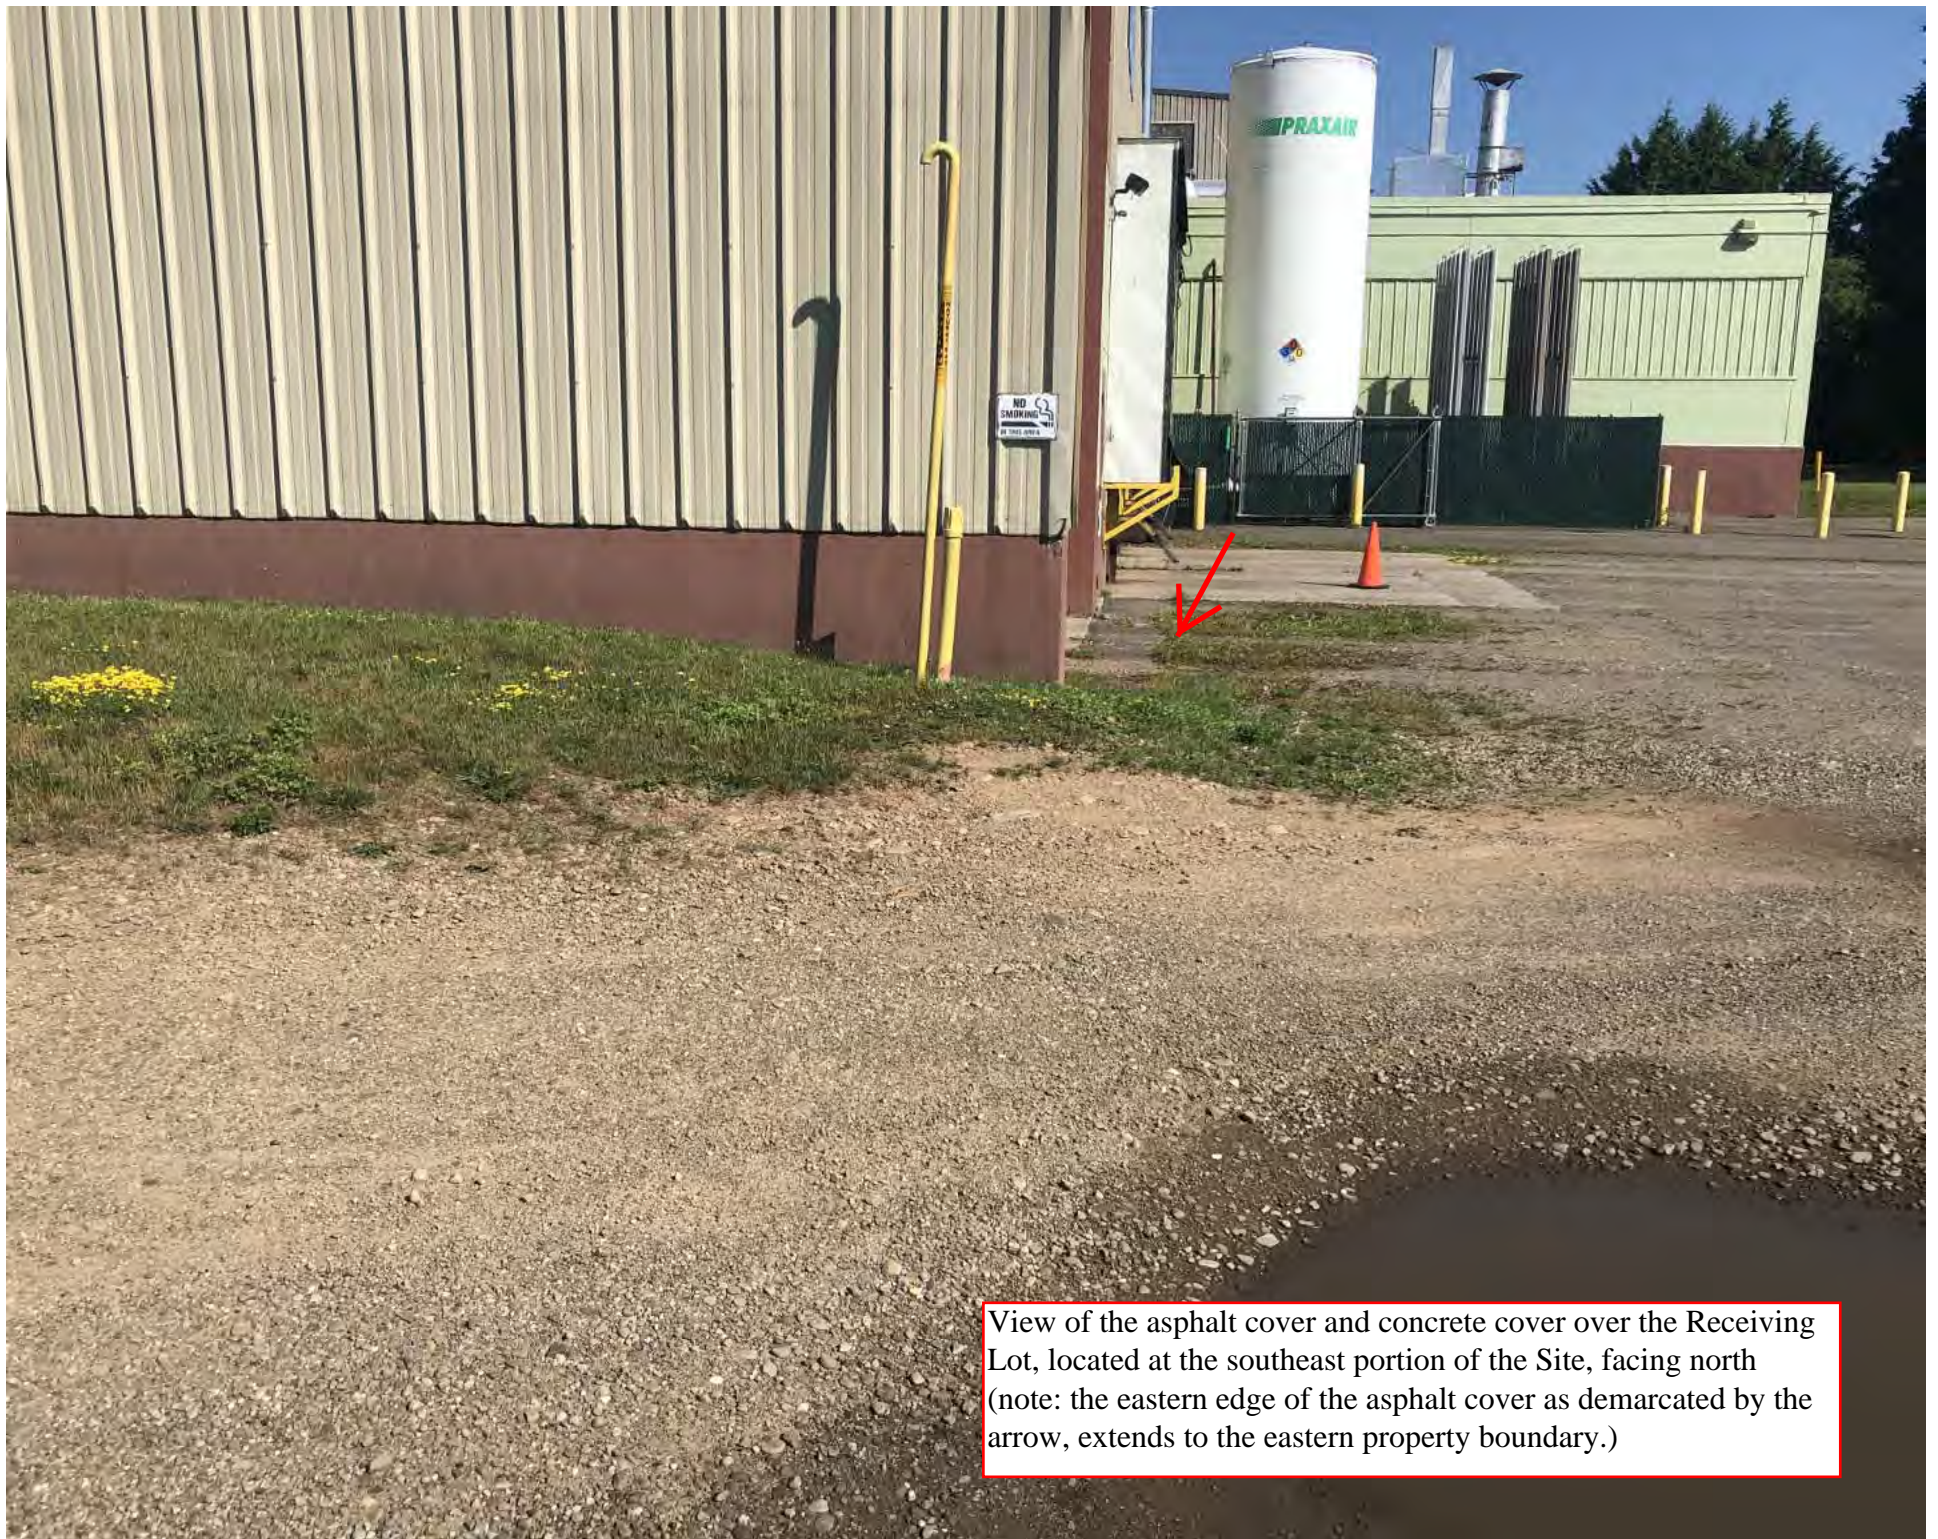
View of the asphalt cover and concrete cover over the Receiving Lot, located at the southeast portion of the Site, facing north (note: the eastern edge of the asphalt cover as demarcated by the arrow, extends to the eastern property boundary.)

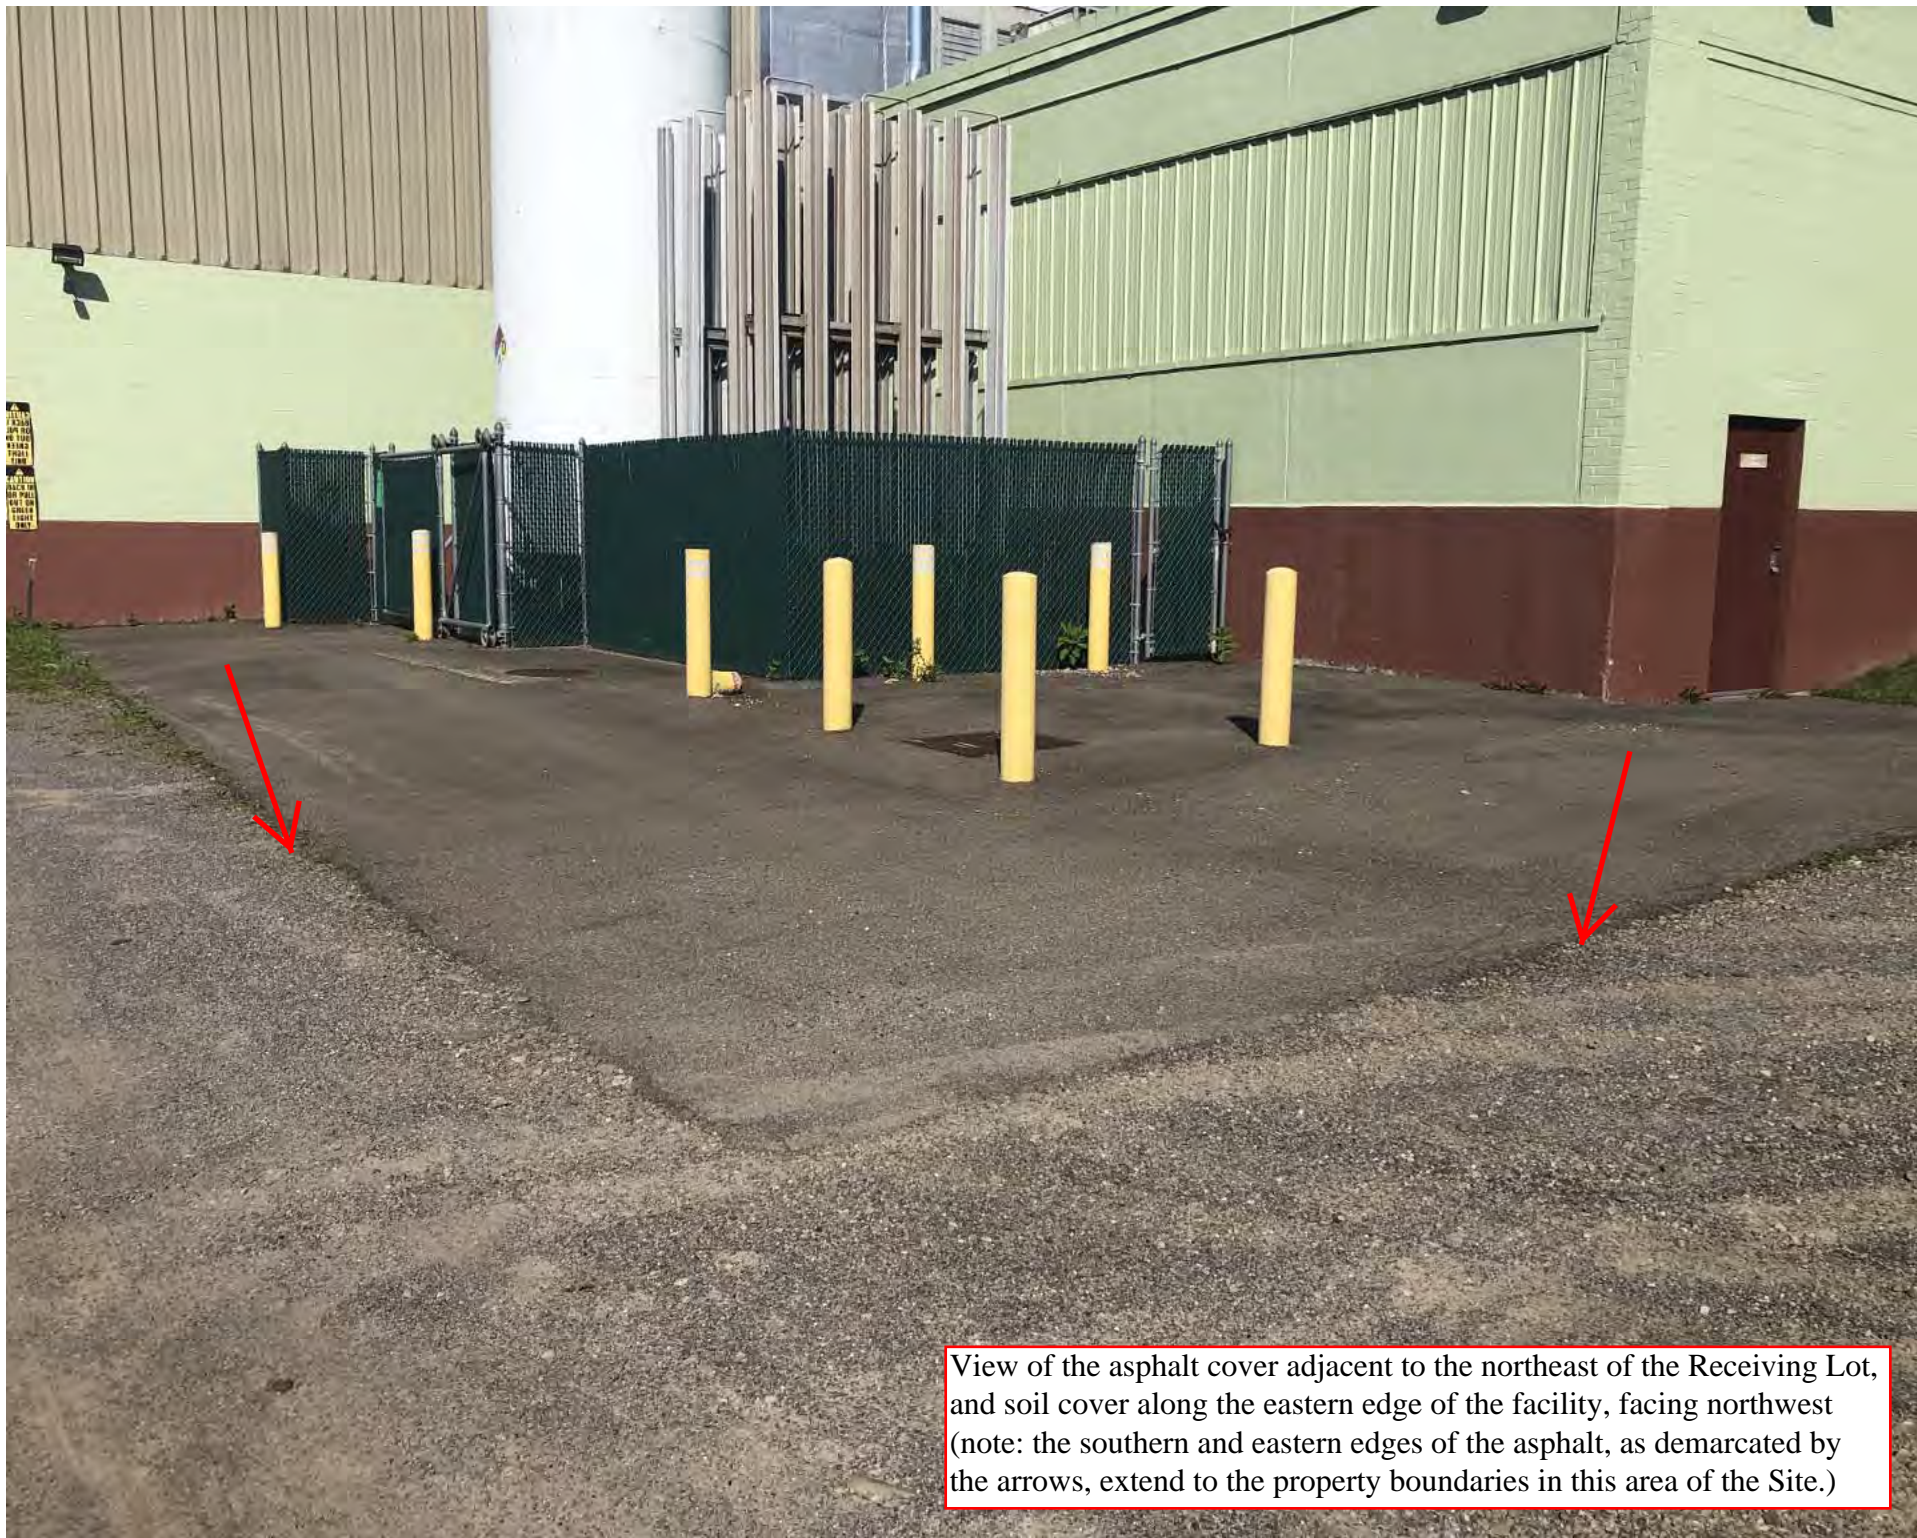
View of the asphalt cover adjacent to the northeast of the Receiving Lot, and soil cover along the eastern edge of the facility, facing northwest (note: the southern and eastern edges of the asphalt, as demarcated by the arrows, extend to the property boundaries in this area of the Site.)

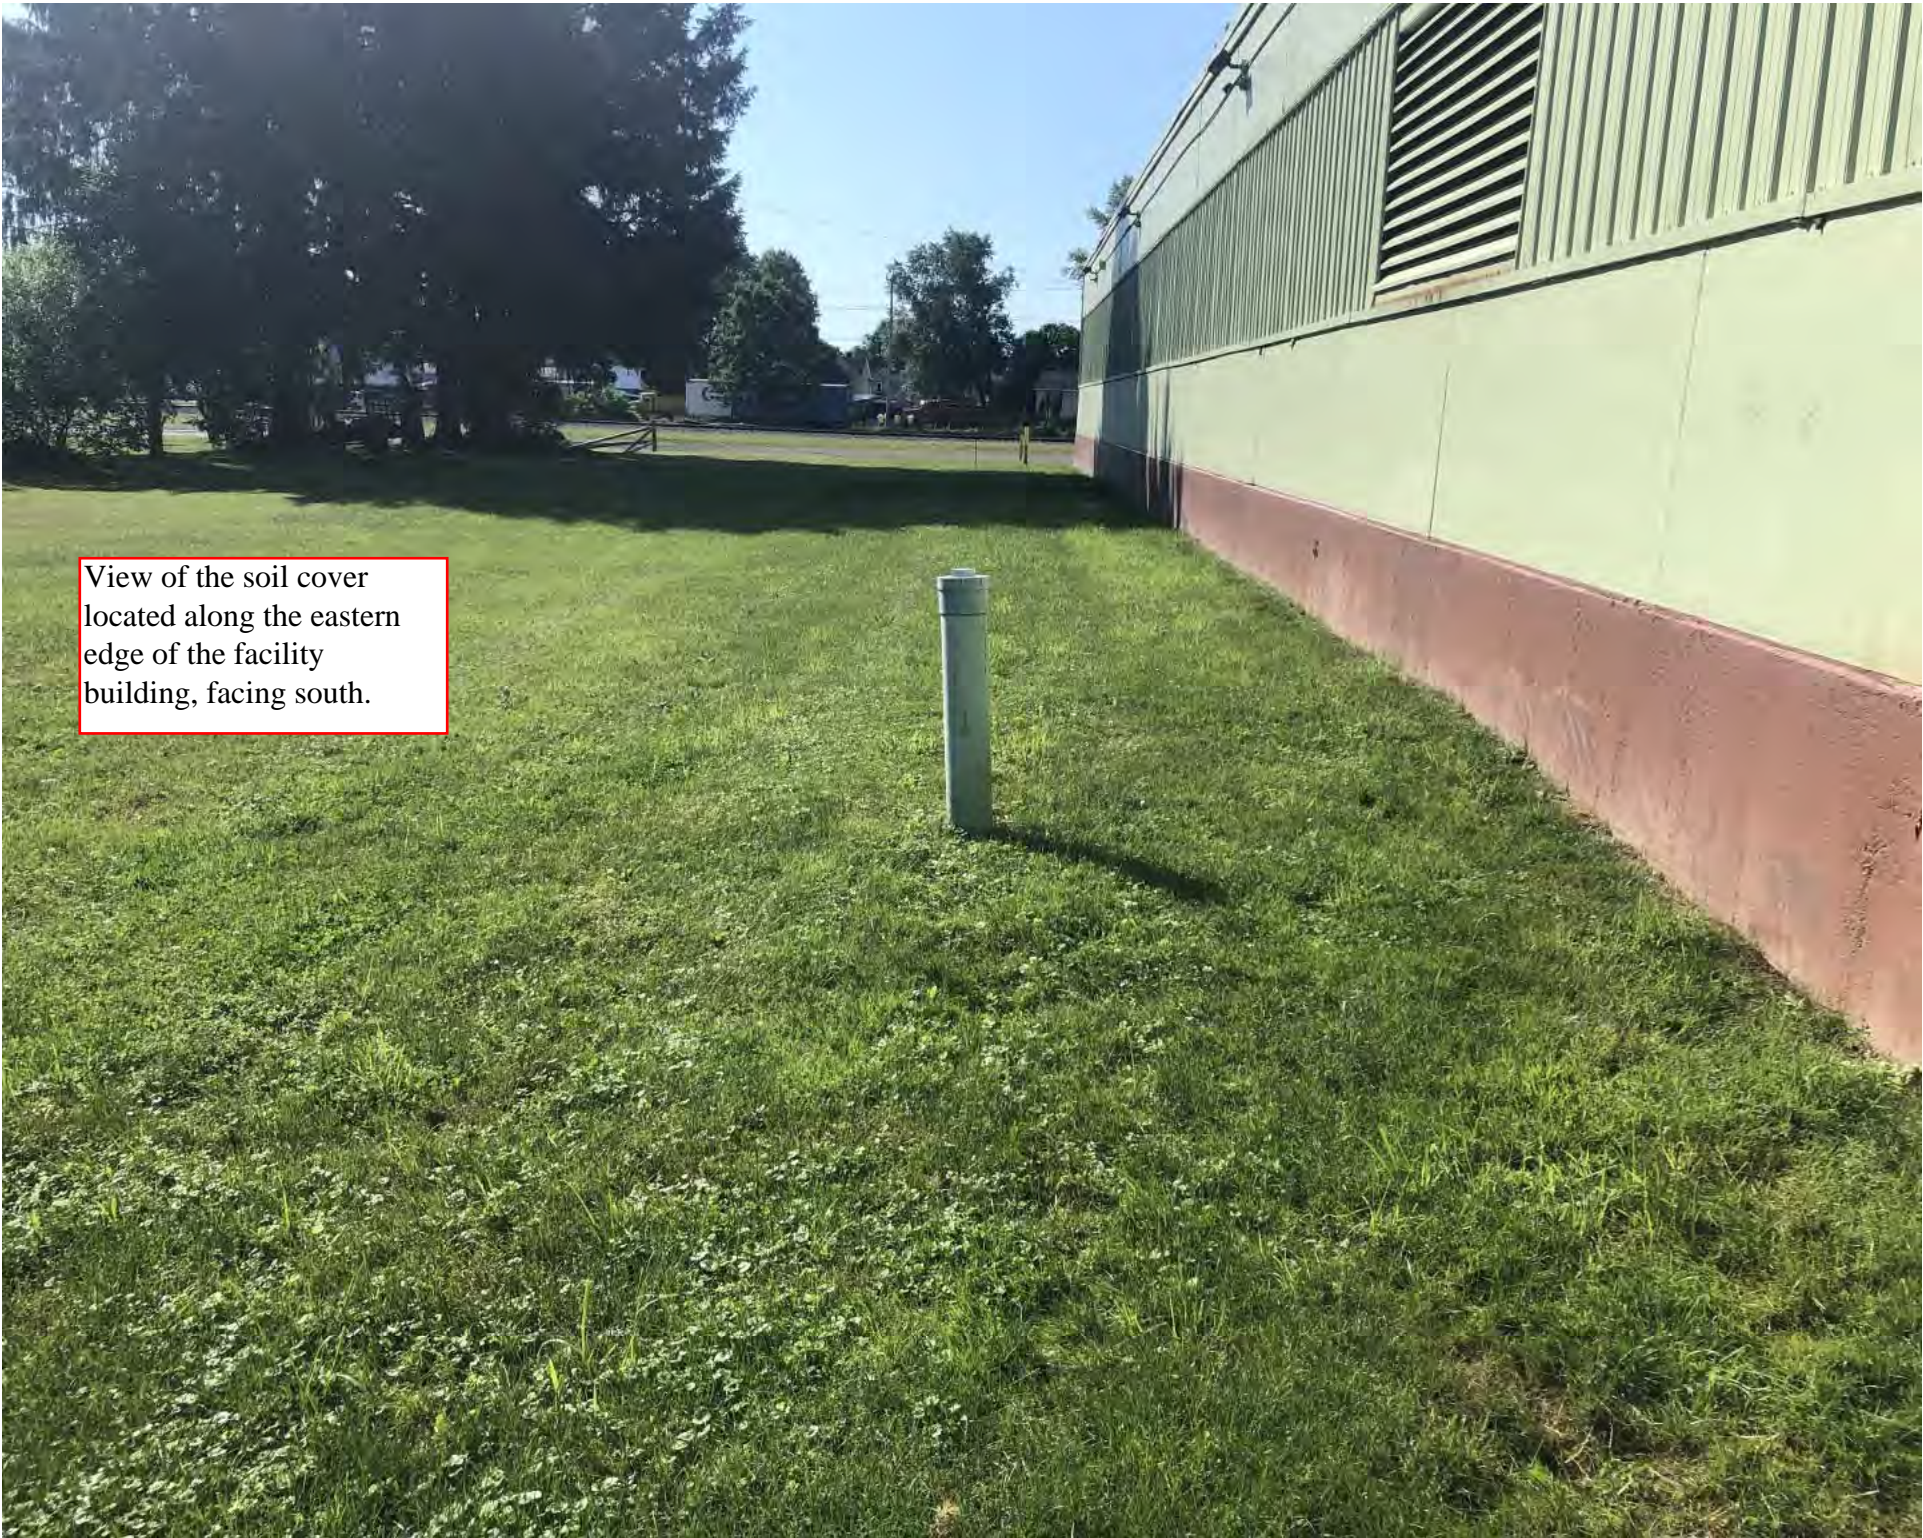
View of the soil cover located along the eastern edge of the facility building, facing south.

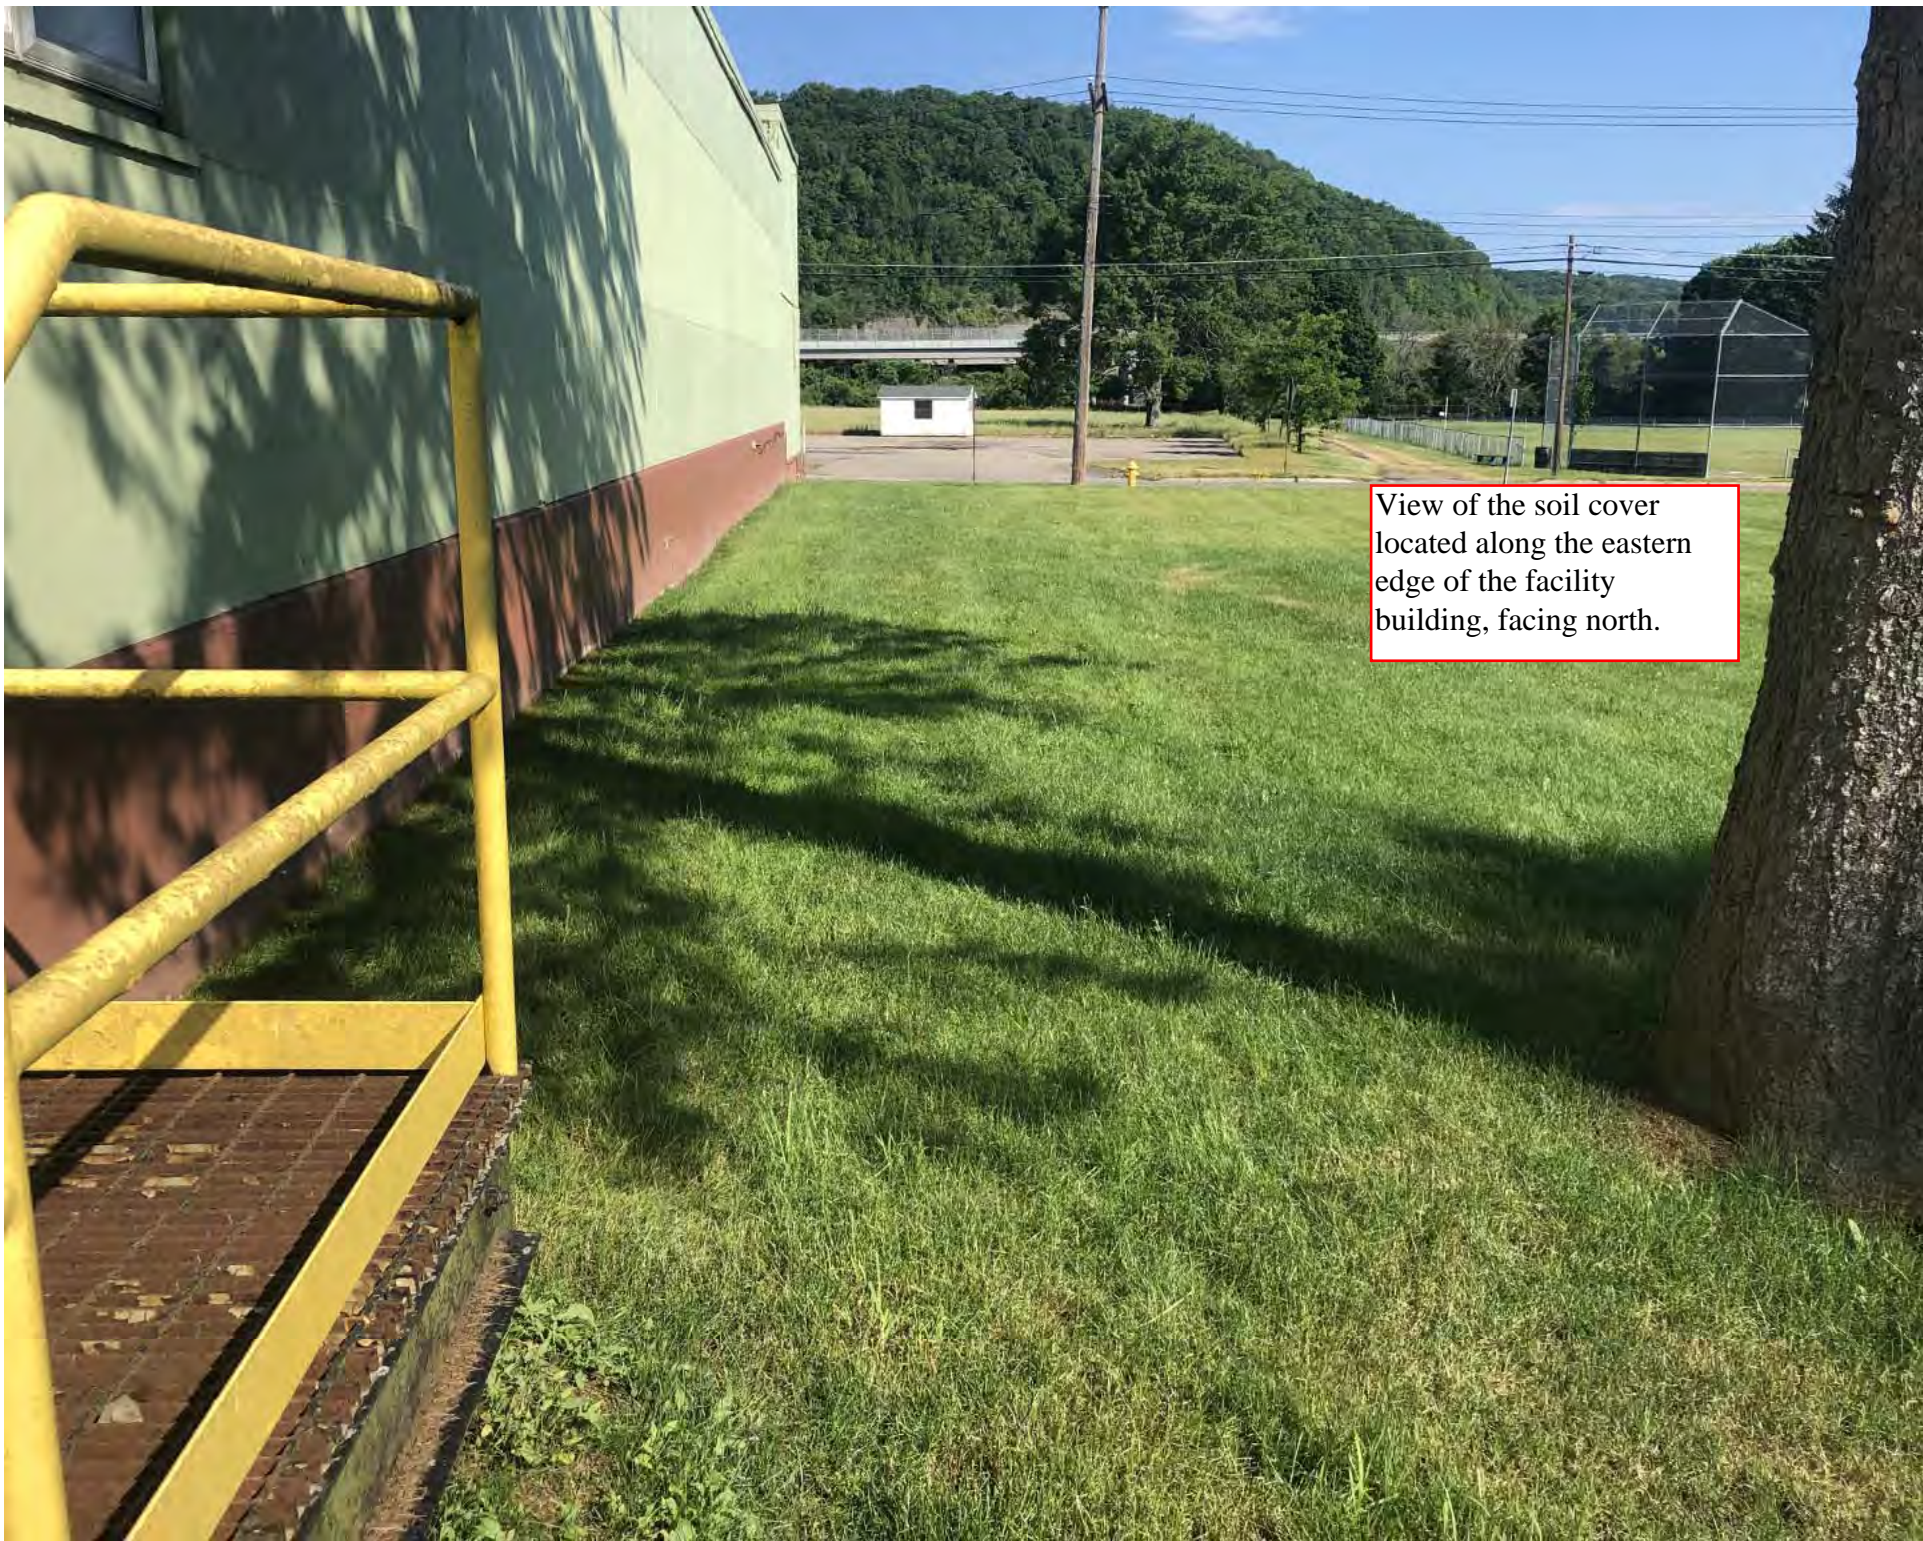
View of the soil cover located along the eastern edge of the facility building, facing north.
