PERIODIC REVIEW REPORT
REPORTING PERIOD: FEBRUARY 11, 2020 THROUGH FEBRUARY 10, 2021

211 FRANKLIN STREET
OLEAN, NEW YORK
NYSDEC SITE NO. C905038

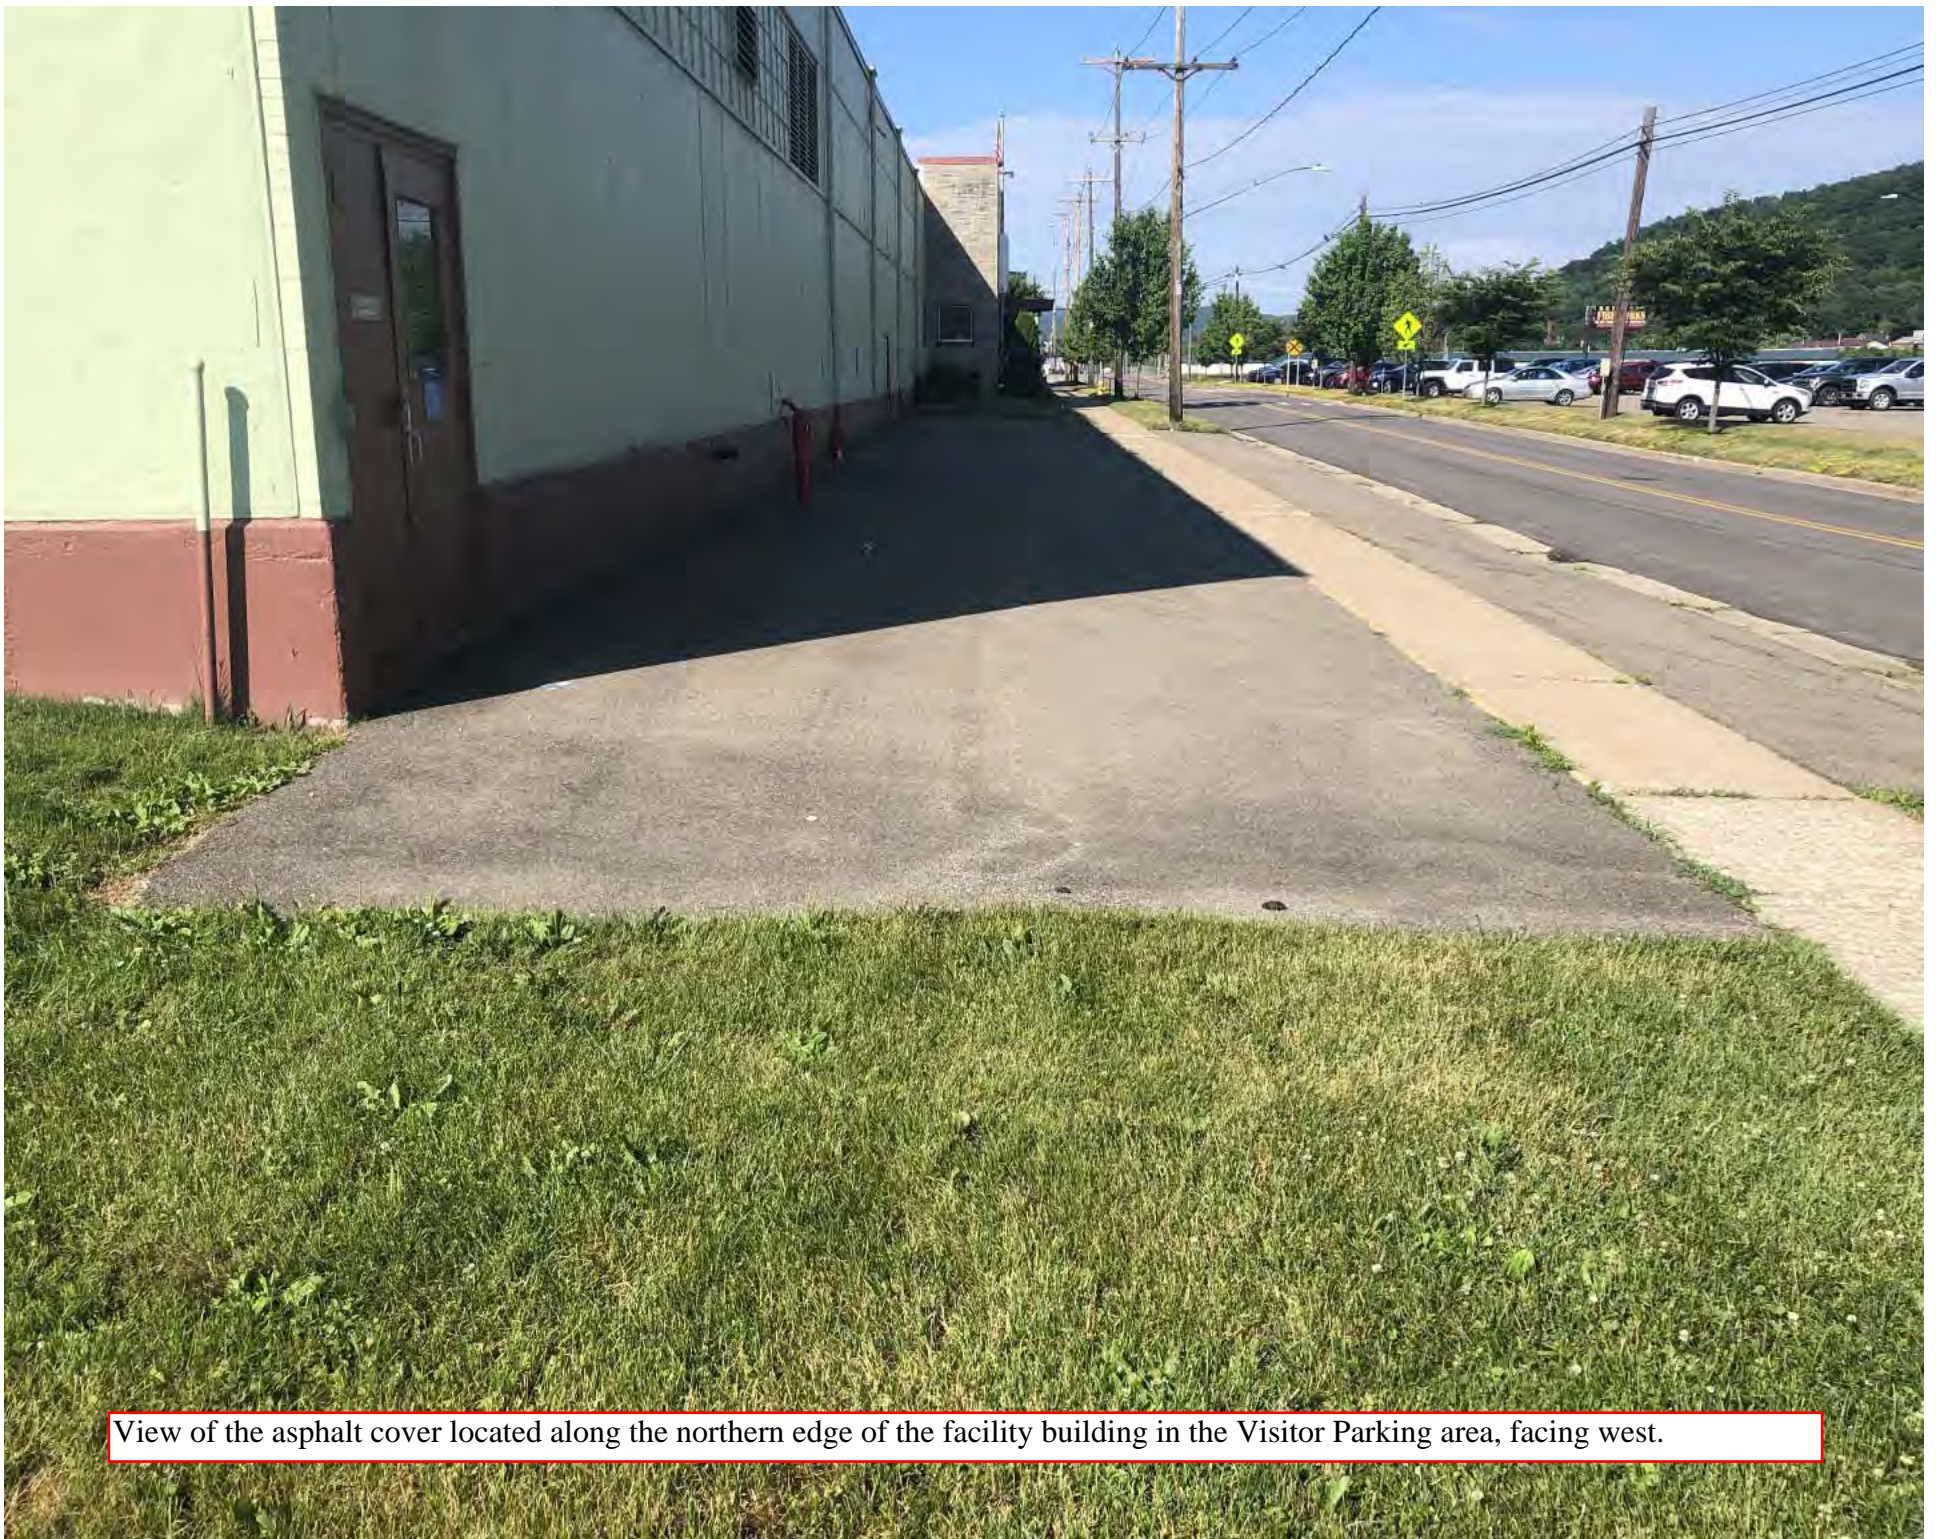
View of the asphalt cover located along the northern edge of the facility building in the Visitor Parking area, facing west.

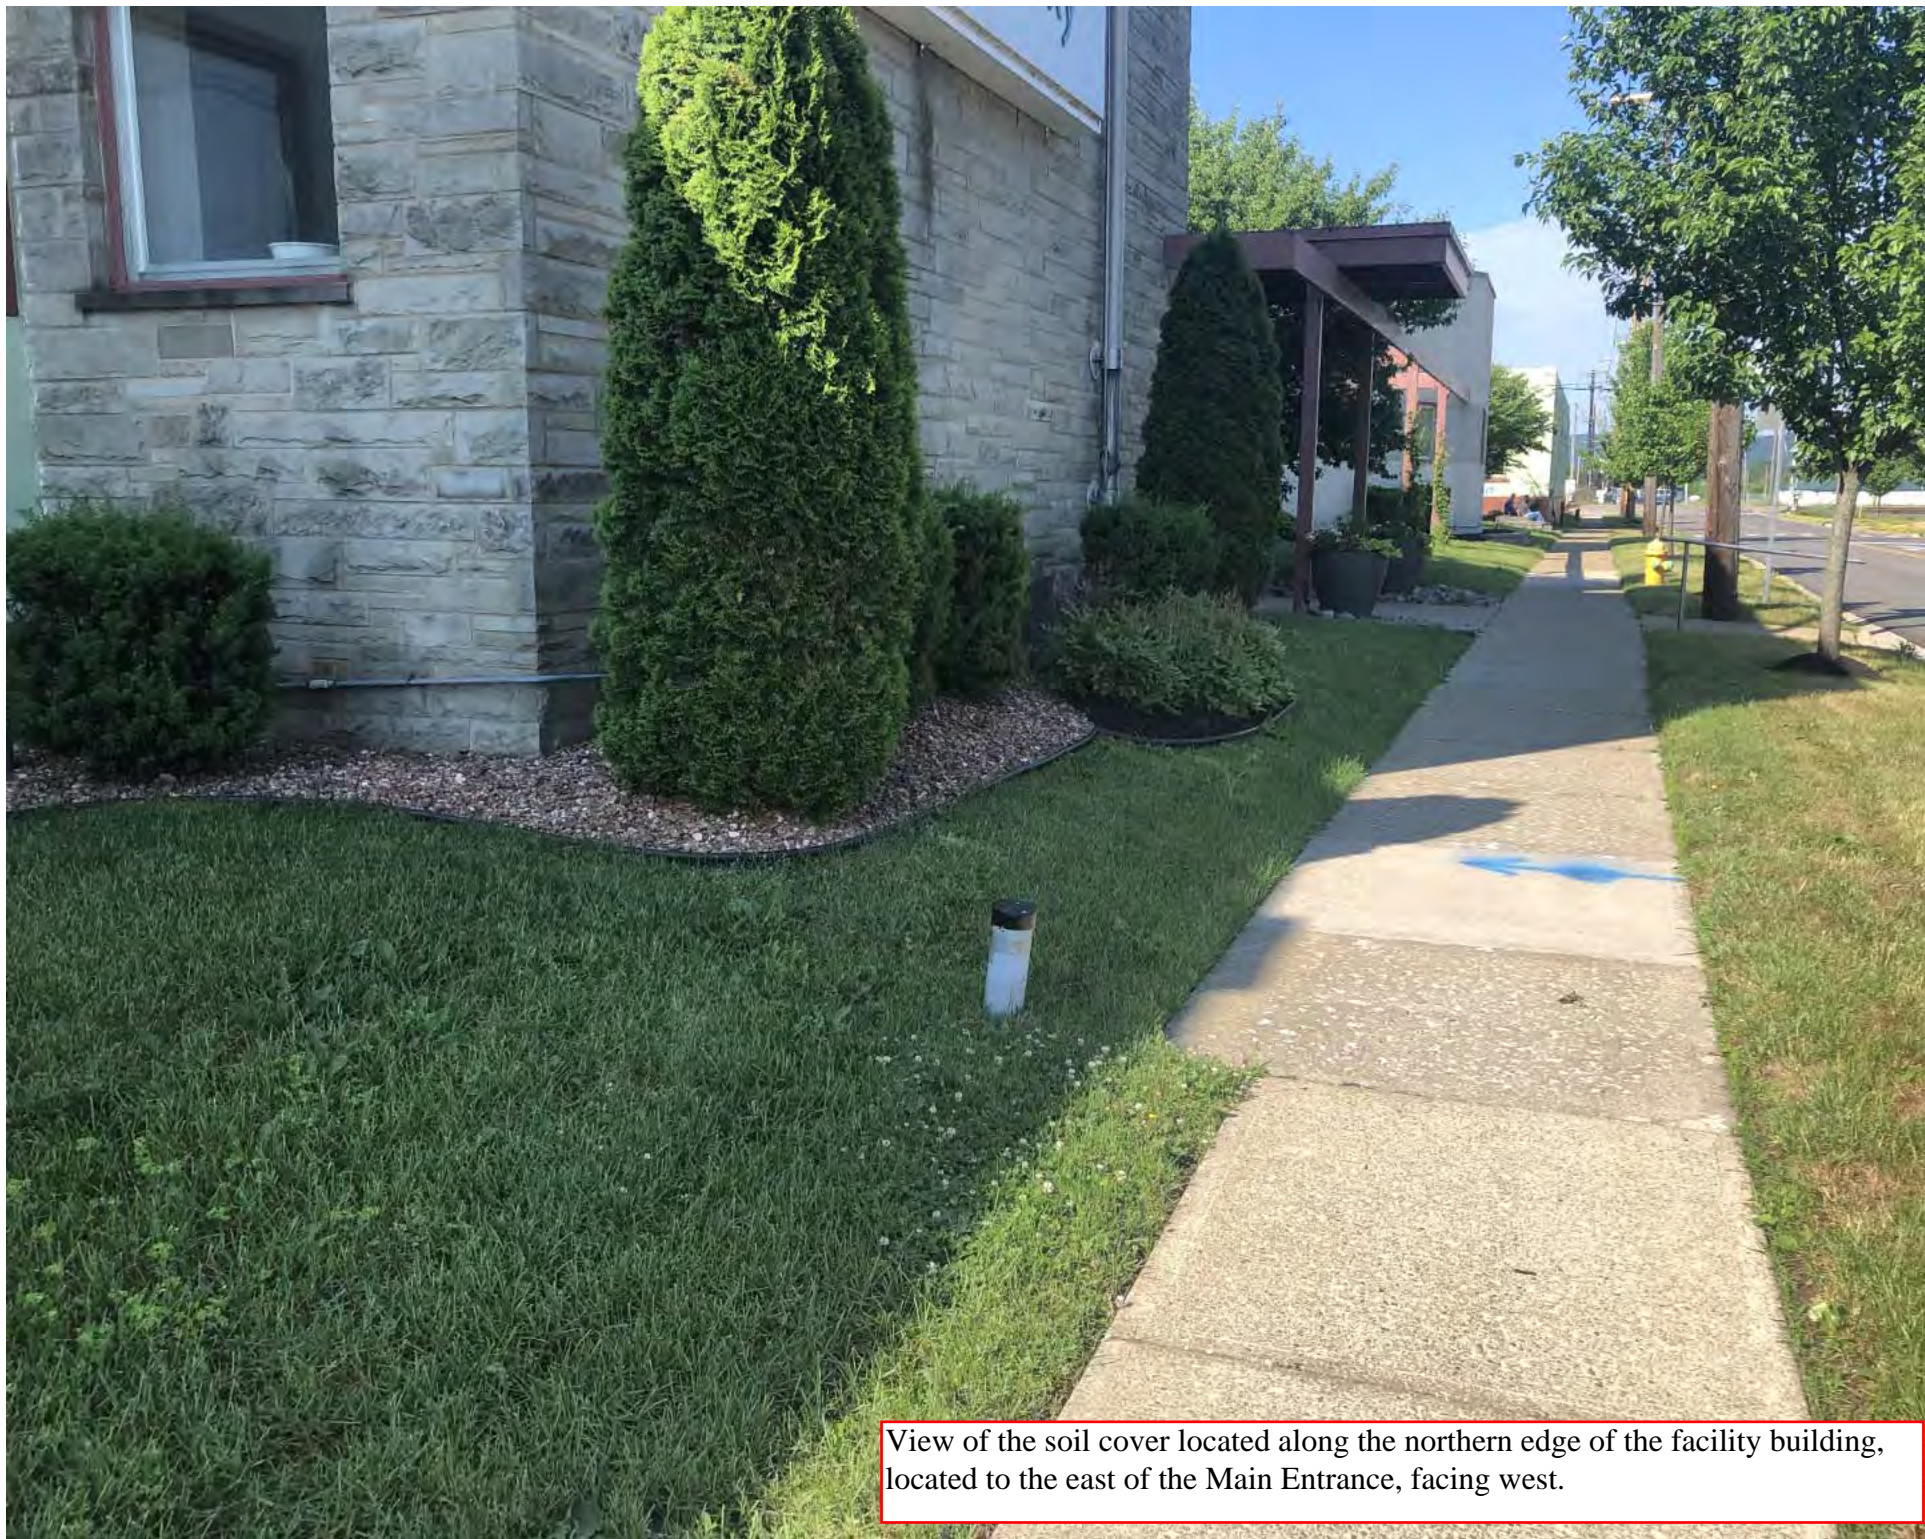
View of the soil cover located along the northern edge of the facility building, located to the east of the Main Entrance, facing west.

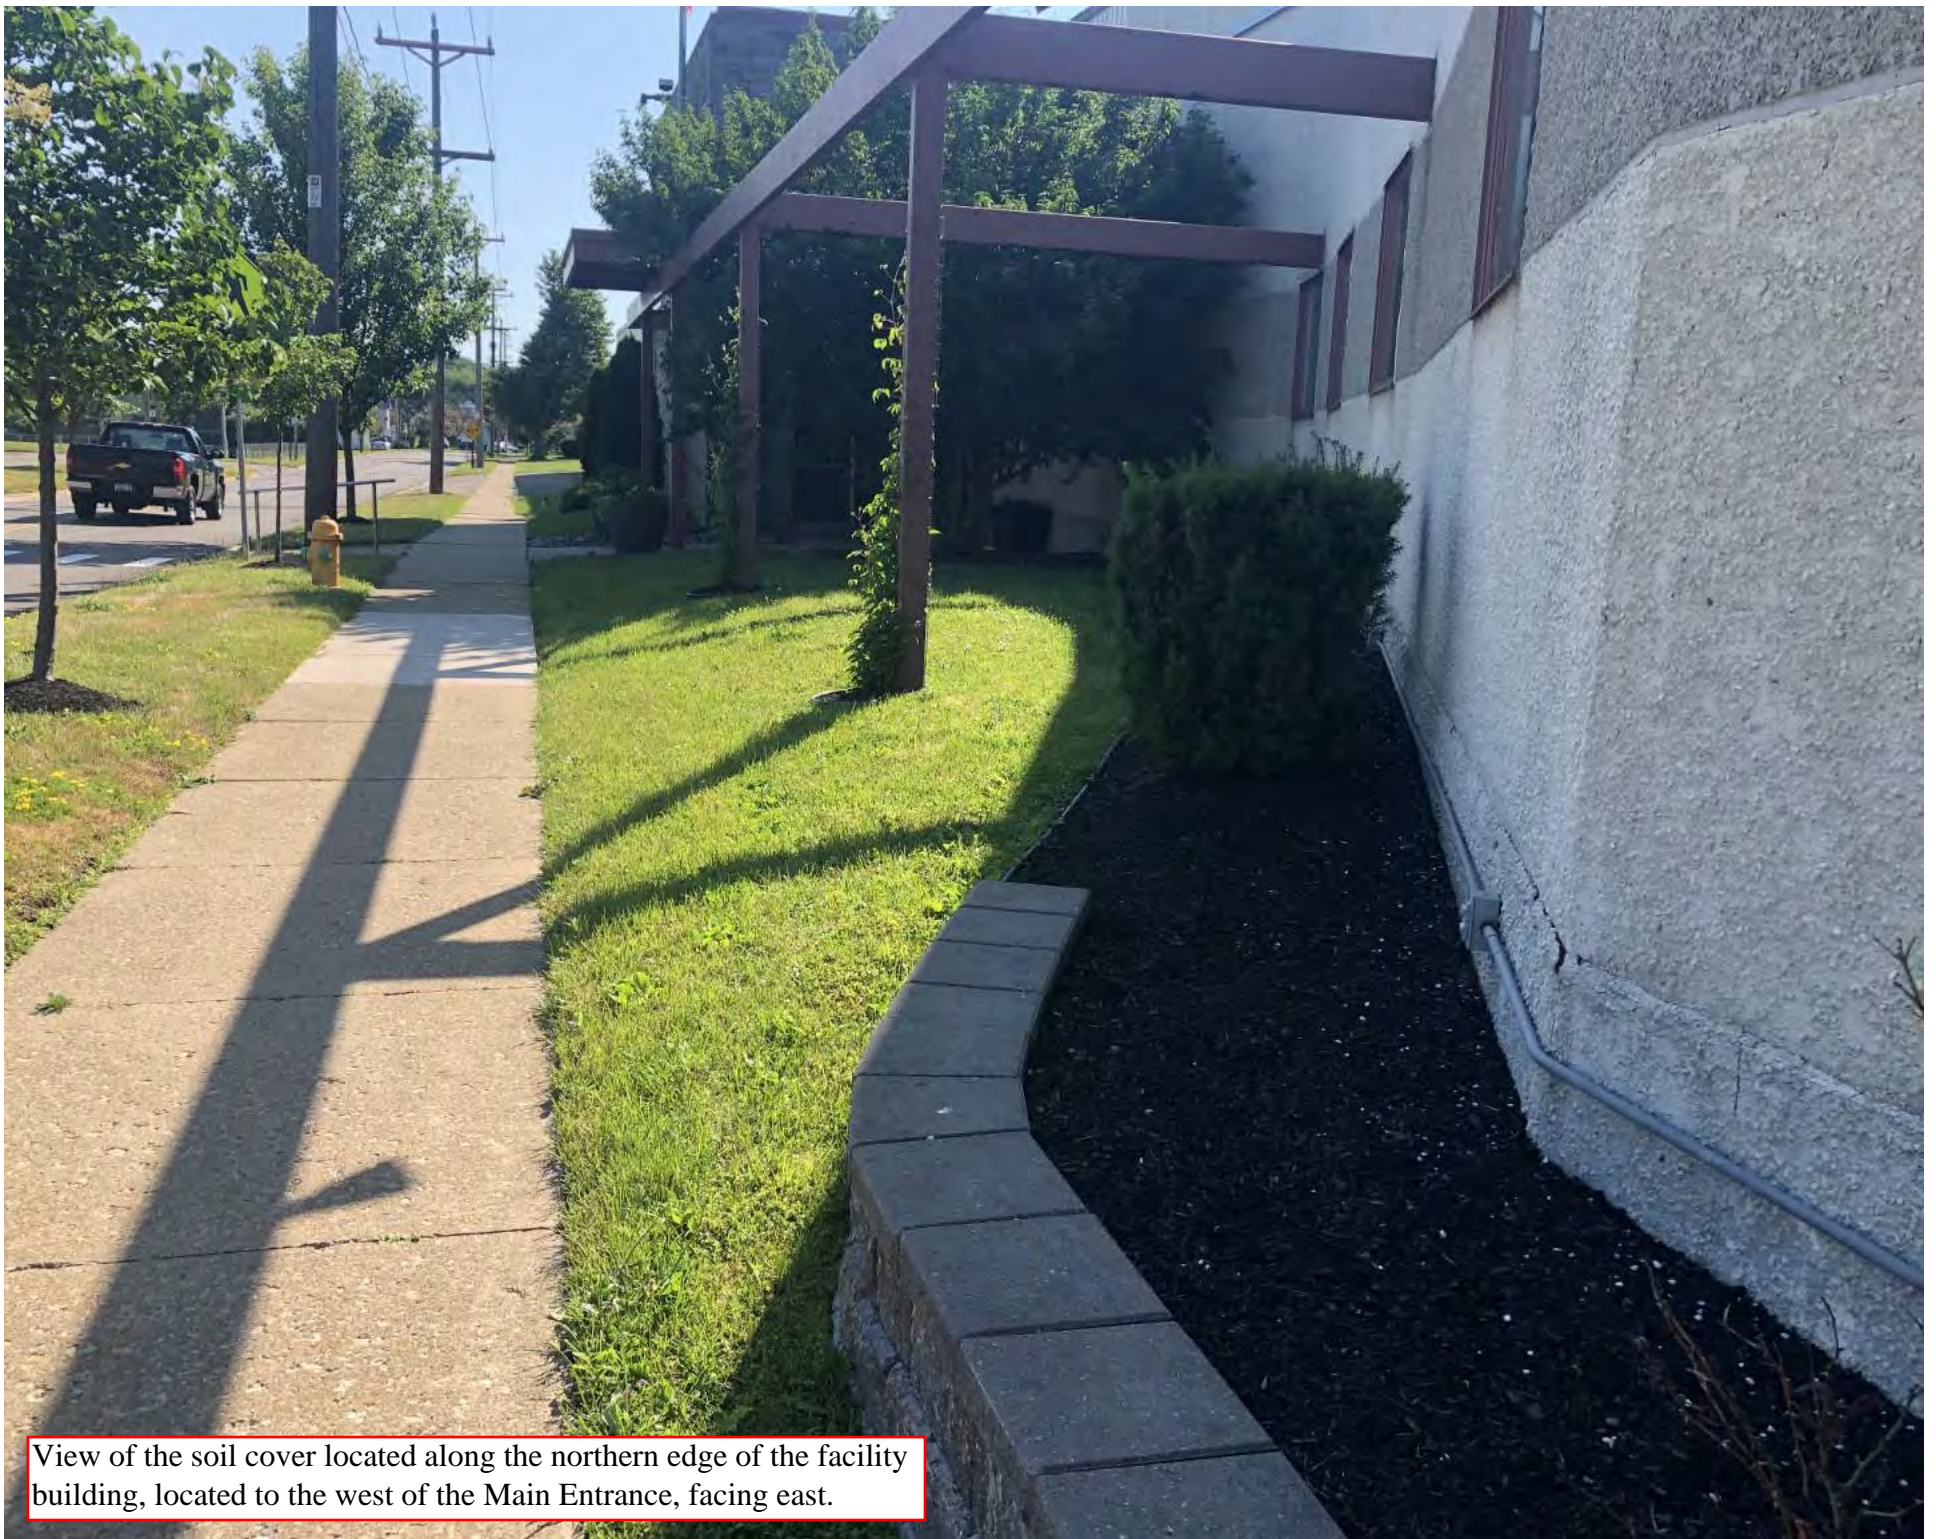
View of the soil cover located along the northern edge of the facility building, located to the west of the Main Entrance, facing east.

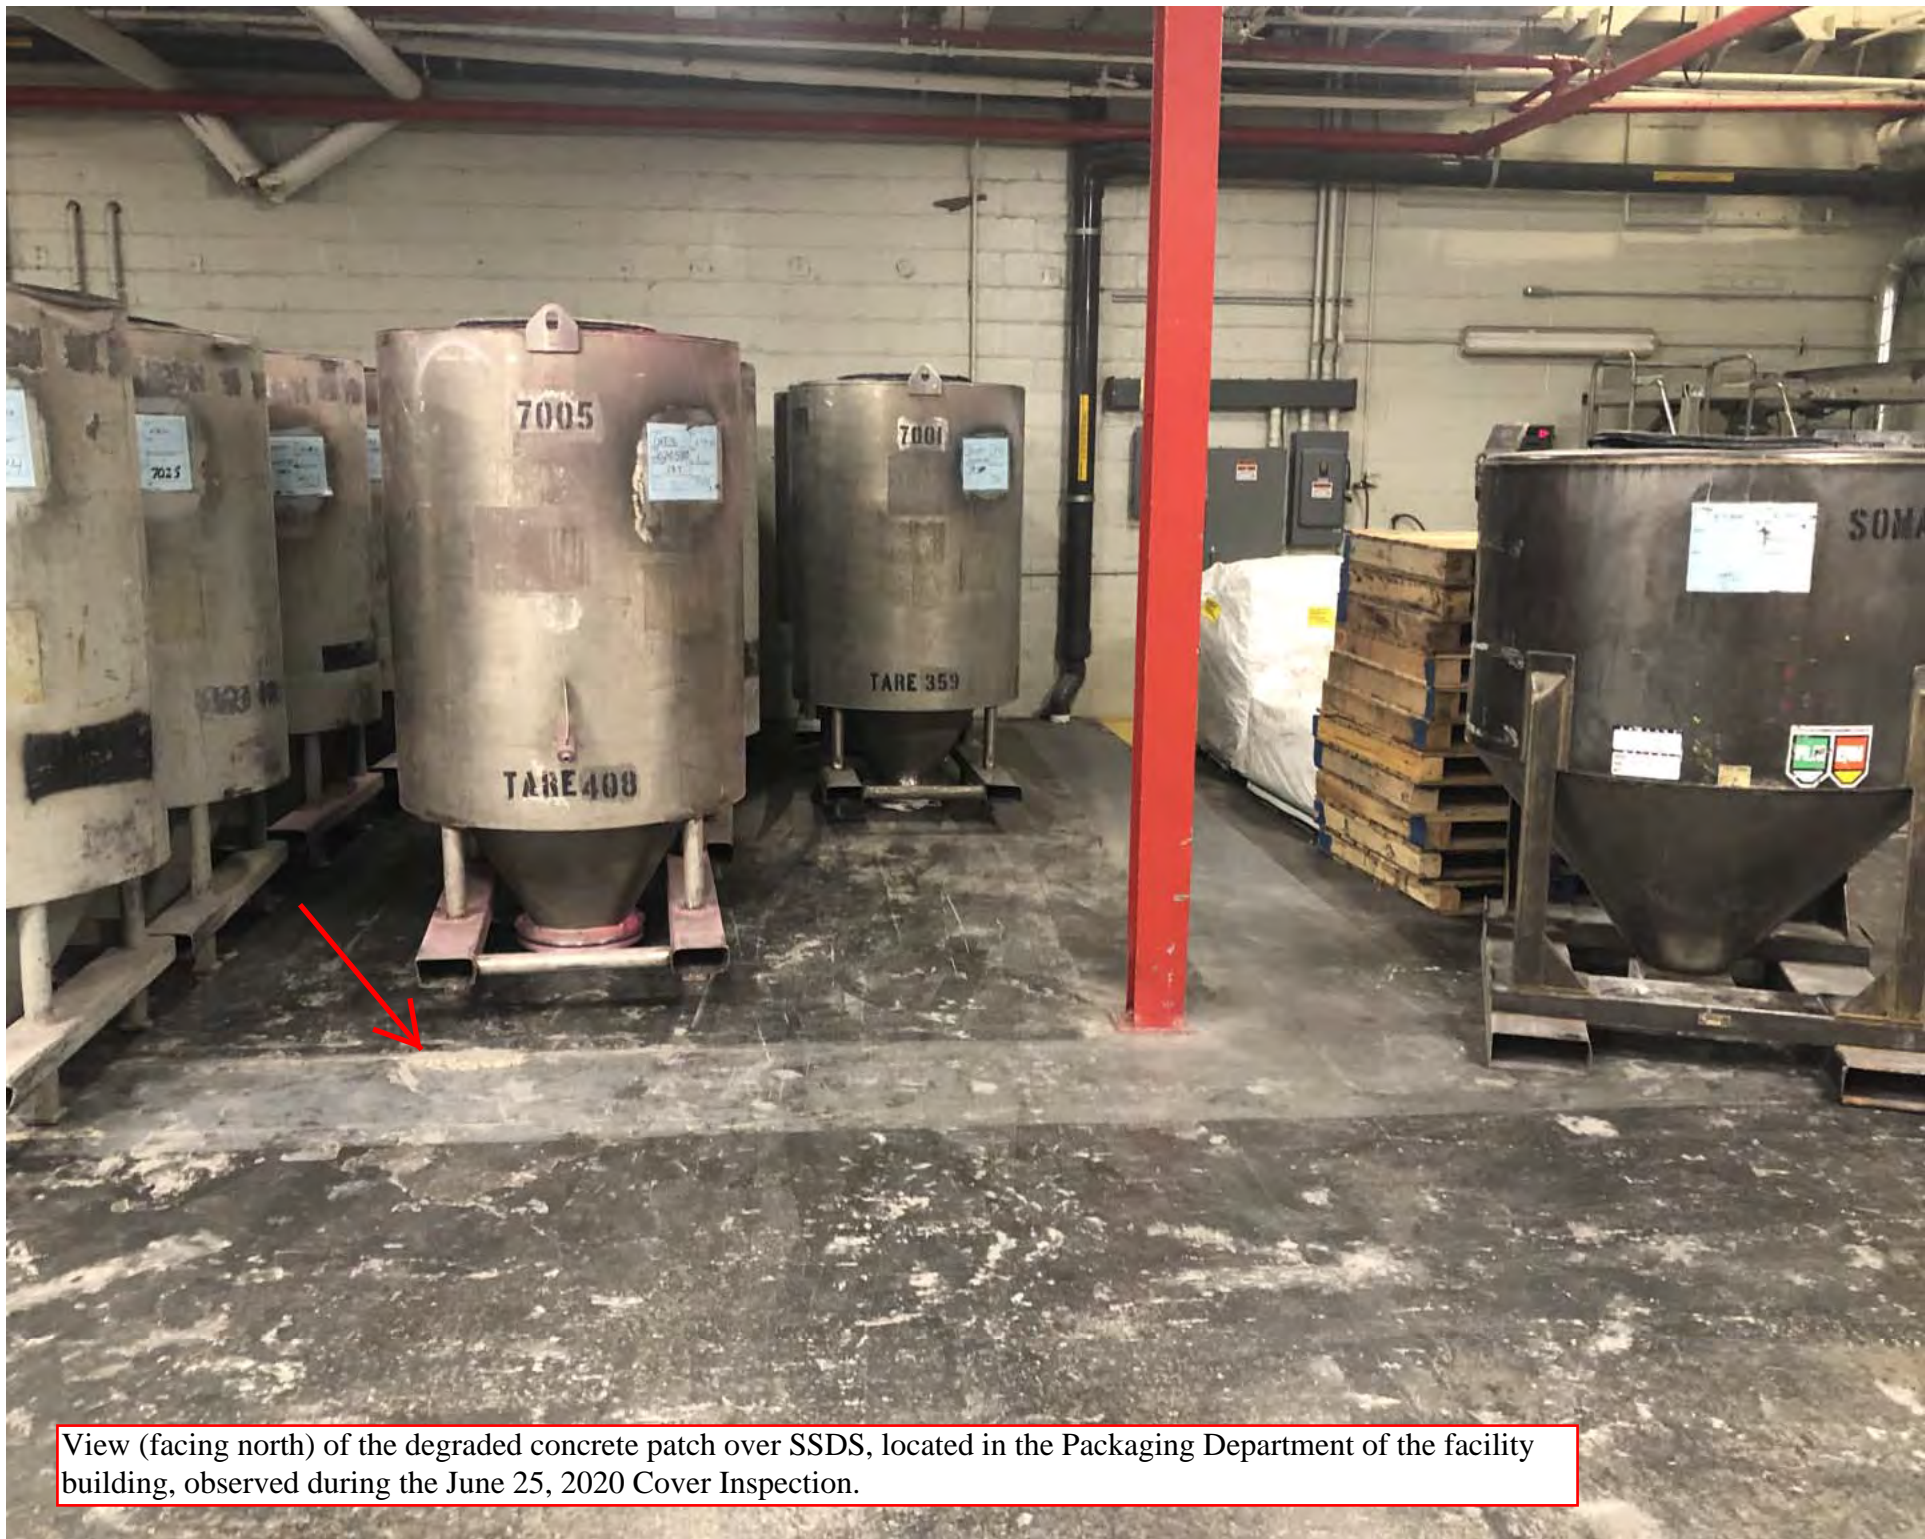
A degraded portion of the concrete backfill located in the Packaging Department portion of the building (i.e., poured to replace portions of the interior floors in the areas where SSDS trenches had been excavated), observed during the June 25, 2020 inspection, was repaired/resurfaced during the reporting period (i.e., subsequent to June 25, 2020). Refer to the photograph of the area taken on June 25, 2020 and of the photograph depicting the repaired/resurfaced area that are included in Attachment B.

• Minor cracking/sloughing and degradation along SSDS patch in N side of parking - Monitor or repair

View (facing north) of the degraded concrete patch over SSDS, located in the Packaging Department of the facility building, observed during the June 25, 2020 Cover Inspection.

(Note: the area of minor degradation/cracking along the surface of the concrete patch associated with the SSDS trench, noted during the June 2020 inspection, was repaired prior to the end of the reporting period. Refer to the attached photograph.)

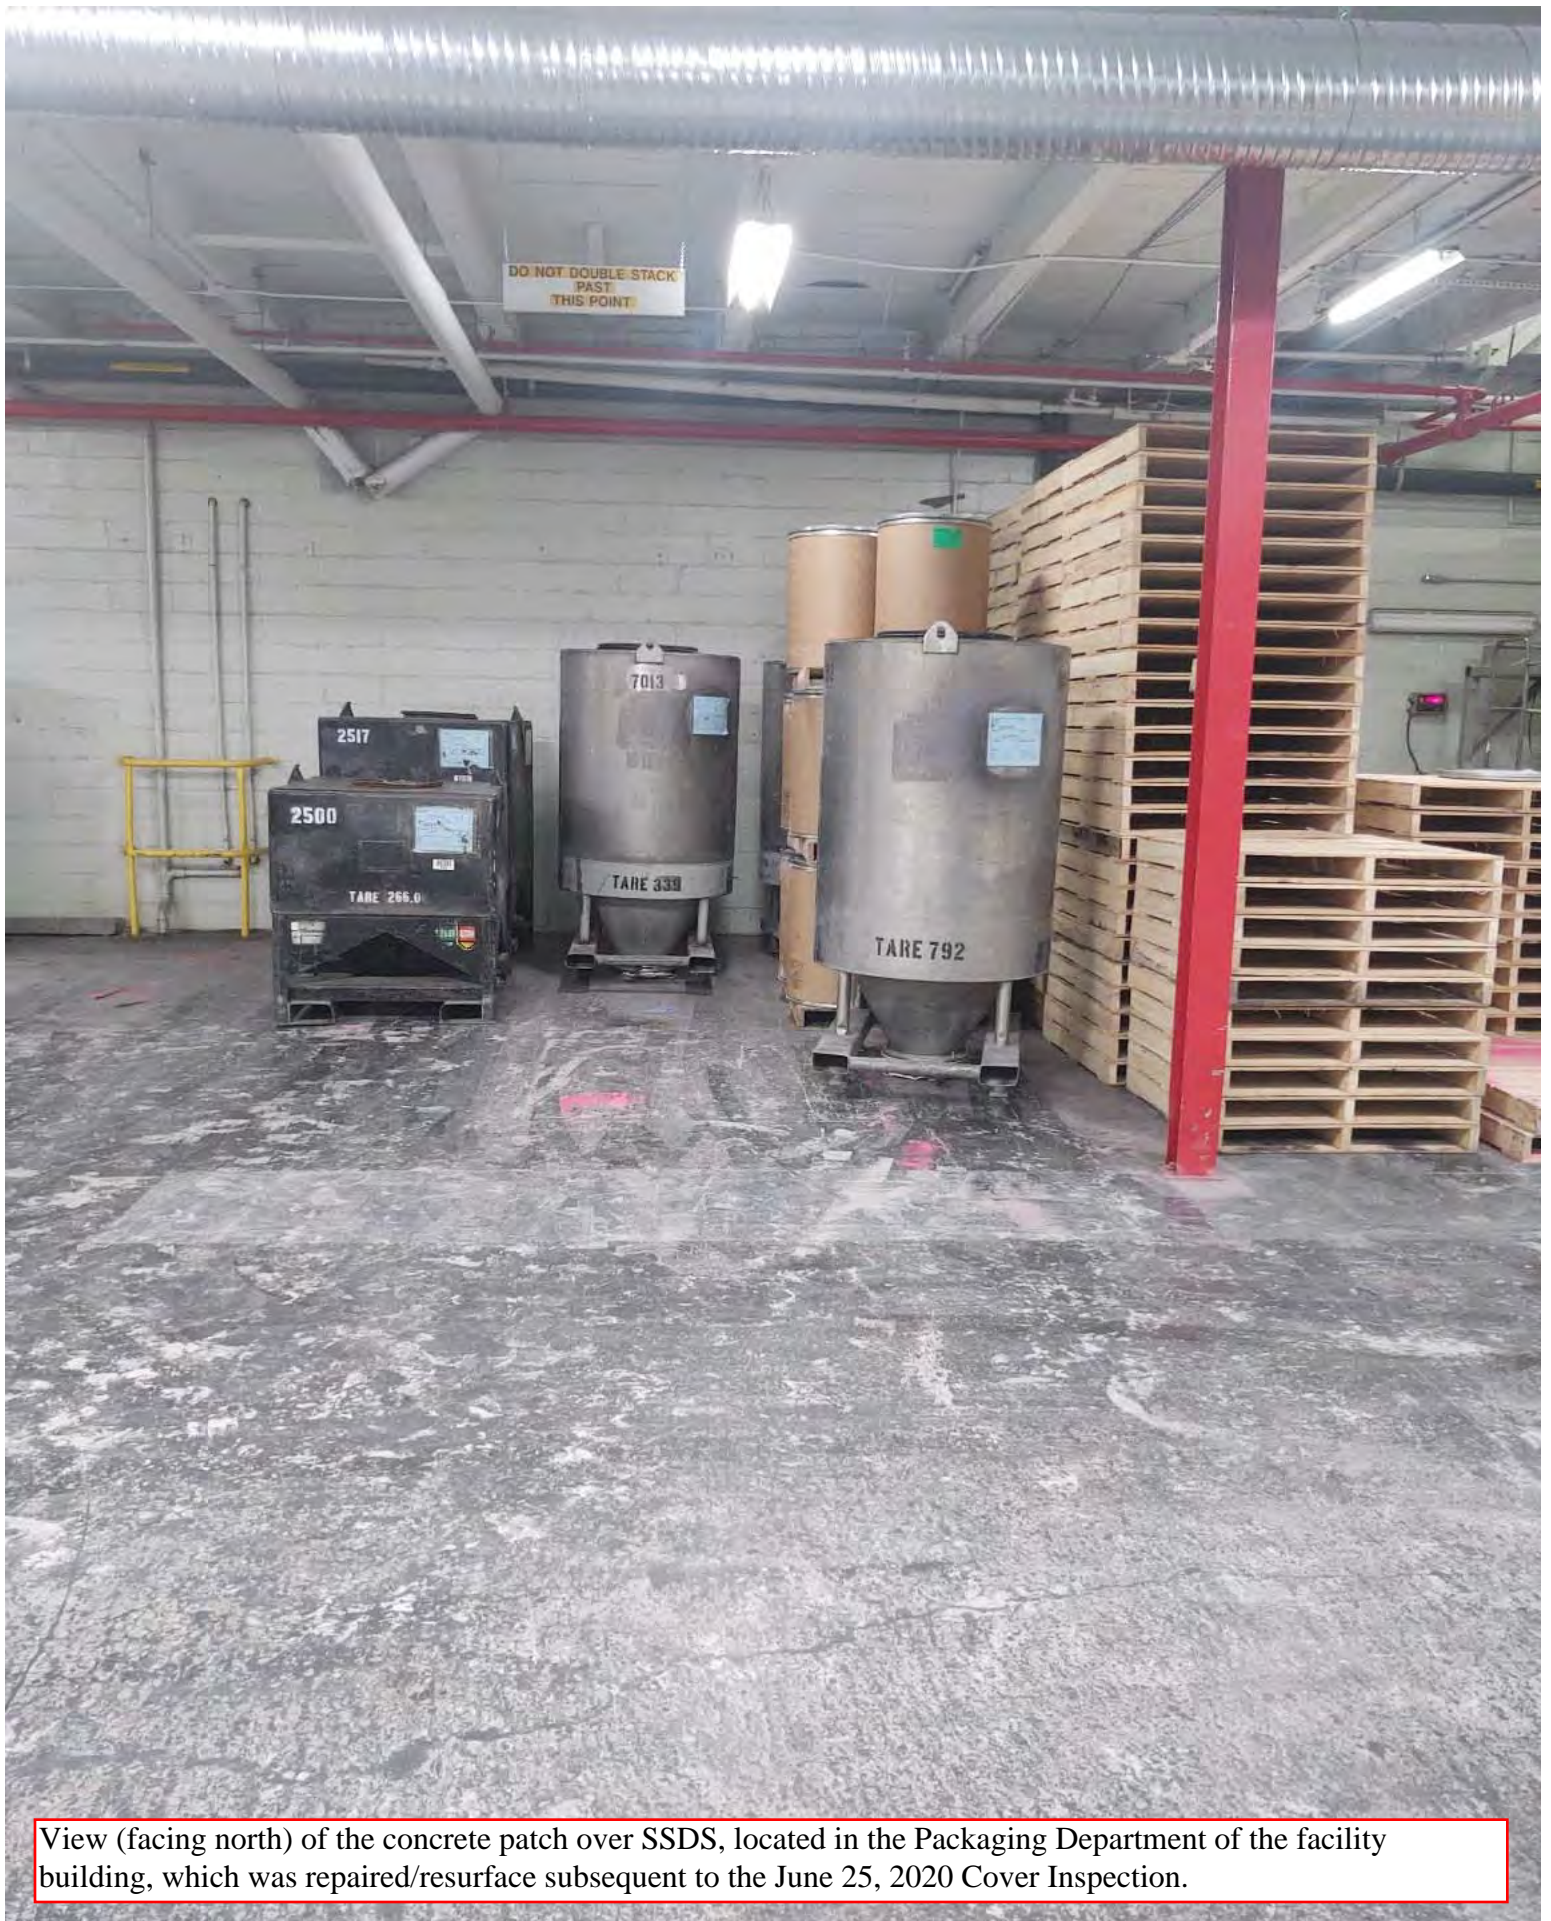
View (facing north) of the concrete patch over SSDS, located in the Packaging Department of the facility building, which was repaired/resurface subsequent to the June 25, 2020 Cover Inspection.
