Remedial Activities Summary Report

Standard Portable
NYSDEC Site No. C907030A
25 West Lake Road, Mayville
Chautauqua County, New York

October 2016

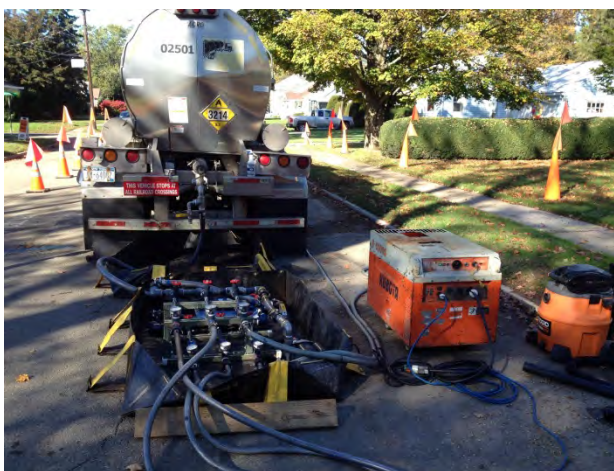
Photograph of an example of the PIP setup.

The remedial pilot testing activities were completed using GES' Permanganate Injection Platform (PIP). The PIP is a mobile, self-contained injection platform that is exclusively used for permanganate injections. The PIP is configured with mixing pumps, injection pumps, flow meters, secondary containment and other hardware to specifically perform permanganate injections. An example photograph of the PIP is provided below.

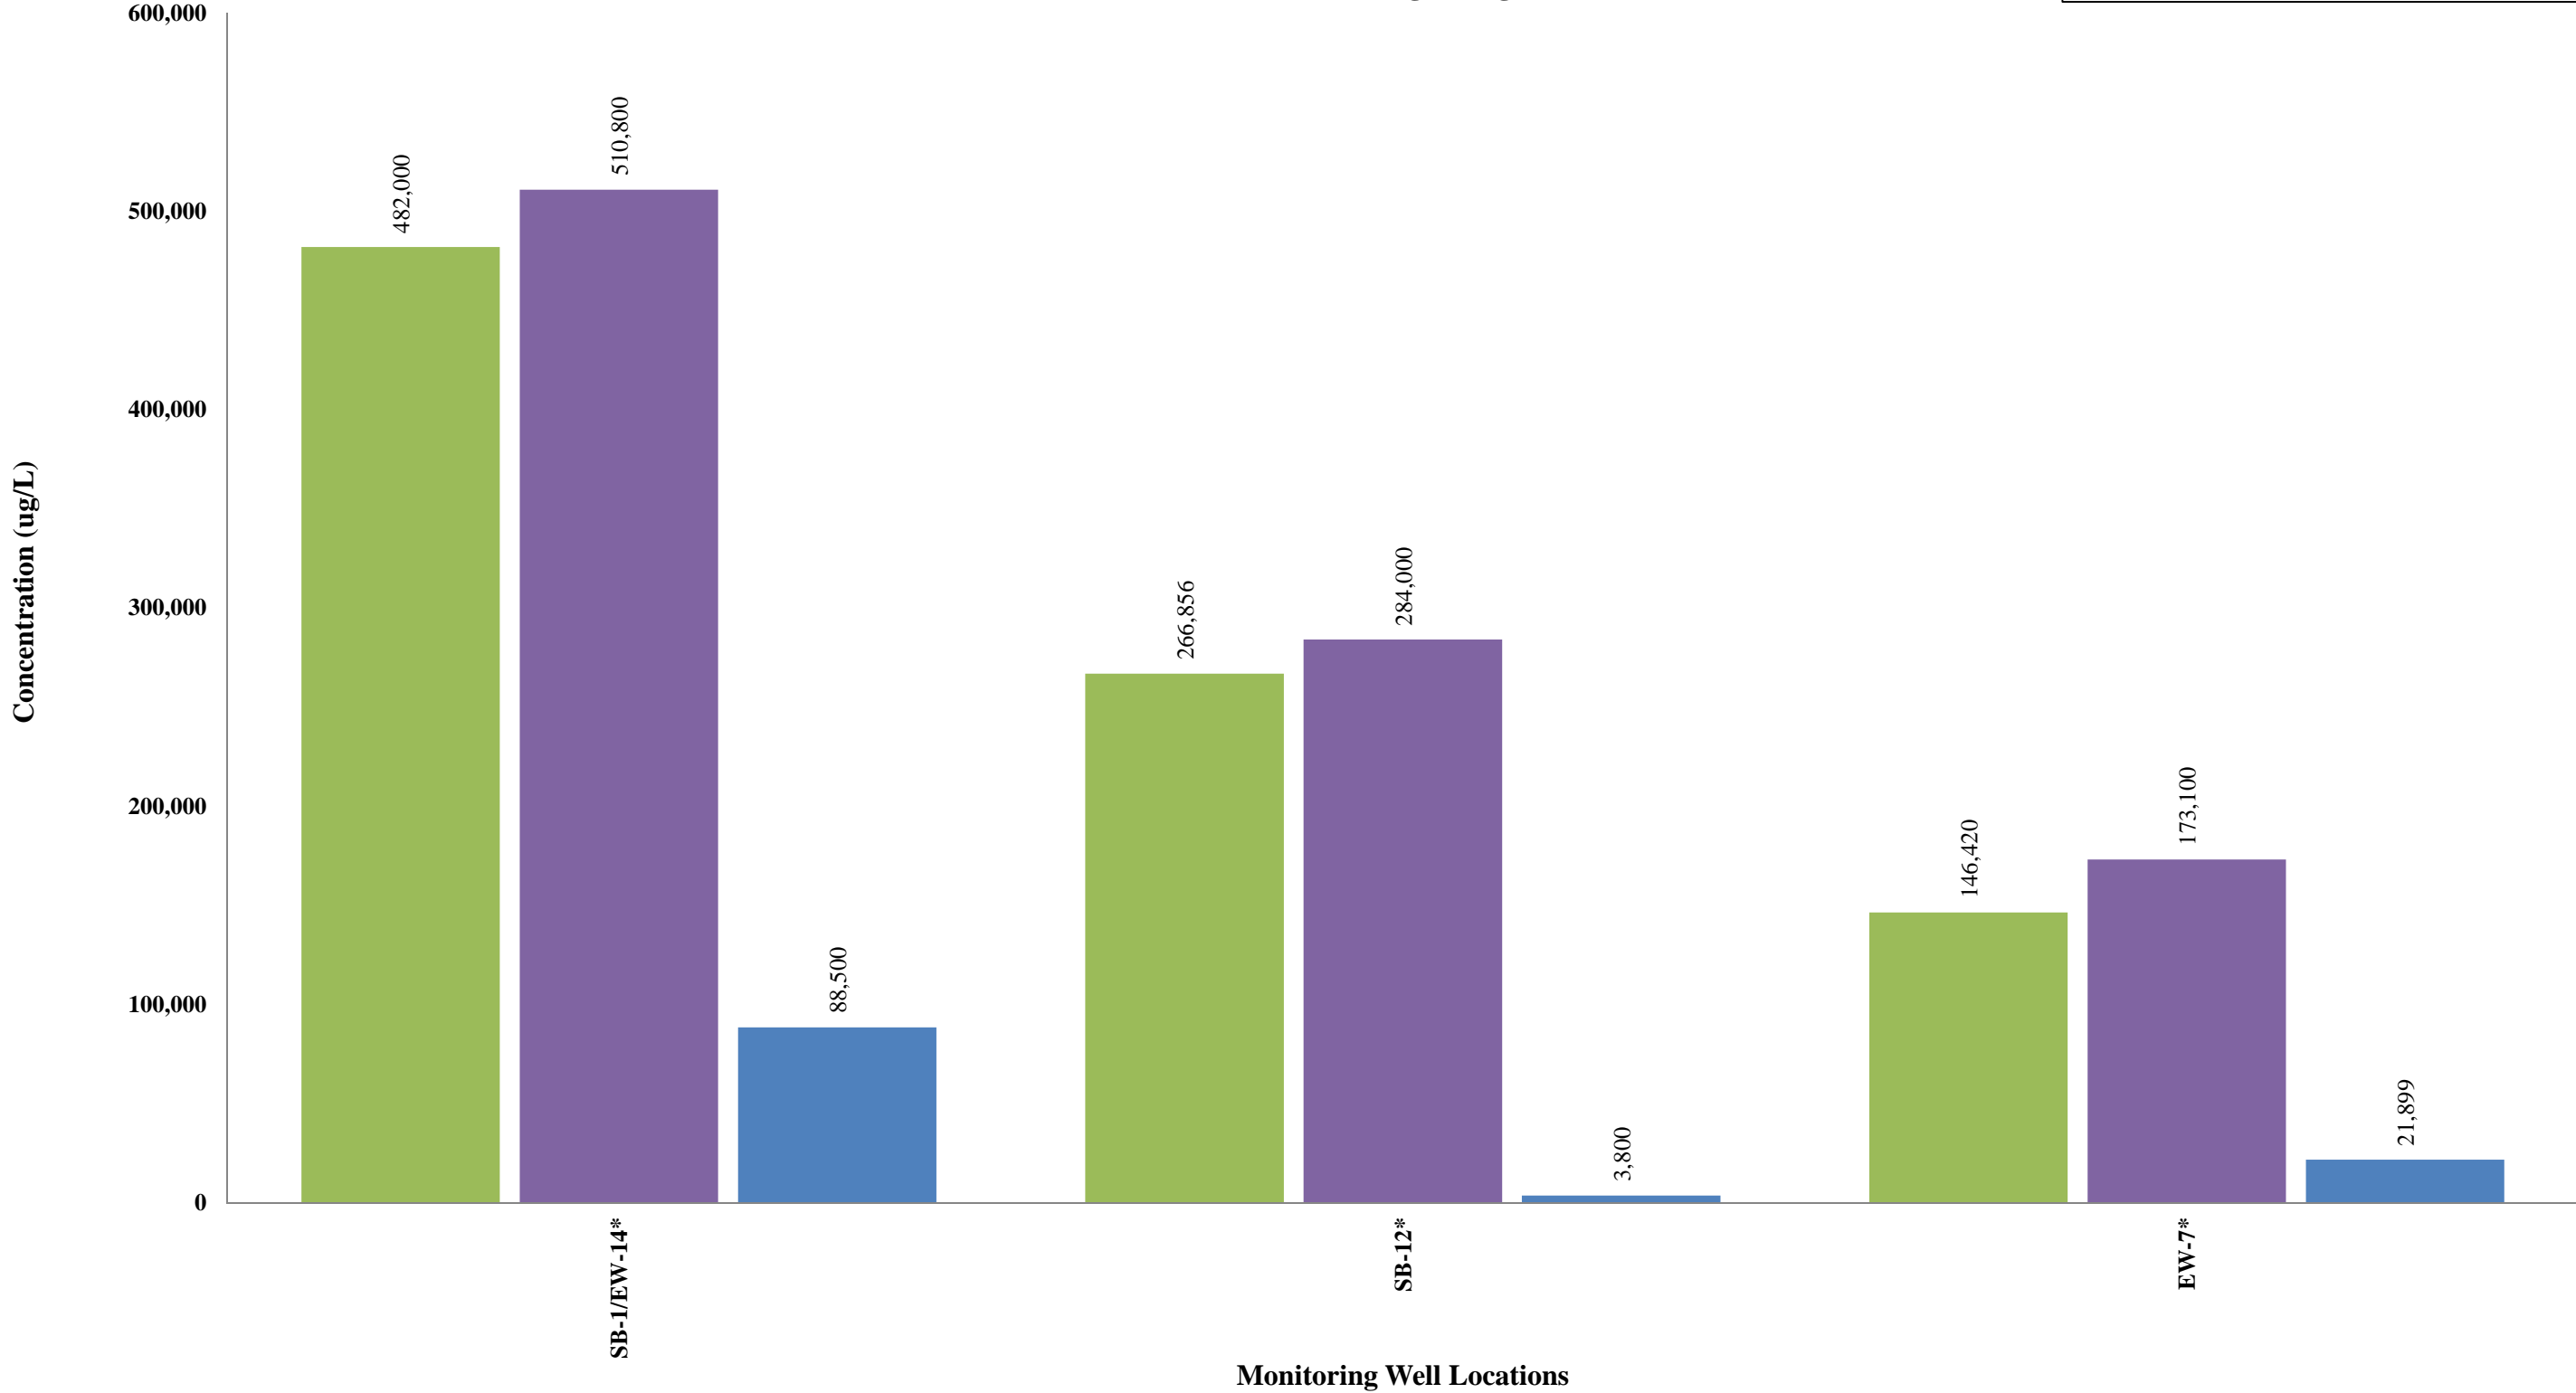
Total Chlorinates - High Range
