# REMEDIAL INVESTIGATION/ ALTERNATIVE ANALYSIS REPORT

160-164 EAST 4<sup>TH</sup> STREET  
DUNKIRK, CHAUTAUQUA COUNTY, NEW YORK  
NYSDEC SITE NO. C907051

September 2025

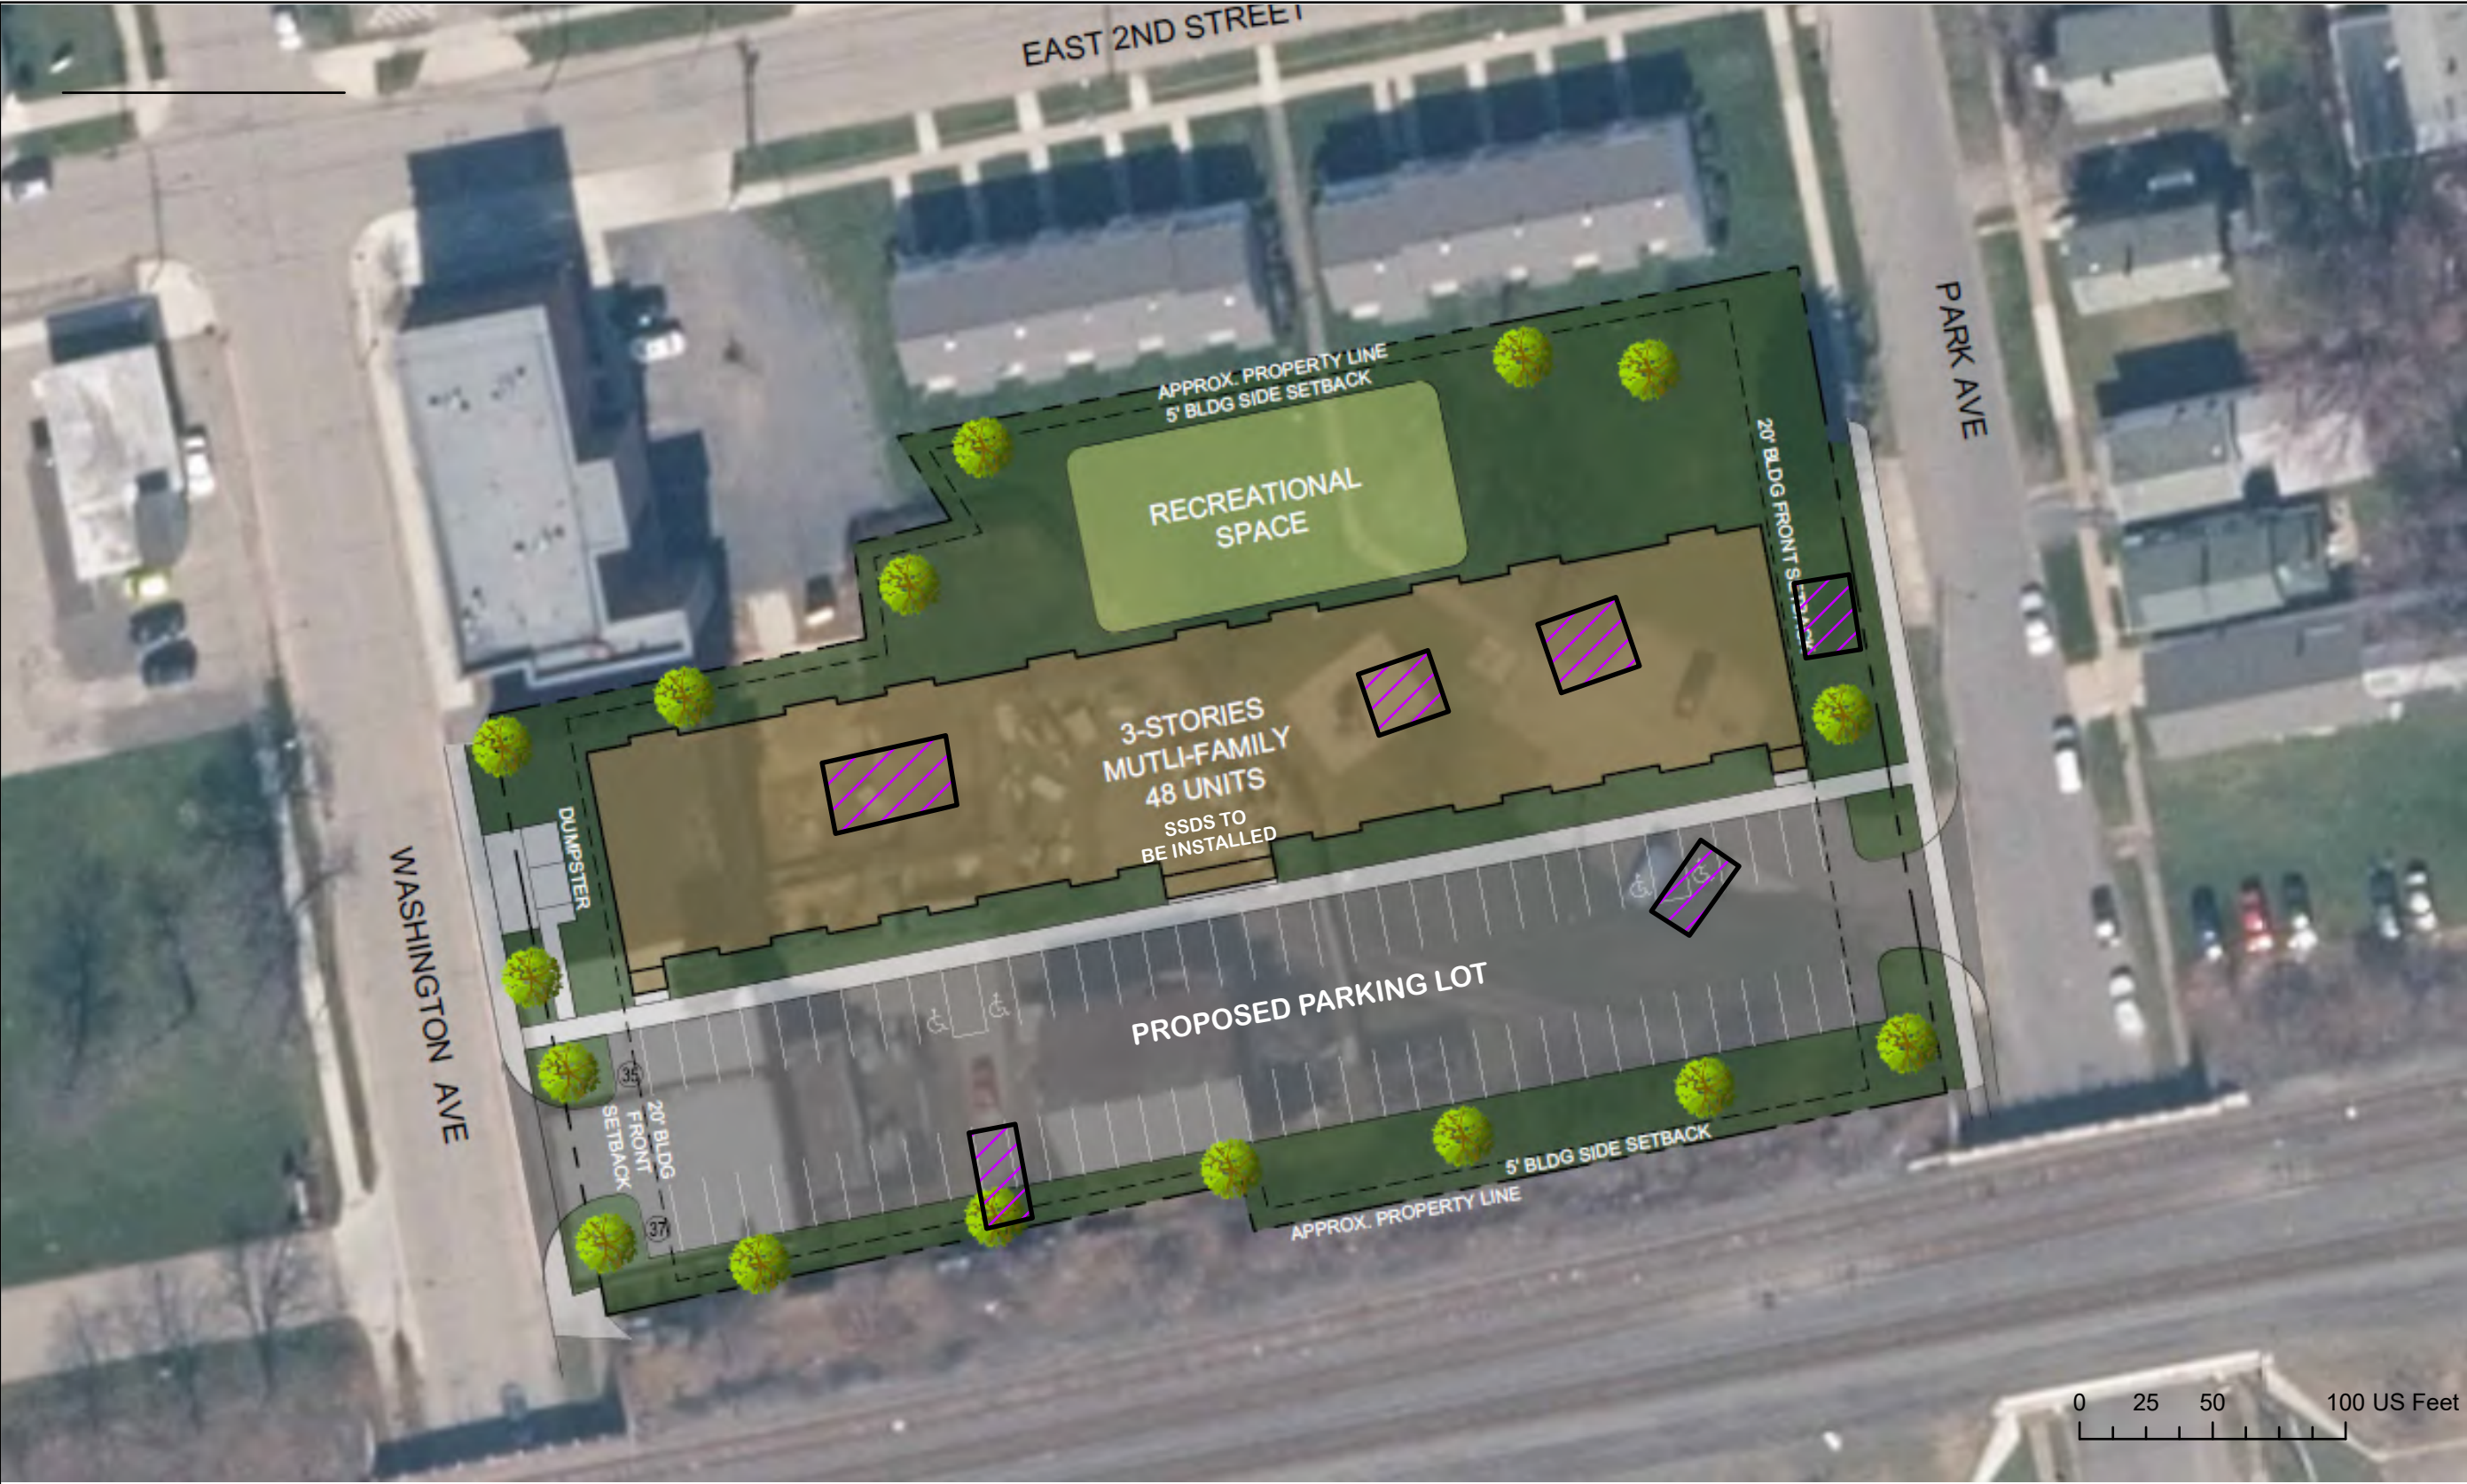
- Property Boundary
- Proposed Asphalt Hardscape
- Proposed Building Footprint
- Proposed Stone/Gras Recreation Area
- Proposed Lawn/Tree Greenspace
- ▨

- 1.) Greenspace Remedial Approach  
-Remove approximately 2 feet of hardscape and/or underlying soils.  
-Replace with 2 +/- feet of clean soils.
- 2.) Hardscape Remedial Approach  
-Soils beneath the areas of proposed new development buildings and hardscape shall be cut/filled to the depth of new building foundations/slabs or hardscape to meet new development grades. Approximate average cuts and fills are as follows: Asphalt= -1.5 ft, Slabs= +3.25 ft, Foundations= -5 ft.  
-Replace with building foundations or hardscape.
- 3.) Soil cover must meet a minimum of 2 feet of clean soil or hardscape meeting NYSDEC restricted residential criteria.

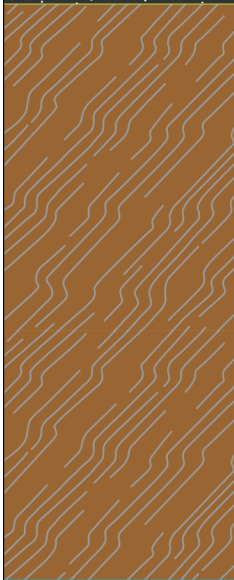
FILL; black loose sand		
2						
3						
4	RI-BH-2 Native	0

NATIVE; stiff grey brown clay	native @ 4'	
5						
6						
7						
8						
9						
10					refusal @ 10'	
11						
12						
13						
14

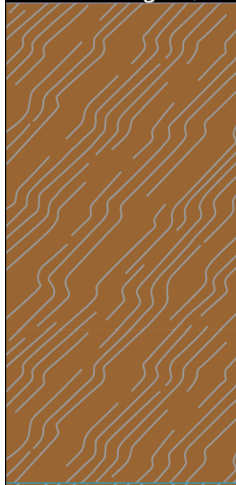
FILL; black silty sand, trace debris	native @ '5
1					
2					
3					
4					
5	RI-BH-7 Native	0

NATIVE; moist soft grey brown clay	
6					
7					
8					
9					
10		0

NATIVE; wet soft grey brown clay	
11					
12					
13					
14

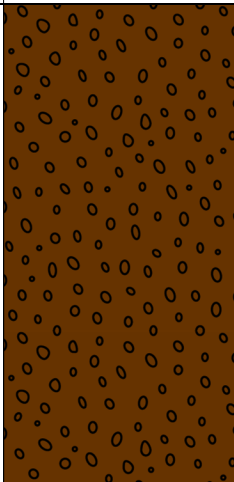
DEPTH (feet)	Sample	PID Reading	DESCRIPTION		REMARKS
0	RI-BH-9 Fill	0

FILL; dark brown sandy loose fill	
1					
2					
3					
4	RI-BH-9 Native	0

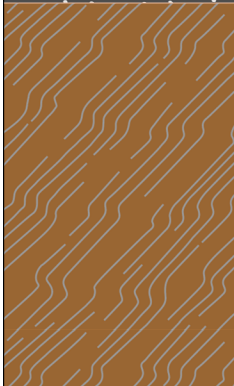
FILL; loose black sandy silt, some grey rocks		
2						
3	RI-BH-14 Native	0

NAITVE; stiff tight grey brown clay	refusal @ 7'	
4						
5						
6						
7						
8						
9						
10						
11						
12						
13						
14

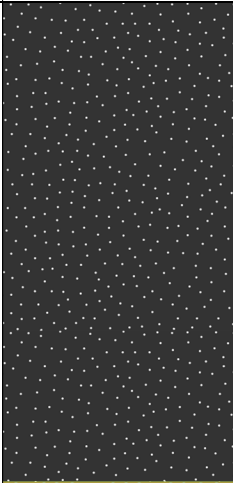
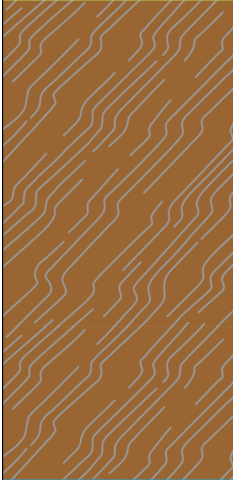
FILL; black loose sand	native @ 5'
1					
2					
3					
4					
5		0

NATIVE; grey brown clay	screen installed 7-12'
6					
7					
8					
9					
10		0	NATIVE; moist grey brown clay		
11					
12					
13					
14

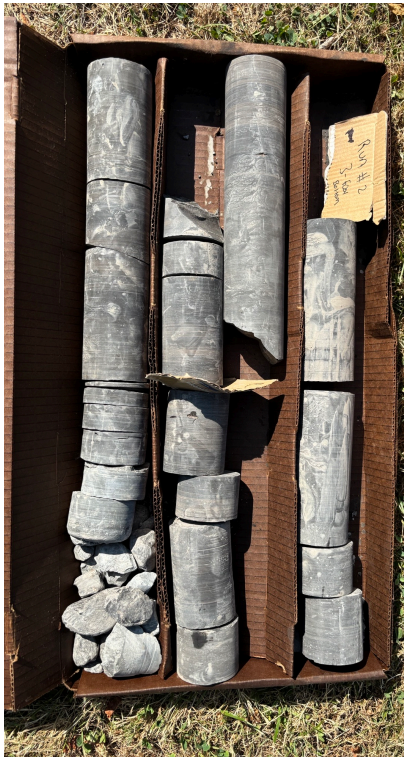
Thinly banded medium gray shale; hard; intensely fractured into coarse gravel-sized pieces; natural fractures Same lithology; natural fractures Same lithology; slightly fractured; mechanical fractures	
14							
15							
16							
17	2	100	100	0

Same lithology; moderately – slightly fractured; mechanical fractures

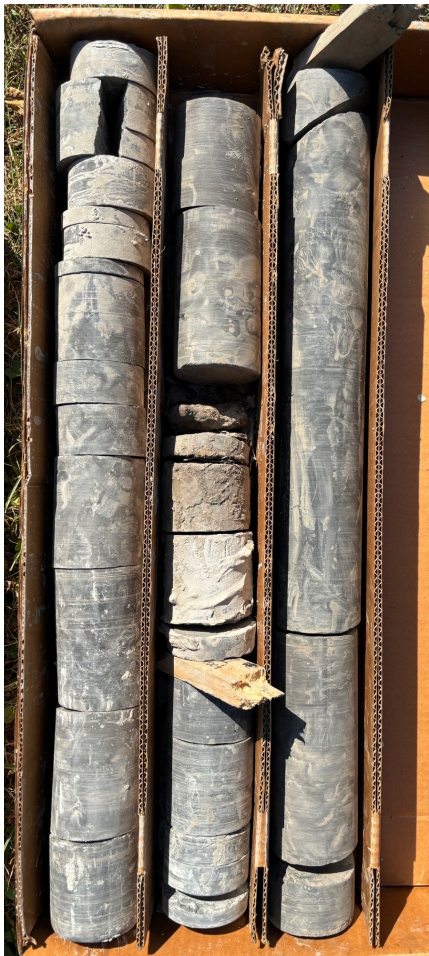
1							
2							
3							
4							
5							
6							
7							
8							
9							
10							
11							
12							
13							
14	0		Rock socket				
15							
16	2	99	84	0		Thinly banded, medium gray shale; hard; numerous mechanical fractures	
17							
18							
19							
20						Same lithology; several natural fractures	
21							
22							
23							
24							
25							
26							
27							
28							
29							
30

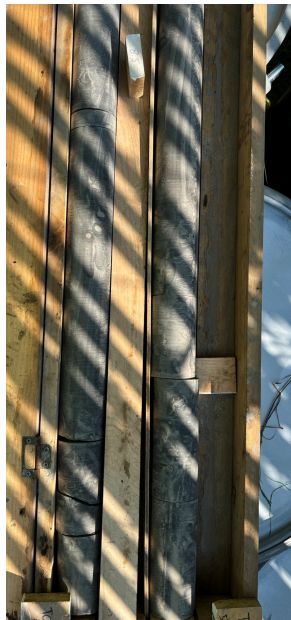
Rock socket

Thinly banded, medium gray shale; hard; moderately - slightly fractured; no natural fractures observed		
17								
18								
19								
20								
21	2	100	100	0		Same lithology and fracturing		
22								
23								
24								
25

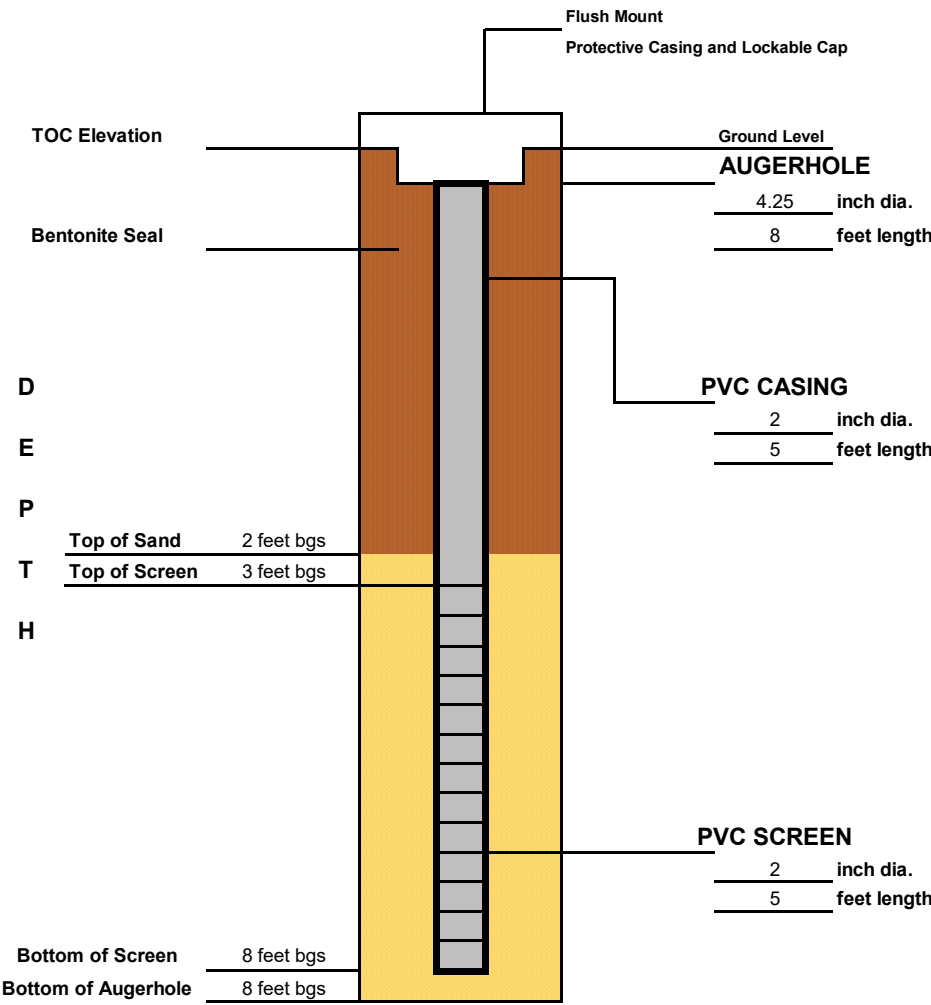
<p>The diagram shows a cross-section of a monitoring well. At the top is a 'Flush Mount' with a 'Protective Casing and Lockable Cap'. Below this is the 'AUGERHOLE' (4.25 inch dia., 8 feet length). A 'Bentonite Seal' is located below the augerhole. The 'PVC CASING' (2 inch dia., 5 feet length) extends from the seal down to the 'PVC SCREEN' (2 inch dia., 5 feet length). The screen is set in a 'Silica Sandpack'. The 'TOC Elevation' is marked at the top of the casing. The 'Ground Level' is indicated by a horizontal line. The 'Top of Sand' is 2 feet below ground surface (bgs), and the 'Top of Screen' is 3 feet bgs. The 'Bottom of Screen' is 8 feet bgs, and the 'Bottom of Augerhole' is also 8 feet bgs. The well is installed in a 'Steel grade box' with a 'Monitor: N/A'.</p>	
Geologist/Technician: Travis Numan			
Drilling Company: Sessler			
Driller: Chris			
Rig Make/Model: 6011DT Rotary Drill

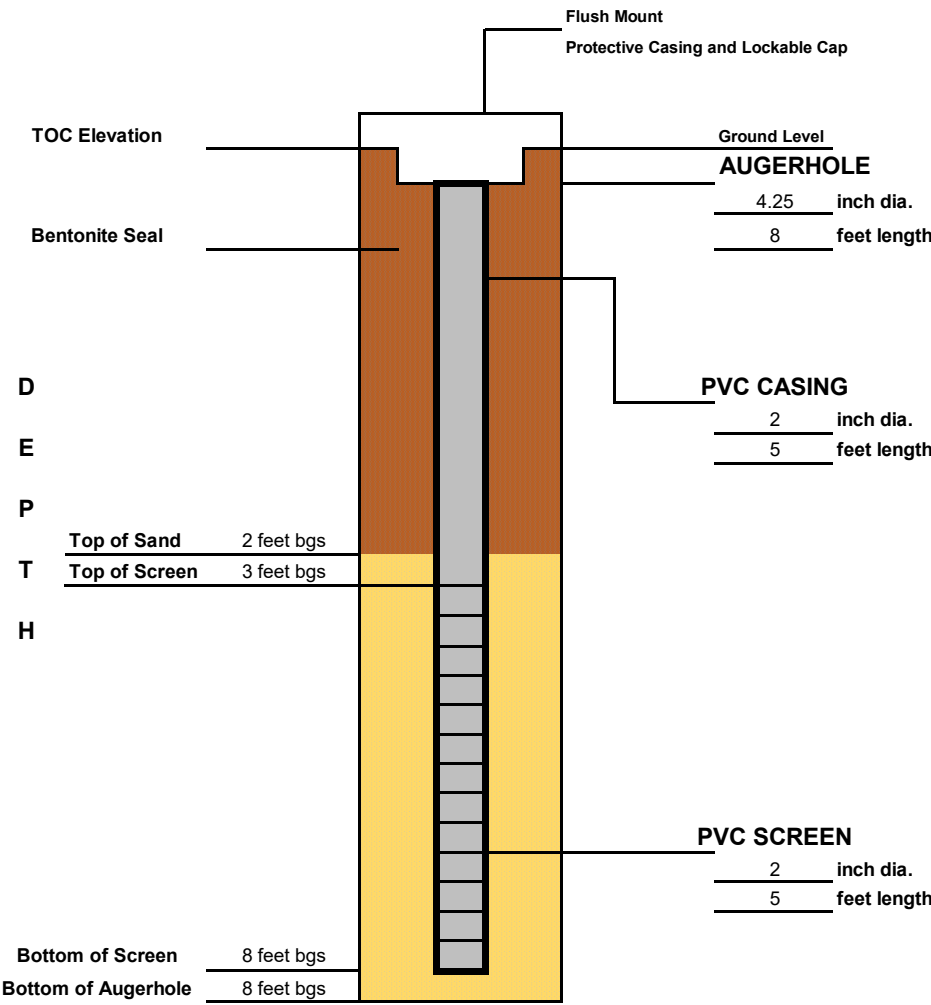
<p>Diagram labels: TOC Elevation, Bentonite Seal, D, E, P, T, H, Flush Mount, Protective Casing and Lockable Cap, Ground Level, AUGERHOLE (4.25 inch dia., 8 feet length), PVC CASING (2 inch dia., 5 feet length), PVC SCREEN (2 inch dia., 5 feet length), Bottom of Screen (8 feet bgs), Bottom of Augerhole (8 feet bgs).</p>	
Geologist/Technician: Travis Numan			
Drilling Company: Sessler			
Driller: Chris			
Rig Make/Model: 6011DT Rotary Drill			
Date: 6/2/2025			
GEOLOGIC LOG			
Depth(ft.)	Description		
	See RI-MW-4 Soil Boring		
WELL DESIGN			
CASING MATERIAL		SCREEN MATERIAL	
Surface: Steel grade box		Type: 2" PVC	
Monitor: N/A		Slot Size: .010"	
		Setting: 3 to 8 feet bgs	
COMMENTS:		FILTER MATERIAL	
Well installed approximately 2' above suspected bedrock/refusal.		Type: #0 Sand	
		Setting: 2 to 8 feet bgs	
		SEAL MATERIAL	
		Type: Bentonite Chips	
		Setting: 0 to 2 feet bgs	
		LEGEND

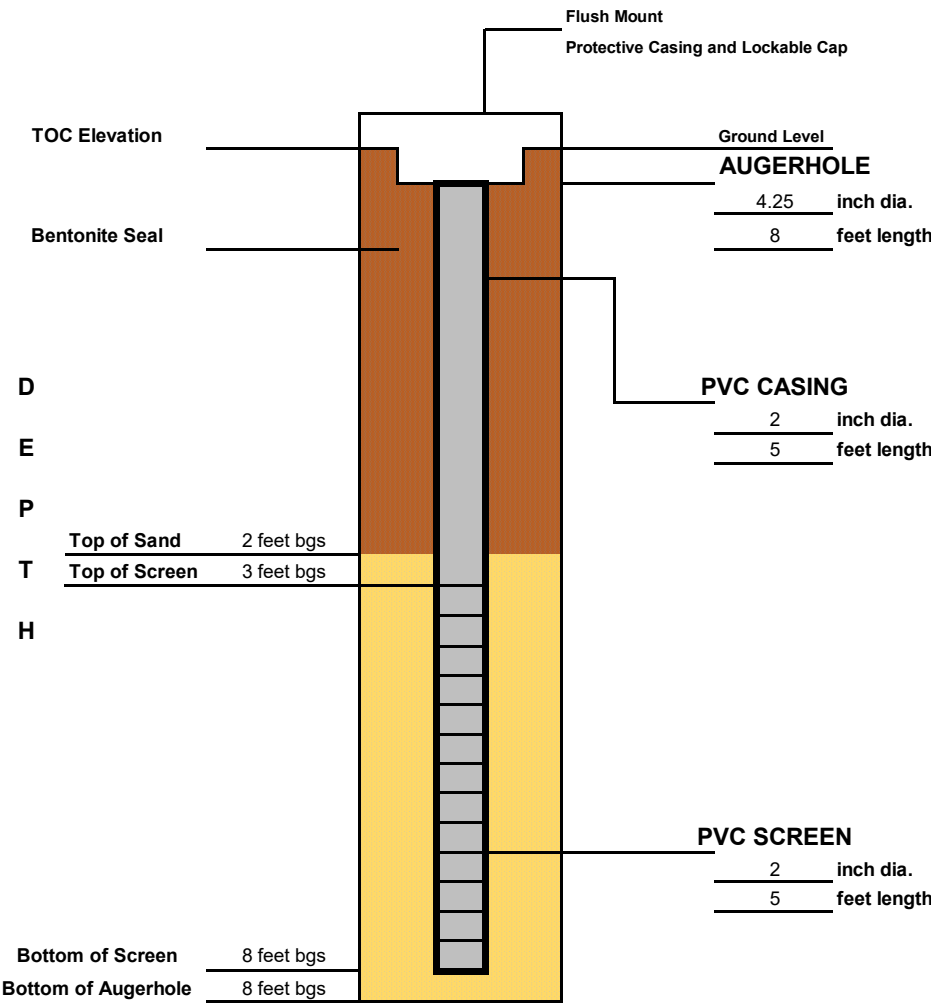
<p>The diagram illustrates the well construction details. It shows a cross-section of the well with various components labeled. At the top, there is a 'Flush Mount' and 'Protective Casing and Lockable Cap'. Below this is the 'AUGERHOLE' with a diameter of 4.25 inches and a length of 8 feet. The 'Bentonite Seal' is located below the augerhole. The 'PVC CASING' has a diameter of 2 inches and a length of 5 feet. The 'PVC SCREEN' has a diameter of 2 inches and a length of 5 feet. The 'Bottom of Screen' is at 8 feet bgs, and the 'Bottom of Augerhole' is also at 8 feet bgs. The 'TOC Elevation' and 'Ground Level' are marked. The 'Depth(ft.)' and 'Description' columns are used for the geologic log.</p>	
Geologist/Technician: Travis Numan			
Drilling Company: Sessler			
Driller: Chris			
Rig Make/Model: 6011DT Rotary Drill			
Date: 6/2/2025			
GEOLOGIC LOG		D	
Depth(ft.)	Description	E

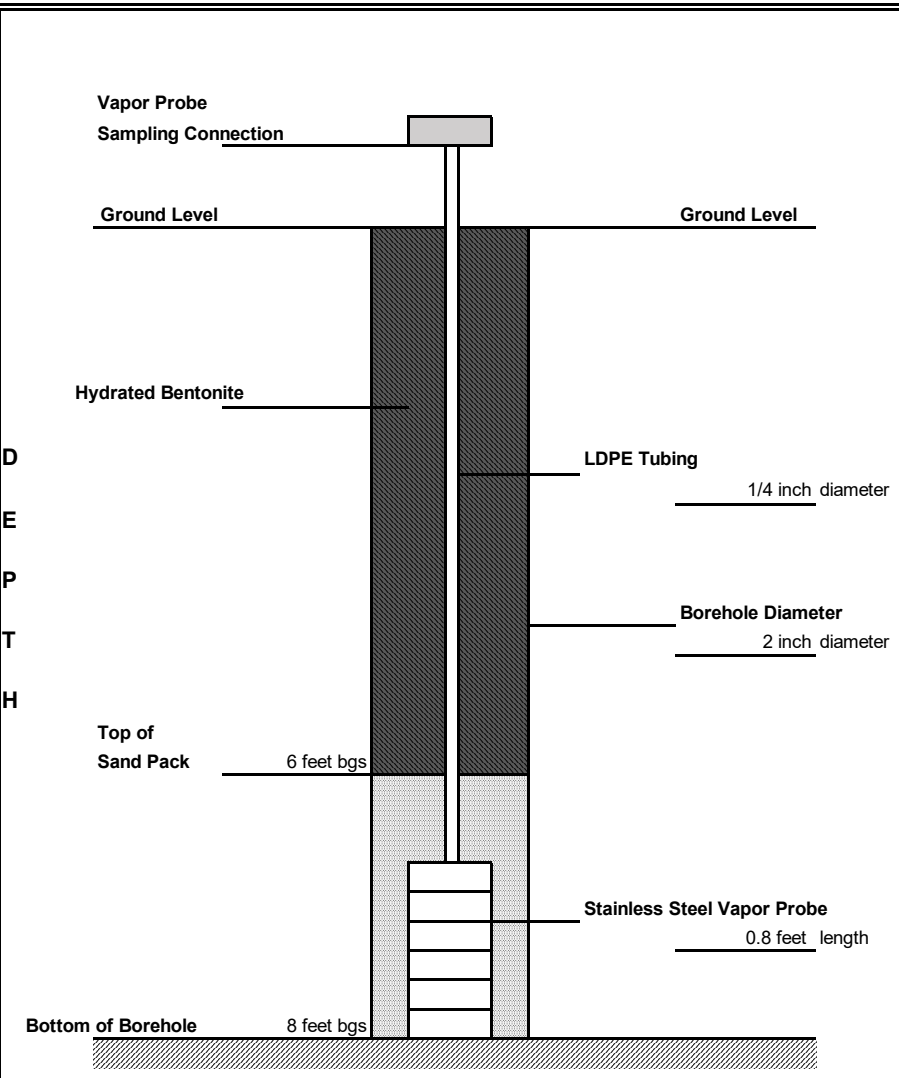
Geologist:	Paul Staub		
Contractor:	Sessler		
Operator:	Chris		
Model:	6011DT Geoprobe		
Date:	5/30/2025		
GEOLOGIC LOG		D E P T H	
Depth(ft.)	Description		
	N/A		
PROBE DESIGN			
CASING MATERIAL	SEAL MATERIAL		FILTER MATERIAL
Surface: N/A	Type: Bentonite Chips		Type: #0 Sand
	Setting: 0 to 6 feet bgs		Setting: 6 to 8 feet bgs
COMMENTS:			LEGEND
			Bentonite Chip Seal
			Sand Pack
Client: Regan	Location: Block of Washington, E. Second, and Park	Project No. C907042	
<b>BRYDGES ENGINEERING</b> <small>IN ENVIRONMENT AND ENERGY, INC.</small>		<b>SOIL VAPOR PROBE CONSTRUCTION DETAILS</b>	
		Probe Number: RI-VP-4

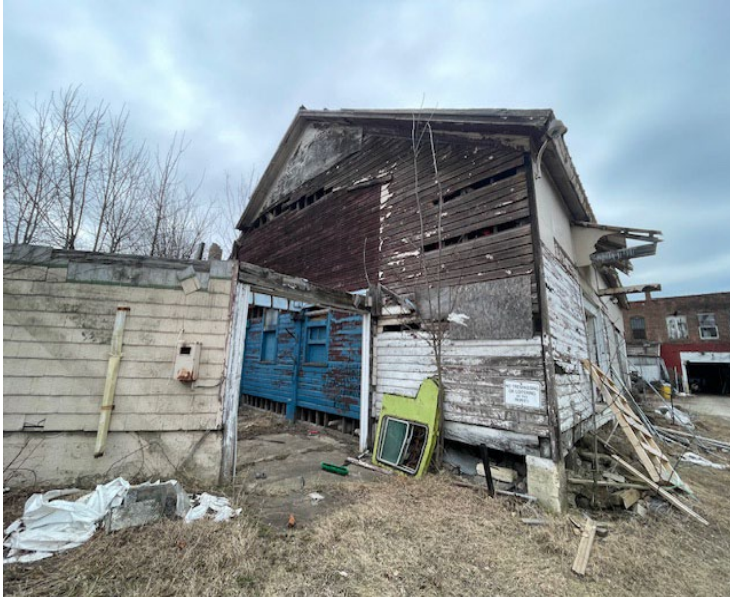
211 Park Ave - Farm Style  
Frame Building

Overall existing exterior  
conditions of the inspection  
site as of 03/24/2025.

Asbestos containing  
materials were not  
identified for this building.

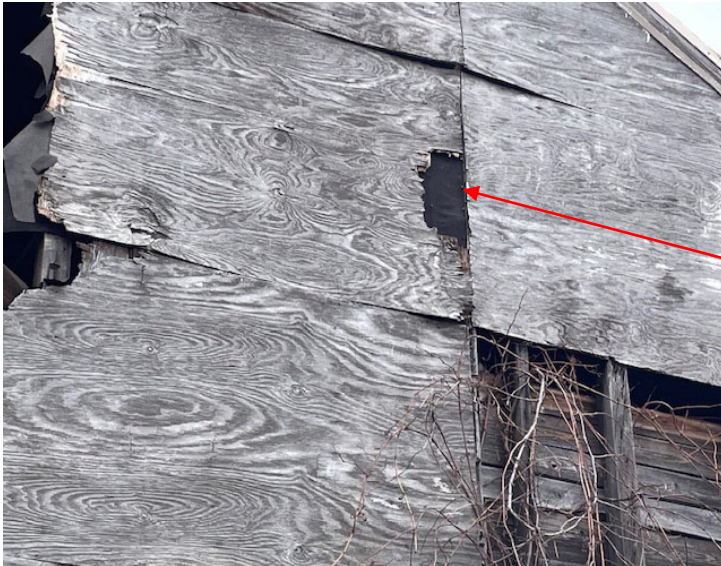
211 Park Ave - Farm Style  
Frame Building

HAN602: Vapor Barrier –  
Under Siding

The material was not found  
to contain asbestos greater  
than 1.0%.

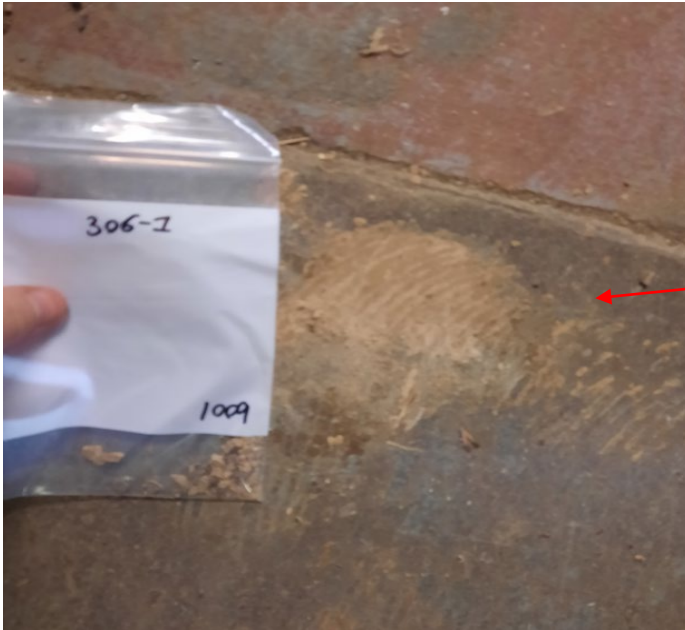
220 Washington Ave  
2 Story Brick Building

HAN306: Residual Mastic

Asbestos containing materials were identified in the above referenced material sampled.

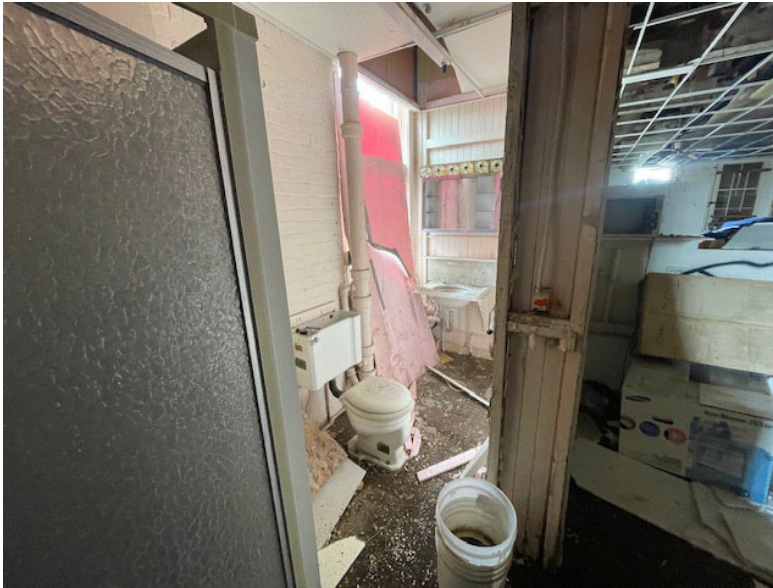
220 Washington Ave  
2 Story Brick Building

Overall existing interior conditions of the inspection site as of 03/24/2025.

Asbestos containing materials were identified in some of the materials sampled for this building.

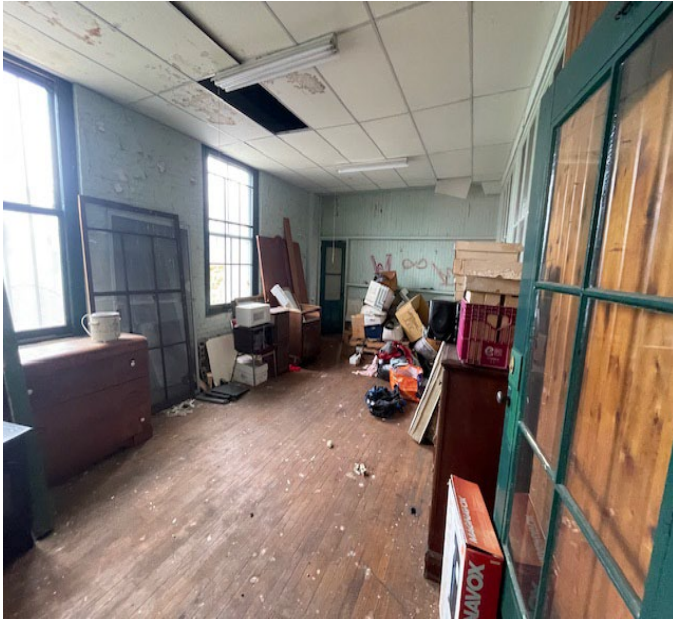
220 Washington Ave  
2 Story Brick Building

Overall existing interior conditions of the inspection site as of 03/24/2025.

Asbestos containing materials were identified in some of the materials sampled for this building.

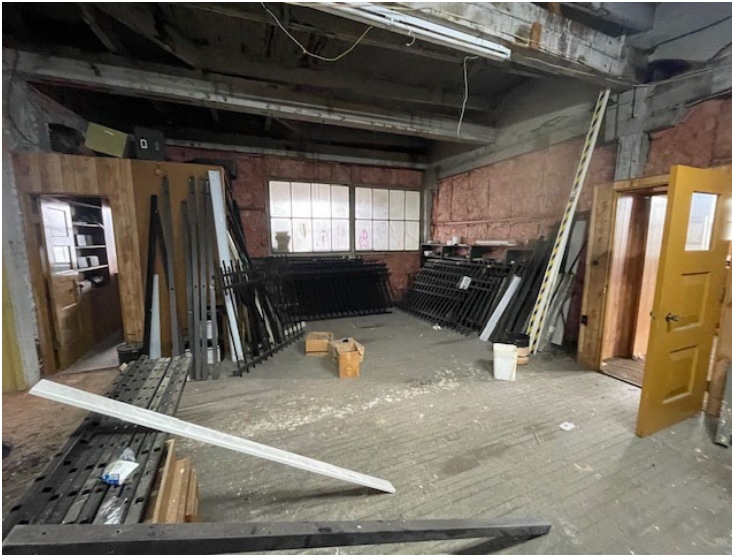
220 Washington Ave  
2 Story Brick Building

Overall existing interior conditions of the inspection site as of 03/24/2025.

Asbestos containing materials were identified in some of the materials sampled for this building.

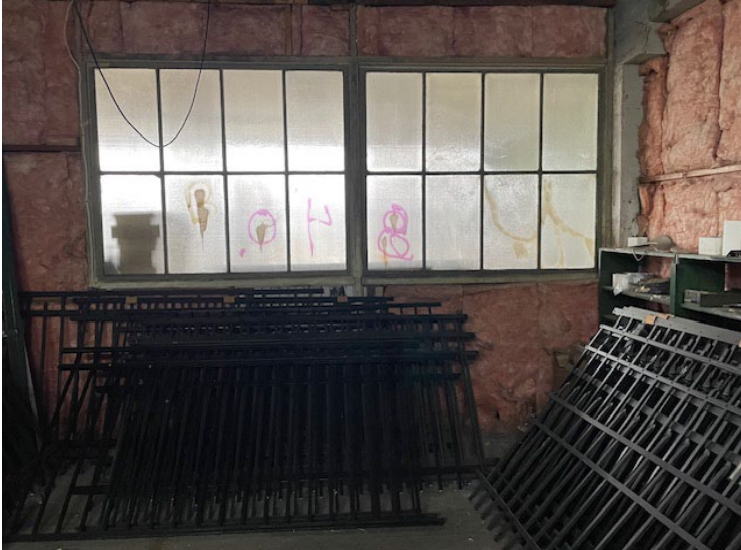
220 Washington Ave  
2 Story Brick Building

Overall existing interior conditions of the inspection site as of 03/24/2025.

Asbestos containing materials were identified in some of the materials sampled for this building.
